Historic Trails

*Prepared by Margie Coffin Brown, Historical Landscape Architect, National Park Service,
Olmsted Center for Landscape Preservation*

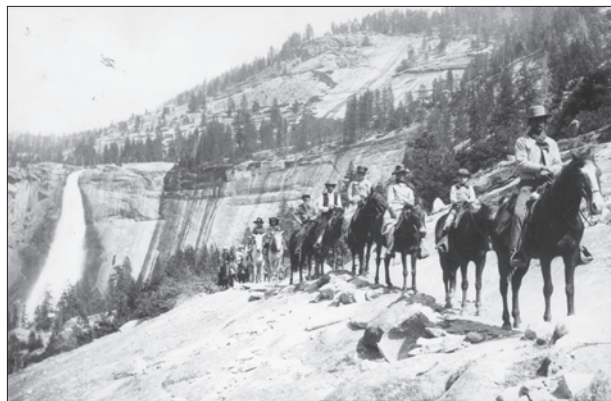
Figure 4. The Nevada Falls Trail in Yosemite near Nevada Falls constructed in 1869 and 1870. Trails that ascended the valley walls were built for saddle tourism but never became roads. (NPS Historic Photo collection, Harpers Ferry Center, HFC-000532)

By the late 1800s, land protection and recreational hiking were firmly rooted in American politics and society. In the Northeast, hotel companies built footpaths as part of their facilities, while in the West similar hotel trails were designed for stock and pack trains into remote country. In California's Yosemite Valley, a network of tourist trails begun in the 1850s expanded as the area was protected as a state park in 1864 and later as a national park in 1890 (Figure 4).

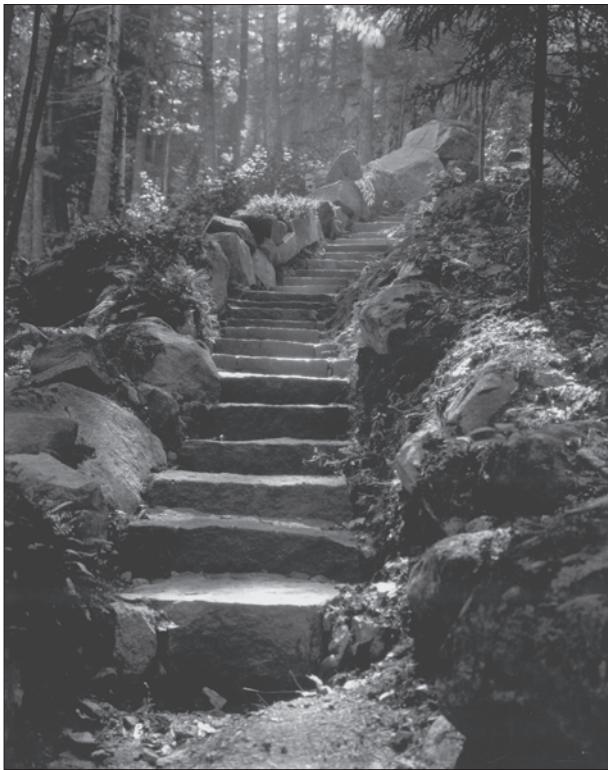
Figure 5. The Emery Path was built in the 1910s by the Bar Harbor Village Improvement Association on Mount Desert Island, Maine (now part of Acadia National Park), which included extensive stonework. (Acadia National Park archives, 1922)

Economic ventures often spurred western trail development, while local village improvement societies and regional hiking clubs constructed many eastern trails. Village improvement societies, widespread throughout the Northeast after the Civil War, used membership dues and funds donated in remembrance of community members to hire local laborers for civic enhancement projects. Promoting picturesque landscape principles, attractive sidewalks, footpaths and drives became a hallmark of the village improvement movement.⁹ Walks were extended beyond villages to surrounding scenic points, symbolically linking civilization and nature (Figure 5).

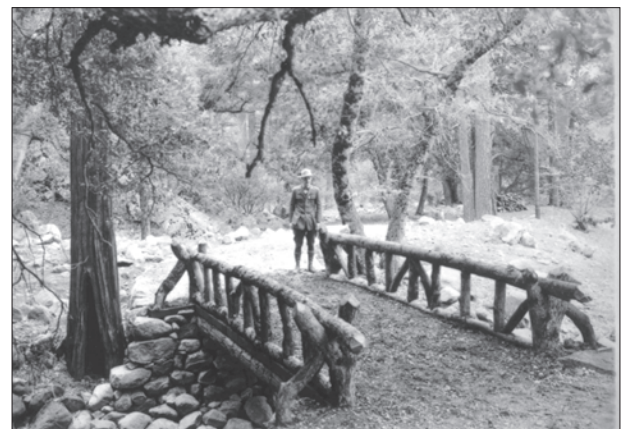
Figure 7. A rustic footbridge over Indian Creek in Yosemite Valley was designed by the NPS Landscape Division and built in 1928 with unpeeled logs, following the picturesque design principles put forth by A.J. Downing. (National Archives, Record Group 79)

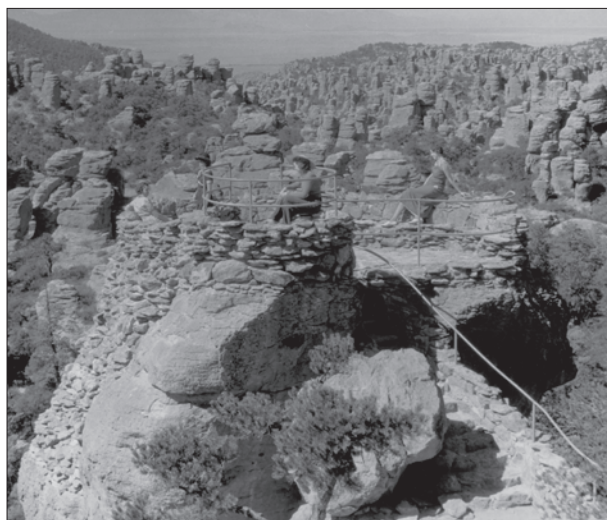
Figure 9. The lookout platform at Massai Point, Chiricahua National Monument, completed by the CCC in 1935, is an example of highly crafted stone steps, stone walls, and ironwork constructed to harmonize with the natural scenery. (NPS Historic Photo Collection, Harpers Ferry Center)

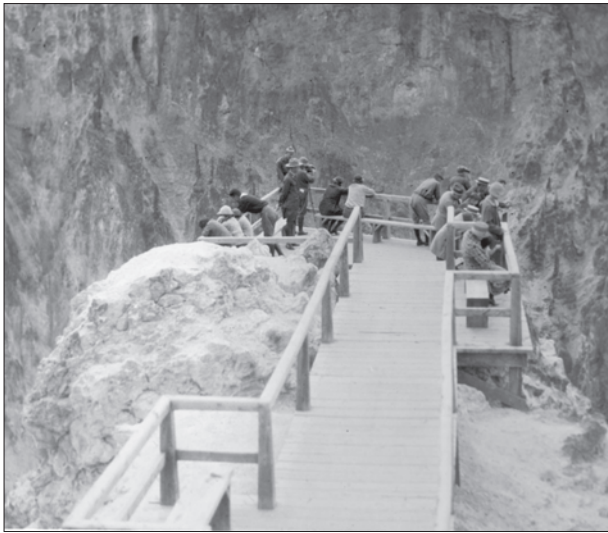
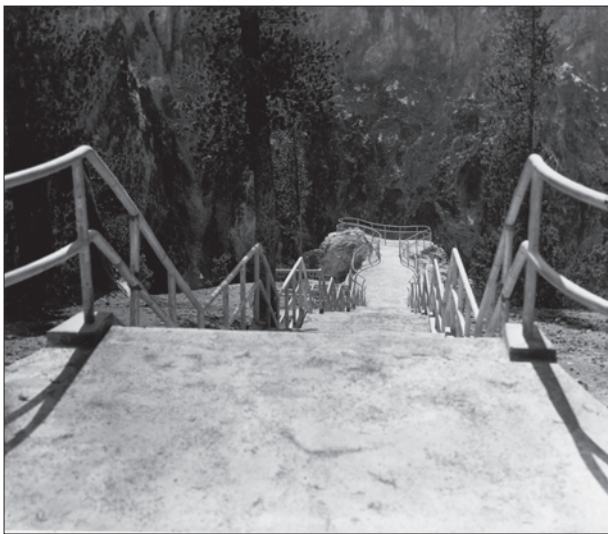
Figure 10. Two views of Inspiration Point in Yellowstone National Park, showing rustic wooden overlook in 1925 and steel and concrete overlook built in 1956 as part of the Mission 66 program. The Mission 66 program, established to bring the National Parks into the modern age, funded the construction of modern roads, trails, utilities, camp and picnic grounds, and many kinds of structures needed for public use or administration to meet the requirements of an expected 80 million visitors by 1966. (NPS Historic Photo Collection, Harpers Ferry Center)

Safety-related trail treatment measures include signs, railings, barriers, tread, and bridges. Historic barriers, such as dry-laid stone walls or iron, wood, or cable railings at precipitous overlooks, have often proved inadequate. The potential for loss of life or serious injury must be considered carefully on trails that attract high numbers of users with varying abilities. Handrails along ledges, over bridges, and at overlooks must be capable of withstanding exposed conditions and heavy use, such as extensive leaning, sitting, hanging, and vandalism. To meet the Secretary's of the Interior's standards, any added safety features should be compatible yet distinguishable from historic features. In many cases this may result in the substitution of steel for rustic wooden features or the addition of steel rails and pins to rustic stone retaining walls (see Figure 10).

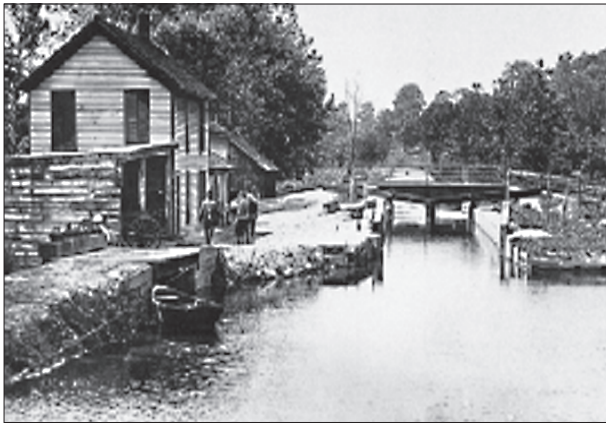
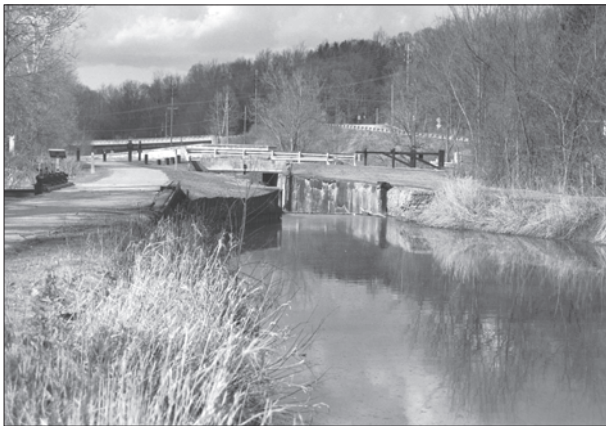
Figure 12. View of Lock 37 on the Ohio & Erie Canal in the late nineteenth century, showing a dwelling and general store, paired with view nearly one century later, showing the Towpath Multi-use Trail within the Cuyahoga Valley National Park. The park was established in 1974 to protect historic resources and create a recreational corridor along the canal. (Cuyahoga Valley National Park)

In the 1970s, a growing interest in recreation, urban open space, linear parks, and environmental protection led to a network of multi-use trails developed on abandoned railroad tracks, former canals, and other unused transportation routes. Many of these trails preserved industrial remnants including water towers, switching signals, stations, bridges and tunnels. Some of these corridors are listed in the National Register as significant symbols of American industry, engineering and labor. Their relatively recent conversions to trails may, in the future, be considered part of an important trend in American history (Figure 12).

Contemporary photographs are useful for documenting the current condition of trail features, particularly when paired with historic photographs taken from similar vantage points, as shown in Figure 12. A video of a trail is also useful. With visual documentation it is important to maintain a concise record of the trail name, number, and location within the trail. For highly crafted trail features, sketches, measured sections, and plans are useful for subsequent phases of analysis and treatment.

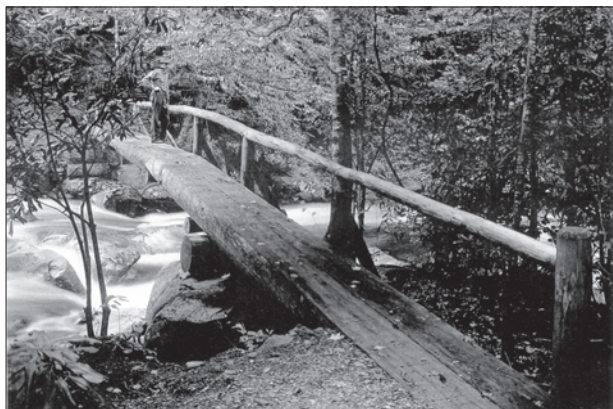
Figure 13. Historic photograph of rustic foot bridge constructed in 1934 by the CCC on the Eagle Rock Creek Trail in the Great Smoky Mountains in North Carolina. (National Archives; NARA MD, 79-42, NC, Box 21)

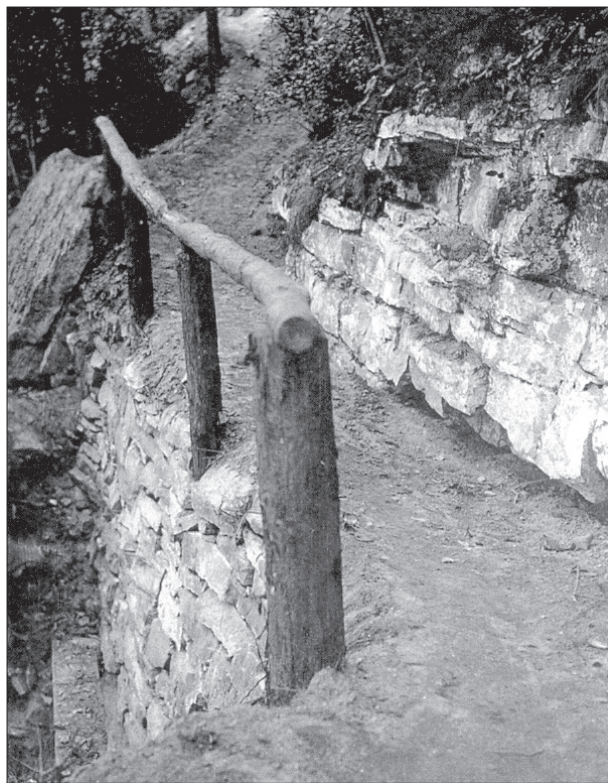
Figure 14. Historic photograph of horse trail, retaining walls, and guard rail built by the CCC in 1935 for a trail south of Sunset Rock in Chickamauga & Chattanooga National Military Park, Georgia. (National Archives; NARA MD, 79-42, GA, Box 14)

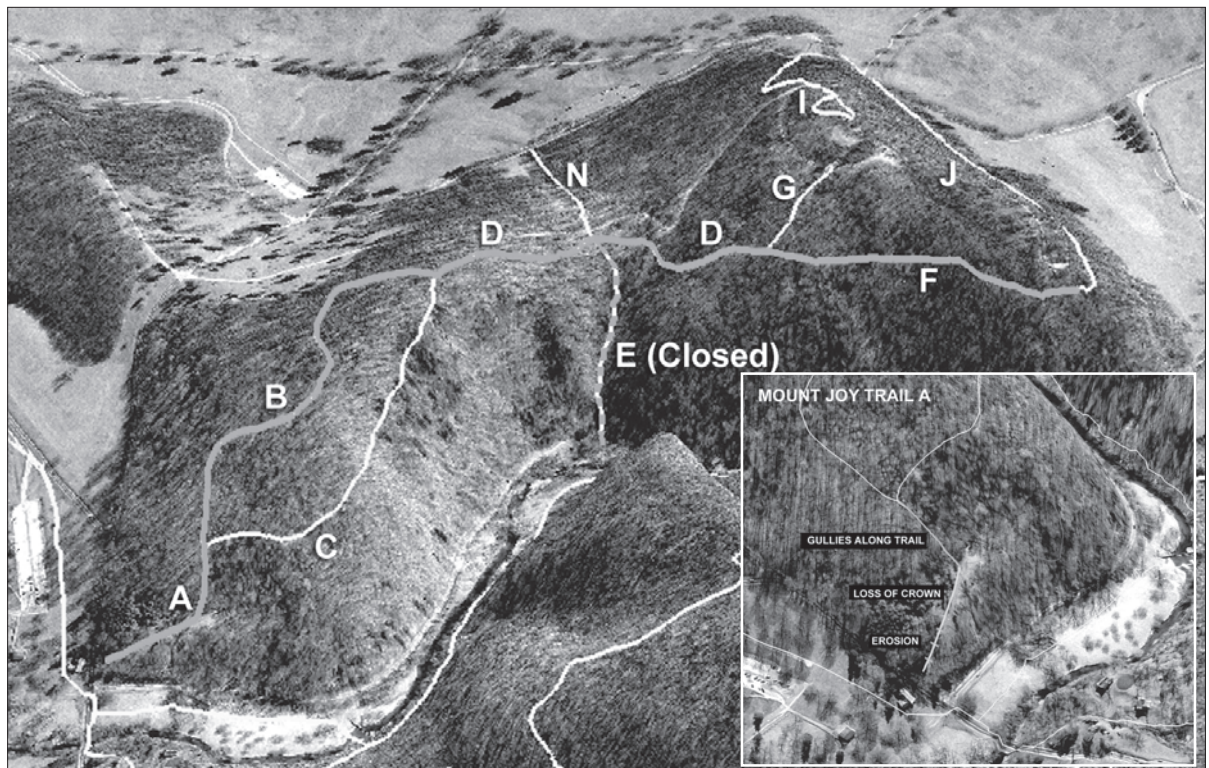
Figure 15. Geographic Information System map layers including an aerial photograph projected with three-dimensional topography, showing the configuration of open and closed historic trails on Mount Joy at Valley Forge National Historical Park, with close-up showing the condition assessment for Trail Section A. (NPS, Olmsted Center for Landscape Preservation, Mark Davison, 2003)

Documenting the trail's existing condition is an essential component of the CLR process. The existing condition documentation includes a geographical survey and field verification to locate and assess the current condition of general landscape characteristics and specific features associated with each trail. A US Geological Survey map at 1:24,000 scale may serve as the base for a survey. GIS and Global Positioning System (GPS) computer technology can be used to develop an electronic map with links to a GIS database with standardized terminology and attributes.²⁰ The database can contain historic, contextual, and trail-specific information. The graphic layers and data can then be manipulated to produce plans that illustrate past periods of development, rerouted sections, existing conditions, and proposed management actions (Figure 15).

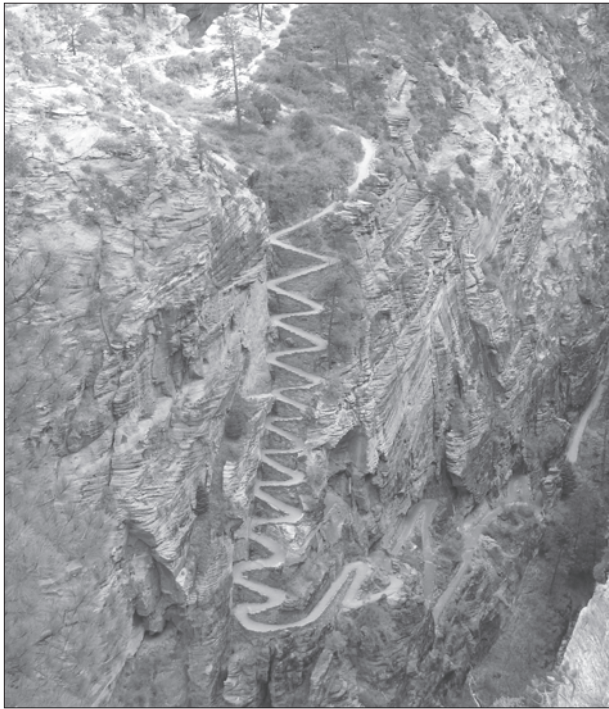
Figure 16. The West Rim - Angels Landing Trail in Zion National Park, which ascends 1,700 feet to the summit, is listed in the National Register under criterion C for its exceptional rustic style design and construction and contains extensive switchbacks, stonework, railings, and chiseled steps. (Zion National Park)

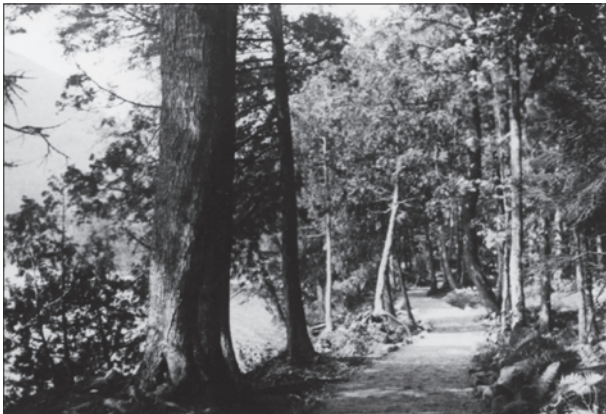
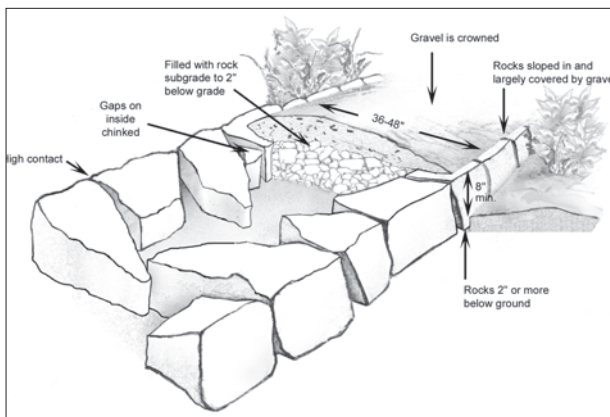
Figure 17. Historic photograph of Great Pond Trail constructed by the CCC in 1937 and contemporary detail showing walled causeway construction for a pond-side trail. (National Archives; NARA MA and Acadia National Park, Barter and Baldyga)

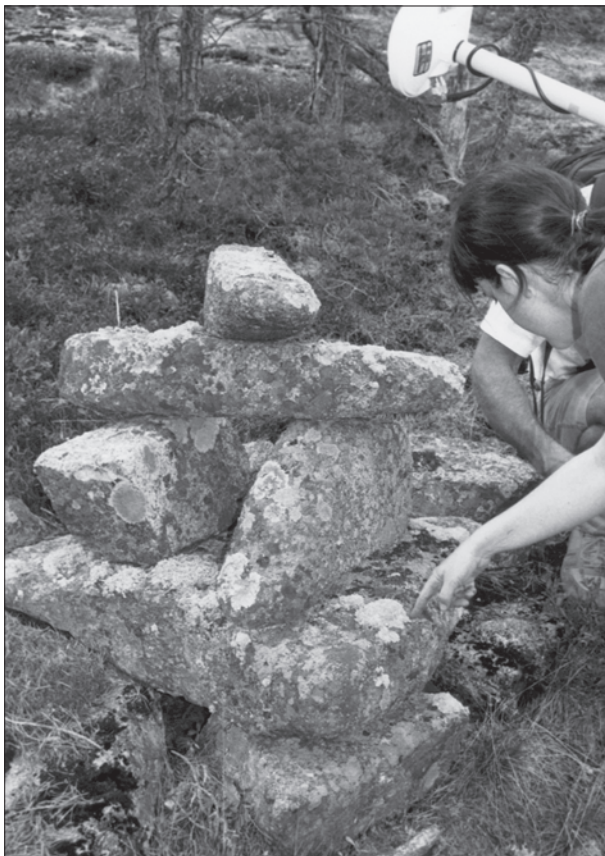
Figure 20. Historic cairn at Acadia National Park. The length of the top stone indicates the direction of the trail. (NPS, Olmsted Center for Landscape Preservation, 1995)

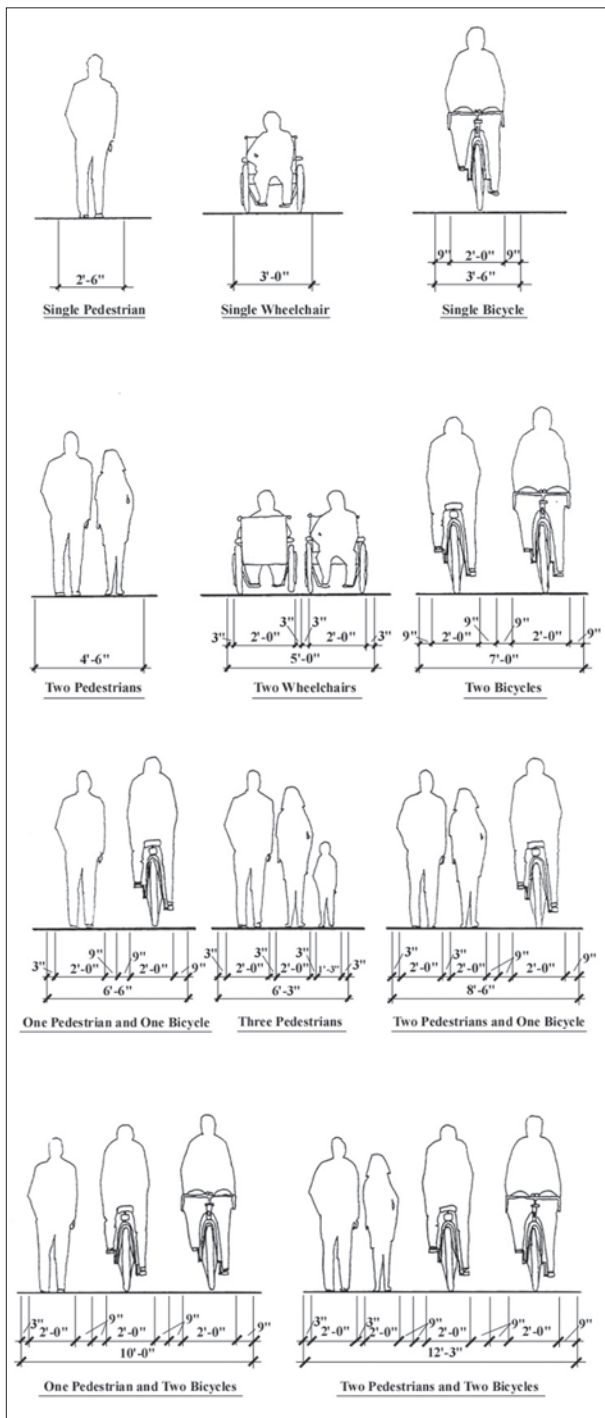
Figure 21. Width studies for different sections of a new interpretive trail to parallel the historic Battle Road within the Minute Man National Historical Park. (Carol R. Johnson Associates, Boston, MA)

To meet multiple interests, segments of a historic trail may be rehabilitated for various users, including people with wheelchairs, horses, bicycles, or dogs. Alterations necessary to allow for multiple users should be evaluated for their impact on the historic route, grade, associated features, and feeling. Through an evaluation process that presents a series of alternatives, it may be determined that certain uses damage the integrity of the historic route and are not appropriate. For example, a towpath trail may be wide enough to accommodate multiple users, whereas a narrow hiking trail with historic stone steps may not. A comprehensive analysis of all circulation systems within an area will aid in developing opportunities for different types of use (Figure 21).

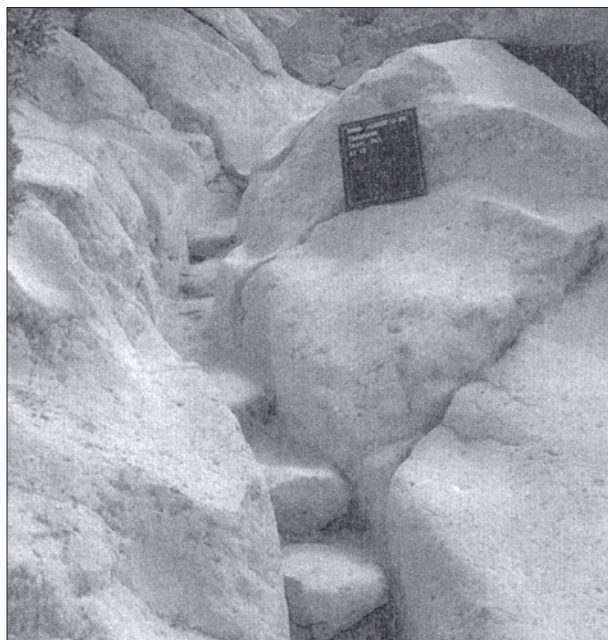
Figure 22. Steps of a similar stone type were added to a heavily eroded section of a Pueblo trail at the Tsankawi Unit of Bandelier National Monument. (Bandelier National Monument)

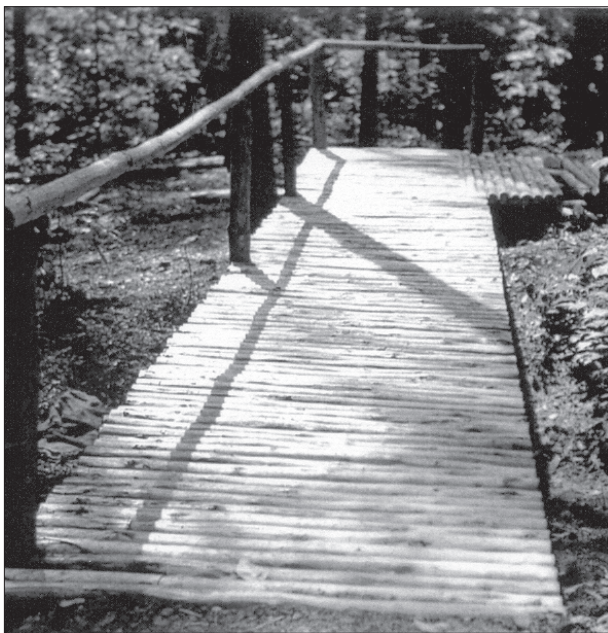
Figure 23. Historic photograph of corduroy bridge constructed by the CCC in Shenandoah National Park in Virginia. (National Archives; NARA MD, 79-42, VA, Box 32)

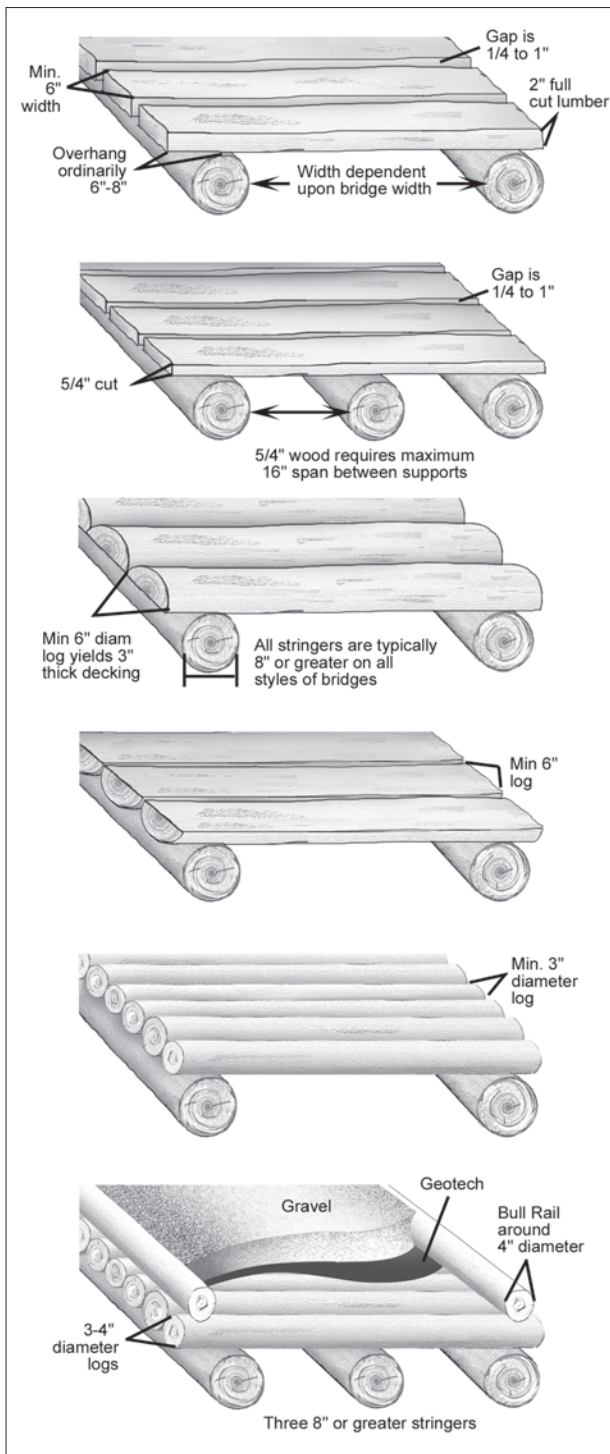
Figure 24. Examples of alternative bridge decking characteristics that reflect CCC era bridges. (Acadia National Park, Barter and Baldyga)

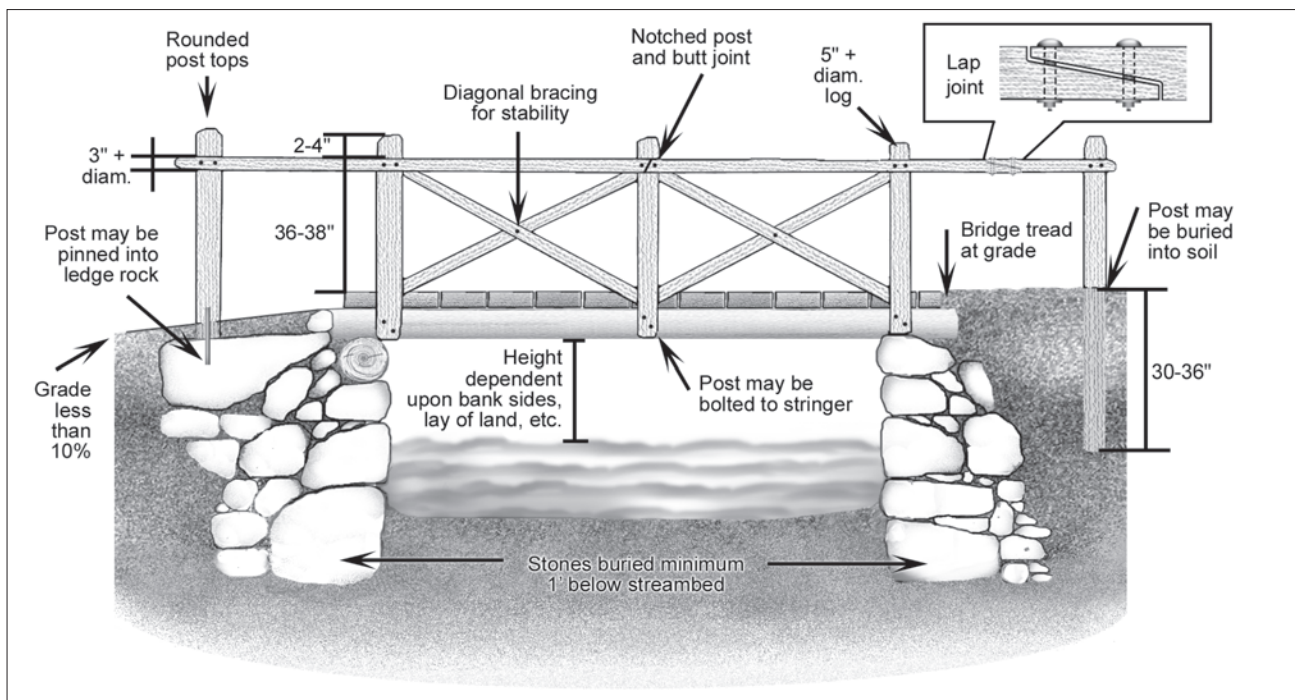
Figure 25. Example of bridge specifications for CCC era bridges. (Acadia National Park, Barter and Baldyga)

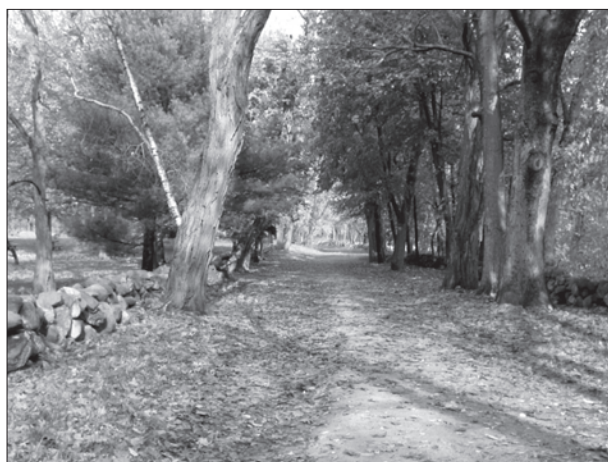
Figure 26. Section of the interpretive trail system in Minute Man National Historical Park that connects to and is similar in character to the historic Battle Road. (NPS, Olmsted Center for Landscape Preservation, Debbie Smith)

Before rerouting, control points or key attractions along the trail should be identified. Rerouted sections should provide new access to the same points. When the historic alignment is no longer tenable, another alternative is to design a parallel trail that enables users to experience the same landscape setting and feeling without adversely impacting the general location. At Minute Man National Historical Park in Massachusetts, an interpretive trail was added that parallels and intersects with the historic Battle Road to improve visitor circulation, safety, and enjoyment in the linear park. The width and surface treatment of the road and trail differ slightly, but both are compatible with the interpreted eighteenth-century landscape (Figure 26).

added, such as EMC²TM or Road OylTM (a pine resin binder) both by Soil Stabilization Products or Stabilizer,TM by Stabilizer, Inc., which is an organic binder made from *Plantago*, a desert plant. Other methods include mixing in dry Portland cement or similar binding agents. The *Plantago* Soil Stabilizer was used effectively as a binder and stabilizer on the Minute Man National Historical Park interpretive trail (see Figure 26).

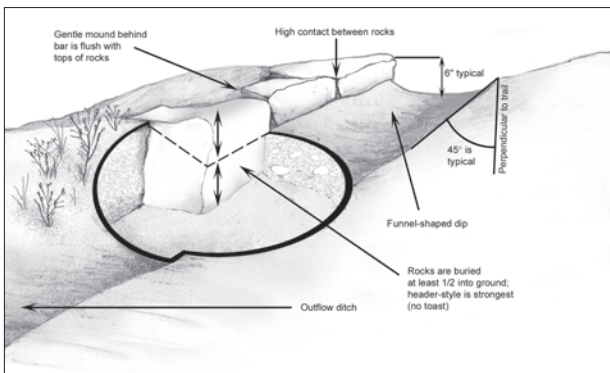
Figure 27. A water bar reinforced with stone. A water dip is similar without the use of stone to direct water off of the trail. (Acadia National Park, Barter and Baldyga)

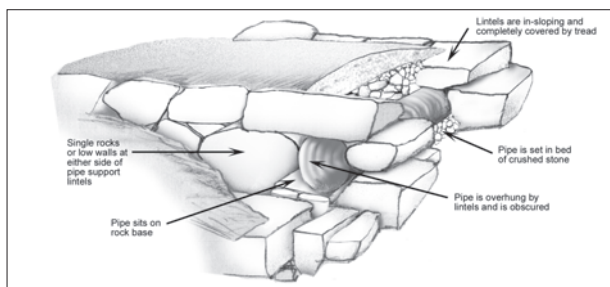
Figure 28. A pipe culvert is concealed with stone headwalls and covered with crushed stone and gravel to provide an uninterrupted tread. (Acadia National Park, Barter and Baldyga)

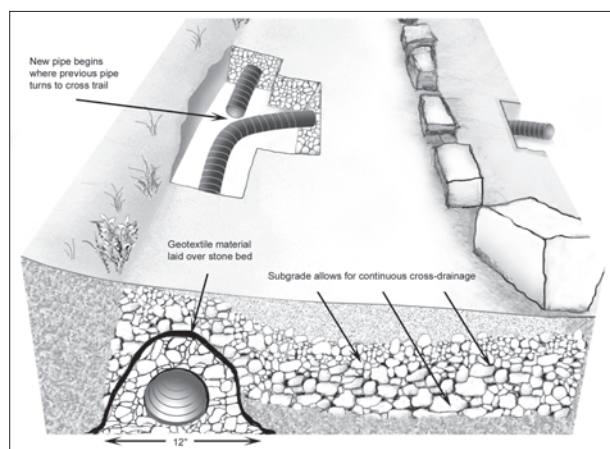
Figure 29. Perforated pipes are added below the treadway to improve drainage but not alter historic character of the treadway. (Acadia National Park, Barter and Baldyga)

New materials and additional drainage may be necessary to preserve sections of historic trails. Underground drainage, such as concealed pipe culverts may be necessary. Similarly, subsurface drains using perforated pipe, gravel and geotextile fabric may aid in directing water under the trail without altering its appearance, though such a solution would not be appropriate in a sensitive archeological area or wilderness area (Figure 29).

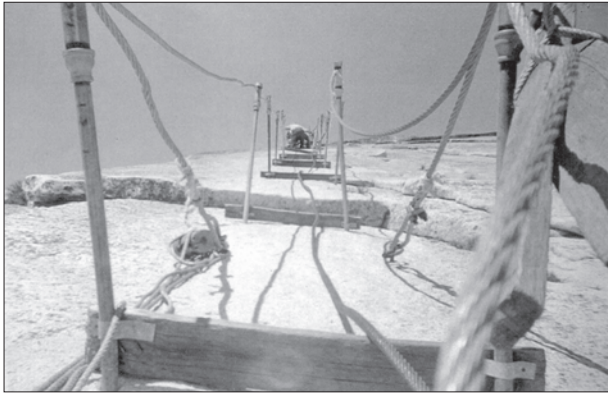
Figure 30. Ascent of Half Dome at Yosemite National Park by steel pipe and cables installed by the CCC in 1939. (National Archives; NARA MD 79G-17C-4. May 1939)

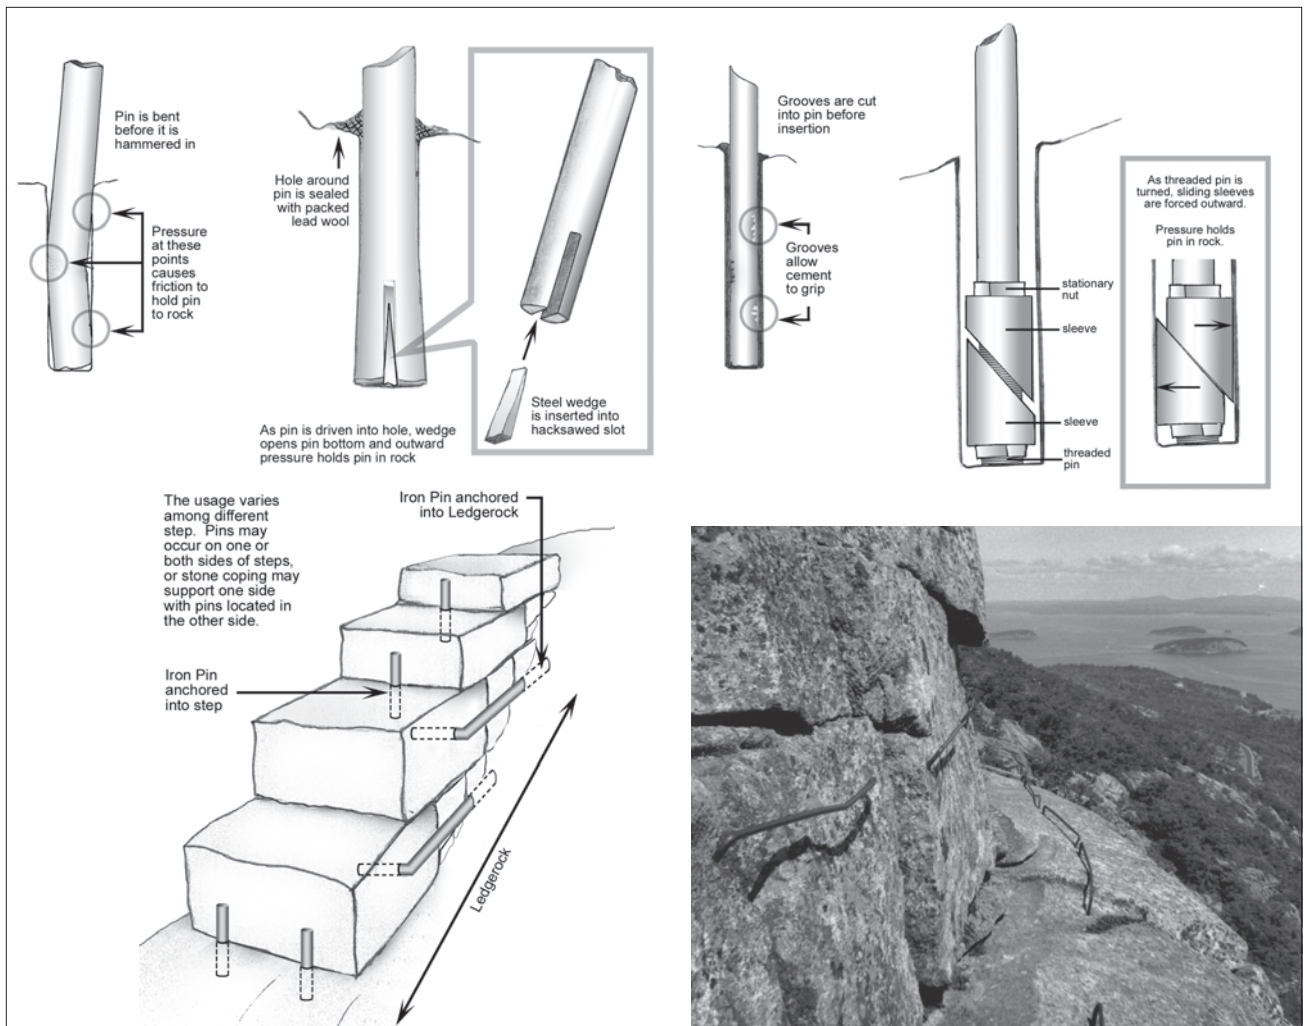
Figure 31. Photograph of the Precipice Trail in Acadia National Park and diagrams for installation of iron rungs. (Acadia National Park, Barter and Baldyga)

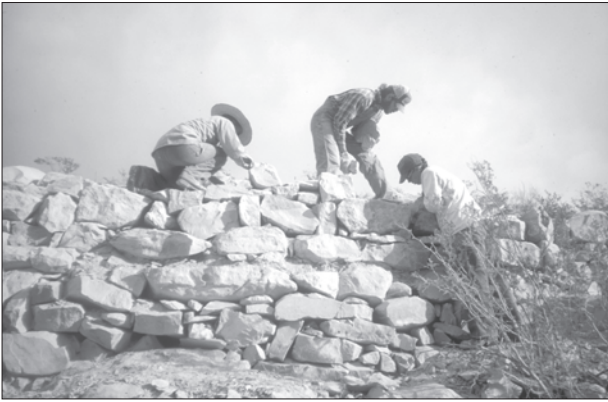
Figure 32. Nearly complete rebuilt wall at Big Bend National Park. To preserve the rough appearance, stones were placed with varied orientations. To improve stability, backfill was carefully laid. The wall was topped with large coping stones and the load was transferred down through the semi-laid backfill. (NPS, Steve Griswold)

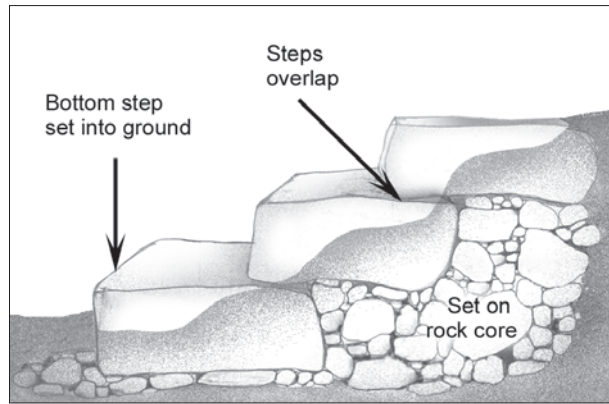
Figure 33. Diagram of slab-laid steps, a common construction used by the CCC in the 1930s. (Acadia National Park, Barter and Baldyga)

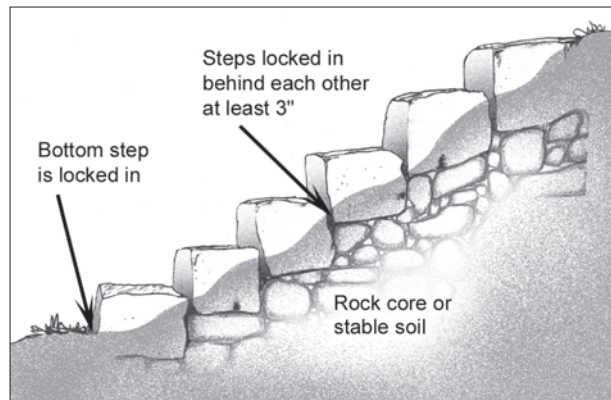
Figure 34. Diagram of set-behind steps, a contemporary method used to prevent stones from slipping downhill with heavy use. (Acadia National Park, Barter and Baldyga)

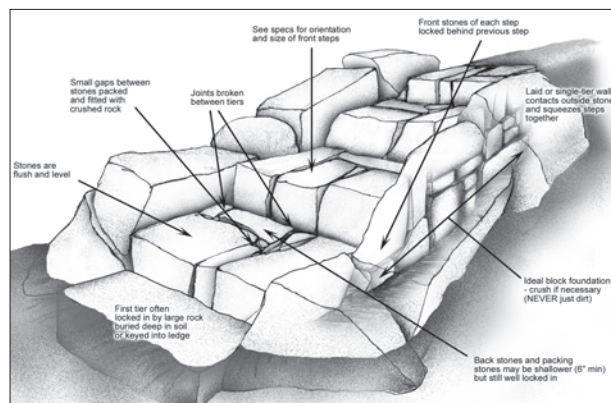
Figure 35. Diagram of rip-rap steps with random size stones used to blend into the surrounding landscape. (Acadia National Park, Barter and Baldyga)

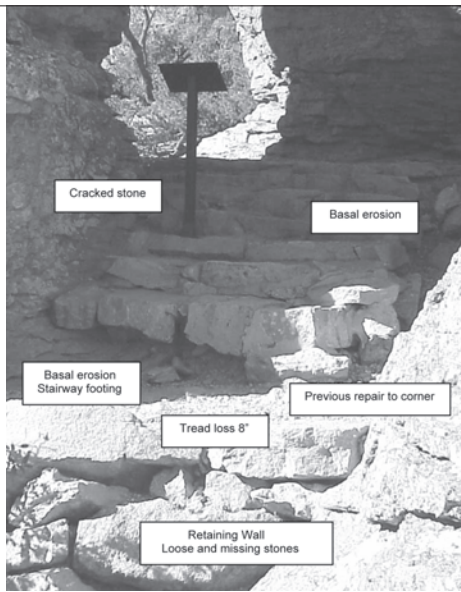
Chiricahua National Monument Feature Form

Figure 36. Treatment work including step repair identified on historic CCC trail in Chiricahua National Monument.

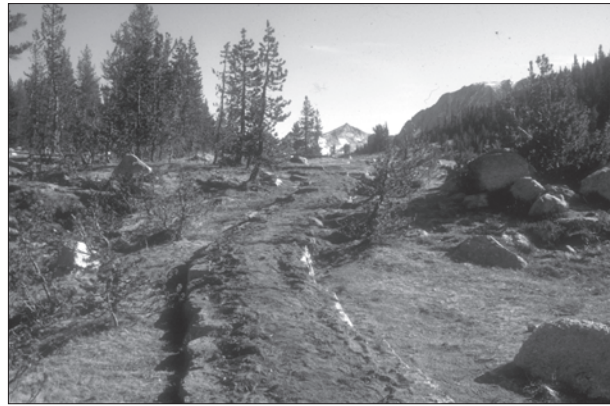
Figure 37. This stone-lined causeway with crowned tread material was constructed in 1985 through Rafferty Meadow in Yosemite NP to repair eroded alpine area. Because the trail is located in a designated Wilderness area, materials were imported by mule. (NPS, Steve Griswold)

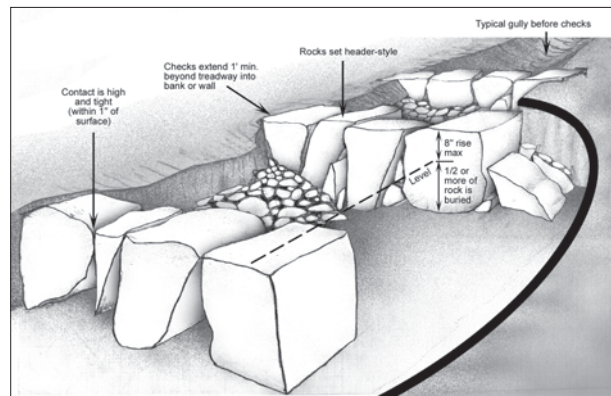
Figure 38. Diagram showing installation of stone checks before they are covered with surface gravel. (Acadia National Park, Barter and Baldyga)

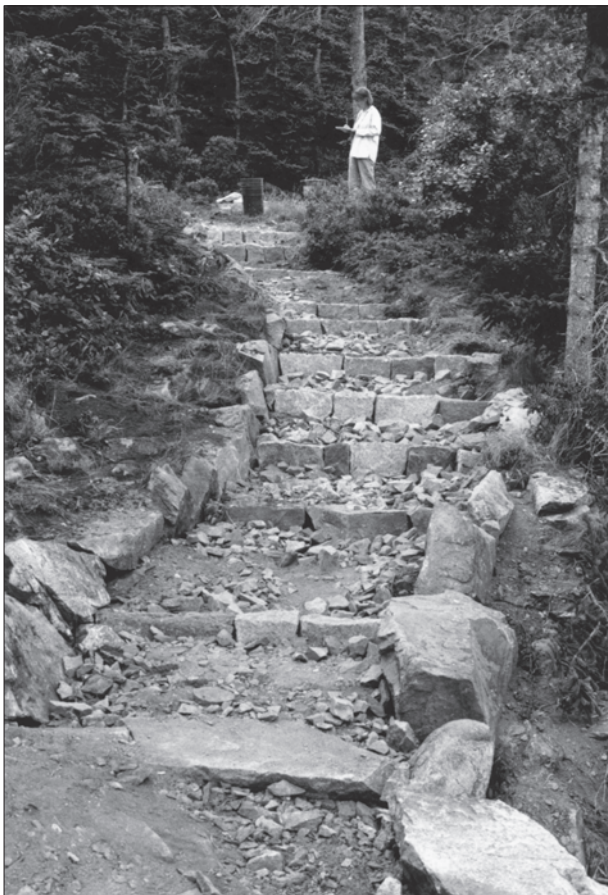
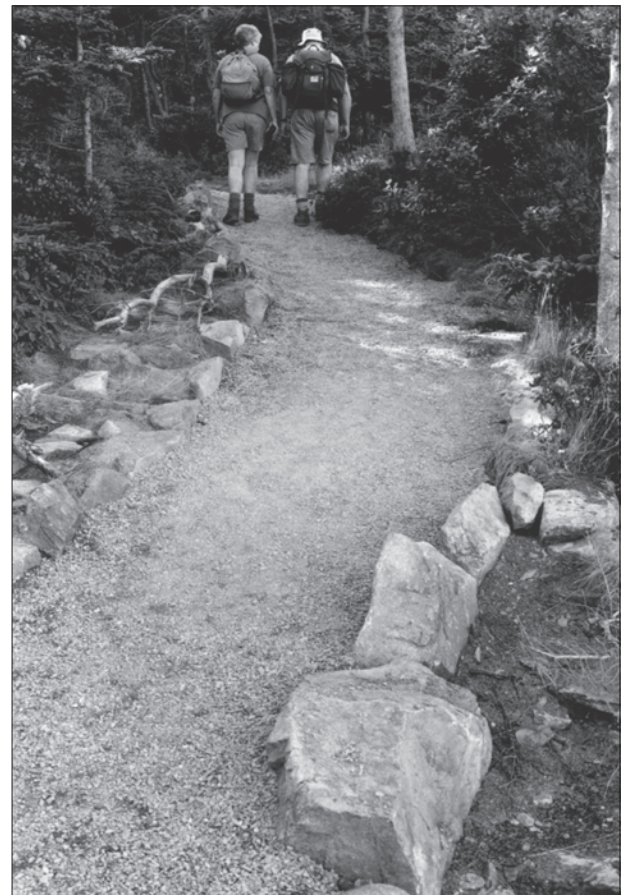
Figure 39. A section of checks installed to repair a gullied trail shown during and after completion on the Ocean Path at Acadia National Park. (NPS, Olmsted Center for Landscape Preservation)
