# Investigation of Spiral Bevel Gear Condition Indicator Validation Via AC-29-2C Using Damage Progression Tests

*Paula J. Dempsey*  
*Glenn Research Center, Cleveland, Ohio*

This report documents the results of spiral bevel gear rig tests performed under a NASA Space Act Agreement with the Federal Aviation Administration (FAA) to support validation and demonstration of rotorcraft Health and Usage Monitoring Systems (HUMS) for maintenance credits via FAA Advisory Circular (AC) 29-2C, Section MG-15, Airworthiness Approval of Rotorcraft (HUMS) (Ref. 1). The overarching goal of this work was to determine a method to validate condition indicators in the lab that better represent their response to faults in the field.

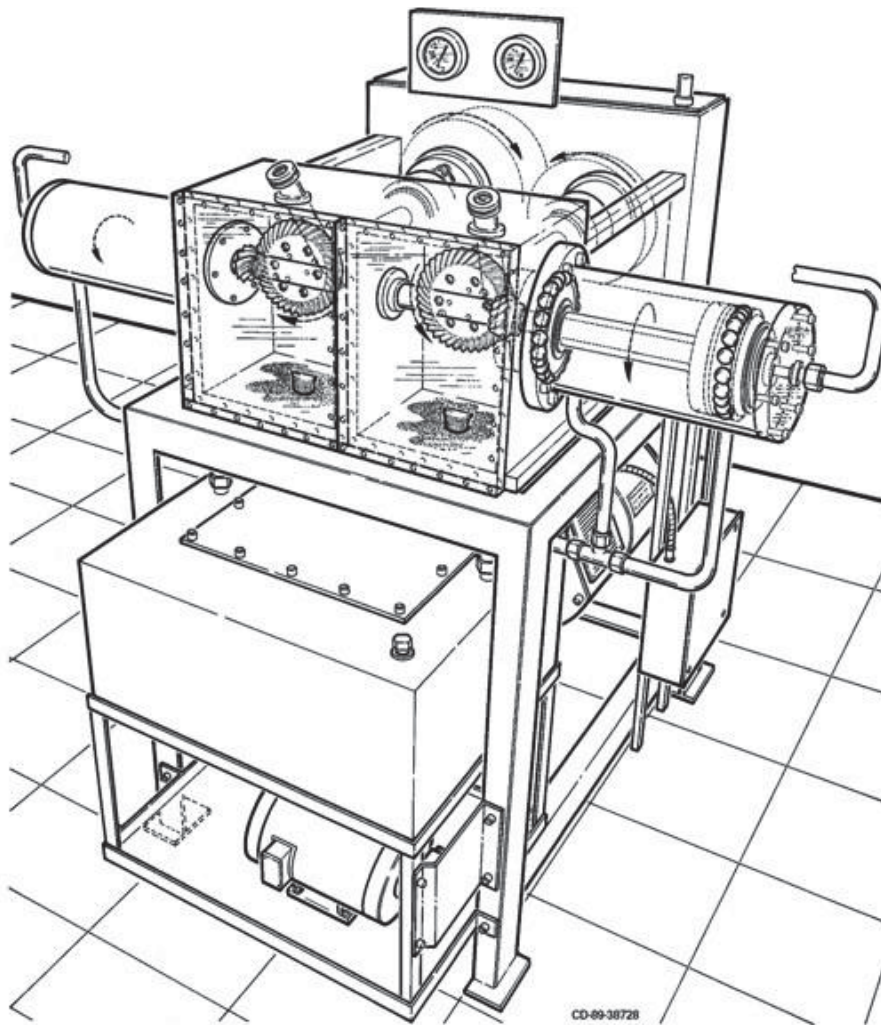
Figure 1.—Spiral Bevel Gear Fatigue Test Rig.

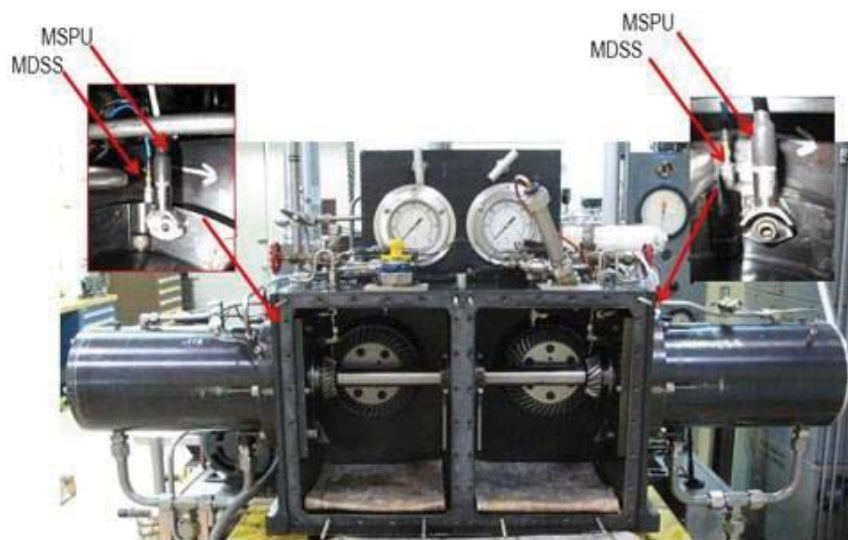
Figure 3.—Location of MDSS and MSPU Accelerometers.

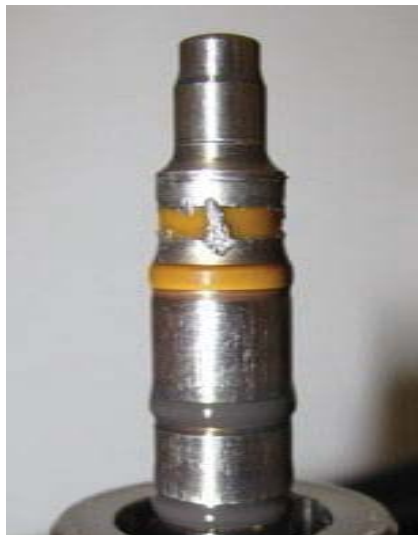
Figure 4.—Photograph of chip detector with captured debris.

Chip indications from the magnetic chip detector, when the gap was closed with debris, were also measured. For this magnetic chip detector, the MDSS records a voltage output from the chip detector until enough debris is collected on the magnet to close the gap. Then, the voltage output drops down to zero. The chip detector is a fuzz burn-off type. The operational principle of the fuzz burn-off chip detector involves the automatic discharge of a capacitor network after debris particles have bridged the gap of the two magnetic electrodes of the detector. A rapidly decaying pulse of energy controlled by capacitor size and operating voltage is applied to the debris bridging the gap. A photograph of debris captured on the chip detector is shown in Figure 4.

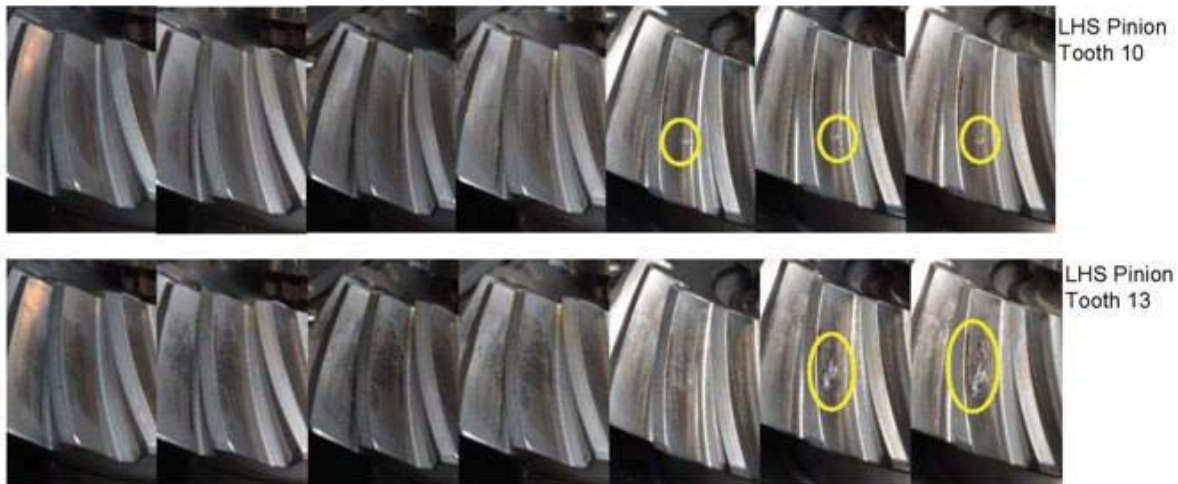
Damage Scale
No damage
micro pitting or edge wear
scuffing
1 tooth macro pitting
2 or more teeth macro pitting

Figure 5.—Test L4545R5050 Pinion Damage Modes.

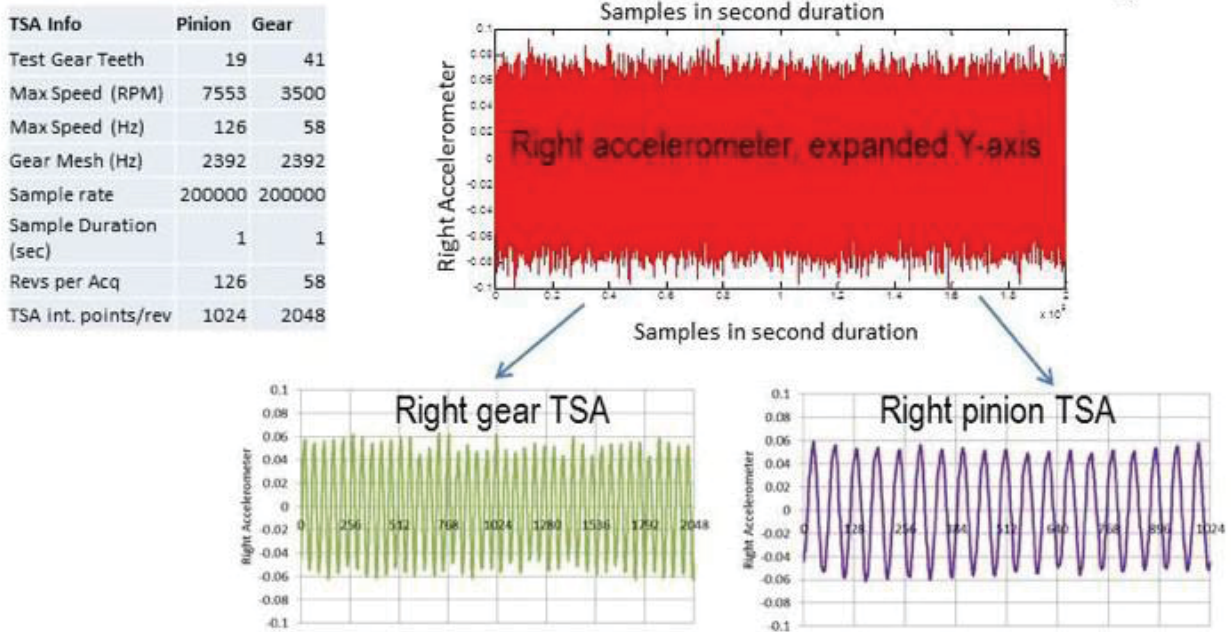
FM4 is one CI used to indicate gear tooth damage. Figure 7, on the left, shows a block diagram of the steps required to calculate FM4 (Figure of Merit 4), a common vibration algorithm used in commercial HUMS (Ref. 21). RMS, also referred to as DA1, is another CI used to indicate gear tooth damage. Figure 7, on the right, shows is a block diagram of the steps required to calculate RMS.

Figure 6.—Information Used to Calculate TSA.

Figure 7.—FM4 and RMS Calculation.

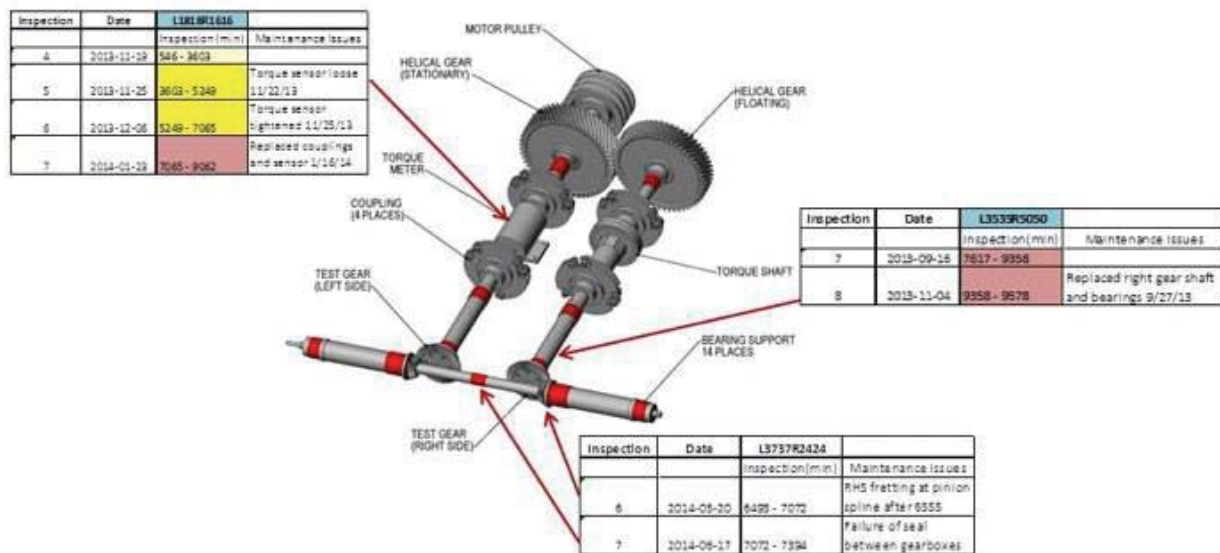
Figure 14.—Maintenance actions to the test rig drive train.

During tests L3030R5050 and L3535R5050 macropitting was observed on one left pinion tooth and two left gear teeth at test completion. During test L1818R1616, macropitting was observed on three left pinion and four left gear teeth at test completion. Edge wear was also observed on the right pinion teeth that was later found to be caused by minor fretting of the right pinion in the support shaft and will be discussed further later in this section. Maintenance actions to the system can affect condition indicator response. Figure 14 identifies maintenance issues to the test rig during testing correlated to the specific test and inspection interval when they occurred. These actions occurred during tests L3535R5050, L1818R1616 and L3737R2424. Maintenance actions must be taken into consideration when reviewing condition indicator response. At the completion of test L3535R5050, the right gear shaft and bearings were replaced. During test L1818R1616, the torque sensor came loose and had to be replaced with its couplings. Test L3737R2424 maintenance action will be discussed later in this section.

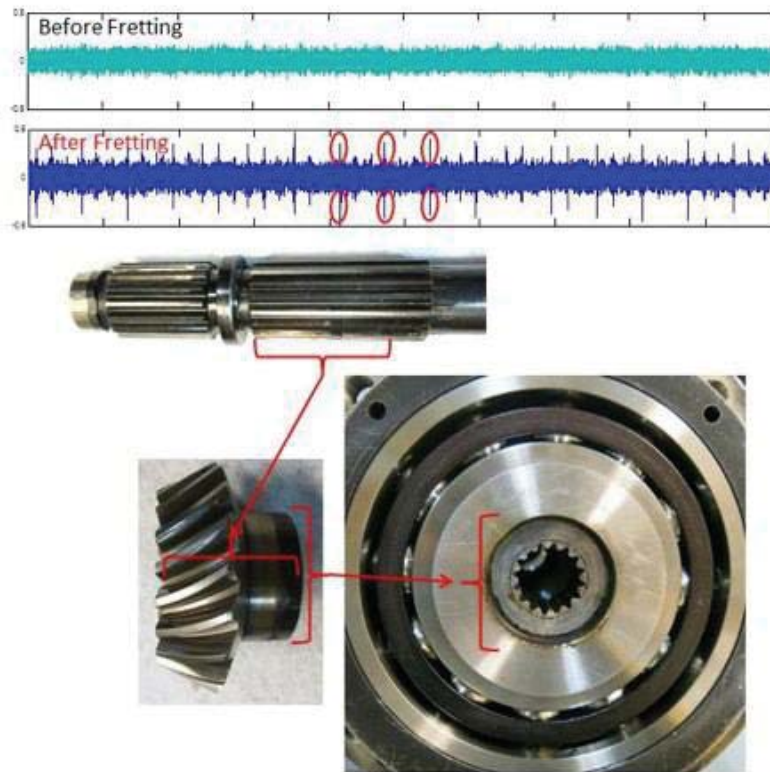
Figure 15.—Fretting of pinion in shaft.

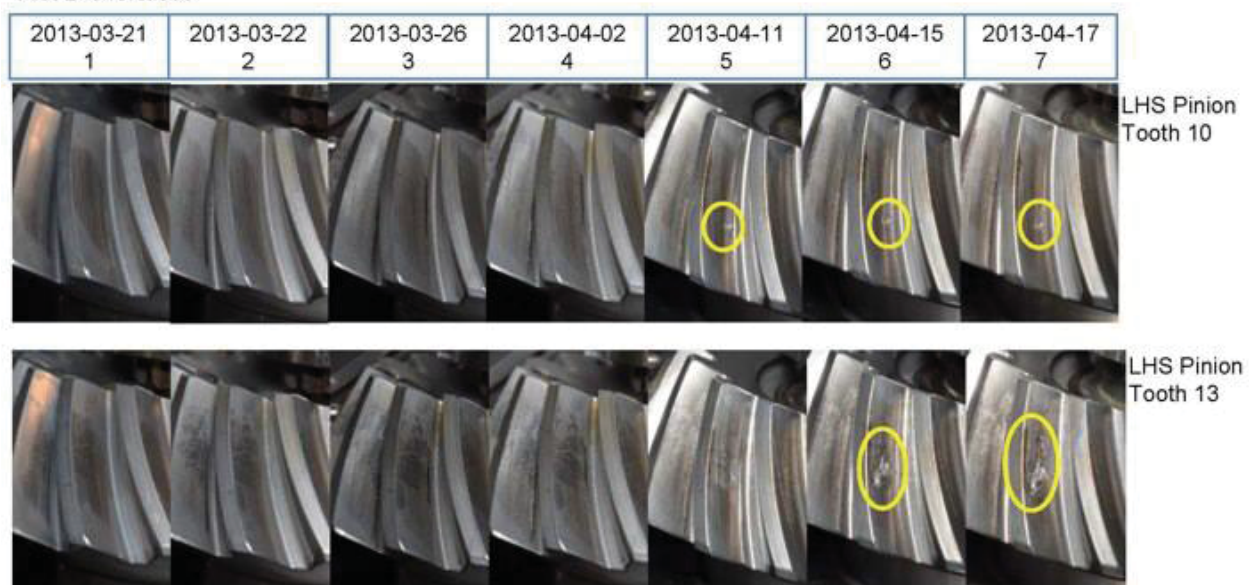
Figure A.1.1.—Test L4545R5050 pinion damage modes.

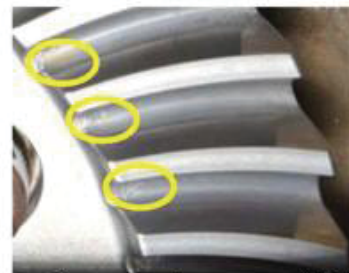
LHS Pinion  
Tooth 6

Surface anomaly on several left  
side gear teeth observed at start  
of test

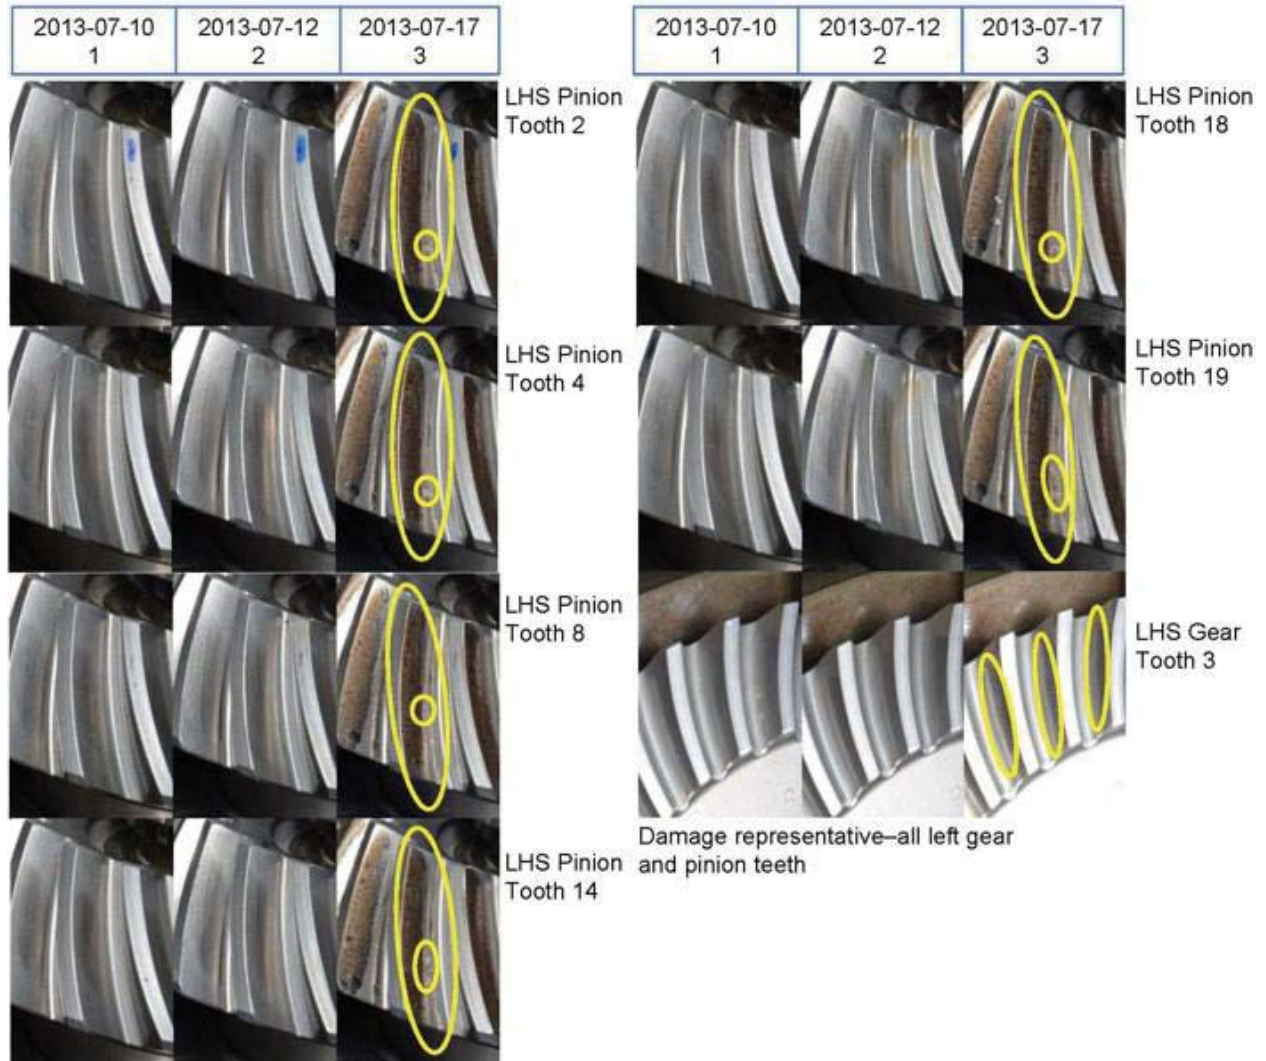
Figure A.1.4.—Test L2020R5050 pinion and gear damage modes.

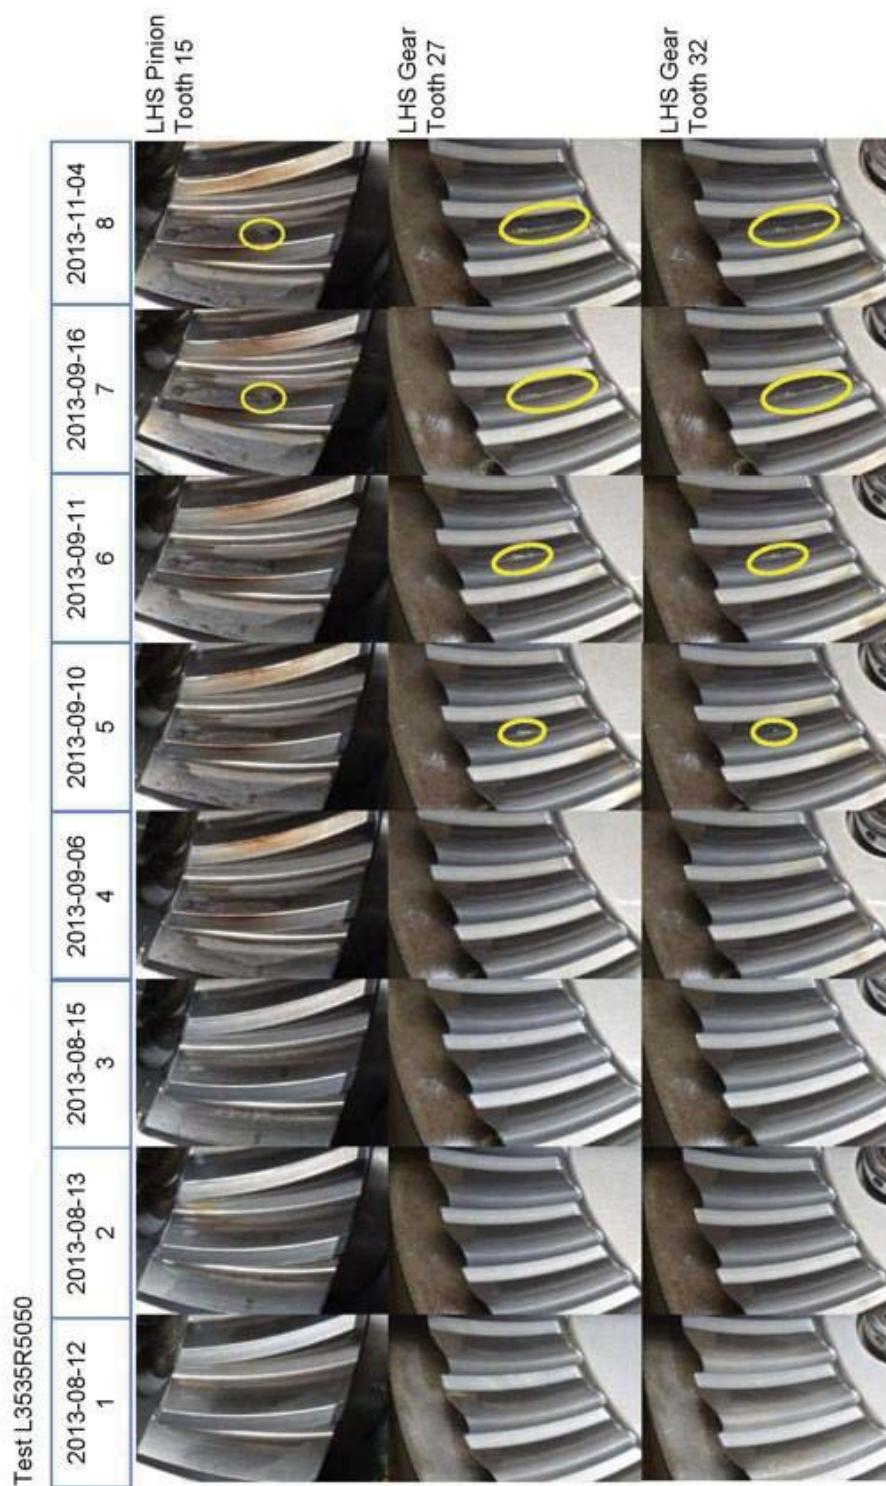
Figure A.1.6.—Test L3535R5050 pinion and gear damage modes.

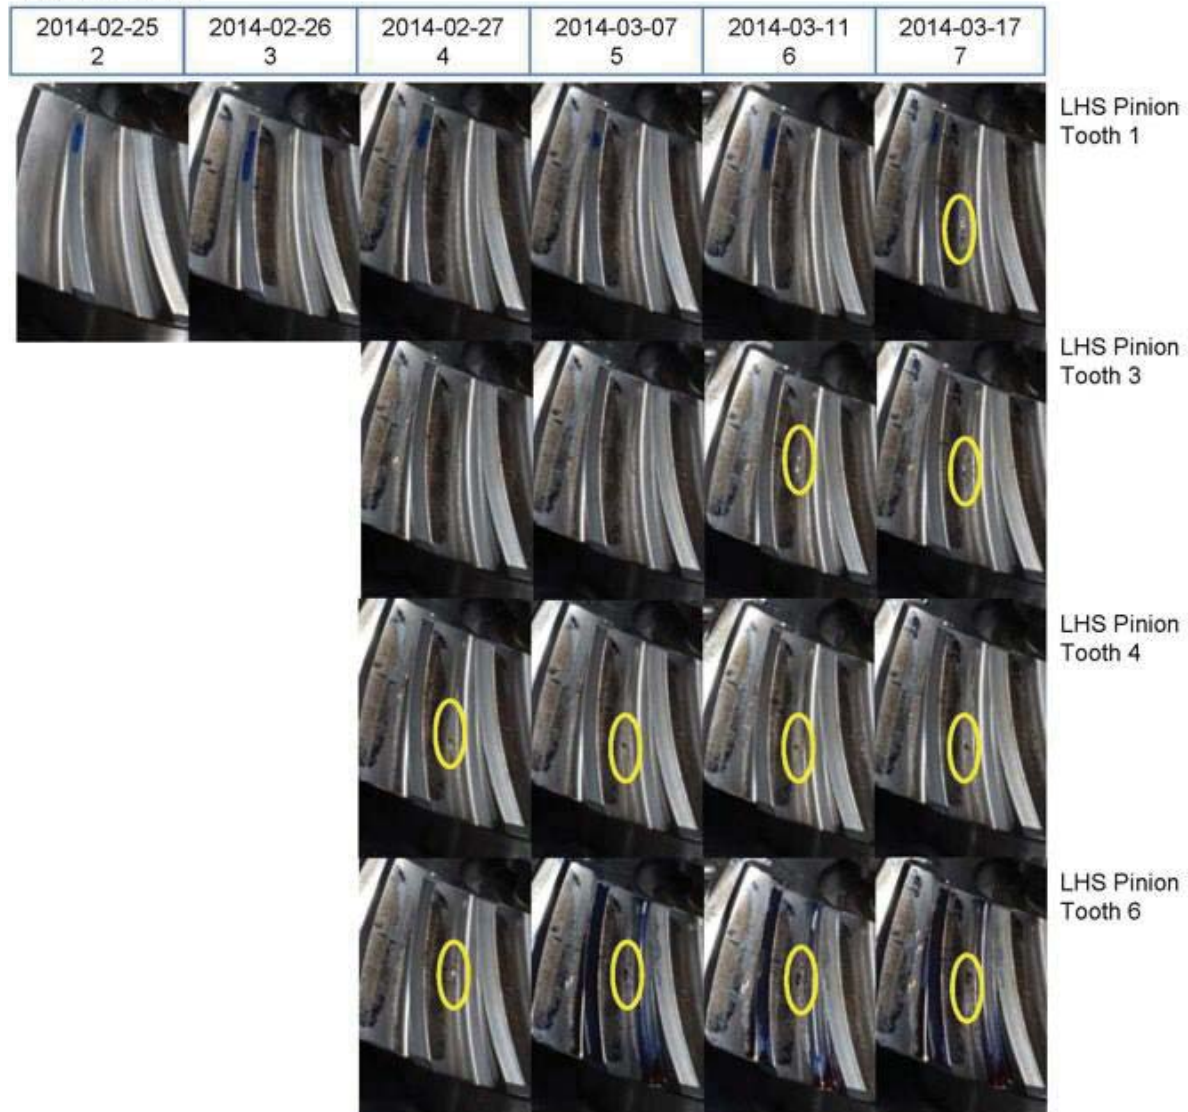
Figure A.1.8.—Test L2121R1919 pinion damage modes.

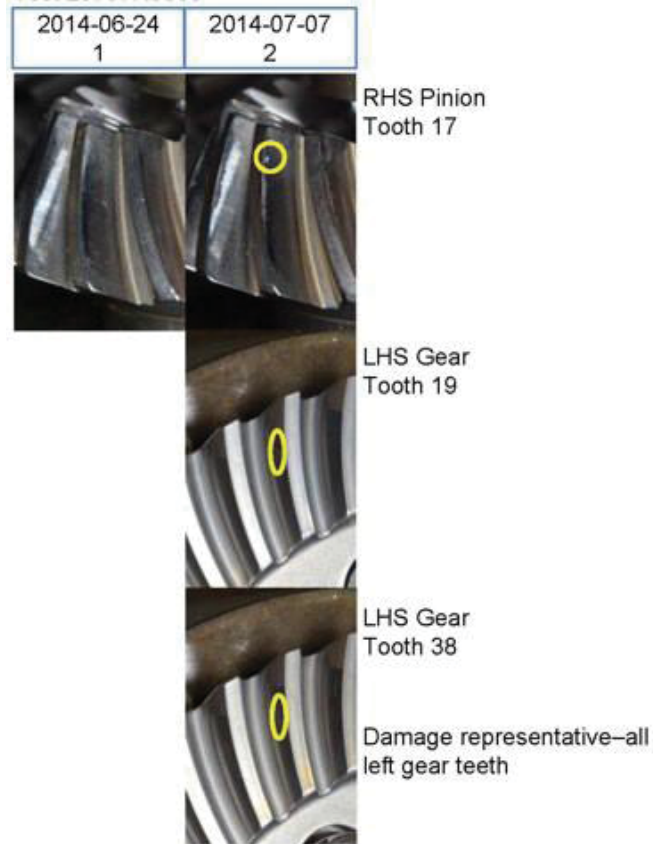
Figure A.1.13.—Test L3737R5036 damage modes.

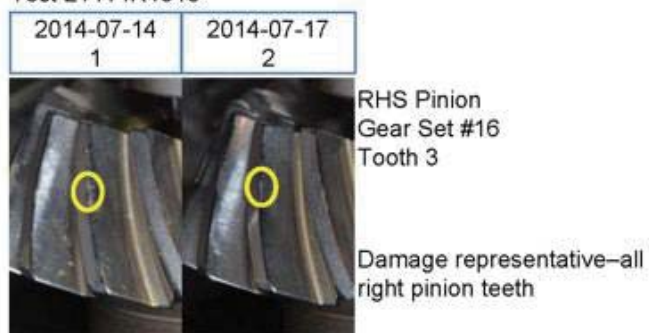
Figure A.1.14.—Test L1414R1616 damage modes.

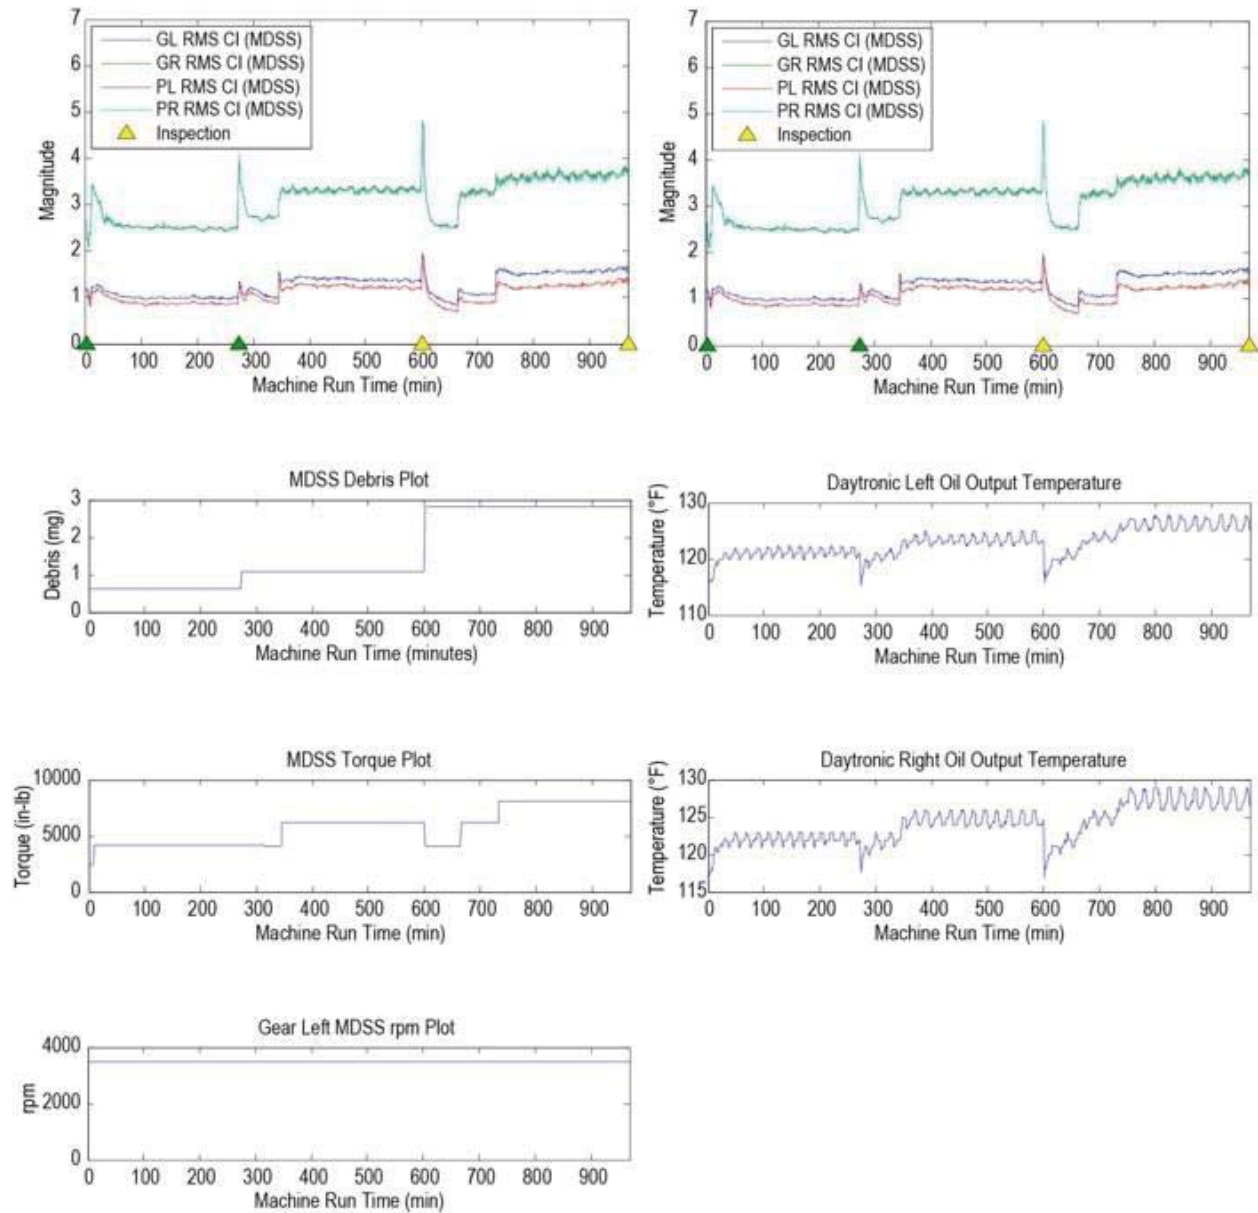
Figure B.13.2.—Test L4444R5252 Plots of RMS and Operational Parameters.

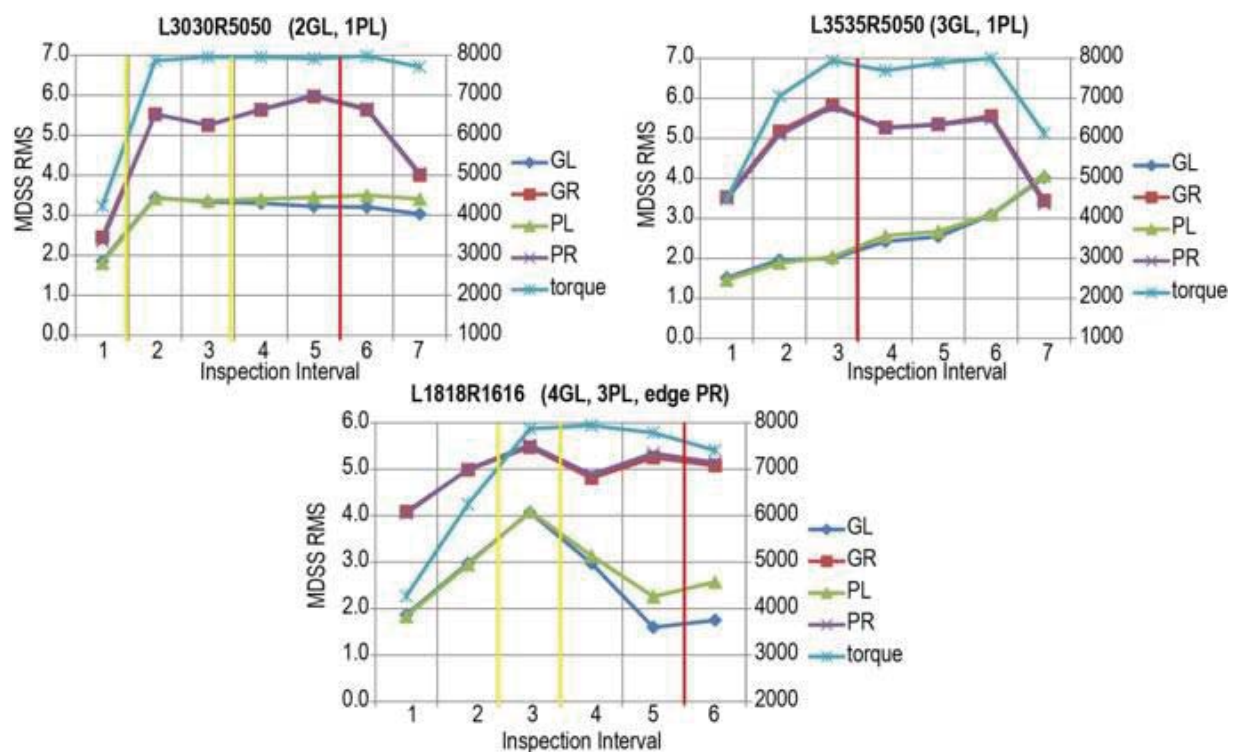
Figure D.2.1.—Compare RMS to damage modes left gear teeth macro pitting L3030R5050 (2GL, 1PL); L3535R5050 (3GL, 1PL); L1818R1616 (4GL, 3PL, edge PR).

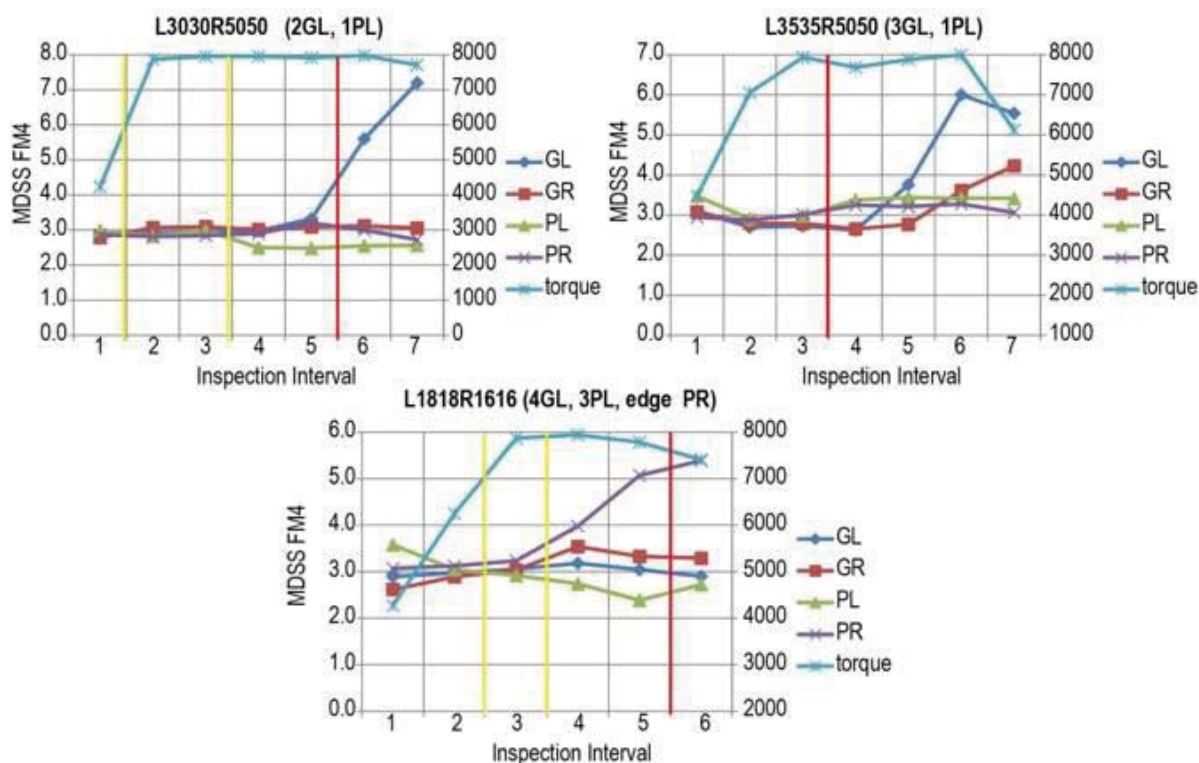
Figure D.2.2.—Compare FM4 to damage modes left gear teeth macro pitting L3030R5050 (2GL, 1PL); L3535R5050 (3GL, 1PL); L1818R1616 (4GL, 3PL, edge PR).

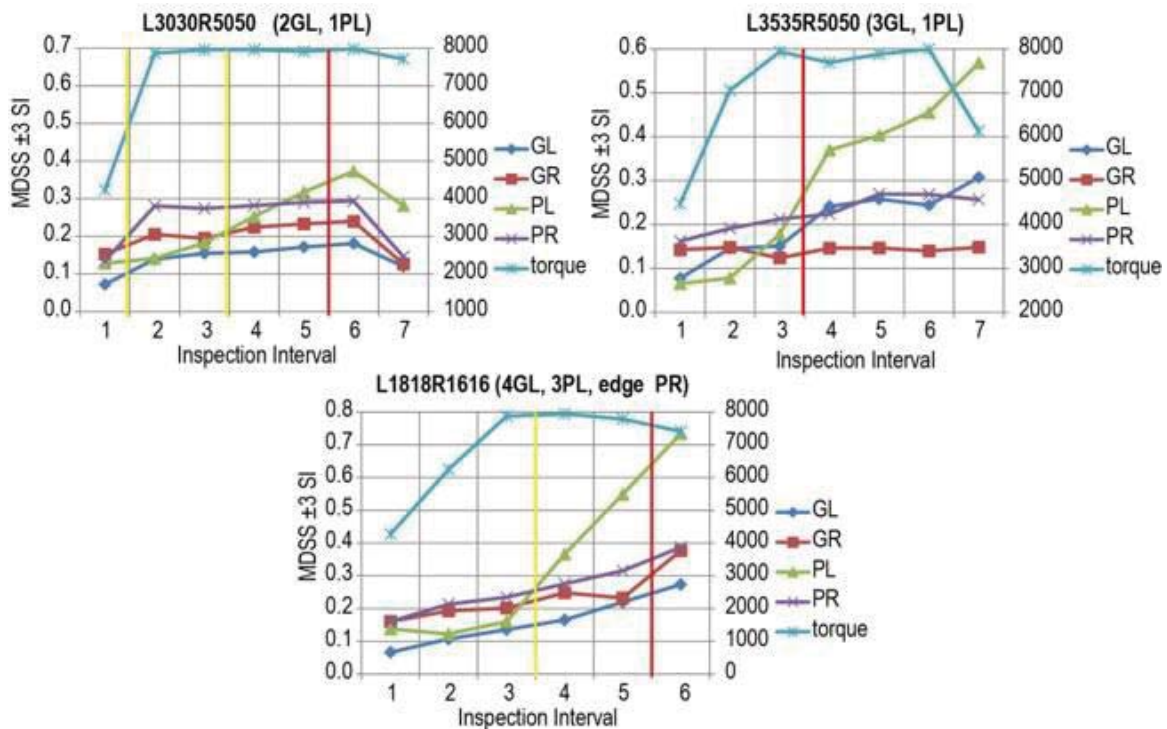
Figure D.2.4.—Compare SI3 to damage modes left gear teeth macro pitting L3030R5050 (2GL, 1PL); L3535R5050 (3GL, 1PL); L1818R1616 (4GL, 3PL, edge PR).

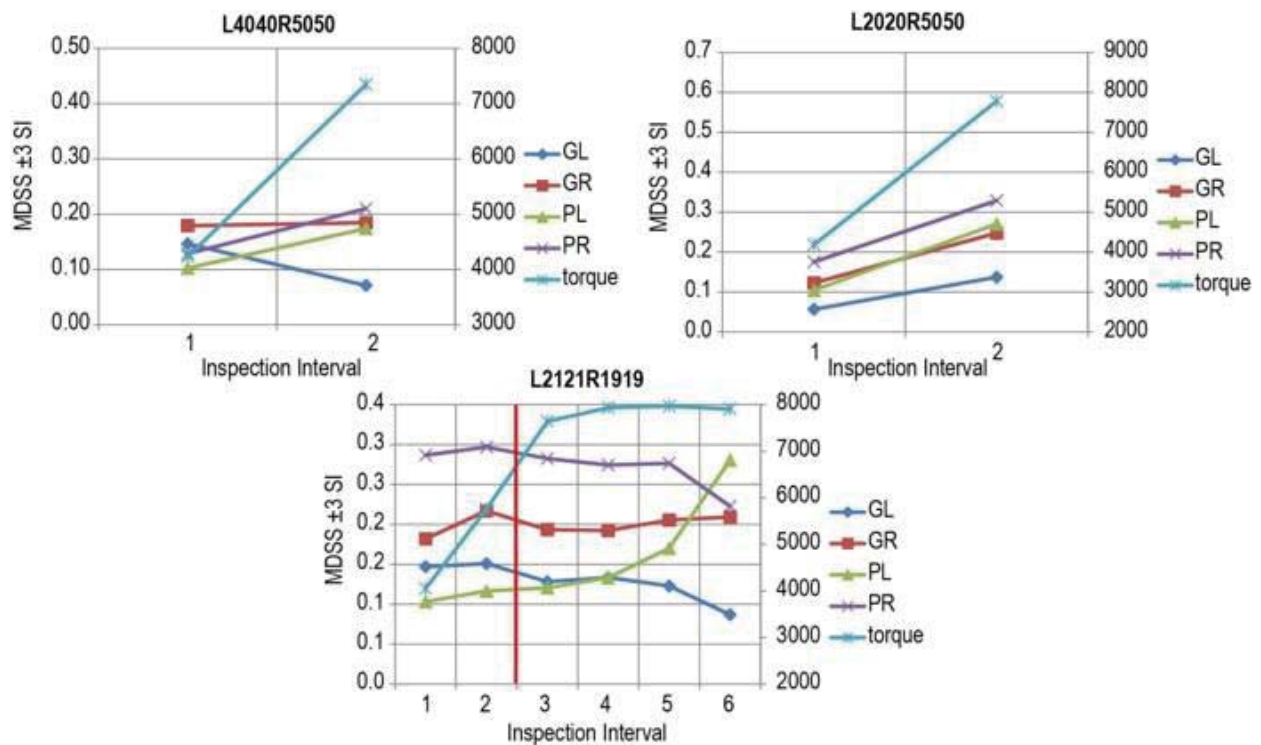
Figure D.3.4.—Compare SI1 to damage modes left pinion/gear scuffing.
