# Investigation of Gearbox Vibration Transmission Paths on Gear Condition Indicator Performance

*Paula J. Dempsey*  
*Glenn Research Center, Cleveland, Ohio*

Helicopter health monitoring systems use vibration signatures generated from damaged components to identify transmission faults. For damaged gears, these signatures relate to changes in dynamics due to the meshing of the damaged tooth. These signatures, referred to as condition indicators (CI), can perform differently when measured on different systems, such as a component test rig, or a full-scale transmission test stand, or an aircraft. These differences can result from dissimilarities in systems design and environment under dynamic operating conditions. The static structure can also filter the response between the vibration source and the accelerometer, when the accelerometer is installed on the housing.

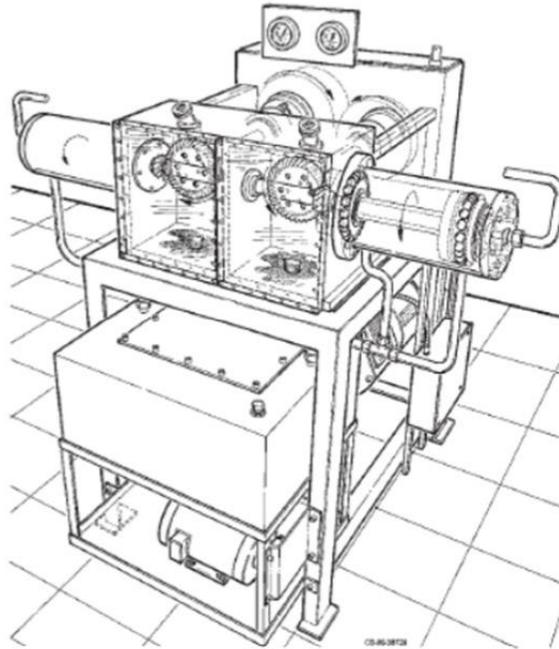
Figure 1.—Spiral bevel gear fatigue test rig at NASA GRC.

Tests were performed in the test rig at NASA GRC. A detailed description of this test facility, as illustrated in Figure 1, can be found in References 5 and 6. In addition to developing gear health monitoring tools, the test facility has been used to study the effects of gear material, gear tooth design, and lubrication on the fatigue strength of gears. Two sets of spiral bevel gears are installed in the test rig and tested simultaneously. Facing the gearboxes per Figure 1, the left gear set (pinion/gear) is referenced as ‘left’ and the right gear set (pinion/gear) is referenced as ‘right’ within this paper.

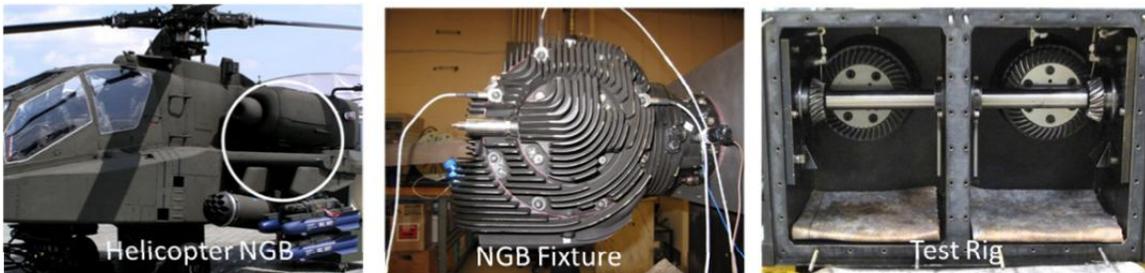
Figure 2.—Three spiral bevel geared systems.

The approach used to assess the effectiveness of vibration transfer paths in predicting CI performance was to compare measurements on three spiral bevel geared systems. These three systems, as shown in Figure 2, are a helicopter NGB, an NGB fixture (an NGB removed from a helicopter and installed in a static fixture), and a test rig (spiral bevel gear fatigue test rig). The latter two are installed at NASA GRC.

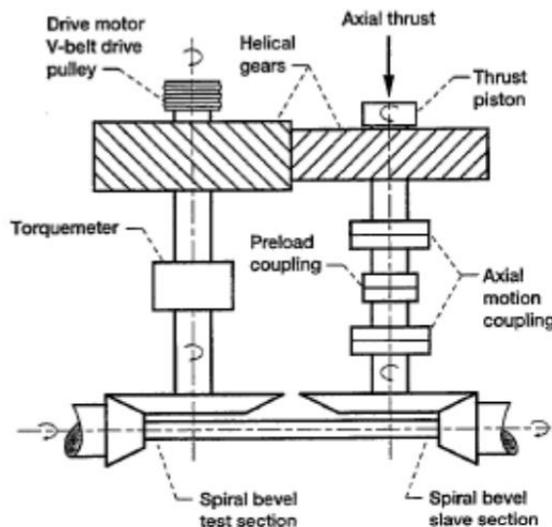
Figure 3 shows the cross-sectional view of the test rig. The facility operates in a closed-loop arrangement where the load is locked into the loop via a split shaft and a thrust piston on the slave side of the rig. This forces a helical gear into mesh per Figure 3. The rotation is obtained using a drive motor connected through v-belts to the helical gear. The spiral bevel gears on the left side operate where the pinion drives the gear. The right side of the facility acts as a speed increaser where the gear drives the

Figure 3.—Cross-section of the test rig.

pinion. The concave side of the pinion is always in contact with the convex side of the gear on both the left and right side of the gearbox. Load and speed are monitored by torque and speed sensors. The 41-tooth gear and 19-tooth pinion gear set are typically tested at a gear speed of 3500 rpm and a pinion speed of 7553 rpm with a gear torque of approximately 8000 in.-lb and a pinion torque of 3707 in.-lb.

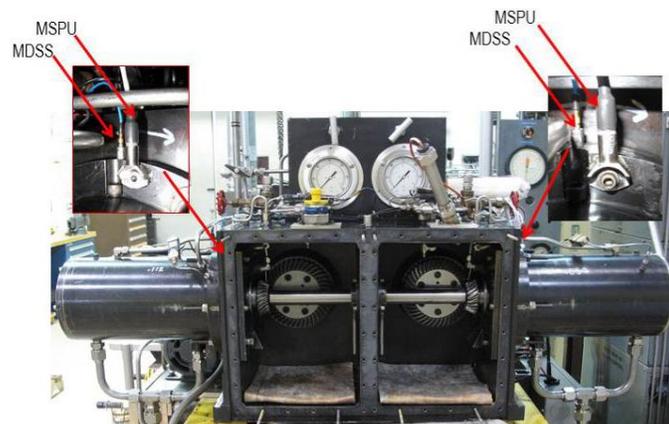
For the MSPU system, accelerometers, with a frequency range of 0.5 to 5 kHz and a resonant frequency of 26 kHz, are also installed on the right and left side of the test rig. These accelerometers are referred to as the Dytran in the analysis that follows. A magnetic tachometer is installed on the right pinion to measure pinion pulses per tooth pass in the MSPU system. The accelerometers were mounted on the housing, in close proximity to the MDSS accelerometers, radially and vertically with respect to the pinion, as shown in Figure 4.

Figure 4.—Locations of accelerometers.

For condition indicator calculations, vibration data were collected for the right and left pinion/gear sets using accelerometers mounted on the right and left side of the test rig gearbox per Figure 4. Data were collected at sample rates that provided sufficient vibration data for calculating time synchronous averaged (TSA) data. The TSA refers to techniques for averaging vibration signals over several revolutions of the shaft, in the time domain, to improve signal-to-noise ratio (Ref. 7). Using a once per revolution signal, the vibration signal is interpolated into a fixed number of points per shaft revolution. Signals synchronous with the shaft speed will intensify relative to the non-periodic signals.

Vibration transfer path (VTP) measurements were recorded on the test rig at NASA GRC from June 3 to June 7, 2013. The objective of this effort was to perceive how an accelerometer responds to the impacts at the gear mesh as they travel through the structure. Since the structure filters this response, it can impact a CI's ability to detect tooth damage at the mesh. The transmission or transfer path of the test rig gearbox was determined by applying an impact force at the mesh and measuring its response with accelerometers installed on the gearbox housing. The same MDSS and MSPU accelerometers used for dynamic measurements were used for VTP measurements on the test rig, as shown in Figure 4.

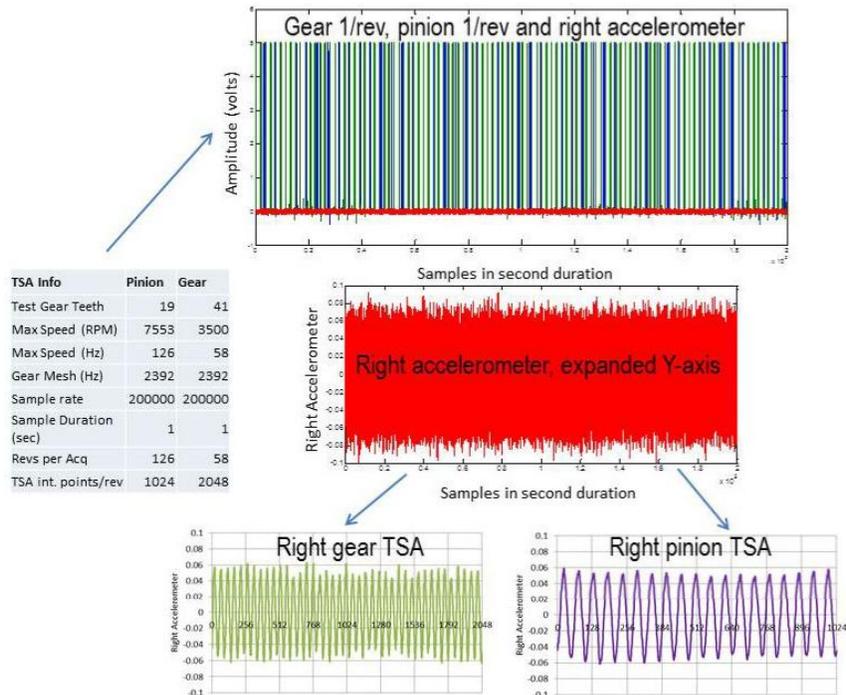
Figure 5 illustrates the information used to calculate the TSA for the right gear and pinion. Using the sample rate of 200 kHz for one second duration and the speed of both shafts, the number of TSA averages for each acquisition is determined. Each average consists of one revolution of the shaft. Each average is made up of the number of linearly interpolated points rounded down to a power of two. A power of two

Figure 5.—Information used to calculate TSA.

data points is required to perform the Fast Fourier Transform (FFT) to convert time domain signals into the frequency domain. According to Figure 5, the top plot displays the right accelerometer data sampled for one second at 200 kHz. The green and blue lines are pulses from the gear and pinion 1/rev signal measured for each shaft rotation during this one second period. Only the right accelerometer is plotted in red in the middle plot with an expanded y-axis scale. The two lowest plots are the TSA signals calculated from the 1/rev and vibration data for the right gear and pinion. Pulses from the 41-tooth gear and the 19-tooth pinion can easily be seen within these two plots.

Figure 6 illustrates the steps required to calculate RMS and SI for each reading. The RMS method uses the interpolated TSA data per Figure 5 to calculate the RMS of the TSA. The SI method uses the TSA data in performing the FFT. Then the peak amplitudes of the FFT data on either side of the GM are used to calculate SI indexes. Note that the x-axis of the plot showing the FFT of the right gear is in shaft orders or multiples of shaft speed. For example, since the gear has 41 teeth, the gear mesh frequency (teeth x speed) shows up at 41 shaft orders.

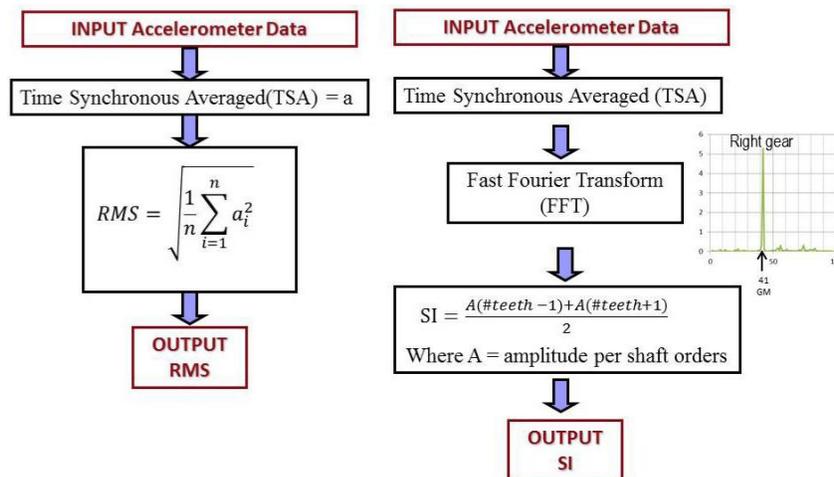
Figure 6.—RMS and SI calculations.

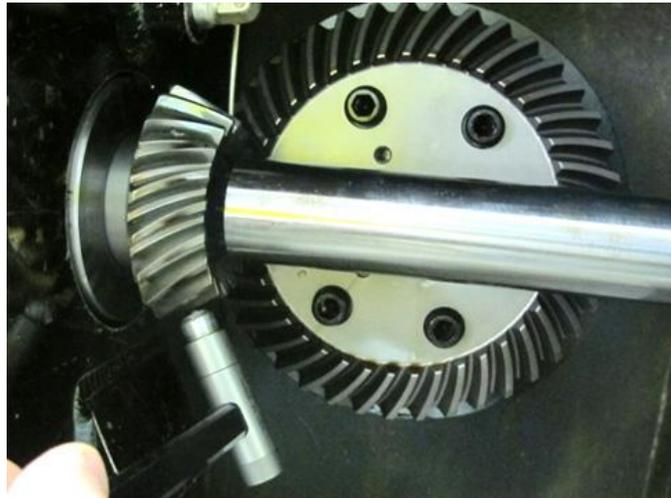
The effects of loads on the transfer path were examined by impacting the hammer on the left pinion in the vertical direction and measuring its response with the MDSS system accelerometers. Accelerations were measured with the HF accelerometers from 0 to 6400 Hz. The test gears were loaded by applying a static torque in the loop. Four design loads were applied and are listed in Table 2. Similarity factors were then calculated comparing the 29 percent design load to the other three loads and are listed in Table 2. According to Table 2, similarity factors above 0.9 indicated the FRFs were similar under varying loads. Representative plots of FRF, Coherence and CDF at 104 percent design load compared to 29 percent load are shown in Figure 8.

Figure 7.—Impact on left pinion in the vertical direction.

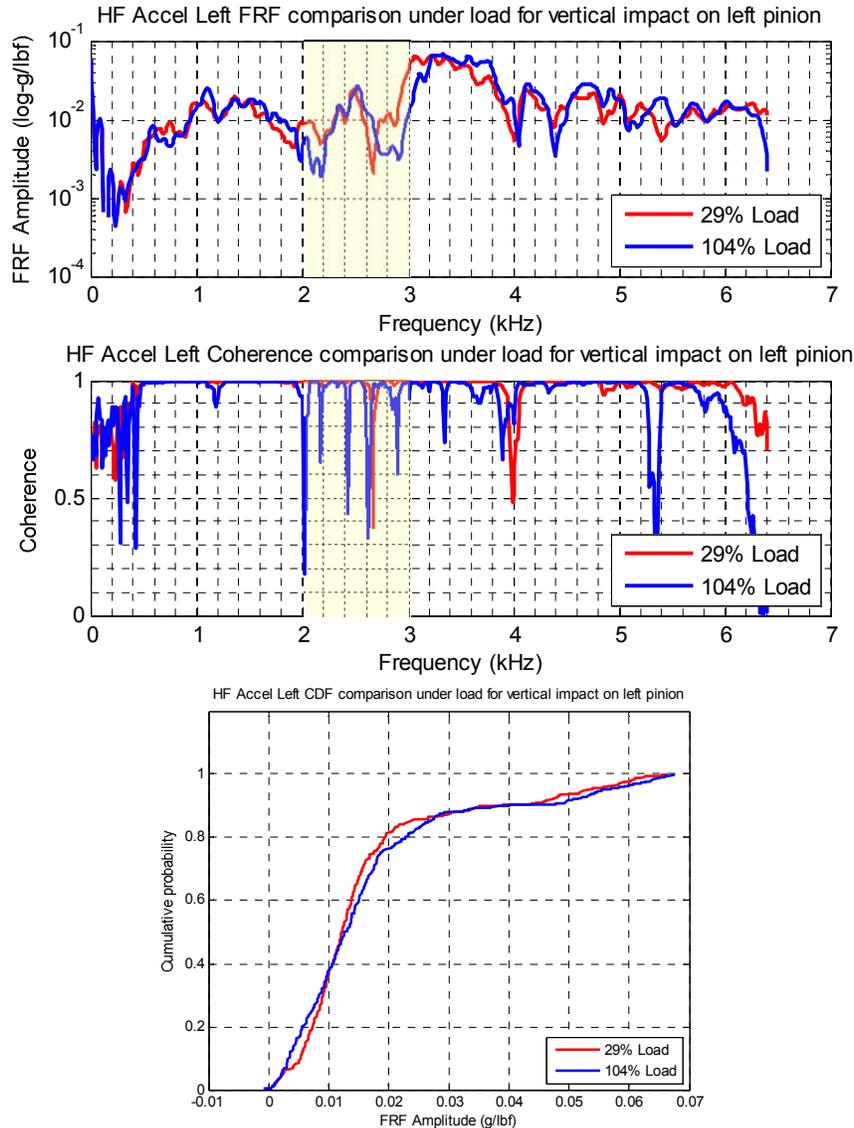
Figure 8.—FRF, Coherence and CDF at 104 percent design load compared to 29 percent load.

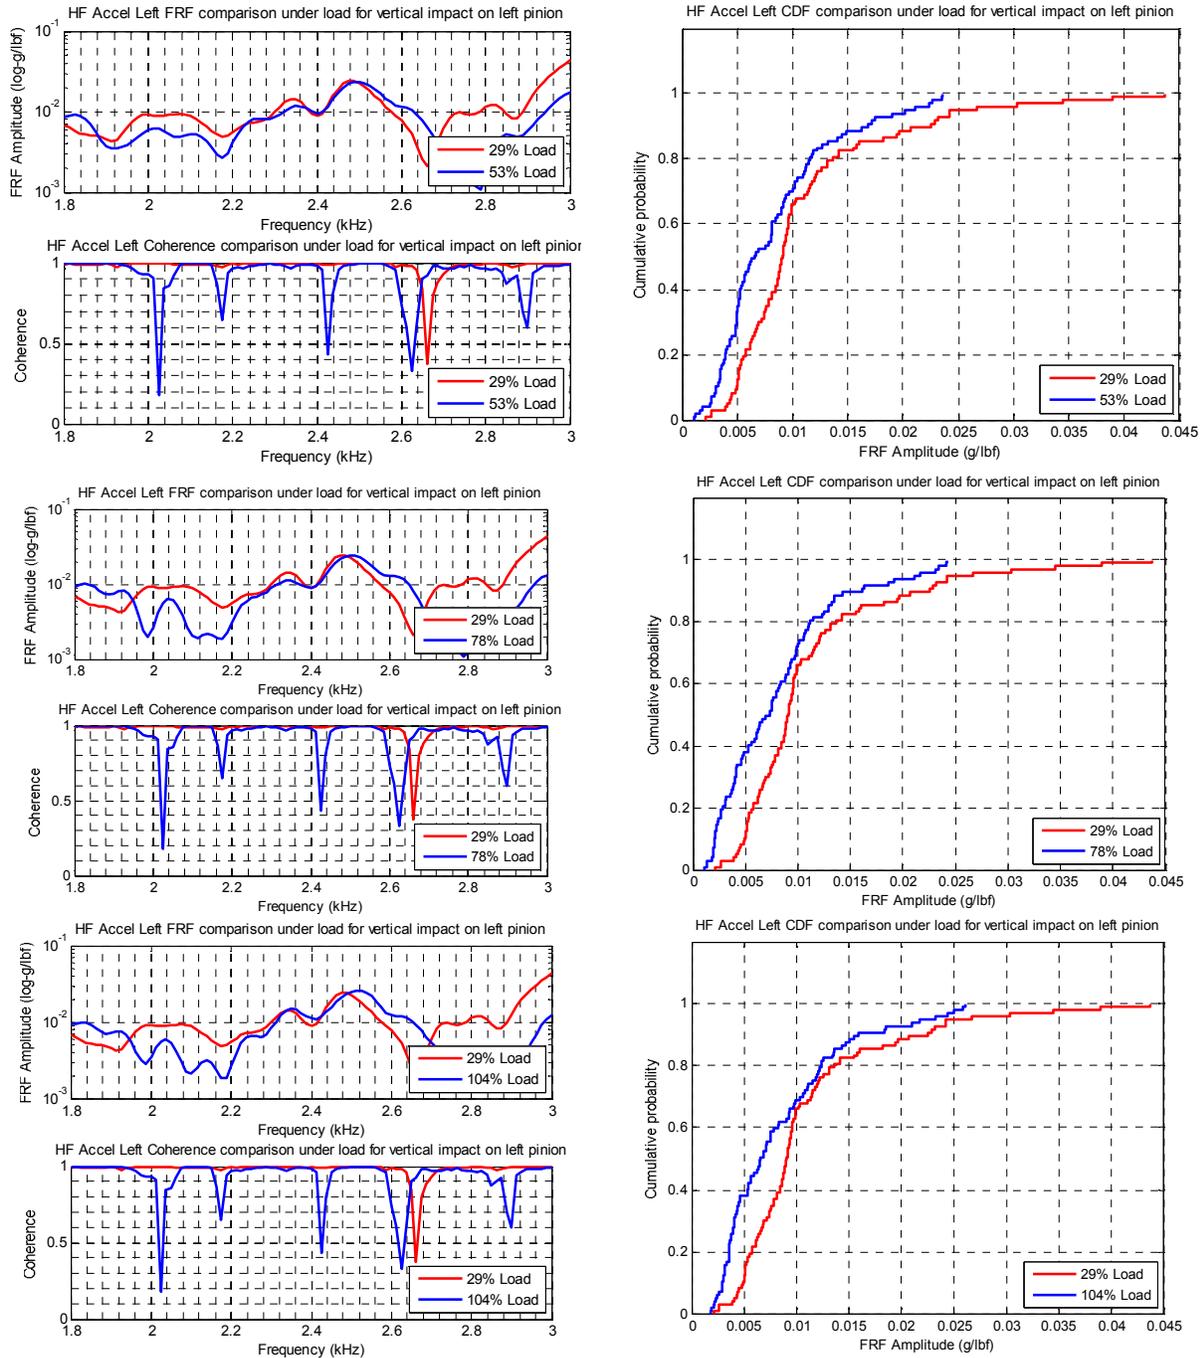
These plots were also generated for a narrow frequency band (1800 to 3000 Hz) around the gear mesh and its sidebands for 3500 rpm gear speed (Table 1). This expanded scale is highlighted in yellow in Figure 8. Similarity factors calculated comparing the 29 percent design load to the other three loads are listed in Table 3. According to Table 3, similarity factors calculated for the narrow band were lower than the full range and decreased with an increase in load. Plots of FRF, Coherence and CDF at the three loads compared to 29 percent design load are shown in Figure 9. These results indicate that for the most accurate system structural characterization, loads similar to the operating loads should be applied during transfer path measurements. Further discussion of results will focus on measurements taken at the load closest to operating load under dynamic conditions. This load is highlighted in Table 3.

Figure 9.—FRF, Coherence and CDF at 53, 78, and 104 percent loads compared to 29 percent load.

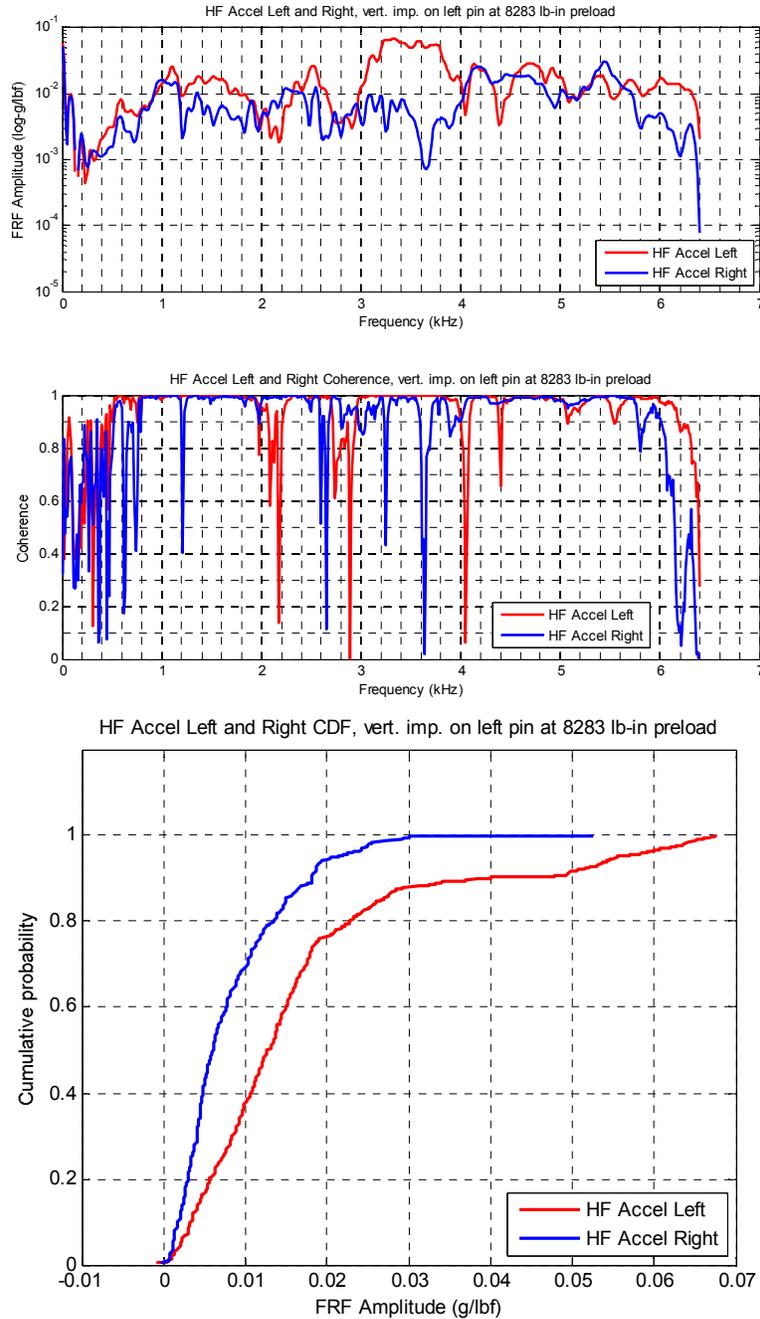
The test rig was designed to test two sets of spiral bevel gears simultaneously with the right and left pinions connected by a cross shaft. This design can make it more challenging to isolate tooth damage on one side of the gearbox from the other side. To investigate how damage on one side can potentially affect the other, impacts were made at the left pinion at 104 percent load and measured on the right and left side accelerometers. Figure 10 shows plots of FRF, Coherence and CDF at 104 percent load measured with the MDSS HF accelerometers on right and left sides of the gearbox. A KS similarity value of 0.65 was calculated for the 0 to 6400 Hz frequency range. The FRF amplitude measured on the left side was higher

Figure 10.—FRF, Coherence and CDF at 104 percent load measured on right and left with HF accels.

than that of the right side due to impacts made closer to this accelerometer. The coherence for the left accelerometer seems better than in the right one across the entire frequency range, which seems reasonable since the location of the impact is closer to the left accelerometer. However, the right accelerometer did respond to this impact indicating the coupling between the right and left pinion through the shaft. The frequency bands from 2.6 to 4.0 kHz and the frequency after 5.4 kHz show big differences in amplitudes between the left and right accelerometers. The resonant frequency appears to be at 3.2 kHz. This is good news because it does not correlate to frequencies used for diagnostic purposes at 100 percent operating conditions of the test rig.

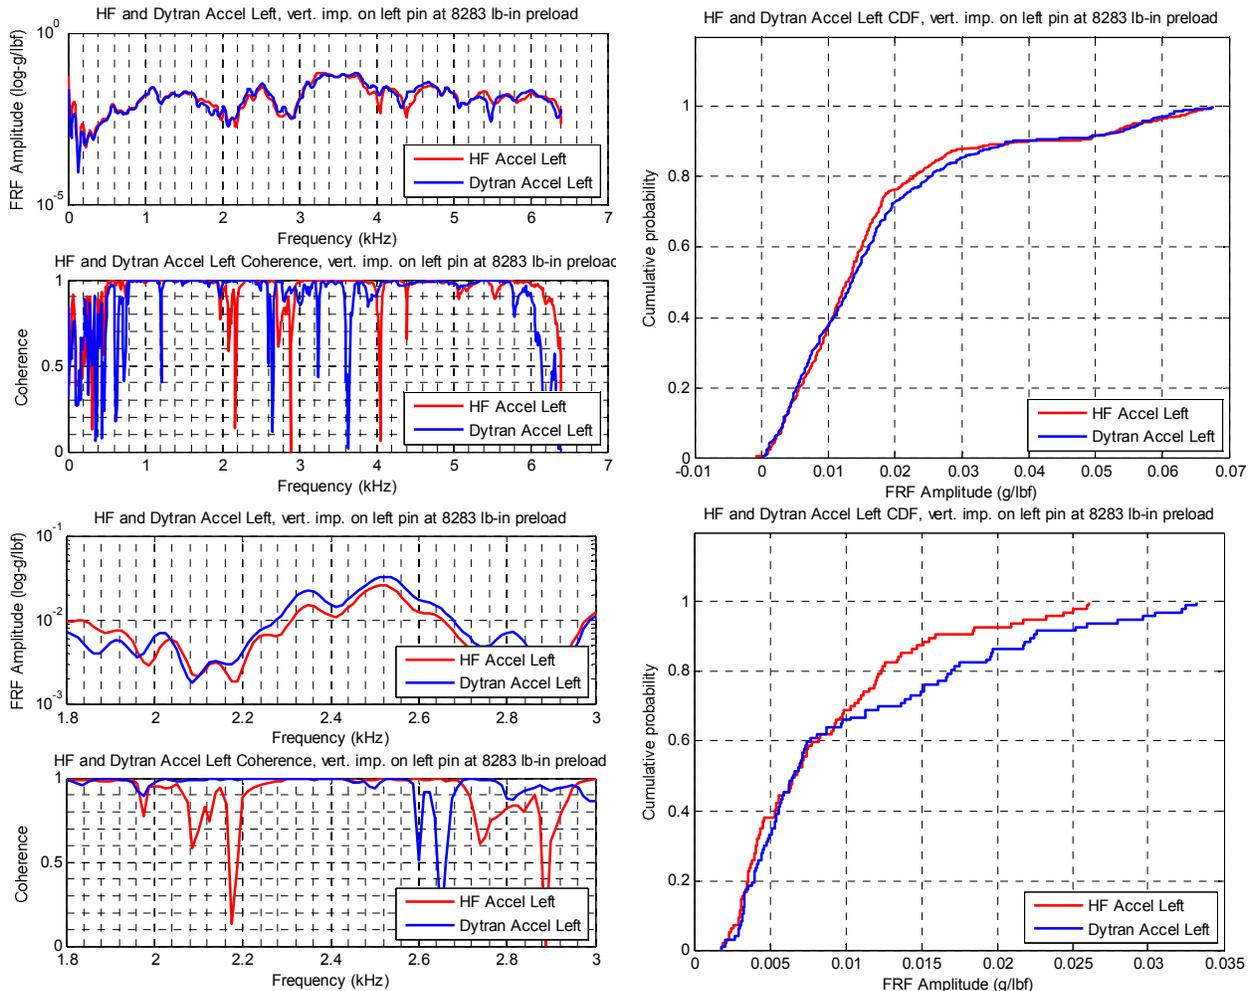
Both the HF and Dytran accelerometers will be used during test rig failure progression tests. Dytran accelerometers used to monitor the helicopter NGB have an integral mounting bracket. To compare both types of sensors, impacts were made at the left pinion at 104 percent load and measured with the HF and Dytran accelerometers installed on the left side of the test rig gearbox. Figure 11 shows plots of FRF, Coherence and CDF at 104 percent load measured with both accelerometers. A KS similarity value of 0.94 was calculated for the 0 to 6400 Hz frequency range and 0.85 for the 1800 to 3000 Hz frequency range. This indicates both types of accelerometers respond within the frequency of interest.

Figure 11.—FRF, Coherence and CDF at 104 percent load measured with HF and Dytran accels.

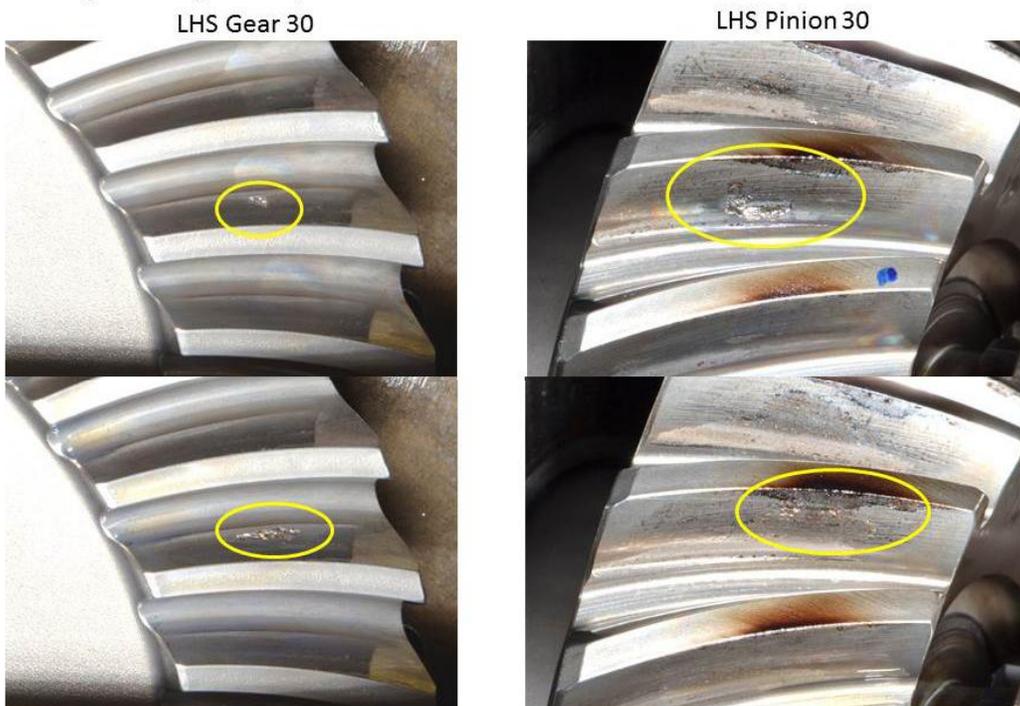
L3030R5050 – after 100 hours  
Damage to left gear and pinion teeth

The first gear set, referred to as L3030R505, completed 100 hours of operation before measurements were taken in support of this research. Damage occurred during the previous 100 hours of testing prior to performing these dynamic tests. Figure 12 is a photograph of the damage observed on the gear and pinion teeth. Figure 13 shows plots of the gear speed, gear mesh frequency and torque during the test. The gear speed in rpm and gear mesh frequency in Hz is plotted on the left y-axis. The torque is plotted on the right y-axis.

Figure 12.—Damage to gear and pinion teeth.

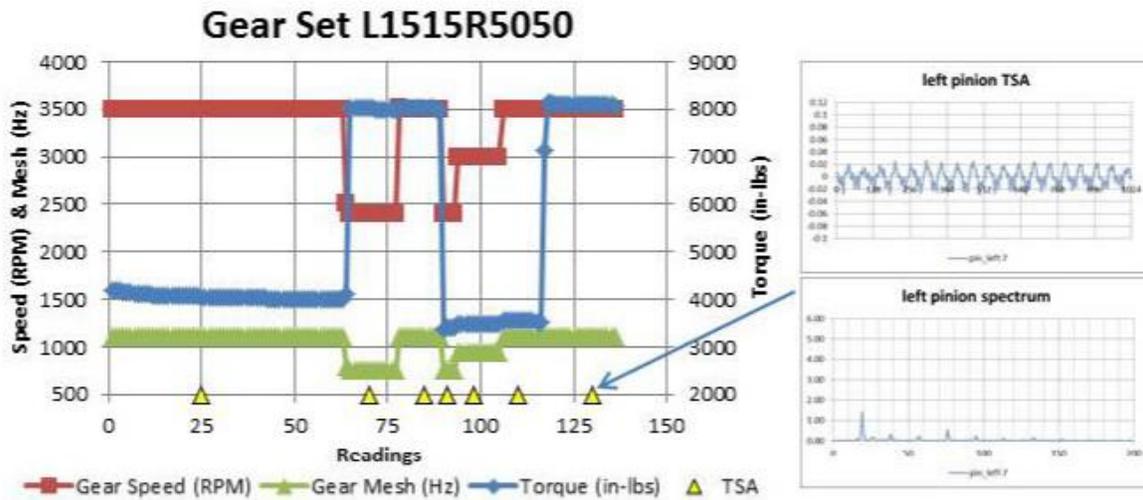
A snapshot of the TSA data and the corresponding spectrum data was plotted for each test condition. The yellow triangles on the x-axis of Figure 13 indicate points where the TSA data were plotted. The TSA time domain data were converted into the frequency domain using FFT. An example of plots of the TSA and the spectrum data for a point on the left pinion is also shown in Figure 13. The interpolated TSA data were averaged to one shaft revolution. The x-axis is the interpolated points of 1 revolution. The y-axis is in volts. The spectrum data plotted is the spectrum of the TSA. The x-axis is in shaft orders. For example, since the gear has 41 teeth, the gear mesh frequency (teeth x rpm) shows up at 41 shaft orders. The pinion shows up at 19 shaft orders due to 19 pinion teeth. The y-axis is in G-scale.

Figure 13.—Gear speed, gear mesh frequency and torque during L3030R5050 test.

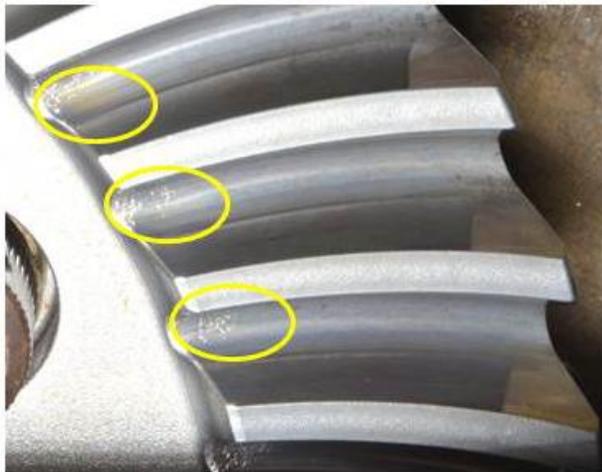
#### LHS Gear 15

The second gear set, referred to as L1515R5050, was installed new on the test rig. An anomaly, due to the manufacturing process, was present at the root of the gear teeth at the start of the testing. Figure 14 shows a photograph of the anomaly observed on the gear teeth.

Surface anomaly on several left hand side gear # 15 teeth

Figure 14.—Gear teeth anomaly on the second gear set.

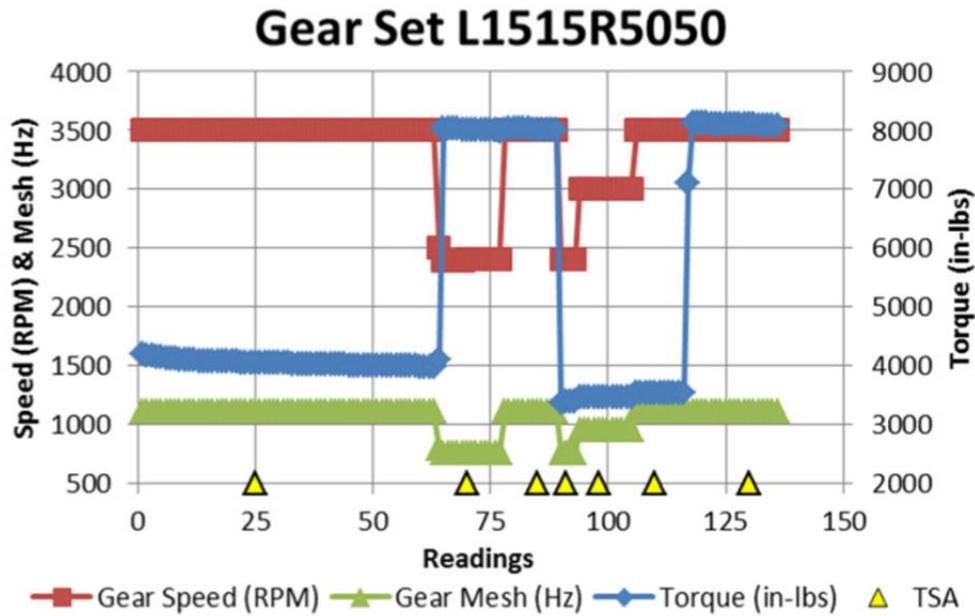
Figure 15 shows plots of the gear speed, gear mesh frequency and torque during the test. The gear speed in rpm and gear mesh frequency in Hz is plotted on the left y-axis. The Torque is plotted on the right y-axis. A snapshot of the TSA data and the corresponding spectrum data was plotted for each test condition. The yellow triangles on the x-axis of Figure 15 indicate the point where the TSA data were collected. Note that the data used for this analysis were limited to points indicated by triangles 1, 3, 7 on the x-axis. The TSA time domain data were converted into the frequency domain using FFT.

Figure 15.—Gear speed, gear mesh frequency and torque during L1515R5050 test.

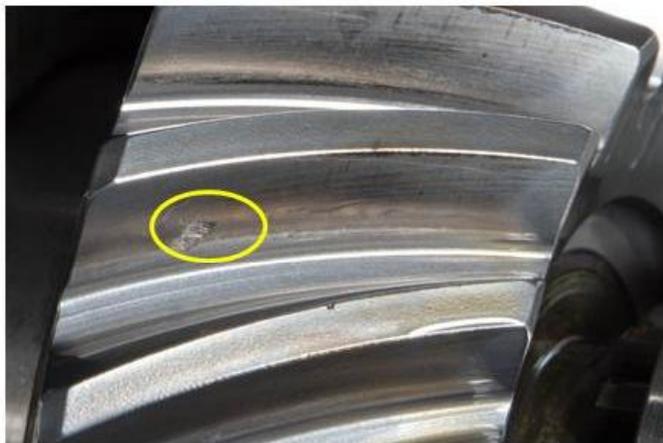
LHS Pinion 15

The second gear set, referred to as L1515R5050, rotated for another 12 hr at 8000 in.-lb. Damage was observed on one pinion tooth at test completion. Figure 16 shows a photograph of the damage observed on the pinion teeth.

Damage to one left pinion tooth prior to collecting this data.

Figure 16.—Damage to one pinion tooth.

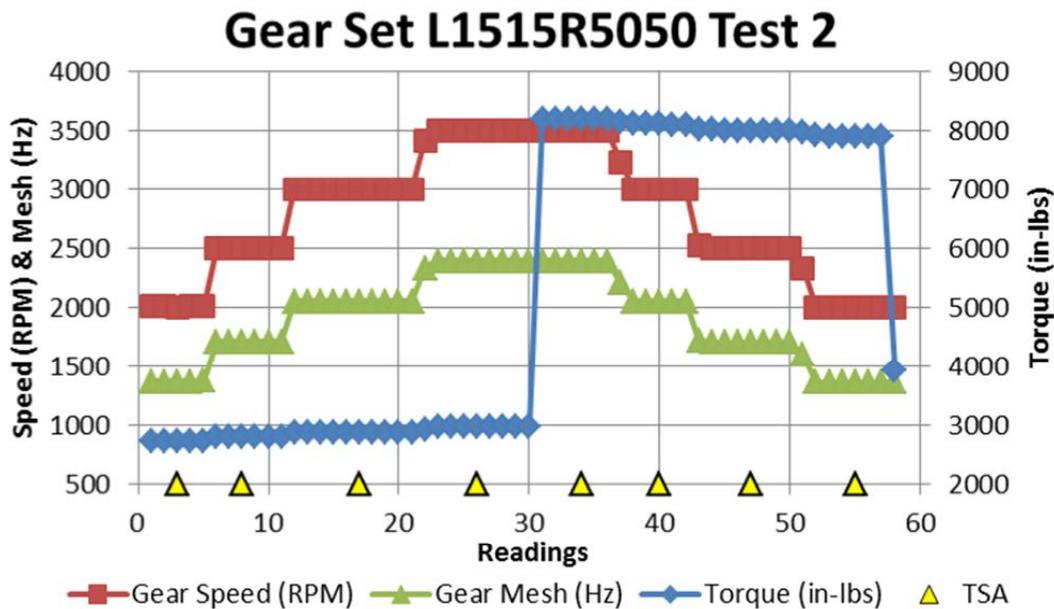
Figure 17 shows plots of the gear speed, gear mesh frequency and torque during the test. The gear speed in rpm and gear mesh frequency in Hz is plotted on the left y-axis. The torque is plotted on the right y-axis. A snapshot of the TSA data and the corresponding spectrum data was plotted for each test condition. The yellow triangles on the x-axis of Figure 17 indicate the point where the TSA data were collected. The TSA time domain data were converted into the frequency domain by performing FFT.

Figure 17.—Gear speed, gear mesh frequency and torque during L1515R5050-2 test with damage.

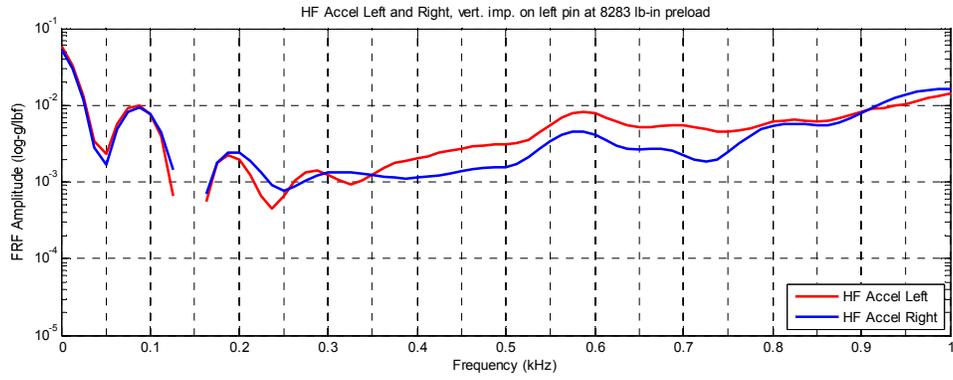
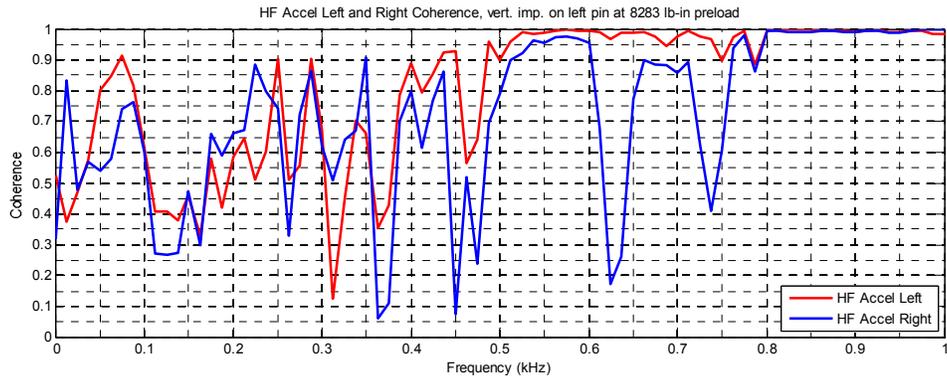
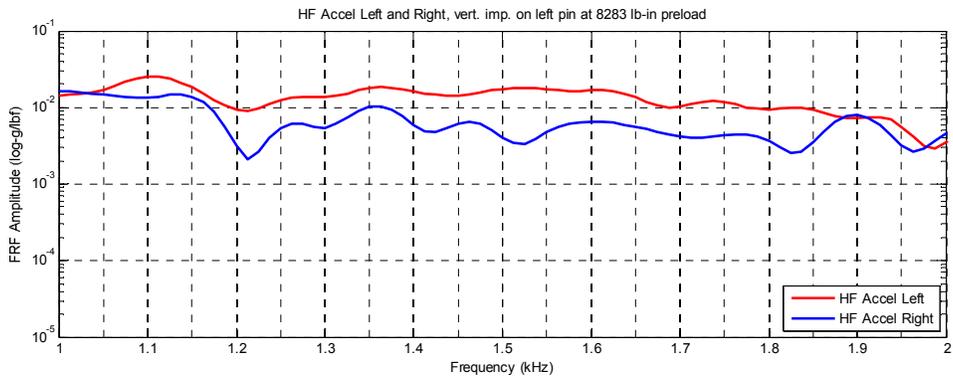
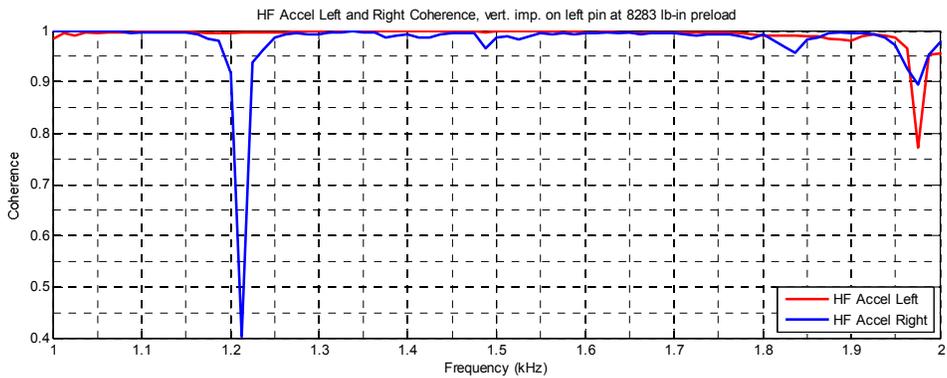
Figure 18.—FRF, Coherence and CDF at 104 percent load measured on right and left.

Accelerometer response changed with varying loads, speeds, gear sets and damage levels. Overall, the right side was more sensitive to changes in speed and load. Due to the environmental conditions affecting vibration response, isolating a relationship between structural FRF response and dynamic conditions was challenging for these datasets. The FRFs and coherence from Figure 10 are plotted in Figures 18 and 19 at 104 and 29 percent load with expanded scales of 0 to 1000 Hz and 1000 to 2000 Hz. The purpose was to determine if the FRFs at the frequencies tested would indicate the observed responses while the rig was rotating. Higher amplitude resonances were observed under low load conditions at lower frequencies possibly indicating the varying response at the lower speeds and loads. However, no unusual response near 2500 rpm (42 Hz) that corresponds to 1708 Hz GM was noted. But according to Figure 10, the resonant frequency appears to be at 3.2 kHz with a larger rise in amplitude between 3.4 and 3.8 kHz when compared to the response at other frequencies. The 2<sup>nd</sup> harmonic of gear mesh at 2500 rpm is equal to 3.4 kHz. The 2<sup>nd</sup> harmonic of the gear mesh for this speed was equal to or larger than the 1<sup>st</sup> for two of the gears tested.

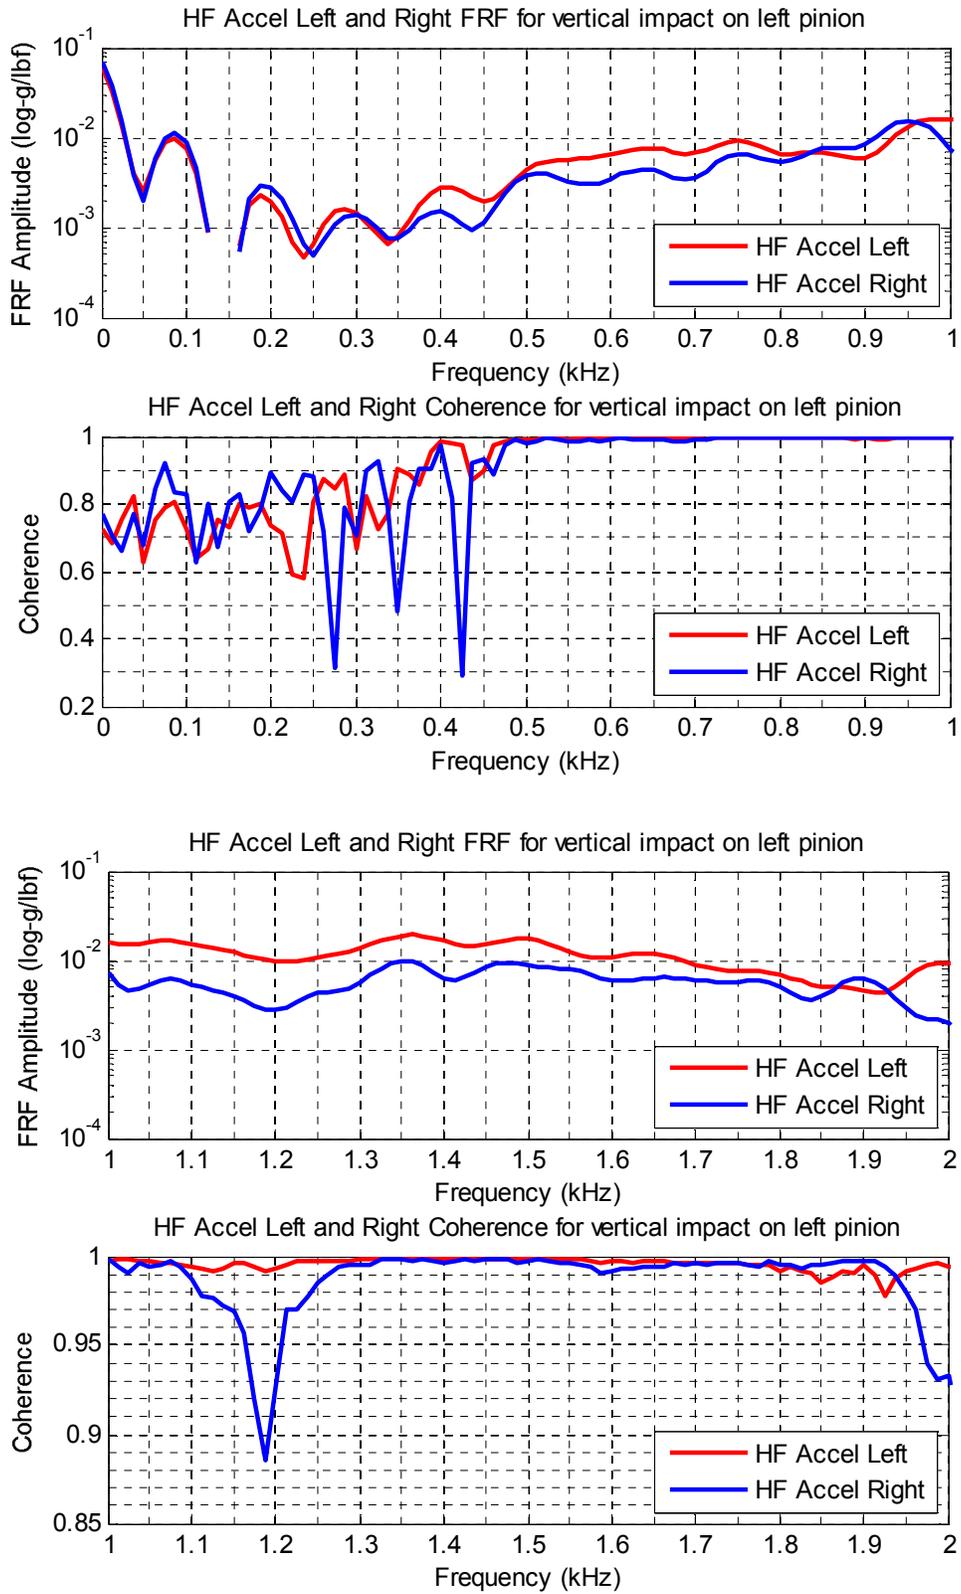
Figure 19.—FRF, Coherence and CDF at 29 percent load measured on right and left.

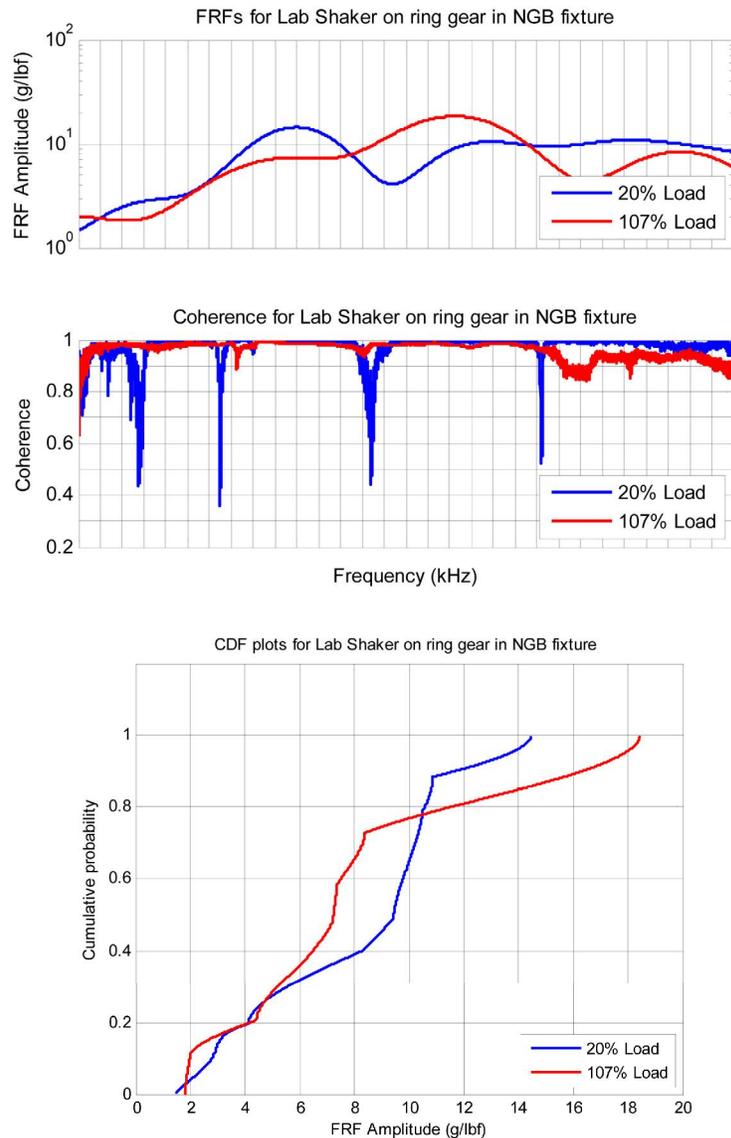
FRFs and coherence were measured with the Dytran accelerometer with the shaker on the ring gear, at a frequency band that contains  $\pm 3$  sidebands around the gear mesh. These measurements were taken at 20 and 107 percent load conditions. These plots and the corresponding CDF plots are shown in Figure 20. The KS Similarity factor within this narrow frequency band between these two loads was equal to 0.68. The coherence improved at the higher load. The shape of the FRF signature changed at the higher load illustrating the importance of assessing the similarities of frequency response within frequencies of interest.

Figure 20.—HUMS FRFs, Coherence and CDF at 20 and 104 percent loads.

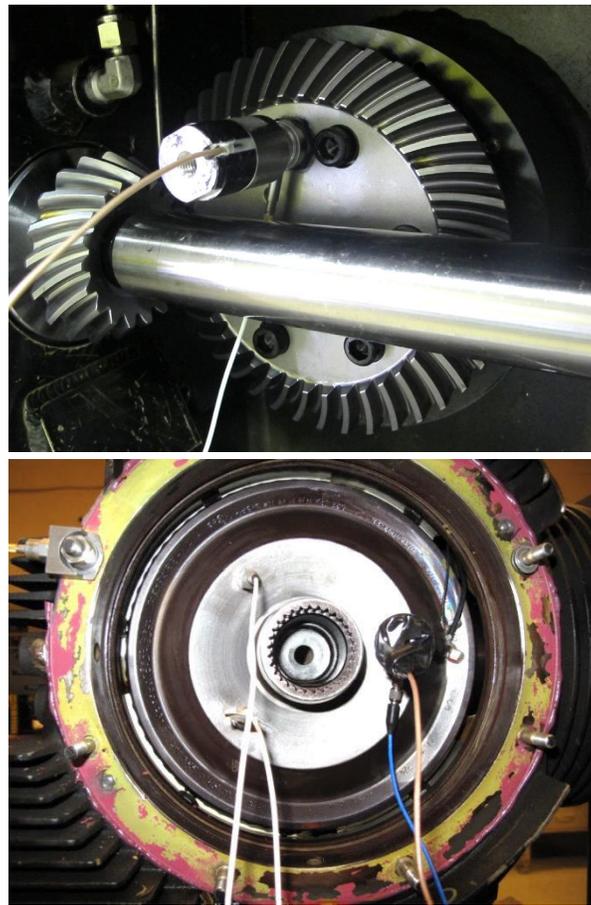
The frequencies of interests are different between the test rig and the helicopter requiring different methods of impact to obtain the 1.8 to 3 kHz versus the helicopter frequency band. It is important to understand how each system structure affects the response of the CI under its operating conditions. The most comparable measurement taken on both systems was the installation of an actuator on the ring gear and measuring the vibration response at the housing. This type of measurement is poor at the lower frequencies of interest for the test rig, due to the low energy of the reaction-mass shaker at low frequency. Figure 21 is a photograph of the piezoelectric actuator installed on the test rig gear and the NGB fixture. The vibration response on the NGB fixture was measured with a high frequency accelerometer with specifications comparable to the test rig HF accelerometers, mounted in the horizontal position. The vibration response on the test rig was measured with the HF accelerometers mounted in the vertical position on the external housing. The gearbox housings are very different, as shown in Figure 2, indicating the vibration transfer paths between the NGB fixture and the test rig would also be different.

Figure 21.—Actuators installed on the test rig and NGB fixture.

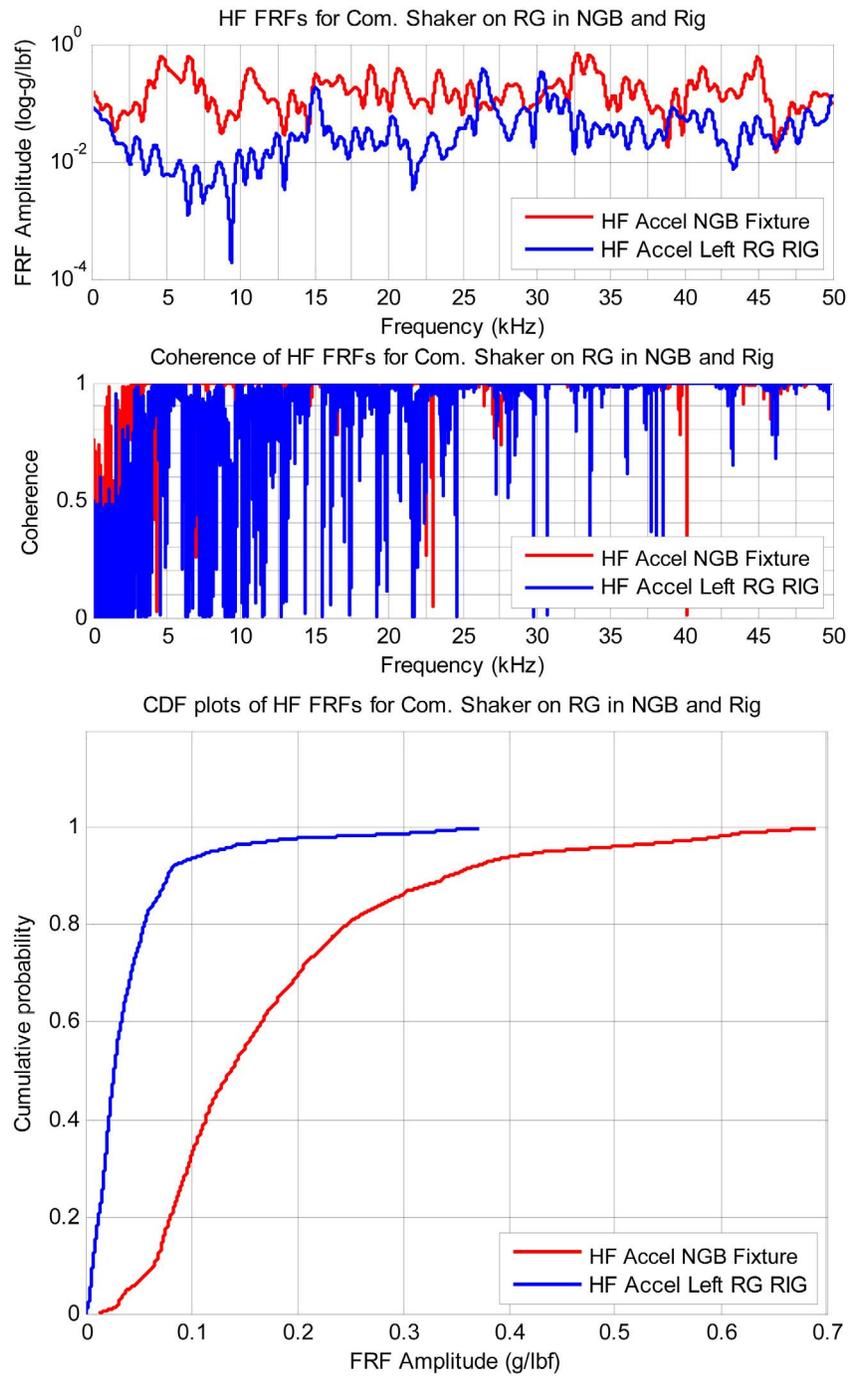
The measurements on the NGB fixture were taken at 4 percent load, while the measurements on the test rig were taken at 46 percent load. The 4 percent load was used for the NGB fixture because these measurements can only be taken at that load. FRFs, coherence and the corresponding CDF plots are shown in Figure 22. The KS Similarity factor for 0 to 50 kHz was equal to 0.25, which indicates very different vibration transfer paths between the two structures. This is no surprise based on the design of the two systems. One interesting observation is that the FRF amplitude is significantly higher on the helicopter indicating the helicopter may be more responsive to gear fault signatures than the test rig. This observation suggests that the helicopter gearbox may generate higher noise that could potentially mask vibration amplitude changes due to faults.

Figure 22.—FRFs, Coherence and CDF of test rig and NGB fixture.
