NASA/TM-2016-219175

# ATD Occupant Responses from Three Full-Scale General Aviation Crash Tests

*Justin D. Littell and Martin S. Annett  
Langley Research Center, Hampton, Virginia*

During the summer of 2015, three Cessna 172 General Aviation (GA) aircraft were crash tested at the Landing and Impact Research (LandIR) Facility at NASA Langley Research Center (LaRC). Three different crash scenarios were represented. The first test simulated a flare-to-stall emergency or hard landing onto a rigid surface such as a road or runway. The second test simulated a controlled flight into terrain with a nose down pitch of the aircraft, and the third test simulated a controlled flight into terrain with an attempt to unsuccessfully recover the aircraft immediately prior to impact, resulting in a tail strike condition. An on-board data acquisition system (DAS) captured 64 channels of airframe acceleration, along with accelerations and loads in two onboard Hybrid II 50<sup>th</sup> percentile Anthropomorphic Test Devices (ATDs) representing the pilot and co-pilot. Each of the three tests contained different airframe loading conditions and different types of restraints for both the pilot and co-

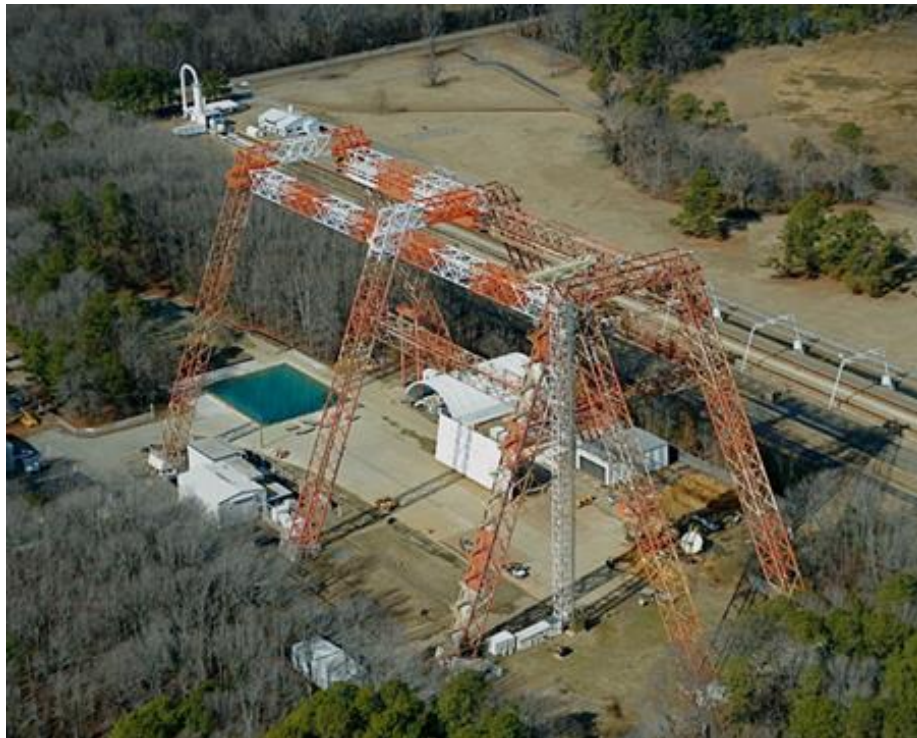
Figure 1 - Landing and Impact Research Facility (LandIR)

Some of the many full-scale tests conducted at LandIR led to improvements in seat certification guidelines [3], the development of parachute recovery system [4], and the development of composite crashworthiness airframe features [5]. The facility continues to provide critical safety research for the aviation community. The LandIR facility is shown in Figure 1.

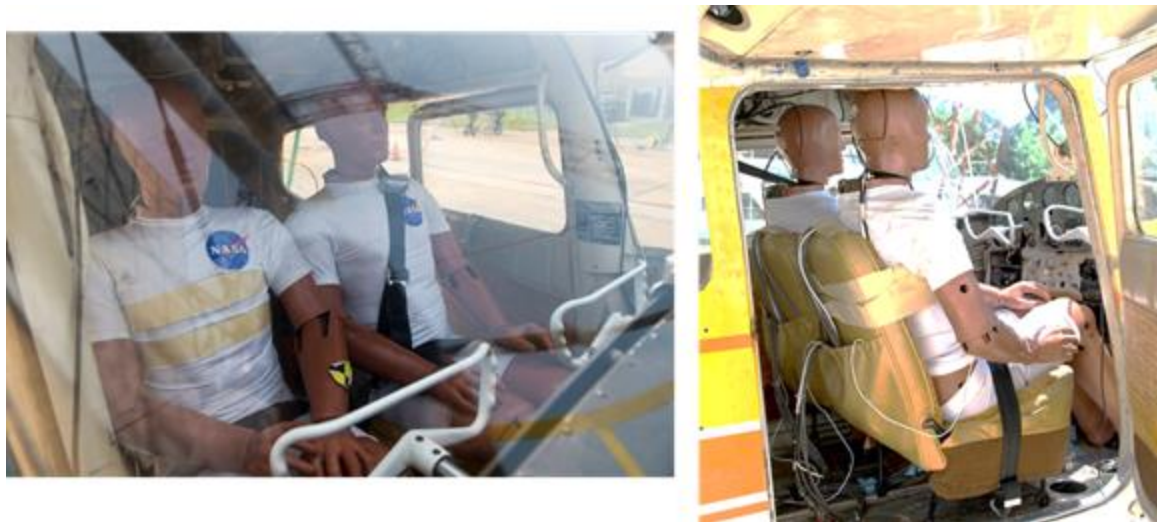
Figure 3 - Test 1 ATD configuration pre-test

The pilot was outfitted with a 3 point restraint, consisting of a fixed lap and shoulder belt. The co-pilot was outfitted with a lap belt only. Figure 3 shows the pre-test setup for the occupants for Test 1. Note since the co-pilot was not wearing a shoulder belt, he was taped into the seat to prevent slouching forward during airplane pullback, prior to impact. The tape was designed to fail upon ground impact.

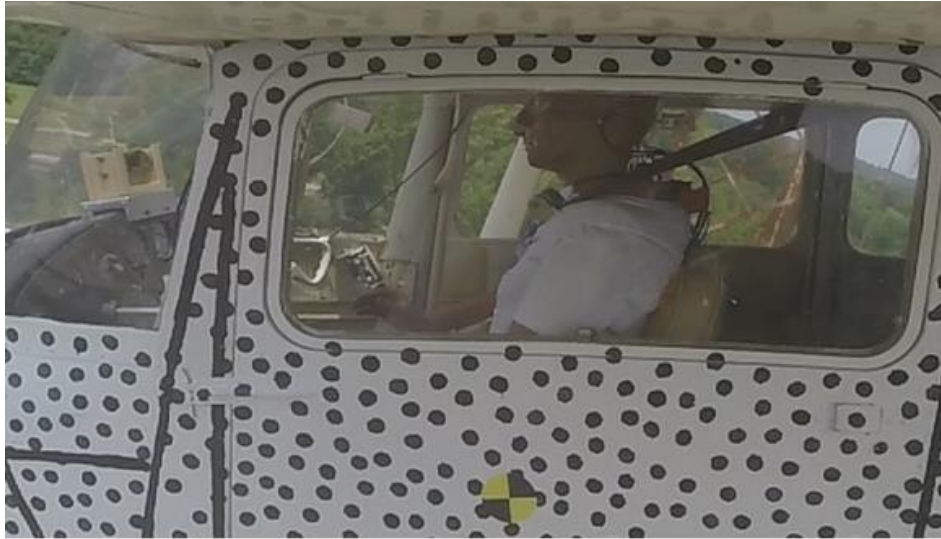
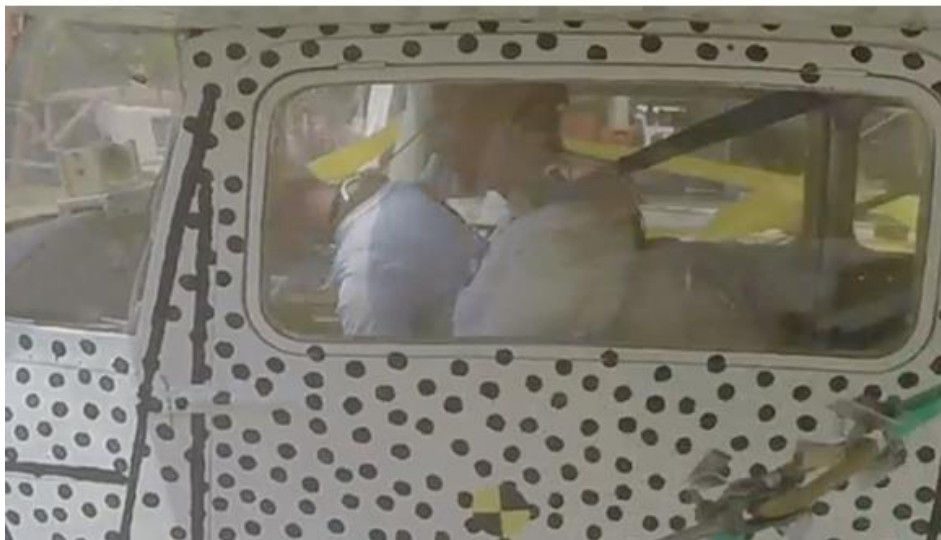
Figure 6 – Test 1 pilot head flail. Before impact (top) and max flail (bottom)

Maximum head flail was further examined for both the pilot and co-pilot. The maximum head flail for the pilot occurred at 1.063 seconds after impact, while the maximum head flail for the co-pilot occurred a short time later at 1.132 seconds after impact. Both of these events occurred from the horizontal deceleration due to the net catch. Figure 6 and Figure 7 show the closest available frame taken from the wing cameras for the pilot and co-pilot, respectively, and compared them to a pre-impact state. Using the best available scaling information based on the known size of the window, the pilot's head experienced slightly less than 4 in. of forward travel. Using the best available scaling information based on the known size of the co-pilot window, the large amount of motion of the co-pilot head achieved a maximum forward displacement of approximately 17 in. when compared to the head prior to impact.

The type of restraint clearly affected the maximum head motion. The addition of the shoulder belt reduced the head motion by approximately 13 in. and clearly prevented the pilot from striking the instrument panel. However, it was unclear from both the wing and the panel video as to whether the co-pilot head had actually made contact with the instrument panel. The acceleration responses from the head are next plotted to obtain insight into the ATD accelerations and loads. Figure 8 first shows the ATD horizontal accelerations.

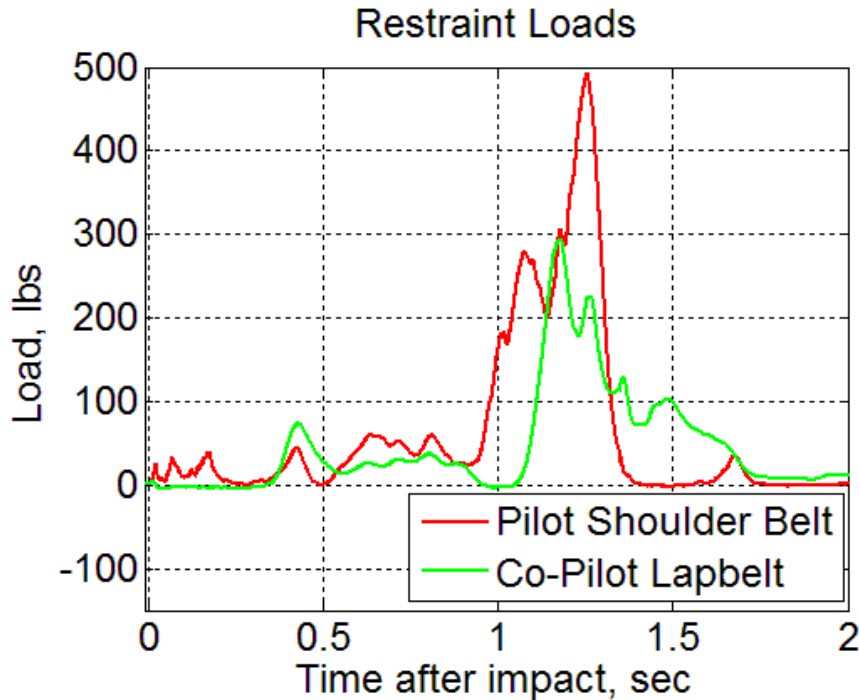
Figure 10 - Test 1 restraint loads

The tension developed in the restraints were next examined and plotted in Figure 10. The tension is measured on the pilot shoulder belt, while the tension is measured on the co-pilot lap belt due to the lack of a shoulder restraint.

The maximum restraint load of 491 lb. occurred at 1.26 seconds after ground contact for the pilot, and the maximum load of 294 lb. occurred at 1.18 seconds after ground contact for the co-pilot. Both of these times were during the horizontal deceleration due to the net capture. While not directly comparable due to differing measurement locations and differing restraint types, it is clear that the shoulder belt required almost 500 lb. of tension to restrain the pilot into the seat with a maximum head displacement of 4 in. Because the shoulder belt was not present in co-pilot, the main restraint was the lap belt, providing almost 300 lb. of tension to restrain the co-pilot into the seat near the co-pilot's pelvic region. The load measured in the pilot shoulder belt was below the 1,750 value specified in the FAR 23.562 [23].

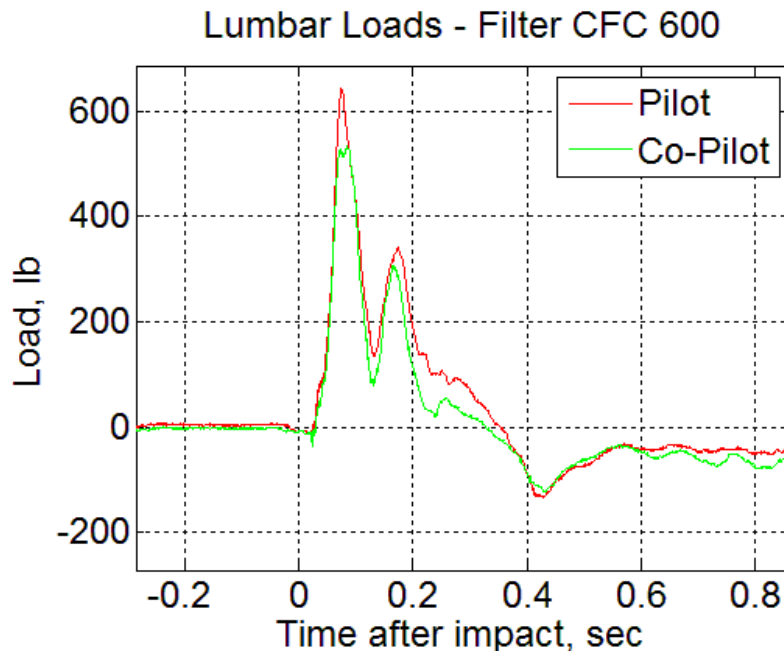
Figure 11 - Test 1 lumbar loads

Lumbar loads were next examined to check for spinal compression injury. Primarily vertical in nature, the main portion of the lumbar loads occurred during the initial ground contact where the highest vertical accelerations also occurred. The lumbar load was minimal during the net capture. Figure 11 shows the measured lumbar loads which occurred during the ground contact.

The pilot lumbar load peaks at 643 lb., while the co-pilot lumbar load shows a peak value of 535 lb., both reaching peaks approximately 0.076 seconds after impact, which was near the beginning of the sustained portion in trapezoidal vertical acceleration profile. The approximate 100 lb. difference could be due to the addition of a shoulder restraint, slight differences in ATD positioning, or the seats themselves. However, both of these values are well below the 1,500 lb. limit established by the FAA in FAR 23.562 [23], indicating spinal compressive fracture likely did not occur.

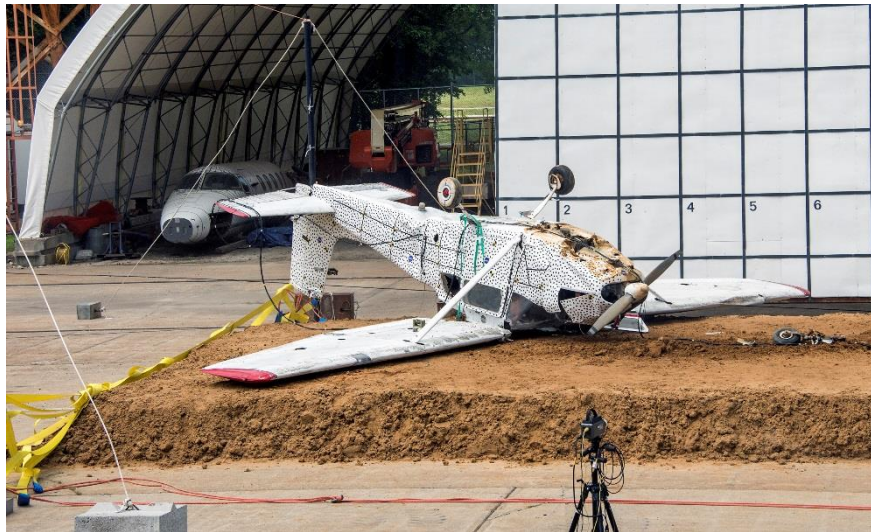
Figure 12 - Post-test orientation of airplane in Test 2

The nose of the airplane first came in contact with the soil due to the nose down configuration of the impact. While the nose and nose gear began plowing into the soil, the forward momentum

caused the airplane to start rotating about the nose/nose gear position, which acted like a pivot point from which to rotate. The airplane started to flip over, which caused the pilot wing to break free and also the tail to buckle. At some point during the flipping rotation, the nose wheel became dislodged from the airframe. The airplane landed upside down almost 2 seconds after impact, and rocked back and forth. Approximately 6.79 seconds after impact, the airplane came to rest, upside down and oriented toward the co-pilot direction. Figure 12 shows the post-crash orientation of the airplane.

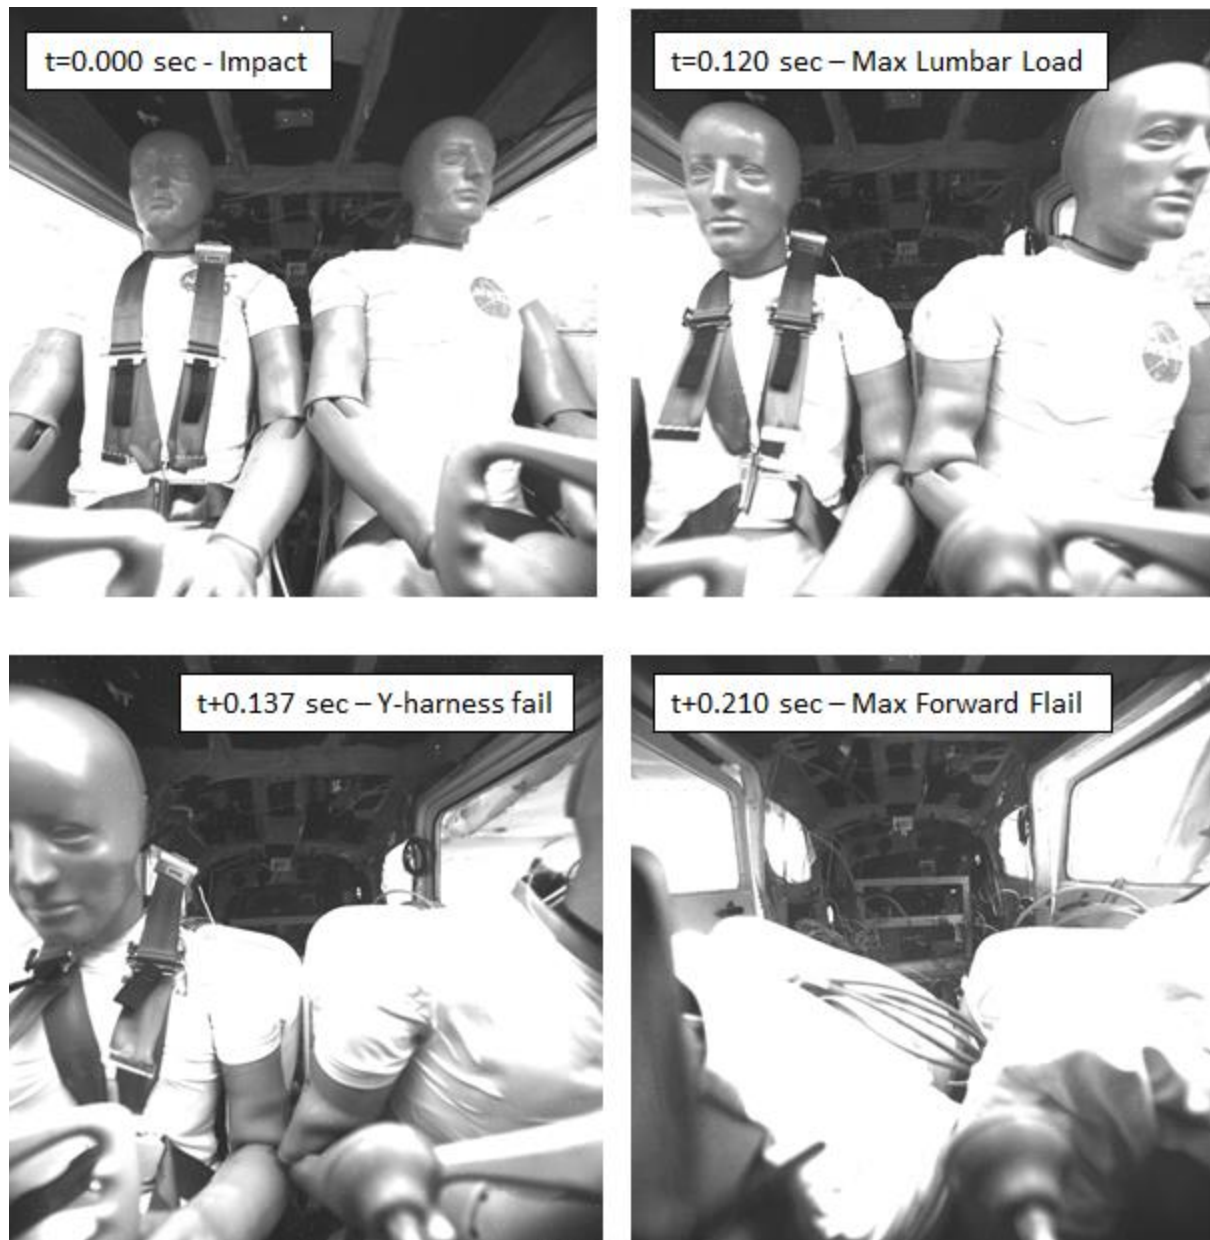
Figure 15 - Test 2 occupant motion sequence - onboard camera

Load cells were located on the lap belt for the pilot and on the left y-harness shoulder strap for the co-pilot. The high speed camera mounted in the instrument panel was able to capture the entire impact event, starting at soil contact and ending after the airplane had flipped upside-down. Four frames of the video are presented in Figure 15. The upper left frame in Figure 15, shows the occupant position at impact. As with Test 1, the ATDs are in a symmetric configuration, sitting upright with their hands on their knees. The upper right frame shows the ATD position at the time of maximum lumbar load, which occurs just after the time of maximum vertical acceleration, but also at the time of maximum horizontal acceleration. The effect of the maximum horizontal acceleration is shown by noting that both ATDs have begun to flail forward. The lower left frame shows a major event happening: the y-harness restraint used on the co-pilot failing at the stitching location. This failure occurred at 0.137 seconds after impact, which is 0.020 seconds after the peak acceleration value measured by the co-pilot floor accelerometers, and will be discussed in detail below. Because this restraint failed, both ATD torsos flailed forward. The lower right frame

shows the maximum forward flail; however, the camera lens was not wide enough to capture the position of each of the ATDs heads at this particular time.

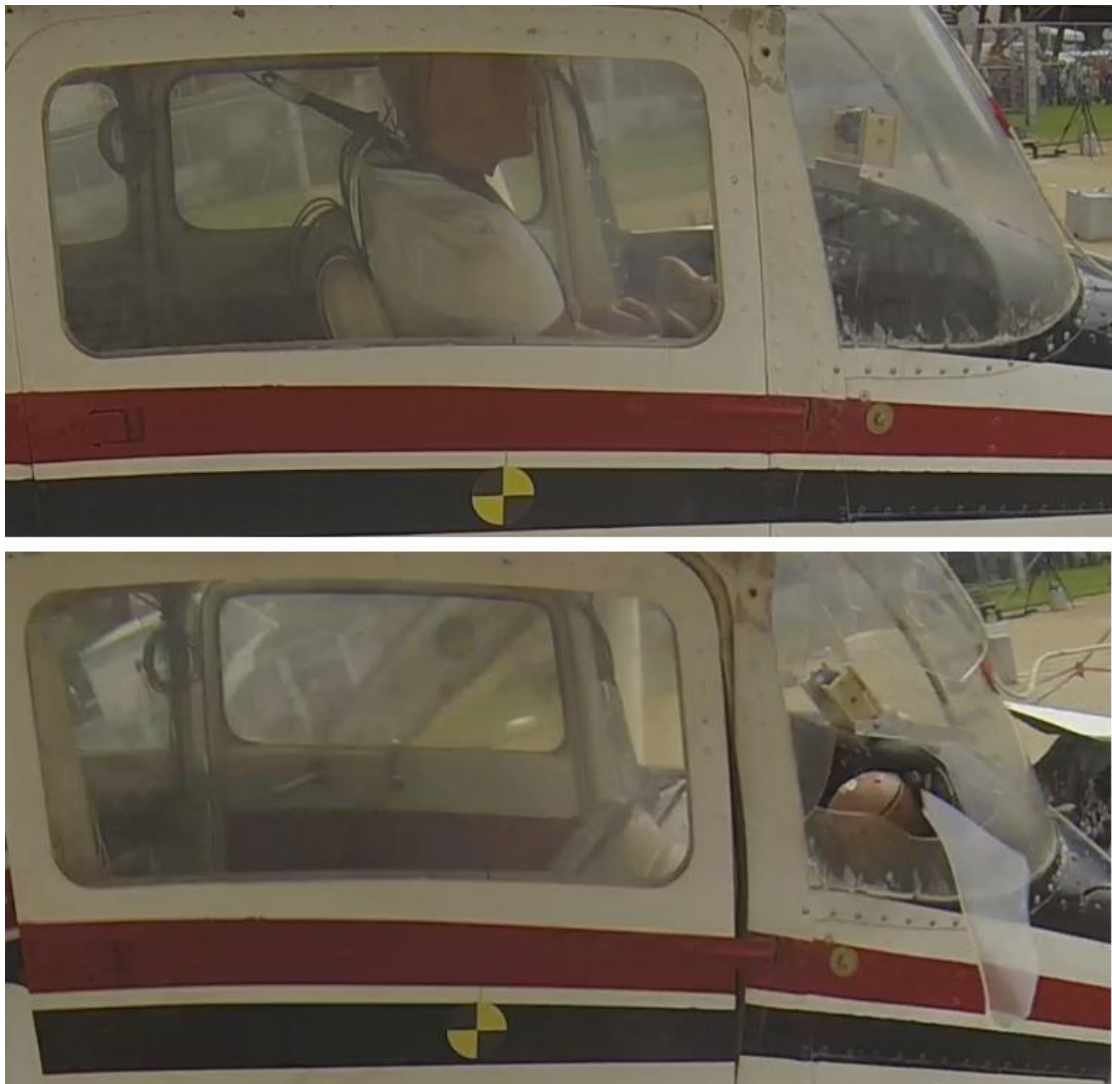
Figure 17 - Test 2 co-pilot head flail. Before impact (top) and max flail (bottom)

The wing camera showing the co-pilot flail was next examined, and is shown in Figure 17. A major result from Test 2 is that the y-harness restraint failed at approximately 0.137 seconds after impact. The failure occurred at the stitching where the “y” portion of the shoulder harness met with the single roof attachment strap. This failure caused the co-pilot to act much like the pilot. However, the additional restraint of the torso due to the y-harness being present (before failure) delayed the forward motion enough that the co-pilot head may have just narrowly missed striking the instrument panel, or potentially struck the instrument panel with much less force than that of the pilot. This finding will be confirmed when examining the acceleration profiles of the ATDs heads.

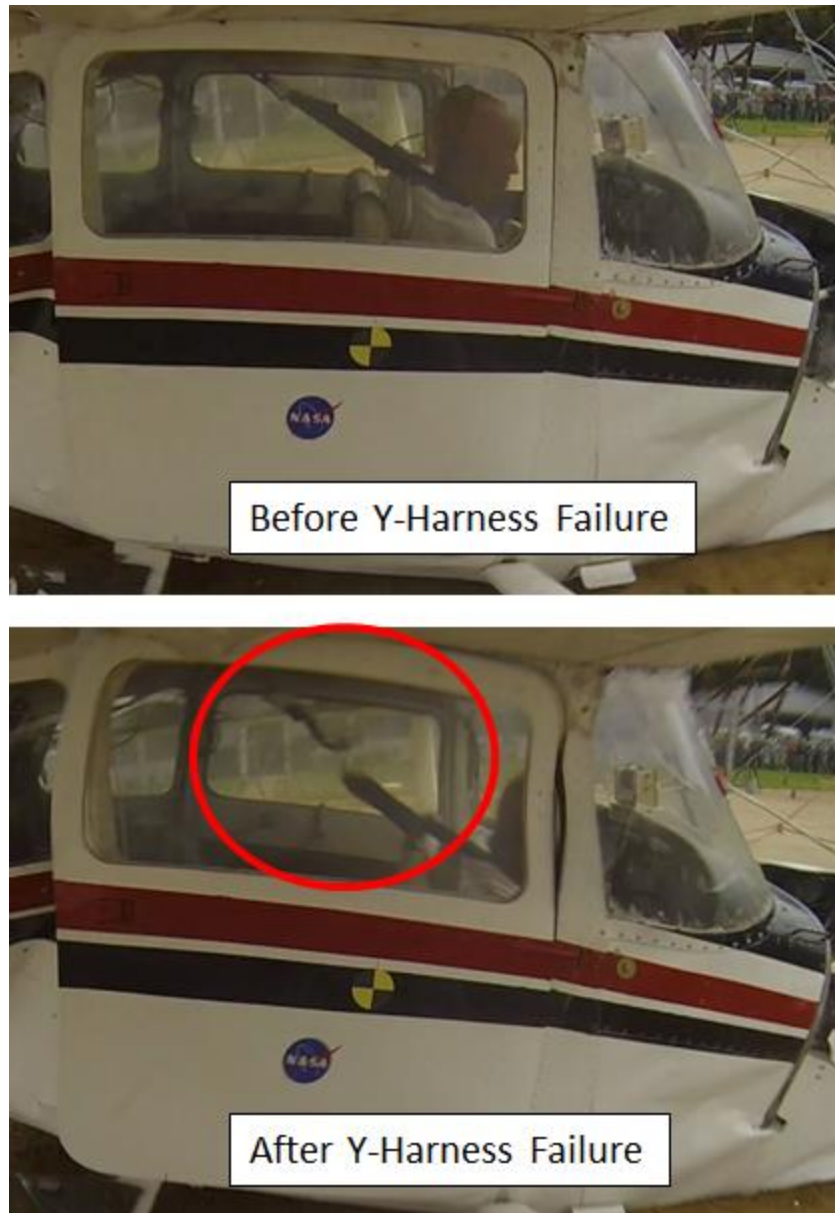
Figure 18 - Test 2 y-harness failure

Figure 18 shows two adjacent frames of video showing the y-harness before and after failure. Post-test inspections of the y-harness showed that it failed in the stitching which connected the y-web portions meant to go over the torso to the single aircraft attachment web. The webbing itself did not fail. Note that because the load cell was measuring a single portion of the y-harness, the loads can be assumed to be double the measured value on both the stitching and aircraft attachment webbing.

In this test, two types of restraints were used, a lap belt only and a lap belt with y-harness. Surprisingly, the y-harness failed in the stitching at the junction between the y and the overhead attachment strap, at an estimated load of 1,140 lb. After the failure, both the pilot and co-pilot head accelerations experienced significant spikes, with the spike in the pilot head being large enough to register over the HIC limit. Even though the y-harness failed and the co-pilot likely impacted the instrument panel or yoke, the severity of the impact was much reduced due to the restraint of the y-harness, prior to failure.

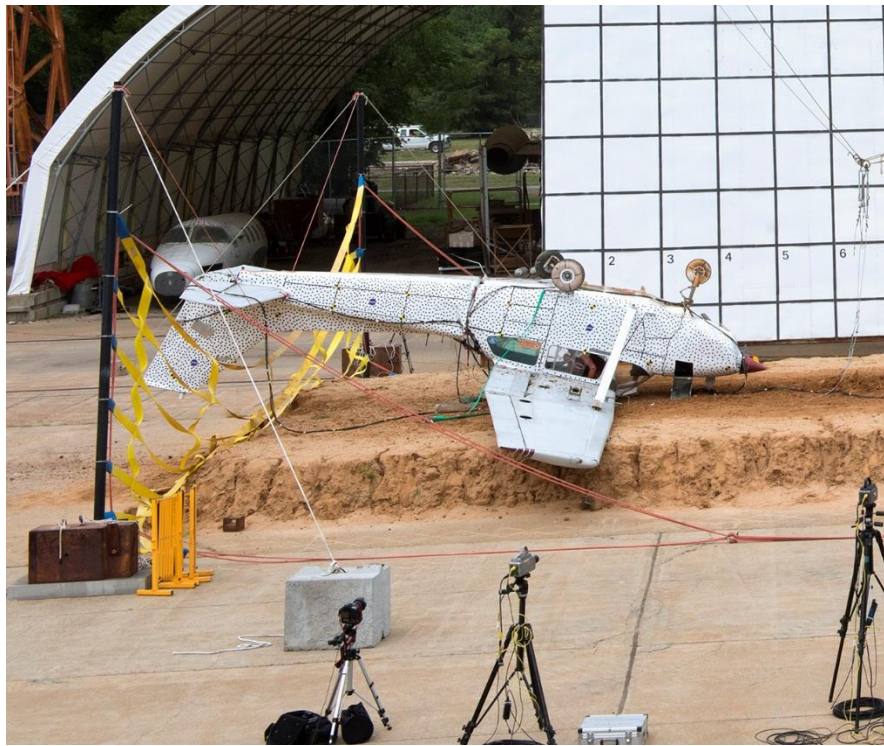
Figure 26 - Post-test orientation of airplane in Test 3

Due to the slight amount of roll and yaw, the airplane left main gear impacted the soil first. Shortly thereafter, the tail contacted the surface at 0.030 seconds after impact. The tail contact created a slap down effect where a significant amount of nose down rotation occurred at a pivot point on the tail. This slap down effect caused the nose gear, along with the nose of the airplane to contact the soil 0.116 seconds after impact. As with Test 2, after the nose gear penetrated into the soil surface, the airplane started to flip around the nose, which acted like a pivot point. Unlike Test 2, however, the tail developed a fracture aft of station 108 at 0.138 seconds after impact. This fracture caused the tail to peel away from the fuselage, acting much like a hinge. A small portion of skin on the bottom of the aircraft retained the tail to the rest of the airplane during the rotation. The rotation of the aircraft lasted until approximately 1.53 seconds after impact, at which time the ceiling of

the airplane contacted the soil. The airplane rocked for a few seconds before finally coming to rest at almost 5 seconds after initial impact. The post-test configuration of the airplane in Test 3 is shown in Figure 26.

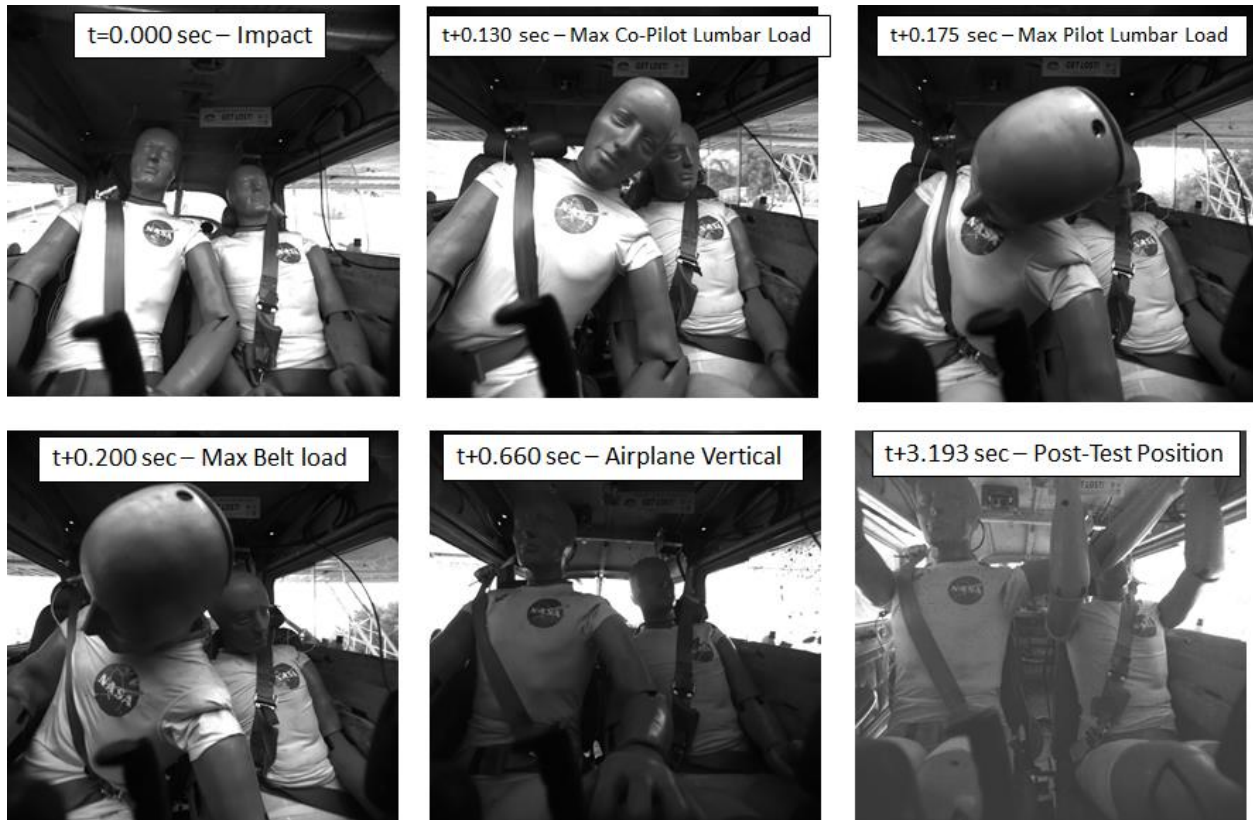
Figure 28 - Test 3 occupant motion sequence - onboard camera

An onboard camera, mounted in the instrument panel, captured the ATD motion throughout the entire crash sequence. Individual frames showing notable events were extracted from the video, and are presented in Figure 28. Airplanes used in Tests 1 and 2 did not have armrests on the doors. The armrests on the doors of the Test 3 airplane obstructed the positioning of the elbows; therefore, the ATDs had to be offset in order to fit in the cabin. The upper left picture shows the co-pilot left arm sitting slightly overlapping the pilot arm. Similar to Test 2, the maximum load in the co-pilot lumbar region is very early in the impact event, occurring at 0.130 seconds after impact. At this point, due to the co-pilot initial position, the co-pilot has started rotating about the shoulder restraint causing the head to lean toward the pilot position. The upper right image shows the pilot at the time of maximum lumbar loading which occurs slightly later in the impact event at 0.175 seconds. At this point, the co-pilot head has started to point straight forward. At 0.200 seconds after impact, the maximum loads developed in the shoulder restraint occurred both for the pilot and co-pilot. The bottom middle image shows both occupants seated normally while the airplane was flipping over, and this image was taken when it had achieved a vertical orientation. The bottom right picture shows the occupants, post-test, with their hands out pointing toward the ground, and in a symmetric configuration. The wing cameras were next examined to show maximum flail in the pilot and co-pilot.

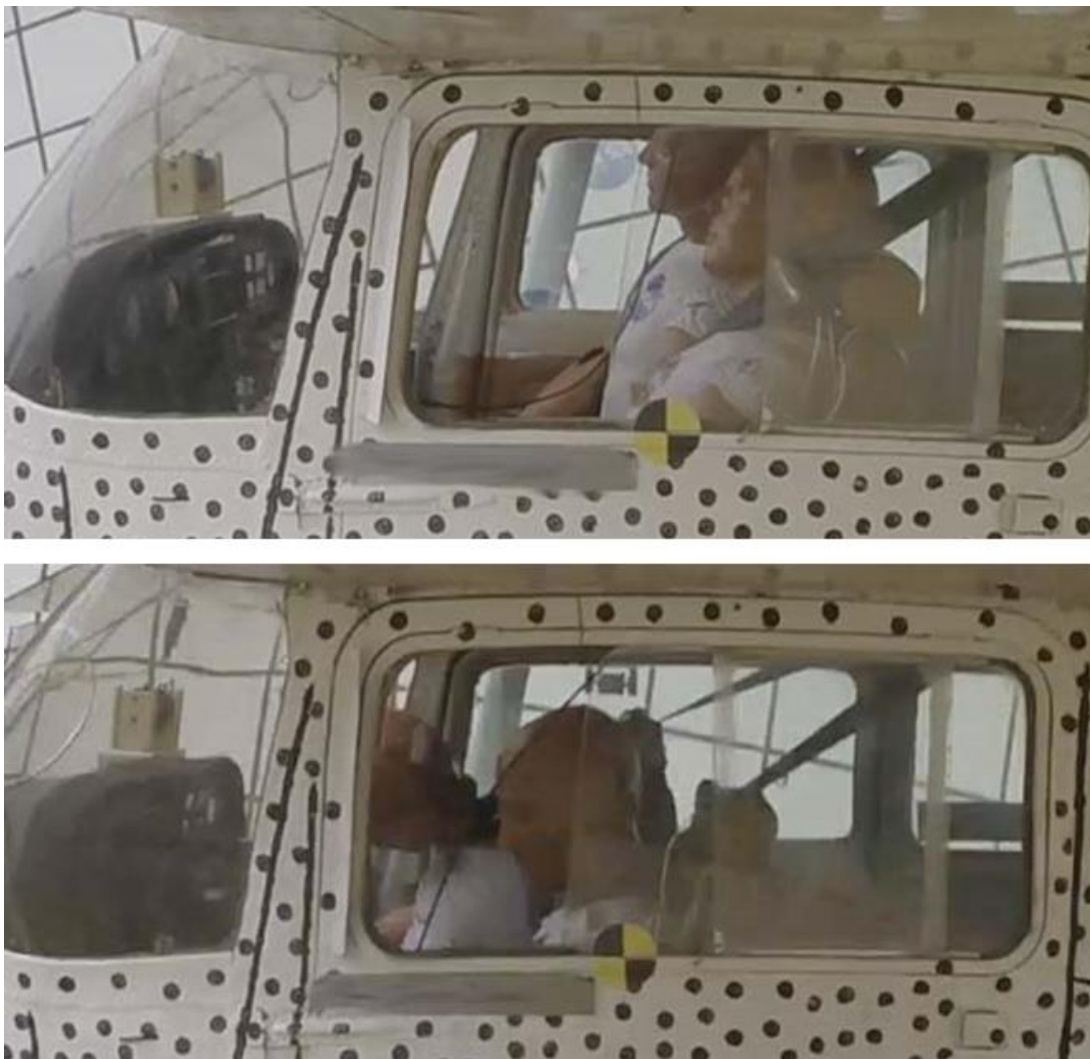
Figure 29 - Test 3 pilot head flail. Before impact (top) and max flail (bottom)

The image series of the pilot taken from the wing camera is shown in Figure 29. Using the best available scaling information based on the window dimensions, the maximum flail encountered in the head of the pilot was 7.27 in. in the forward direction. However, the pilot was never in danger of striking either the yoke or the instrument panel, even with the rotation and flipping over of the airplane.

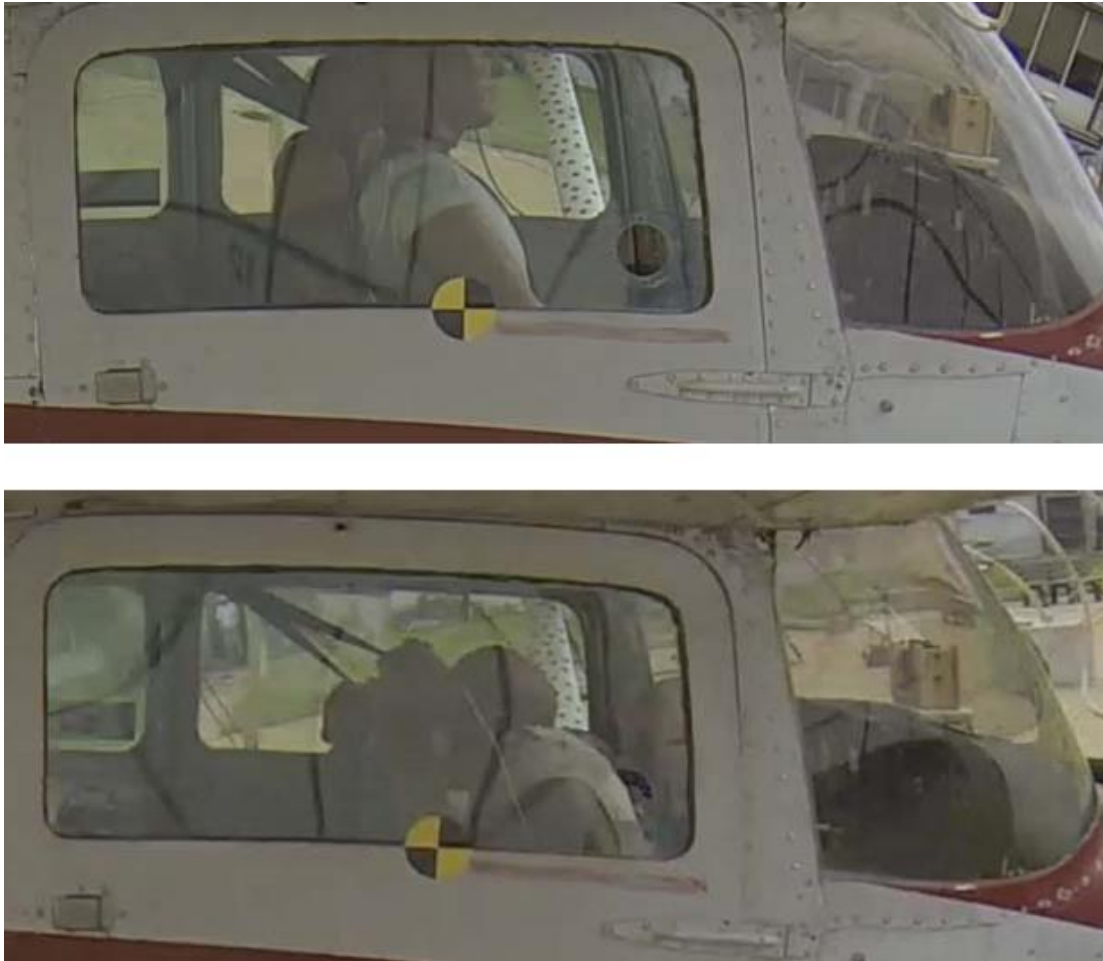
Figure 30 - Test 3 co-pilot head flail. Before impact (top) and max flail (bottom)

The co-pilot flail was next examined and is shown in Figure 30. Using the best available scaling information based on the window dimensions, the maximum flail encountered in the head of the co-pilot was 12.5 in. in the forward direction, which was approximately 5.25 in. more than the pilot.

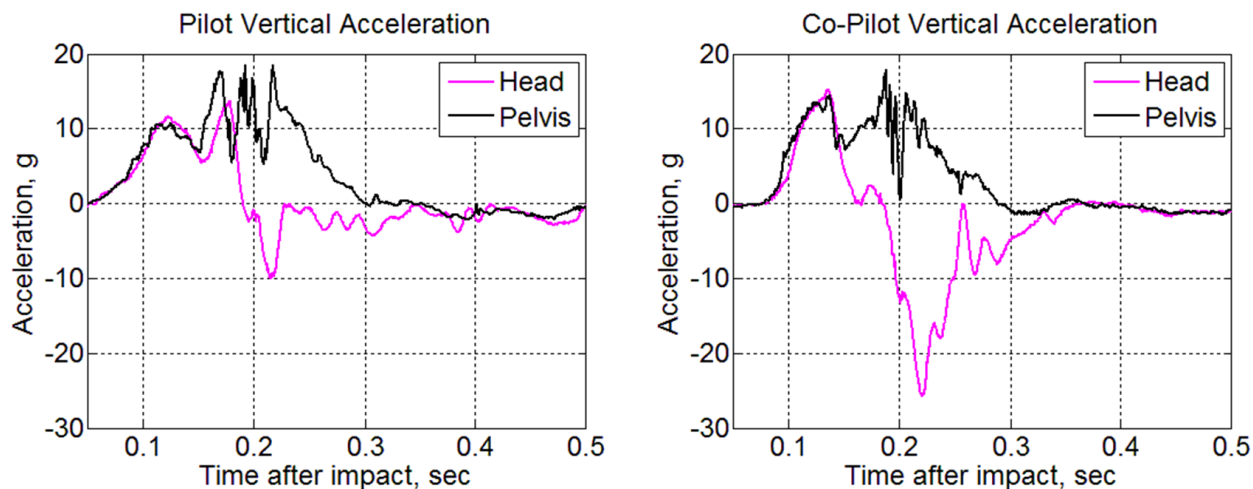
Figure 34 - Test 3 ATD vertical acceleration. Pilot (left) and co-pilot (right)

Vertical accelerations were next examined, and are shown in Figure 34. The pilot and co-pilot also experienced similar vertical magnitudes and shapes, with the notable exception of the head of the co-pilot. Due to the large amounts of rotation of the co-pilot head and torso around the shoulder harness, the head reaches a maximum acceleration of -25.7 g at approximately 0.22 seconds after impact, which is near the time of maximum belt load and also maximum flail. The pilot, in contrast, only experiences a maximum acceleration of -9.9 g. The pelvic vertical accelerations were almost identical both in shape and magnitude, reaching peaks of 18.5 g and 18.0 g for the pilot and co-pilot, respectively. These numbers were then used for the HIC computation, which is shown in Table 4. Because neither the pilot nor co-pilot head impacted either the instrument panel or yoke, the HIC limits for Test 3 were well below the established limits of 1,000.

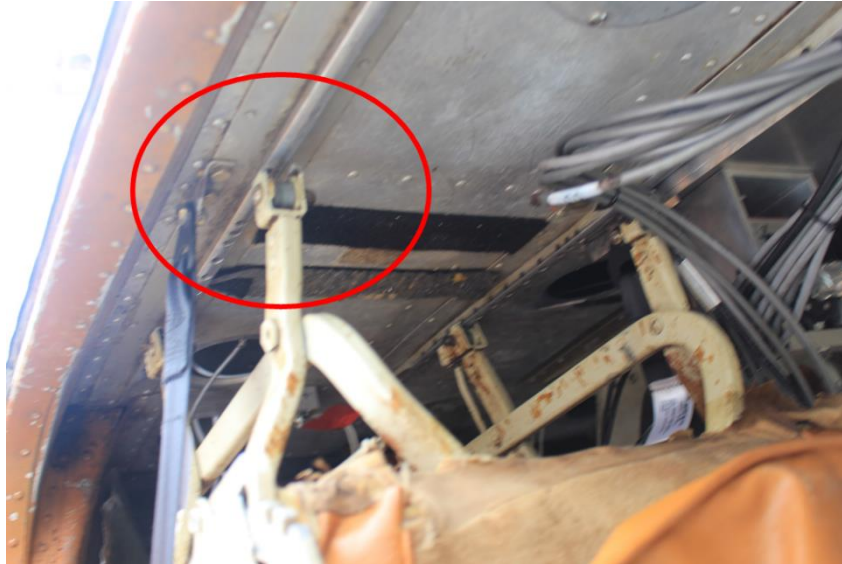
Figure 35 - Test 3 co-pilot seat pullout

Similarly to Test 2, the aircraft experienced a large amount of rotation due to it flipping over at impact. The chair rails were examined for signs of pull out or failure. The co-pilot chair was pulled out on the rear outboard leg, and cracking was evident in the rail itself. The pilot seat fared much better with no signs of pullout or seat rail cracking. The pullout in the co-pilot chair is presumably due to the large amount of forward motion experienced in the co-pilot. The pilot, in contrast, did not experience significant motion. A picture of the co-pilot rear outboard leg taken at the impact location immediately after Test 3 is shown in Figure 35.

co-pilot from severely striking the yoke or instrument panel, saving what could have been a cranial fracture. In Tests 2 and 3, there were clear signs of seat rail failures and seat pullout. These failures were mainly due to the large amount of forward flail of the occupants compounded with the rotation of the airplane during the test.
