Upstream Factors Affecting Tualatin River Algae— Tracking the 2008 *Anabaena* Algae Bloom to Wapato Lake, Oregon

Scientific Investigations Report 2015–5178

By Stewart A. Rounds, Kurt D. Carpenter, Kristel J. Fesler, and Jessica L. Dorsey

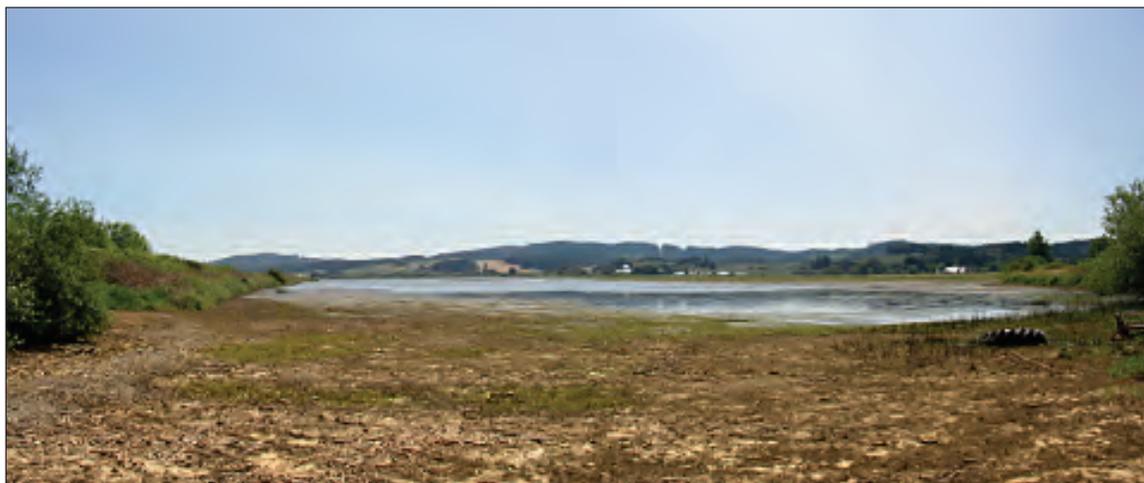
Figure 2. A partially drained Wapato Lake, Oregon. (Photograph taken by Stewart Rounds, U.S. Geological Survey, July 19, 2008.)

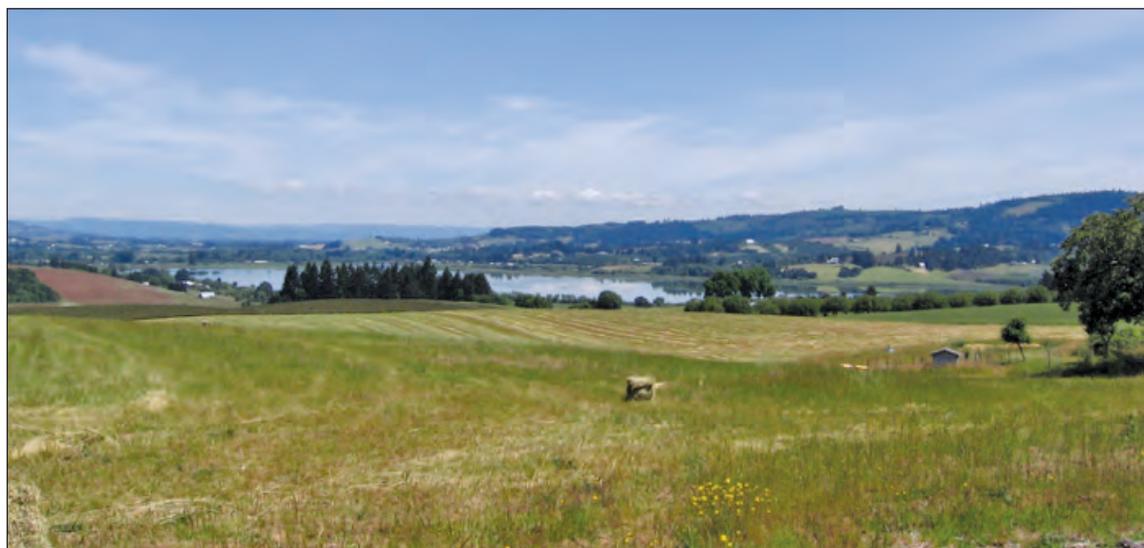
Figure 3. Wapato Lake, Oregon, viewed from the west. (Photograph taken by Matt Nussbaumer, City of Hillsboro, June 25, 2008.)

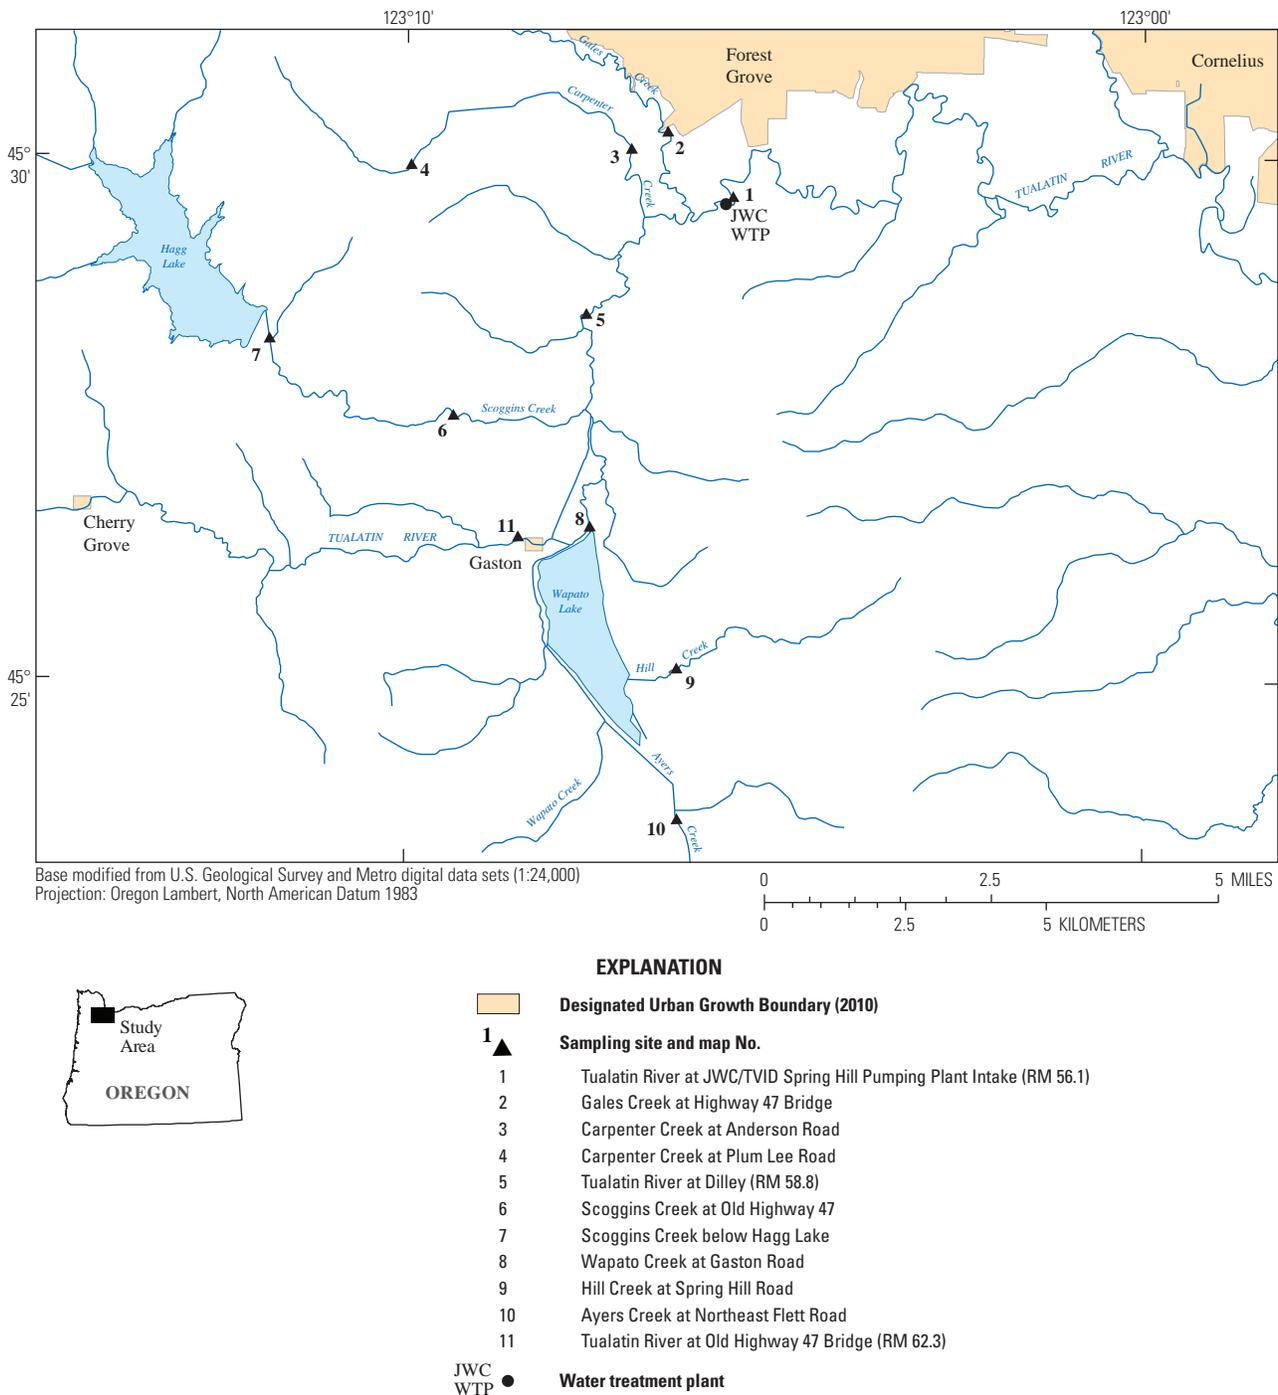
Figure 5. Sampling sites in and near the Wapato Lake agricultural area in the upper Tualatin River basin, Oregon.

The Wapato Lake agricultural area near Gaston (fig. 5) includes a 730-acre lake and wetland that historically supported a wild crop of wapato, a potato-like bulb considered a “First Food” of Native Americans. Winter rains once expanded the seasonally inundated area to nearly 1,500 acres, creating an extensive wetland with scrub-shrub plant communities that supported large numbers of resident and migrating bird populations and waterfowl (U.S. Fish and Wildlife Service, 2007; Clean Water Services, 2010). The soils

onions and other crops. Irrigation water was delivered through a diversion at RM 61.9 on the Tualatin River. Water pumped out of the lake flows into Wapato Creek, which flows north for about 1 mile until it joins the Tualatin River at RM 60.1. The Spring Hill pumping plant that feeds the JWC WTP is located at RM 56.1, only 4.0 mi downstream of the confluence of Wapato Creek with the Tualatin River. In 2008, the U.S. Fish and Wildlife Service began to purchase parcels of the lakebed inside the levees and now manages the area as the Wapato Lake National Wildlife Refuge. During the period of interest in 2007–08, however, the area was still managed by the Wapato Improvement District.

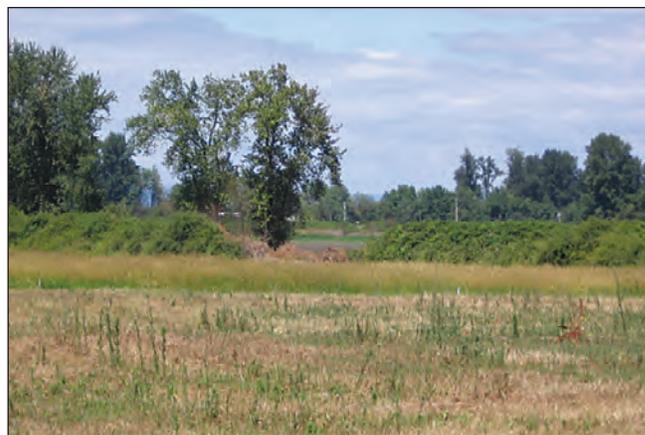
On December 2–3, 2007, more than 6 in. of rainfall were recorded at several weather stations across the Tualatin River basin, causing near-flood levels in the Tualatin River at Gaston (RM 62.3) and Dilley (RM 58.8). The peak streamflow at Dilley was nearly 10,000 ft³/s—almost identical to the peak streamflow recorded during the large flood of February 1996. During these high-water conditions, a small section of the aging levee on the west side of Wapato Lake failed

Figure 6. Breached dike before repair, west side of Wapato Lake, Oregon. (Photograph taken by Matt Nussbaumer, City of Hillsboro, July 30, 2008.)

(figs. 6–7), causing water to inundate the lakebed to a depth of approximately 7–9 ft. The levees normally keep water levels in the lake low by diverting tributaries around the outside of the lake and restricting inflows to rainfall, groundwater seepage, and some leakage through the levees. Without first repairing or temporarily patching the levee, Wapato Improvement District personnel could not pump flood waters out of the lake because discharges would return to the lake through the levee breach. The breach could not, however, be repaired because high water levels prevented access. Consequently, the lake was not drained in early spring as usual, and water remained ponded on the lakebed until early summer when river levels finally receded enough to render the breach inconsequential. The levee may or may not have been temporarily patched in early June, but a full levee repair was completed in early September 2008.

The 2008 Wapato Lake algae bloom was an important reminder that proactive engagement in the watershed is important. JWC expended more than \$300,000 in extra treatment costs during summer 2008, mainly associated with the need to add powdered activated carbon to resolve taste-and-odor issues. JWC also donated services and materials to the Wapato Improvement District to fully repair the Wapato Lake levee.

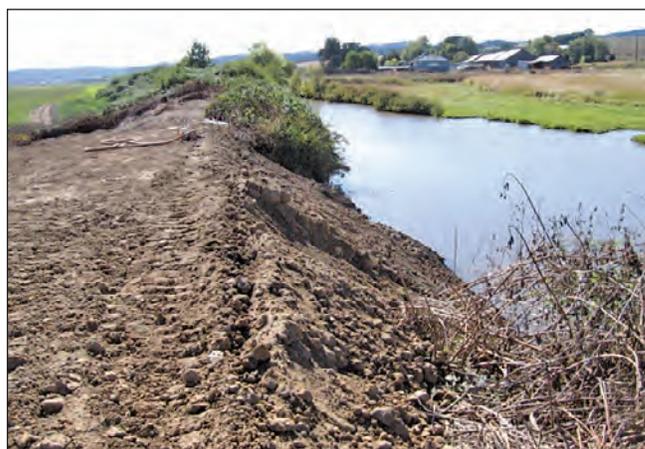
Figure 7. Repaired levee separating Wapato Lake and Wapato Creek on the west side of Wapato Lake, Oregon. (Photograph taken by Matt Nussbaumer, City of Hillsboro, September 23, 2008.)

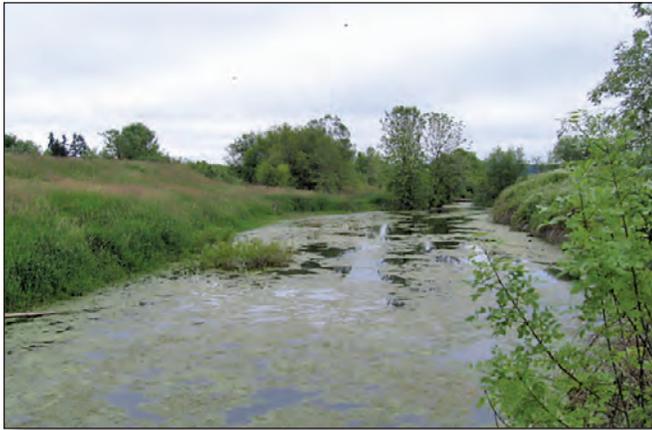
As water remained on the lakebed into early summer, the water warmed, became nutrient-enriched, and developed a bloom of algae (fig. 8). Some water likely left the lake through the levee breach as river levels began to recede. Once water levels dropped below the levee breach, pumps were turned on and the algae-laden and nutrient-rich lake water was discharged to Wapato Creek and then downstream to the Tualatin River at RM 60.1. During pumping, a number of dead fish (carp, catfish, bluegill, and perch) were observed (fig. 9) that presumably had entered the lake with the floodwaters. These fish may have died as a result of warm temperatures, low DO concentrations, or injuries sustained while passing through the pumps (Oregon Department of Environmental Quality, 2008).

Figure 8. Algal bloom and duckweed in the internal canal leading to the pump house at Wapato Lake, Oregon. (Photograph taken by Matt Nussbaumer, City of Hillsboro, on June 18, 2008.)

calls were received by JWC, and the local media published several stories on the drinking-water issue. JWC attempted to remedy the issue with various operational and distribution methods, but without success. Suspecting certain taste-and-odor compounds in the raw source water, JWC staff began to look for potential sources during their routine stream-monitoring activities. On June 11, JWC staff were alerted that Wapato Lake was still full of water; normally it would have been pumped out and growing crops by June. Also on June 11, floating algal mats were observed in the internal Wapato Lake canal that routes lake water to the pump house ([fig. 8](#)).

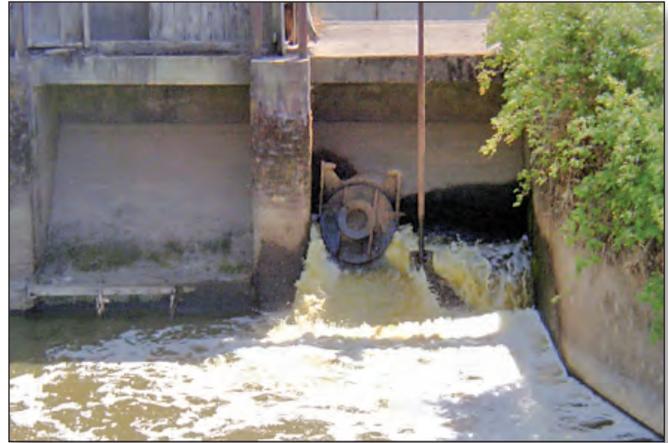
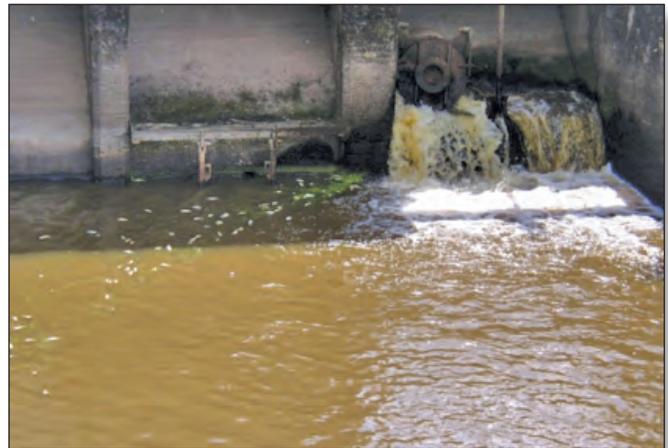
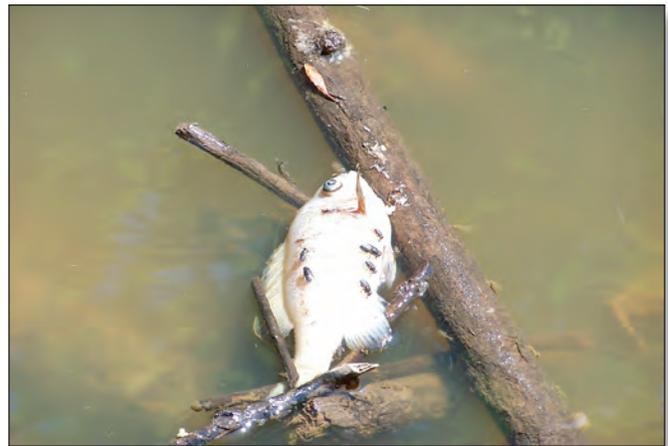
Figure 9. Wapato Improvement District's pump house discharge from Wapato Lake, Oregon (A–B) and dead fish in the discharge pool (B–C). (Photographs A and B taken by Stewart A. Rounds, U.S. Geological Survey, August 8, 2008; photograph C courtesy of the U.S. Fish and Wildlife Service.)

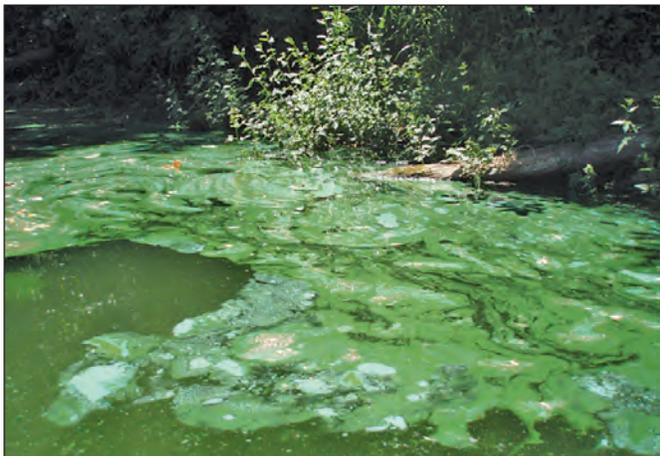
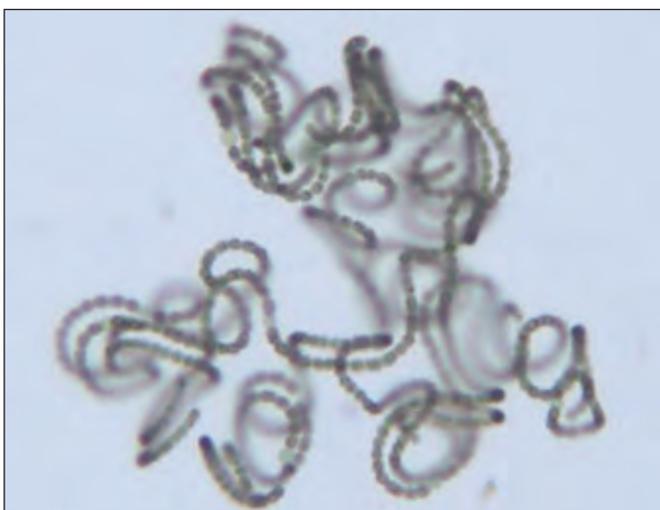
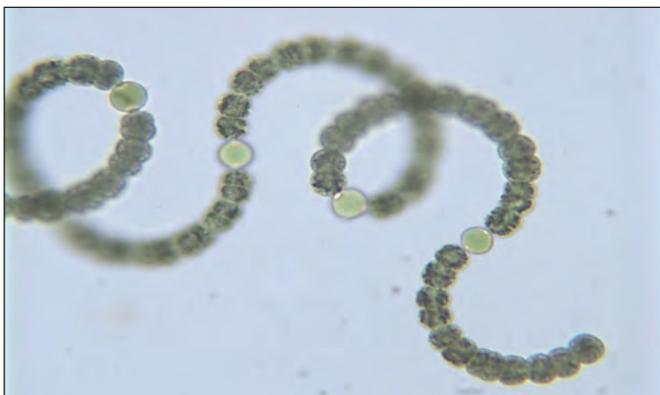
The Wapato Lake discharge was the likely cause of nuisance surface scums of algae many miles downstream (fig. 10) and a contributor to low-DO conditions later that summer (Carpenter and Rounds, 2013, table 14). Algal growth in Wapato Lake was the likely source of geosmin and organic carbon that required additional treatment by JWC's water treatment plant. Geosmin has a taste and smell that often is described as "earthy" or "musty," and is resistant to oxidation by the conventional drinking water treatment methods typically used by the JWC WTP (Izaguirre and others, 1982), potentially resulting in drinking water with an objectionable taste and smell.

Figure 10. Floating mats of blue-green algae (*Anabaena flos-aquae*) in the Tualatin River upstream of Stafford Road (A) and microscopic views of a colony (B) and filament of *Anabaena* (C) in the Tualatin River, Oregon. (Photograph A taken by Brian Wegener, Tualatin Riverkeepers, July 17, 2008; photographs B and C taken by Kurt Carpenter, U.S. Geological Survey, July 9, 2008.)

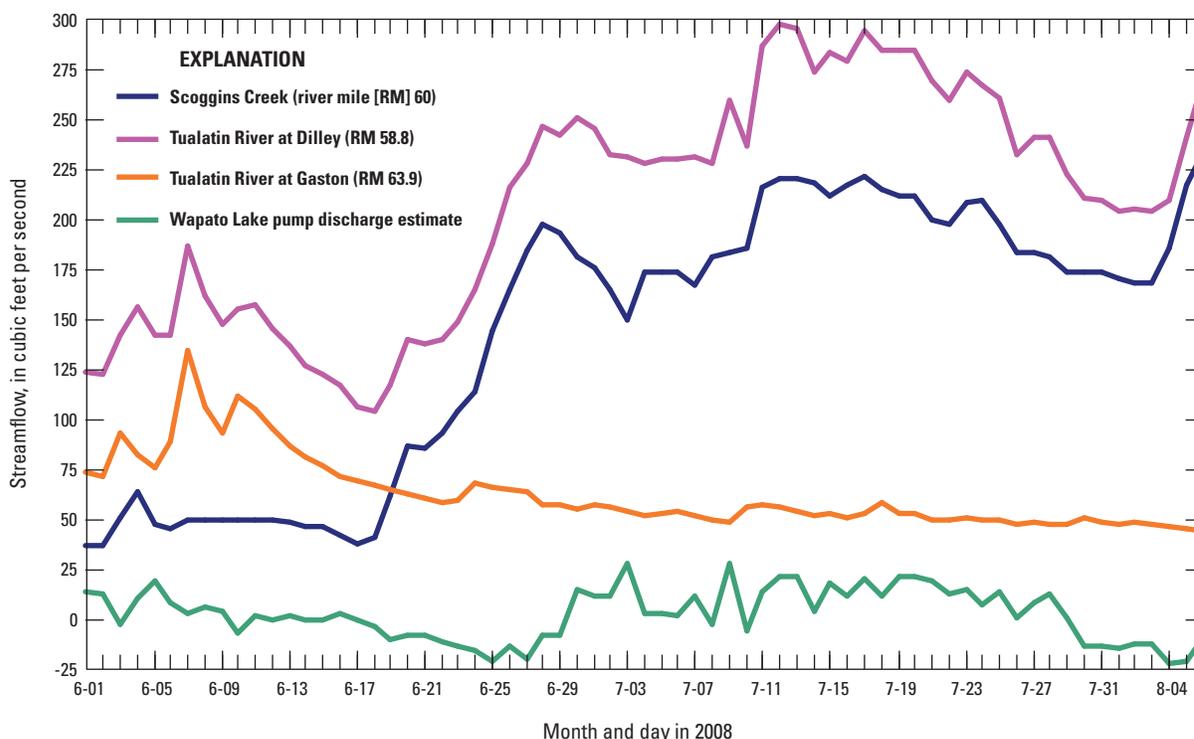
Figure 11. Estimated discharge from the Wapato Creek drainage (and Wapato Lake), as estimated from a mass balance of measured streamflows in Scoggins Creek and the Tualatin River, Oregon, June–July 2008.

The algal bloom in the lower Tualatin River ended soon after pumping from Wapato Lake mostly ceased (large pump turned off) at the end of July (fig. 11), as evidenced by a return to normal DO conditions at the water-quality monitor at RM 24.5 about 5 days later (fig. 14, table 3). Samples collected by ODEQ on August 1 confirmed that water-quality conditions had returned to more-normal levels in Wapato Creek and the Tualatin River at Dilley (table 10). The public health advisory was lifted July 25 after it was evident that *Anabaena* concentrations in the lower Tualatin River had decreased substantially (table 6).

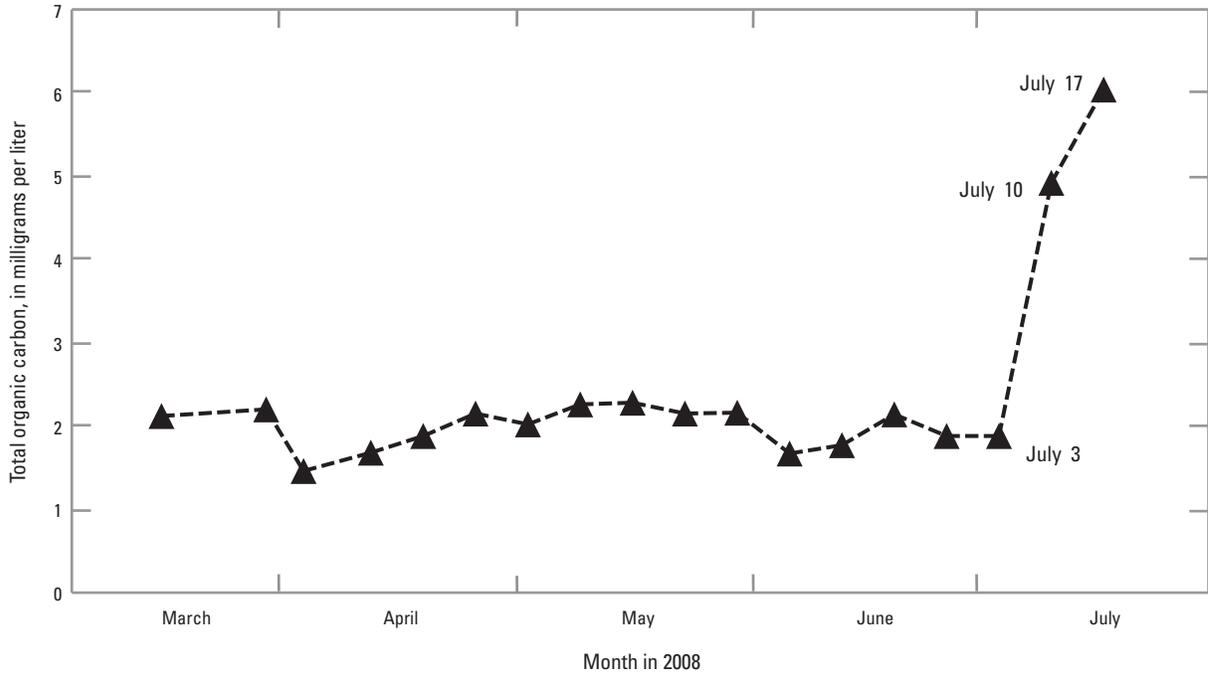
Figure 12. Total organic carbon concentrations in the Tualatin River at the Spring Hill pumping plant (river mile 56.1), Oregon, March–July 2008.

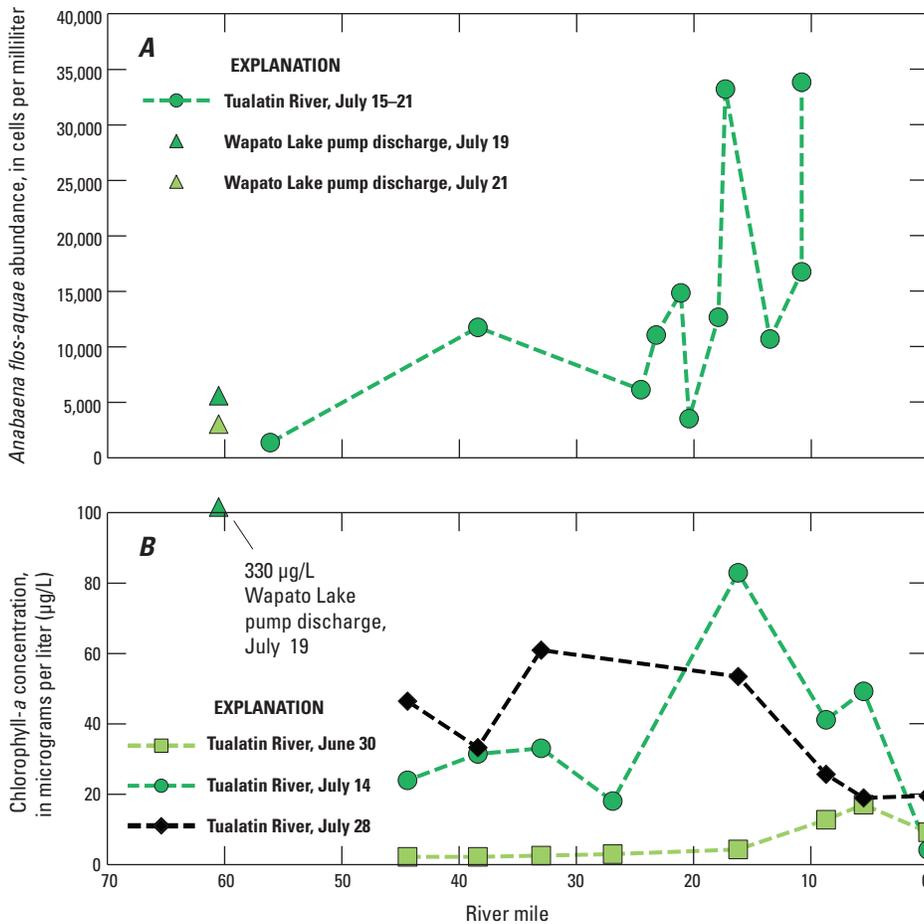
Figure 13. Longitudinal pattern in *Anabaena flos-aquae* abundance (A) and chlorophyll-*a* concentrations (B) in the Tualatin River along with measurements from the Wapato Lake pump discharge, Oregon, July 2008. (A) Samples were collected during a 7-day period (July 15–21), and travel times vary between sites; therefore, values are not necessarily comparable between sites, but the general pattern is valid (see table 6 for specific data points). (B) Data are from Clean Water Services (see table 5).

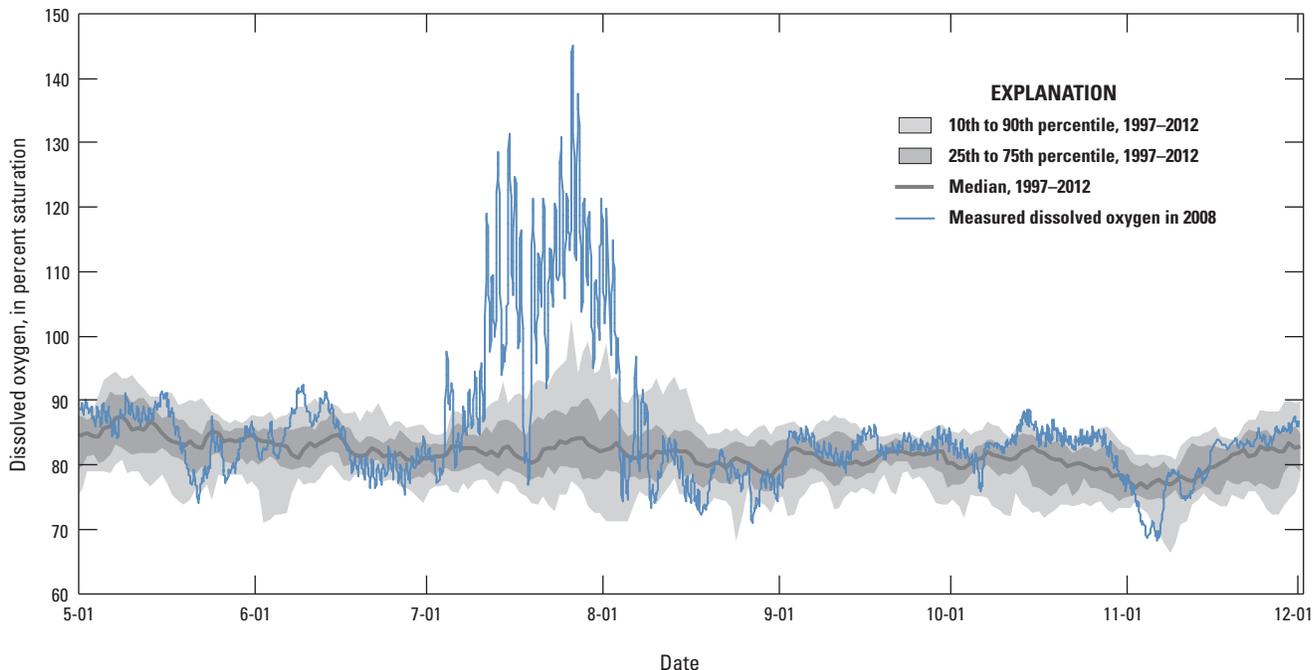
Data from the USGS continuous monitor in the Tualatin River near Scholls (RM 24.5) for 1997–2012 show that, except for 2008, photosynthetic production of DO by algae never has been high enough to achieve supersaturated conditions at that site (fig. 14). In 2008, however, supersaturated DO conditions occurred at the RM 24.5 site during most of July and extending into early August, peaking at greater than 140 percent of saturation in late July. Under normal conditions, small populations of algae enter the reservoir reach from upstream. The decreased shading (more light) in the reservoir reach causes the algae to grow faster, and a bloom may reach substantial levels by the time it travels downstream as far as RM 16.2 or farther. These anomalous conditions at RM 24.5 clearly indicated that a well-developed algal bloom was entering the reservoir reach from upstream, rather than developing within the reservoir reach.

Figure 14. Comparison of measured dissolved oxygen percent saturation in the Tualatin River near Scholls, Oregon (river mile 24.5) in 2008 with long-term conditions in 1997–2012.

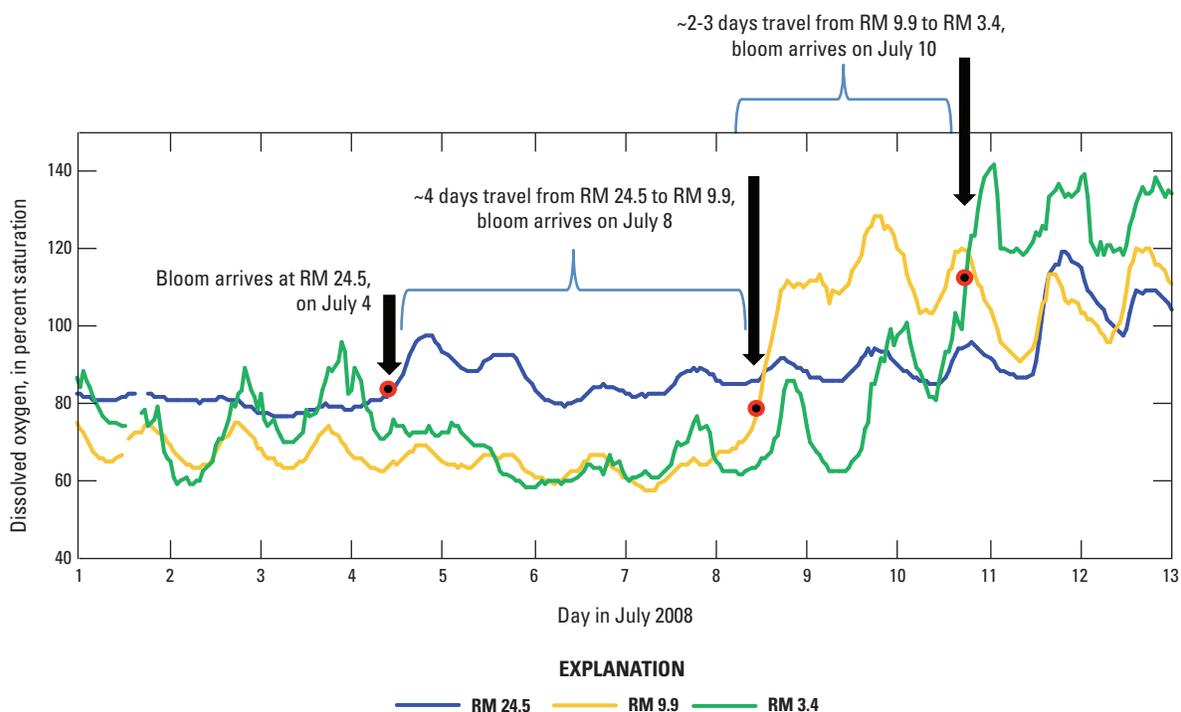
Preliminary evidence pointed to Wapato Lake discharges as a potential source of downstream changes in water quality and the algal community. To confirm that Wapato Lake pump discharges were indeed the cause of the *Anabaena* bloom in the lower Tualatin River, and to determine how the river responded to this inoculation of plankton and nutrients, water-quality data from continuous monitors located at Highway 219 (RM 44.4), near Scholls (RM 24.5), at Cook Park (RM 9.9), and at Oswego Dam (RM 3.4) were analyzed, accounting for the travel time between those locations. Specific increases in the measured DO concentration can be used as tracers for algal photosynthesis and an indication of when the bloom reached each location.

Figure 15. Dissolved-oxygen percent saturation in the Tualatin River at river miles (RM) 24.5, 9.9, and 3.4, showing a substantial increase in dissolved oxygen associated with the arrival of the *Anabaena* bloom at each location, Tualatin River, Oregon, July 2008. Arrows and red dots indicate when the dissolved oxygen signals reached each monitoring location.

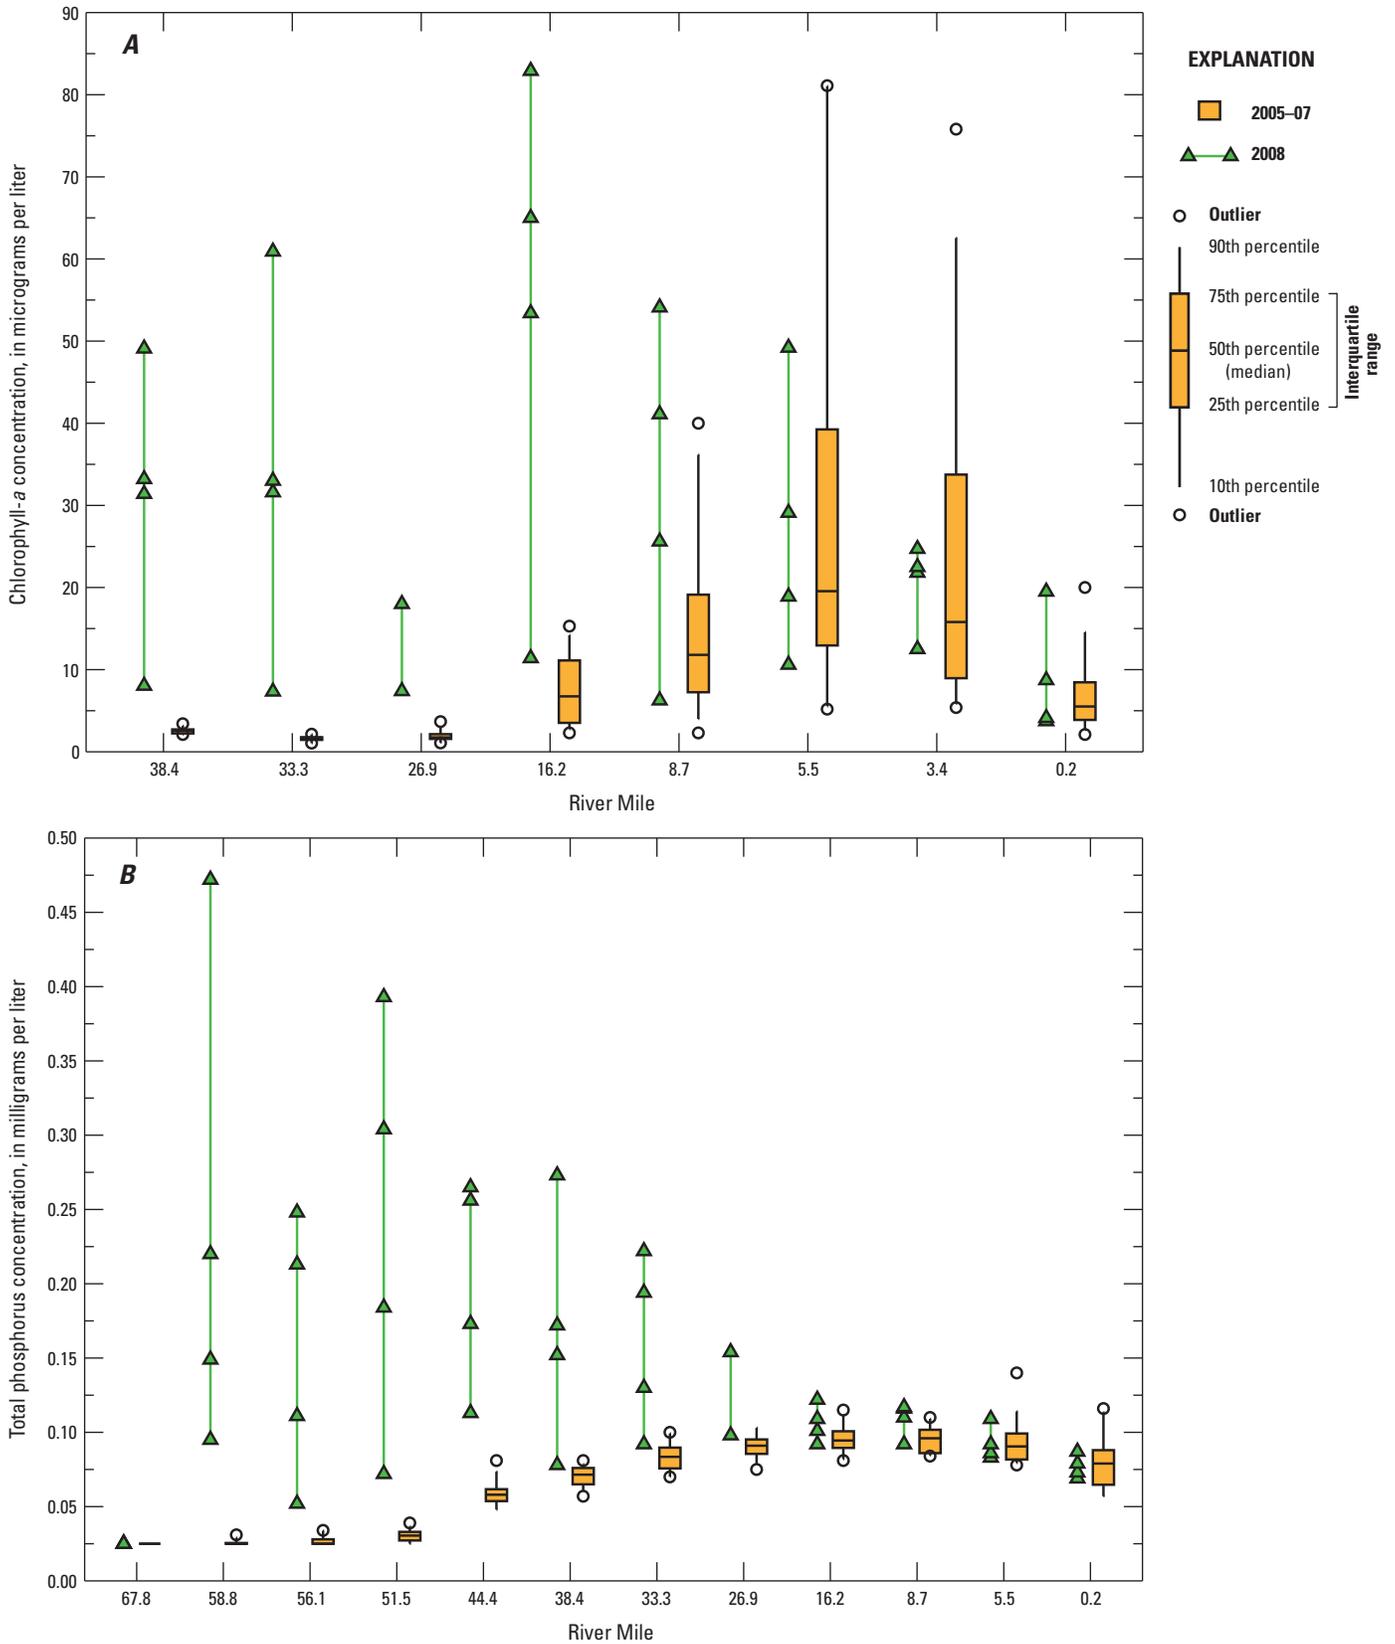
The 2008 Tualatin River algal bloom was anomalous in many ways, but particularly because it included high-biomass conditions farther upstream than in normal years. At Rood Bridge (RM 38.4), the median and maximum chlorophyll-*a* concentrations in July were greater than 30 µg/L and nearly 50 µg/L in 2008 (fig. 16A), respectively, whereas values at that location were less than 5 µg/L in July 2005–07. At Highway 219 (RM 44.4), chlorophyll-*a* concentrations in 2008 were similar to those at Rood Bridge (table 5). Farther upstream, total chlorophyll concentrations in Wapato Creek at Gaston Road were substantially higher than at other sites in the upper Tualatin River basin in June and July (table 4), with median and maximum values of 190 and 675 µg/L, respectively. In late July, elevated total chlorophyll levels (13–37 µg/L, table 4) also were measured in the Tualatin River at Dilley (RM 58.8) and at the Spring Hill pumping plant (RM 56.1). Total chlorophyll measurements at other sites upstream of the Spring Hill pumping plant, including the Tualatin River upstream of the Wapato Creek confluence and other tributary streams, clearly show that the Wapato Lake discharge had the greatest influence on chlorophyll levels at the Spring Hill pumping plant (table 4). In August, measured chlorophyll concentrations in Wapato Creek at Gaston Road decreased to the 10–14 µg/L range as pumping of the lake decreased and stopped. All these data confirm that Wapato Lake discharges were a source of high-chlorophyll water that affected chlorophyll levels downstream all the way into the reservoir reach.

Unusually high total phosphorus concentrations also occurred in July 2008 at all sites from Dilley (RM 58.8) downstream to the reservoir reach (fig. 16B, table 5), and those values were consistent with high total phosphorus concentrations discovered in Wapato Lake drainage water on July 19 (table 7). The phosphorus data indicate that the increase in concentration in the Tualatin River occurred between the Cherry Grove (RM 67.8) and Dilley (RM 58.8) sampling sites, a reach that includes inputs from Wapato and Scoggins Creeks. Data from CWS showed low concentrations in Scoggins Creek and Henry Hagg Lake. A mass balance of total phosphorus loads in the Tualatin River between Cherry Grove and Dilley indicates that the Wapato Lake discharge can account for most or all of the increase in phosphorus in that river reach, assuming that the total phosphorus concentration of 2.5 mg/L in the Wapato Creek sample from July 19 was representative, and that Wapato Lake pumping rates were similar to those estimated in the analysis shown in figure 11. Using a flow of about 21 ft³/s (about 72 percent of the full pumping capacity) from Wapato Creek, phosphorus inputs from Wapato Lake would have accounted for about 83 percent of the total phosphorus load in the Tualatin River at Dilley on July 19, with Scoggins Creek contributing about 8 percent and the upper Tualatin River just 2 percent.

Figure 16. Comparison of (A) chlorophyll-a and (B) total phosphorus concentrations in the Tualatin River, Oregon, July 2005–07 and July 2008.
