*A Report on the 1991 Excavations at
Ulysses S. Grant National Historic Site,
St. Louis, Missouri*

A REPORT ON THE 1991 EXCAVATIONS AT
ULYSSES S. GRANT NATIONAL HISTORIC SITE,
ST. LOUIS, MISSOURI

Midwest Archeological Center
Technical Report No. 49

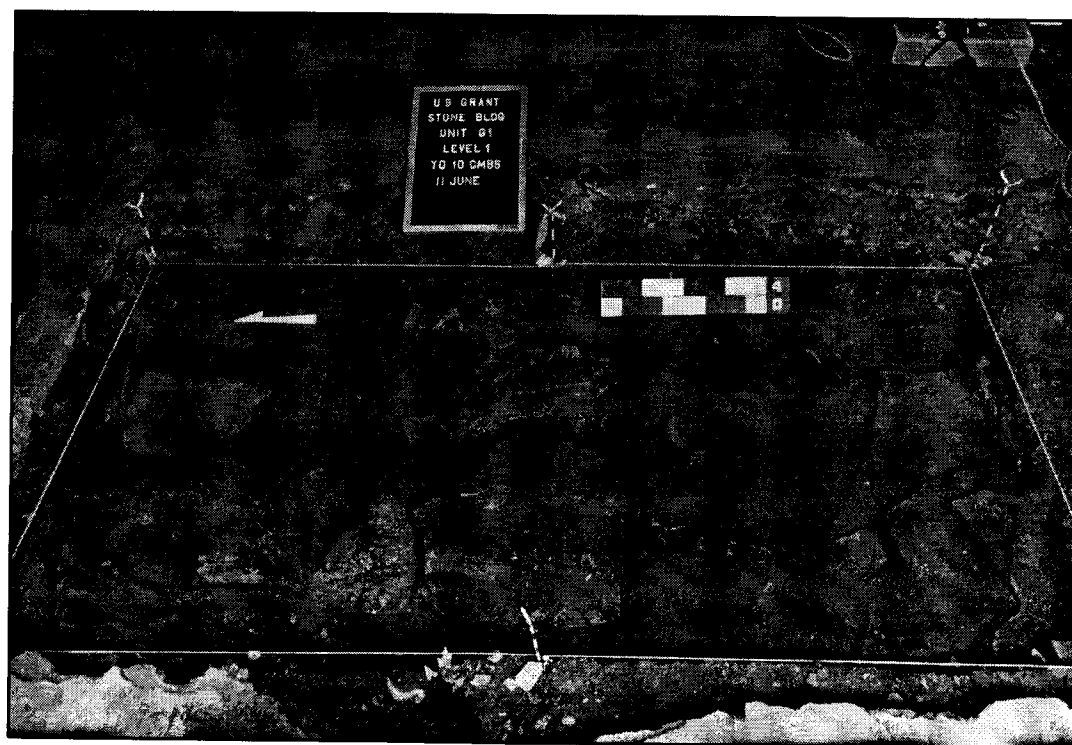
Figure 23. Unit G1, Level 1, showing foundation.

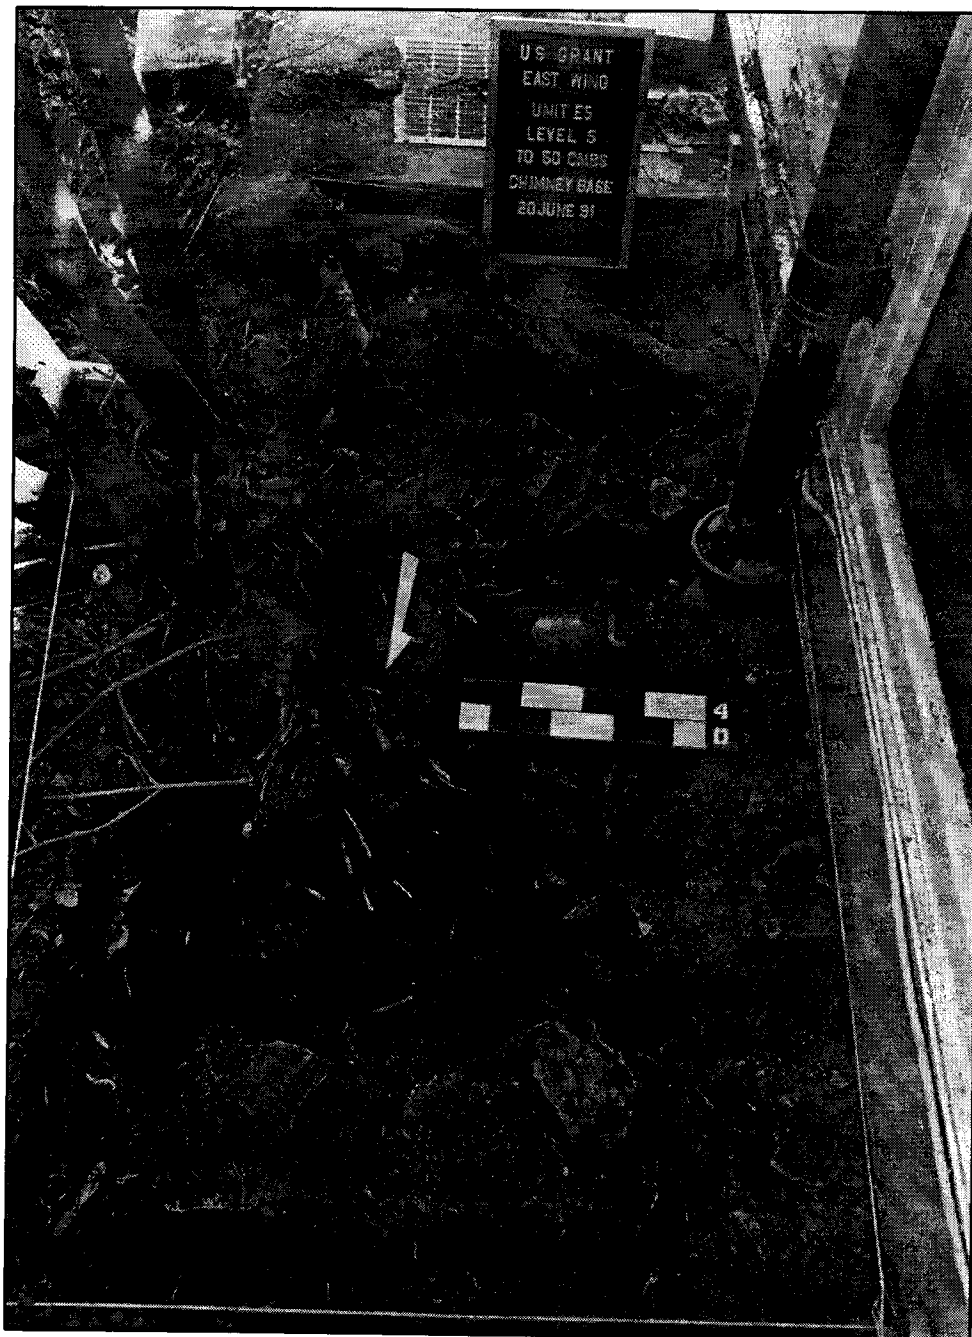
Figure 27. Chimney base ruins in Unit EW5.
