NASA/TM—1998–208539

# **Final Report on Life Testing of the Vapor Compression Distillation/Urine Processing Assembly (VCD/UPA) at the Marshall Space Flight Center (1993 to 1997)**

*P. Wieland, C. Hutchens, and D. Long*

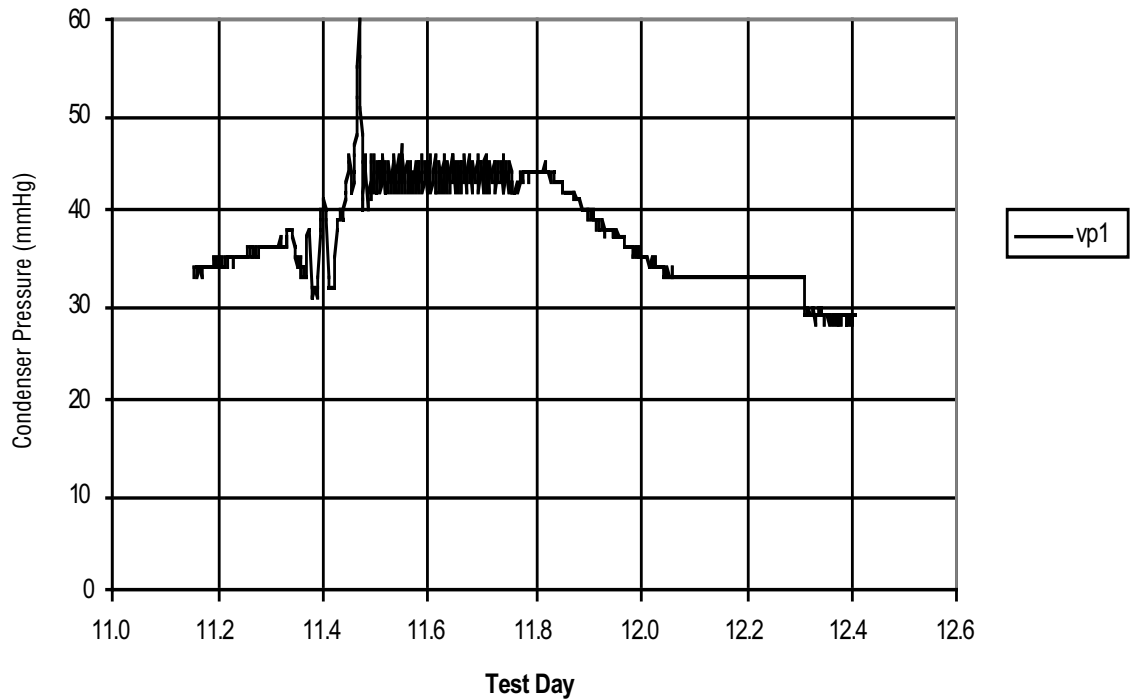
**4.4.2.1.5 High Temperatures and Pressures in the Still.** As shown in figures 19 and 20, at the beginning of a processing cycle, high temperatures and pressures occurred in the still during the first 40 min before coming down to the desired ranges. The temperature was measured at the outlet of the compressor (vt1) and indicated the temperature close to the gears. The temperature spiked above the alarm set-point of 93 °C (200 °F) due to the excessive load on the compressor and/or inadequate cooling of the gears. The pressure was measured in the condenser (vp1) and reached about 60 mmHg. These same conditions occurred during previous testing (see the Stage 9 report <sup>8</sup>) and were attributed to air in the wastewater tank collecting at the top of the tank, where the outlet is located, and being injected into the still (in microgravity the air would likely be more evenly distributed throughout the liquid). Therefore, until liquid was injected into the still, no evaporative cooling would occur. The condition of the compressor gears was also found to be a factor. After test day 37, when the Vespel<sup>®</sup> gear was replaced, the temperature and pressure spikes were reduced considerably, to within the desired ranges (as shown in figures 21 and 22). After test day 65, when a sample port (number 19) was added to the top of the feed tank, the temperatures and pressures at startup were reduced further (as shown in figures 23 and 24). In the process of collecting samples of the feed mixture, at the beginning of each processing cycle, the air was purged from the supply line. The transition time required to reach normal operating conditions was reduced from over 3 hr to under 2 hr, due to replacing the Vespel<sup>®</sup> gear and purging air prior to a processing run.

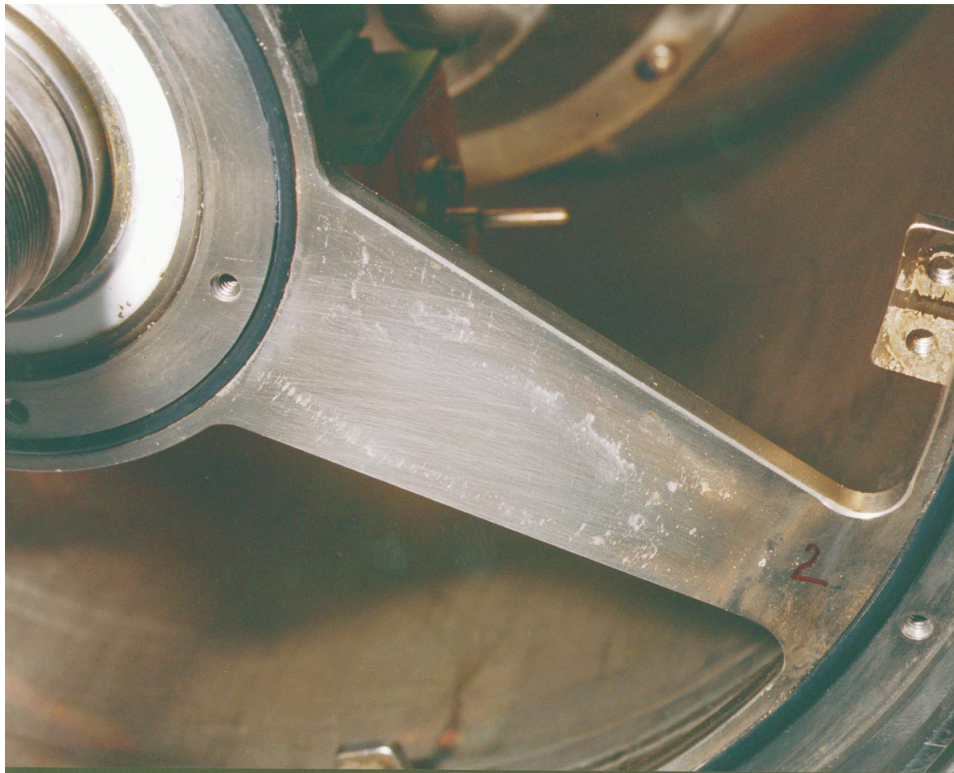
- An O-ring seal was missing between the condenser end plate and the drum. However, there was no indication of liquid leakage, so the metal-to-metal contact apparently provided an adequate seal.
- Some slight corrosion was evident between the condenser end plate and the drum spokes, as shown in figures 37 and 38.
