# Imprint of the Past:

## Ecological History of Greenwich Bay, Rhode Island

Imprint of the Past: Ecological History of Greenwich Bay, Rhode Island. EPA/600/R-12/050.

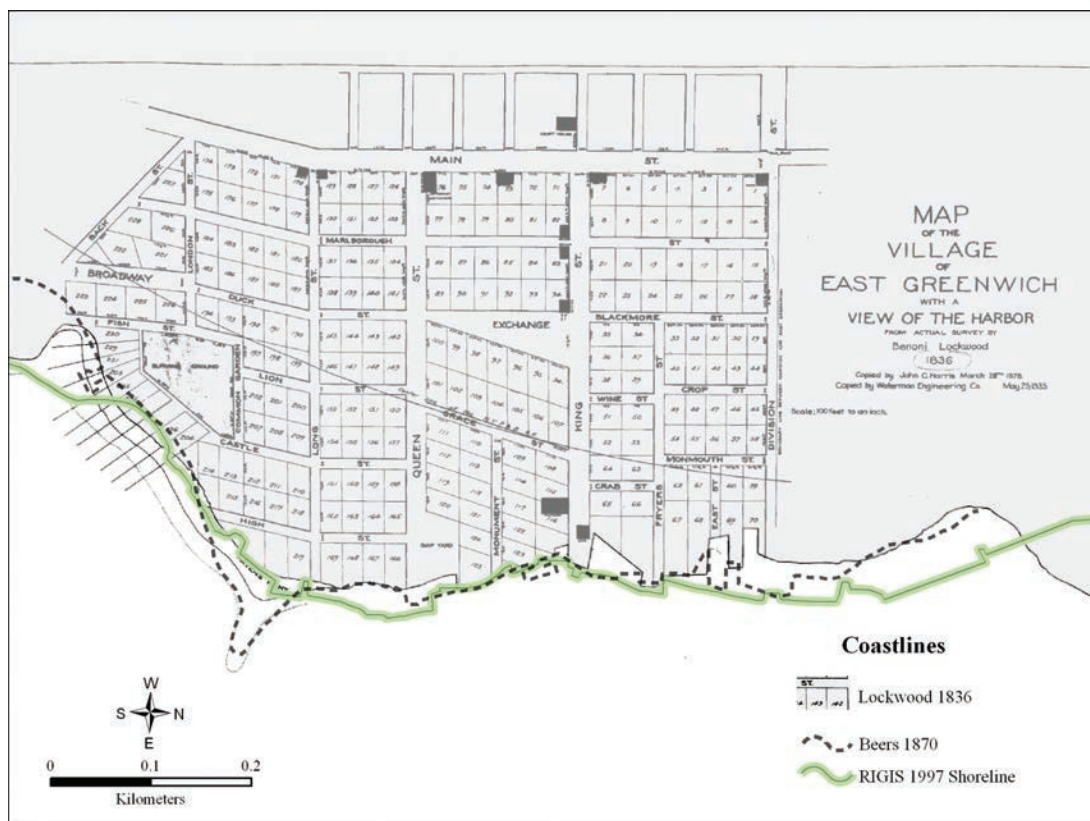
**Figure 2.** Greenwich Cove shoreline at East Greenwich for three dates. The map of the village was made by Benoni Lockwood in 1836 [149]. The 1870 coastline is from the Atlas of the State of Rhode Island and Providence Plantations by D.G. Beers [63]. The 1997 coastline is from RIGIS, 1:5000 town boundaries.

During the Maritime Period (c. 1730 to c. 1820) more land was cleared to accommodate the growing population, and there were some changes in the shoreline. We don’t have specific data for the watershed, but in 1700 about 78% of the land in Rhode Island was forested, and by 1820 only 54% was forested [42]. As mentioned above, evidence of sedimentation in Apponaug Cove was noted by a historian [32] and confirmed by a scientific study [47]. By 1836 the East Greenwich shoreline was filled in places and hardened by wharfs. More changes in the shoreline occurred later, as shown in Figure 2.

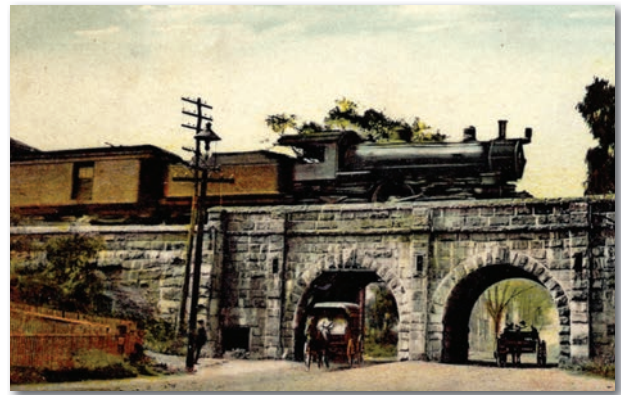
Railroad bridge crossing King Street, East Greenwich. King Street, which goes down the hill to the waterfront, was the main street in East Greenwich until the time of the Civil War. King Street lies between two hills, Meeting House Hill to the north and Rope Walk Hill to the south. Excavation through these hills for the railroad caused sediment to wash down into the cove. (Bruce MacGunnigle, private collection)

The process of building the railroad had ecological and social consequences for Greenwich Bay and its watershed. Extensive excavations were made through two hills in East Greenwich (Rope Walk Hill and Meeting House Hill) to make a level grade for the railroad tracks [52]. Most likely, sediment was washed down the hill into Greenwich Cove during this excavation. A railroad bridge was constructed across the upper section of Apponaug Cove. Fill was used at the site of the bridge and narrowed the opening across the cove forming an inner and outer section of the cove. The constriction of the bridge accelerated the tidal flow under it,

scouring sand from the channel and depositing it in a bar west of the bridge [47]. Pollution from coal-burning locomotives probably led to higher concentrations of lead, zinc, and copper in the soil along the railroad and water at the bridge [66]. The railroad also influenced the social fabric of the both communities because many Irish immigrants were brought in to build it.

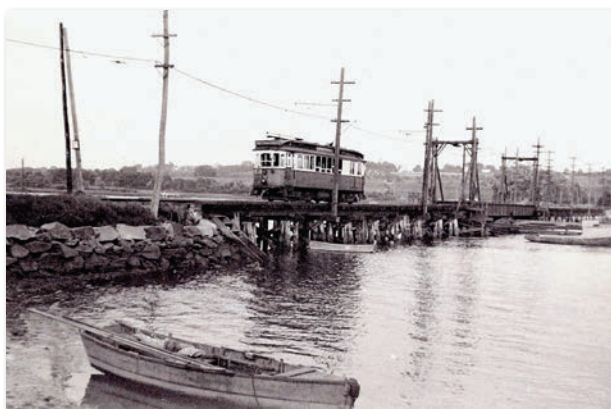
Trolley crossing Warwick Cove. About 1900 the trains to Oakland Beach were replaced by electrified trolleys. The middle section of the trestle over Warwick Cove was a drawbridge that allowed boats to pass. (Warwick Historical Society)

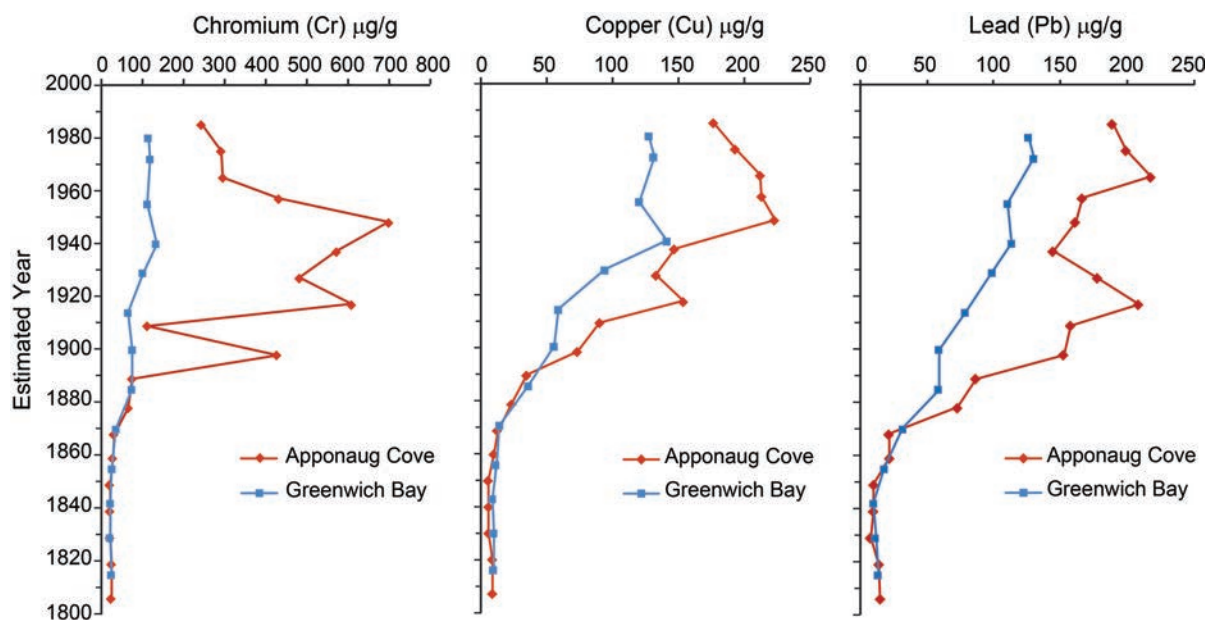
**Figure 7.** Profiles of chromium, copper, and lead concentrations in sediment cores taken from Apponaug Cove and Greenwich Bay. Data from Corbin [78].

and then decreased rapidly to the top of the core (1980s). This profile reflects the expansion of the mill in the late 1800s, an unexplained dip about 1910 followed by a rise, the economic recession and replacement of most of the mill buildings in the 1920s and 1930s, and the end of the mill operation in 1958. The sediment profile for copper, another metal used in textile dyeing, was similar: the copper concentration increased in the late 1800s, dipped in the 1920s and 1930s, reached the maximum concentration about 1950, and then decreased (Fig. 7). The core from the middle of Greenwich Bay also showed increases in chromium and copper concentrations in the late 1800s and had maximum concentrations in 1940-50; but the maximum concentrations were lower, about 5-fold for chromium and one half for copper, than those in Apponaug Cove (Fig. 7). Chromium readily binds to sediment particles. So chromium discharged from the mill in the wastewater would bind to sediment particles, which settled out in Apponaug Cove, leaving less chromium to reach the middle of Greenwich Bay. Copper does not bind as readily to sediment particulates, so more copper would be carried further from the mill. This might account for the smaller difference in maximum concentrations of copper for the two cores. The concentrations of chromium and copper in the Greenwich Bay core decreased only slightly from the maximum concentration, indicating that there were other sources of these metals besides the mill in Apponaug. Sediments in the middle of Greenwich Bay were also exposed to contaminants from the East Greenwich WWTF and industries in East Greenwich and on Chepiwanoxet Point.

The concentration of lead started increasing in the cores in the 1870s and continued to increase (steadily in the Greenwich Bay core but more variably in the Apponaug Cove core) until about the 1970s, when there was a small decrease to the top of the core (Fig. 7). Lead was used in textile production, but the textile industry was not a major source of this metal. In the late 1800s, lead, and also copper, started to increase rapidly in the environment from the burning of coal [79]. Leaded gasoline, a major source of lead, was used from the 1920s to the 1970s. The slight decrease in lead at the

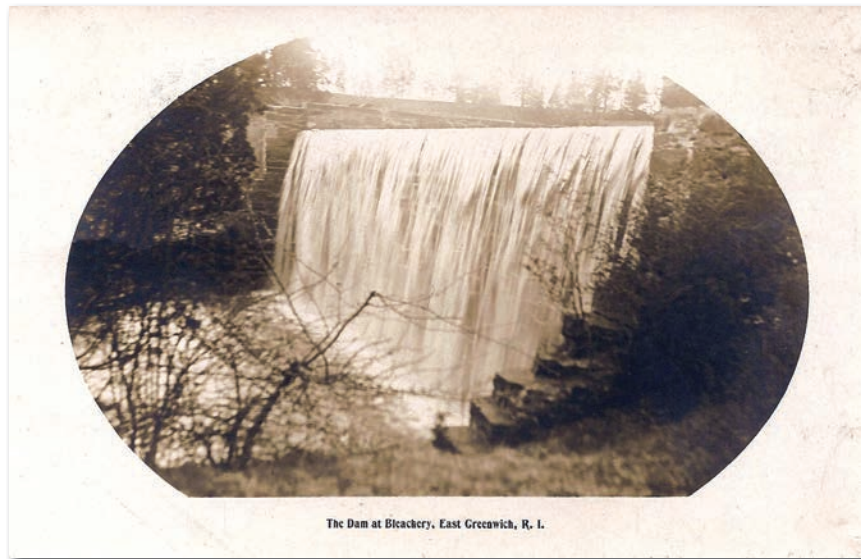
Bleachery Pond Dam, postcard postmarked Oct 14, 1908. The height of Bleachery Pond dam, 16 feet, gives it a low priority for restoration of the anadromous fish run on the Maskerchugg River. Today the East Greenwich Municipal Land Trust manages 5.5 acres of land at Bleachery Pond. Walking paths are accessible from the northern side of the Maskerchugg River near Post Road. (Bruce MacGunnigle, private collection)

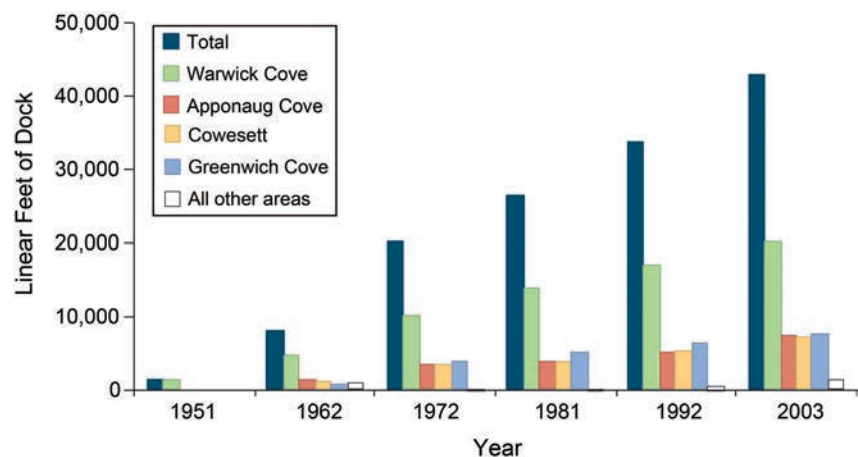
**Figure 12.** Length of docks (marinas, yacht clubs, commercial, and private docks) in Greenwich Bay measured from historical aerial photographs (RIGIS).
