# Preliminary Assessment of Vertical Stability and Gravel Transport along the Umpqua River, Southwestern Oregon

By Jim E. O'Connor, J. Rose Wallick, Steven Sobieszczyk, Charles Cannon, and Scott W. Anderson

Open-File Report 2009–1010

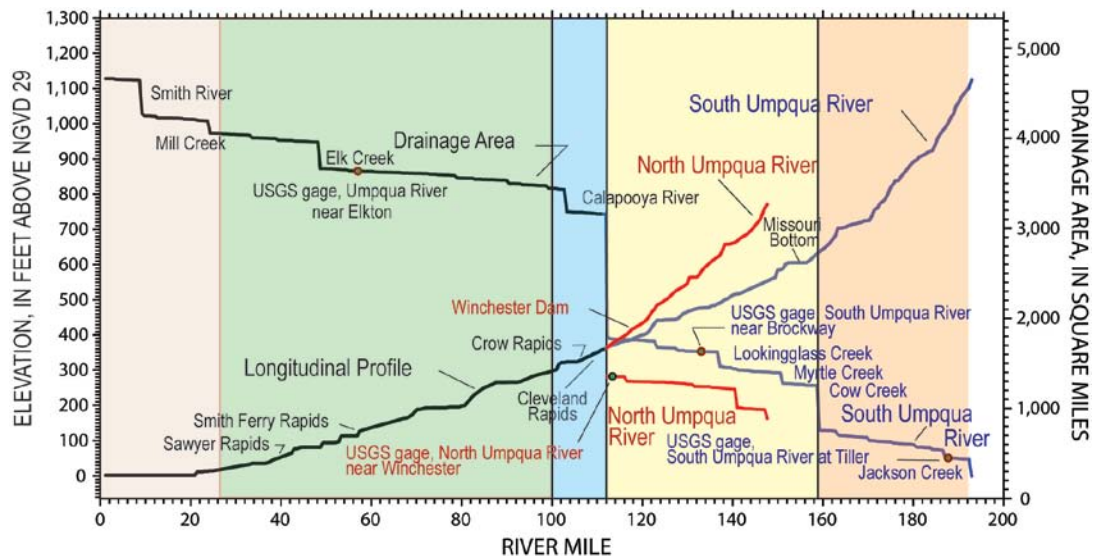
Figure 2. Longitudinal profile, cumulative drainage area, valley reach boundaries, and locations of streamflow-gaging stations for the Umpqua River, southwestern Oregon. Drainage area calculated from USGS 10-meter digital elevation data.

After exiting the Western Cascades physiographic province, the North and South Umpqua Rivers flow generally westward before joining 6 mi northwest of Roseburg. For another 12 mi, the mainstem Umpqua River meanders northwestward through two large valleys before bisecting the higher portion of the Coast Range within a narrow valley trending northwest and then west for 90 mi before exiting into the coastal plain for the last 10 mi before entering the Pacific Ocean. The main tributaries of the mainstem Umpqua River are the Smith River (371 mi<sup>2</sup>), Elk Creek (292 mi<sup>2</sup>), and the Calapooya River (246 mi<sup>2</sup>). The Umpqua River begins at the confluence of North Umpqua and South Umpqua Rivers at RM 111.8, where the North Umpqua River drains 1,359 mi<sup>2</sup>, with all major inflow entering upstream of the study area at Little River (206 mi<sup>2</sup>) and Steamboat Creek (164 mi<sup>2</sup>). At the confluence, the South Umpqua River has a drainage area of 1,801 mi<sup>2</sup>, with the main tributaries in the study area being Lookingglass Creek (161 mi<sup>2</sup>), Myrtle Creek (119 mi<sup>2</sup>), Cow Creek (499 mi<sup>2</sup>), and Jackson Creek (189 mi<sup>2</sup>) (figs. 1 and 2).

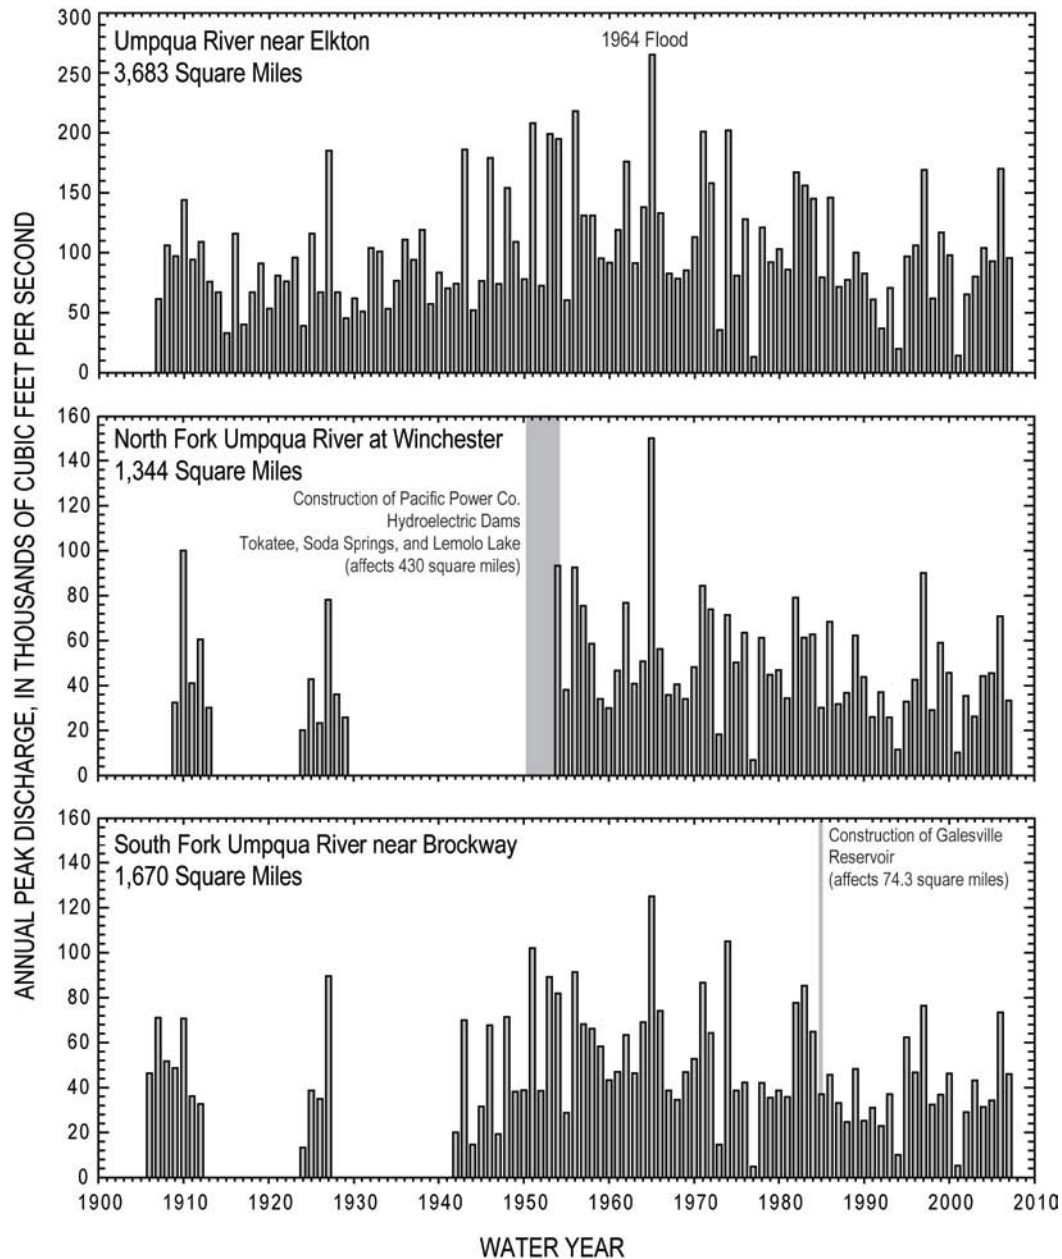
Figure 3. Annual peak flows for selected USGS streamflow-gaging stations in the Umpqua River basin, southwestern Oregon.

recurrence-interval flow is about 49,000 ft<sup>3</sup>/s for the North and South Umpqua Rivers, and 94,500 ft<sup>3</sup>/s for the mainstem Umpqua River (Harris and others, 1979). Since the early 1950s, flow has been slightly regulated by Pacific Power hydroelectric projects on the North Umpqua River; likewise, on the South Umpqua River, construction of Galesville Reservoir in 1985 on Cow Creek may slightly affect peak and low flows, although plots of peak flows (fig. 3) show no marked effect of the dams for either river.

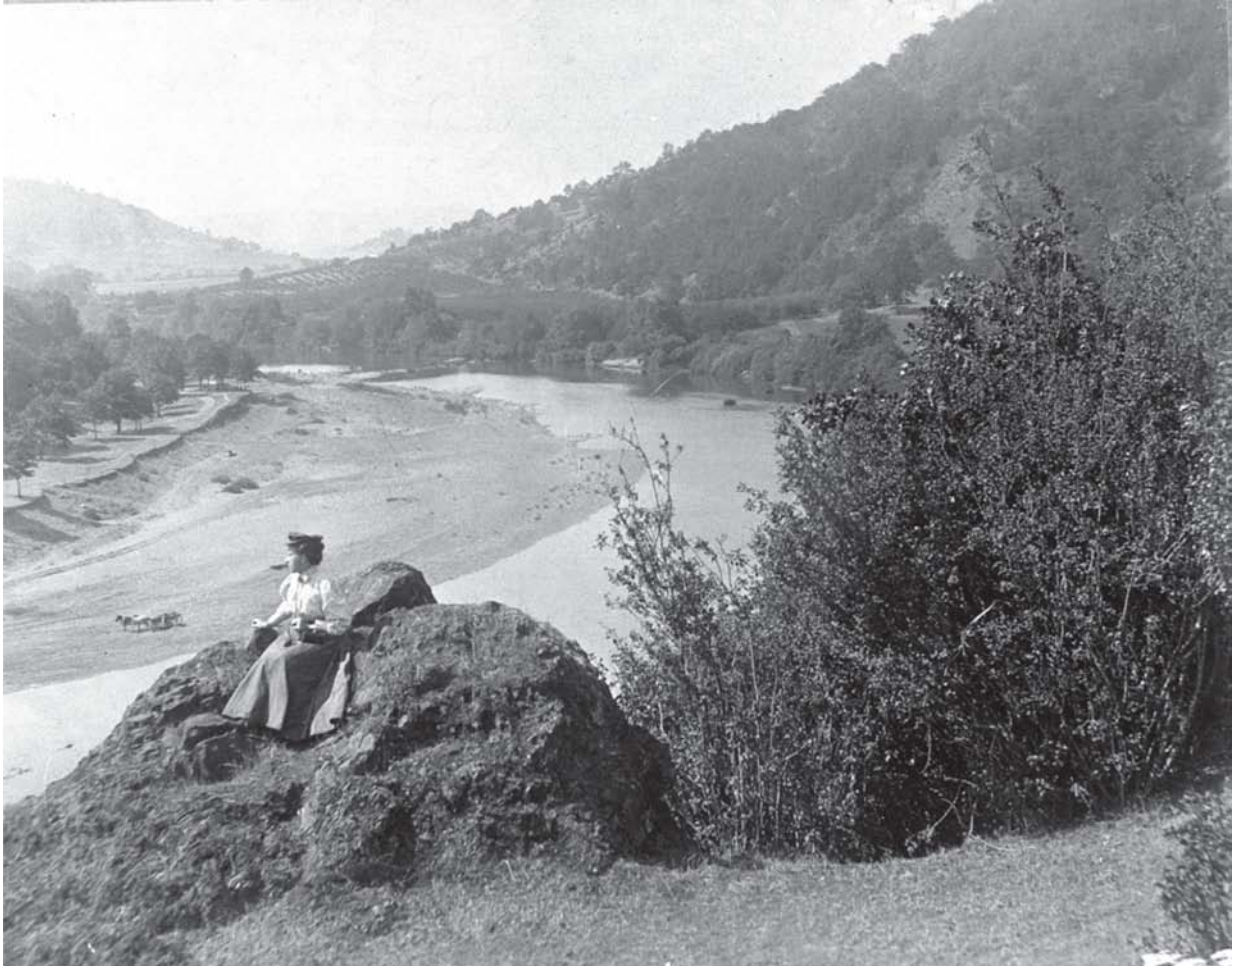
Figure 4. Circa 1890s photograph of South Umpqua River upstream of Mount Nebo near Roseburg, Oregon. Courtesy Douglas County Museum (Photograph N5549a)

bars flanking the channel (fig. 4). We have found fewer early descriptions of the Days Creek Reach of the South Umpqua River at the time of first exploration, but it too was apparently locally flowing on bedrock, at least near its downstream end, because inchannel potholes near the Cow Creek confluence were targets for gold miners in the 1850s (Beckham, 1986, p. 93).

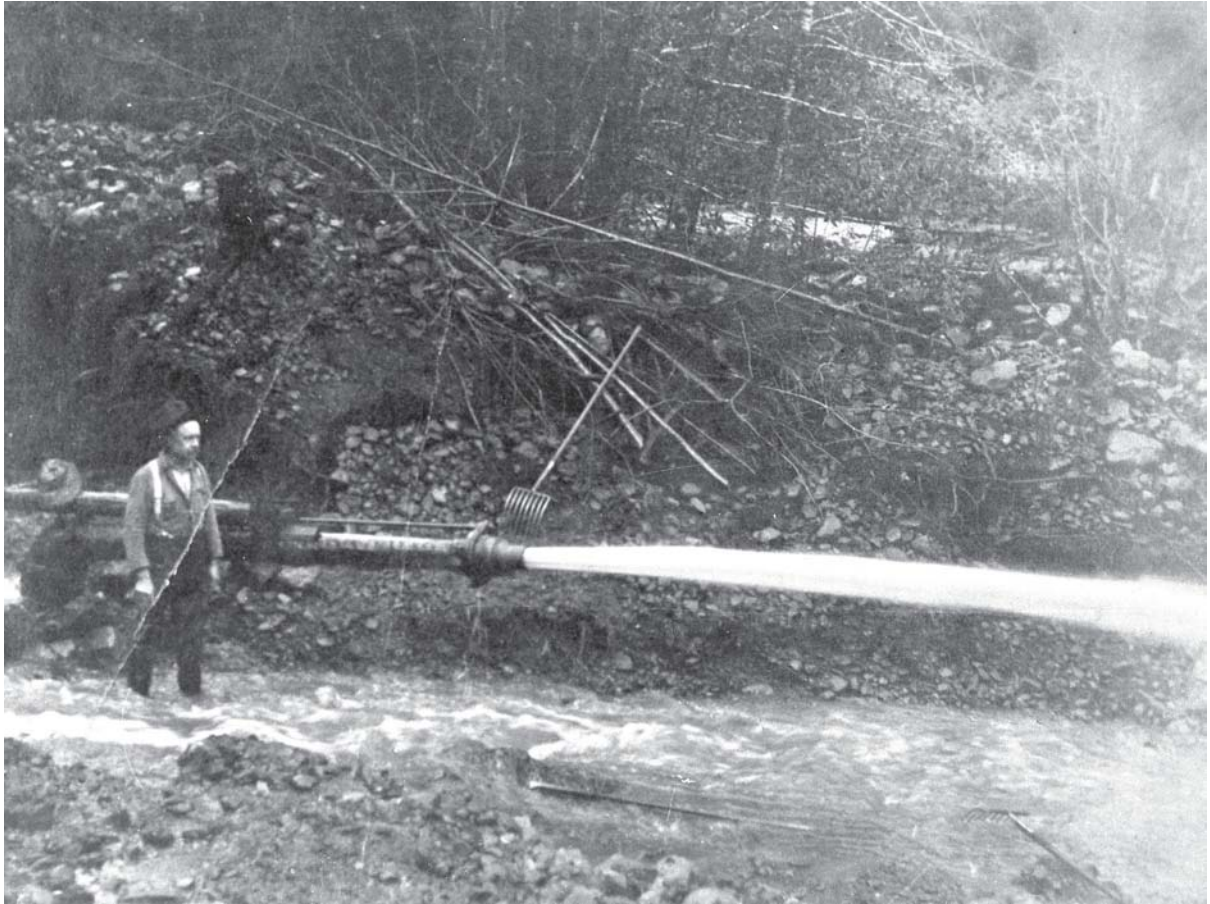
Figure 5. Hydraulic mining in the Olalla District, Lookingglass Creek drainage, Oregon. Courtesy of Douglas County Museum (Photograph N5155), undated.

Gold mining in the Umpqua River basin began in 1852 on the South Umpqua River near Riddle and in lower Cow Creek (Beckham, 1986, p. 225–226). The widespread placer mining on the South Umpqua River and its tributaries Olalla Creek (fig. 5; a tributary of Lookingglass Creek), Myrtle Creek, Cow Creek, and Coffee Creek (Diller, 1914; Ramp, 1972) probably had the most significant effects on instream gravel conditions. All these drainages enter the South Umpqua River within the Days Creek and Roseburg Valley Reaches. Placer mining in the late 19th and early 20th centuries involved extensive excavation of alluvial terraces flanking the present watercourses, in places aided by elaborate hydraulic works (fig. 5). Beckham (1986, p. 93) suggested tremendous effects to the stream channels from these activities:

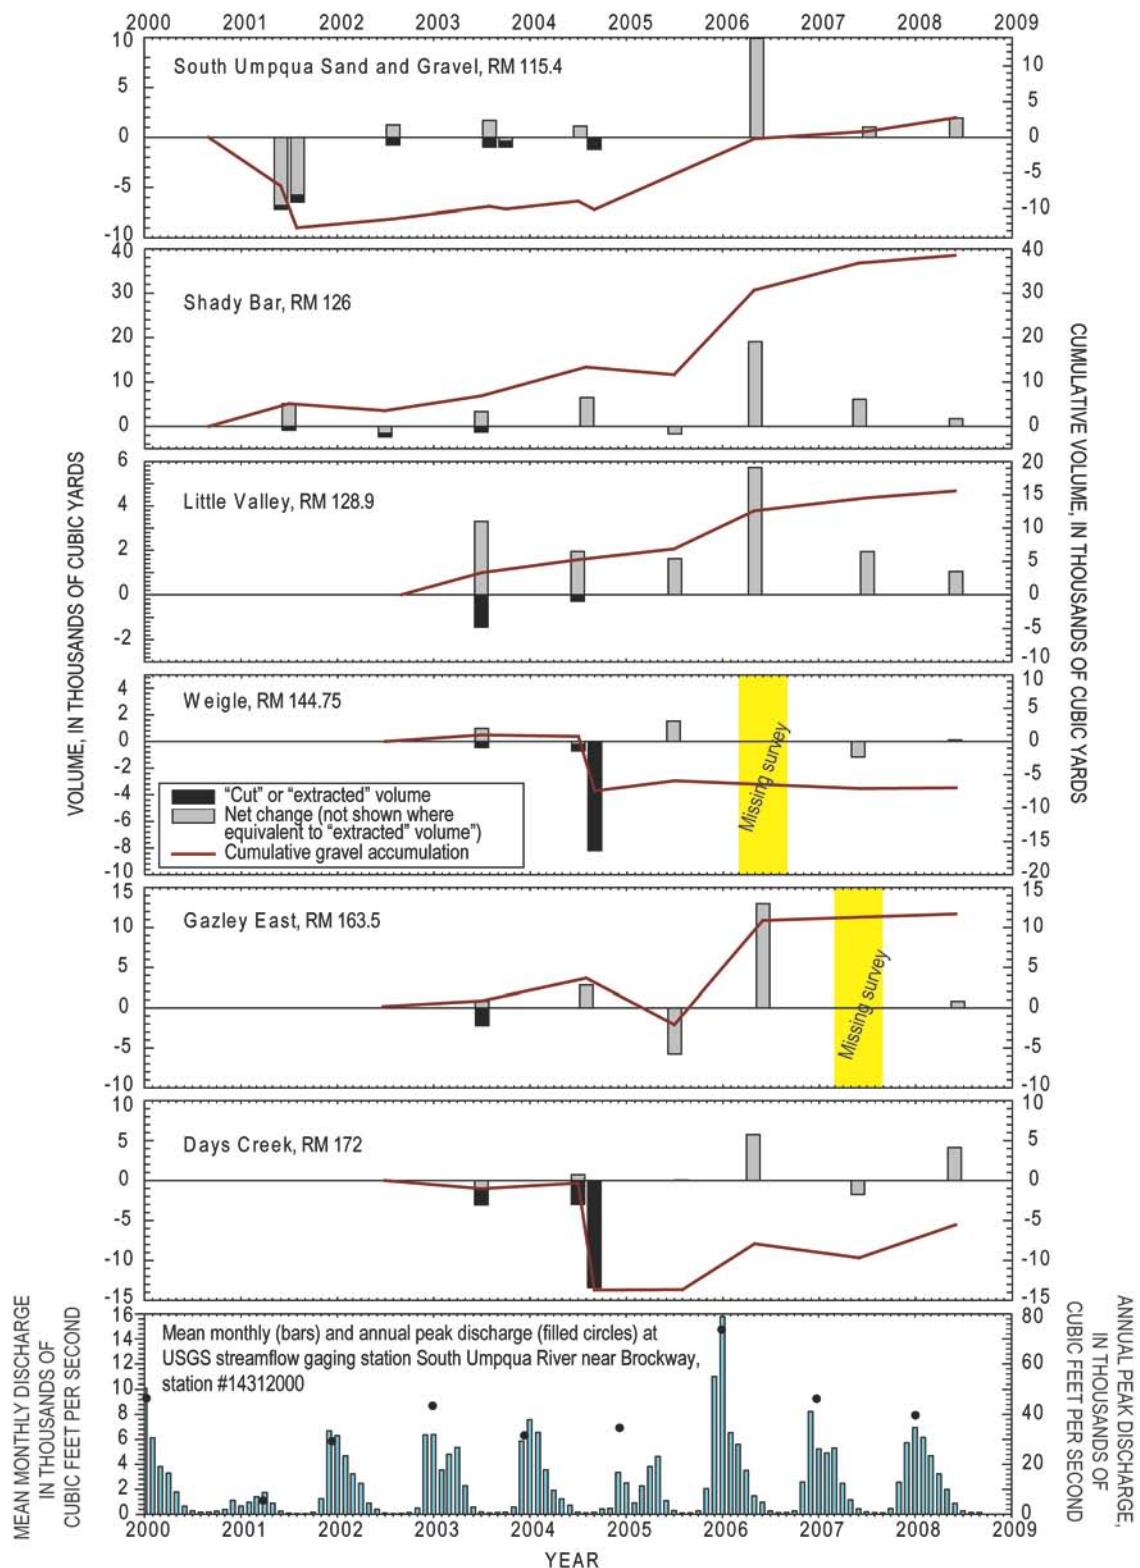
Figure 6. Summary of gravel bar volume changes, 2000–2008, at instream gravel mining sites along the South Umpqua River, southwestern Oregon. Data from surveys provided by IE Engineering, Roseburg, Oregon (written commun., 2008). For sites with missing surveys, cumulative totals assume no net change for period of missing data. Mean monthly and annual (water year) peak flows are from USGS data for streamflow-gaging station South Umpqua River near Brockway, station 14312000.

Survey information for the six sites of gravel bar mining on the South Umpqua River show that removal volumes in 2001–04 ranged up to 13,390 yd<sup>3</sup> but typically were less than 10,000 yd<sup>3</sup> per year at each site. From these records and communication with individual operators, none of the analyzed bars have been mined after 2004. Since then, each of the six bars has accumulated gravel, with four of the six bars now showing positive balances relative to the original provided survey (and it is possible the Weigle Bar also has had a net accumulation because survey data spanning the 2006 high flow was not available). Deposition volumes are most easily assessed for 2004–08, during which there was no mining and all changes to bar volumes resulted from fluvial erosion and deposition. Nearly all bars grew significantly (aggrading as much as 2 ft) during the winter of 2005–06, in conjunction with high flows, including the Dec. 31, 2005, peak of 73,400 ft<sup>3</sup>/s—the highest peak flow on the South Umpqua River since December 1996. The only bar that clearly has not regained the volume of sediment documented in the first survey is Days Creek bar at RM 172. In all cases, the net changes in volumes, averaged over our mapping of bar area, total less than 1 ft of bar-surface elevation change.

These surveys on the sites on the South Umpqua River show that active gravel transport by the river tends to rebuild the forms of mined gravel bars, especially after large flows and multiple years of no mining. But because these mined gravel bars have enhanced depositional space resulting from excavation, they are likely to preferentially accumulate gravel after mining and the survey results can not be used directly to determine long-term gravel accumulation or flux rates, although the survey data for the last few years may help provide bounds for such determinations. Also, since the first surveys post-date a long history of mining at many of these bars, long-term trends of bar changes and current bar status relative to undisturbed conditions cannot be determined directly from the surveys, although cursory analysis of systematic changes in bar area (described below) also indicates little overall change during 1939–2005. Nevertheless, extraction of gravel from these bars—in some years totaling more than 35,000 yd<sup>3</sup> for the six bars evaluated here—certainly reduces the overall flux of bed material through the river. Whether or not such volumes are significant relative to the overall bed-material transport and therefore affect long-term channel conditions for these reaches and downstream remains unanswered.

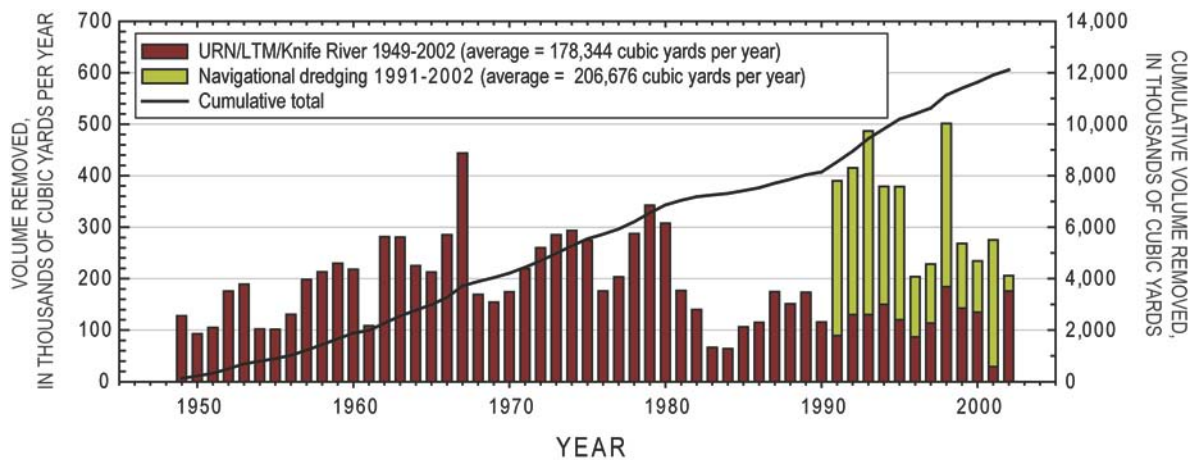
Figure 7. Excavation volumes for 1949–2002, for the Umpqua River Navigation (and successor companies) mining site along lower Umpqua River below RM 27, southwestern Oregon. Volumes for 1949–71 as reported by CH2M HILL (1971); Volumes for 1971–2002 from Umpqua River Dredging reports, as supplied by Lidstone and Associates (written commun., 2008).

The Tidal Reach between RM 0 and 27.5 has experienced substantial bed-sediment removal to maintain navigation depths in the channel and for sand and gravel aggregate, summing to more than 1.2 million yd<sup>3</sup> for 1949–2002 (fig. 7). The main area of aggregate removal has been between RM 19 and 22, where extraction has averaged about 175,000 yd<sup>3</sup>/yr by the Umpqua River Navigation Company and its successors. Targeted analyses of the reach of aggregate mining in the 1970s (CH2M-Hill, 1971) and subsequently by Lidstone and Associates (written commun., 2008) and Janine Castro (U.S. Fish and Wildlife Service, written commun., 2008) also furnish repeat cross sections, channel soundings and thalweg profiles. Inspection of these data indicate that this reach is dynamic, with areas of deepening and shoaling, but that the general trends for most time sequences is channel deepening along the thalweg, locally as much as 5 ft, with areas of dredging not being refilled. In the case of the 1971 CH2M-Hill analysis, excavations in areas not mined for more than 5 years had not been refilled. Our preliminary interpretation of these observations is that the supply of bed material is less than the 175,000 yd<sup>3</sup> average annual bed-material removal rate. This value, however, is not directly comparable with bed-material transport values for other reaches because the much lower channel gradient of the Tidal Reach probably results in a larger proportion of the upstream derived sediment load—which is primarily transported as suspended load—becoming bedload in this reach of lower flow velocities and channel gradient.

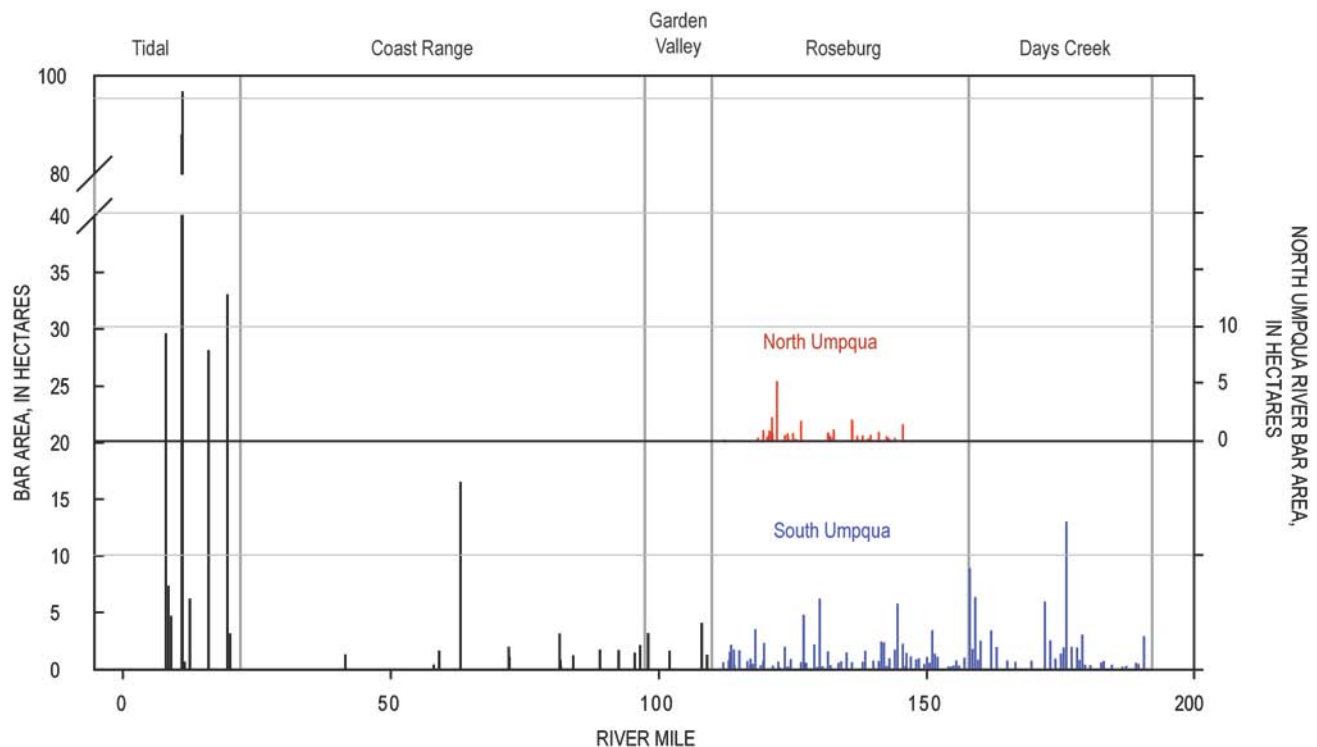
Figure 9. Distribution and size of fluvial sediment accumulations in the Umpqua River, southwestern Oregon, study area as mapped from 2005 National Agriculture Imagery Program aerial photographs at a scale of ~1:5,000. Within the Tidal Reach (RM 0–27.5), mapped areas consists primarily of extensive vegetated mud flats; elsewhere, mapped areas are primarily gravel bars. For plotting purposes, river miles for the North Umpqua Reach (RM 0–36) have been added to the Umpqua River at the confluence of the North and South Umpqua Rivers (RM 111.8).

The broad-scale mapping for the entire study area shows that most numerous gravel bar deposits are along the South Umpqua River, especially the Roseburg Valley Reach, where both the frequency and size of gravel bars exceed gravel deposits on the North Umpqua and mainstem Umpqua Rivers (except the Tidal Reach) by at least a factor of two (fig. 10; table 1). From the confluence of the North and South Umpqua Rivers downstream, the frequency of gravel bars diminishes and sand and gravel accumulations are sparse. An exception is Maupin Bar at RM 63, with an area of 38 acres (153,000 m<sup>2</sup>), which stands out at about 10 times larger than other bars along the Coast Range Reach of the Umpqua River. Although the Tidal Reach has several very large sediment accumulations within and flanking the channel, these features are chiefly mud and sand flats and are not directly comparable with the gravel bars upstream. Findings from the bar mapping are corroborated by our field observations, which revealed only rare gravel deposits along the mainstem Umpqua River, even at the heads of rapids and insides of meander bends where gravel deposits typically accumulate in rivers of this size and gradient.

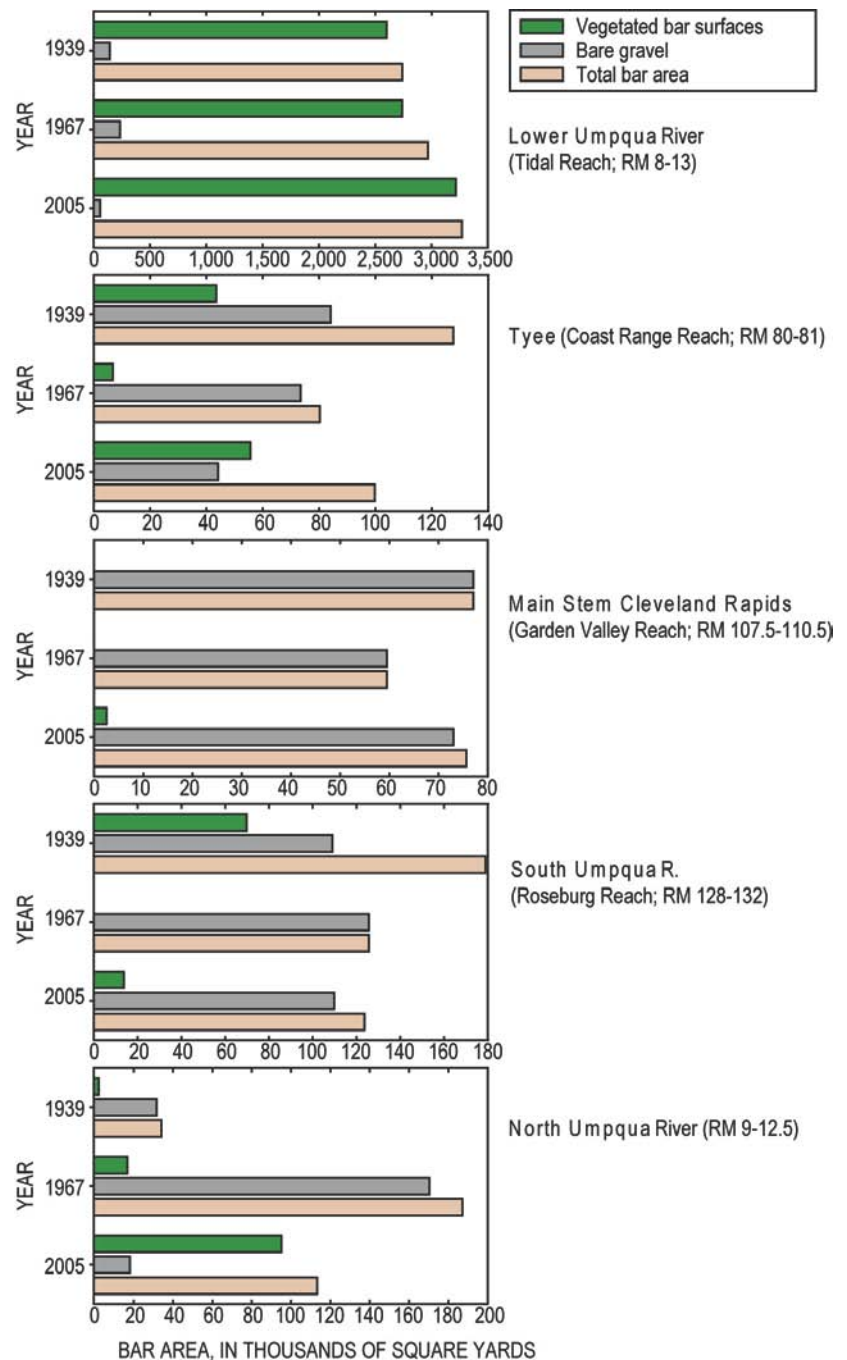
Figure 10. Mapped bar areas for selected reaches of the Umpqua River basin, southwestern Oregon, from aerial photographs dated 1939, 1967, and 2005.

The historical channel mapping shows no systematic trends in bar area or channel for 1939–2005 (figs. 10–15). Several locations had decreased bar area between 1939 and 1967, which likely was due to erosion by the 1964 flood. At the Tyee site (fig. 11), a large midchannel bar feature eroded between 1939 and 1967, followed by bar growth between 1967 and 2005. Similarly, the bar at RM 109 in the Cleveland Rapids photograph site (fig. 12) was present in the 1939 photographs, was absent in 1967 and then reappeared with larger area by 2005. The largest changes in channel morphology were near RM 130 on the South Umpqua River, where the channel avulsed around a large midchannel island between 1939 and 1967 (fig. 13). Gravel bars at the North Umpqua River photograph site (fig. 14) increased in area and frequency 1939–67, but many of these newly deposited surfaces appeared vegetated, inactive or were eroded by 2005, resulting in a decrease in bar area. At nearly all bars mapped between 1939 and 2005, losses in bar area 1939–67 are coupled with decreases in the vegetated bar area, and aerial photographs show that many of the vegetated bars present in the 1939 photographs were bare gravel in the 1967 photographs, probably owing to the high flows of 1964.

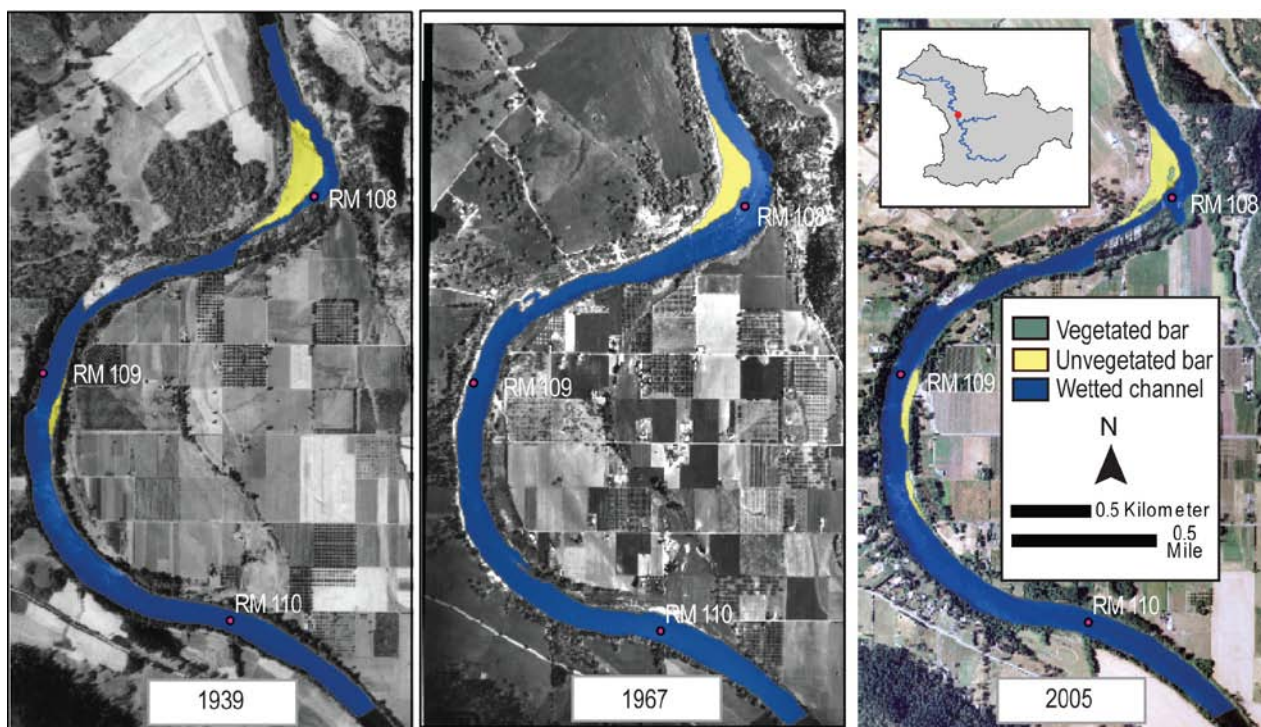
Figure 12. Mapped channel and bar features for the Umpqua River at Cleveland Rapids site (RM 107.5–110.5), southwestern Oregon, 1939–2005.

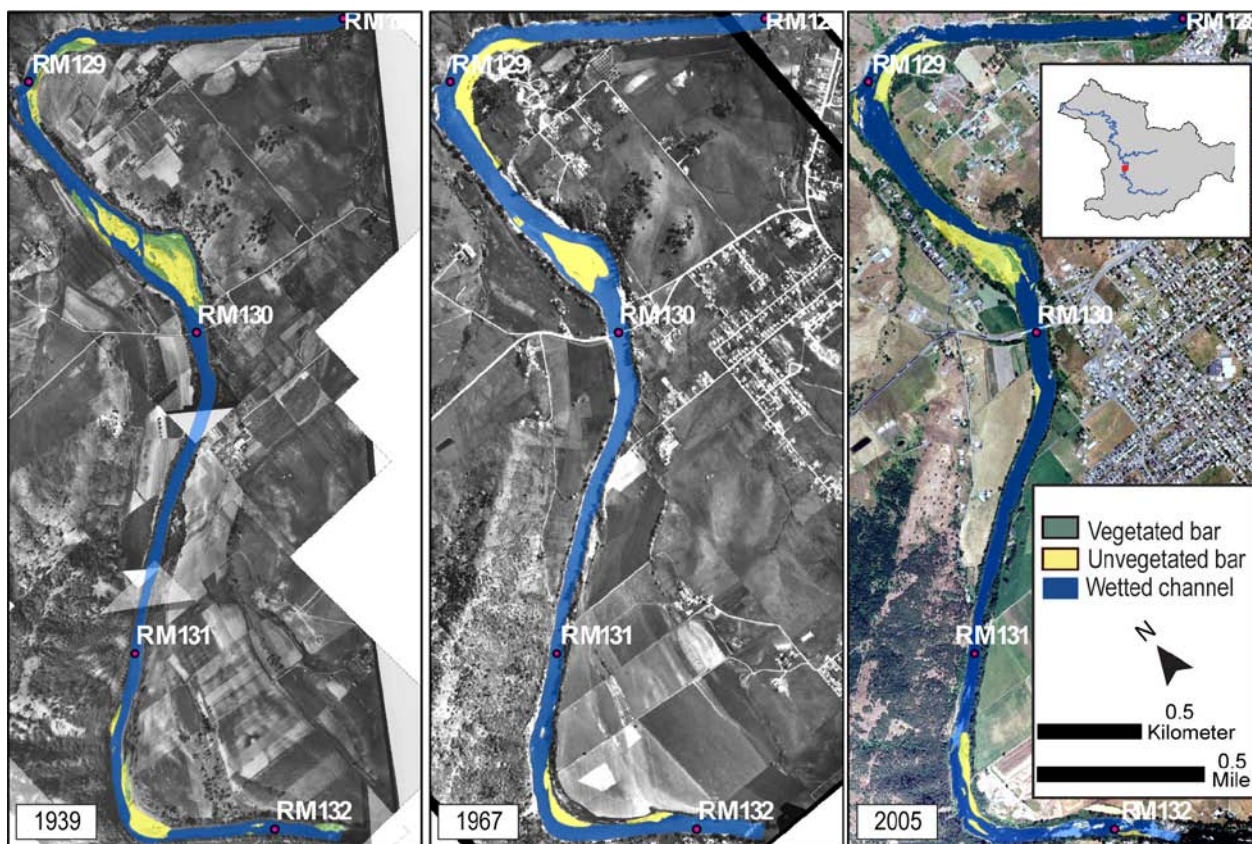
Figure 13. Mapped channel and bar features at the South Umpqua River site (RM 128–132), southwestern Oregon, 1939–2005.
