44 PRESERVATION BRIEFS

The Use of Awnings on Historic Buildings: Repair, Replacement, and New Design

National Park Service
U.S. Department of the Interior

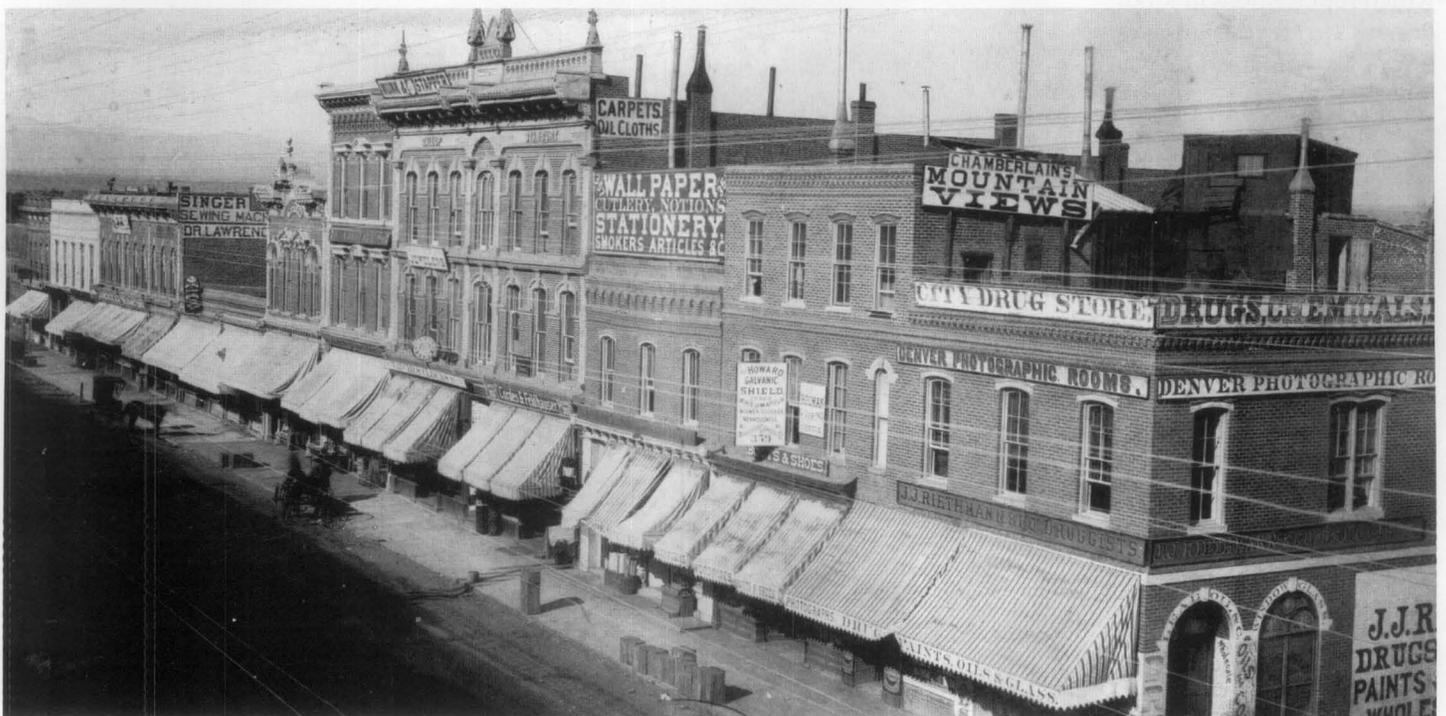
Figure 1. Storefront awnings over sidewalks and entrances were typical features of American streetscapes for much of the 19th and 20th centuries. Photo of Larimer Street, Denver, Colorado, c. 1870, Denver Public Library, Western History Collection, x-22058.

between interior and exterior, they were remarkably efficient and cost effective. Awnings permitted window-shopping on rainy days; they protected show window displays from fading due to sunlight. On the primary facade and near eye level, they were central to a building's appearance. Manufacturers came up with attractive, attention-getting awnings featuring distinctive stripes, ornate valances and painted lettering and logos. With a wide range of color and pattern choices, owners could select an awning that complemented the building and get both style and function in a relatively affordable package (Figs. 1 and 2).

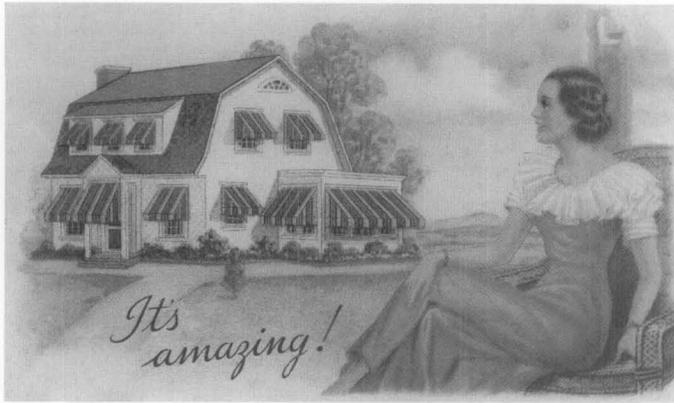
Figure 2. Awnings were an easy way to dress up and distinguish homes of virtually any style. Image: Otis Awning Fabrics Company brochure, c. 1920s.

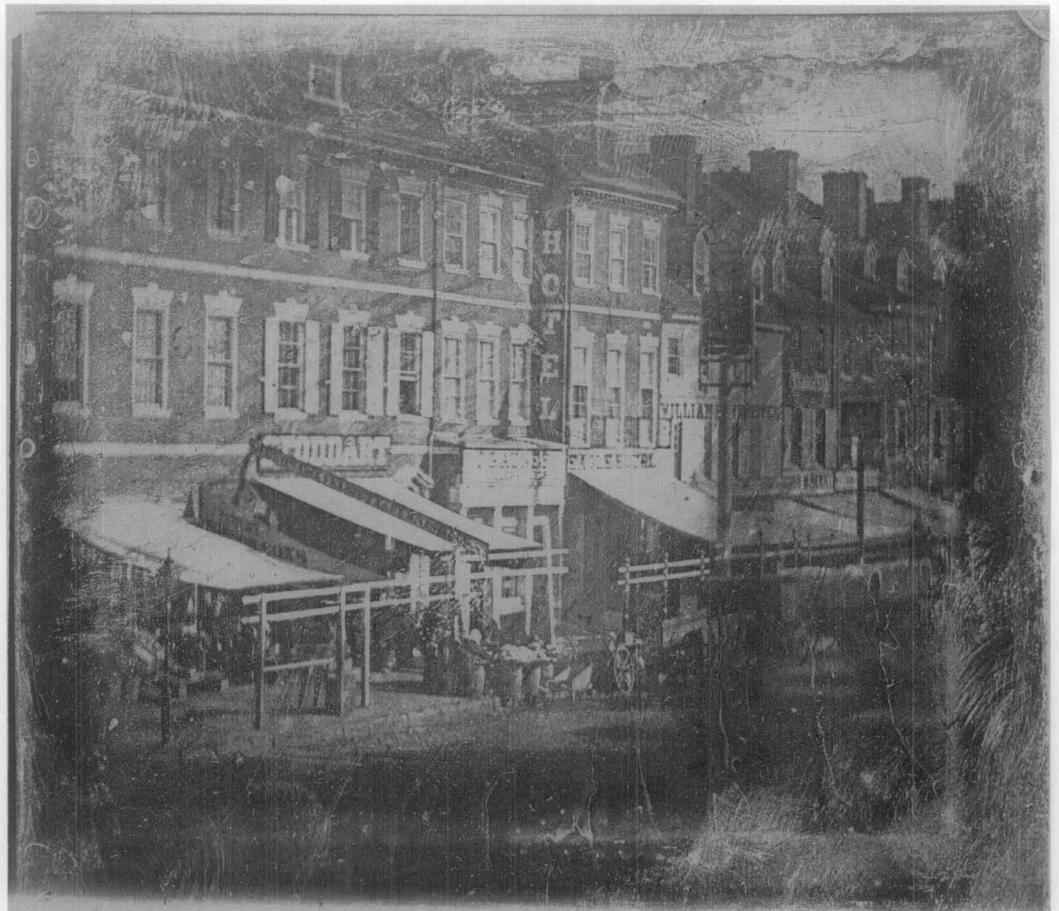
Figure 3. Early 19th century awnings featured canvas coverings stretched between the building facade and post-supported front bars. Projecting frameworks of extension bars were not common until later in the century. Photo: Second Street, Philadelphia, c. 1841, Print and Photo Collection, The Free Library of Philadelphia.

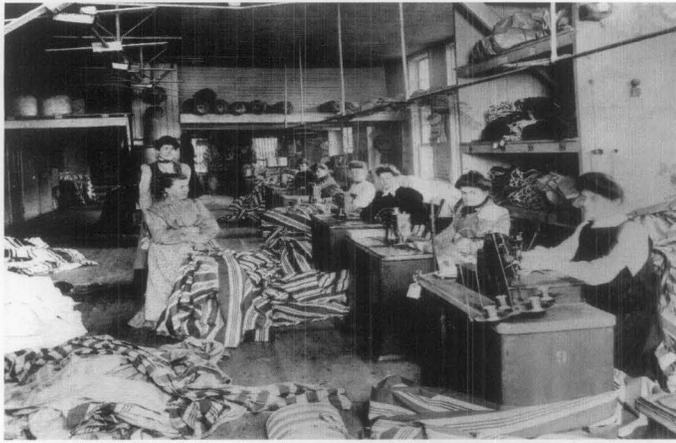
Figure 4. This 1892 photo shows the canvas sewing room of a large awning manufacturer. The wide variety of custom sizes and shapes, and the natural shrinkage of canvas demanded considerable skill in measuring, cutting and sewing. Photo: The Astrup Company.

awnings. Photographs from the mid-1800s often show the bare framework, suggesting that the covering was extended only when necessary. Canvas duck was the predominant awning fabric (Fig. 4). A strong, closely woven cotton cloth used for centuries to make tents and sails, canvas is a versatile material with a relatively short lifespan compensated for by its low cost.

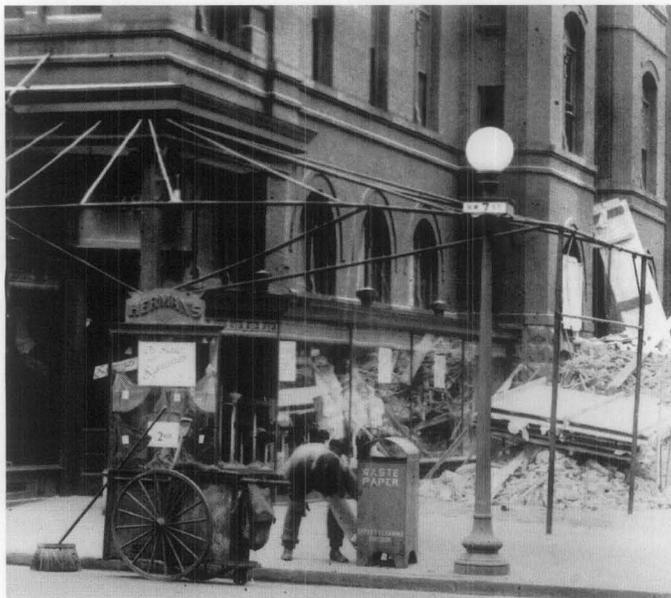
Figure 5. During the second half of the 19th century, iron plumbing pipe became a popular material for fixed awning frames. Here, a pipe frame without its canvas cover extends around the corner of a building in Washington, D.C. Photo: Library of Congress, Prints and Photographic Division, LC-USZ62-121160.

Awnings became a common feature in the years after the Civil War. Iron plumbing pipe, which was quickly adapted for awning frames, became widely available and affordable as a result of mid-century industrialization. It was a natural material for awning frames, easily bent and threaded together to make a range of different shapes and sizes (Fig. 5). At the same time the advent of the steamship forced canvas mills and sail makers to search for new markets. An awning industry developed offering an array of frame and fabric options adaptable to both storefronts and windows.

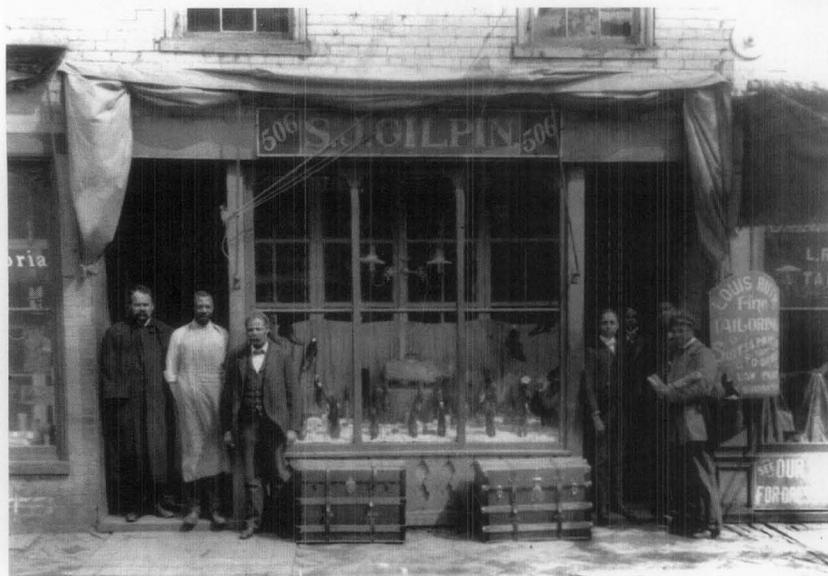
Figure 6. A 19th century shoe store in Richmond, Virginia, had an operable awning retracted against the building facade. Hinged extension arms were raised and lowered allowing for an awning configuration easily changed in response to weather conditions. This photo shows how the fabric gathered and was exposed to the elements when retracted—part of the reason roller awnings later became prevalent. Photo: Library of Congress, Prints and Photographic Division, LC-USZ62-99053.

Operable Awnings. In the second half of the 19th century, manufactured operable awnings grew in popularity (Fig. 6). Previously, most awnings had fixed frames—the primary way to retract the covering was to roll it up the rafters by hand. Operable systems for both storefront and window awnings had extension arms that were hinged where they joined the facade. The arms were lowered to project the awning or raised to retract the awning using simple rope and pulley arrangements. Because the canvas remained attached to the framework, retractable awnings allowed a more flexible approach to shading—shopkeepers and owners could incrementally adjust the amount of awning coverage depending upon the weather conditions. When the sun came out from behind clouds, the awning could be deployed with ease. In case of sudden storms, owners could quickly retract the awning against the building wall where it was protected from wind gusts.

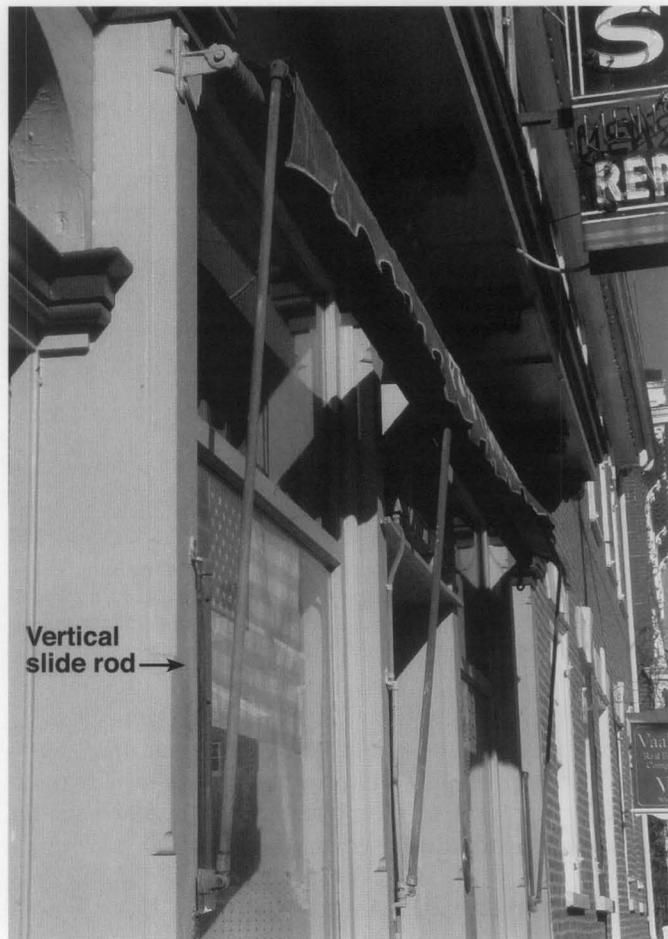
Figure 8. The roller bar at the top of a fixed-arm awning is cranked to release the fabric. As the canvas unfurls the vertical arms swing downward from their lower point. Because the pictured awning had a large projection, extending far from the building wall, the lower hinges were mounted on vertical slide rods affixed to the facade. When the awning is lowered, the bottom hinges of the arms travel up the slide rod to increase headroom beneath the fully extended awning.

Most 19th century roller awnings had fixed arms that were similar to those found on the earlier operable awnings. The arms hinged flush to the building when the awning was retracted and, with the help of gravity, straightened out over the sidewalk when extended. When a storefront awning’s projection exceeded its drop by more than a foot, its long arms were connected to an adjustable slide rod rather than hinged directly to the building facade—increasing head room along the sidewalk (Fig. 8).

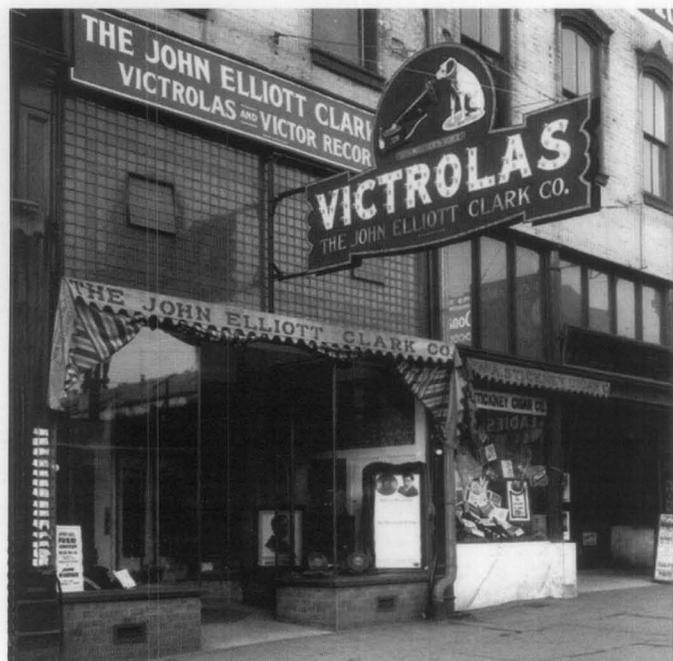
Figure 7. Early 20th century photo showing two operable awnings, an early version on the left and a next-generation roller awning on the right. The roller awning, with no side panels and just the valance showing, presented a clean storefront appearance. Photo: Utah State Historical Society, used by permission, all rights reserved.

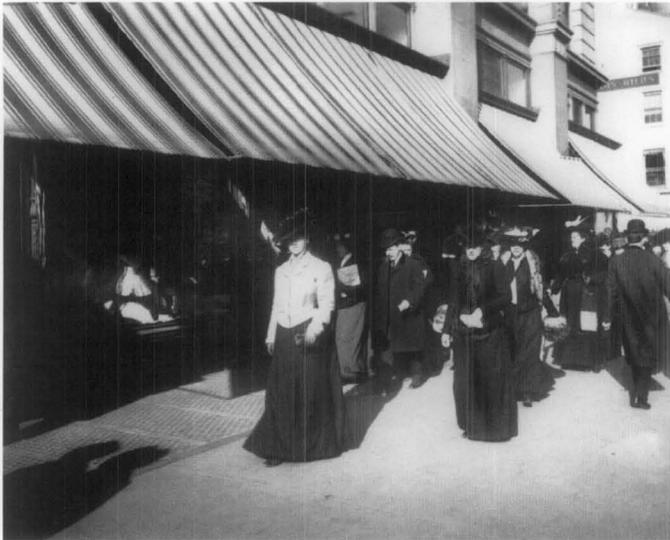
Figure 9. A wide selection of striped patterns took the awning beyond its original, utilitarian function to serve as a decorative and appealing building feature. Photo: Library of Congress, Prints and Photographic Division, LC-D4-62072.

enhanced the decorative schemes of buildings, and in some cases, served as a building’s primary decorative feature (Fig. 9).

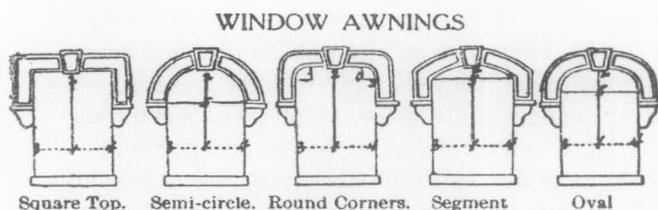
Figure 10. The expanding awning industry manufactured frames and cut fabric for every type of window and door opening. This 19th century catalog illustration provides measuring instructions to assure a custom fit. Awnings were typically set within the window opening.

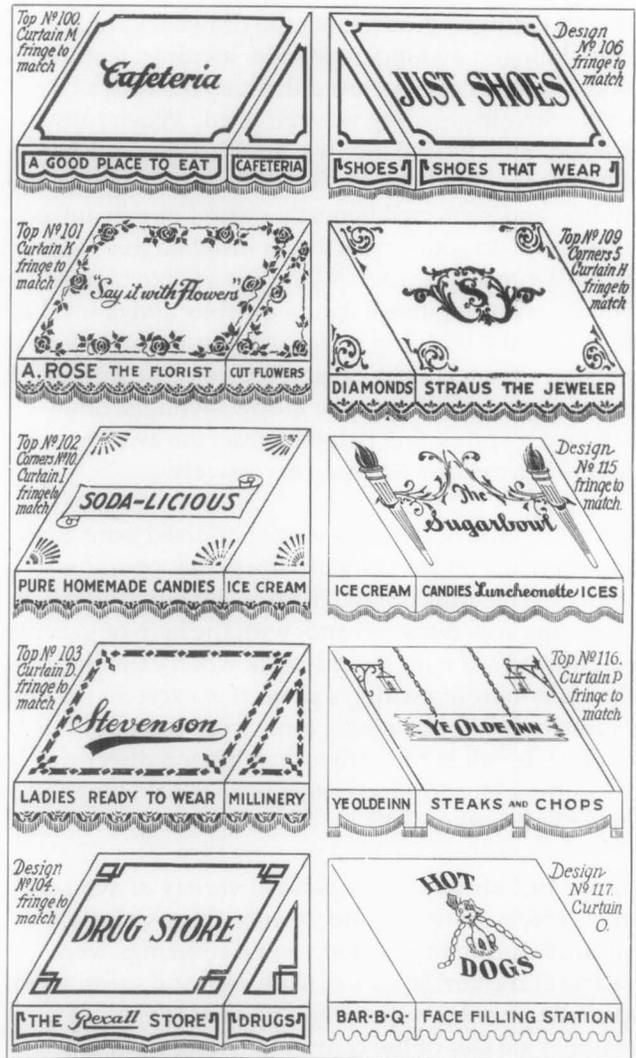
22 DESIGNS FOR STORE AWNINGS

Figure 11. A page from an early 20th century catalog shows lettering and signage that could be applied to commercial awnings. Image: Anchor Industries, Inc.

Awnings increasingly functioned as signs identifying the proprietor's name, goods on offer, or year of establishment. It was a trend that would culminate over a century later with awning installations in which shelter was secondary to advertisement (Fig. 11).

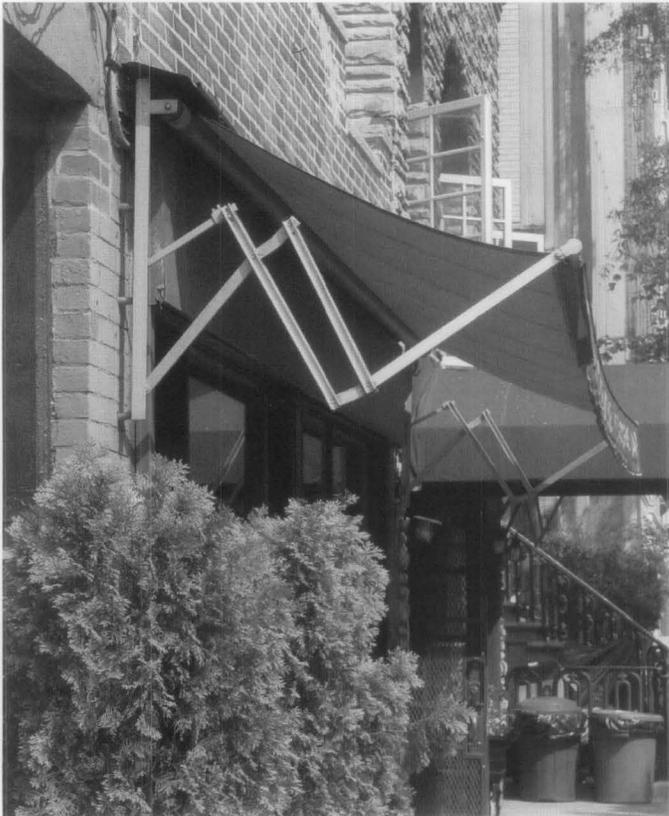
Figure 12. Scissors-arm awnings have a pair of vertical, hinged arms on either side of the assembly supporting the front bar. To unfurl the awning, the roller is cranked and the arms extend outward pulling the cover away from the roller.

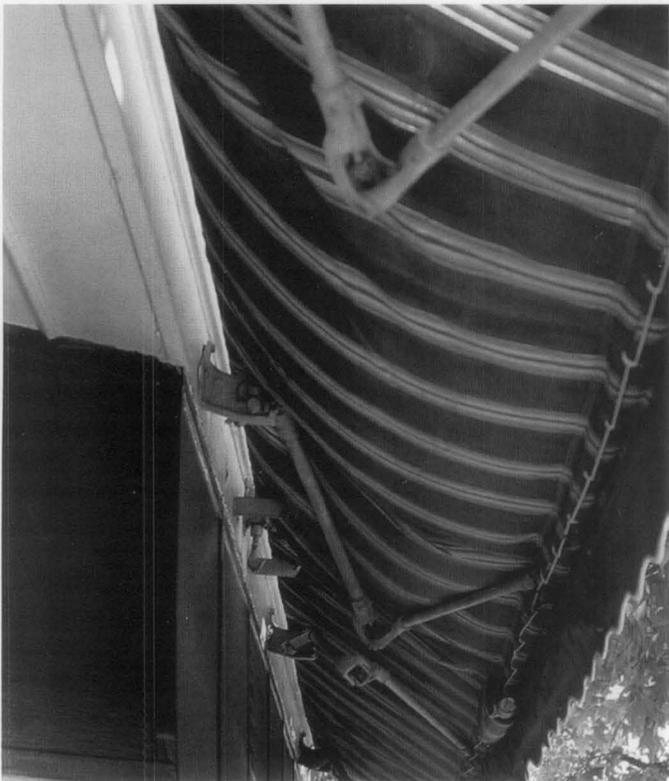
Figure 13. Lateral-arm awnings were preferred on long elevations, especially those with sheet glass (where vertical arms could not be fastened to the building facade). When lateral arm awnings were installed across a broad storefront or porch, manufacturers recommended spacing the arms at approximately eight foot intervals.

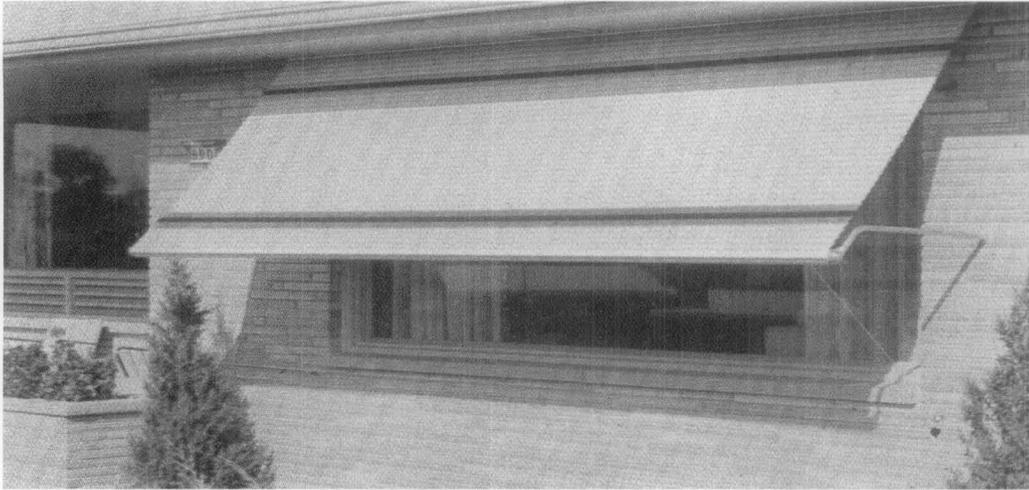
Figure 14. The years after World War II saw the widespread adoption of aluminum awnings on both storefronts and residences. Operable aluminum awnings incorporated a spring-loaded roller into the frontbar.

Widely available by the 1950s, aluminum awnings were touted as longer-lasting and lower-maintenance than traditional awnings. Though used on small-scale commercial structures, they were especially popular with homeowners. Aluminum awnings were made with slats called “pans” arranged horizontally or vertically. For variety and to match the building to which they were applied, different colored slats could be arranged to create stripes or other decorative patterns. While aluminum awnings were usually fixed, in the 1960s several operable roller awnings were developed, including one with the trade name Flexalum Roll-Up (Fig. 14).

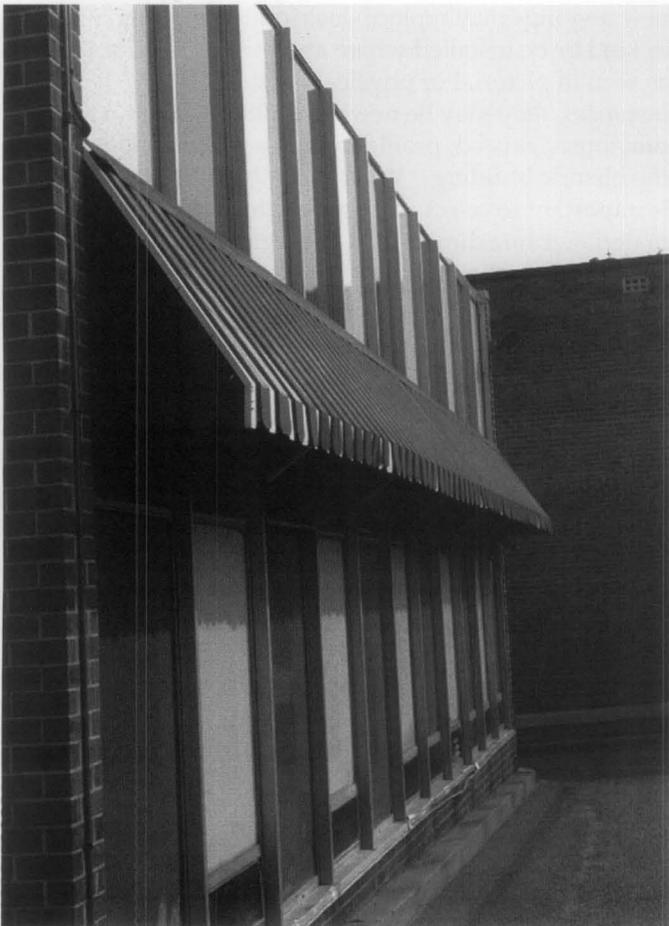
Figure 15. This 1950s-era dry cleaner has an aluminum awning that, with its vertical pattern and alternating stripes, complements the facade's porcelain enamel panes and aluminum mullions. The awning forms an essential element of the building's historic character.

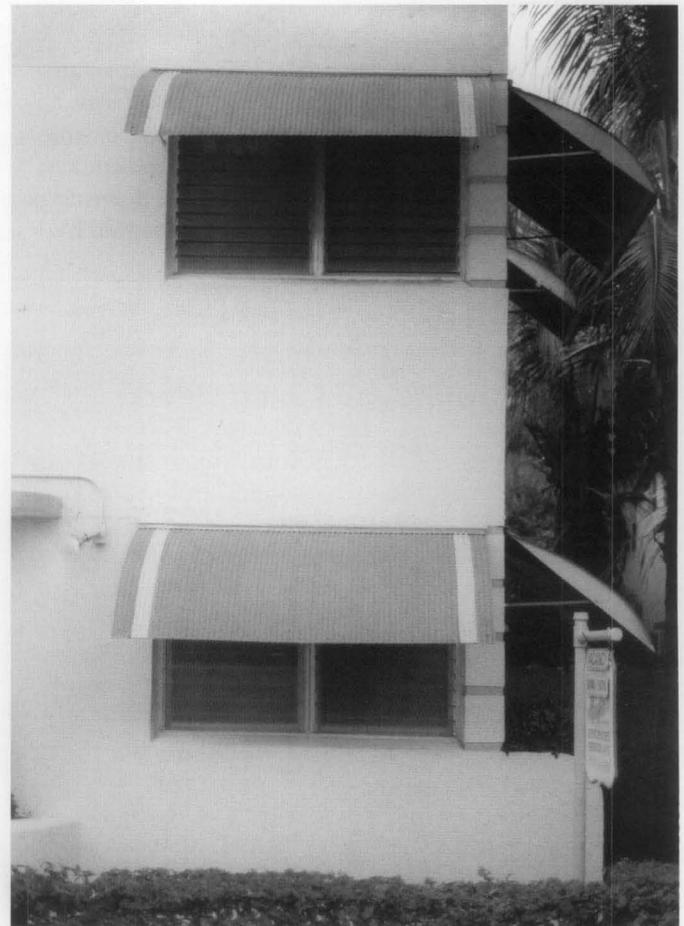
Figure 16. These fiberglass "clamshell" awnings, although not as old as the 1930s building to which they were affixed, are important features that have acquired significance. They were retained when the building was recently rehabilitated.

If awnings already exist on a historic building, they should be evaluated to determine whether they are appropriate to the age, style, and scale of the building, using the criteria identified below. Backlit awnings and dome awnings are usually inappropriate for 19th century and other historic buildings, while aluminum awnings may be perfectly compatible with buildings from the 1950 or 60s (Fig. 15). The time is approaching when some aluminum awnings may even be considered appropriate to older buildings, if the awnings formed part of an updated storefront, or are central features of an intact postwar refashioning of the building's exterior (Fig. 16).

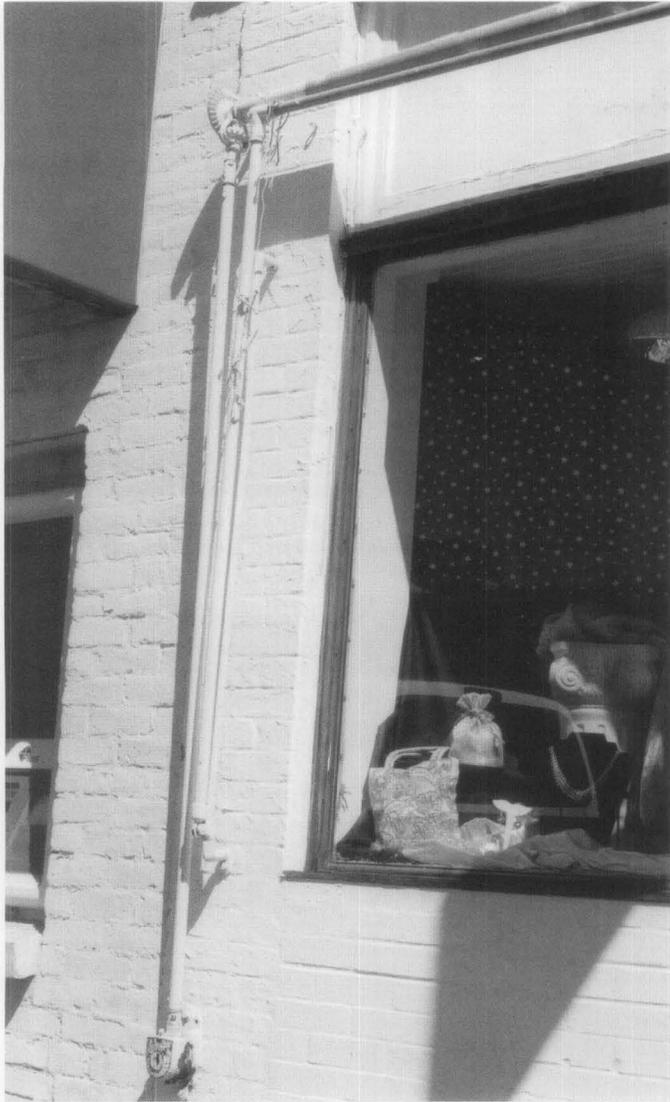
Figure 17. A gearbox, slide rod, roller, front bar, and extension arm reveal that this 19th century building once featured a retractable awning. It is likely that with minor repairs the surviving hardware could again be made operable, recovered with a canvas or acrylic fabric, and reused to service the storefront.

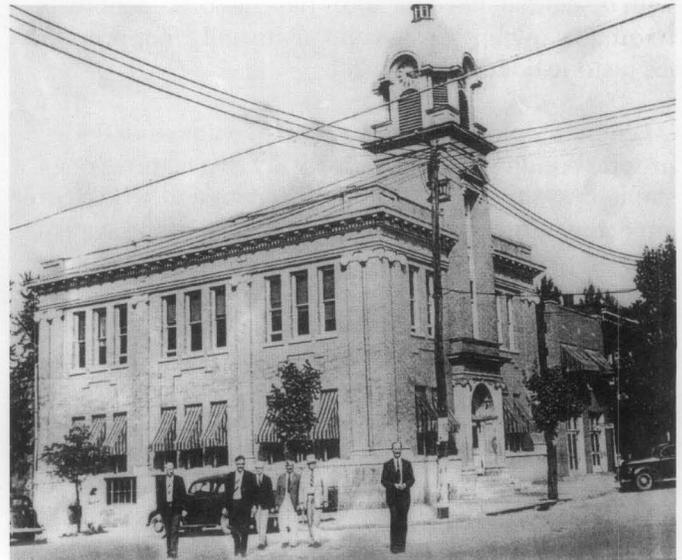
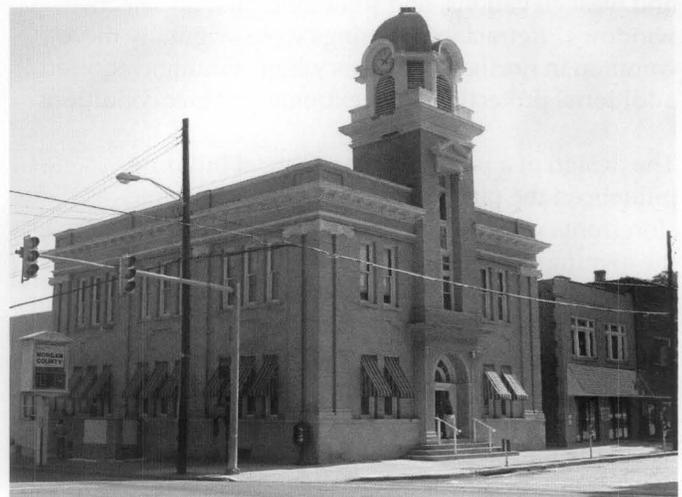
Figure 18. (Above) When the county clerk in Morgan County, West Virginia, was looking to reduce glare in the courthouse offices she located a 1940s photo showing sets of awnings on the first floor. (Below) Using the historic photos as a guide, new awnings with a similar shape and stripe pattern were installed increasing the comfort of employees and protecting county records from direct sunlight. Above photo: Frances Widmeyer and Debra Kesecker.

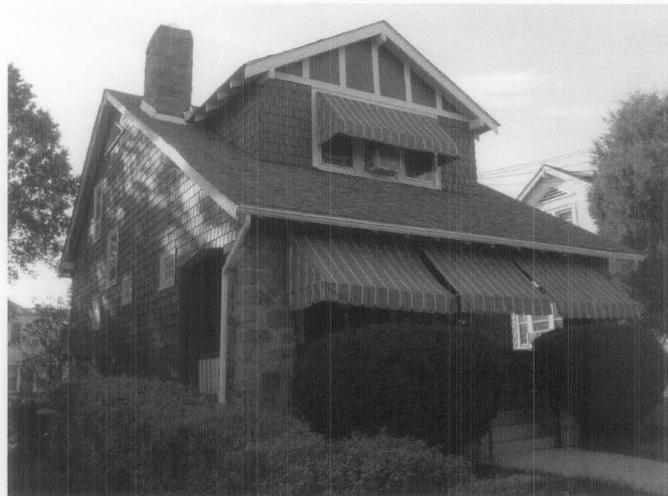
Figure 19. Simple shed-type awnings with acrylic or canvas coverings and free-hanging valances are appropriate for most historic residences featuring rectilinear openings.

Shape. Traditionally, both residential and commercial awnings were triangular in section, usually with a valance hanging down the outside edge (Fig. 19). Early examples of these "shed" awnings had simple

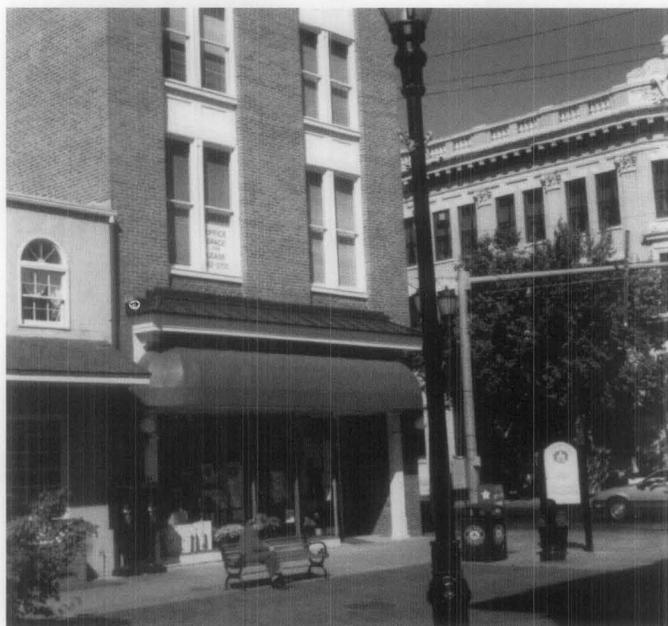
Figure 20. A dome awning was an inappropriate addition to this circa 1890s building. In order to qualify for historic tax credits the new vinyl awning was replaced with a shed awning with a canvas-like woven acrylic covering.

Generally, traditional shed awnings are appropriate for most historic window, door, and storefront installations. It is preferable (and in some historic districts, required) that these awnings have free-hanging valances, the flapping bottom pieces so characteristic of historic awnings. Quarter-round awnings, modern mansard awnings, and other contemporary commercial designs with distended, fixed valances have no precedent in traditional awning design and are usually inappropriate for historic buildings (Fig. 20).

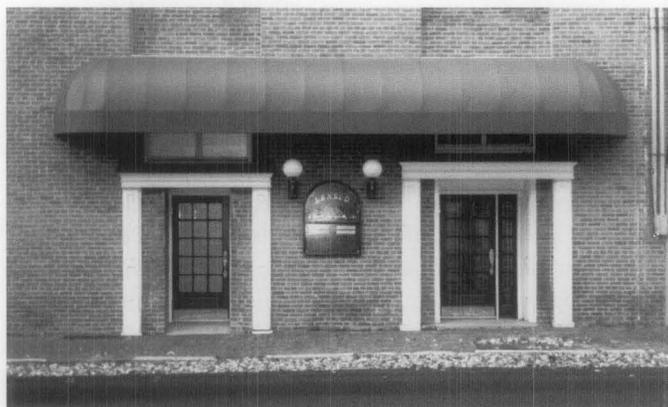
Figure 21. Single awnings should not be set over more than one door or window bay. A separate shed awning with a canvas or acrylic covering would be more appropriate over each of these openings.

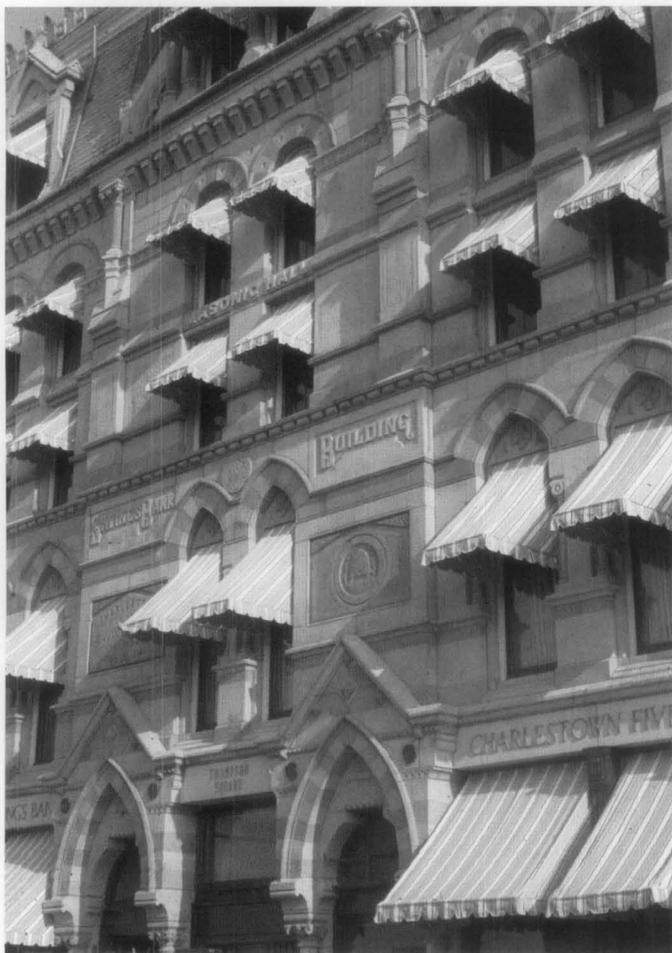
Figure 22. These window awnings today match what would have appeared in the 19th century. The fabric is slightly loose on the frames, the valances hang freely, each window bay has its own awning, and the awning frames are set within the openings. Photo: Mike Jackson.

when installing new awnings on historic buildings to ensure that the covering not obscure the building's distinctive architectural features (Fig. 22). Also, new awning hardware should not be installed in a way that damages historic materials. Clamps and fasteners used to attach awning frames should penetrate mortar joints rather than brick or other masonry surfaces. If new backboards and rollers are installed, care needs to be taken not to damage cornices or transoms. Finally, awning placement, size, and shape must be compatible with the historic character of the building (Figs. 23 and 24).

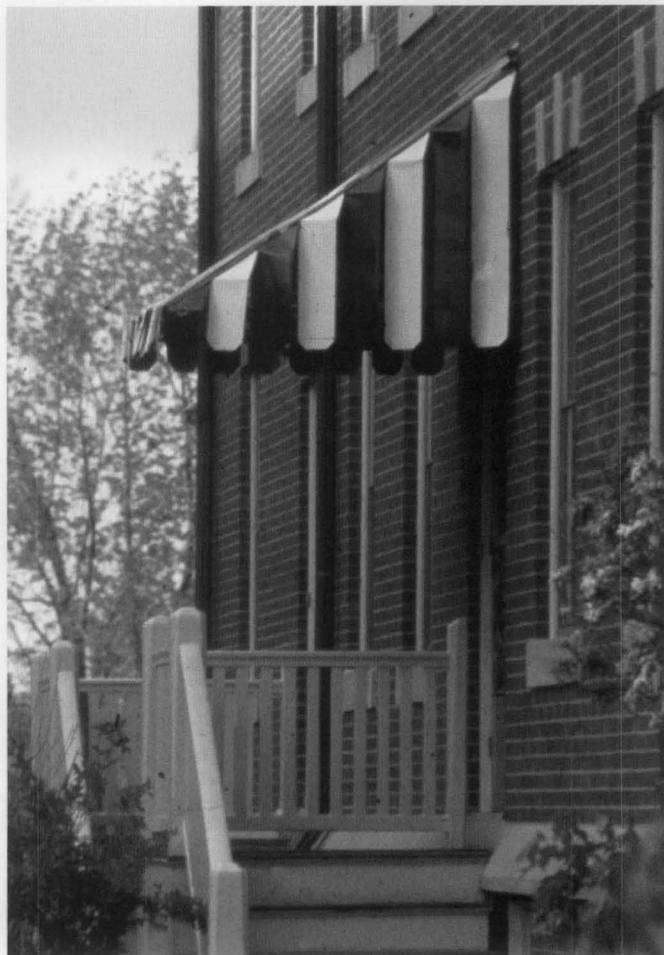
Figure 23. This postwar aluminum awning does not contribute to the character of this 19th century residence and could be replaced during a rehabilitation project with a fabric shed awning more in keeping with the building's age and appearance.

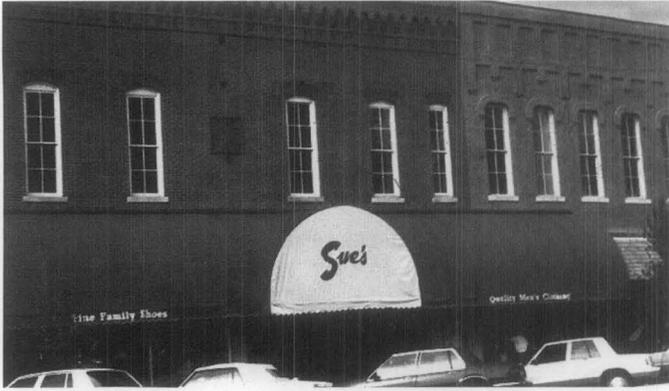
Figure 24. This awning, extending across much of the building, is incompatible in shape. Of greater concern, however, is that its size wholly overshadows the modest historic building behind.

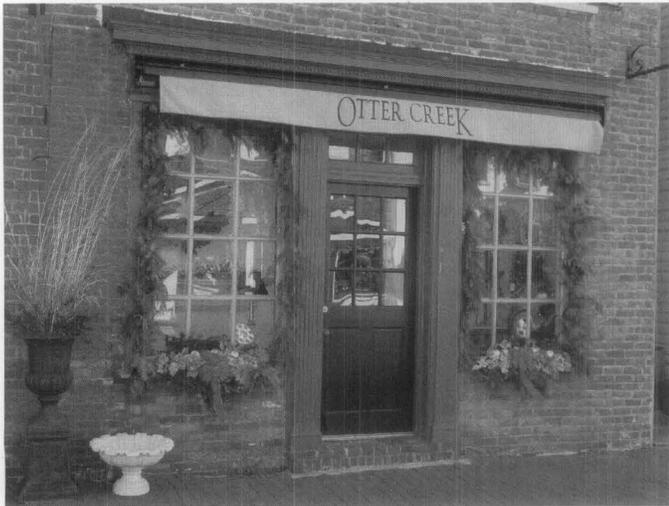
Figure 25. Appropriate lettering, as on this roller awning valance, can function as distinctive signage without detracting from the historic character of the building.

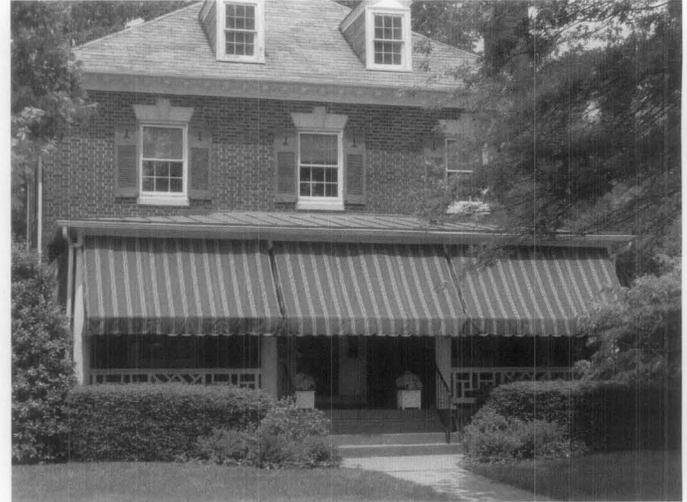
Figure 26. The green and burgundy stripes that decorate these porch awnings complement the matching shutters and brick facade.

Color. As in the past, variety in awning color is an appropriate characteristic when reintroducing awnings in historic districts. Since the 19th century, awnings have featured a range of different stripe patterns and an extensive color palette (Fig. 26). These lively, even whimsical,

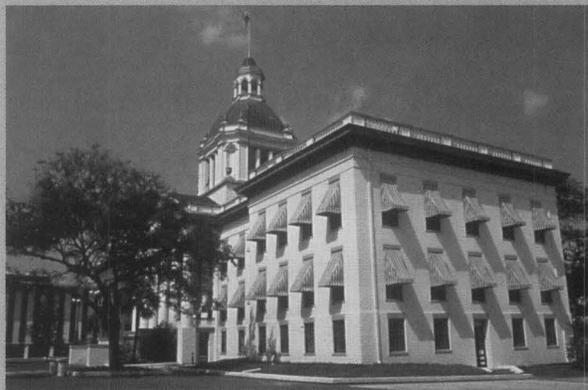
Awnings were reinstalled on the east, west, and south windows of the Florida State Capitol in the 1980s. With a design based on those seen in historic photographs of the building, the new awnings allowed a downsizing of the HVAC system by 25 tons. After installation, the exposed glass surface in a typical first floor office accounted for only 46% of the required cooling load, down from 72%. Photo: Division of Historical Resources, Florida Department of State.

Although their effectiveness can be affected by many factors including location, climate, window size, and glass type, the energy efficiency advantages of awnings are clear. According to the Department of Energy, awnings can reduce heat gain up to 65% in south facing windows and up to 77% on windows facing east. Awnings reduce stress on existing air conditioning systems, and make it possible to install new HVAC systems with smaller capacity, thus saving purchasing and operating costs. Air conditioners need to work less hard, less often. When used with air conditioners, awnings can lower the cost of cooling a building by up to 25%.¹
