NIST Special Publication 1126

Summary of Full-scale Experiments to Determine Vulnerabilities of Building Components to Ignition by Firebrand Showers

December 2011

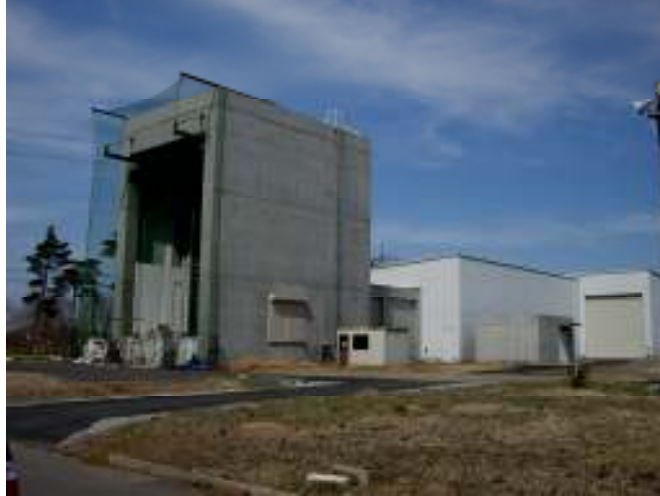
Figure 2b Photograph of FRWTF.

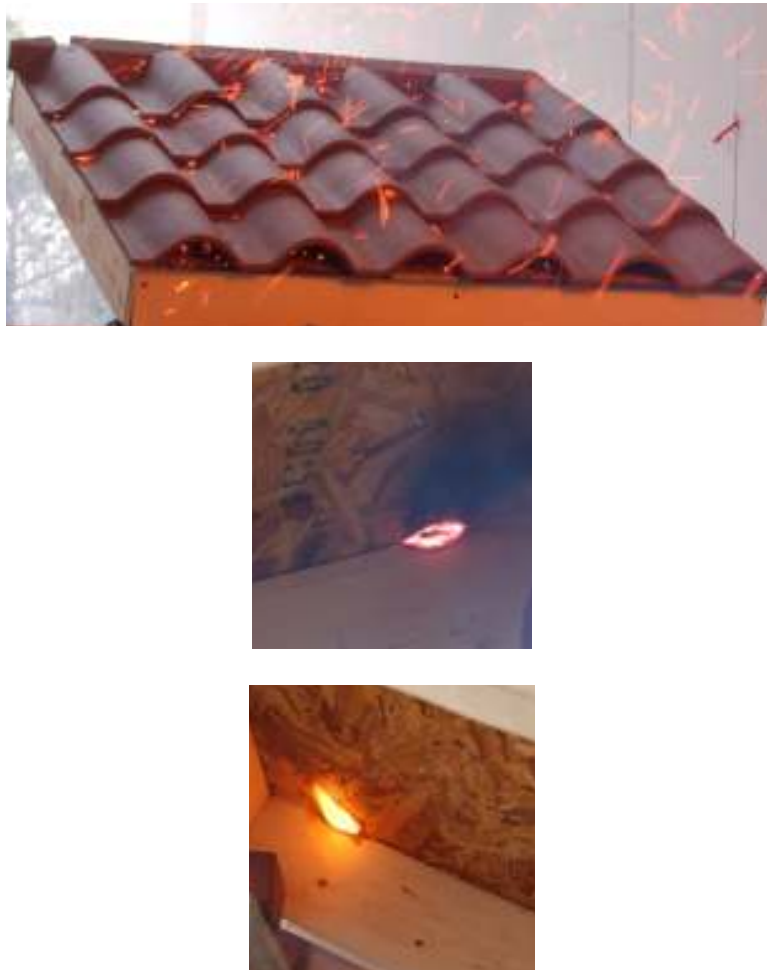
Figure 5 Images of experiments conducted using OSB/CT without bird stops installed. Intense SI was observed within the OSB base layer and eventually FI was observed. The wind tunnel speed was 7 m/s and the Firebrand Generator was located 2.0 m from the CT roofing assembly.

When new, ceramic tile roofing assemblies are constructed by placing a base layer of oriented strand board (OSB), then tar paper (TP) is installed on top of the OSB for moisture protection, and finally ceramic tiles (CT) are applied. Aged or weathered ceramic tile roofing assemblies were simulated by not installing tar paper. For simulated aged ceramic tile roof assemblies, without the installation of bird stops, the firebrands were observed to be blown under the ceramic tiles (see **Figure 5**). Bird stops, as the name suggests, are intended to mitigate the construction of nests by birds under the ceramic tiles. During the experiments, eventually, several firebrands would collect and would produce smoldering ignition (SI) within the OSB base layer. With continued application of the airflow, holes were formed within the OSB and eventually the SI would transition to flaming ignition (FI). Simulated aged ceramic tile roof assemblies, with bird stops installed, were also constructed for testing. Even though bird stops were installed, many firebrands were able to penetrate the gaps that exist between the ceramic tiles and the bird stops. These firebrands were observed to produce SI within the OSB base layer; holes were observed in some cases within the OSB base layer. The SI ignition never transitioned to FI when bird stops were applied.

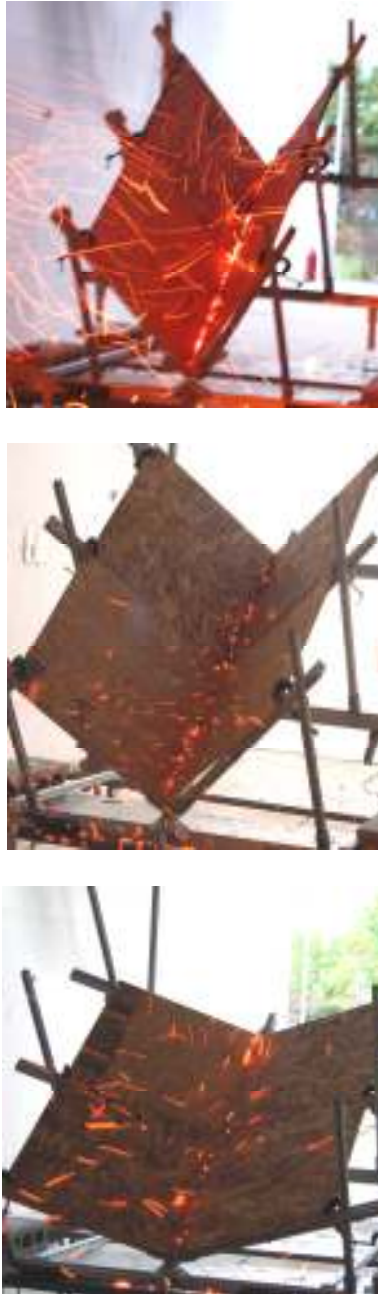
Figure 6 Bare OSB full-scale sections used for testing. (a) Angle of 60°; smoldering ignition observed (b) Angle of 90°; smoldering ignition observed (c) Angle of 135°; no ignition observed. The wind tunnel speed was 7 m/s in each case.

For ignition testing of roofing base layer materials (OSB), at an angle of 60°, the firebrands were observed to collect inside the channel of the OSB crevice (see **Figure 6a-c**). The firebrands that collected in the crevice produced SI where they landed, eventually resulting in several holes in the OSB. The OSB continued to smolder intensely near the locations where the firebrands landed. Eventually a transition to FI was observed on the back side of the OSB. As the angle was increased to 90°, similar behavior was observed where the firebrands that collected initiated intense smoldering. Eventually, holes were formed at these locations in an identical manner to the 60°. While SI was observed, it was not possible for a transition to flaming to occur. As the angle was increased to 135°, ignition was no longer possible.

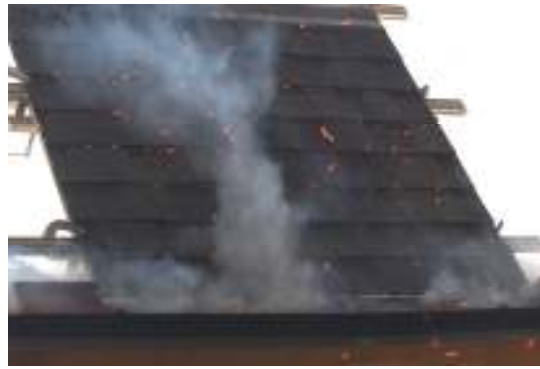
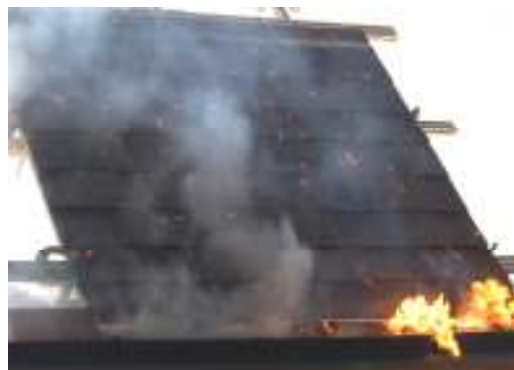
Figure 8 Section of full-scale roof assembly. (a) Smoldering ignition of needles/leaves inside gutter (b) Transition to flaming ignition. The wind tunnel speed was 7 m/s.

Figure 8a-b displays typical results obtained from the experiments. The firebrands that were deposited inside the gutter produced SI inside the gutter. The smoldering intensified and ultimately this transitioned to FI. The asphalt shingles were observed to melt once exposed to the intense flaming that occurred inside the gutter. The flames, however, did not spread up the roof section. While the flames did not spread upwards along the roof, these images are very important since they clearly show the dangers of not cleaning gutters. The influence of pre-heated shingles as well as aged shingles was not addressed.

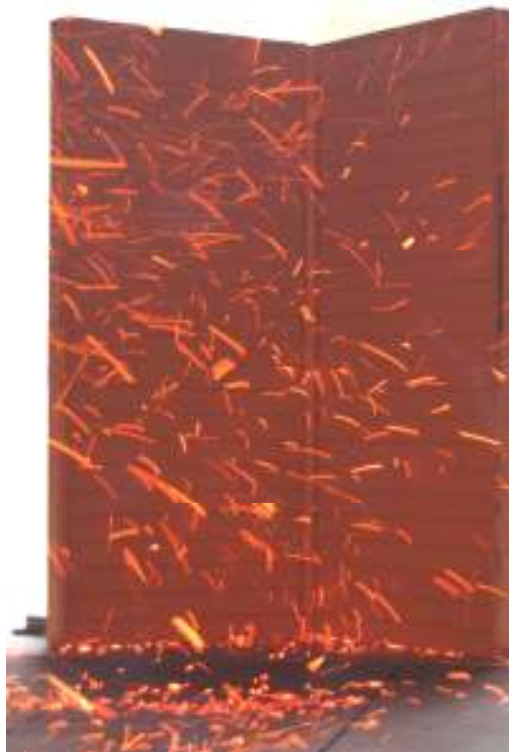
Figure 14 (b) Picture of vinyl siding corner assembly under firebrand bombardment.

For experiments with vinyl siding (see **Figure 14b** for typical experiment) conducted at 7 m/s and 9 m/s, the firebrands were observed to melt the siding to the point where holes developed through the material. A picture of this is shown in **Figure 15**. While burns were observed in the moisture barrier at both wind speeds (Tyvek), ignition of the OSB sheathing was only observed for vinyl siding tests at 9 m/s and when the sheathing was dried. It is important to

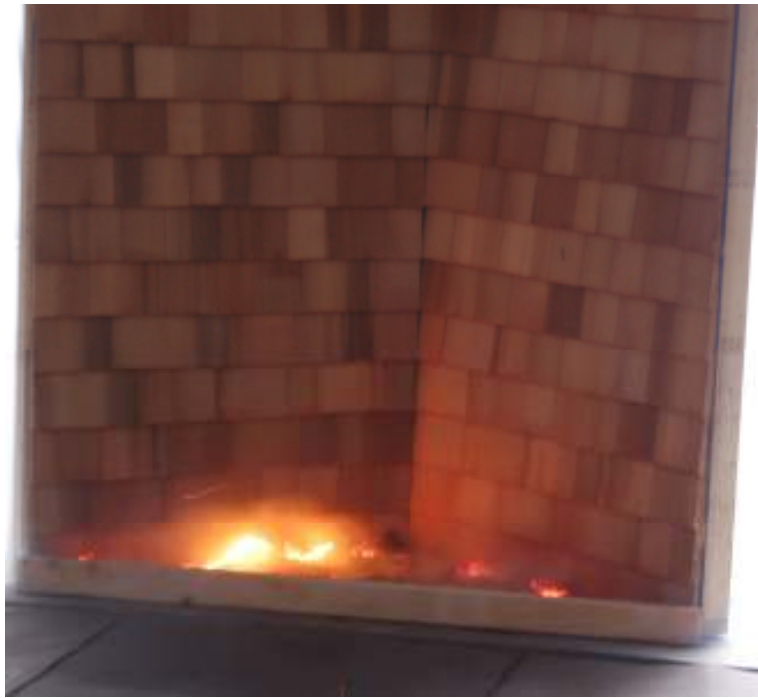
Figure 17 Images of untreated cedar shingle siding ignited under firebrand attack at a wind tunnel speed of 7 m/s.

When considering untreated cedar shingle siding, similar results were observed; namely ignition of the wall assembly itself (see **Figure 17**). The fire retarded cedar shingle siding performed very well. Even though the fine fuels exposed the wall assembly to flames, ignition of the cedar shingle siding was not observed, nor did any ignition occur in the OSB sheathing.

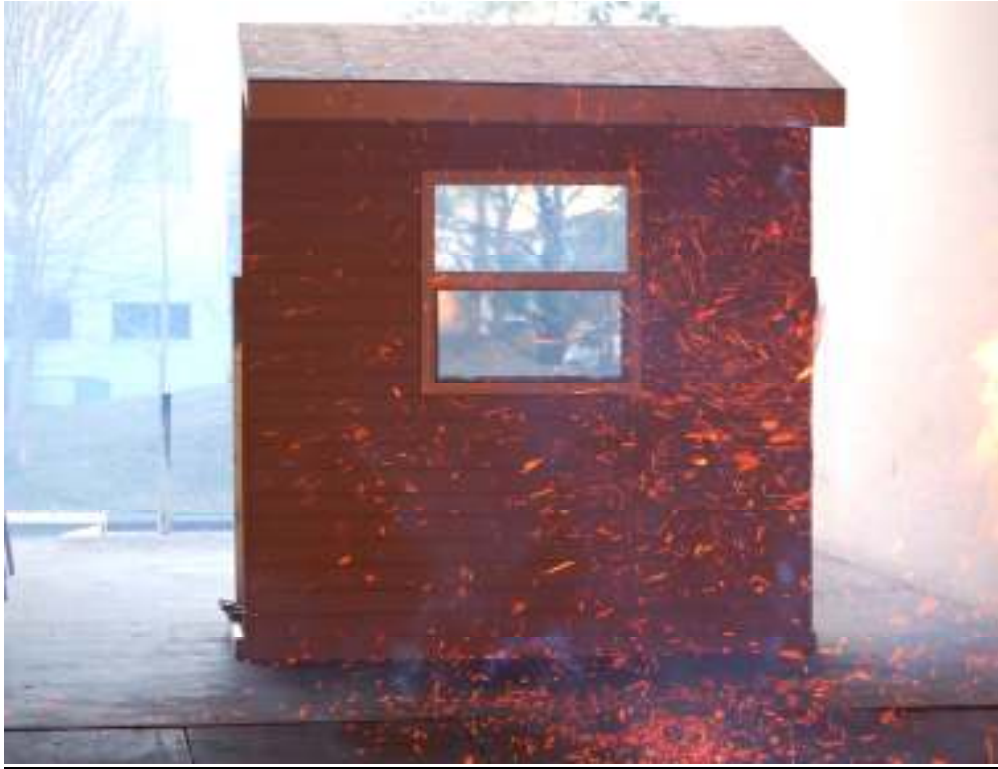
Figure 21 Picture of wall/eave assembly fitted with a vertically sliding, double hung window exposed to firebrand showers at a wind tunnel speed of 9 m/s.

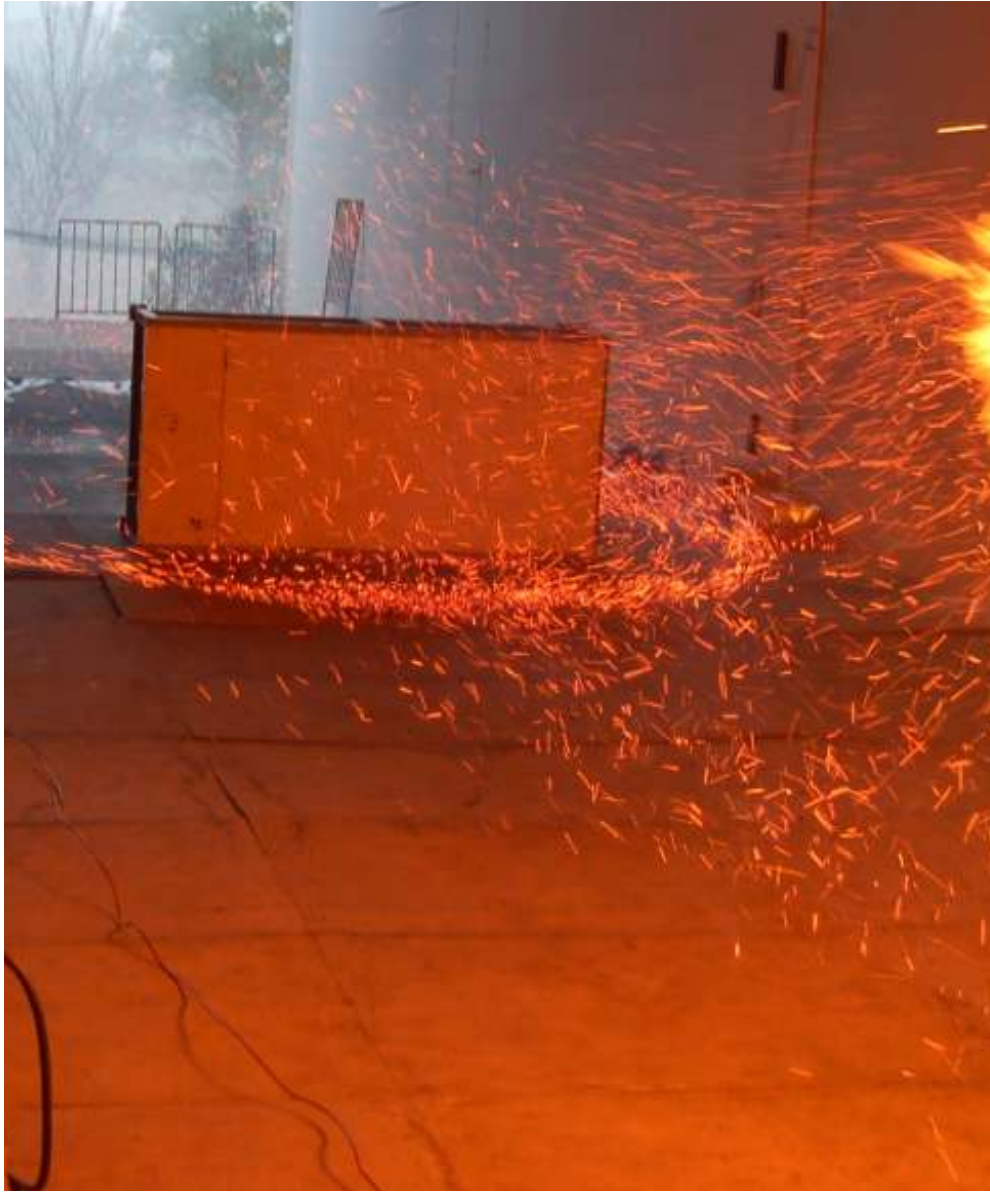
Figure 22 Image of firebrands flowing around one of the obstacles used.

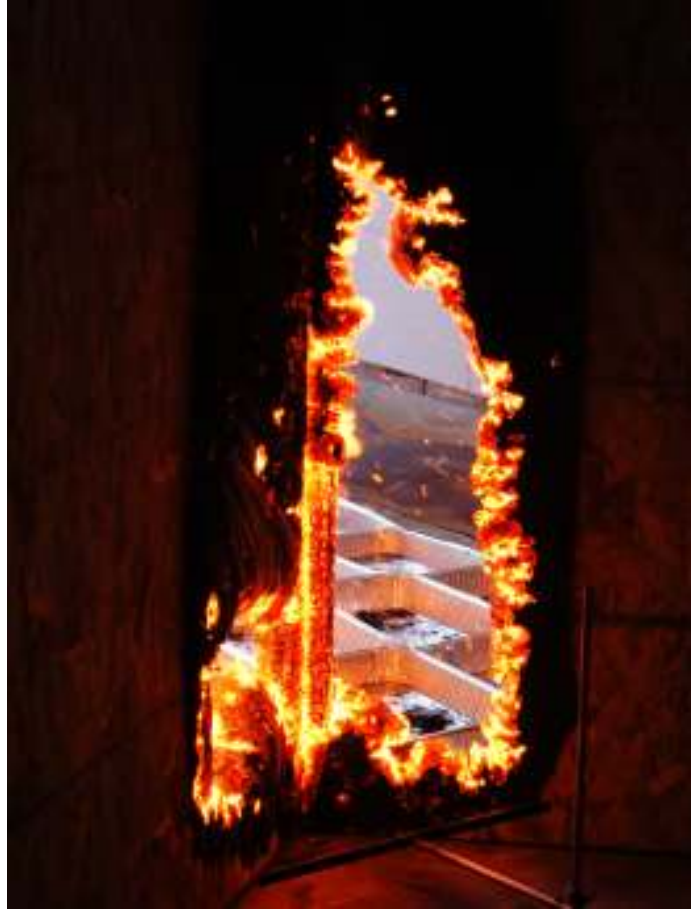
Figure 30 Firebrand generation from a burning re-entrant corner at 8 m/s applied wind. Firebrands are produced on the backside of the assembly and are collected using an array of water pans downstream.

tunnel on, experiments were conducted until the wall assembly could no longer support itself. Firebrands were collected by using a series of water pans placed behind the assemblies. After deposition into the water pans, the firebrands were filtered from the water using a series of fine mesh filters. Firebrands were dried in an oven and the mass and size of each firebrand was measured by a precision balance and using digital image analysis, respectively. A figure of a full-scale re-entrant corner, ignited using a propane burner, and burning under an applied wind speed of 8 m/s is shown in **Figure 30**.

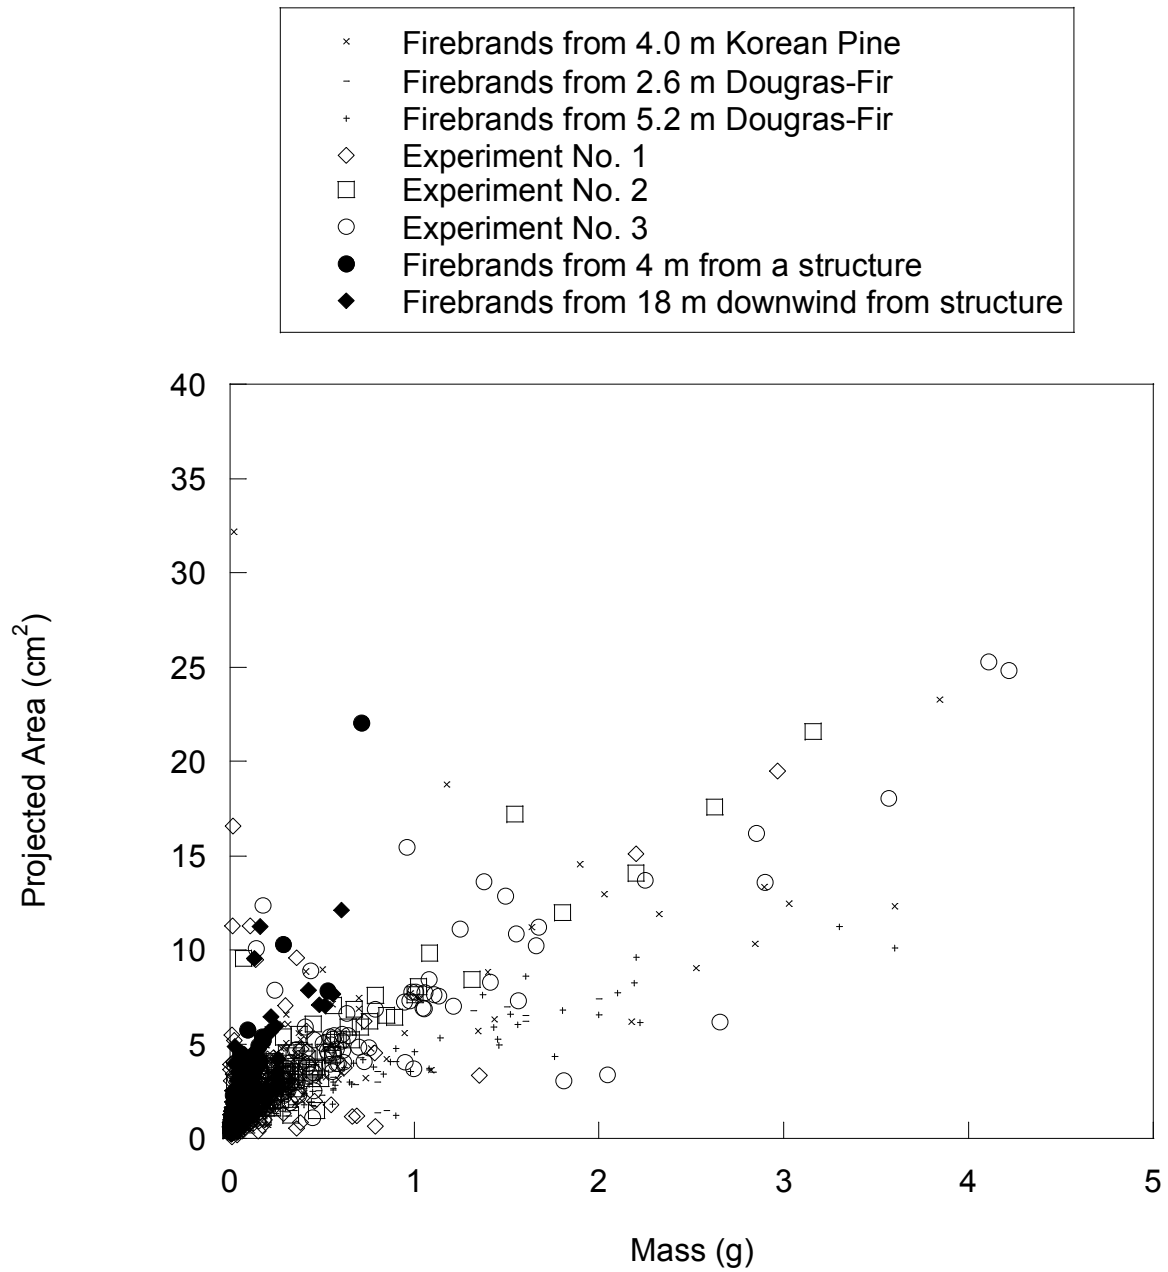
Figure 31 Size and Mass Distribution of Firebrands.
