**NISTIR 7342**

# **Full-Scale Evaluation of Positive Pressure Ventilation In a Fire Fighter Training Building**

Stephen Kerber  
William D. Walton

July 2006

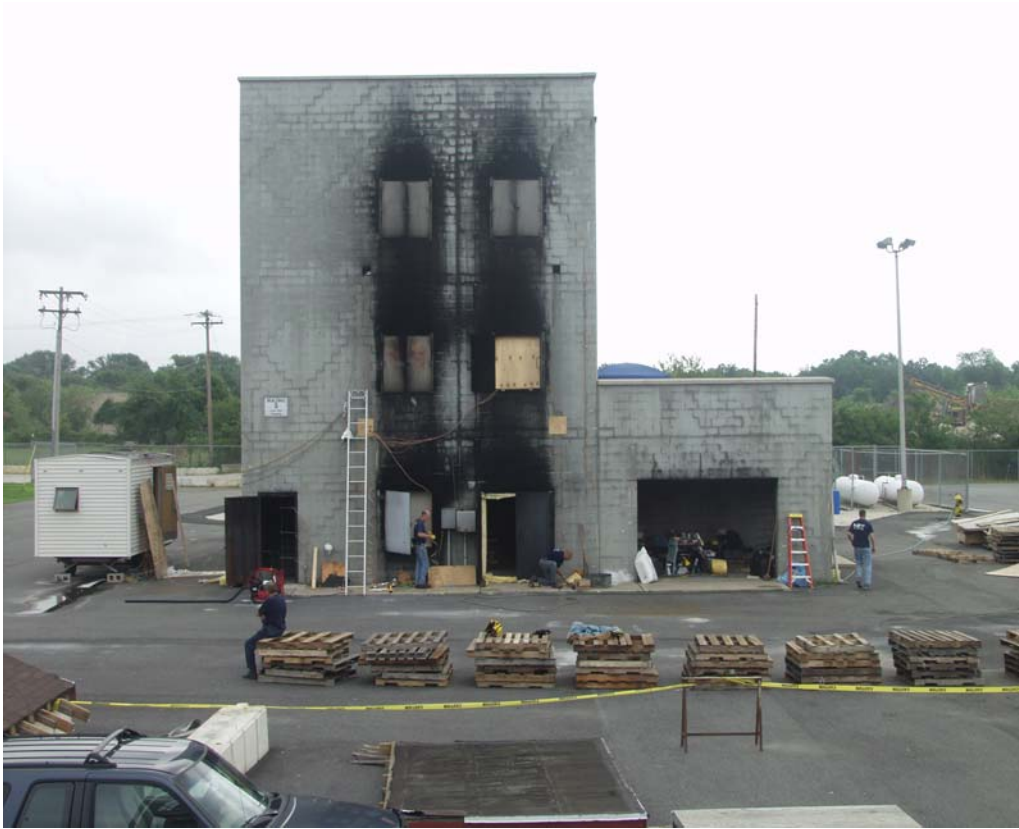
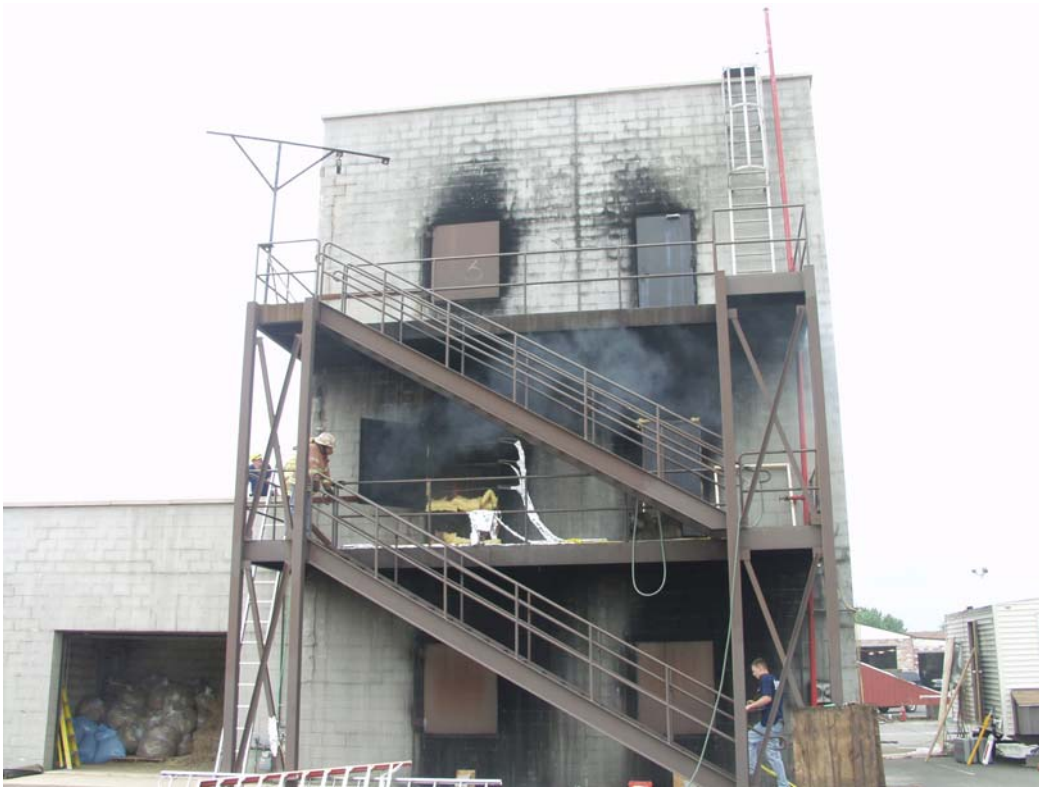
Figure 2. Front of Fire Fighter Training Burn Building

A series of full-scale experiments were performed at the Delaware County Emergency Services Training Center in Sharon Hill, Pennsylvania in a three-story fire fighter training burn building (Figures 2, 3). The burn building was concrete block construction with concrete floors and steel windows and doors. Temperature resistant panels protected the interior walls of the structure. Gypsum board on wood frames and fiberglass insulation were used to isolate sections of the building (Figure 4). The ceiling heights in the rooms were 3.4 m (11.0 ft) and the slab thickness between the first and the second floors was 0.2 m (8.0 in).

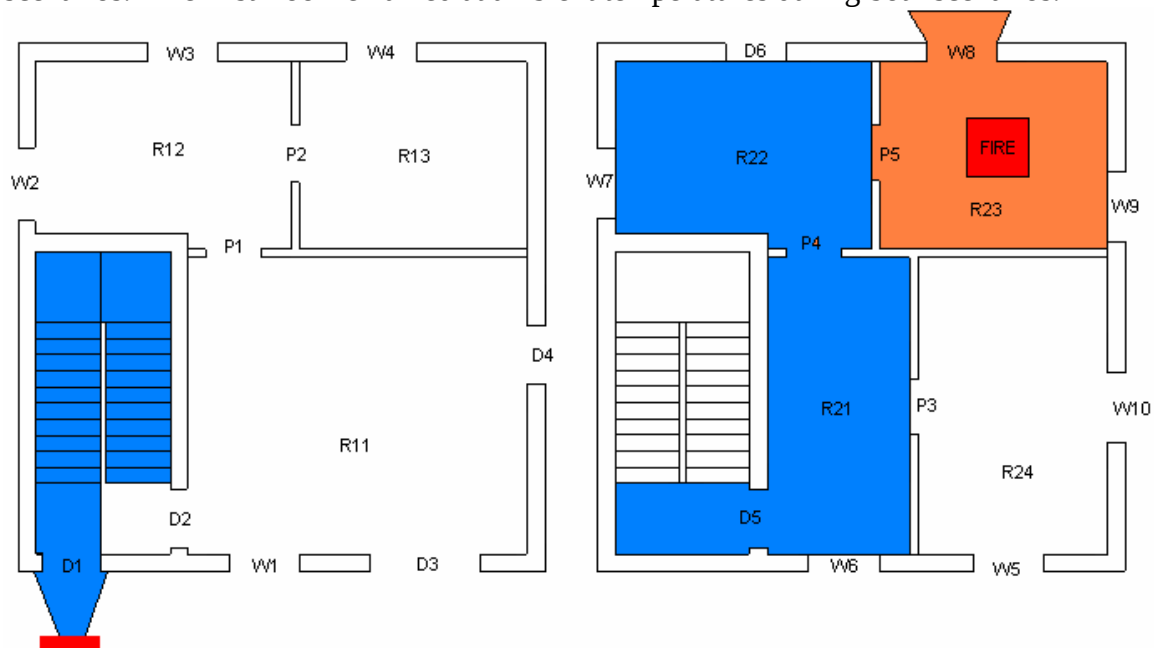
Figure 20. Configuration 1 Layout

The maximum fire room temperature for the naturally ventilated test was 550 °C (1020 °F) and the maximum temperature for the PPV ventilated test was 780 °C (1440 °F) (Figure A-1). In the adjacent room (R22), the temperature with PPV was nearly 50 °C (90 °F) higher than the naturally ventilated test. All of the other rooms in the structure had approximately the same maximum temperatures at the ceiling level for both scenarios. The first floor remained at ambient temperatures during both scenarios.

At the 0.61 m (2 ft) height, where victims may have been located, the maximum temperature in the fire room was 180 °C (356 °F) for the naturally ventilated test and 370 °C (698 °F) for the PPV ventilated test. The temperature in the PPV ventilated test was 190 °C (342 °F) greater than in the naturally ventilated test, which was most likely
