Preliminary Assessment of Channel Stability and Bed-Material Transport in the Rogue River Basin, Southwestern Oregon

Open-File Report 2011–1280

U.S. Department of the Interior
U.S. Geological Survey

By Krista L. Jones, Jim E. O'Connor, Mackenzie K. Keith, Joseph F. Mangano, and J. Rose Wallick

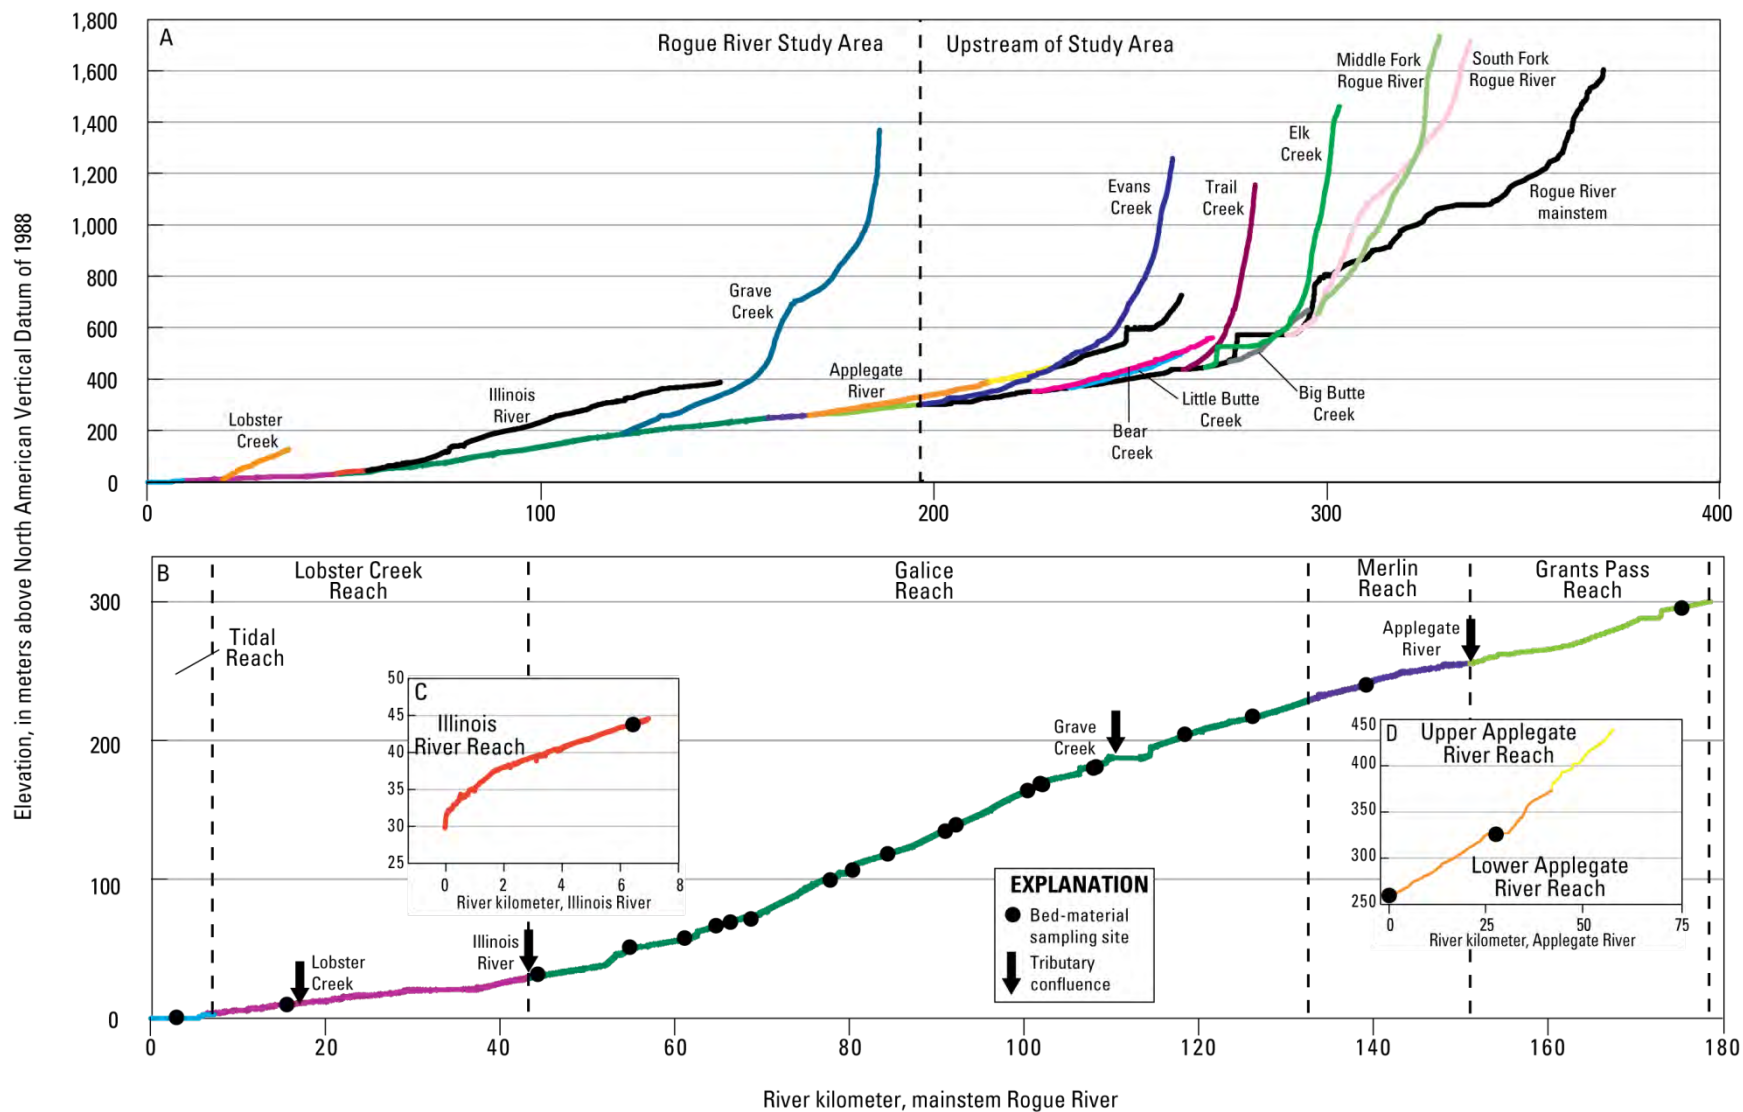
Figure 2. Diagrams showing longitudinal profiles for the Rogue River basin and study areas on the Rogue, Illinois, and Applegate Rivers, southwestern Oregon. Elevations derived from the U.S. Geological Survey 10-m Digital Elevation Model (DEM)

The longitudinal profile for the basin (fig. 2A) shows a smooth gradation in water surface slope along the Rogue River from its headwaters to its confluence with the Pacific Ocean. This profile, in conjunction with the abundant gravel bars observed to the mouth of the river and the relatively small tidal reach, indicates that the Rogue River has transported gravel to the Pacific Ocean at a rate that has exceeded the depositional accommodation space created by Holocene sea-level rise. Hence, the Rogue River basin differs from the many Coast Range drainages where bed-material deposition has not kept pace with sea-level rise, resulting in longer tidal reaches (Komar, 1997). The wide valley bottom in the lowest portion of the study area in part reflects Holocene filling of the Rogue River Valley.

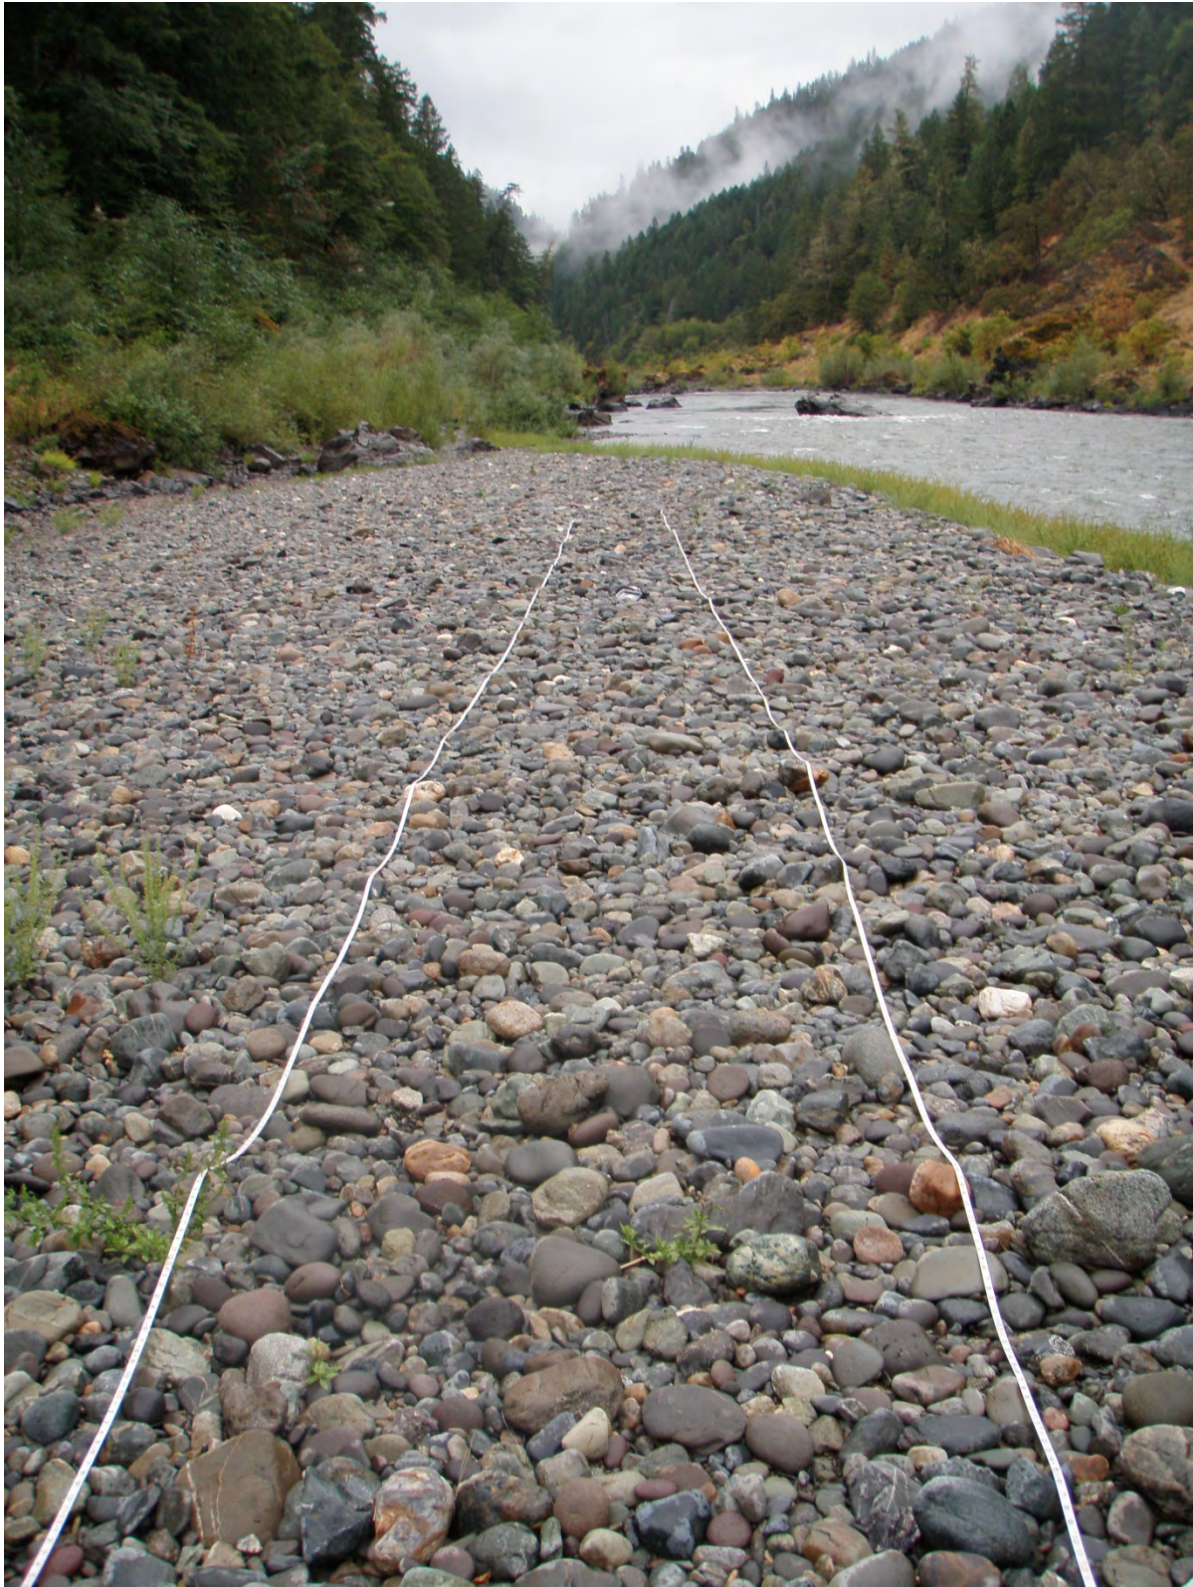
Measurement transect at the Telephone Hole Bar in the Galice Reach.

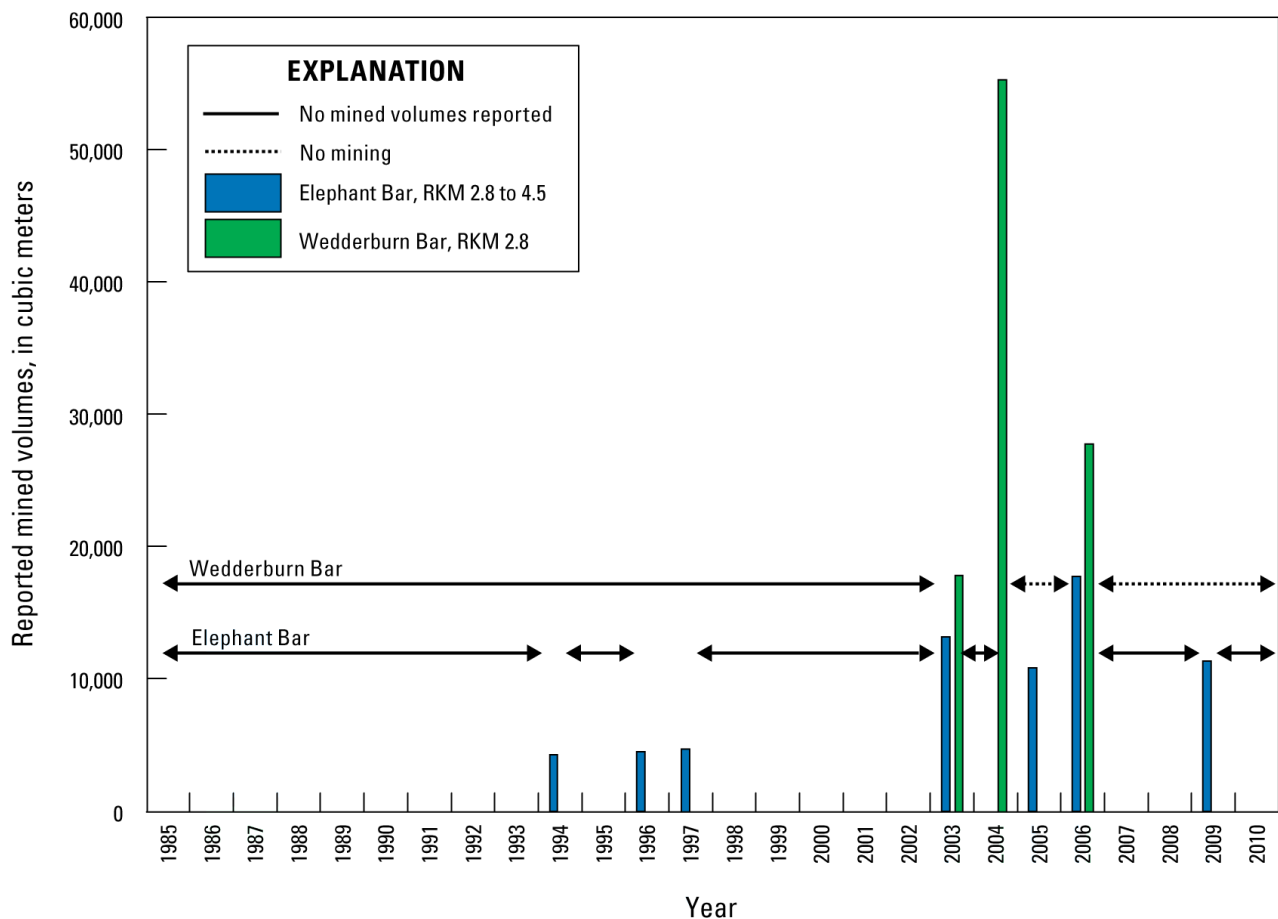
Figure 16. Graph showing partial volumes of gravel mined from 1985 to 2010 along the lower Rogue River, southwestern Oregon. Data for Wedderburn Bar were provided by Robert Elayer (Tidewater Contractors, Inc., written commun., 2010) and Elephant Bar by Christy Leas (Oregon Department of State Lands, written commun., 2011) and Alex Liverman (Oregon Department of Environmental Quality written commun., 2011).

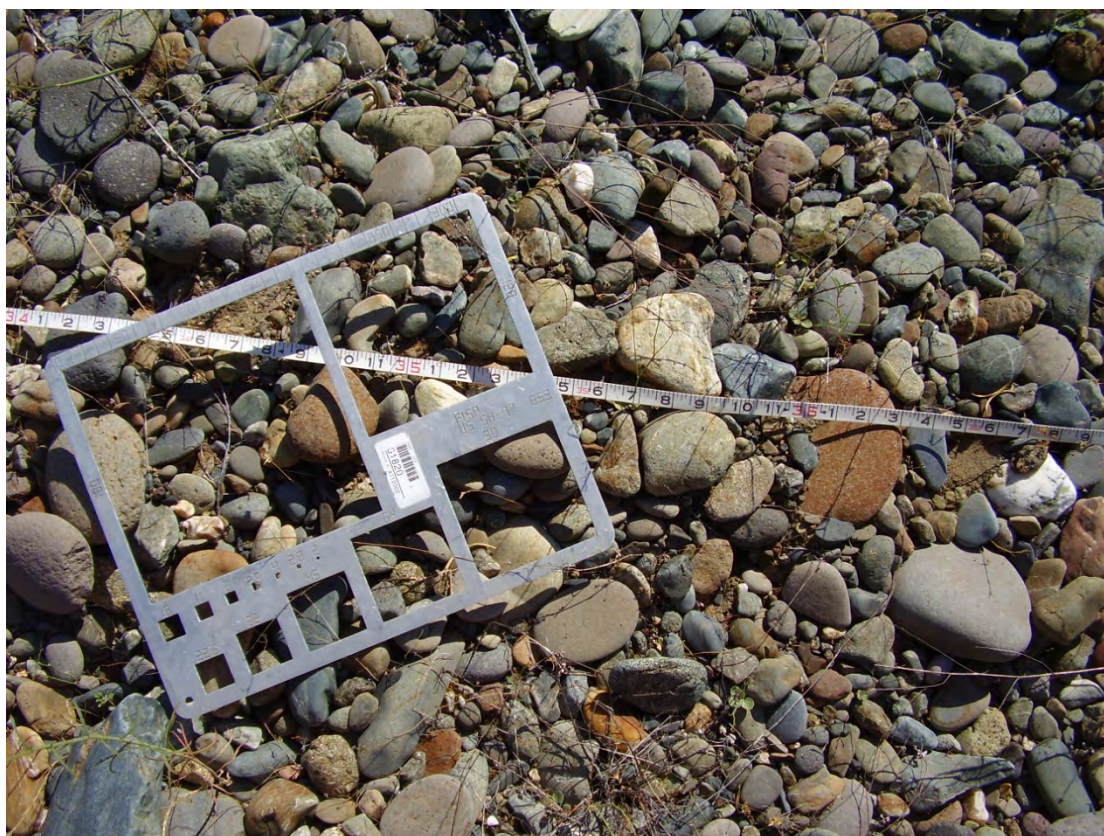
Gravelometer template used to measure the diameter of surface particles.
