Hydrologic Study at Farm Creek Marsh, Dorchester County, Maryland, from April 2015 to April 2016

Scientific Investigations Report 2019–5032

By Charles W. Walker, Todd R. Lester, and Christopher W. Nealen

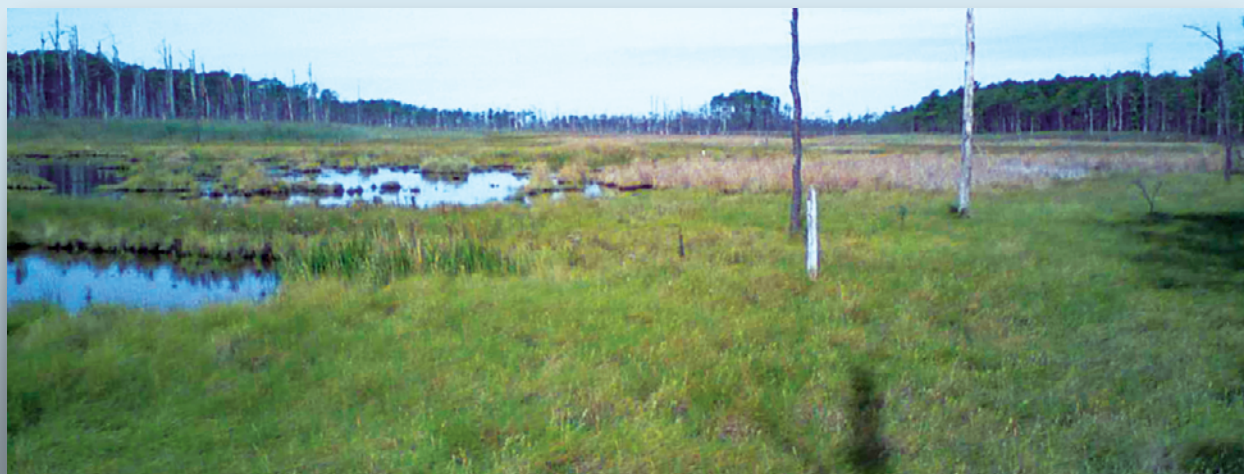
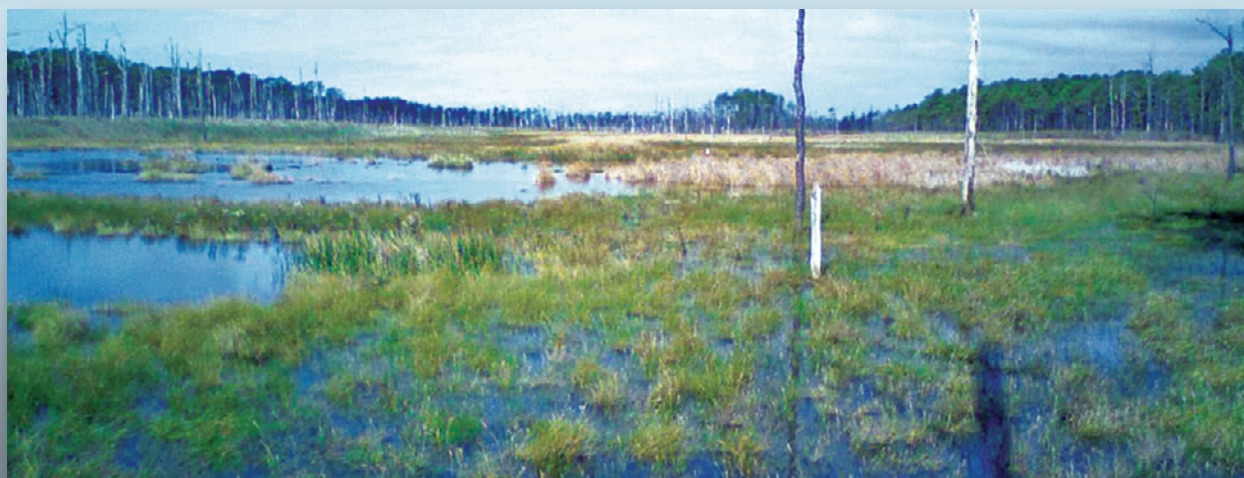
Cover. Photographs of Farm Creek Marsh taken near marsh surface-water monitor DO Fe 45, top, on September 23, 2015, and bottom, during the coastal storm on October 5, 2015 (Photographs by Todd R. Lester, U.S. Geological Survey).
