# “The Abrasion of Photovoltaic Glass: A Comparison of the Effects of Natural and Artificial Aging”

David C. Miller,<sup>1\*</sup> Asher Einhorn,<sup>1</sup> Clare L. Lanaghan,<sup>1</sup> Jimmy M. Newkirk,<sup>1</sup>  
Bobby To,<sup>1</sup> Derek Holsapple,<sup>1</sup> Joshua Morse,<sup>1</sup> Paul F. Ndione,<sup>1</sup> Helio R. Moutinho,<sup>1</sup>  
Aesha Alnuaimi,<sup>2</sup> Jim J. John,<sup>2</sup> Lin J. Simpson,<sup>1</sup> Chaiwat Engtrakul<sup>1</sup>

46th IEEE Photovoltaic Specialists Conference (PVSC)

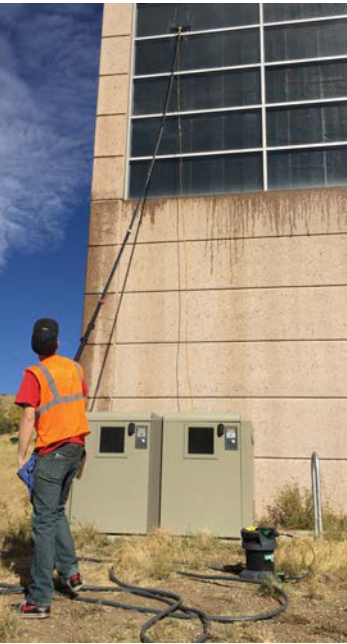
Vendor cleaning building glazings (at NREL campus).

- Much of the damage to coatings results from cleaning.
- PV leverages cleaning methods and equipment from the building glazing industry.

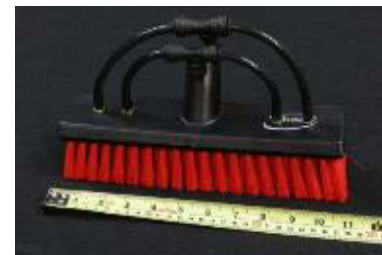
Example PE pole fed water jet brush marketed to the PV industry.

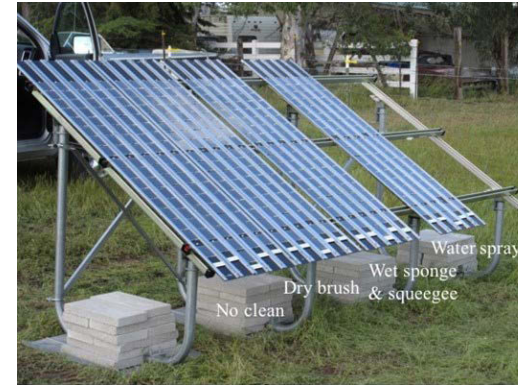
- 7.5 cm x 7.5 cm coupons.
- Includes AR, AS (-phobic & -philic), reference glass.
- Black backpane (similar temperature to PV).

**Original specimen set deployed at Sacramento.**

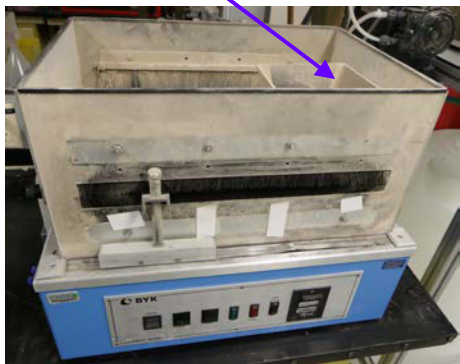
hopper & test dust

front view (lid removed)

- Custom dry dust chamber added to commercial tester.
- A4 “coarse” AZ test dust abrasive (ISO 12103).
- Dust dispensed with each cycle.
- Compare polyamide (Nylon 6,12), hog bristle, polyester bristles. 3.8 cm length.

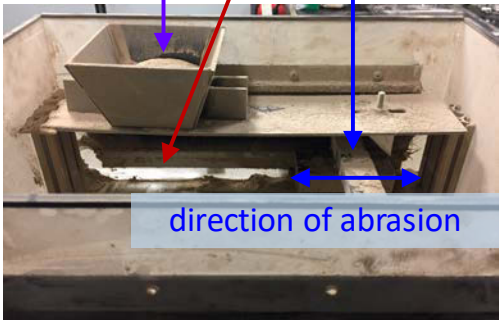
hopper & test dust  
specimen location  
shuttle & brush

back view

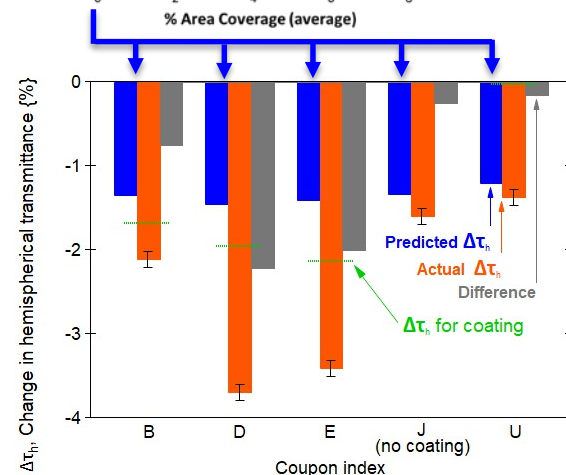
Change in hemispherical transmittance for Dry Brush cleaned specimens after 1 year in Dubai. NREL | 6

- *Actual*  $\Delta\tau_h$  consistently exceeds  $\Delta\tau_h$ .
- ⇒ coating abrasion damage and/or removal.  
 ⇒ results from: optical-scattering, -absorption, and cemented surface layer.

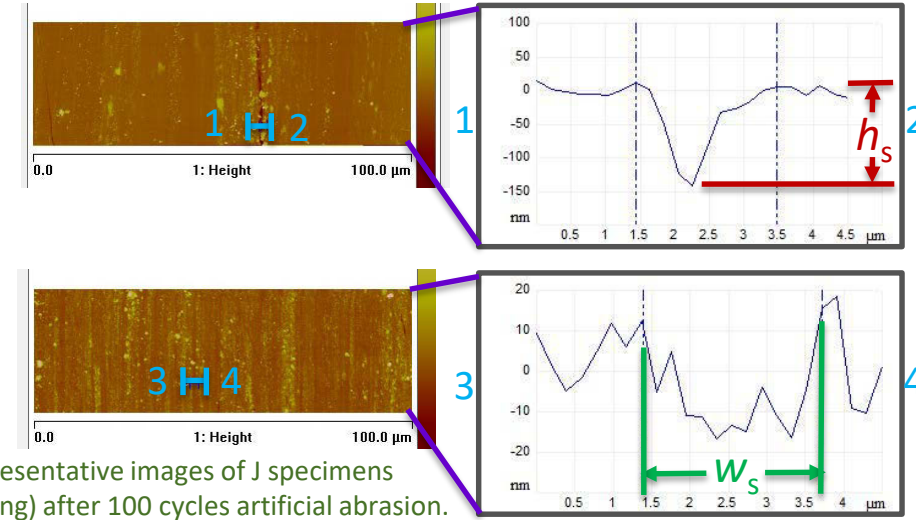
- Large individual scratches → max  $h_s$  at 100 cycles.
- Numerous subtle scratches → avg  $w_s$  and  $h_s$ .
- Scratches in field coupon study wider (5x, on average).
- Scratches in artificial abrasion study deeper (2x).
- Bristle diameter  $\gg w_s$  and  $h_s$ .

- Large  $w_s$  &  $h_s$  observed at 20k cycles, from individual scratches for PA and PE bristles.
- Tribological deposition of a thin film of contamination suspected for dry brush test.

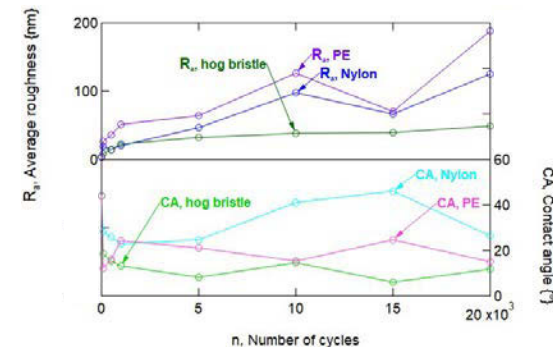
Surface roughness and surface energy as a function of the number of dry-brush cycles for J (no coating) glass.

- $\tau_h$  decreased, optical scattering increased with  $n$ .  
-  $\tau_h$  decreased for  $n < 500$ .
- Complex evolution of  $R_a$  &  $CA$  with  $n$  for PA & PE.  
-  $CA$  decreased from initial  $43^\circ$ . (Surface energy increased).  
- Peak and valley trend at large  $n$  was repeatable.  
(multiple measurements and replicate specimens).
- Corresponding loss of  $\tau_h$  & increased  $haze$  consistent with increased  $R_a$ .
- Immediate decrease in  $CA$  may result from surface cleaning, e.g., pumice scrub cleaning.
- Increase in  $haze$  for  $n > 10000 \Rightarrow$  glass (no coating) can be cleaned many times (e.g., over years) with minimal  $\Delta\tau_h$ .
- Complex evolution: tribological deposition of thin film of contamination.
