A History of National Park Service Clean-up Efforts at the Historic Coal Creek Mining District, Yukon- Charley Rivers National Preserve

Natural Resource Report NPS/YUCH/NRR—2015/1099

December 2015

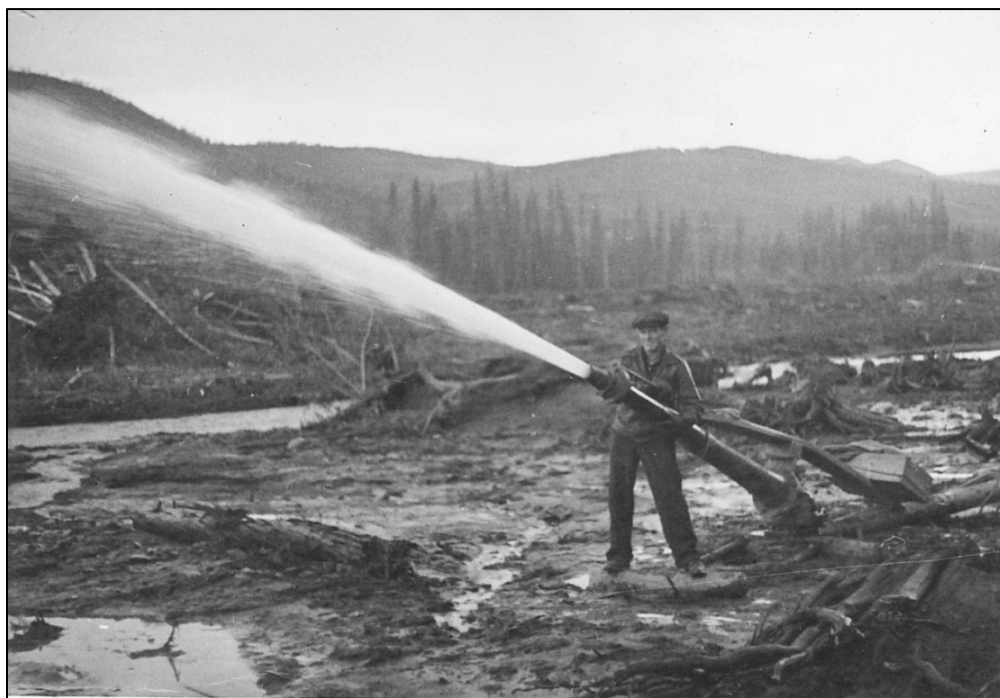
Photo 2. A dredge worker using a "giant" to remove soil and thaw permafrost, ca. 1936. National Park Service, Hendricks Family Collection.

same. The practice of placer mining by machine is a multi-step process that involves stripping the land of trees and topsoil, thawing the permanently frozen ground below, and excavating enormous amounts of gravel with the dredge as it eats its way across the landscape. Water is essential to placer mining, and at Coal Creek the employees of Gold Placers, Inc. used water cannons to blast away topsoil and to speed the thawing of the permafrost. They diverted water to create lakes in which the dredge floated on its steel pontoons. And they washed thousands of tons of sediment into the creek. The result was what one historian called “a world turned upside down.”⁴

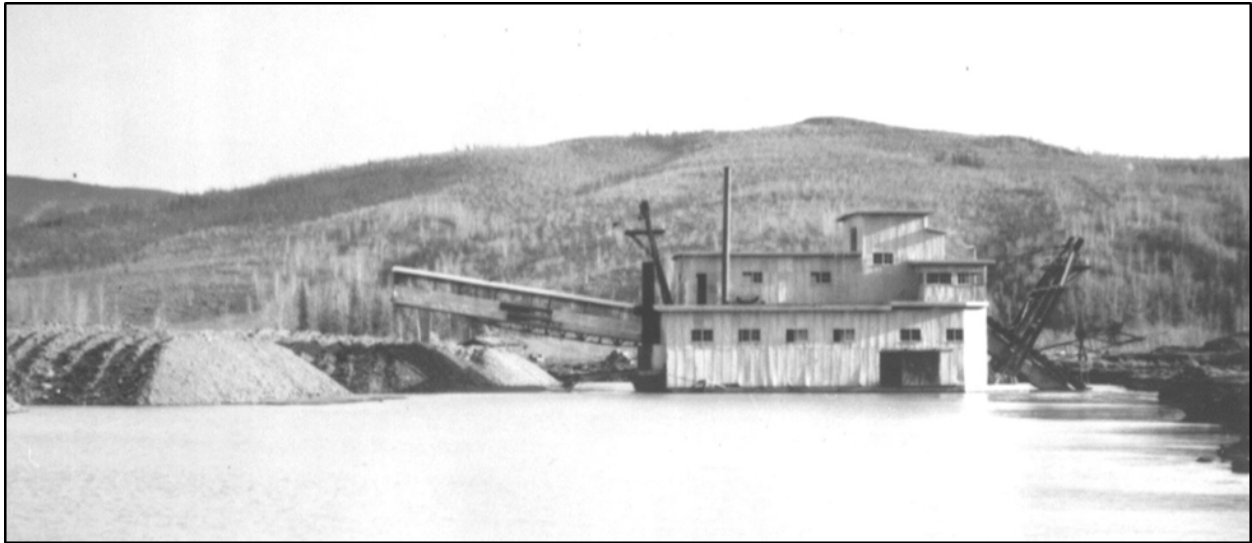
Photo 3. The Coal Creek dredge operating in the early 1940s. Note tailings piles at rear of the dredge. National Park Service, Bill Lemm Collection.

As the gold dredge advanced up and down the Coal Creek drainage it excavated twenty feet into the earth and scooped thousands of tons of gravel into its gavel-washing interior. Whereas a single miner using hand-tools might wash one cubic yard of gravel in a day, the dredge processed 3,000 in a 24-hour period. Water jets, revolving tumblers, and multiple sluice boxes separated gold from the waste material, which poured out of the back to create arc-shaped mounds of discarded rock called *tailings*. The dredge operated more or less continuously for the next two decades, meandering wherever the richest concentrations of subterranean gold could be found. In the process the channel of Coal Creek was repeatedly altered and most of the valley floor was scooped up, processed for gold, and re-deposited, ultimately producing around three million dollars in precious metals. After major operations under Gold Placers, Inc. ended in 1960, the dredge and mining claims were leased by individuals who mined periodically between the 1960s and 1980s. Today the dredge’s tailings—tell-tale signs of industrial placer mining—cover roughly eight miles of the Coal Creek valley. In addition the valley floor contains the massive hulk of the dredge, the mobile camp used by company employees, assorted buildings and roads, cabin ruins, garbage dumps, 55-gallon steel drums, abandoned vehicles, steam boilers, mobile drill rigs used for prospecting, and countless odds and ends left behind long ago. Another legacy of mining is less visible—contaminants in the soil like petroleum and the mercury used to capture small particles of gold in sluice boxes.

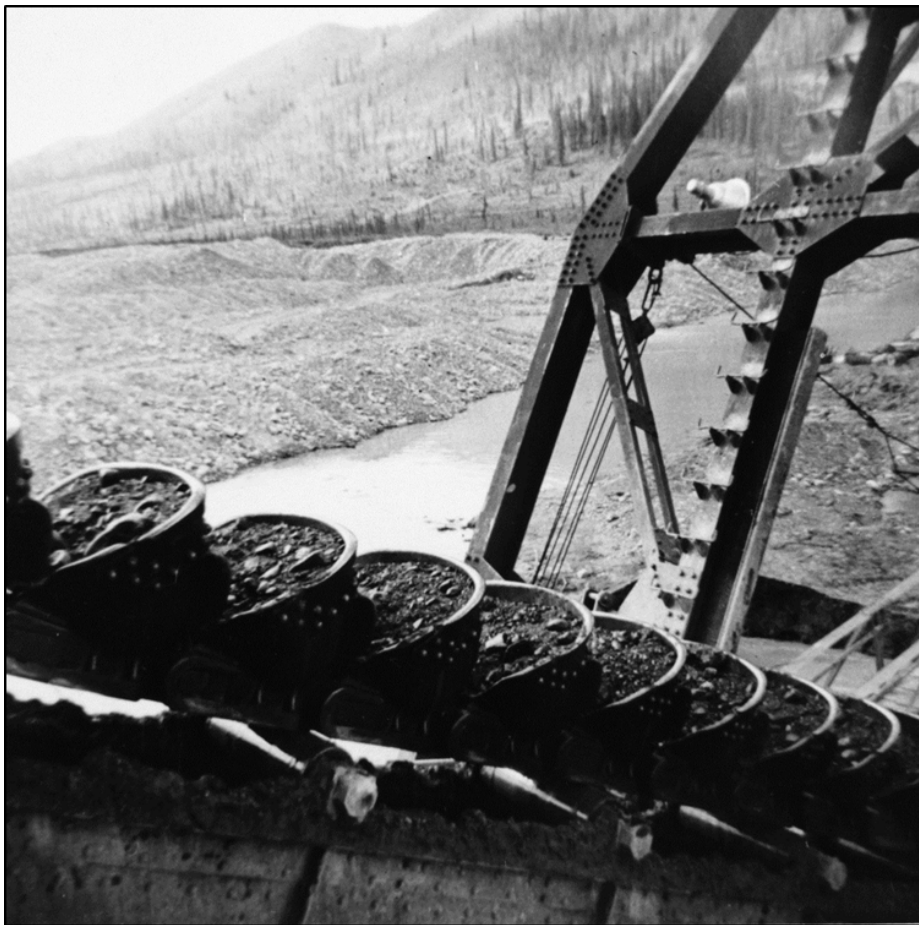
Photo 4. Coal Creek dredge bucket line with tailings piles in the background, ca. 1938. National Park Service, Hendricks Family Collection.

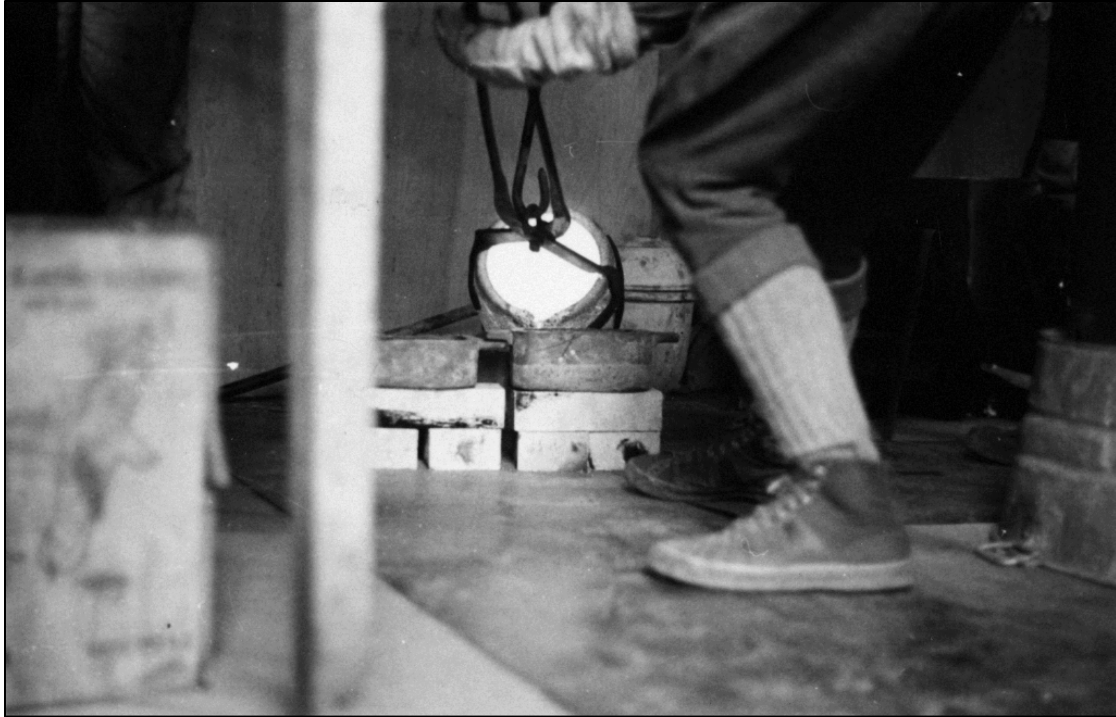
Photo 5. A dredge employee pouring molten gold into forms to create gold bars, ca. 1936. National Park Service, Stanton Patty Collection.

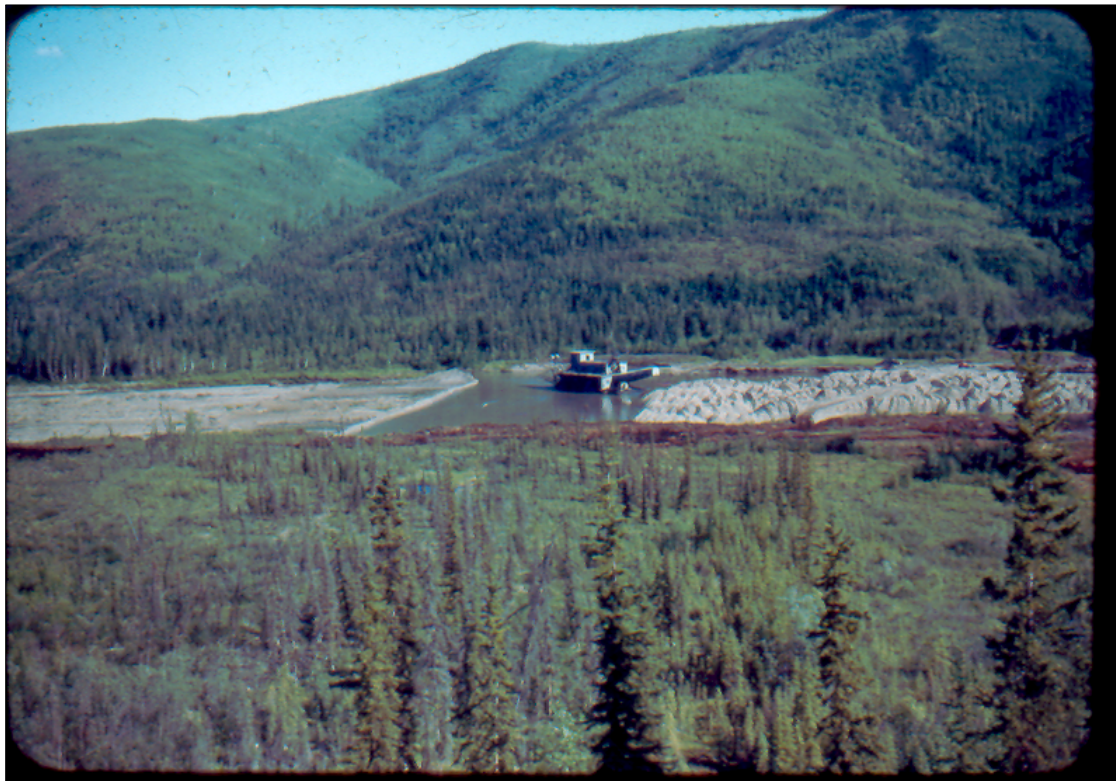
Photo 6. View of Coal Creek dredge and tailings piles, July 1954. National Park Service, Patty Family Collection.

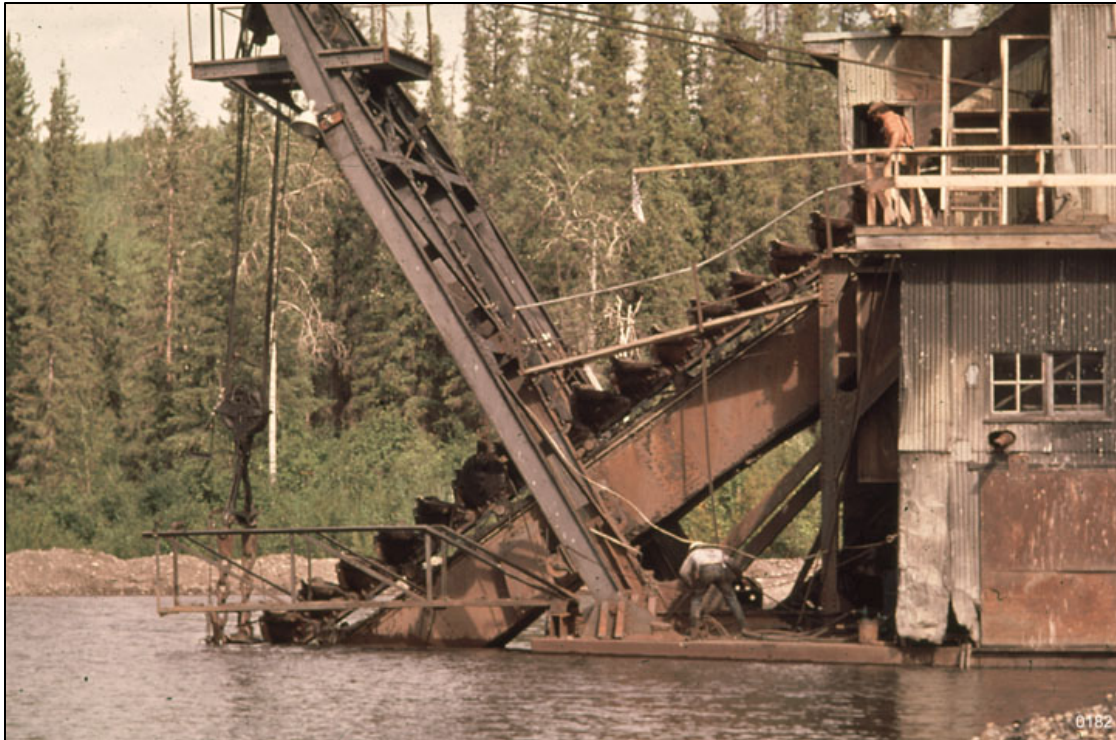
Photo 7. The Coal Creek dredge operating under new management, August 1974. National Park Service, Coal Creek Collection.

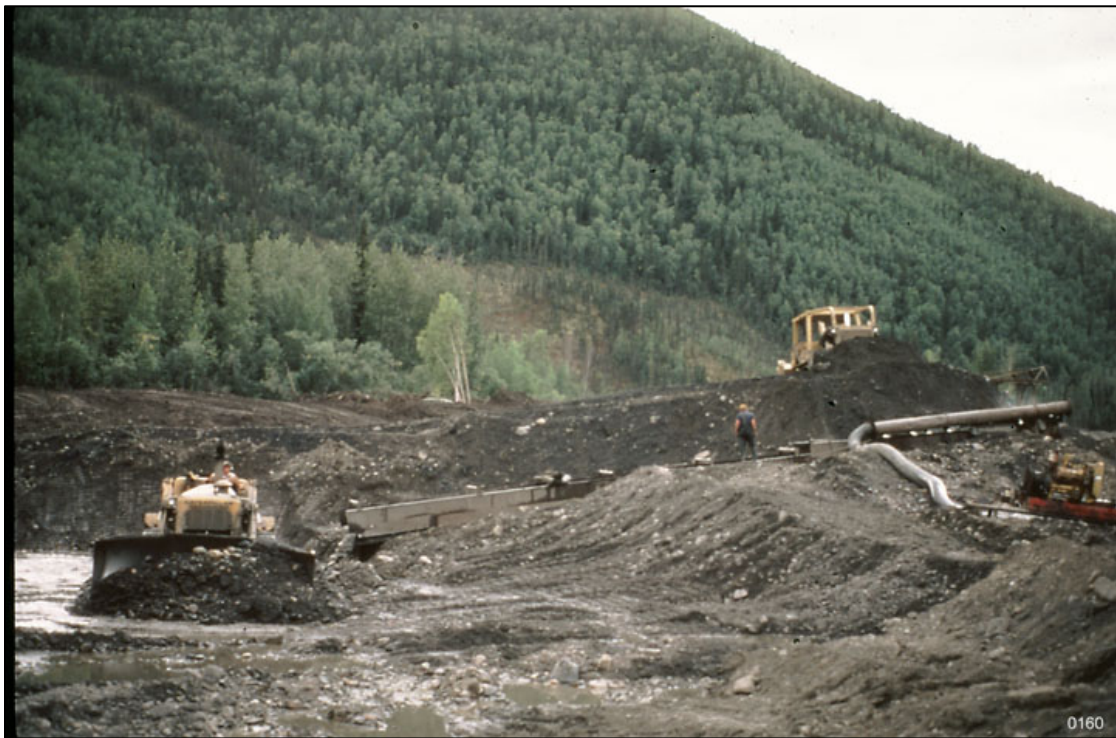
Photo 8. Bulldozers move gold-bearing gravel for sluicing at Coal Creek, 1974. National Park Service, Coal Creek Collection.

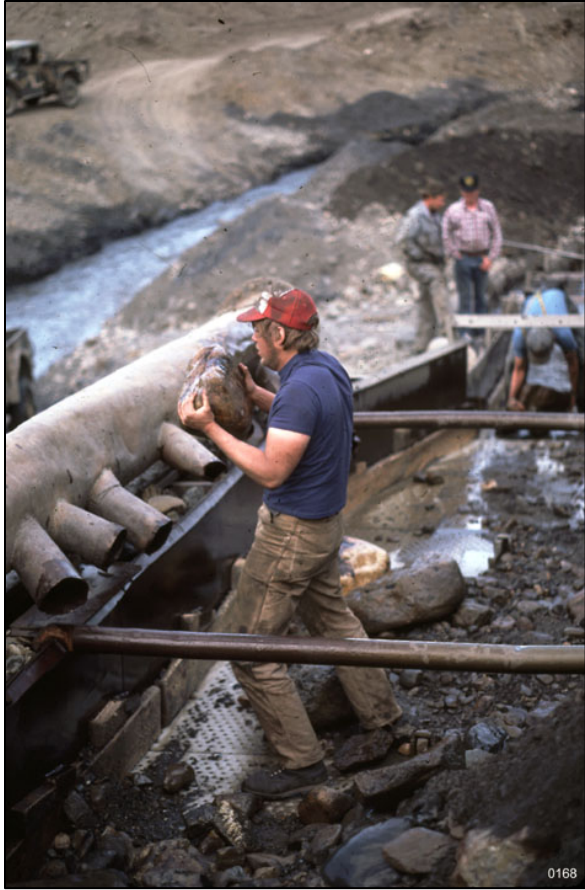
Photo 9. Removing boulders from a sluice box at Coal Creek, 1974. National Park Service, Coal Creek Collection.

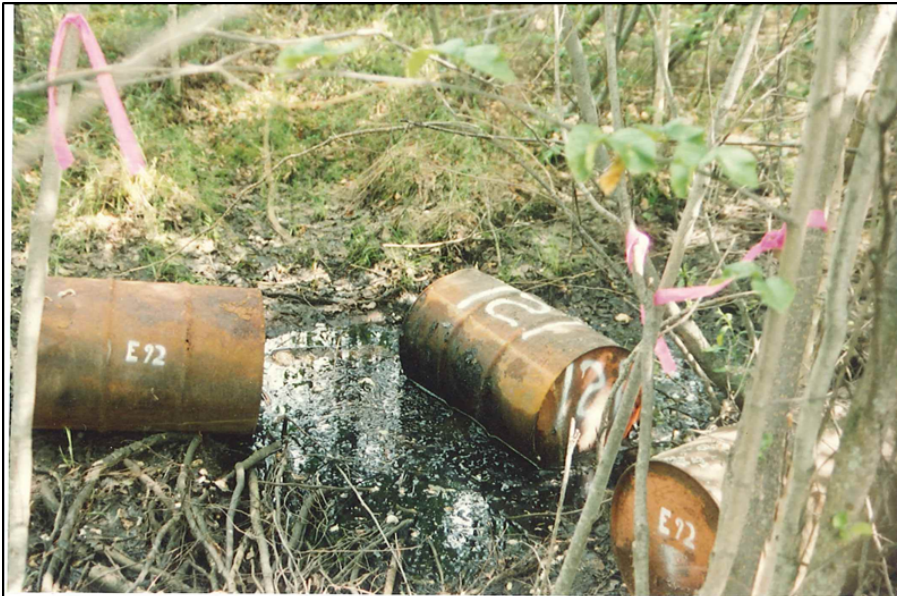
Photo 10. Leaking barrels numbered as part of clean-up efforts in the 1990s. National Park Service, Coal Creek Hazardous Waste Cleanup.

batteries to Fairbank by truck to be recycled.⁷ The survey of abandoned storage drums began by painting numbers on the drums and marking them with bright survey tape to make finding them later an easier task. The survey identified 579 drums in the Coal Creek drainage, 109 of which contained an unknown product, waste, or water.⁸

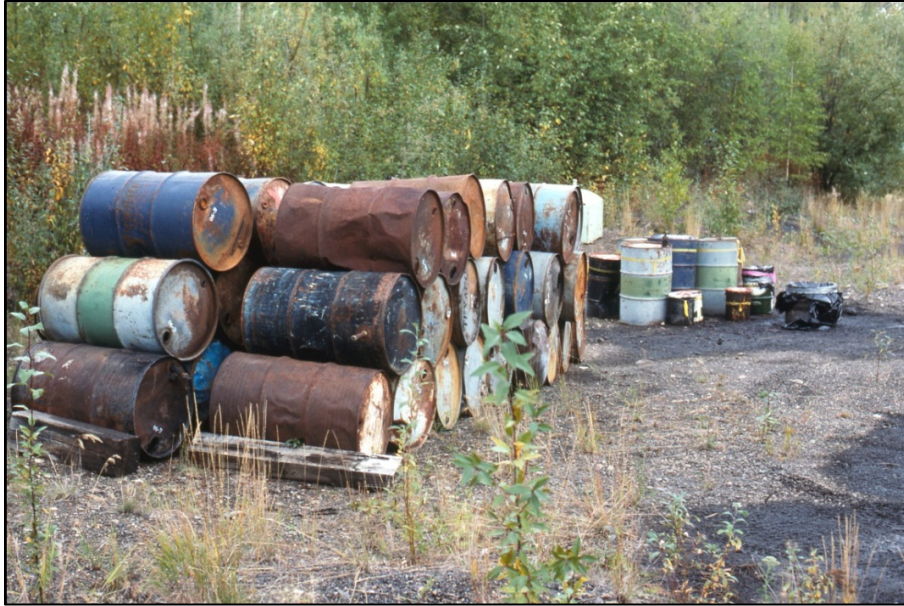
Photo 11. Stockpile of 55-gallon drums at the Coal Creek airstrip, 1992. National Park Service, Coal Creek Hazardous Waste Cleanup.

While attempting to understand the scope of contamination and hazardous materials at Coal Creek, the National Park Service had identified several areas of concern: mercury in soil at Coal Creek Camp, lead and petroleum contamination in soils at various locations, and a broad distribution of badly deteriorated 55-gallon drums. In 1994, workers began a major clean-up project that included the removal of 830 drums and 18 lead-acid batteries from the watershed. From the drums, 2,500 gallons of waste fuels and 1,200 lbs. of grease were recovered and recycled. Over 500 gallons of contaminated water, 380 lbs. of paint solids and liquids and 2,500 lbs. of solid waste were also recovered and removed. As an additional benefit, over 46,000 lbs. of scrap steel recovered from the drums was delivered to a recycling facility in Fairbanks.

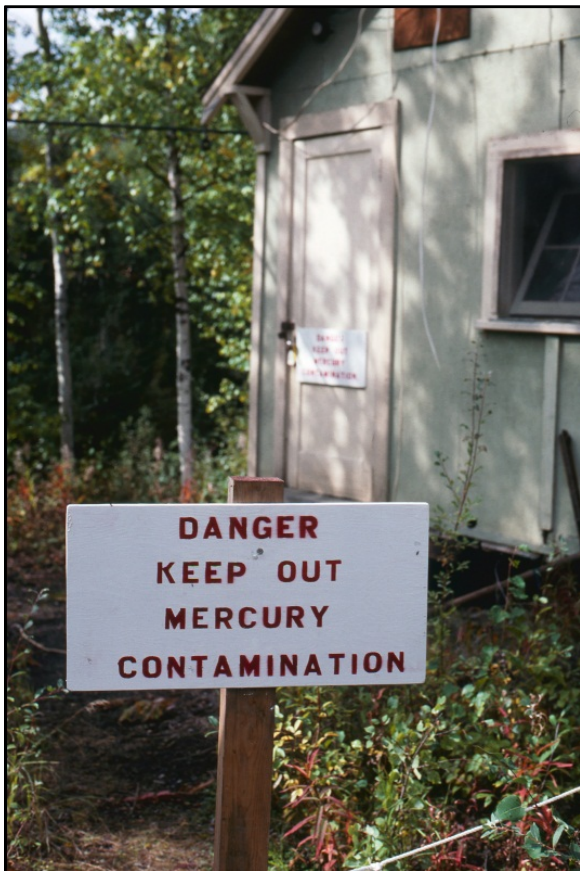
Photo 12. Sign warning visitors and employees about soil contamination at Assay Office, 1990. National Park Service, Coal Creek Hazardous Waste Cleanup.

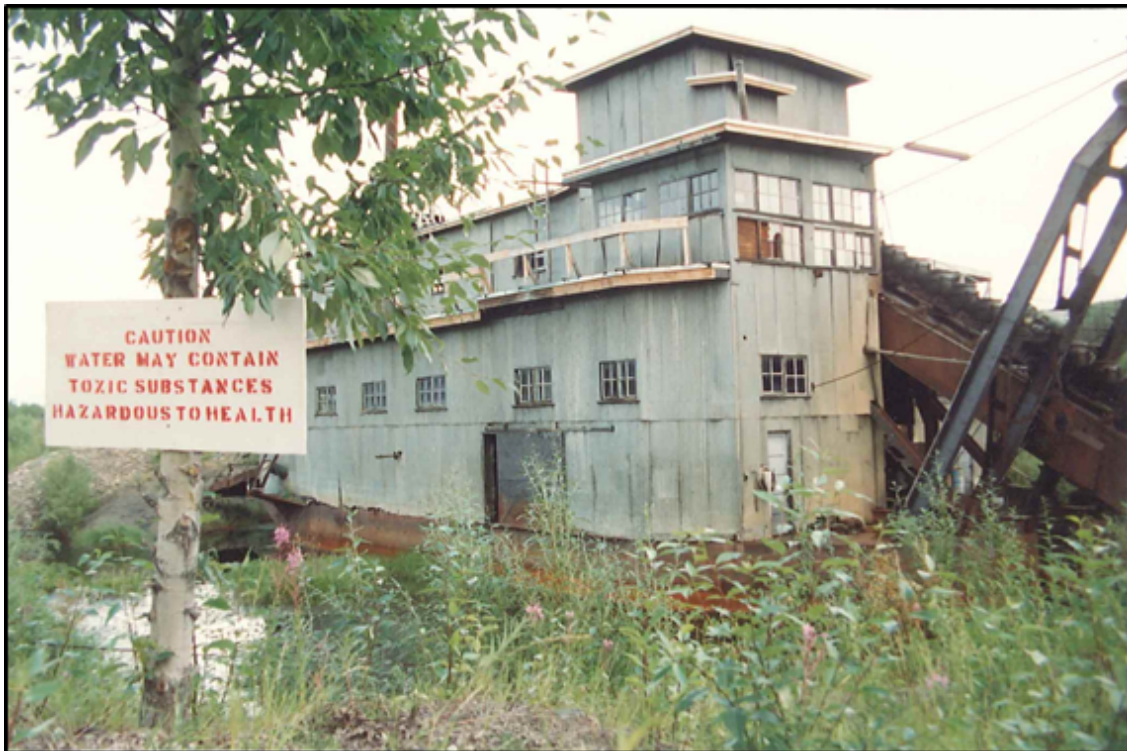
Photo 13. Sign warning visitors and employees about contamination at Coal Creek dredge, 1992. National Park Service, Coal Creek Hazardous Waste Cleanup.

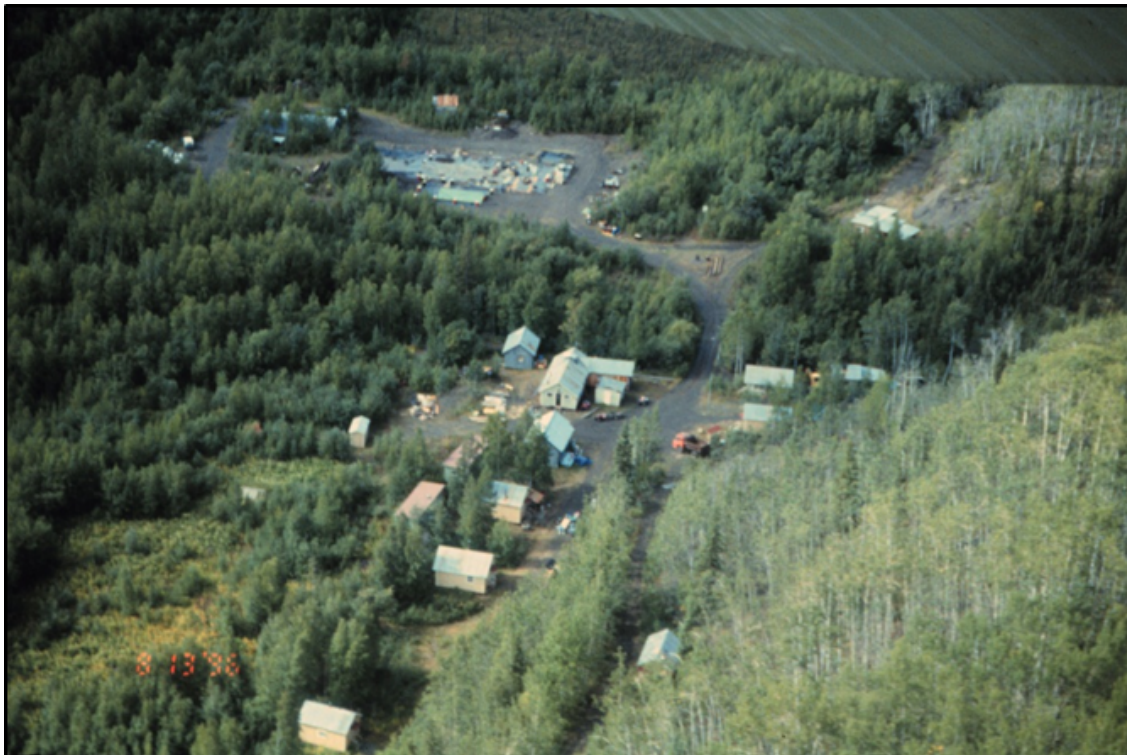
Photo 14. Aerial view of Coal Creek Camp during clean-up efforts, 1996. National Park Service, Coal Creek Hazardous Waste Cleanup.

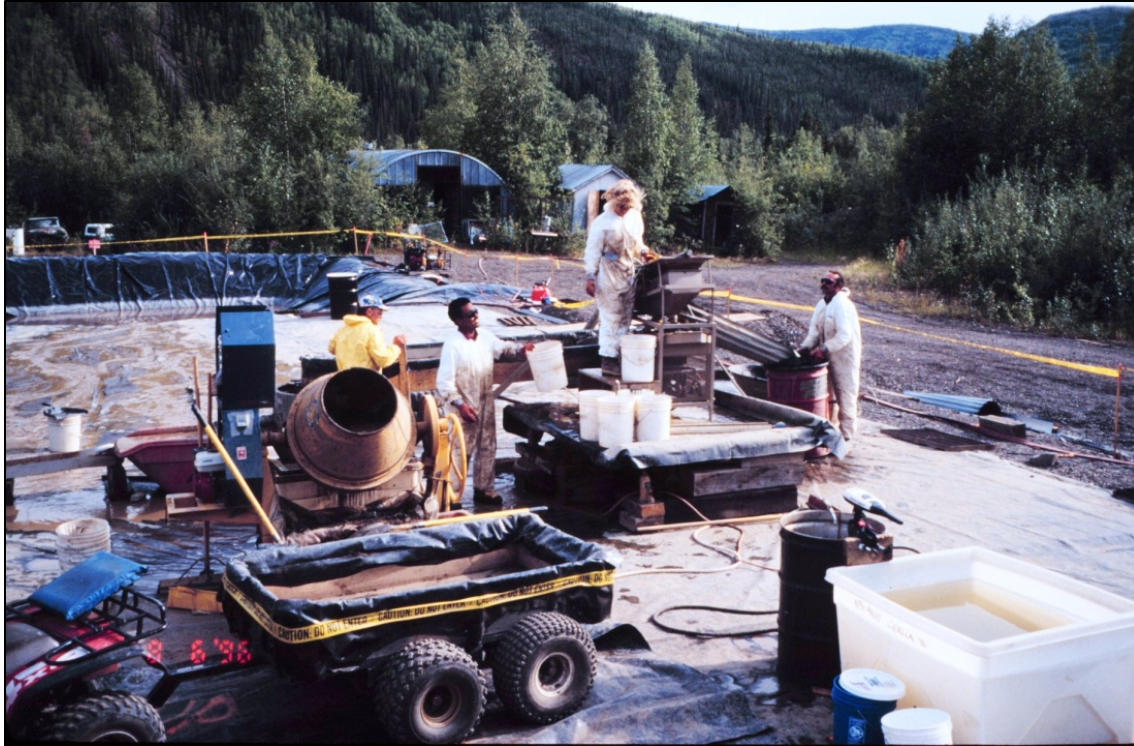
Photo 15. Workers passing contaminated soil through a separating plant at Coal Creek Camp, 1996. Photograph courtesy of Linda Stromquist.

The second phase of the project involved construction of an on-site soil washing facility for mercury-contaminated soil removed from the vicinity of the Assay Building. Nearby, in the camp's equipment yard, technicians assembled a 4,000-square-foot plastic-lined work pad and a recycling pond with a capacity of 14,000 gallons. As loads of soil arrived on the pad, they were fed into a cement mixer and turned into a light slurry with a combination of water and a commercial ore cleaning solution designed to recover "floured" or fine-particulate mercury. After mixing, the slurry transferred to a commercial soil washing machine designed to collect heavy metals using a hydraulic jig, a copper plate, and a series of sluice boxes. The waste water and soil particles ended up in the recycling pond, and 172 pounds of mercury concentrates were shipped off-site for disposal. In the end the process was very much like placer mining, but instead of capturing gold, on this occasion the goal was to collect tiny particles of liquid mercury.¹⁰

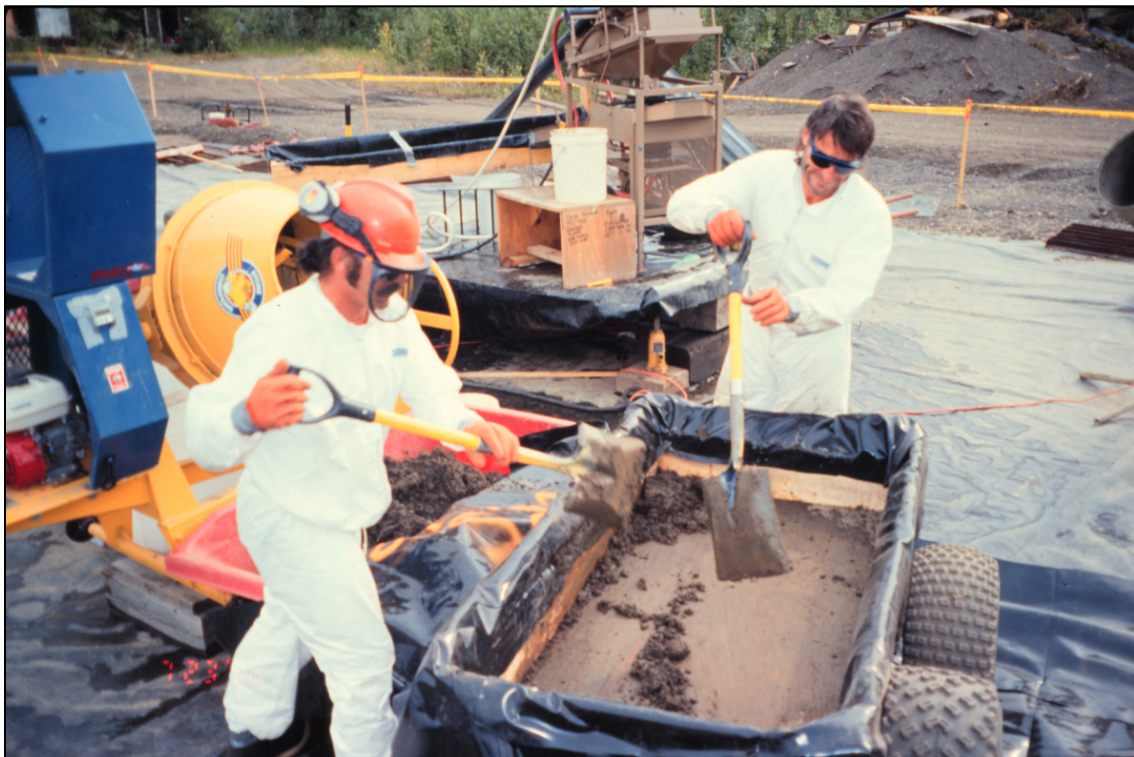
Photo 16. Members of clean-up crew shoveling soil into the mechanical separator, 1996. Photograph courtesy of Linda Stromquist.

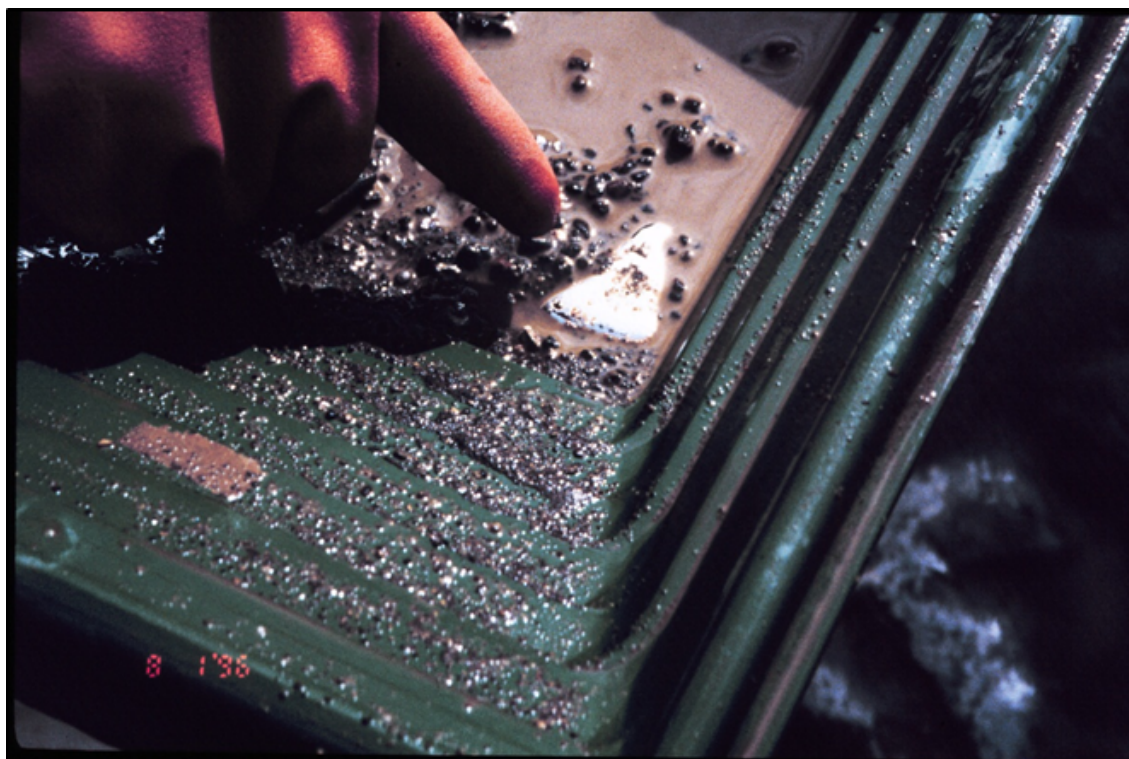
Photo 17. Example of mercury collected by the mechanical separator, 1996. Photograph courtesy of Linda Stromquist.
