NASA Technical Memorandum 82955

Corrosion of Simulated Bearing Components of Three Bearing Steels in the Presence of Chloride-Contaminated Lubricant

Prepared for the
Annual Meeting of the American Society of Lubrication Engineers
Cincinnati, Ohio, April 24-28, 1983

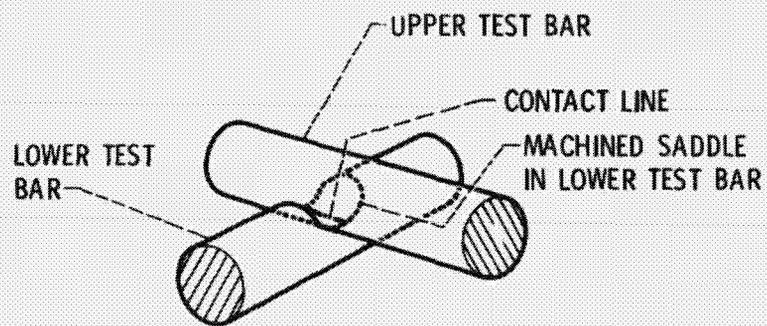
Figure 1. - Corrosion test bar contact.

The chemical composition of the materials used in these tests is given in Table 1. The test specimens were made from rolling-contact (RC) rig test bars (11). Rod materials of approximately 13 mm (0.5 in) in diameter were heat treated to obtain a nominal Rockwell C hardness of 62. The heat treating cycles are described in Table 2. Cylindrical bars 76.2 mm (3.0 in) long and 9.5 mm (0.375 in) in diameter were ground from the heat treated rods. Half of the test bars were ground with saddles as shown in Fig. 1 with a radius slightly greater than the bar radius. This saddle provides a contact and crevice situation to simulate the contact of a ball or roller and a bearing raceway as shown in Fig. 1. Both the cylindrical and the saddle surfaces were ground to a finish of 0.15 to 0.20 μm (6 to 8 μin).

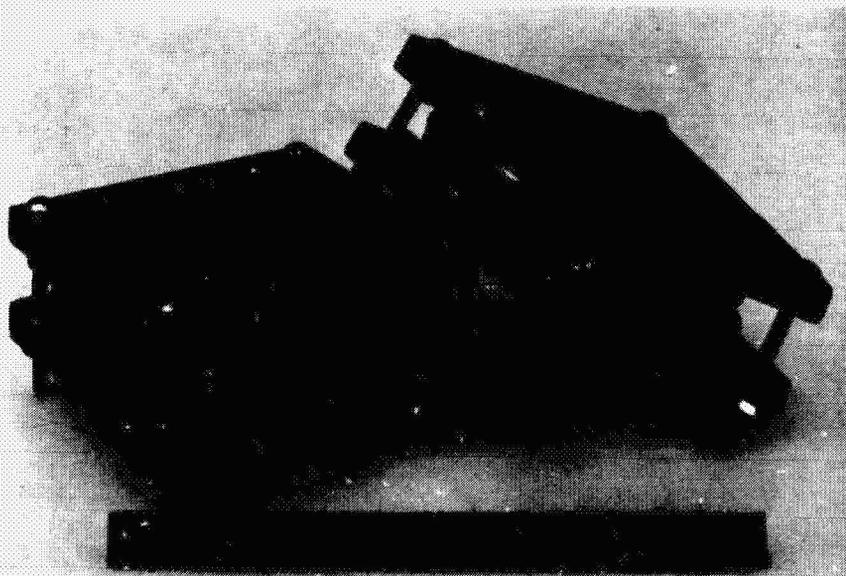
Figure 2. - Specimens and test fixtures after corrosion test.

The bars were then placed in a special fixture, shown in Fig. 2, with the lower two bars having the saddle, and the mating two bars placed across the saddles. This arrangement produces a contact and crevice situation similar to that in a ball or roller bearing and provides the opportunity for the crevice corrosion mechanism. The fixture was made of polyethylene material. The fixture was clamped together and suspended in a large beaker which was then loosely covered with aluminum foil. This assembly, called the corrosion cell, was then cycled alternately between a 339 K (150° F) oven and a 276 K (37° F) refrigerator. Total exposure was 14 cycles, each cycle consisting of 8 hours in the oven and 16 hours in the refrigerator. Corrosion cells were assembled with each of the three materials.

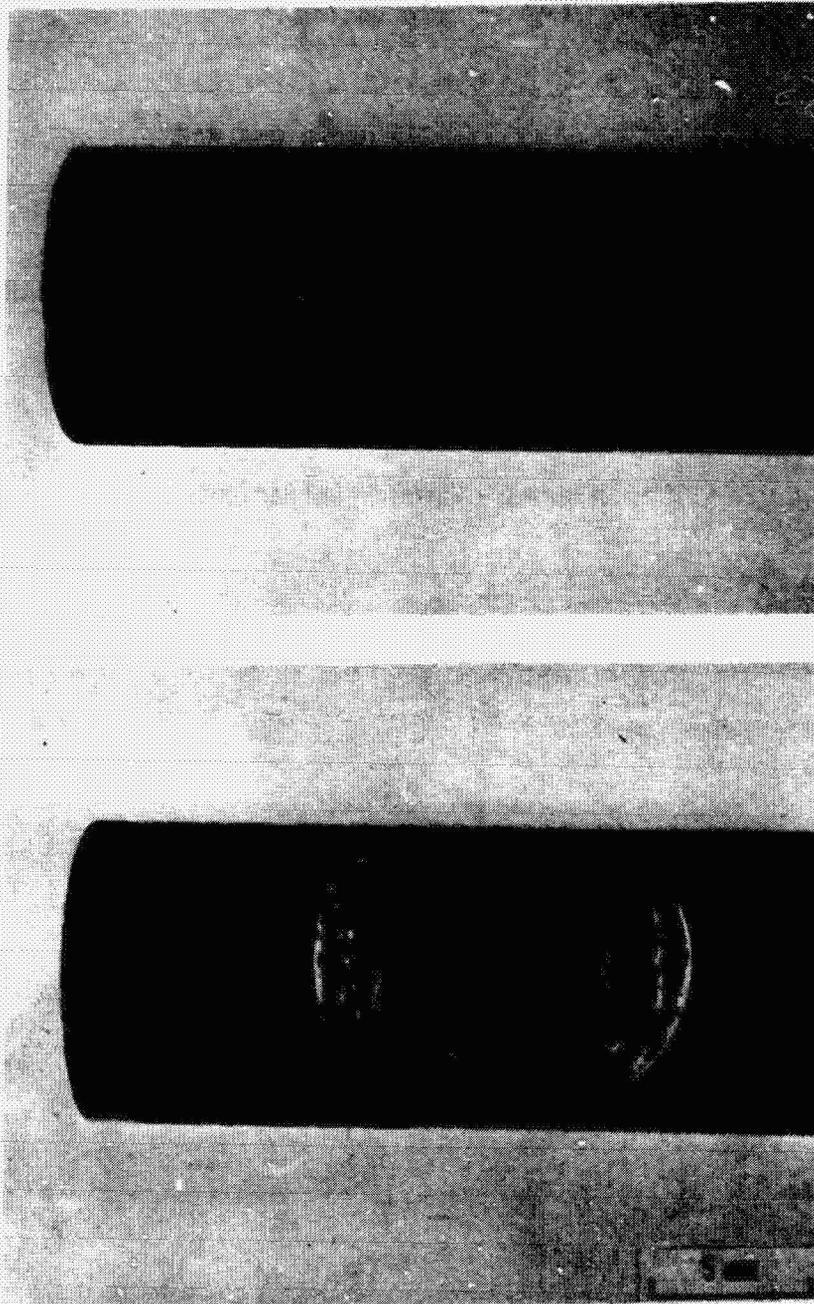
Figure 3. - Macrophotos of AISI 52100 specimens after corrosion test.

Corrosion tests were performed with test bars of AMS 5749, AISI 52100, and AISI M-50 assembled to simulate crevice corrosion in the presence of a lubricant-chloride solution. After the 14 thermal cycles were completed, the test bars were cleaned and examined. Visual inspection revealed that AISI M-50 and AISI 52100 had extensive corrosion damage. A slight amount of corrosion was present on the AMS 5749 bars. As shown in Figs. 3 and 4, the corrosion was not limited to crevice corrosion, but pitting corrosion also occurred on exposed surfaces of both materials. The slight amount of corrosion on the AMS 5749 bars appeared to be limited to the saddle area where crevice corrosion occurred, as shown in Fig. 5.

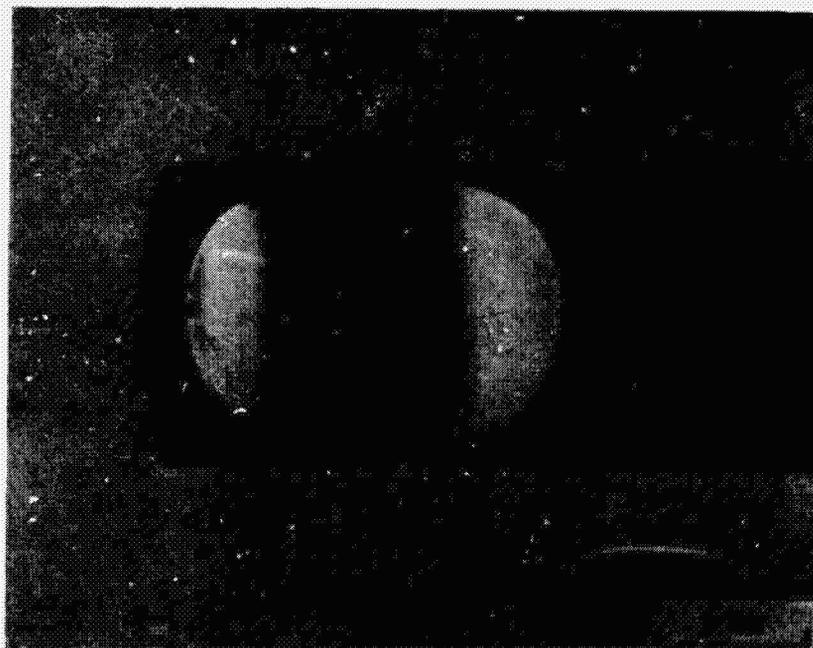
Figure 5. - Macrophotos of AMS 5749 specimens after corrosion test.

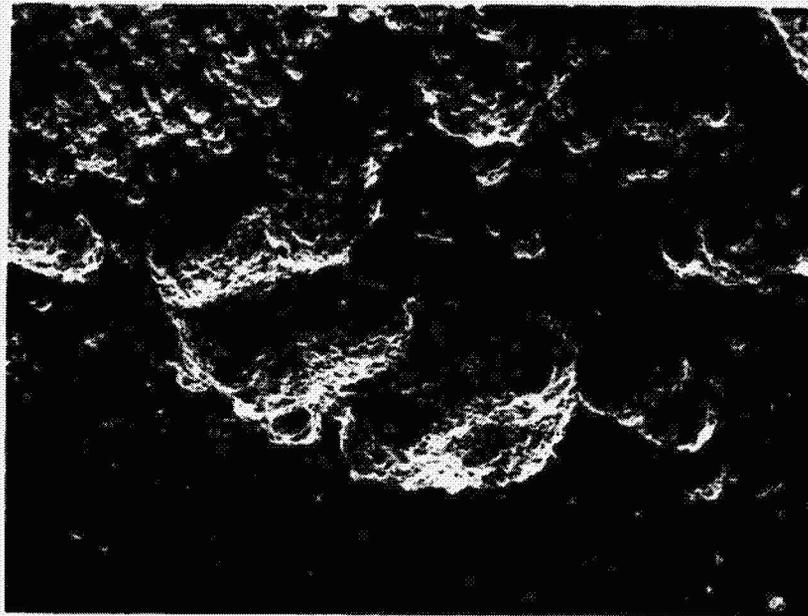
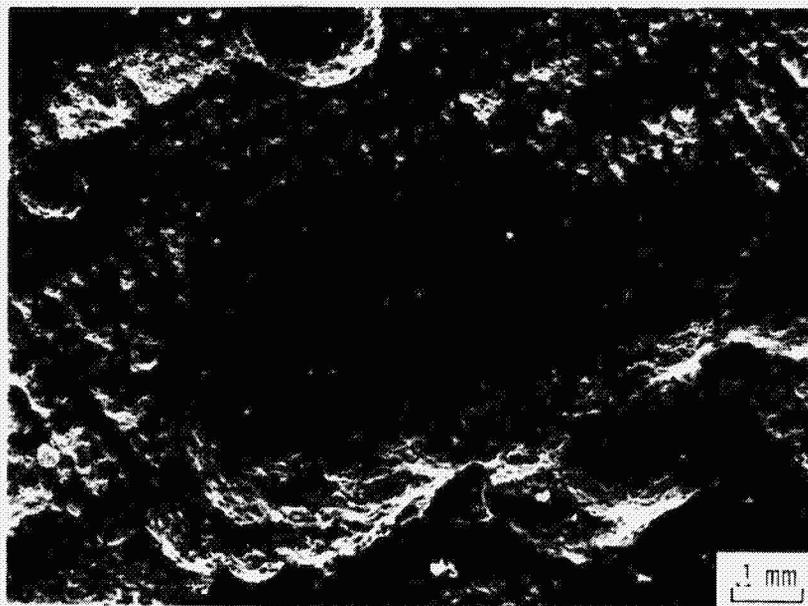
Figure 7. - Scanning electron micrographs of AISI M-50 specimen after corrosion test.

For a detailed examination of the corrosion damage, scanning electron microscopy was employed. Typical corrosion areas are shown in Figs. 6 to 8. In general, there was no significant difference between the corrosion in the crevice areas and that on the exposed surfaces. Differences were noted between the appearance of the AISI M-50 and the AISI 52100. The corrosion on AISI 52100 appeared to cover more surface area, but the corrosion pits on the AISI M-50 bars appeared to be deeper. This observation is not readily apparent in Figs. 6 and 7, but test bars of both materials were sectioned through typical corrosion pits for further observations.
