Assessment of Physical, Chemical, and Hydrologic Factors Affecting the Infiltration of Treated Wastewater in the New Jersey Coastal Plain, with Emphasis on the Hammonton Land Application Facility

Scientific Investigations Report 2010–5006

By Timothy J. Reilly, Kristin M. Romanok, Steven Tessler, and Jeffrey M. Fischer

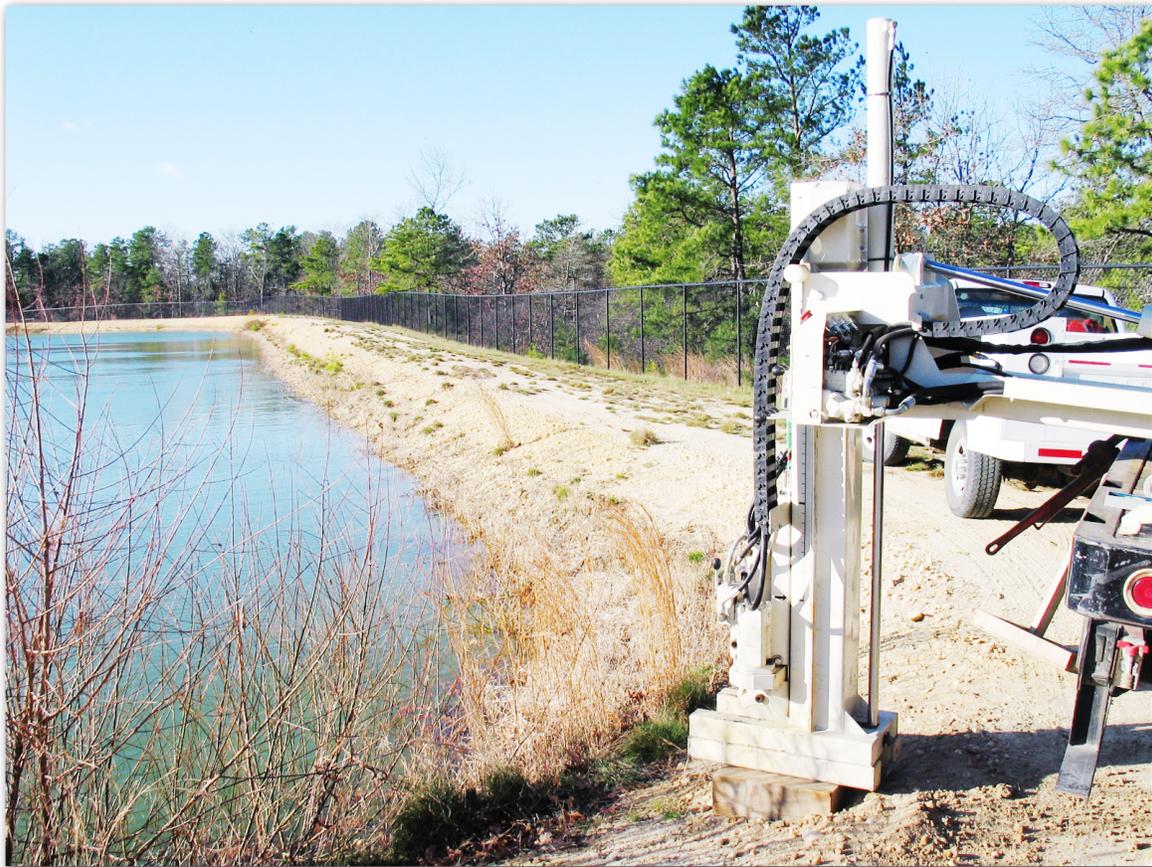
Cover. U.S. Geological Survey scientists prepare to collect soil cores using a direct push system adjacent to trench 2, Hammonton Land Application Facility, southern New Jersey.

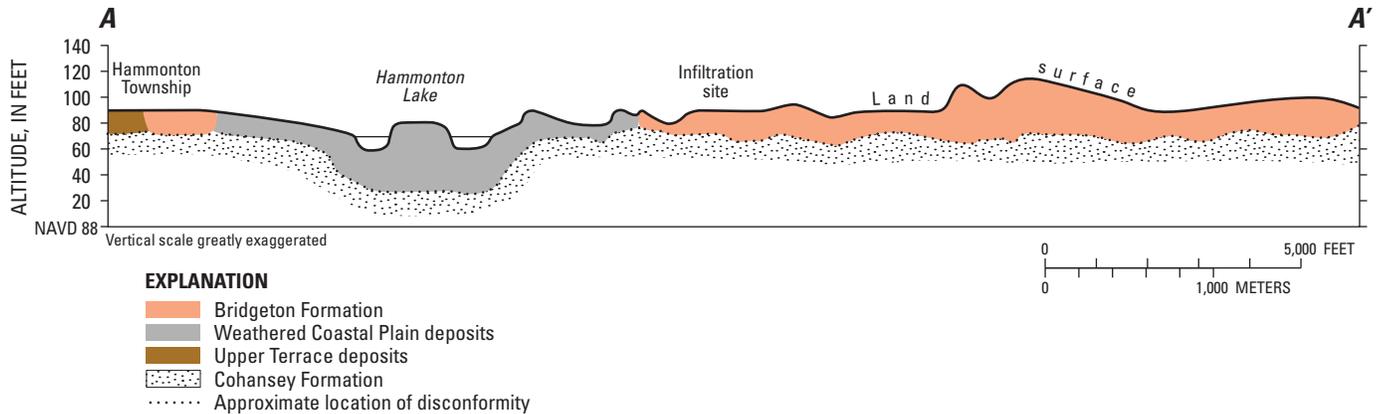
Figure 3. Geologic section A–A' showing surficial geology in the vicinity of the Hammonton Land Application Facility in the Pinelands National Reserve, southern New Jersey. (Line of section shown in fig. 2)

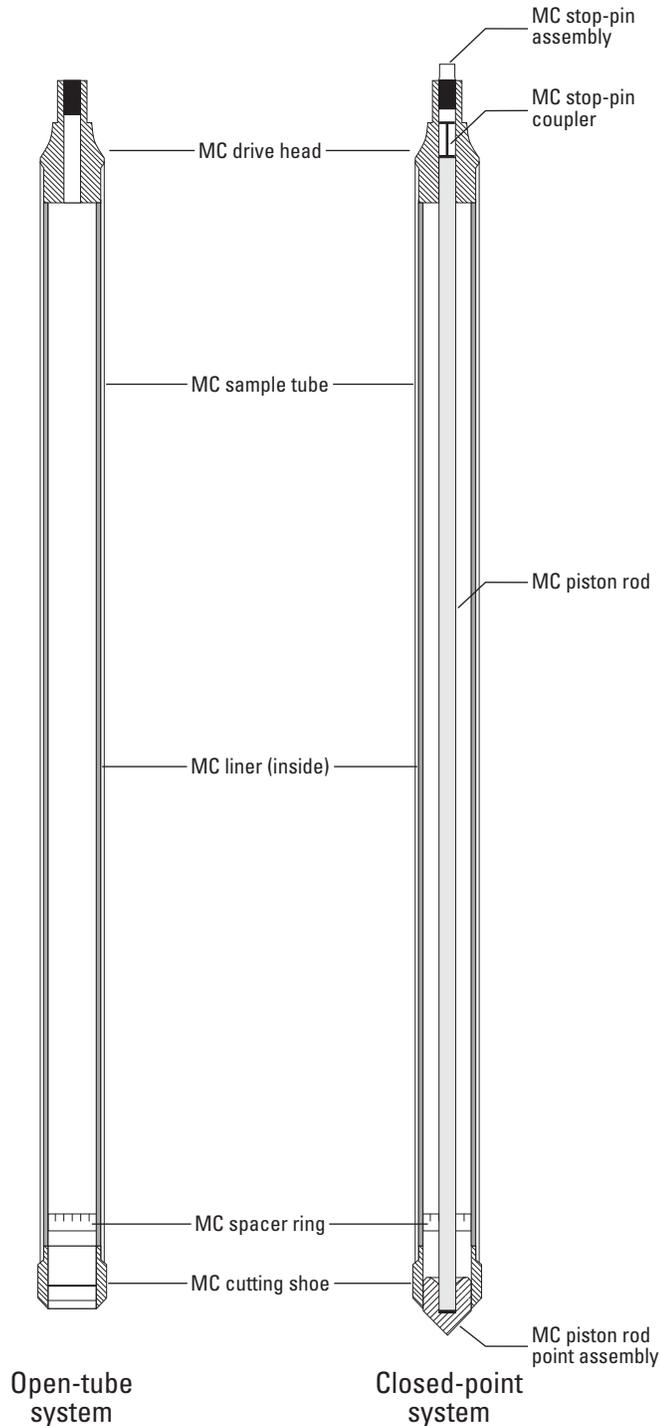
Figure 4. Open-tube and closed-point soil sampler configurations. (MC, Macro Core®)

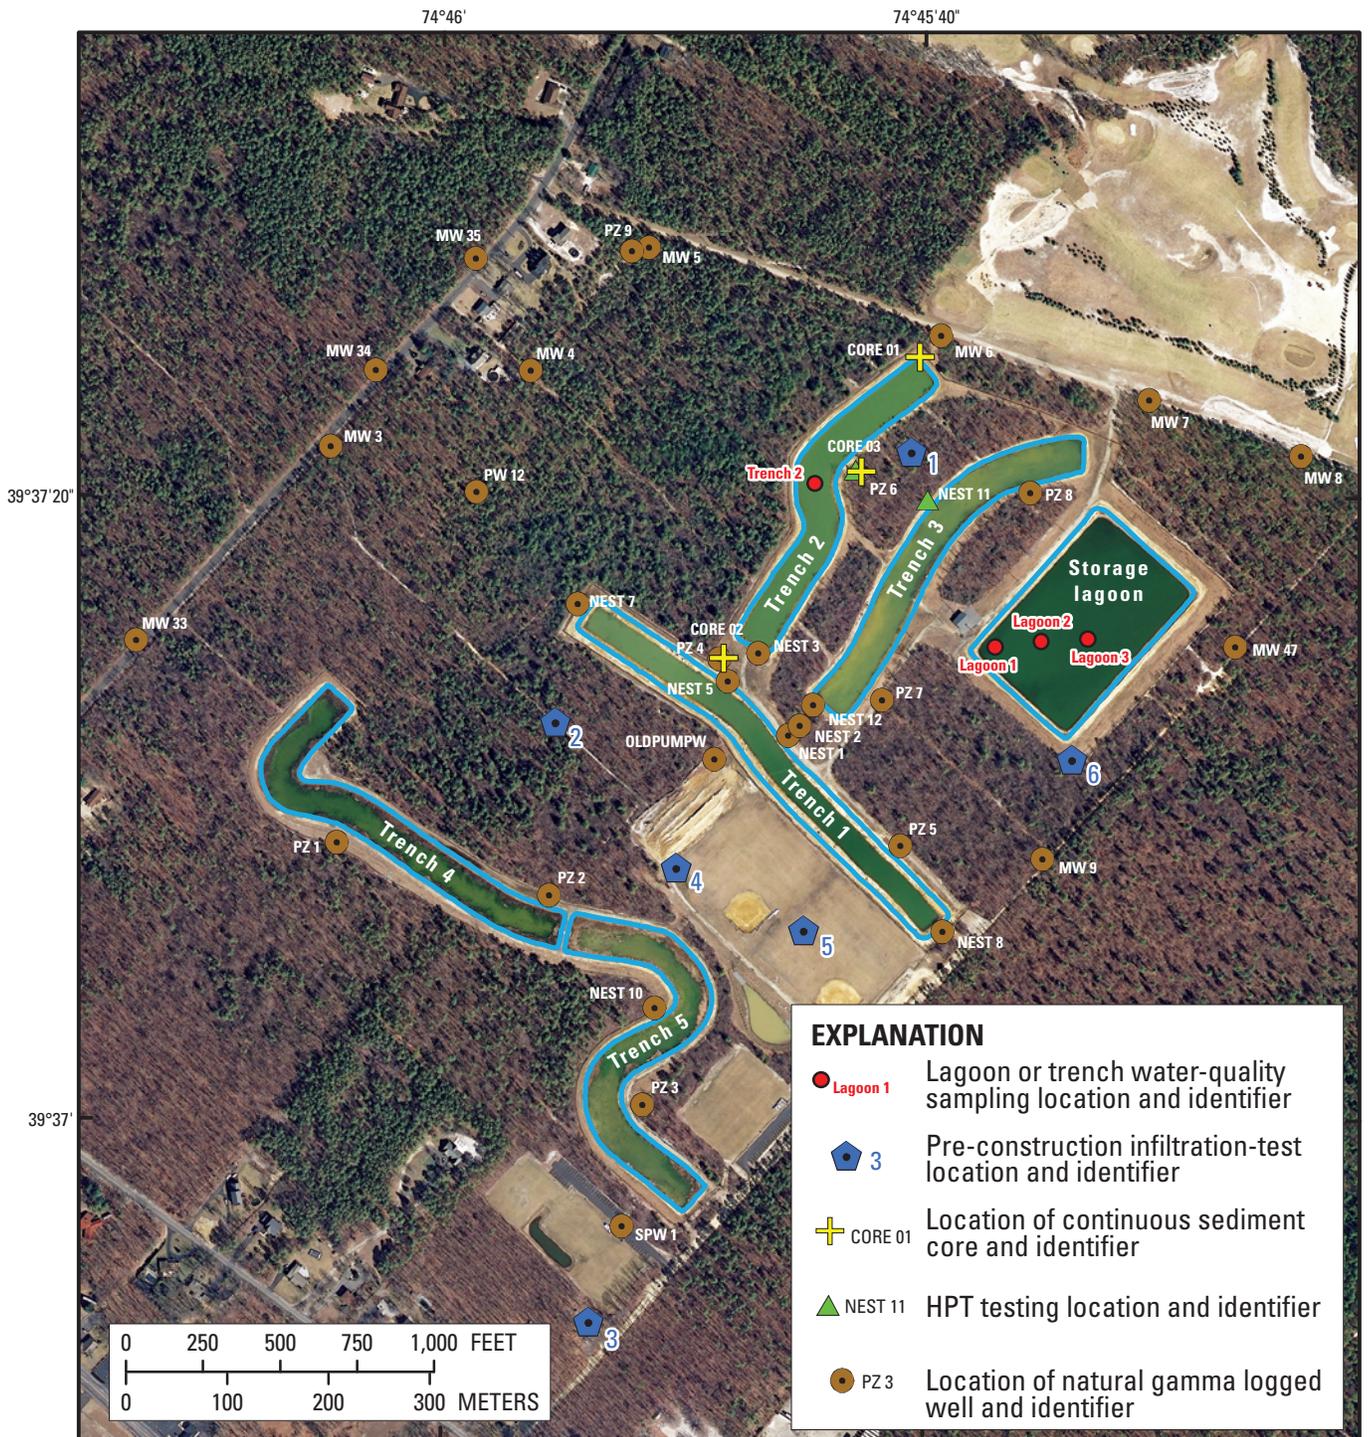
Figure 5. Locations of wells, lagoon and trench sampling sites, infiltration tests, continuous sediment cores, and Hydraulic Profile Tool (HPT) testing at the Hammonton Land Application Facility, southern New Jersey.

Hydraulic testing was conducted at three sites (fig. 5) with a Hydraulic Profiling Tool (HPT) system manufactured by Geoprobe Systems (Salina, Kansas). As the HPT is driven into unconsolidated sediments by direct-drive at 0.79 in/min, clean water is pumped through a screen on the side of the HPT probe at about 250 mL/min and the resulting injection pressure is recorded. Relative hydraulic properties are determined by evaluation of injection pressure and flow rate; a formation with lower hydraulic conductivity would have a higher pressure response and a lower flow response than a more hydraulically conductive formation. The HPT system also measures soil electrical conductivity with an integrated Wenner array. High electrical conductivities are generally associated with fine-grained formations, although they can also be influenced by the chemistry of pore fluids (high ionic strengths, contaminants) and the mineralogy of the sediments. The electrical conductivity and pressure response of the system are calibrated and tested before and after each log. Additional operational and technical specifications for the HPT are detailed in the standard operating procedure (Geoprobe Systems, 2007).

Within the storage lagoon, samples of treated effluent were collected from three locations on December 6, 2006, and May 3, 2007 (fig. 5). During both sampling events, a multi-parameter water-quality meter was used to determine changes in pH, temperature, specific conductance (SC), and dissolved-oxygen content (DO) with depth. Field staff noted that the lagoon was well mixed, as pH, temperature, SC, and DO did not vary with depth or, in the case of the December 6, 2006, sampling event, between sampling locations. Vertical composite samples were collected at each location using a weighted bottle sampler and were composited in an acid-washed, methanol-rinsed Teflon churn.

Groundwater samples were collected from selected monitoring wells, piezometers, and drive points. Locations of sampled wells are shown in figure 5 and construction information is given in table 1. Wells MW 5 and MW 8 were selected for sampling as they are located on the perimeter of the facility downgradient from the infiltration trenches. Wells PZ 4, PZ 5,

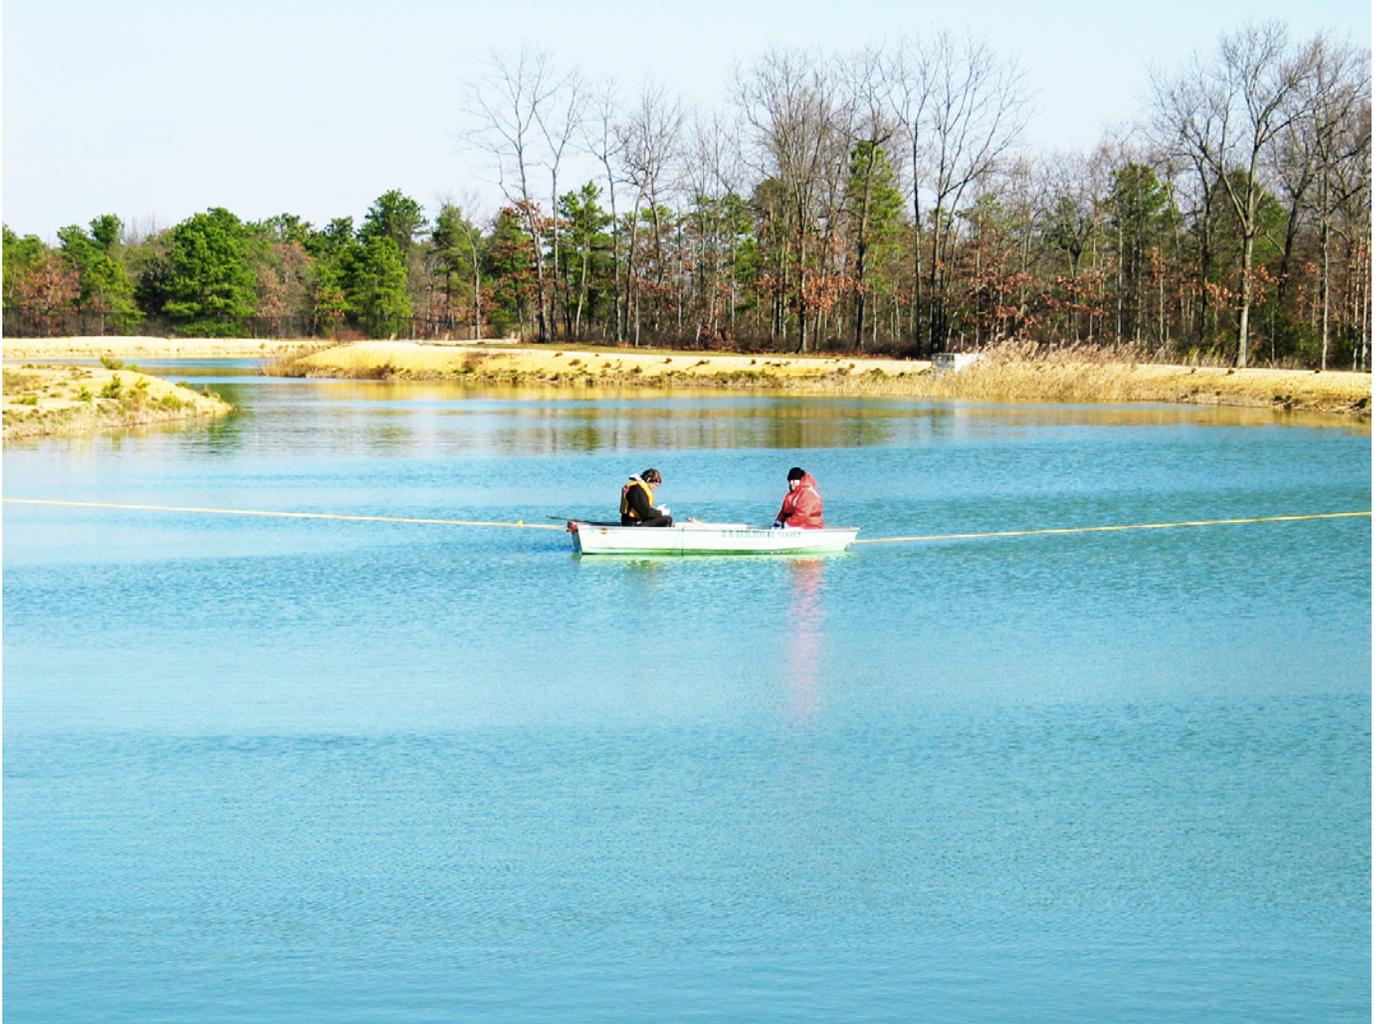
Figure 6. Water-quality sampling in trench 2, Hammonton Land Application Facility, southern New Jersey.

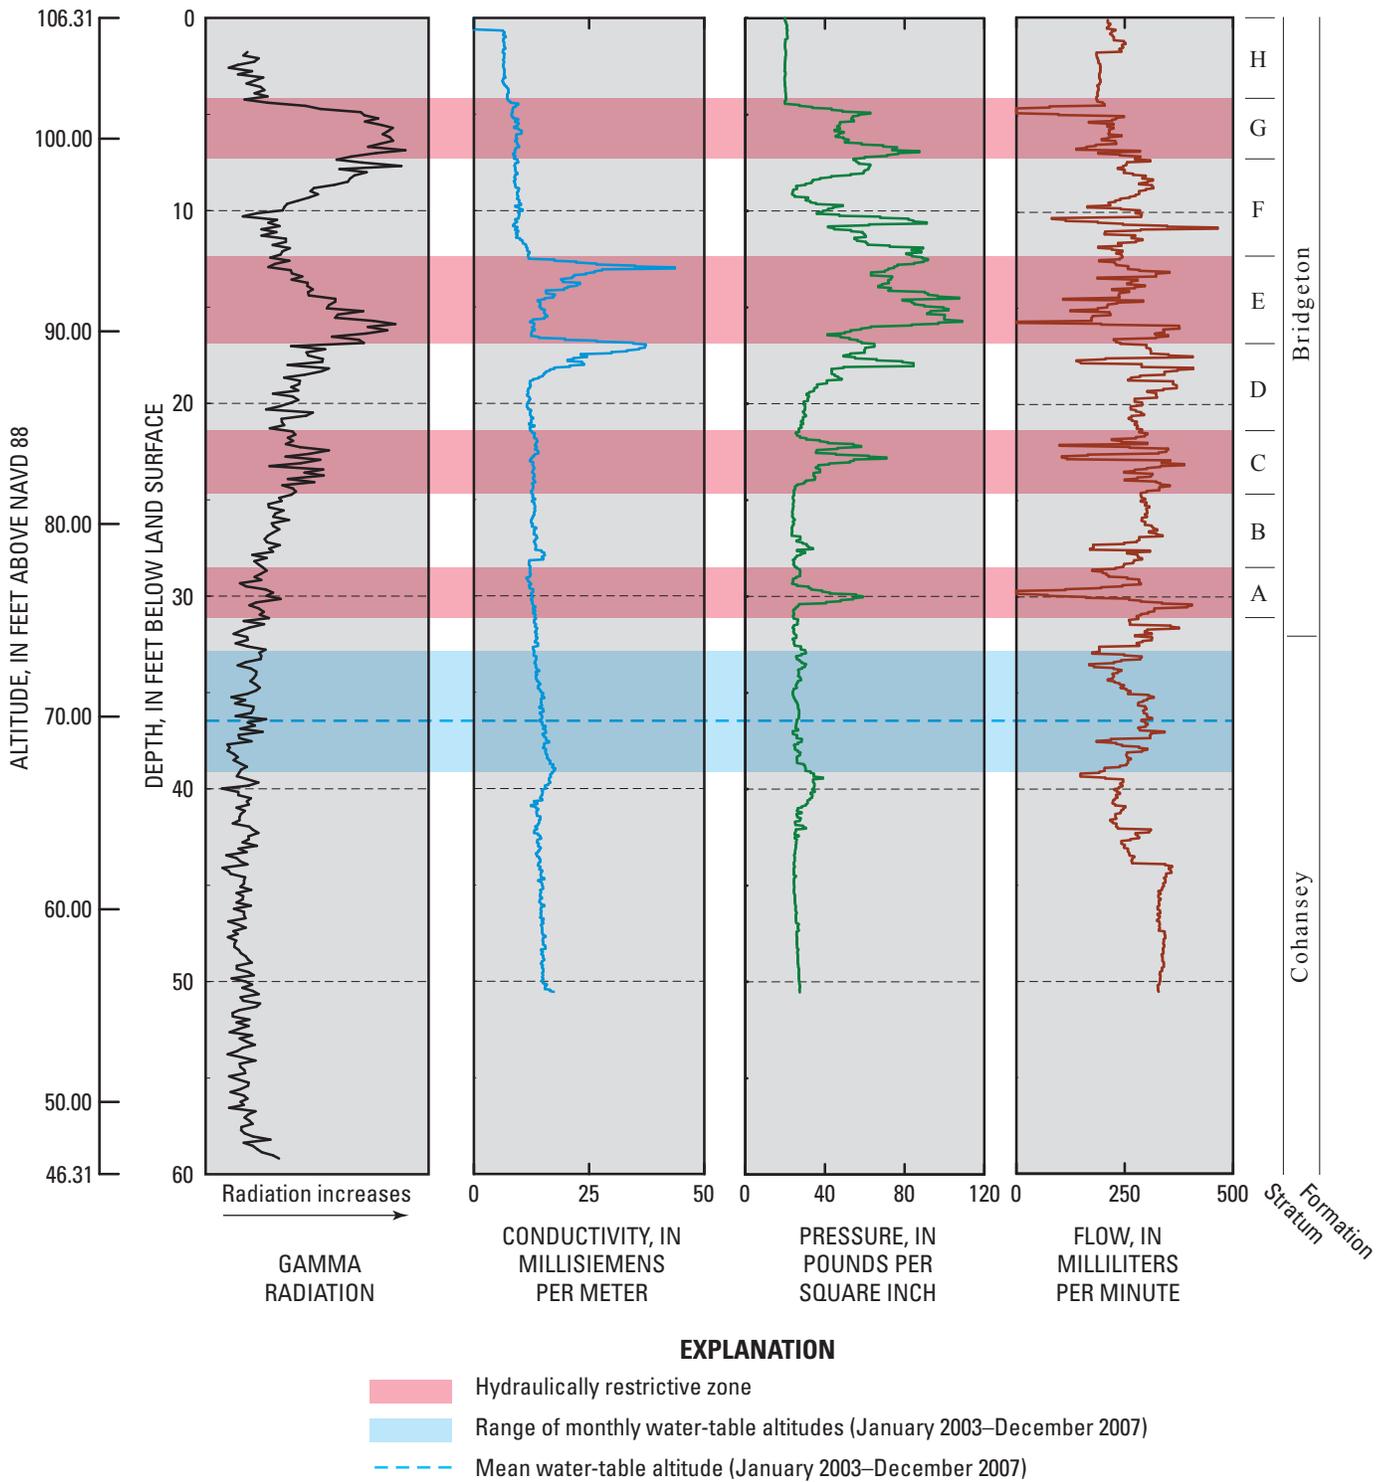
Figure 7. Geophysical logs of piezometer 6, Hammonton Land Application Facility, southern New Jersey.

Eight strata (A–H) within the overlying Bridgeton Formation were identified and correlated throughout the Hammonton LAF (fig. 7). The oldest stratum (stratum A) is 2.65 ft thick and extends from 75.06 to 77.71 ft above NAVD 88. HPT testing shows pressures greater than 40 psi and flow rates as low as 0 mL/min, indicating that stratum A is hydraulically restrictive. The sediment within stratum A is characterized by very fine to coarse, ferric iron oxide-stained sands (Hammonton LAF core 03, app. 4). As the coring process can disaggregate poorly cemented sediments, the presence of iron oxide-stained grains indicates that this stratum may be cemented. Ferric iron concretions are present as a result of repeated cycles of water saturation and desaturation that cause microbial reduction and oxidation of iron and, after repeated wet and dry cycles, can cause impermeable iron stones to form (Soil Survey Division Staff, 1993). The proximity of seasonal high water-table altitudes measured at PZ 6 from January 2003 to December 2007 to the base of stratum A indicate that modern periodic water-table fluctuations may be the source of the cements.

Stratum C is 3.3 ft thick and extends from 81.51 to 84.81 ft above NAVD 88 (fig. 7). The upper 1.25 ft of this stratum is characterized by interbedded fine sand and massive clay and slightly silty fine sand (Hammonton LAF core 03, app. 4). Sediment from the lowermost 1 ft of stratum C was not recovered during coring. HPT testing shows pressures greater than 40 psi and flow rates as low as 79 mL/min. Natural-gamma-radiation measurements are generally elevated above background levels in this stratum. Sediment descriptions and results of HPT testing and natural-gamma-radiation logging all indicate that stratum C is hydraulically restrictive.

Stratum D is 4.77 ft thick and extends from 84.81 to 89.28 ft above NAVD 88 (fig. 7). This stratum is characterized by silty and clayey fine sands except for a sandy clay extending from 87.81 to 89.28 ft (Hammonton LAF core 03, app. 4). With the exception of the sandy clay, results of HPT testing show pressures less than 40 psi and flow rates generally greater than 250 mL/min. Natural-gamma-radiation measurements are near background levels. Sediment descriptions and results of HPT testing and natural-gamma-radiation logging all indicate that stratum D is not hydraulically restrictive. HPT testing and sediment descriptions indicate that the sandy clay within this unit is hydraulically restrictive, but as it is not characterized by elevated natural-gamma radiation, it is not possible to map this bed.

Stratum E is 4.59 ft thick and extends from 89.28 to 93.87 ft above NAVD 88 (fig. 7). This stratum is characterized by silty sands and sandy clays (Hammonton LAF core 03, app. 4). Results of HPT testing show pressures greater than 40 psi and flow rates as low as 0 mL/min. Natural-gamma-radiation measurements are generally elevated above background levels in this stratum. Sediment descriptions and results of HPT testing and natural-gamma-radiation logging all indicate that stratum E is hydraulically restrictive.

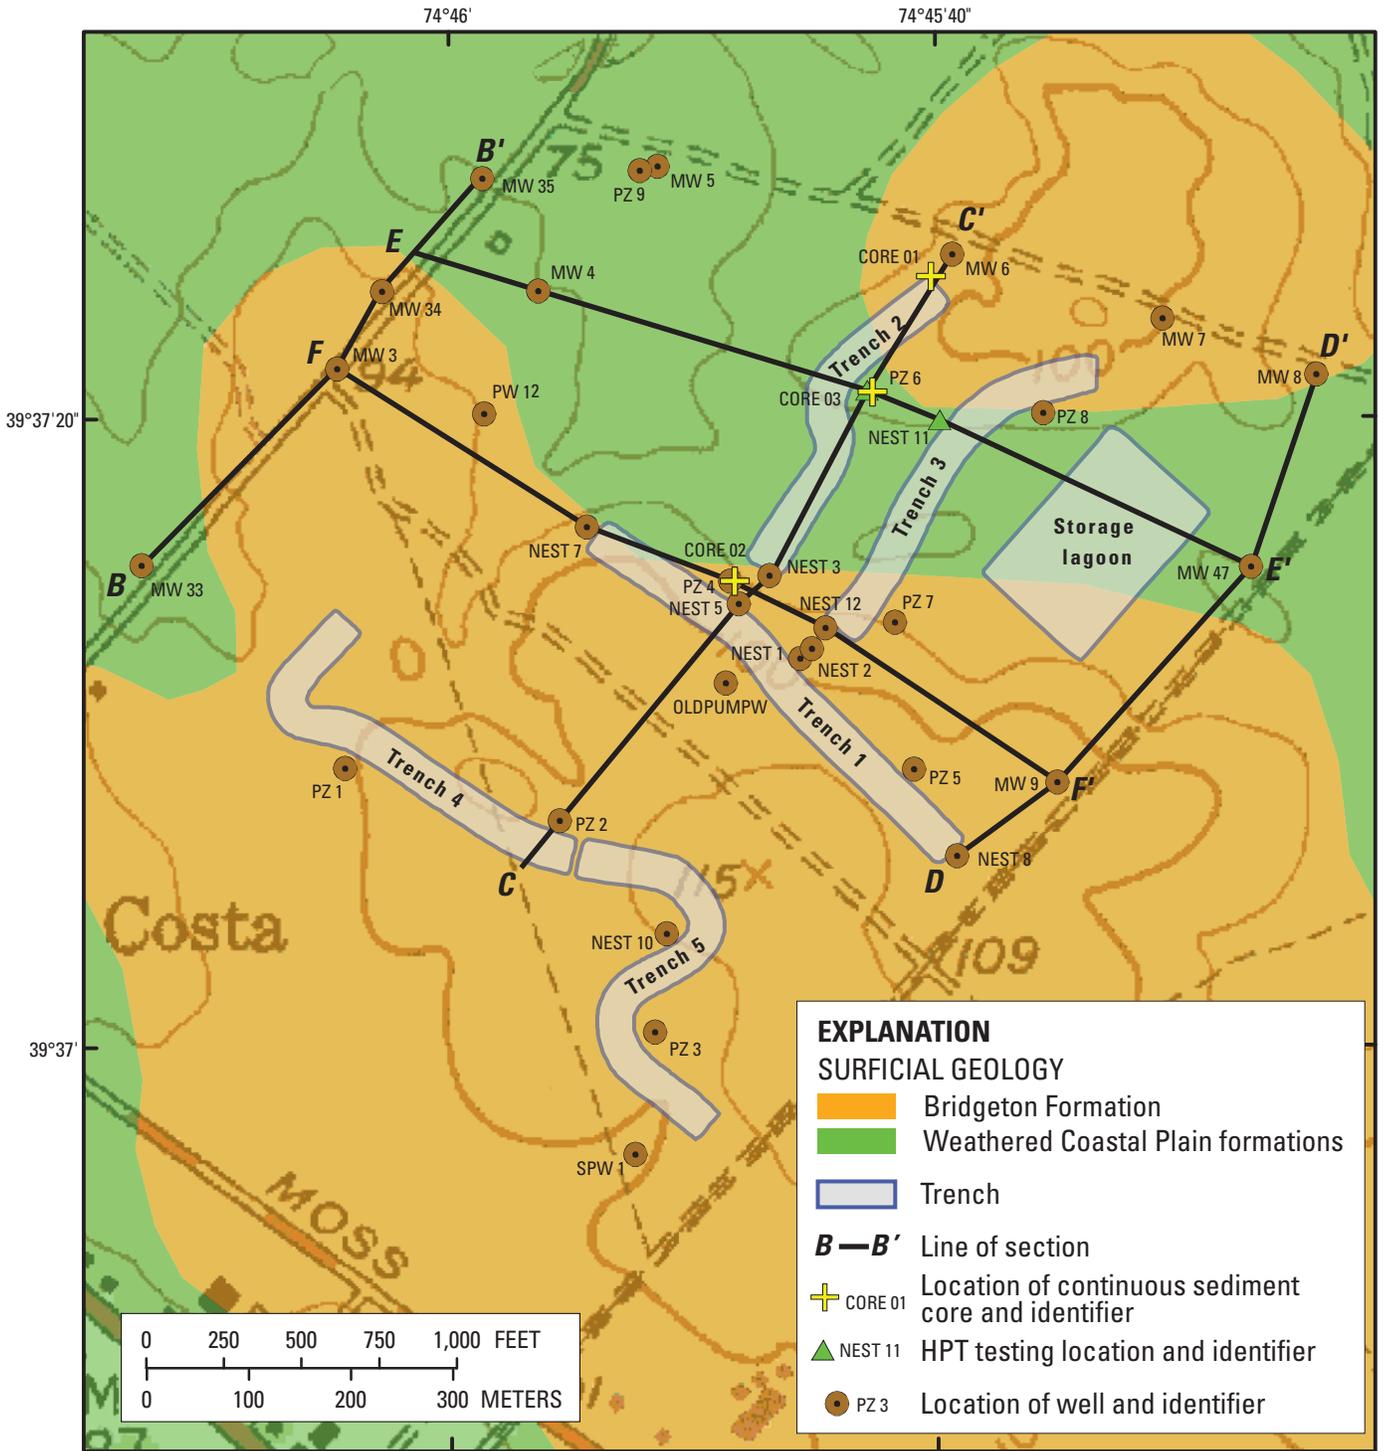
Figure 8. Locations of wells, trenches, continuous sediment cores, Hydraulic Profiling Tool (HPT) testing, and lines of section, Hammonton Land Application Facility, southern New Jersey.

LAF were examined (figs. 8 and 9 a–e). Section *C–C'* (fig. 9b) runs along strike through the center of the facility and includes well PZ 6. The position of section *C–C'* allows direct comparison of other wells within the section to the natural-gamma and HPT logs from well PZ 6. The three shallowest lower conductivity zones are observed in all wells; the deepest is observed in wells MW 6, PZ 2, and PZ 6. Bedding is nearly horizontal in this section and altitude is relatively constant along the section. Section *E–E'* (fig. 9d) runs parallel to the dip direction and includes wells PZ 6 and Nest 11 MW C. The four shallowest lower conductivity zones observed in well Nest 11 MW C correlate with the shallowest lower conductivity zone identified in PZ 6. The deeper two lower conductivity zones in well Nest 11 MW C correlate with the second shallowest lower conductivity zone identified in PZ 6. The third shallowest lower conductivity zone was observed only in PZ 6, likely as a result of erosion, as evidenced by the topography of this section. As in section *C–C'*, bedding is nearly horizontal, indicating that the lower conductivity zones are planar features. The depth of the deepest lower conductivity zone identified in well PZ 6 is located in section *D–D'* by correlation with MW 47 (fig. 9c). A lower conductivity zone in Nests 8 MW C and MW 9 between 90 and 95 ft may correlate with the shallowest lower conductivity zone initially identified in PZ 6 and well Nest 11 MW C, indicating that the middle two lower conductivity zones identified in sections *C–C'* and *E–E'* may not extend to the eastern portion of the Hammonton LAF. Identification of the deepest lower conductivity zone in sections *B–B'* and *F–F'* (figs. 9a and e) indicates that the zone is present throughout the Hammonton LAF. The origin of this and other lower conductivity zones is unclear. Because the Bridgeton Formation is a series of fluvial deposits, it is possible that these nearly horizontal and continuous to semi-continuous zones may be remnants of floodplains. Alternatively, these zones may have been created post-deposition by iron cementation of sands associated with paleo-groundwater fluctuations.

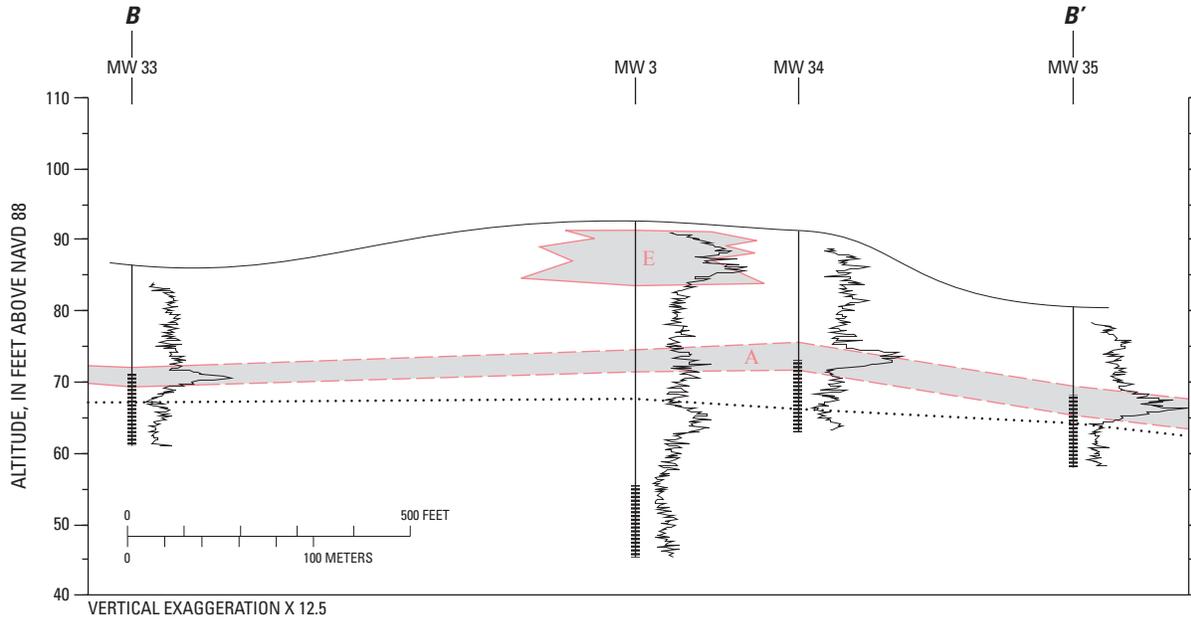
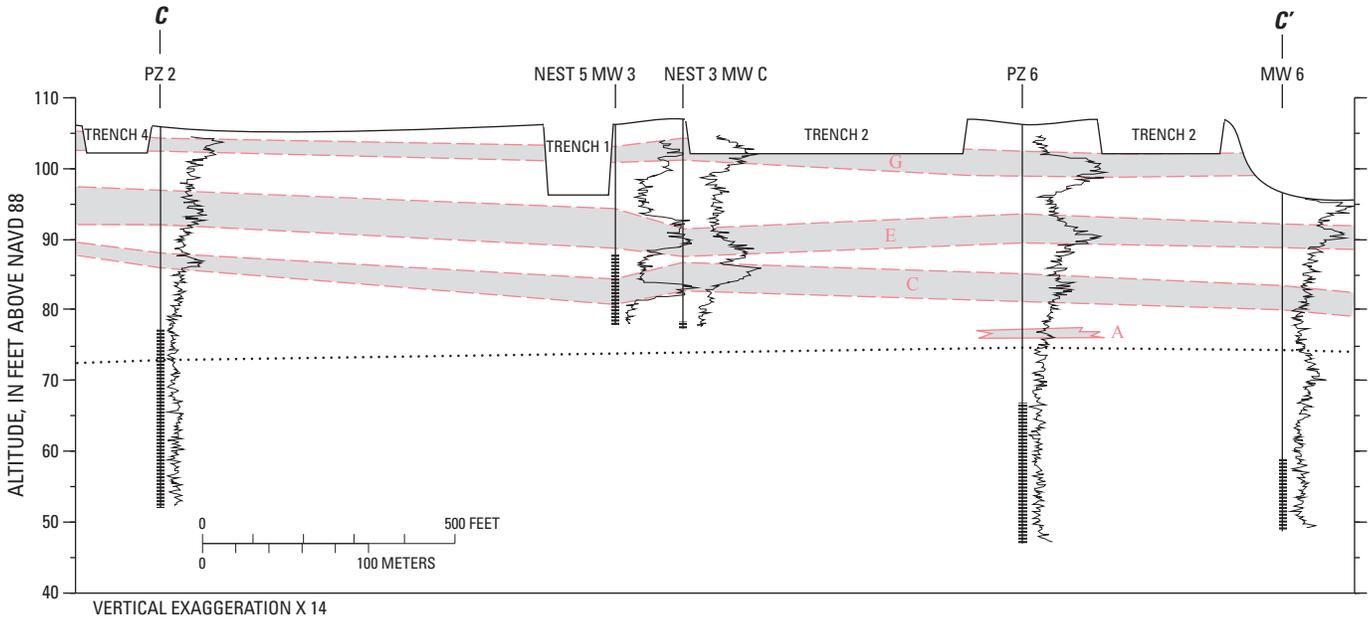
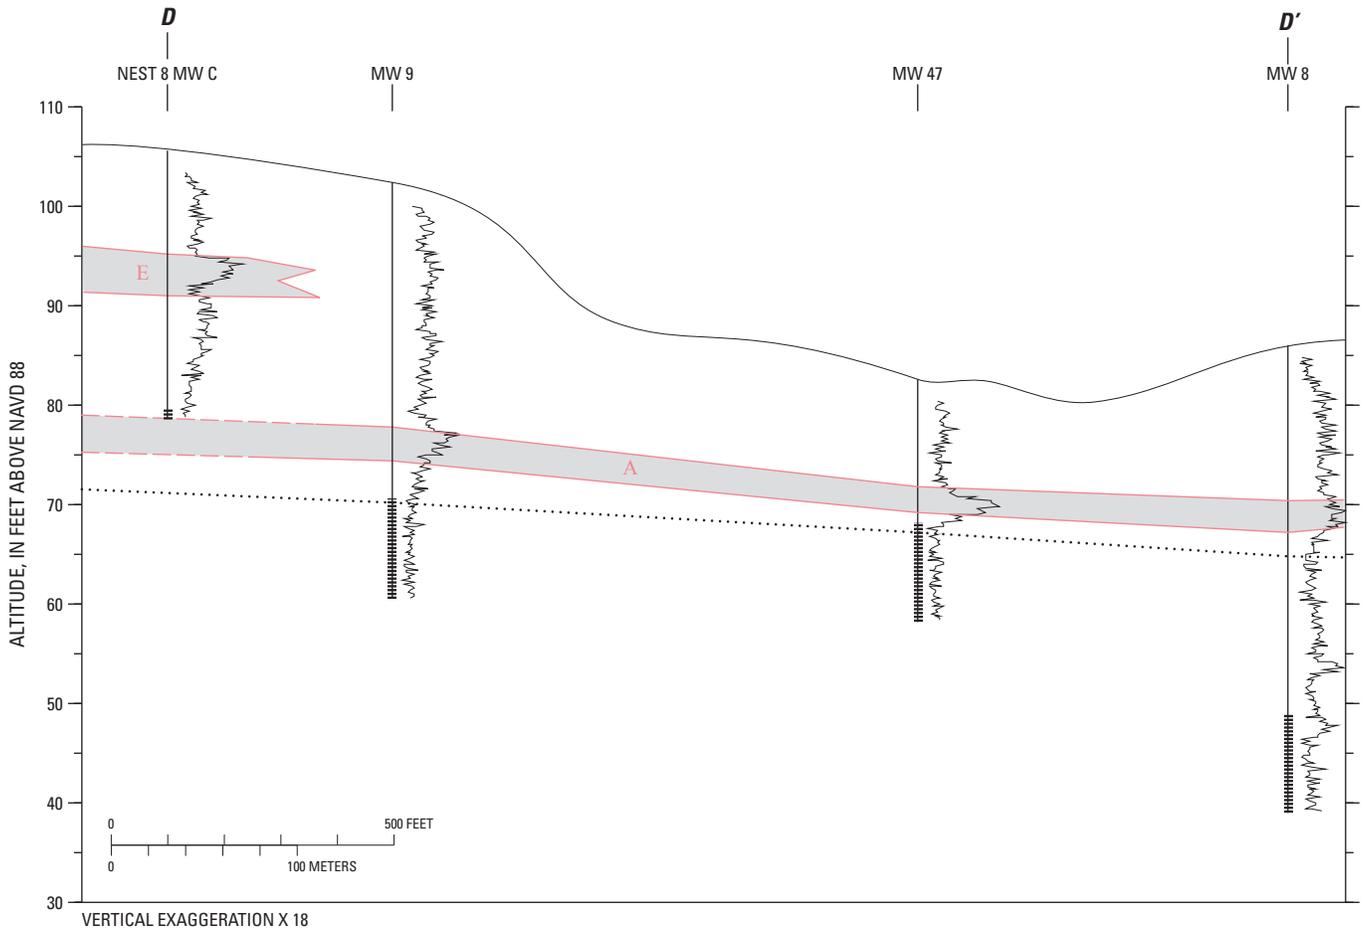
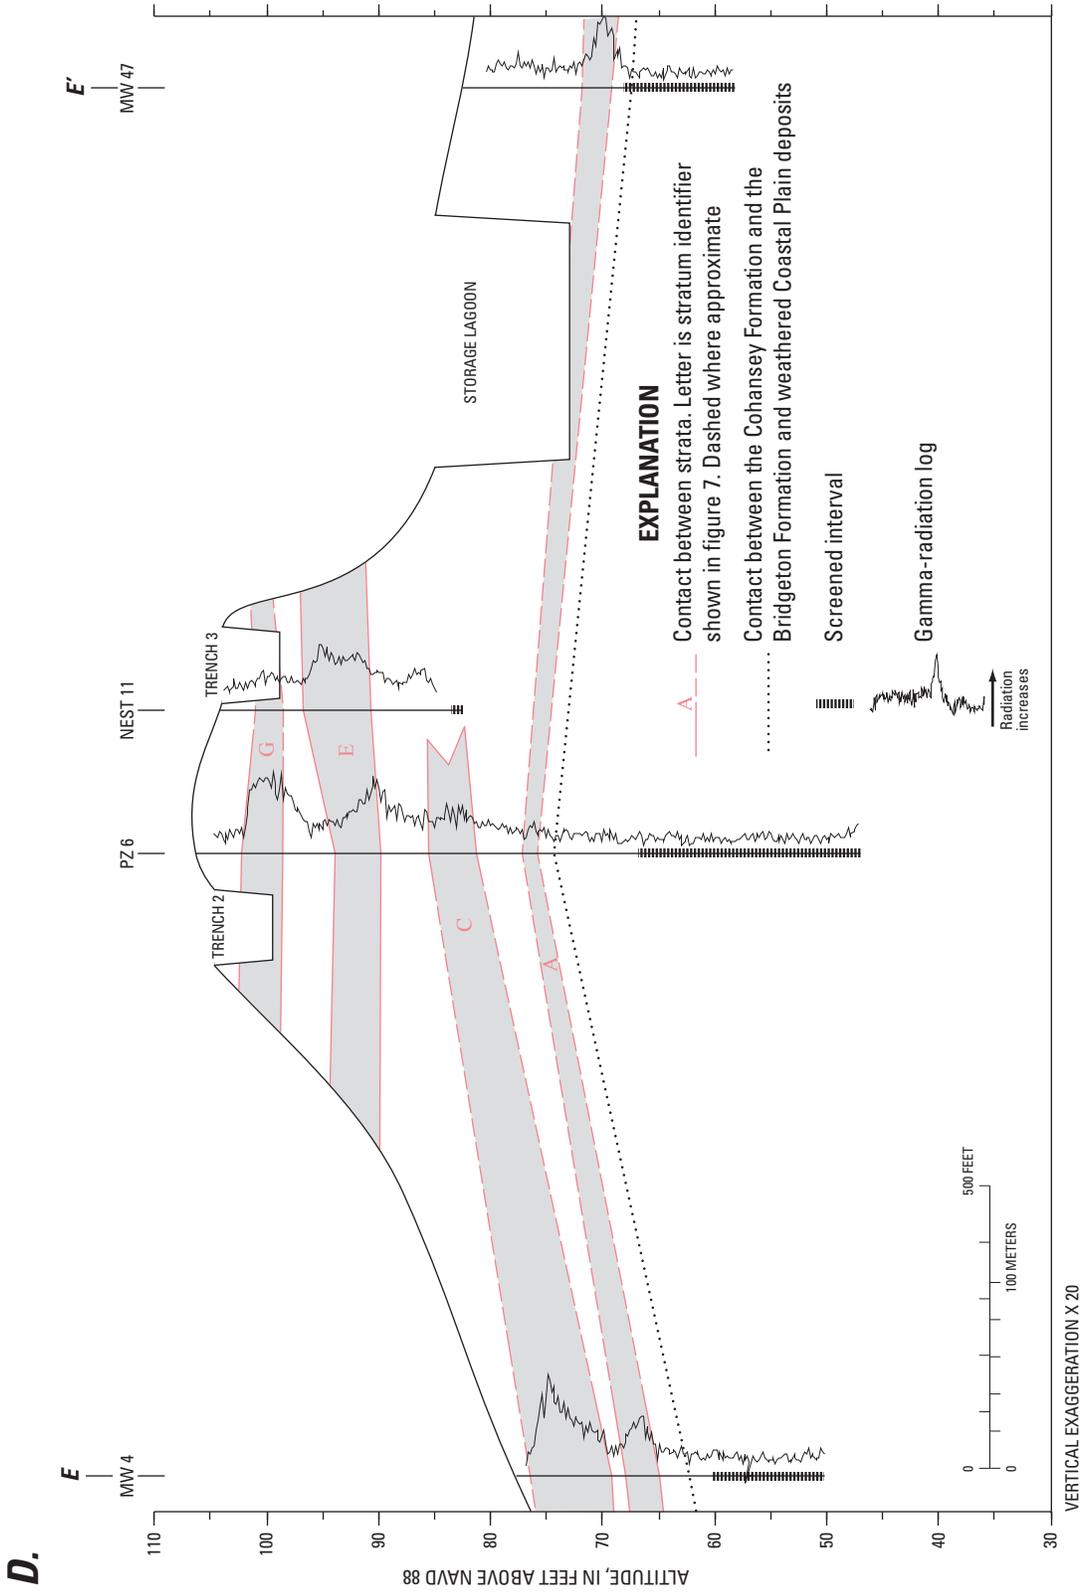
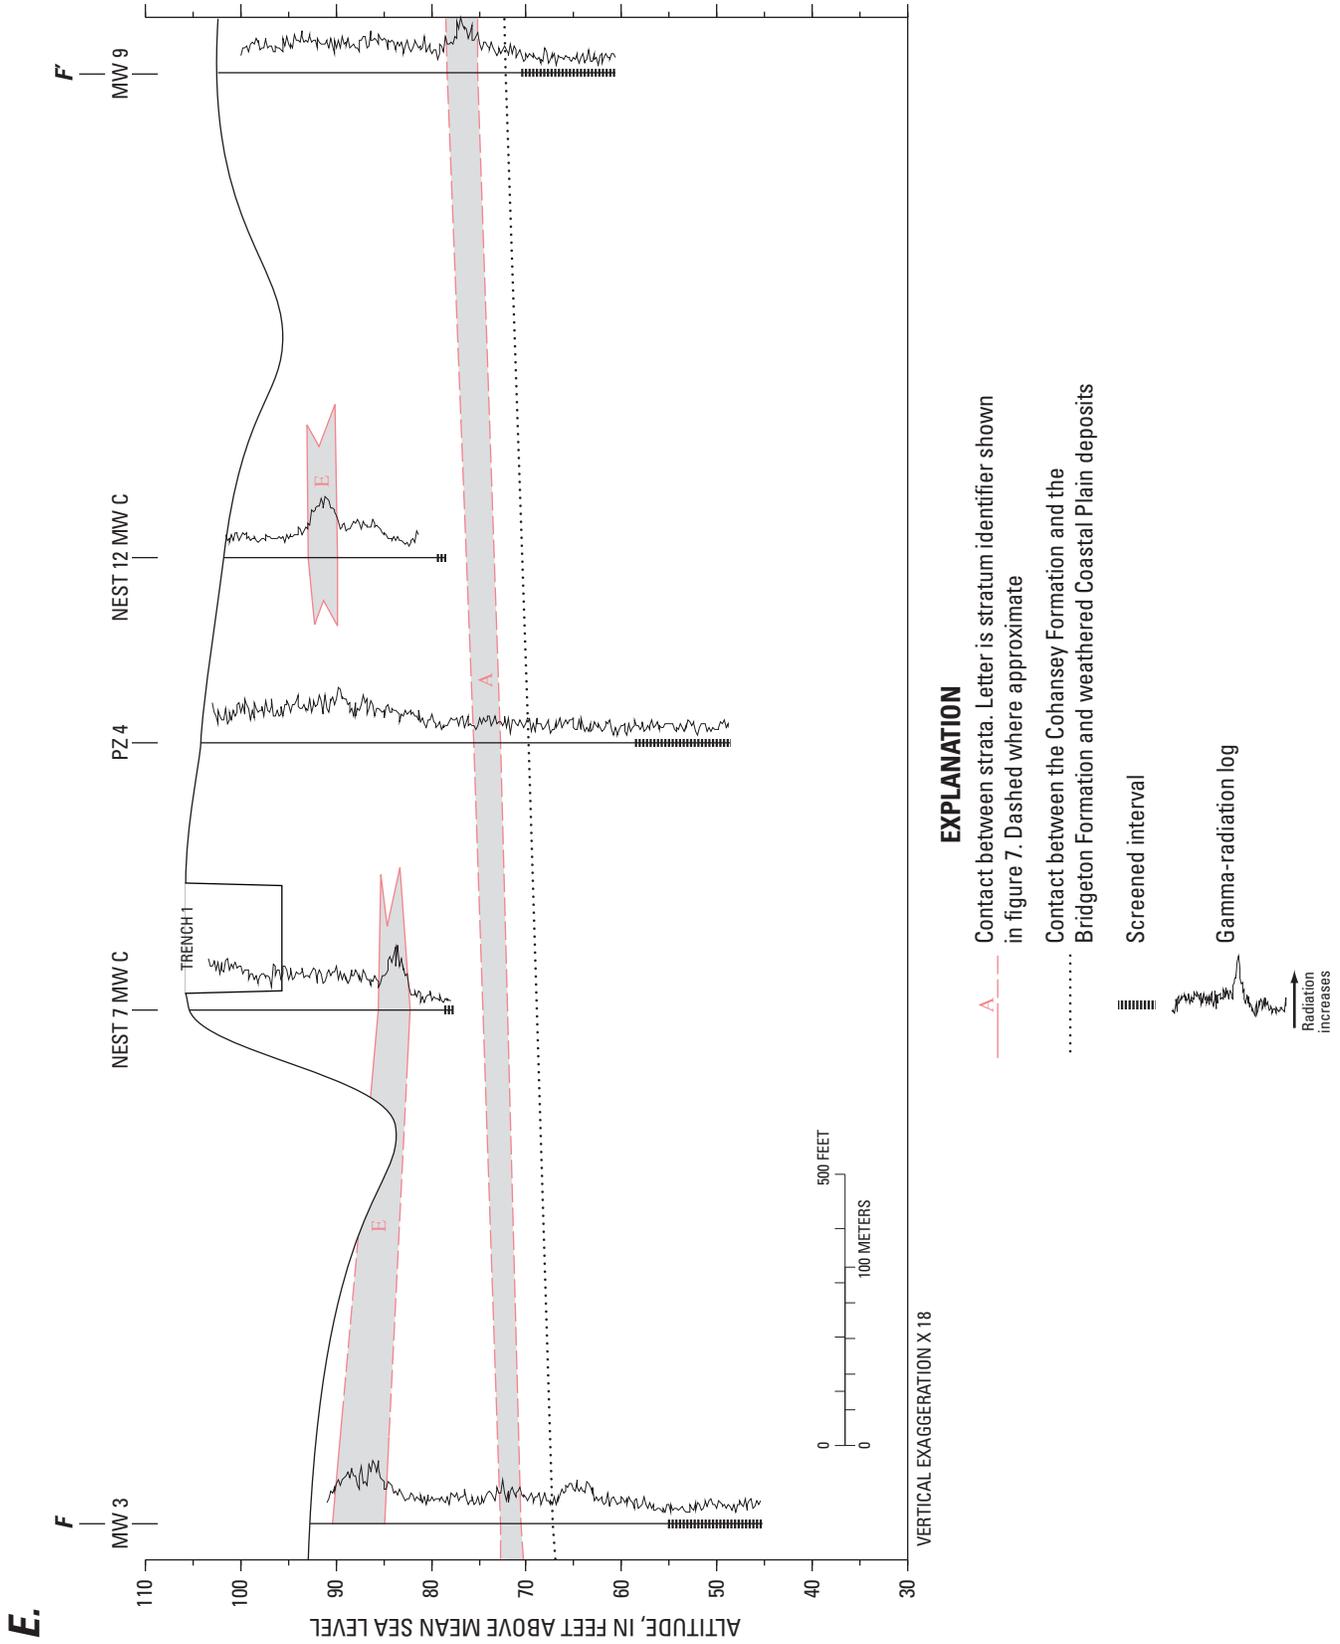
Figure 9. Hydrogeologic cross sections (A) B-B', (B) C-C', (C) D-D', (D) E-E', and (E) F-F', Hammonton Land Application Facility, southern New Jersey.

Peaks in natural-gamma radiation are correlated between selected logged wells to map the extent of lower hydraulic conductivity units in the strike and dip sections. The altitude of the contact between the Cohansy Formation and the Bridgeton Formation and weathered Coastal Plain deposits varies throughout the site, but generally is within 2 ft of the position observed at PZ 6 (fig. 7). The units of the New Jersey Coastal Plain generally strike northeast-southwest and dip gently to the southeast (Zapeczka, 1989). Three sections along strike and two sections along dip through the Hammonton

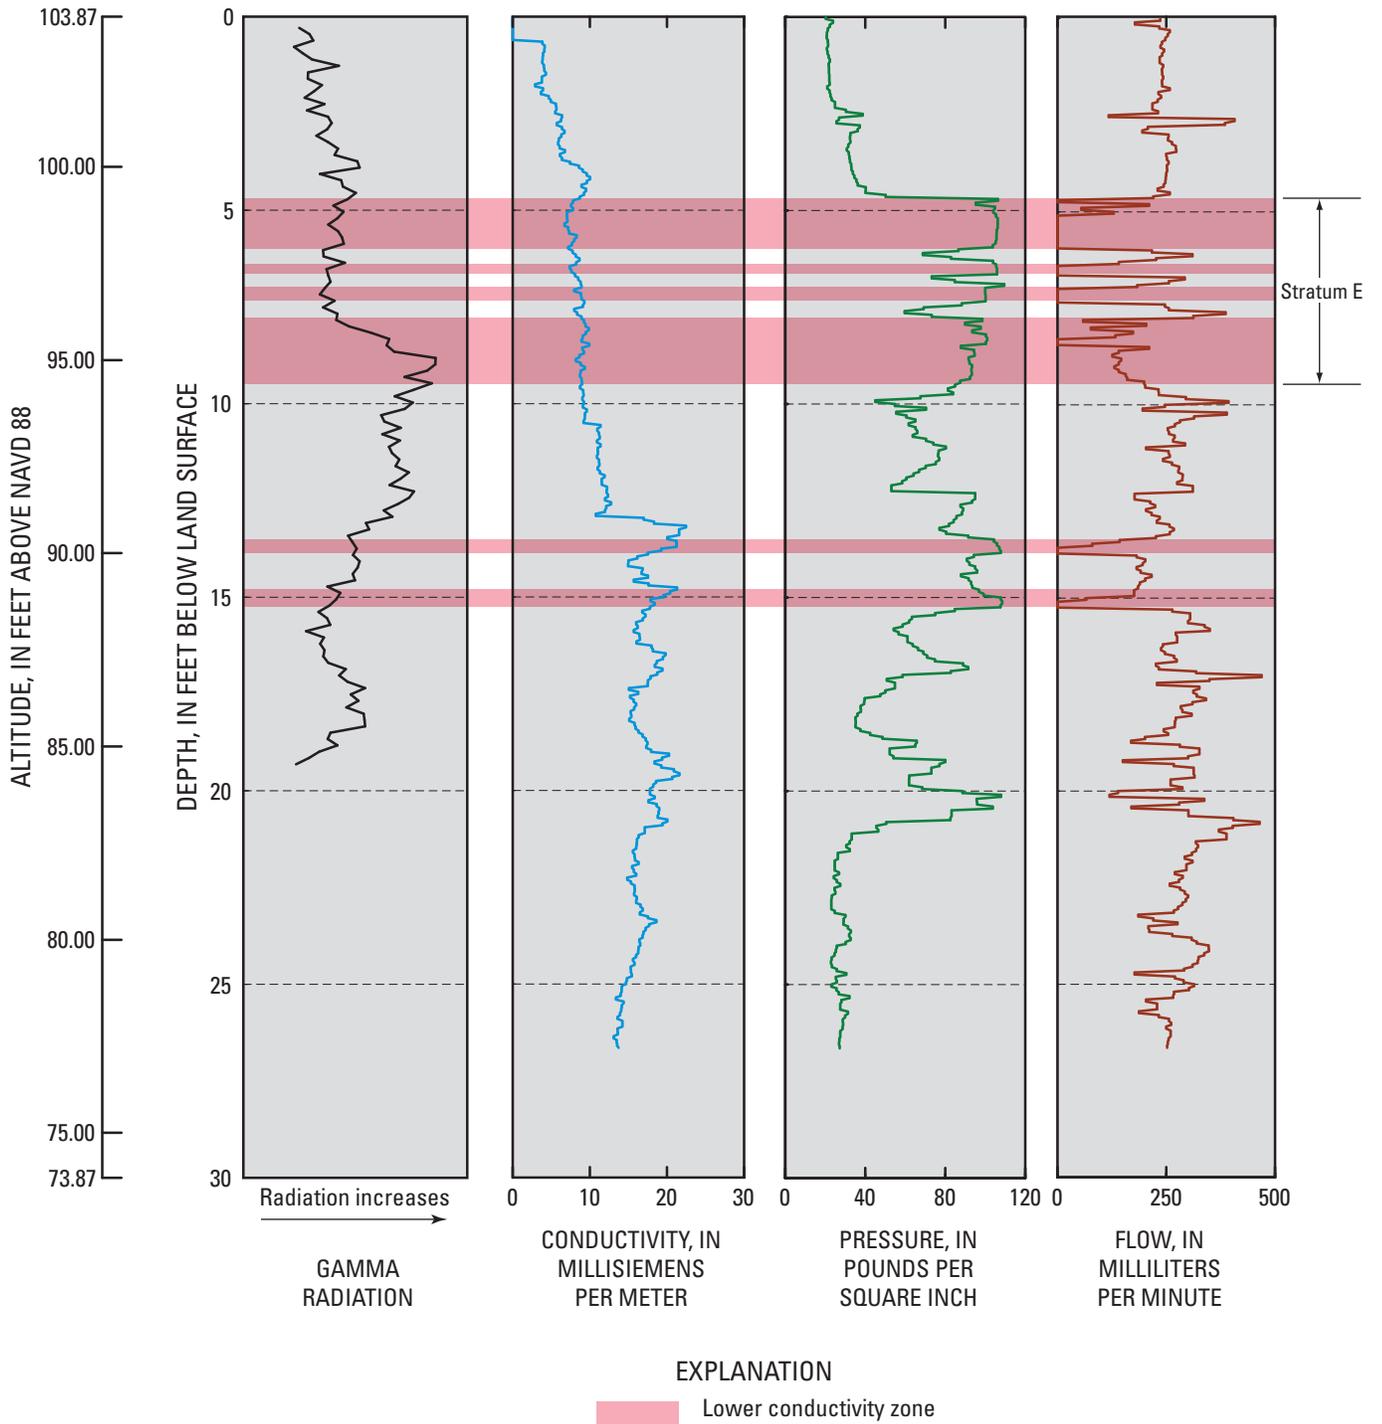
Figure 10. Geophysical logs of well Nest 11 MW C, Hammonton Land Application Facility, southern New Jersey.

On January 11, 2007, USGS personnel hand-augured a hole adjacent to Nest 11 to determine the nature of an observed gamma-radiation high that began at about 8 ft bls and peaked at 9 ft bls during gamma logging of well Nest 11 MW C (fig. 10). The hand-augured hole was 20 ft west of trench 3 and 3 ft east of well Nest 11 MW C (fig. 11). The hole was dug to refusal at approximately 6 ft deep and then began to fill with water. The water level in the hole rose to 4.9 ft bls.
