Assessment of Physical, Chemical, and Hydrologic Factors Affecting the Infiltration of Treated Wastewater in the New Jersey Coastal Plain, with Emphasis on the Hammonton Land Application Facility

Scientific Investigations Report 2010–5006

By Timothy J. Reilly, Kristin M. Romanok, Steven Tessler, and Jeffrey M. Fischer

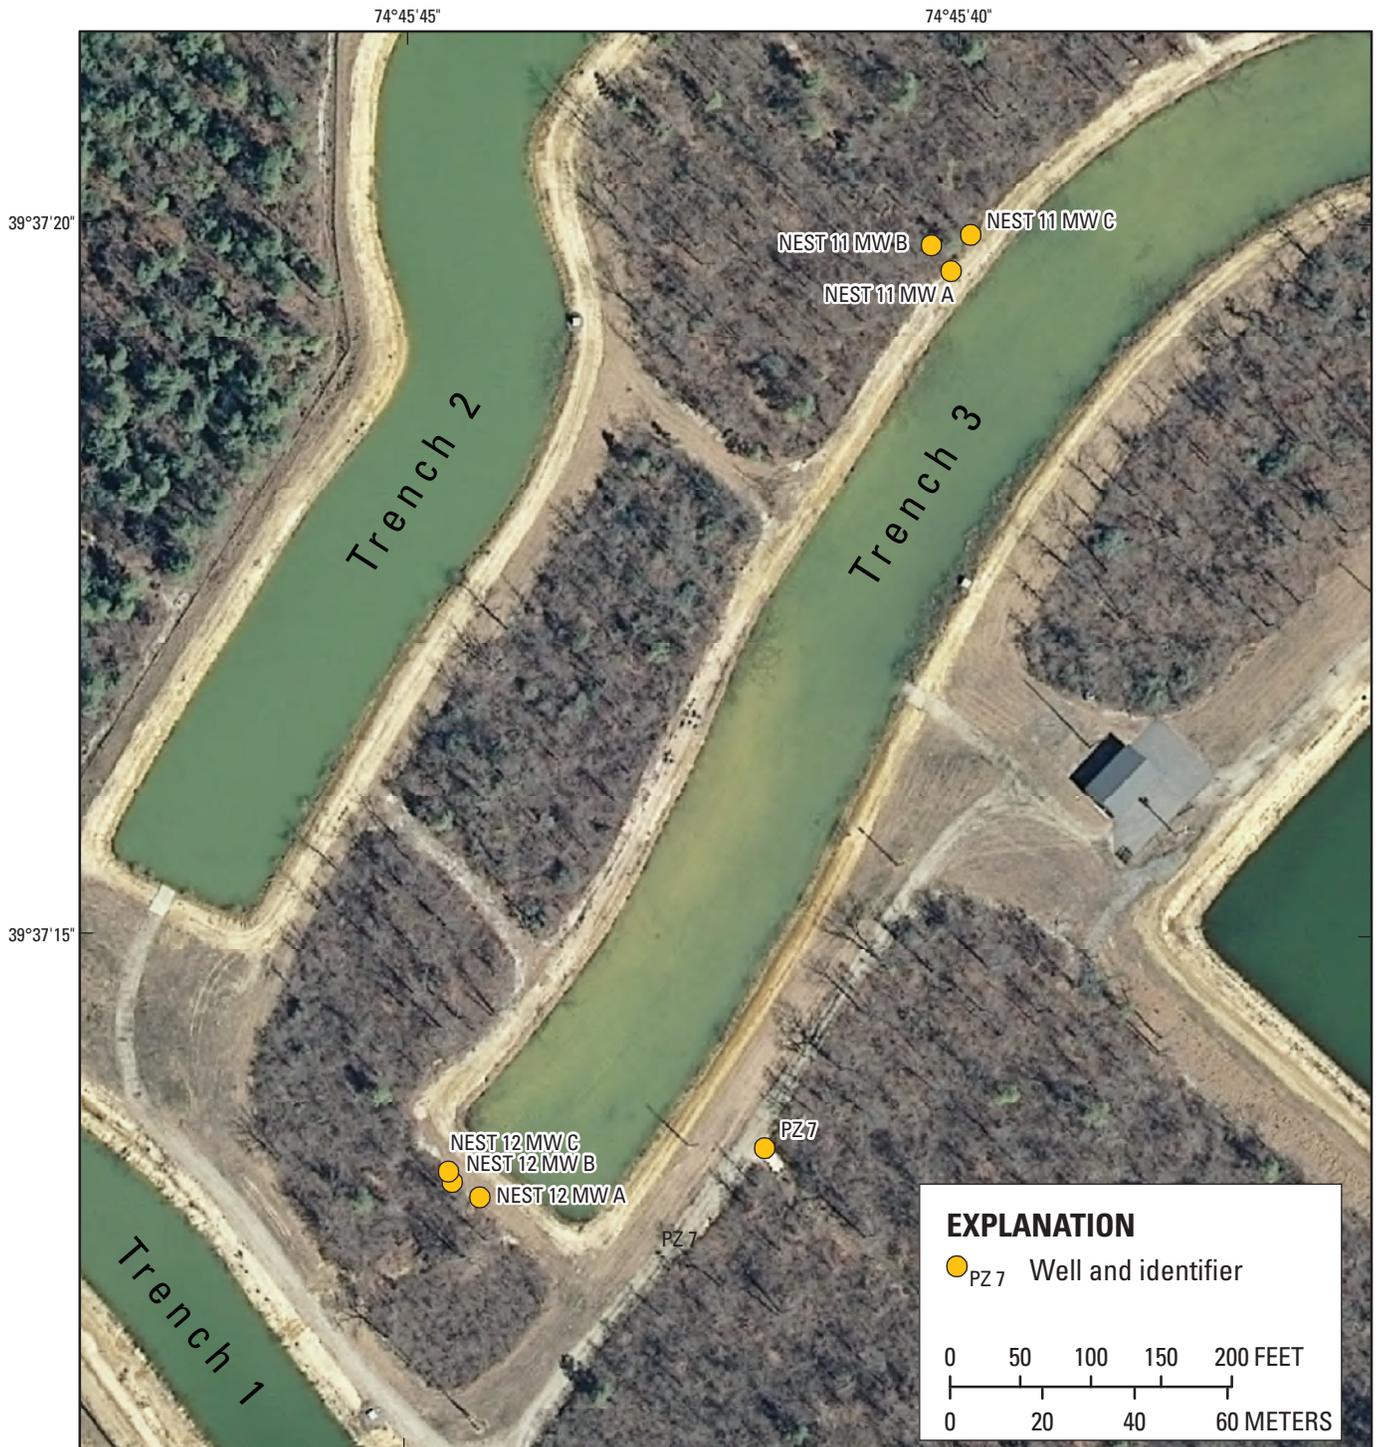
Figure 11. Locations of wells used to determine the altitude of perched water, Hammonton Land Application Facility, southern New Jersey.

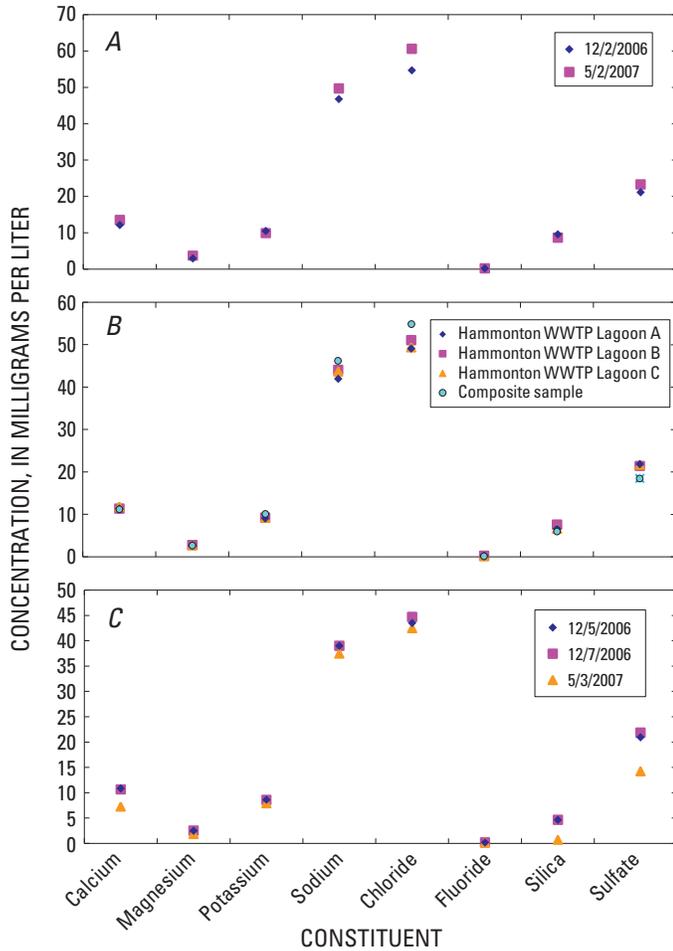
Figure 12. Concentrations of selected ions in (A) 24-hour composite samples of treated effluent collected at the Hammonton Waste Water Treatment Plant (WWTP) on December 2, 2006, and May 2, 2007; (B) samples of treated wastewater collected from the storage lagoons at the Hammonton Land Application Facility (LAF) on December 6, 2006, and May 3, 2007 (composite sample); and (C) samples of treated wastewater collected from trench 2 at the Hammonton LAF on December 5 and 7, 2006, and May 3, 2007, southern New Jersey.

(figs. 12b, 13b, and 14b), which indicates that the storage lagoon is well mixed both laterally and vertically. Vertical profiles of temperature, pH, DO, and SC collected in December 2006 and May 2007 indicate little vertical stratification. Therefore, during follow-up sampling in May 2007, a single vertically and spatially composited sample was collected.

As with the WWTP, some differences in the chemistry of the water in the storage lagoon were noted between the concentrations in the May 2007 sample and the mean concentrations in December 2006 (figs. 12b, 13b, and 14b).

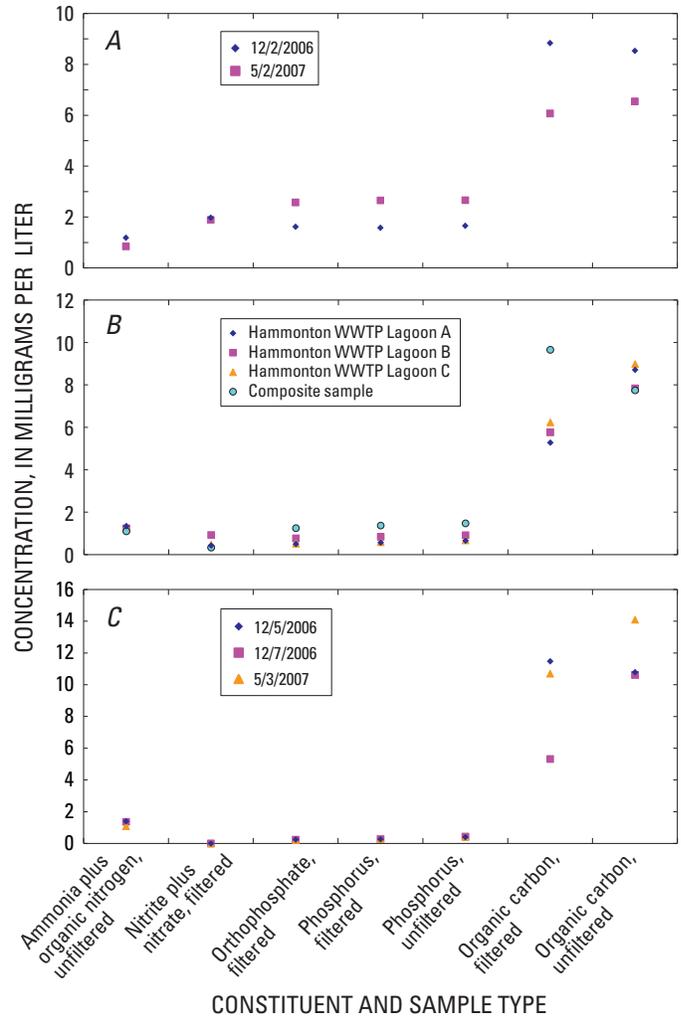
Figure 13. Concentrations of selected nutrients in (A) 24-hour composite samples of treated effluent collected at the Hammonton Waste Water Treatment Plant (WWTP) on December 2, 2006, and May 2, 2007; (B) samples of treated wastewater collected from the storage lagoons at the Hammonton Land Application Facility (LAF) on December 6, 2006, and May 3, 2007 (composite sample); and (C) samples of treated wastewater collected from trench 2 at the Hammonton LAF on December 5 and 7, 2006, and May 3, 2007, southern New Jersey.

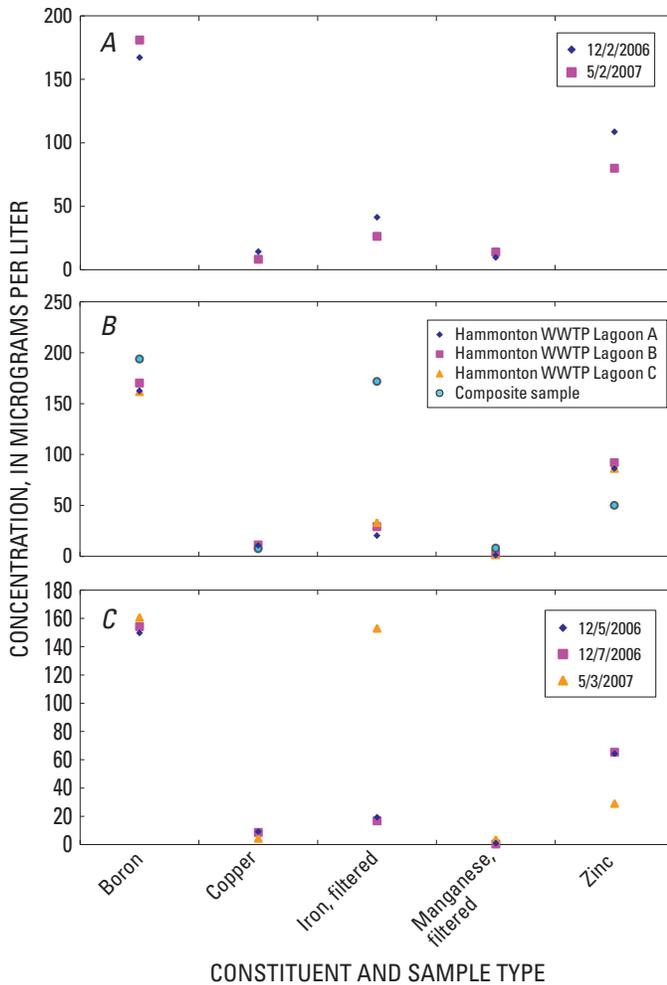
Figure 14. Concentrations of selected trace elements in (A) 24-hour composite samples of treated effluent collected at the Hammonton Waste Water Treatment Plant (WWTP) on December 2, 2006, and May 2, 2007; (B) samples of treated wastewater collected from the storage lagoons at the Hammonton Land Application Facility (LAF) on December 6, 2006, and May 3, 2007 (composite sample); and (C) samples of treated wastewater collected from trench 2 at the Hammonton LAF on December 5 and 7, 2006, and May 3, 2007, southern New Jersey.

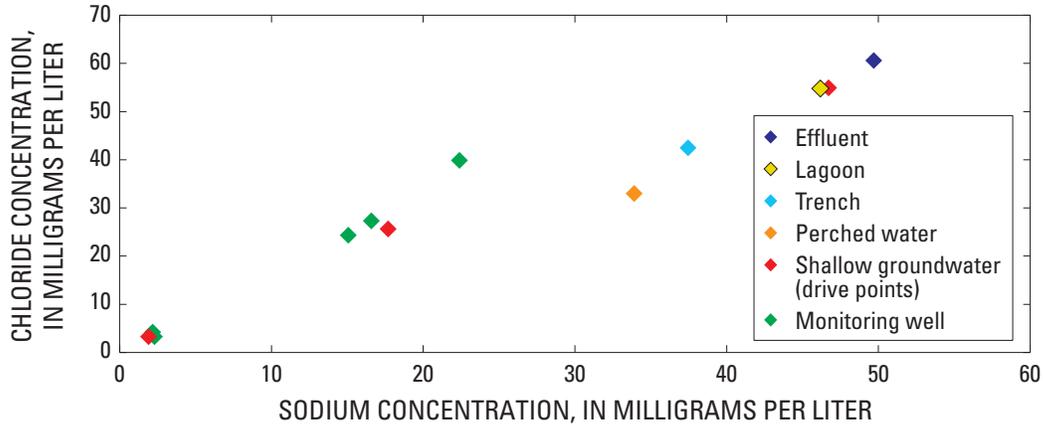
Figure 15. Relation between concentrations of sodium (filtered) and chloride (filtered) ions in samples of treated wastewater from selected locations within the Hammonton Waste Water Treatment Plant and Land Application Facility, southern New Jersey.

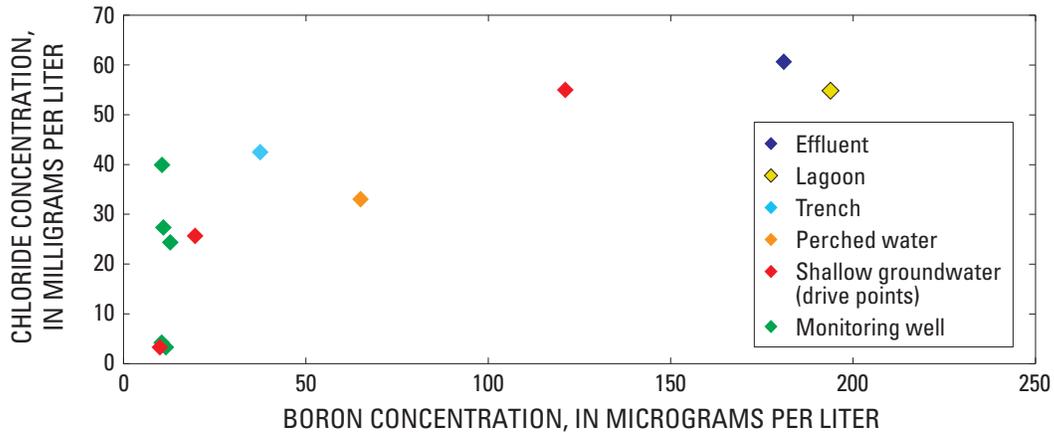
Figure 16. Relation between concentrations of boron (filtered) and chloride (filtered) ions in samples of treated wastewater from selected locations within the Hammonton Waste Water Treatment Plant and Land Application Facility, southern New Jersey.

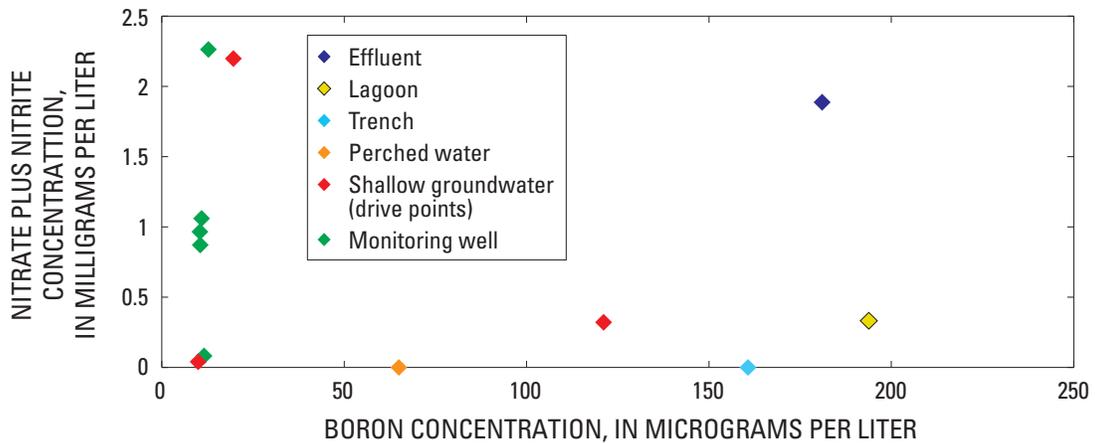
Figure 17. Relation between concentrations of boron (filtered) and nitrate plus nitrite (filtered) ions in treated wastewater from selected locations within the Hammonton Waste Water Treatment Plant and Land Application Facility, southern New Jersey.

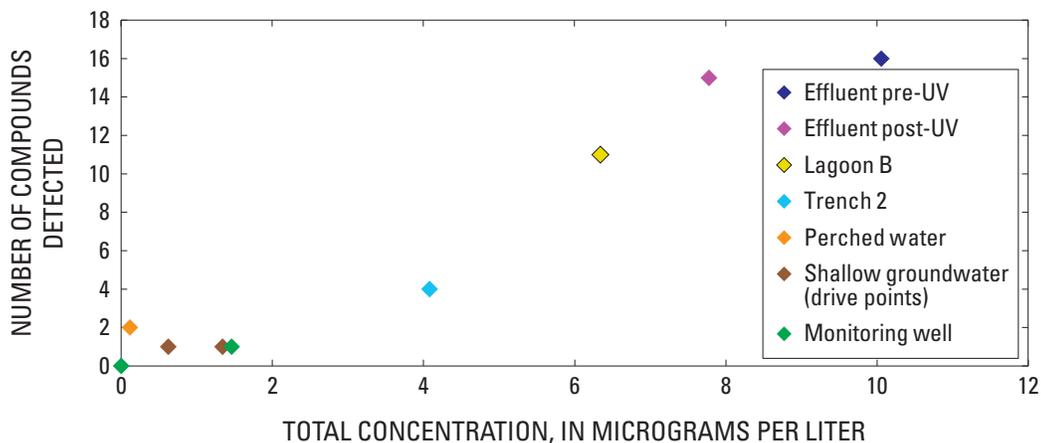
Figure 18. Relation between total concentration and number of wastewater indicator compounds detected in samples of treated wastewater from selected locations within the Hammonton Waste Water Treatment Plant and Land Application Facility, southern New Jersey. [UV, ultraviolet]

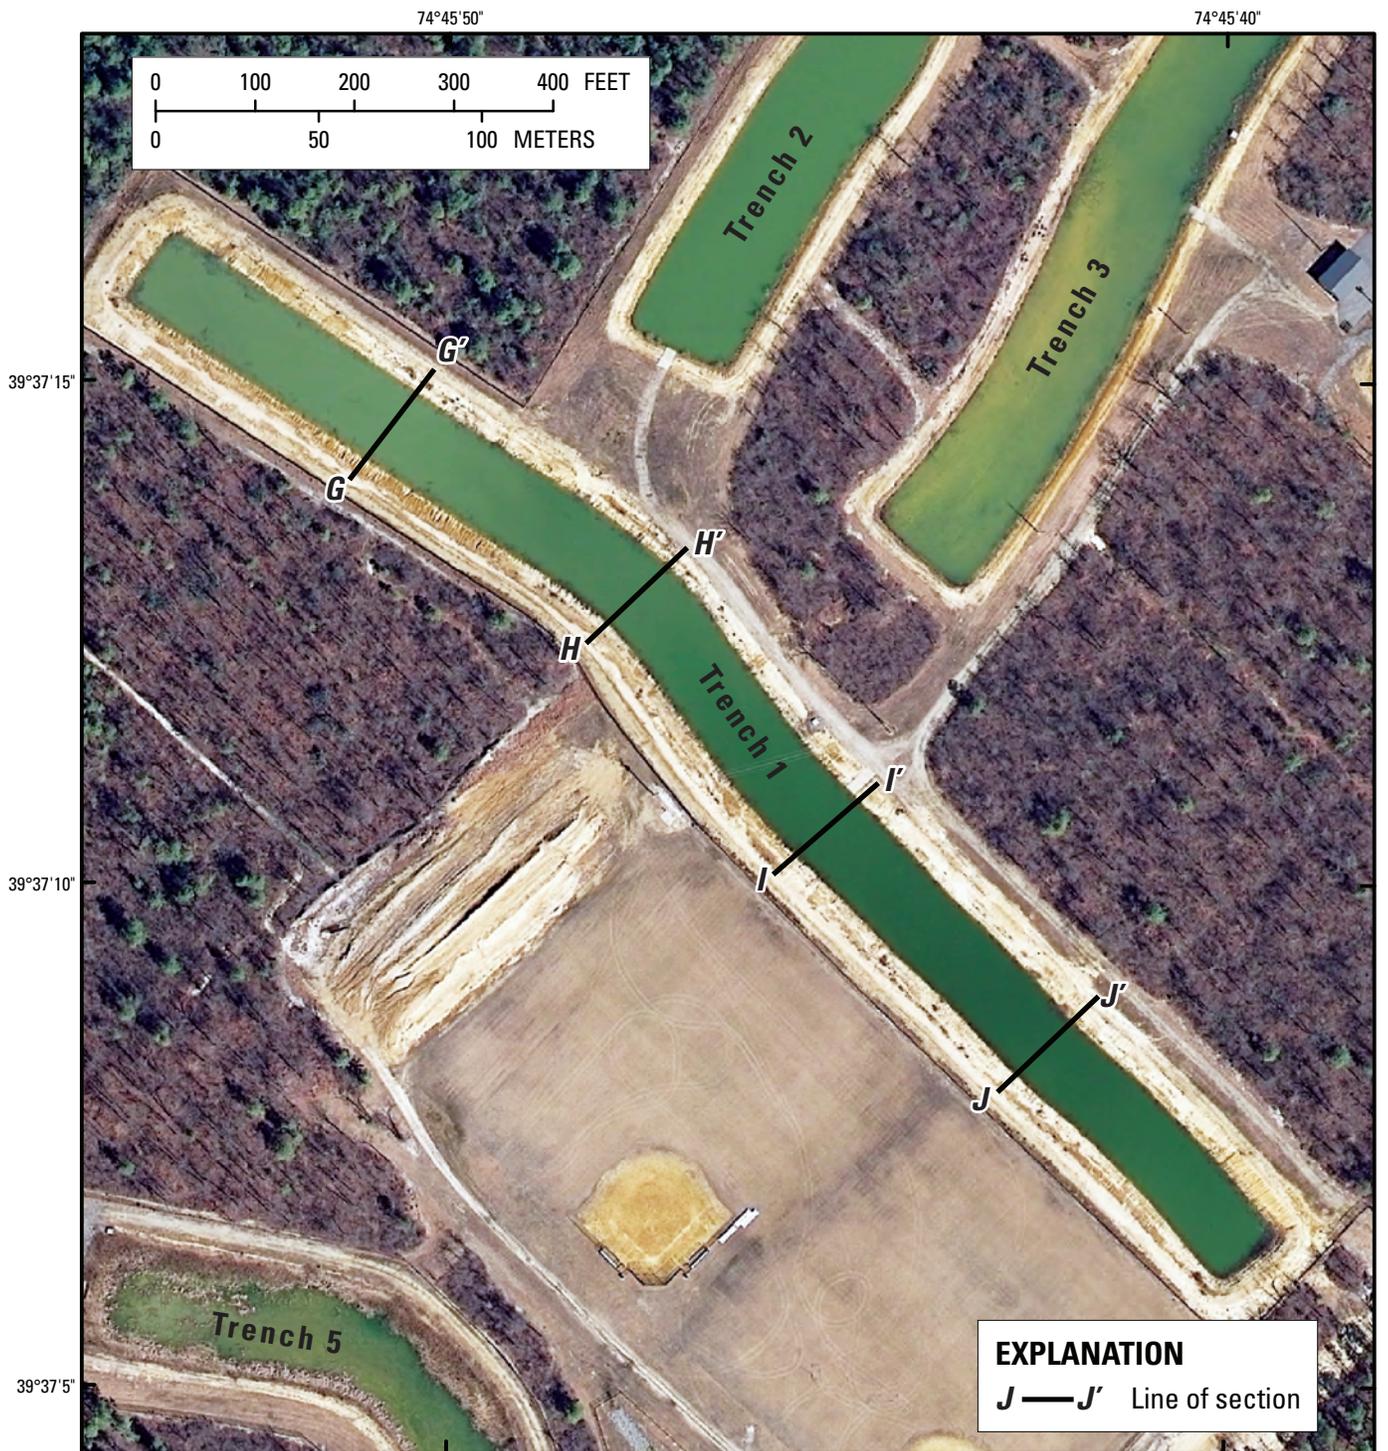
Figure 19. Lines of section across trench 1 along which land-surface altitudes were measured, Hammonton Land Application Facility, southern New Jersey.

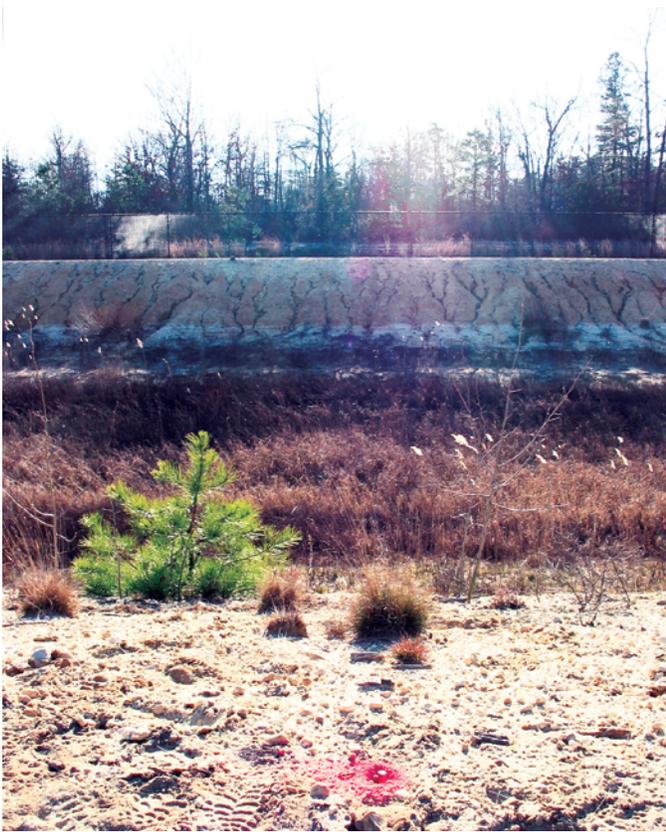
Figure 21. Erosional features of the southern wall of trench 1, Hammonton Land Application Facility, southern New Jersey.

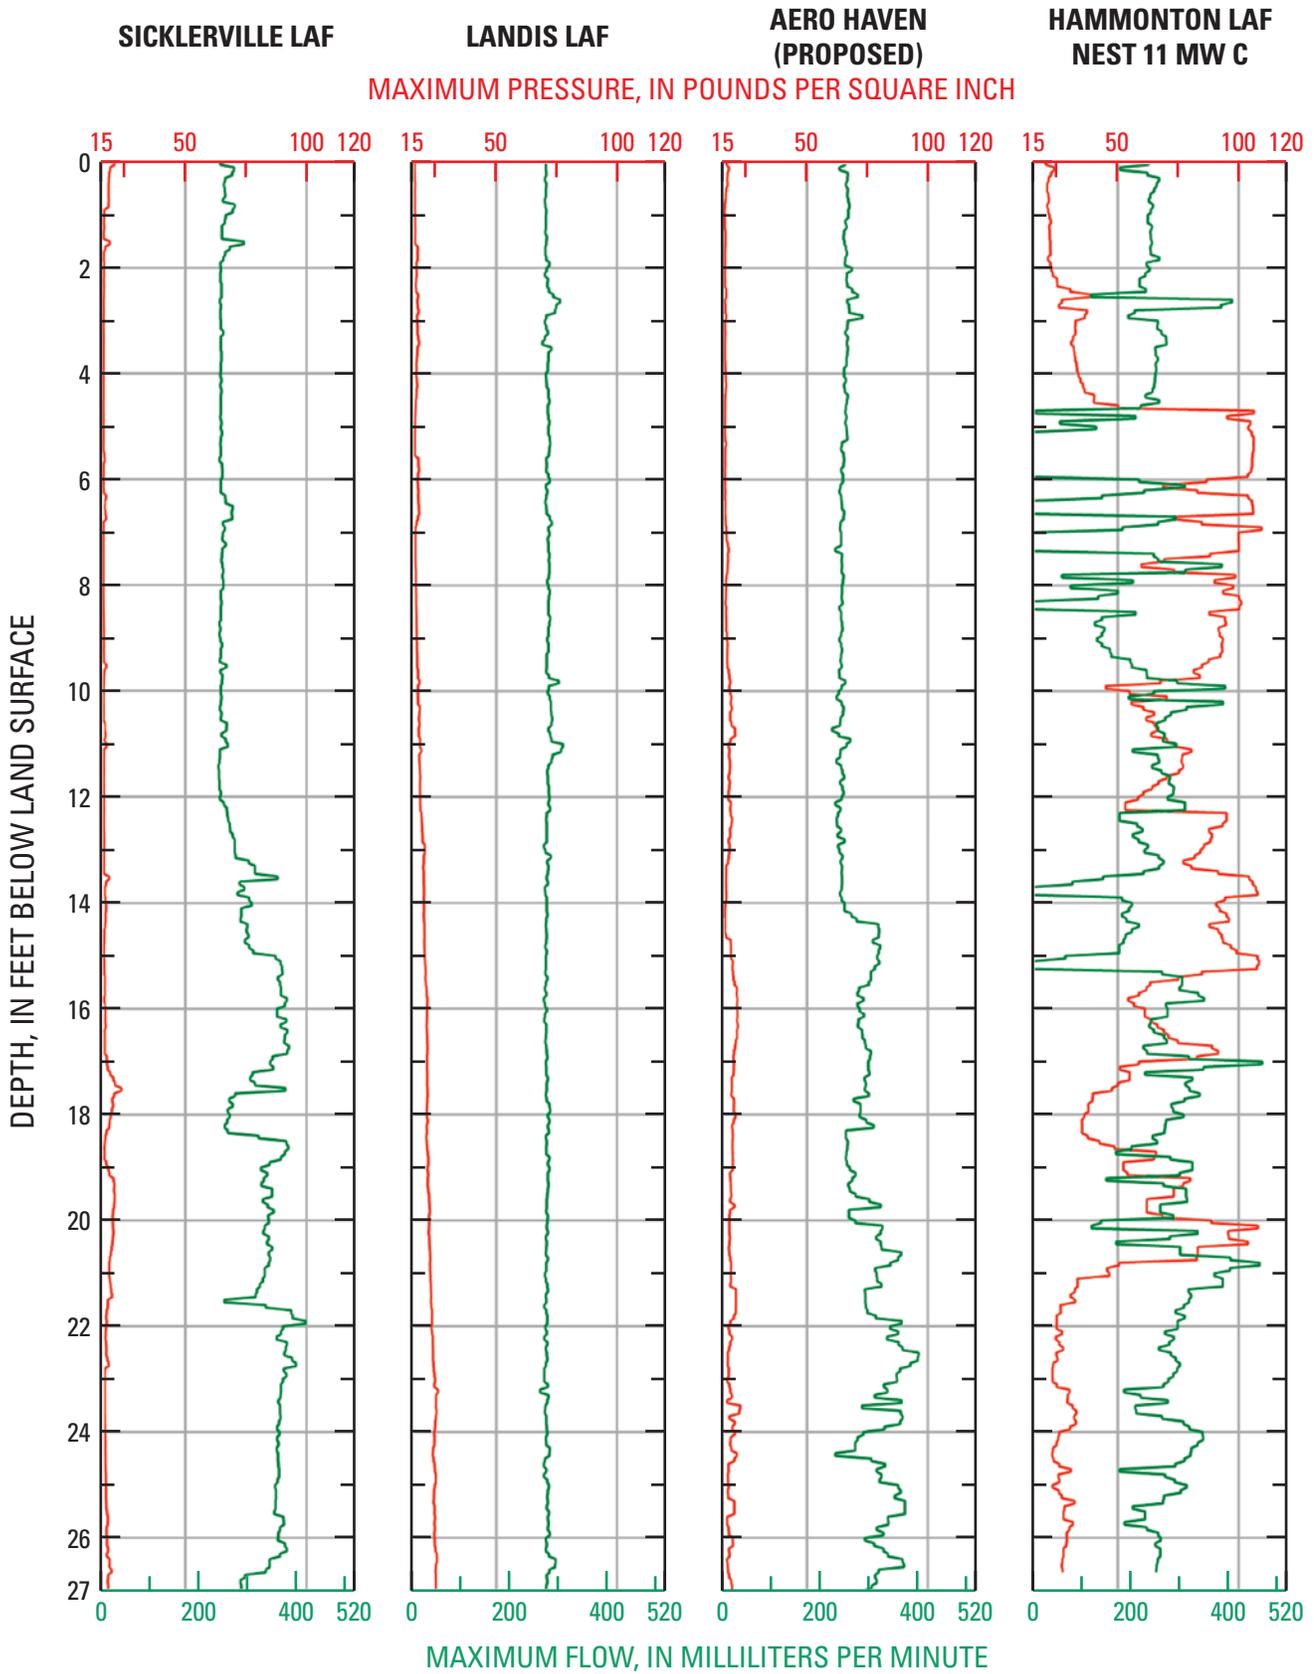
Figure 22. Comparison of results of Hydraulic Profiling Tool tests conducted at selected existing and proposed land application facilities (LAFs) in southern New Jersey.

facilities are not underlain by strata that restrict flow. Although both the Sicklerville and Hammonton LAFs are underlain by the Bridgeton Formation, the HPT results indicate no impediments to infiltration at Sicklerville, a condition due, at least in part, to maintenance regimes at Sicklerville that call for the periodic excavation of trenches to a depth of up to 12 ft below the current trench-floor altitude. Excavated sediments are removed and replaced with clean sand. Variations in the grain size of the Bridgeton Formation based on differences in the depositional and erosional history of the unit between Hammonton and Sicklerville also must contribute to the difference in hydraulic properties. The Landis LAF is underlain by Lower Terrace deposits, which consist of gravels that, on the basis of HPT testing, have nearly uniform hydraulic properties with no restrictive strata. HPT results for Aero Haven are similar to those for the Landis and Sicklerville LAFs. This is not surprising, as the site is underlain by the sand and pebble gravels of Upper Terrace and weathered Coastal Plain deposits of similar parent material. Although a more comprehensive site investigation prior to siting infiltration trenches is
