NASA/TM-1998-208742

Room Temperature and Elevated Temperature Composite Sandwich Joint Testing

Sandra P. Walker
Langley Research Center, Hampton, Virginia

November 1998

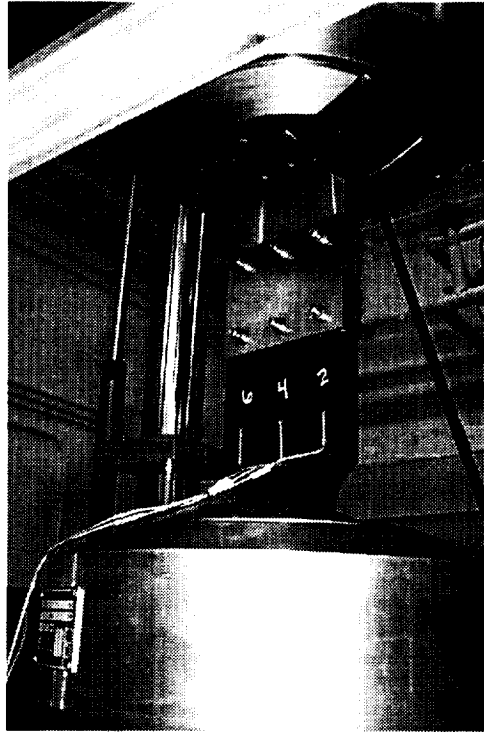
Figure 1. Single-row joint specimen mounted in test machine using hydraulic grips for the room temperature test.

The room temperature specimen was tension tested using hydraulic grips in a 220 kip test machine. A photograph of the specimen mounted in the test machine is shown in Figure 1. The load was applied to the end grip tabs of the joint specimen through the hydraulic grips using a grip pressure of 5500 psi. The test machine was set in stroke control and a displacement rate of 0.01 in/min was used to apply the load to the joint specimen. The applied load versus ram displacement is plotted in Figure 2. The first indication of initial damage was observed at 31 kips, where a 10% reduction in the load was recorded and a cracking noise was heard. Subsequently, loading of the joint continued until an ultimate load of 40 kips was obtained. At the ultimate load, a 10 kip reduction in the load was observed, and the test was stopped. Since the first load reduction was less than 20%, which was considered in this test to indicate ultimate failure, the load of 40 kips was considered the ultimate failure load. The measured back-to-back strains from strain gauges, SG3 and SG4, located at the center of the specimen, are plotted in Figure 3 with the applied load. The location of SG2, SG4, and SG6 can be observed in Figure 1, where SG1, SG3, and SG5 correspond to the same locations on the opposite facesheet, respectively. The strains measured from SG1 and SG2 are plotted in Figure 4 with the applied load. At the ultimate failure load of 40 kips, a maximum strain of 2530 $\mu\text{in./in.}$ was measured at SG4 in the center of the specimen and a minimum strain of 1944 $\mu\text{in./in.}$ was measured at SG2. Examination of the specimen after testing to failure showed bearing damage at all three bolt hole locations in the composite sandwich specimen. A photograph indicating the bearing damage is given in Figure 5. Later inspection of the specimen also revealed a confined area of delamination in the composite laminate, in the neck down region to the grip end.

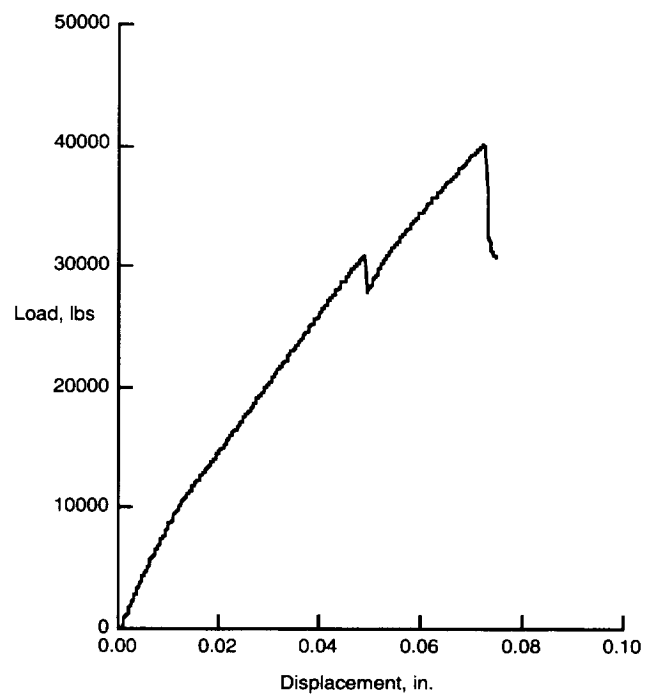
Figure 2. Load versus displacement for the room temperature single-row joint test.

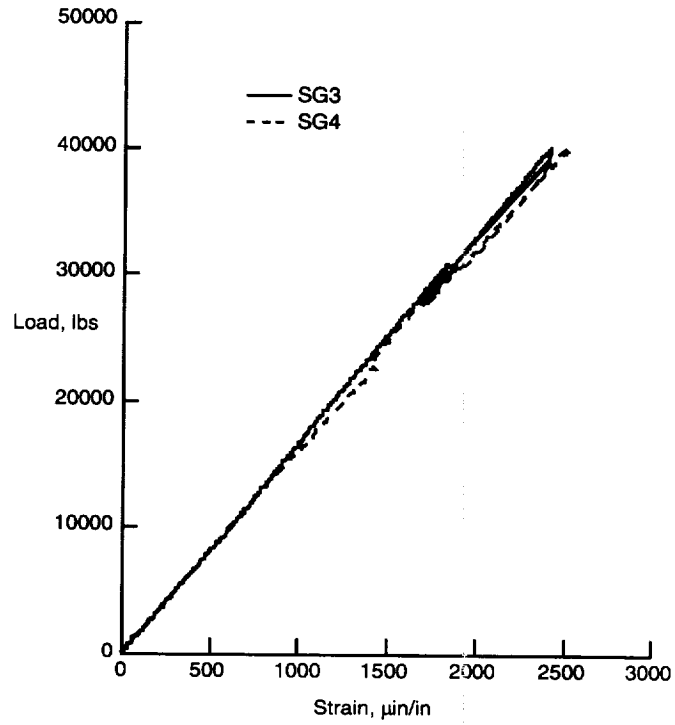
Figure 3. Back-to-back measured strains at the center of the room temperature joint specimen.

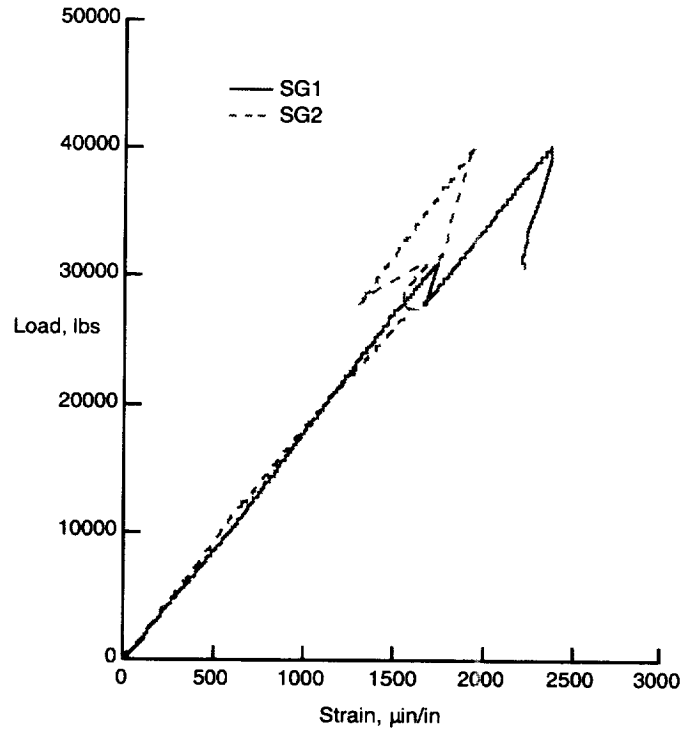
Figure 4. Measured strains from strain gauges SG1 and SG2 of the room temperature joint specimen.

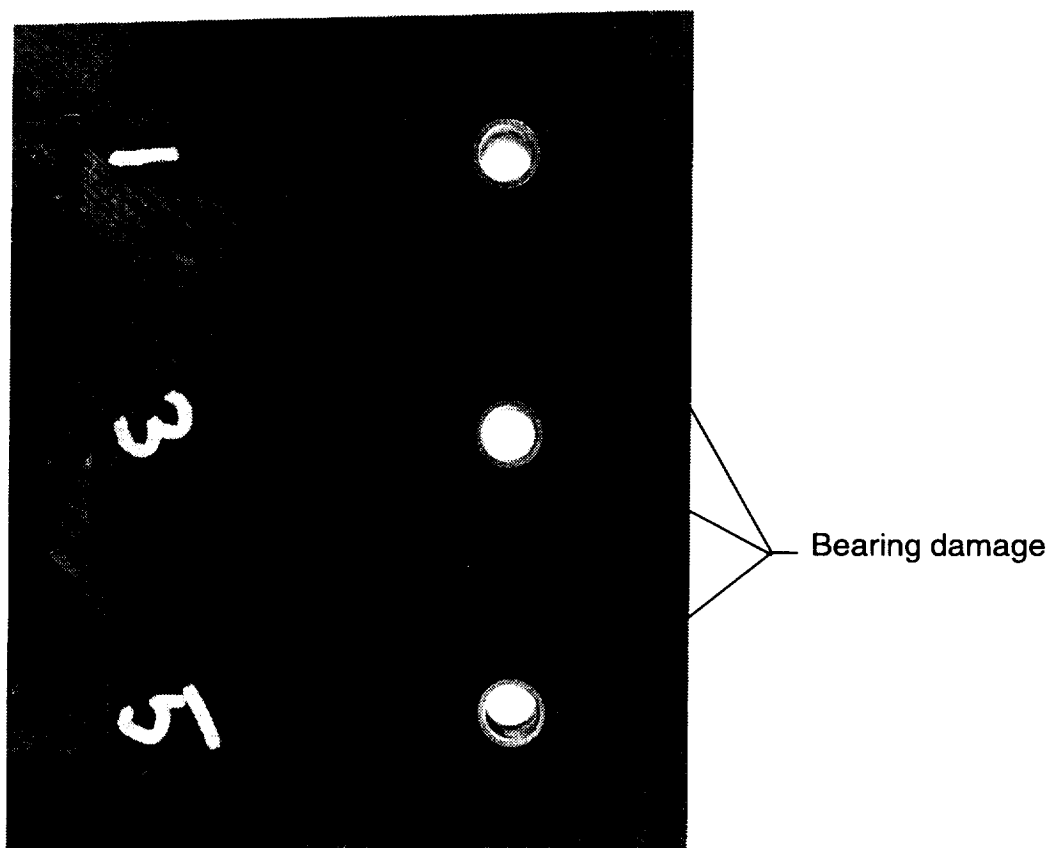
Figure 5. Single-row joint Specimen 1 after testing to failure.

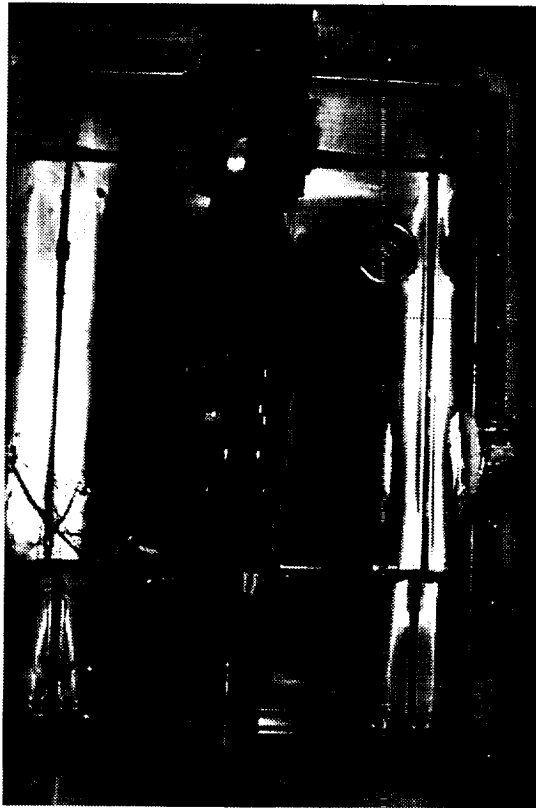
Figure 6. Single-row joint specimen mounted in test machine for elevated temperature testing.

The elevated temperature specimens were modified to allow for a pinned connection to introduce the load and use of an existing oven in the 110 kip test machine. A one inch diameter hole was drilled in the center on the composite grip end tab and a 1.25 inch diameter hole was drilled in the metallic grip end tab to allow for the pin connections on each specimen. The oven enclosed both the specimen and fixturing as shown in Figure 6. Prior to heating the specimen in the oven, coupon samples of the fiberglass material that was bonded to the composite grip ends were heated in an oven to 350°F. The fiberglass is used to protect the composite from damage when hydraulic grips are used and there were concerns that the fiberglass material might burn at this test temperature. No material changes were observed when the fiberglass coupons were heated nor when the joint specimens with the fiberglass tabs bonded to the composite material were heated. Eight thermocouples were mounted on the composite specimen, four on each facesheet. The specimens were heated to approximately 350°F while the test machine maintained a load of approximately 200 lbs on the specimens. Temperature variations were minimal and all temperature measurements ranged between 348°F and 354°F on the specimen throughout the duration of the test. When the desired temperatures were reached, the specimen was loaded using a displacement rate of 0.01 in/min. The load-displacement diagram and strain measurements are given in Figures 7-9 for Specimen 2 and Figures 10-12 for Specimen 3. Of the two specimens tested at 350°F, Specimen 2 failed at an ultimate load of 26 kips and Specimen 3 failed at 24 kips. Unlike the room temperature specimen tested, the elevated temperature tests reached an ultimate failure load without any prior load reductions. The ultimate strain measurements ranged from 1641 $\mu\text{in./in.}$ at the center gauge SG4 to 1354 $\mu\text{in./in.}$ at gauge SG1 for Specimen 2 and from 1560 $\mu\text{in./in.}$ at the center gauge SG3 to 1288 $\mu\text{in./in.}$ at SG6 for Specimen 3. Also, unlike the room temperature test where all three bolt hole locations displayed bearing damage, both elevated temperature specimens showed significant bearing damage only at the center and one side bolt hole with almost no visible bearing damage at the third bolt hole location. A non-uniform distribution of the load between fasteners would partially attribute to the strength reduction for the elevated temperature test specimens.

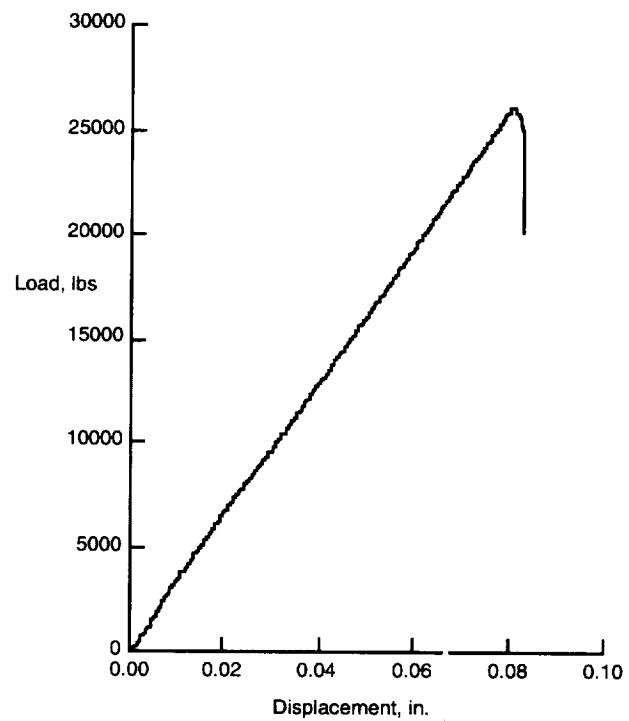
Figure 7. Load versus displacement for Specimen 2 tested at 350°F.

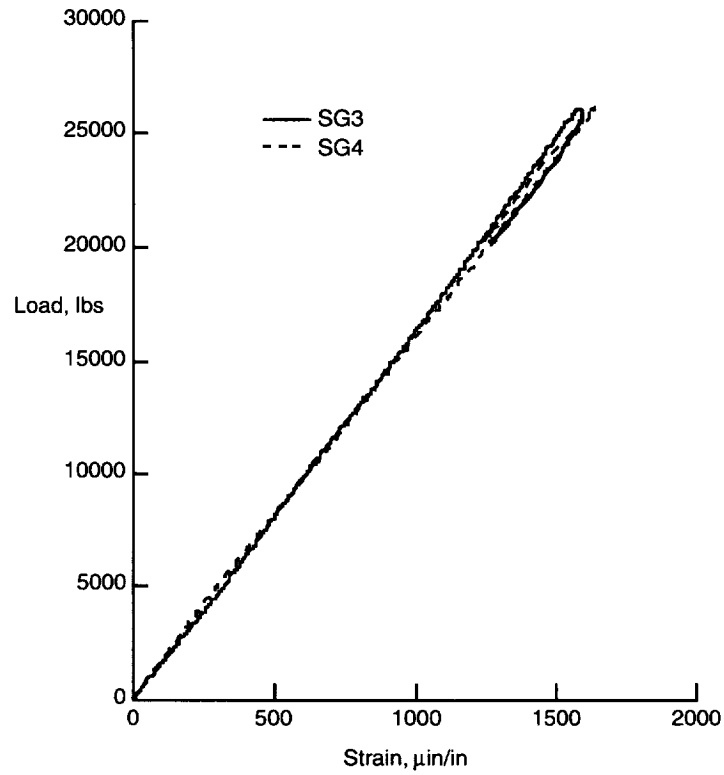
Figure 8. Back-to-back measured strains at the center of Specimen 2 tested at 350°F.

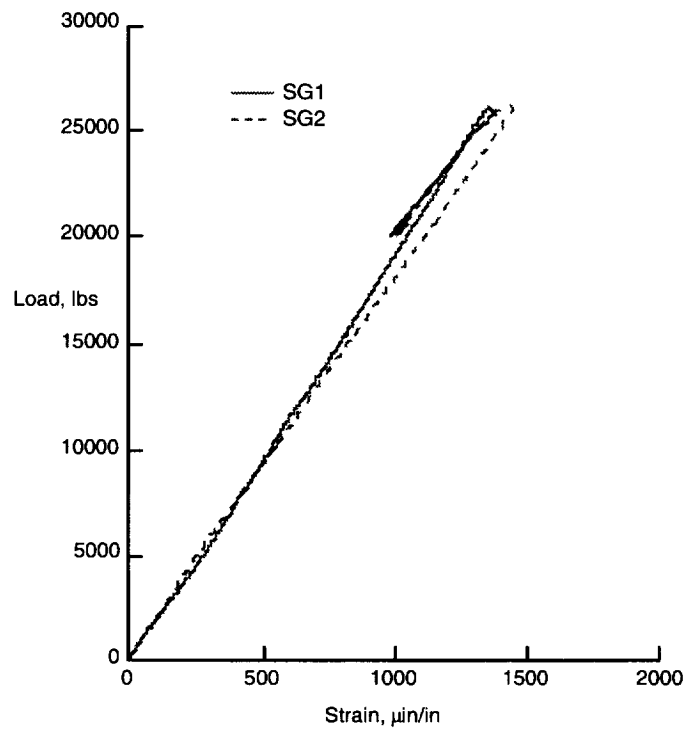
Figure 9. Measured strains from strain gauges SG1 and SG2 on Specimen 2 tested at 350°F.

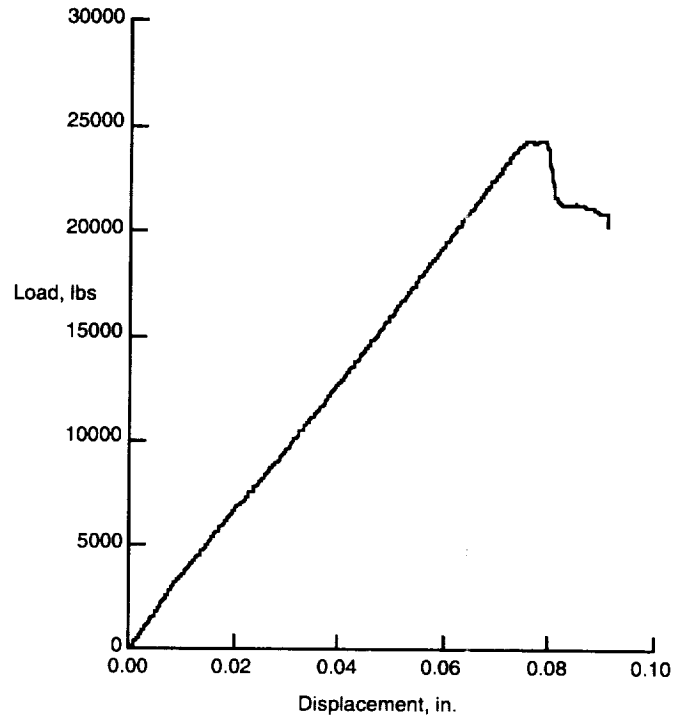
Figure 10. Load versus displacement for Specimen 3 tested at 350°F.

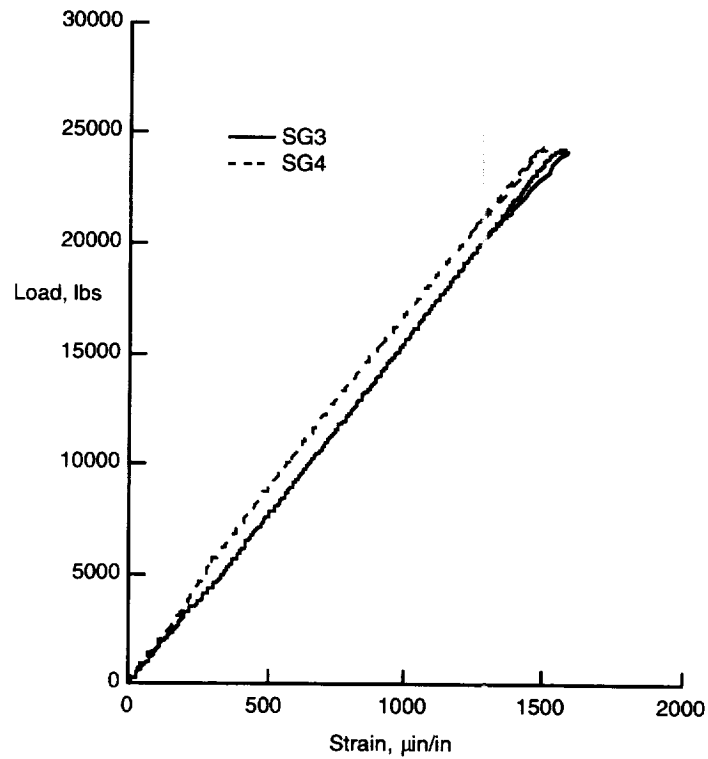
Figure 11. Back-to-back measured strains at the center of Specimen 3 tested at 350°F.

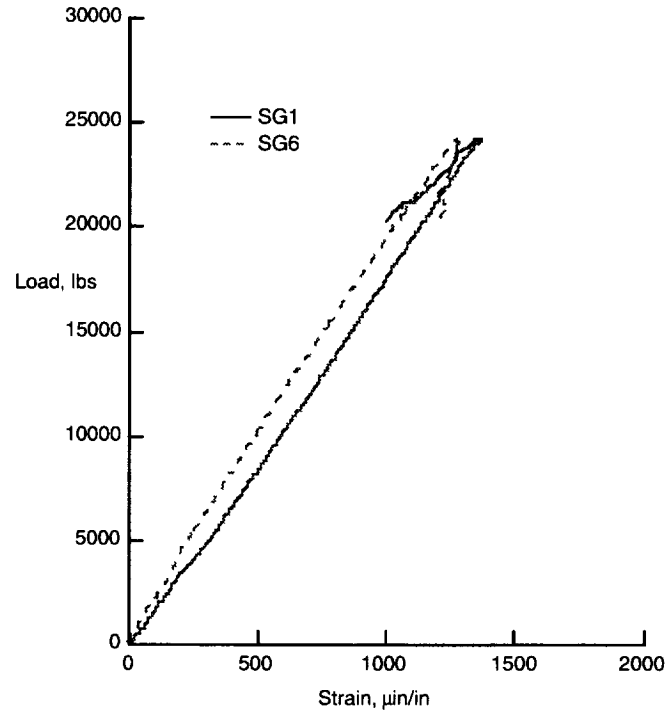
Figure 12. Measured strains from strain gauges SG1 and SG6 on Specimen 3 tested at 350°F.

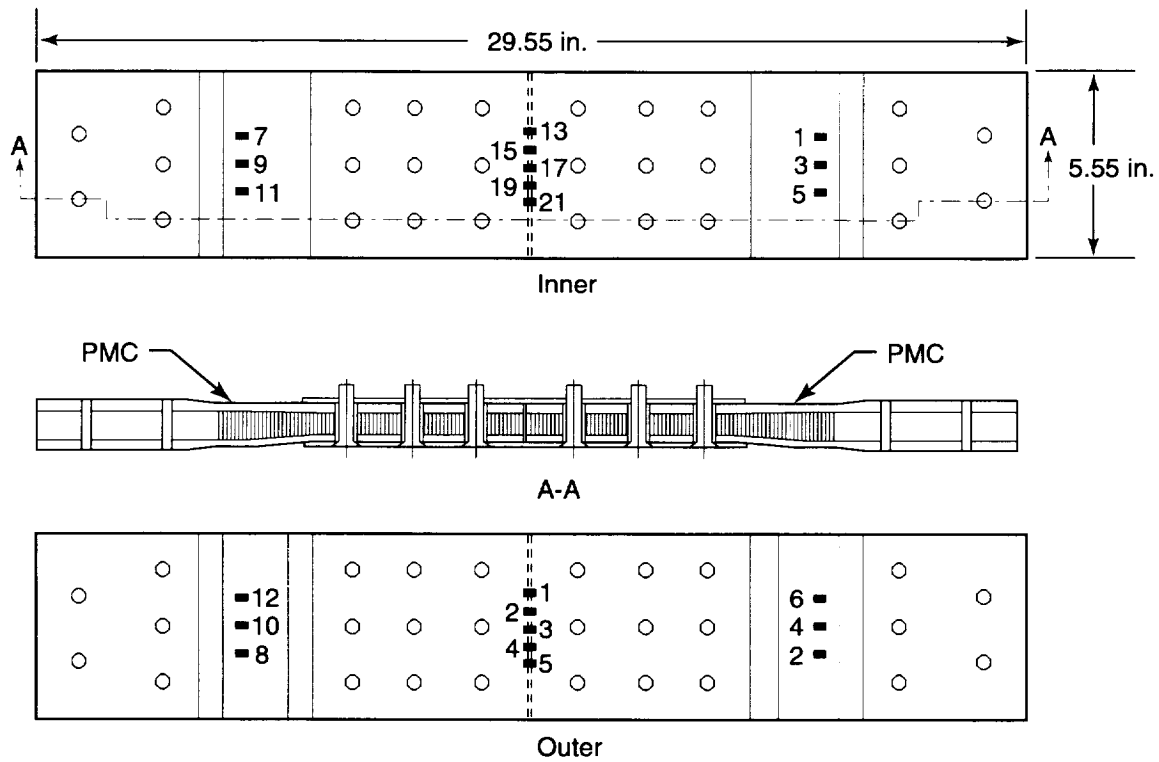
Figure 13. Schematic drawing of PMC to PMC multi-row joint specimen including strain gauge locations.

to be tested in static tension and the remaining two were to be tested in fatigue. A sketch of a PMC to PMC joint specimen and a sketch of a PMC to SPF/DB specimen, including strain gauge locations, are given in Figures 13 and 14, respectively. As can be observed in the figures, both joining components were tapered down under the outer splice plate to provide a smooth aerodynamic surface between the splice plate and joining components. On the inner (spar) side, the PMC to PMC specimen was designed with a flat inner splice plate and the PMC to SPF/DB specimen had a tapered T-section inner splice plate. The tapering splice plate design was included to provide a more uniform fastener load distribution. A photograph of the two specimens is shown in Figure 15 where a top view (outer wing surface side) of a PMC to PMC specimen and a bottom view (wing spar side) of a PMC to SPF/DB specimen are shown.

The PMC to PMC specimens were instrumented with 22 back-to-back strain gauges as shown in Figure 13. On each side, five gauges were located across the center of the splice plates and three were located on each composite sandwich about 1.5 inches from the edge of the splice plate. The PMC to SPF/DB specimens had a total of 17 strain gauges as shown in Figure 14. On the outer splice plate, five gauges were located across the center as on the PMC to PMC specimen. Three back-to-back gauges were located on the PMC sandwich about 2 inches from the edge of the splice plate. On the SPF/DB component, four gauges were located on the outer surface and two on the inner surface. The two back-to-back gauges were located 0.4 inch from the edge of the splice plate and the other two gauges on the outer surface were located about 2.5 inches from the splice plate.

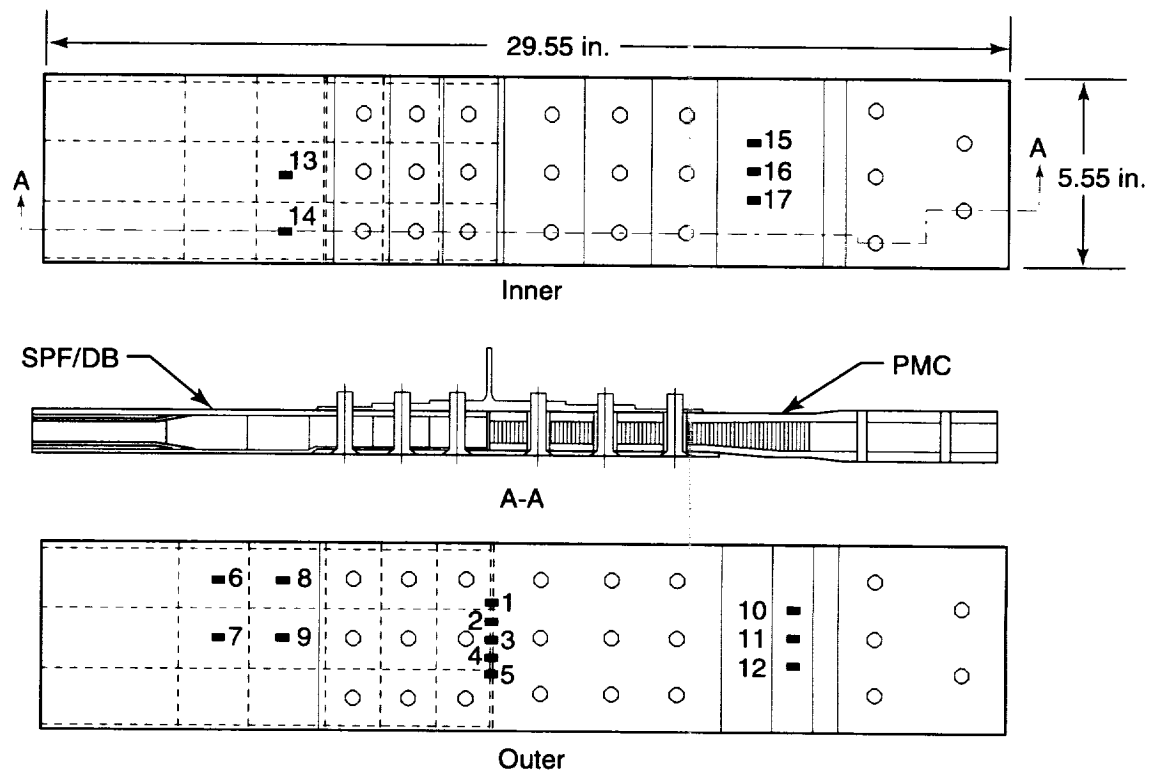
Figure 14. Schematic drawing of PMC to SPF/DB multi-row joint specimen including strain gauge locations.

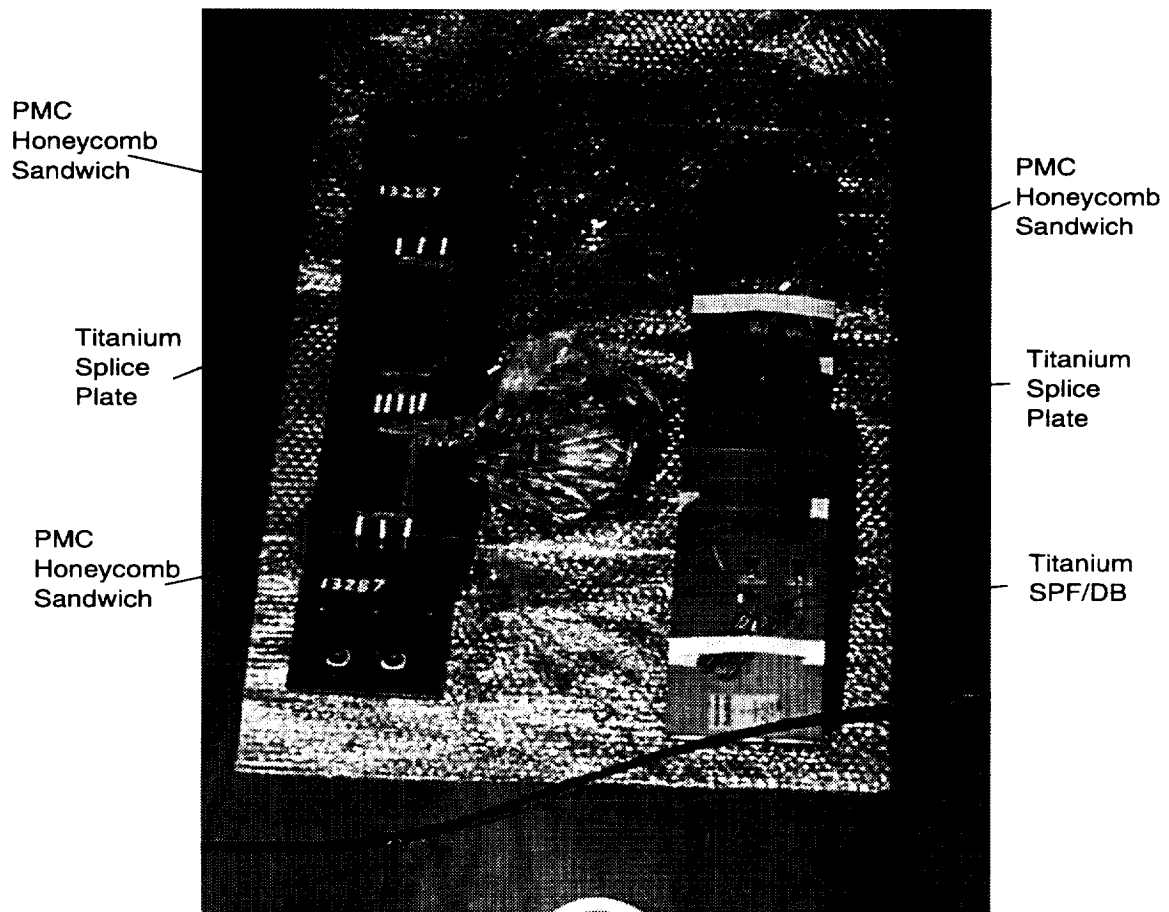
Figure 15. Multi-row joint test specimens.

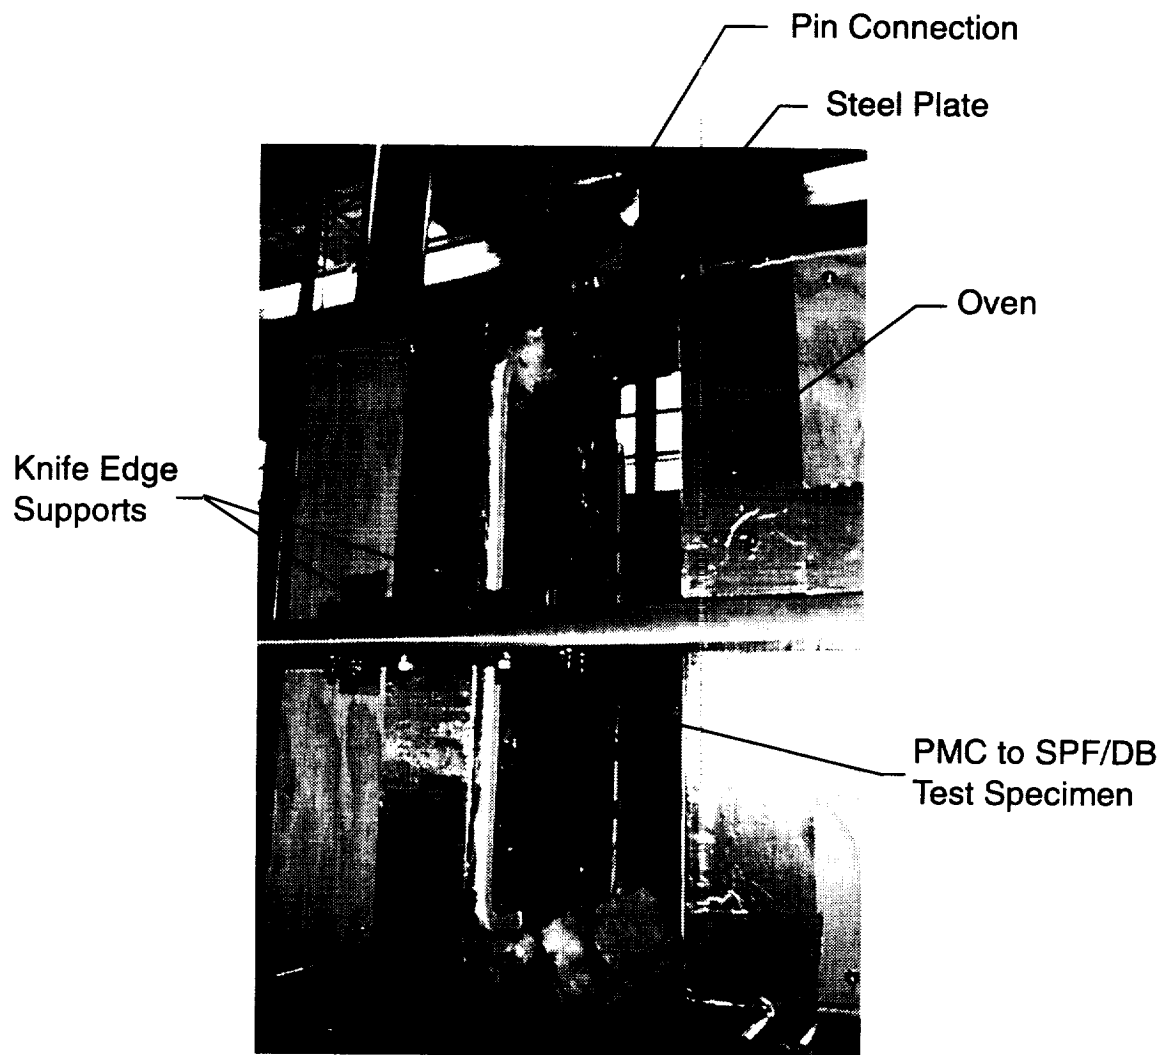
Figure 16. Multi-row joint static tension testing configuration.

All four static tension tests were conducted using the same fixtures for connecting the test specimen to the 220 kip test machine. A photograph of one of the PMC to SPF/DB specimens mounted in the test machine is shown in Figure 16. The specimen fixtures were designed and fabricated at NASA Langley Research Center. Two steel plates are attached on each end of the specimen by five steel 0.5 inch diameter bolts. The steel plates are also attached to the test fixture through a pin connection on each end as pointed out in Figure 16. Back-to-back horizontal knife edge supports are used to prevent out-of-plane displacement along the centerline of the test specimen while it is being loaded in tension. Without this constraint, there would be significant out-of-plane motion under tensile loads due to eccentricities in the specimen as was revealed by a finite element analysis of the test specimen.¹

For the elevated temperature tests, a Thermatron heater was used to blow hot air through a duct and into an oven that was built to enclose the specimen. The oven box along with a specimen mounted in the test fixture can be seen in Figure 16. The specimens were heated while the test machine maintained a preset load of approximately 100 lbs. Six back-to-back thermocouples were located on the specimen and monitored during heating until a nearly uniform temperature of 350°F was reached. Once acceptable temperatures were achieved, load was applied to the specimens at the displacement rate of 0.04 in./min. During the application of the load to the specimens, the temperatures ranged from 342°F to 352°F on the PMC to PMC joint specimen and from 344°F to 350°F on the SPF/DB to PMC joint specimen. The load-displacement diagram for the PMC to PMC specimen tested at 350°F is given in Figure 26. After an ultimate load of 110 kips was achieved, a 25% increase in the displacement was observed as the load slightly dropped. The specimen was then considered failed and the applied load was removed. Examination of the specimen after testing revealed a slight bending in the splice plates, apparently due to fastener bending. Removal of the splice plates showed significant bearing damage in the composite sandwich as can be viewed in Figure

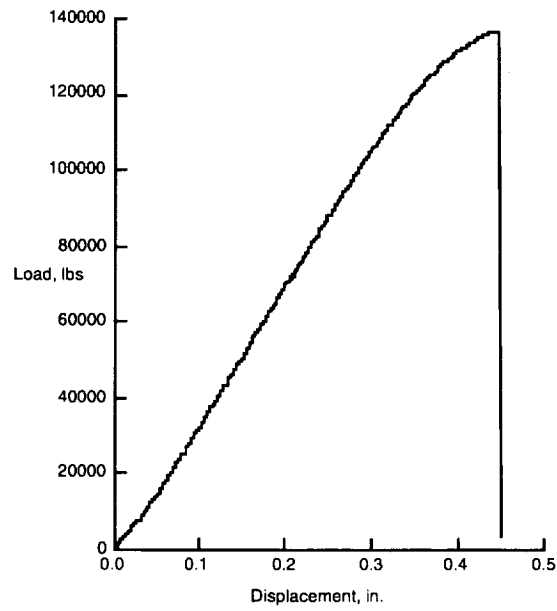
Figure 17. Load versus displacement of the PMC to PMC joint specimen tested at room temperature.

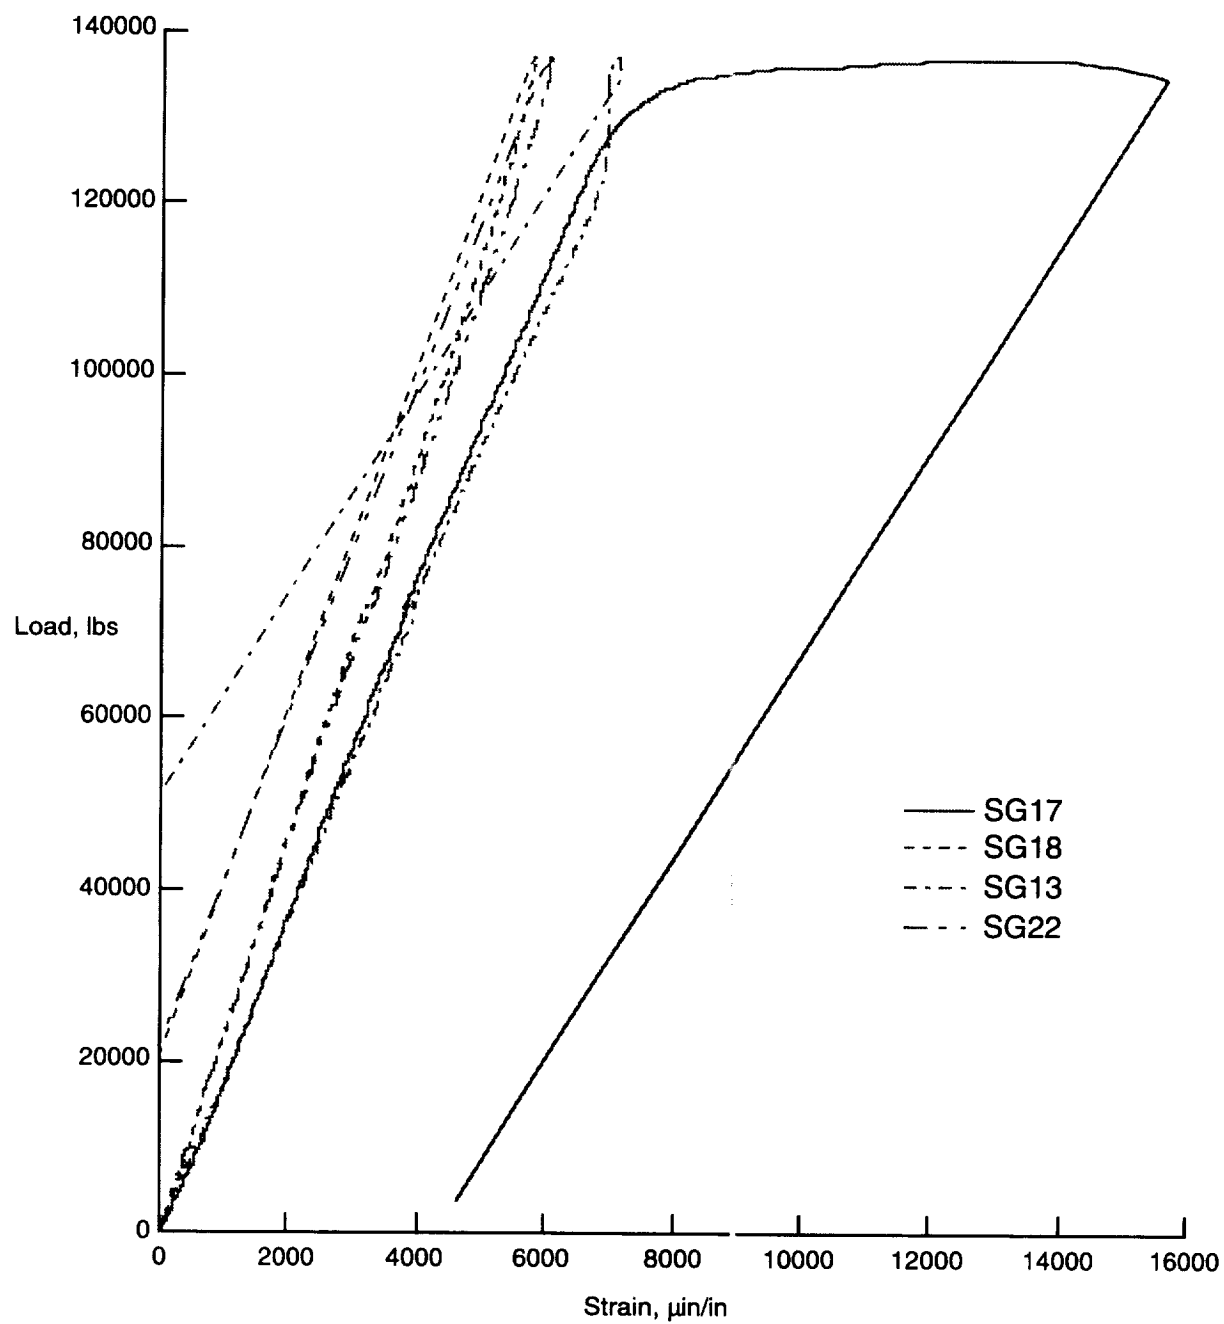
Figure 19. Strains measured at the center of the splice plate for the PMC to PMC joint specimen tested at room temperature.

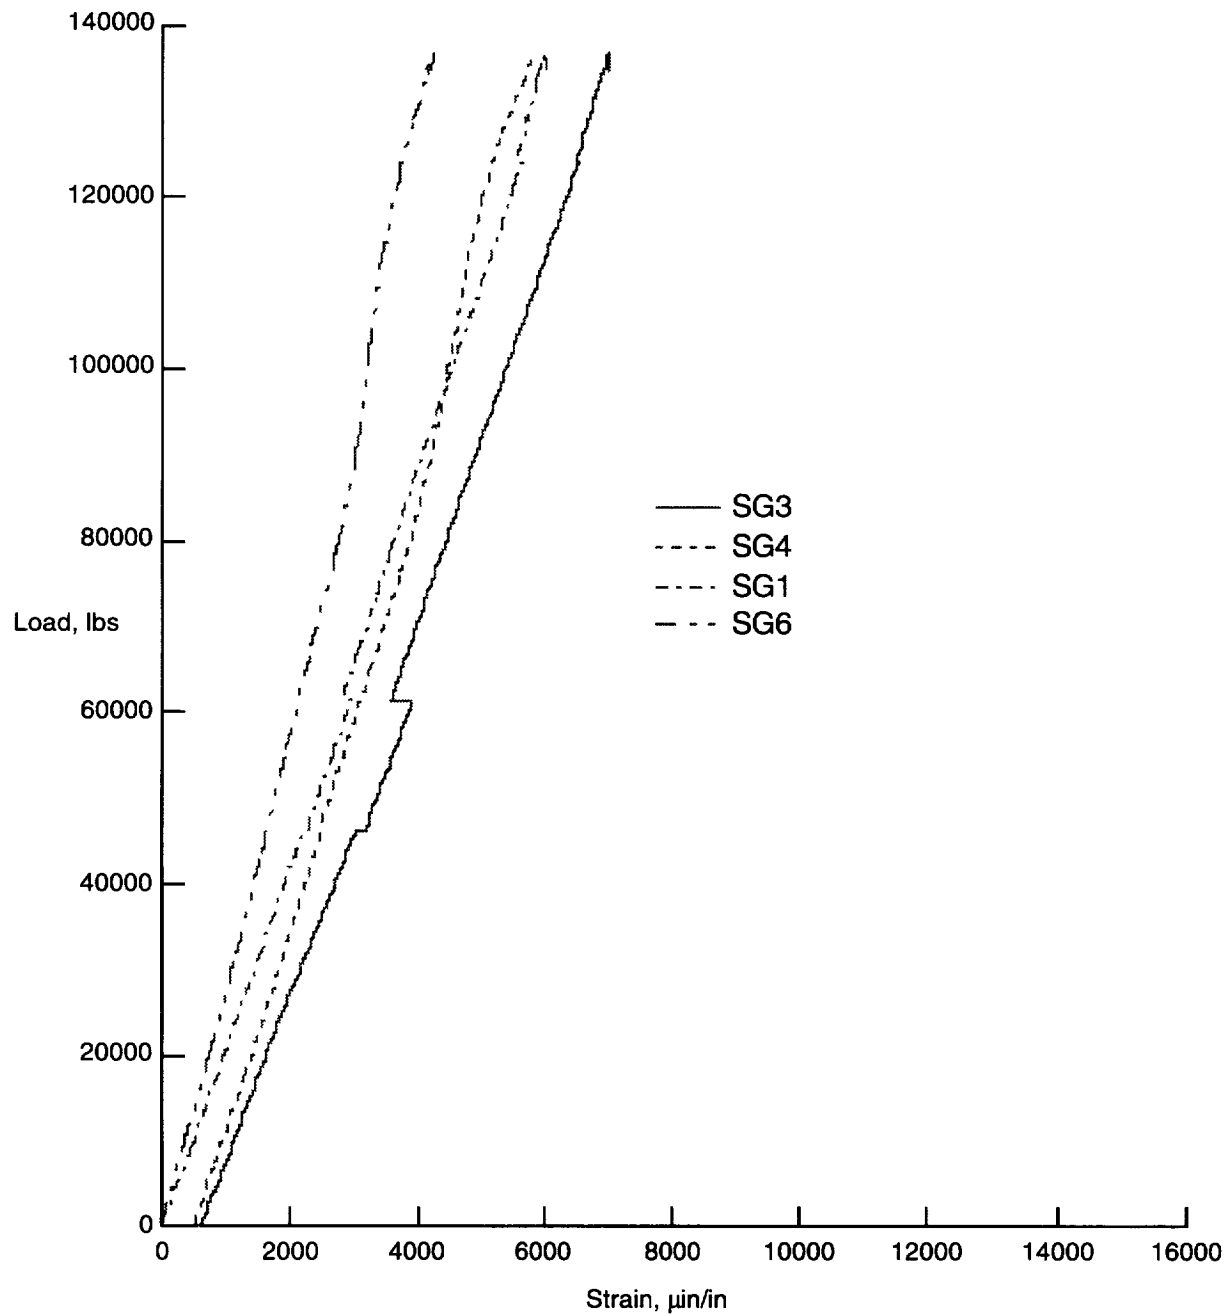
Figure 20. Strains measured on the composite sandwich for the PMC to PMC specimen tested at room temperature.

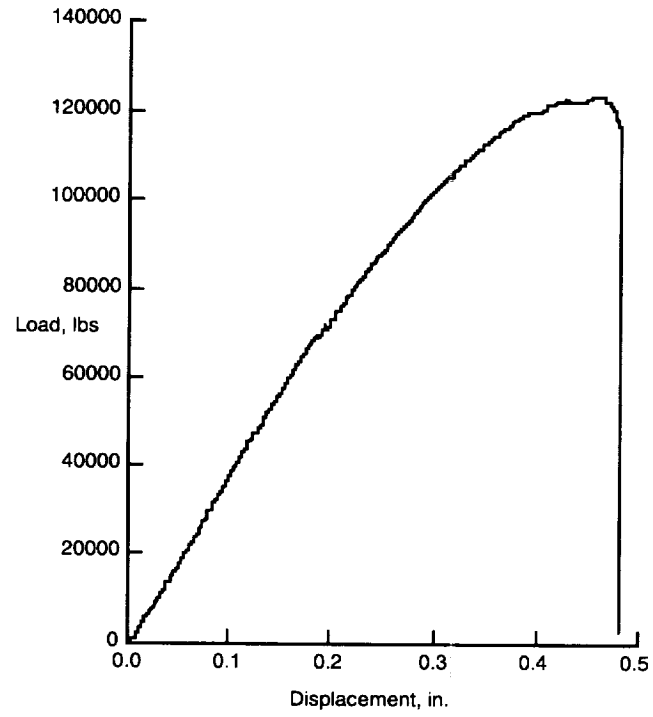
Figure 21. Load versus displacement for the PMC to SPF/DB joint specimen tested at room temperature.

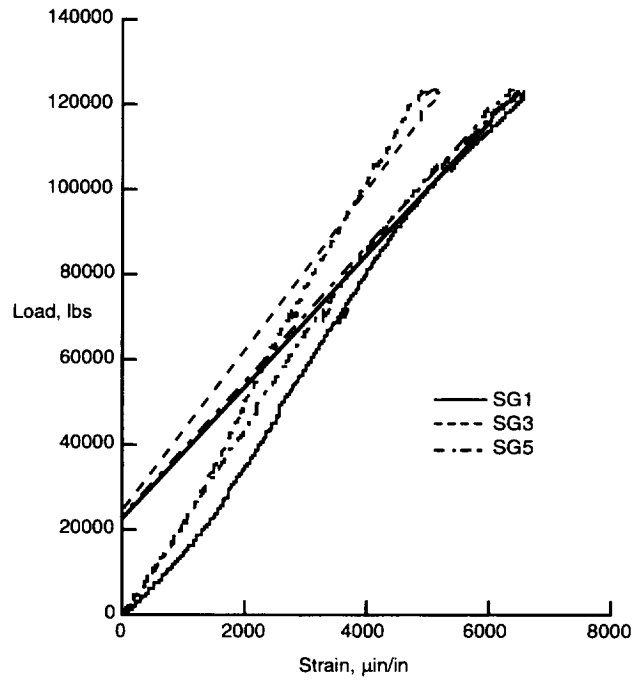
Figure 23. Strains measured at center of top splice plate for the PMC to SPF/DB joint specimen tested at room temperature.

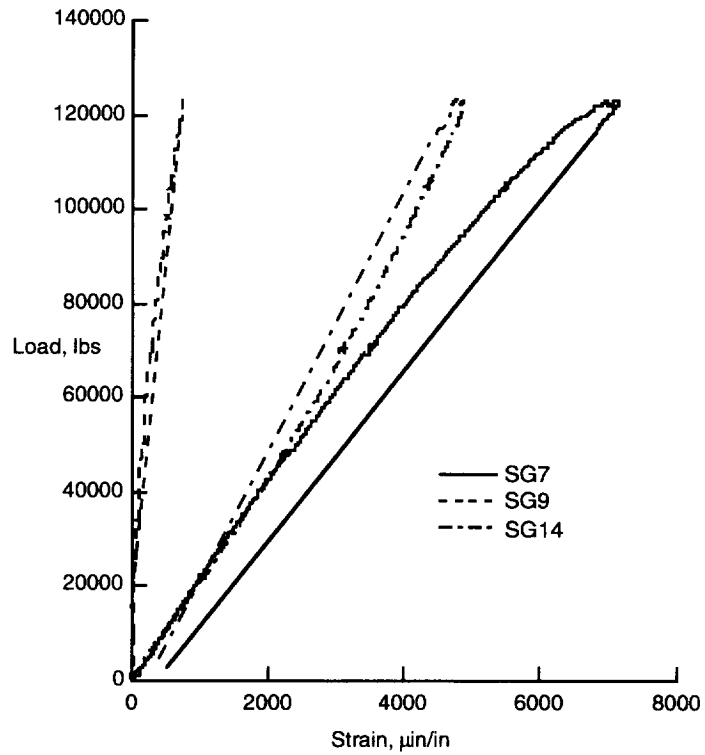
Figure 24. Strains measured on the SPF/DB component for the PMC to SPF/DB joint specimen tested at room temperature.

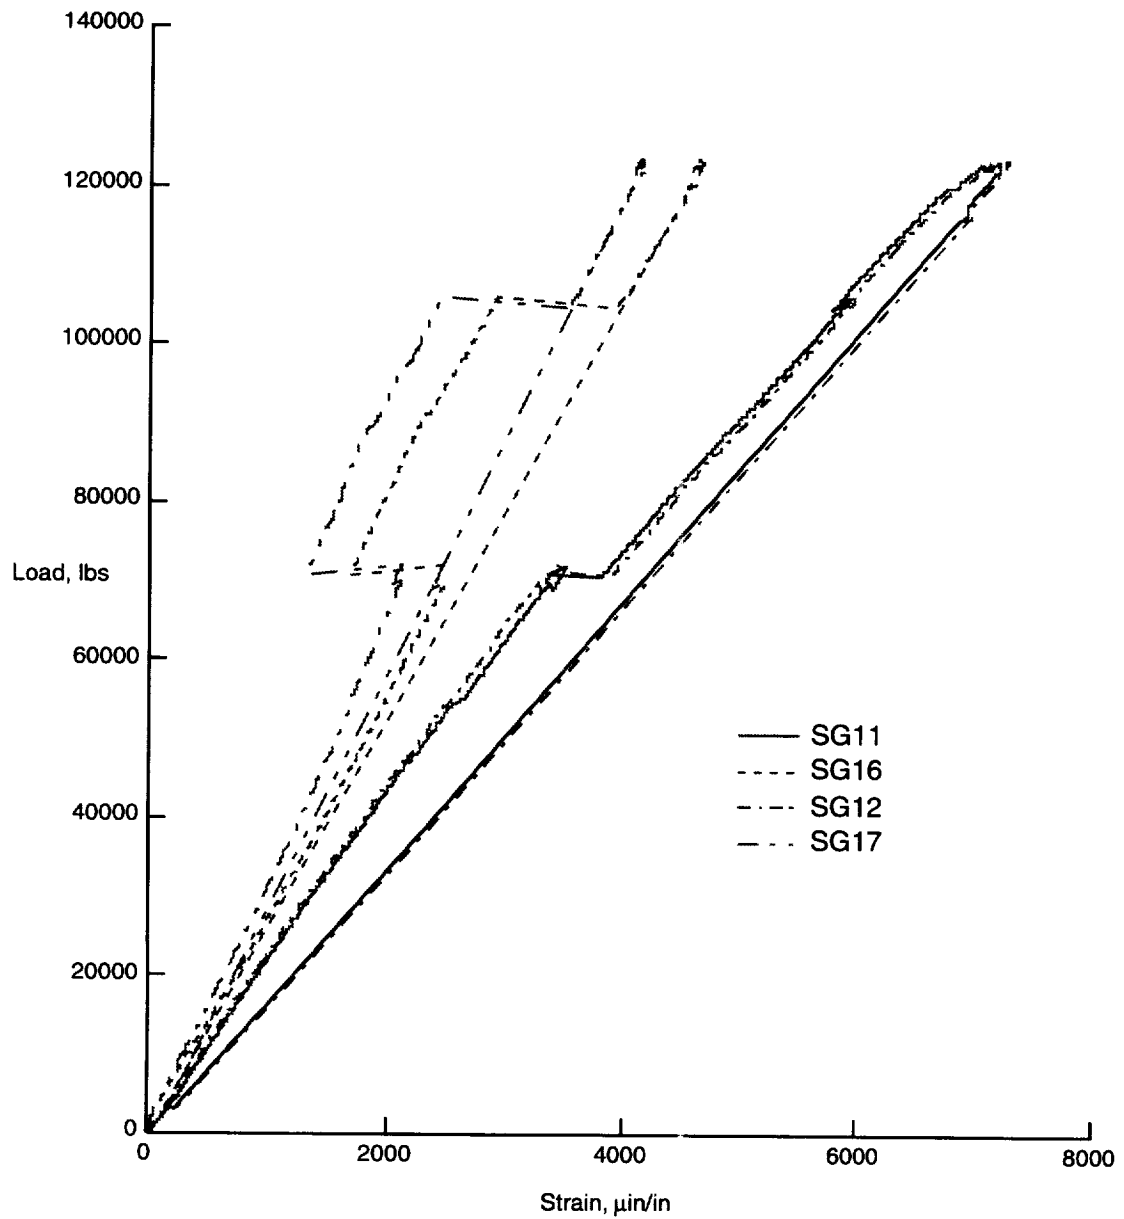
Figure 25. Strains measured on the PMC sandwich component for the PMC to SPF/DB joint specimen tested at room temperature.

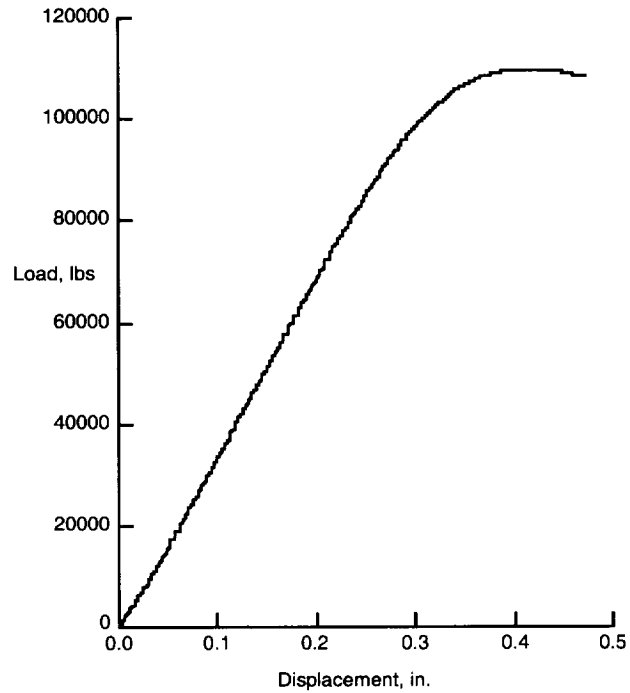
Figure 26. Load versus displacement for the PMC to PMC joint specimen tested at 350°F.

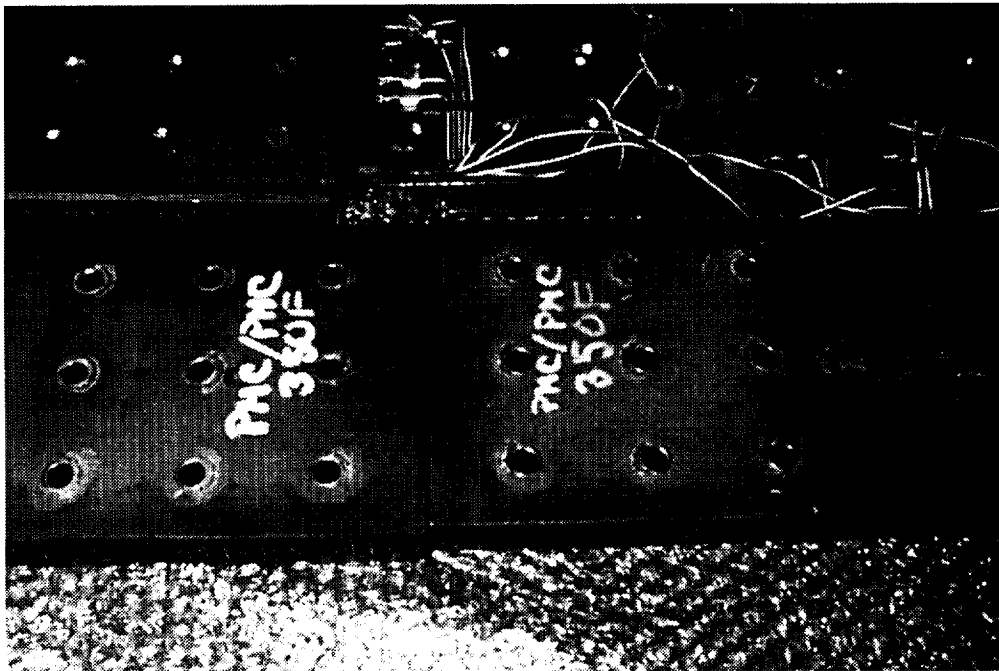
Figure 27. PMC to PMC joint specimen after testing at 350°F and having the splice plates removed for examination of the composite sandwich components.

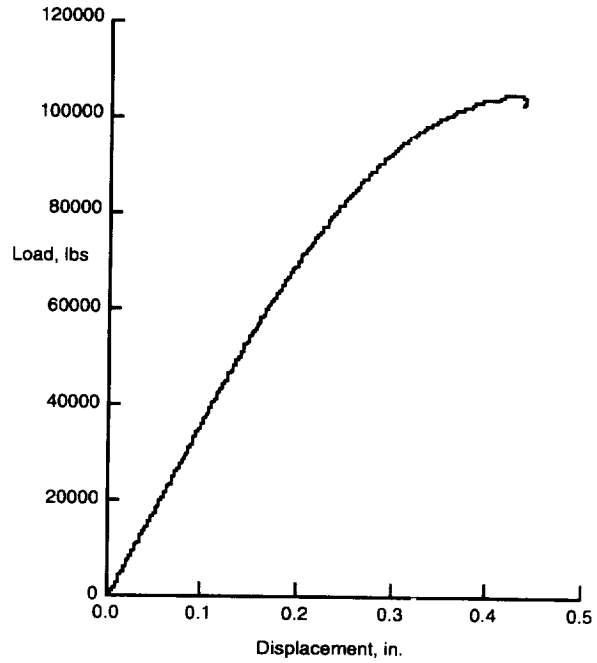
Figure 28. Load versus displacement for the PMC to SPF/DB joint specimen tested at 350°F.

27. The load-displacement diagram for the PMC to SPF/DB joint specimen tested at 350°F is given in Figure 28. An ultimate load of 105 kips was achieved before the inner splice plate experienced a tension failure at the outer row of fasteners as shown in Figure 29. The appearance of the failed specimen was very similar to the room temperature specimen which also experienced a tension failure of the inner splice plate. After removal of the splice plate, examination of the specimen tested at 350°F showed severe bearing damage in the composite sandwich.

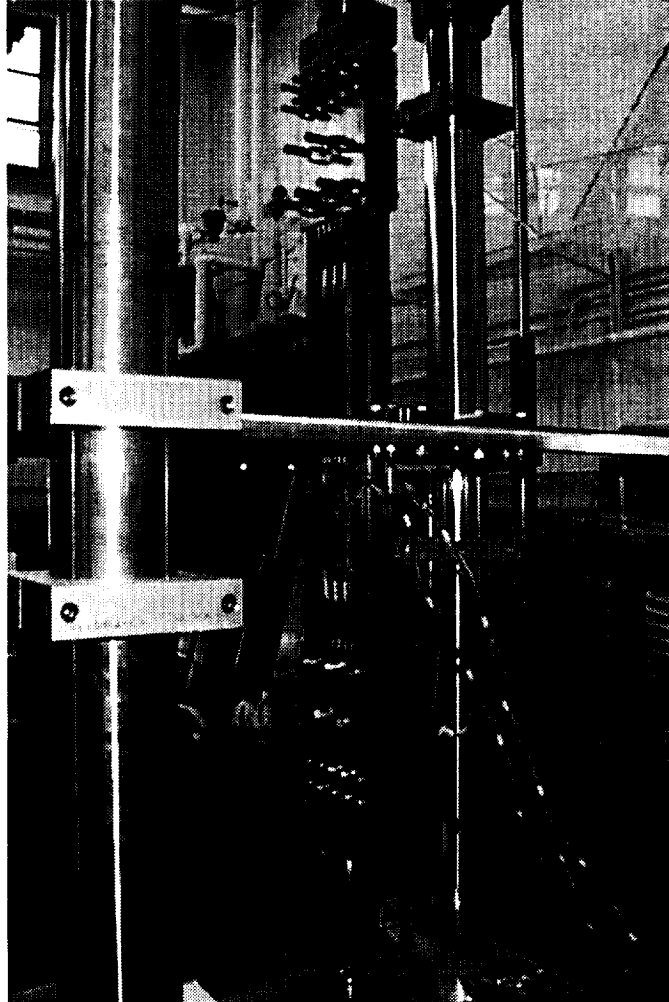
Figure 30. PMC to PMC joint specimen mounted in test machine for fatigue testing.

The fatigue tests were conducted in the same 220 kip test machine as the static tests. A photograph of the PMC to PMC joint specimen mounted in the test machine is shown in Figure 30. The fixture connecting the specimen to the test machine is shown in the figure. It consisted of back-to-back steel splice plates connected to another steel end fitting in a multifastener arrangement on each end of the specimen. This differs from the static test fixture where a pin connection was utilized. A 50 ft-lb torque was applied to each fastener used in the fixture to prevent slipping at the fixture connection.

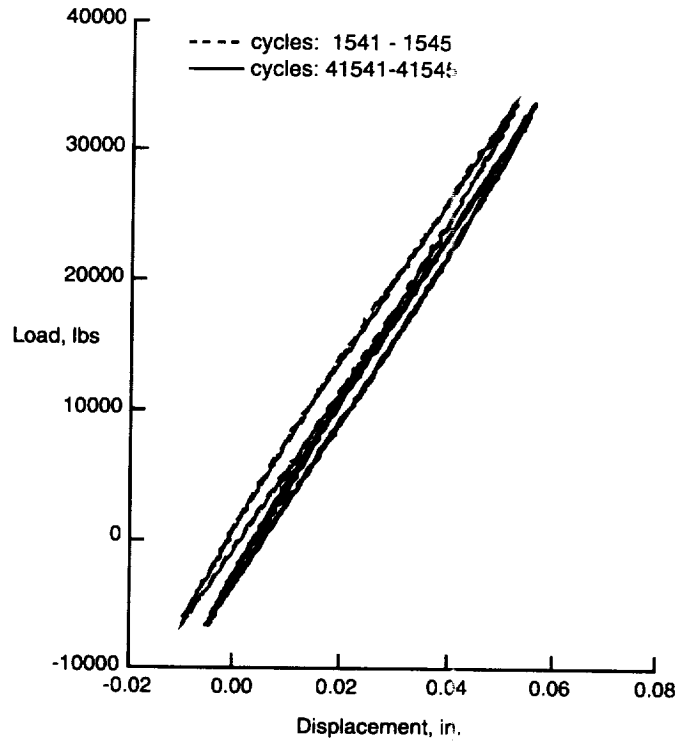
Figure 31. Load versus displacement test data for the PMC to PMC joint specimen tested under cyclic loading.
