NASA/TM-1998-208742

Room Temperature and Elevated Temperature Composite Sandwich Joint Testing

Sandra P. Walker
Langley Research Center, Hampton, Virginia

November 1998

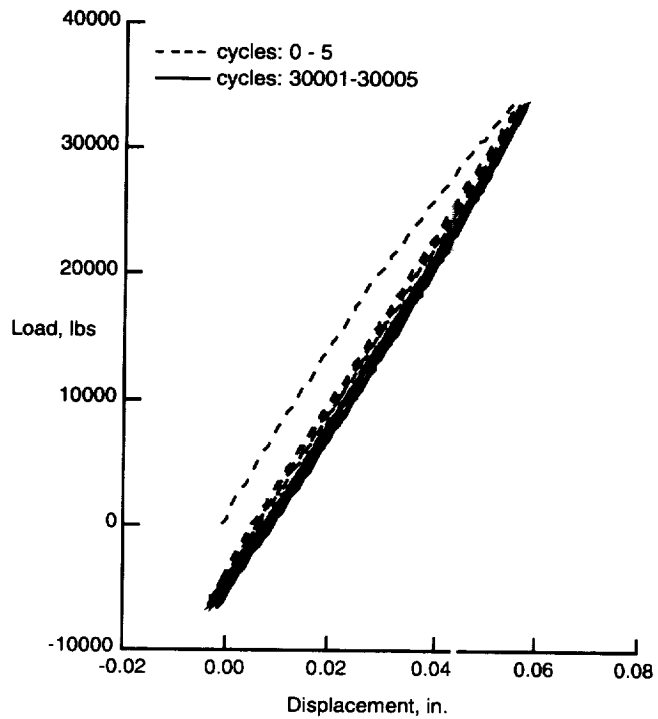
Figure 32. Load versus displacement test data for the PMC to SPF/DB joint specimen tested under cyclic loads.
