Effects of Hillslope Gully Stabilization on Erosion and Sediment Production in the Torreon Wash Watershed, New Mexico, 2009–12

Scientific Investigations Report 2018–5026

By Anne Marie Matherne, Anne C. Tillery, and Kyle R. Douglas-Mankin

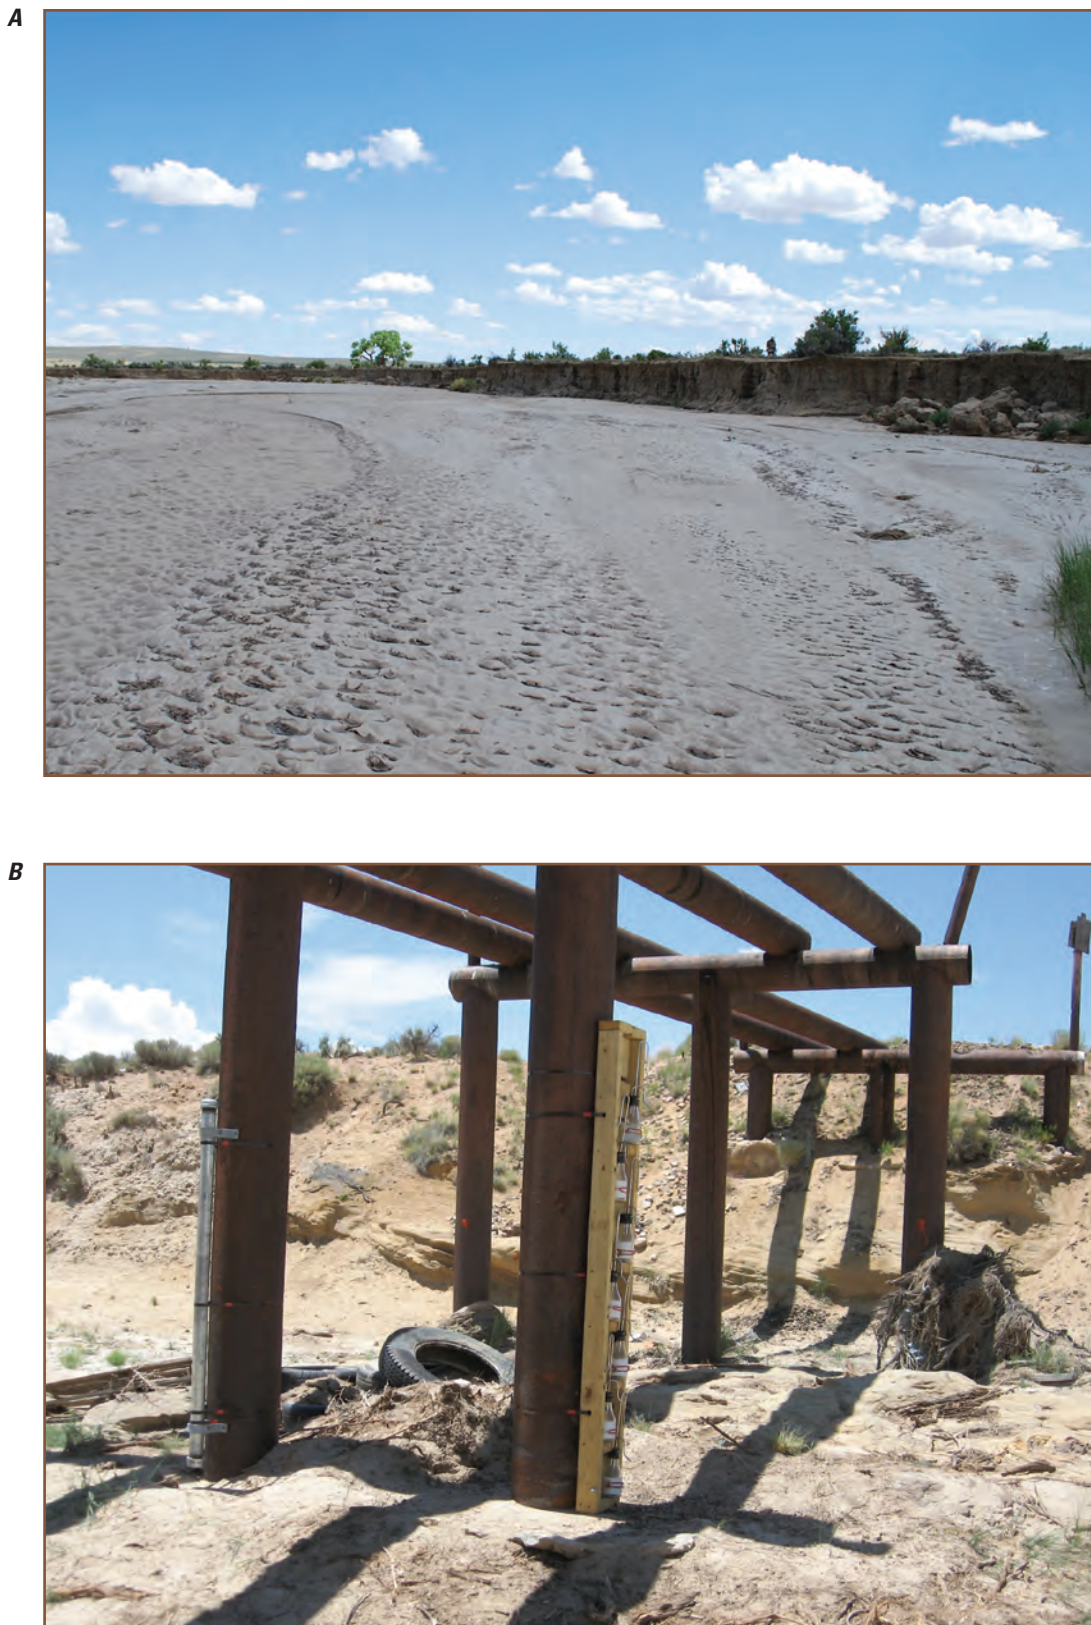
Figure 2. Typical main-stem channel morphology in the Torreon Wash watershed including incised and shallow channels. *A*, Torreon Wash above Papers Wash, July 27, 2009. (Photograph by Ellen Soles.) *B*, Penistaja Arroyo. Crest-stage gage and single-stage sediment sample bottles attached to bridge piers are shown, July 24, 2009.

The Torreon Wash watershed is composed of Cretaceous and lower Tertiary age sandstones and shales (Love, 1986; Anderson and others, 1997), which produce easily erodible, well-drained, loamy soils (Natural Resources Conservation Service, 2013a, b). Deposits of fine windblown sands are also present over much of the Rio Puerco watershed (Norden, 1963). Elevations in the Torreon Wash watershed range from near 7,300 feet (ft) above the North American Vertical Datum of 1988 (NAVD 88) at the headwaters to about 6,100 ft at the confluence with Arroyo Chico (fig. 1). The watershed is characterized by a rolling landscape that has numerous drainages and arroyos incised into the alluvial valley fill. In some locations, Torreon Wash and its tributaries are incised to more than 30 ft below the valley surface, whereas in other reaches, such as upstream from the confluence with Papers Wash, the channel is wide, shallow, and non-incised (fig. 2A).

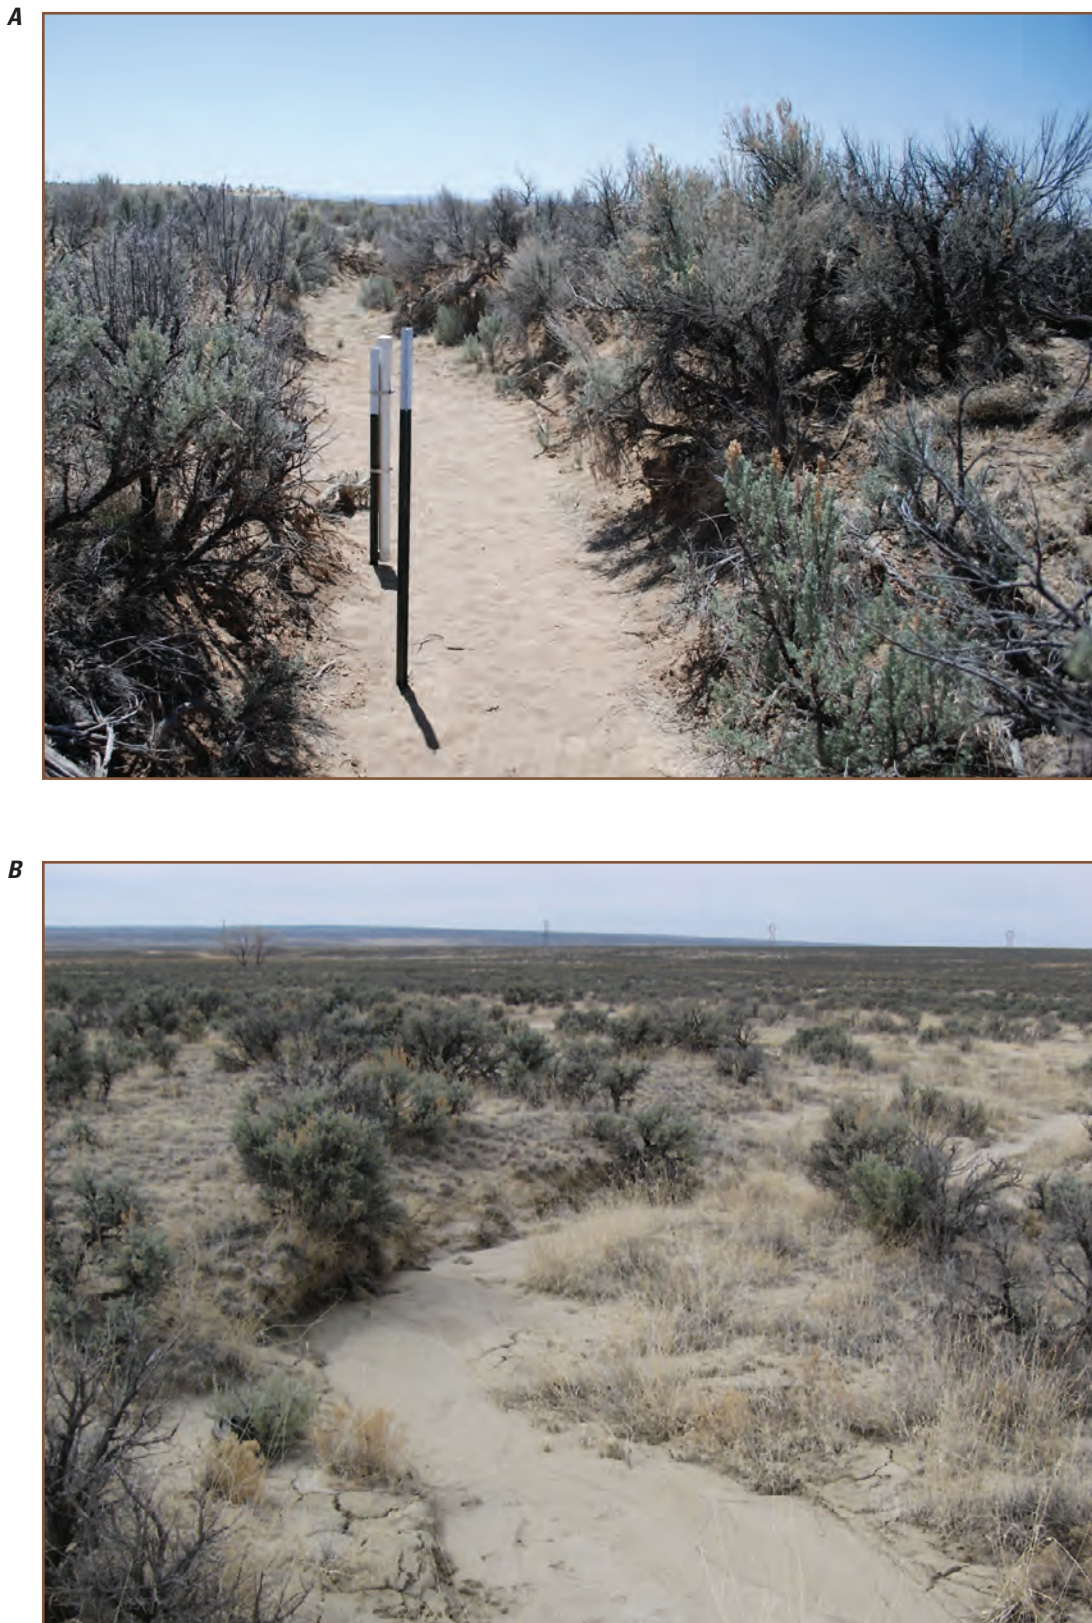
Figure 5. Channel configuration at the beginning of the study period, untreated sites. *A*, Penistaja Arroyo site. Instrumentation in channel is mini-crest-stage gage. *B*, Papers Wash site.

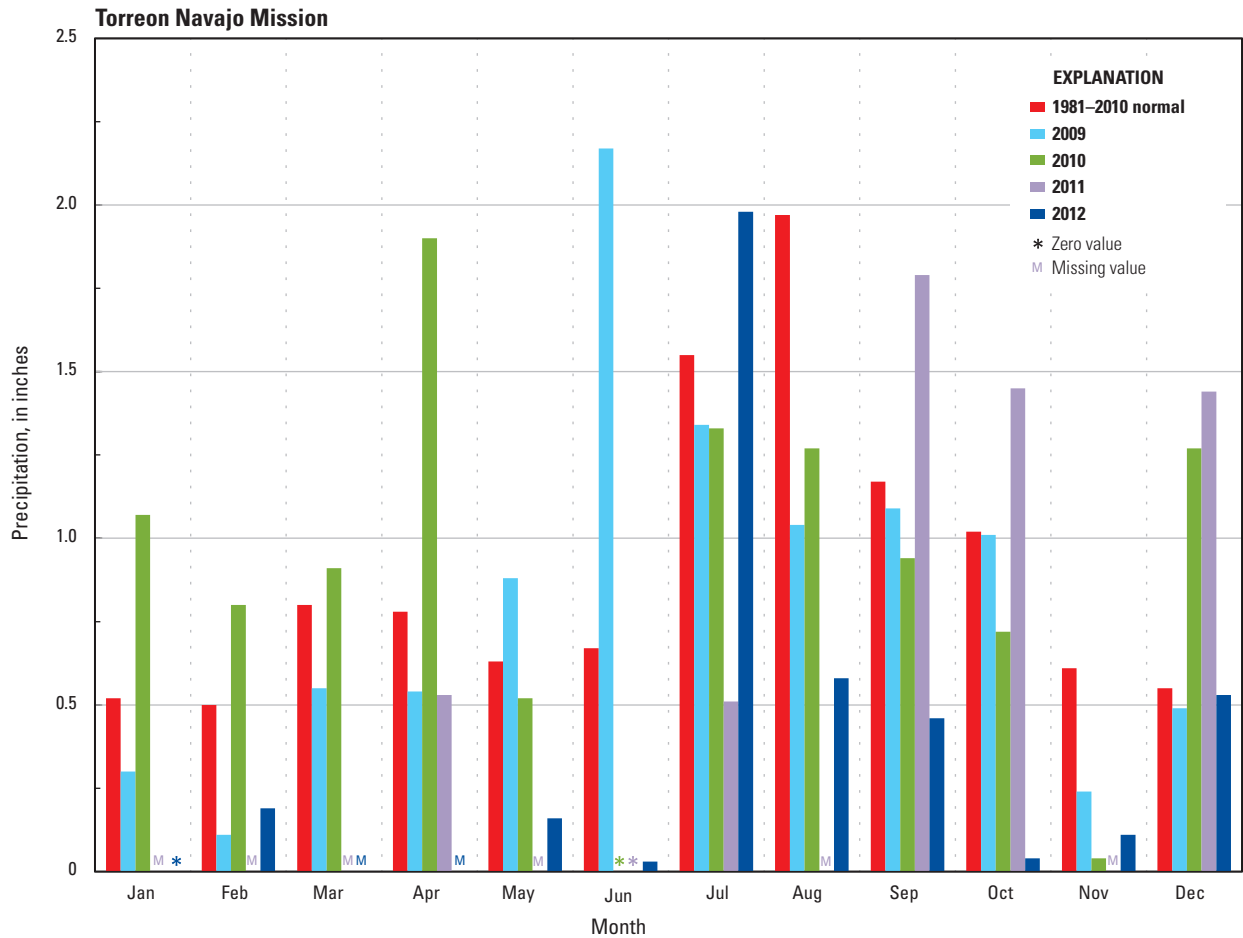
Figure 7. Monthly precipitation at Torreón Navajo Mission for the 30-year normal period 1981–2010, and for 2009, 2010, 2011, and 2012.

The 30-year normal (1981–2010) annual precipitation for Torreon Navajo Mission was 10.77 in/yr (National Climatic Data Center, 2013). Average annual precipitation in 2009 was 9.76 in., -1.01 in. below normal, and in 2010 was exactly normal at 10.77 in. There were 6 months of missing data at Torreon Navajo Mission in 2011, and 2 months of missing data in 2012, so onsite annual precipitation values were not calculated for those years. Comparison of monthly values for 2009–12 to station normals shows seasonal patterns and variability among years (fig. 7). Monthly normal values generally demonstrate the expected monsoonal precipitation pattern, with maxima in July and August (33 percent of annual rainfall), tapering through September and October (20 percent of annual rainfall). Precipitation for 2009 was below normal for all months except May and June, whereas 2010 was wetter than normal during winter and spring months (January–April and December) and drier than normal for the remaining months. For the 6 months having reported data in 2011, precipitation was below normal through July and above normal from September through December. Precipitation for 2012 was below normal for all months except July.

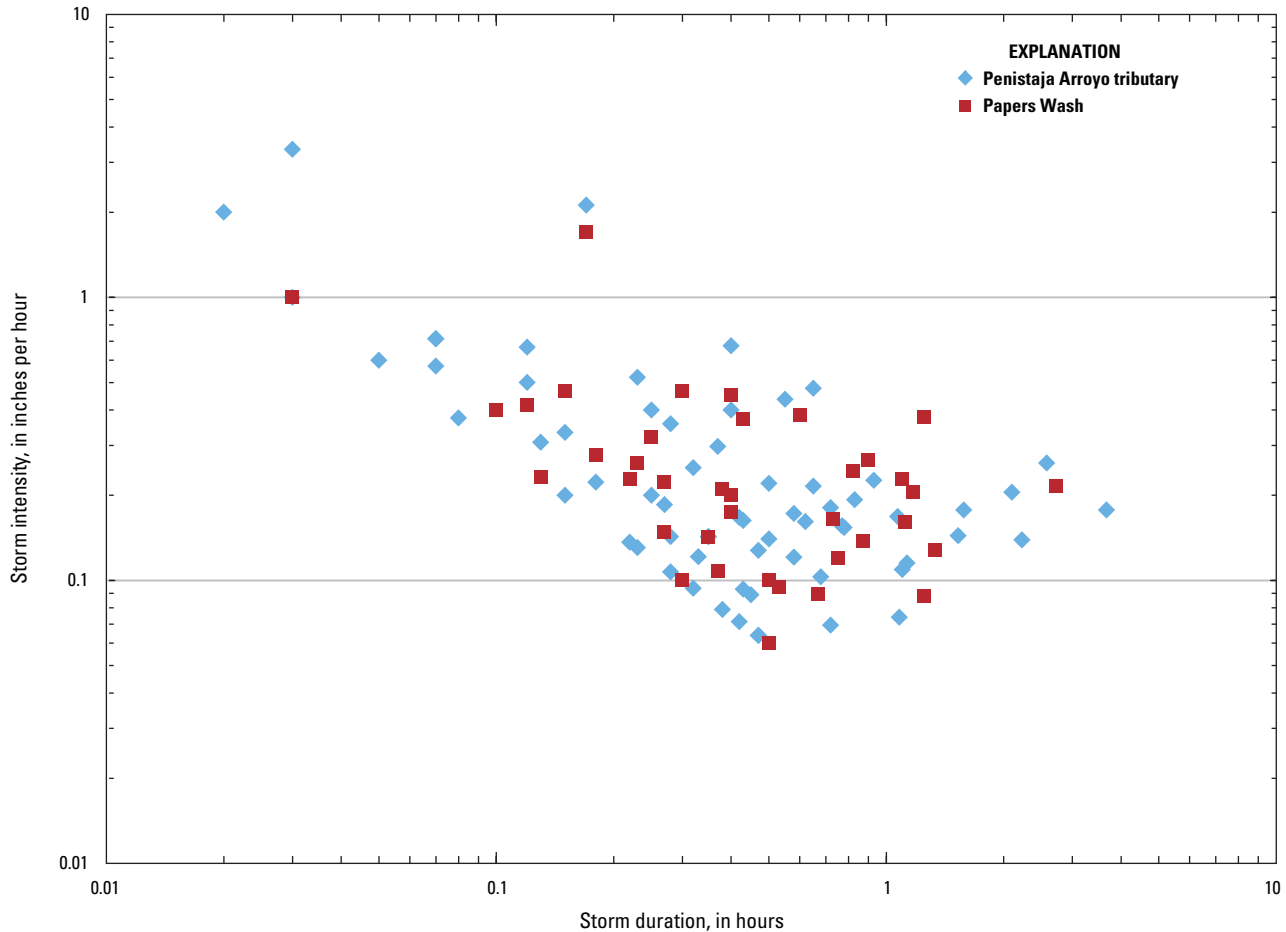
Figure 8. Storm intensity compared to storm duration at the Penistaja Arroyo and Papers Wash sites.

equal to 0.3 inch per hour (in/h), and about 85 percent at the Penistaja Arroyo site and 95 percent at the Papers Wash site were less than or equal to 0.5 in/h (fig. 8). The longer-duration events (>1 hour) recorded rainfall within an intensity range of less than 0.4 in/h. Of the few higher intensity events, most were only a few minutes in duration, with the exception of one event at both sites on June 9, 2009. On this date, 0.36 in. of precipitation was recorded at the Penistaja Arroyo site and 0.29 in. was recorded at the Papers Wash site in about 10 minutes, which is approximately a 2-year-recurrence-interval, 10-minute-duration event (0.315 in.) for the Torreón Navajo Mission station location (Bonnin and others, 2011). A more extended precipitation record would allow precipitation to be better characterized at these sites, including more events at the extremes of intensity and duration.

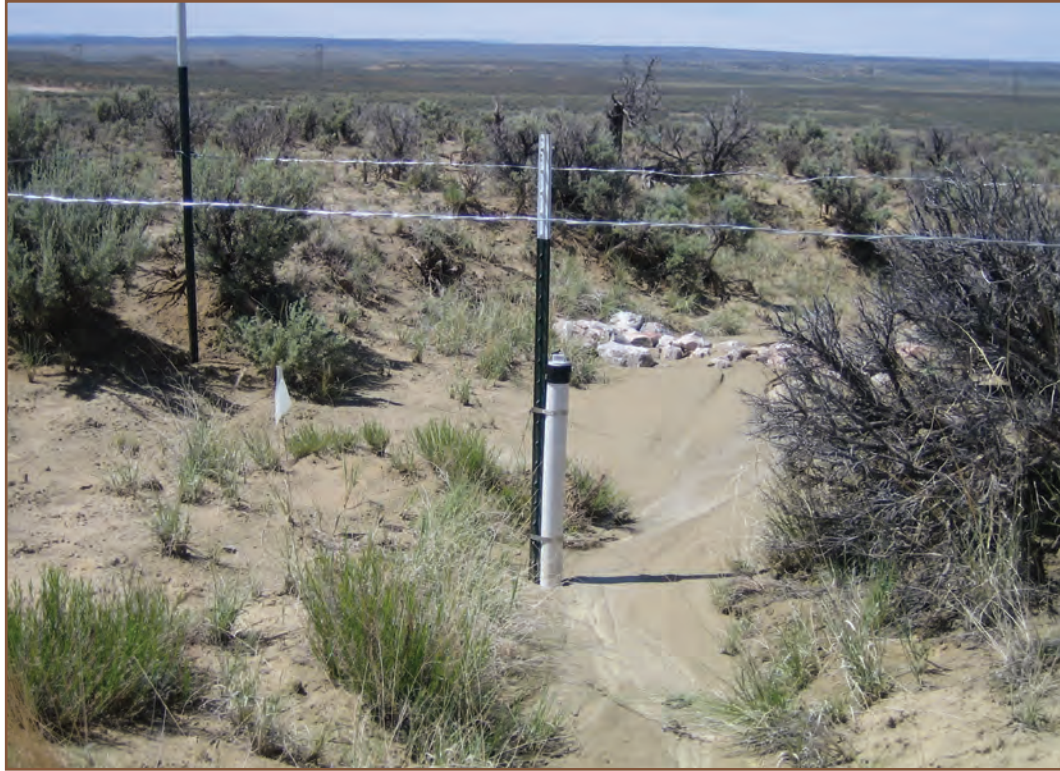
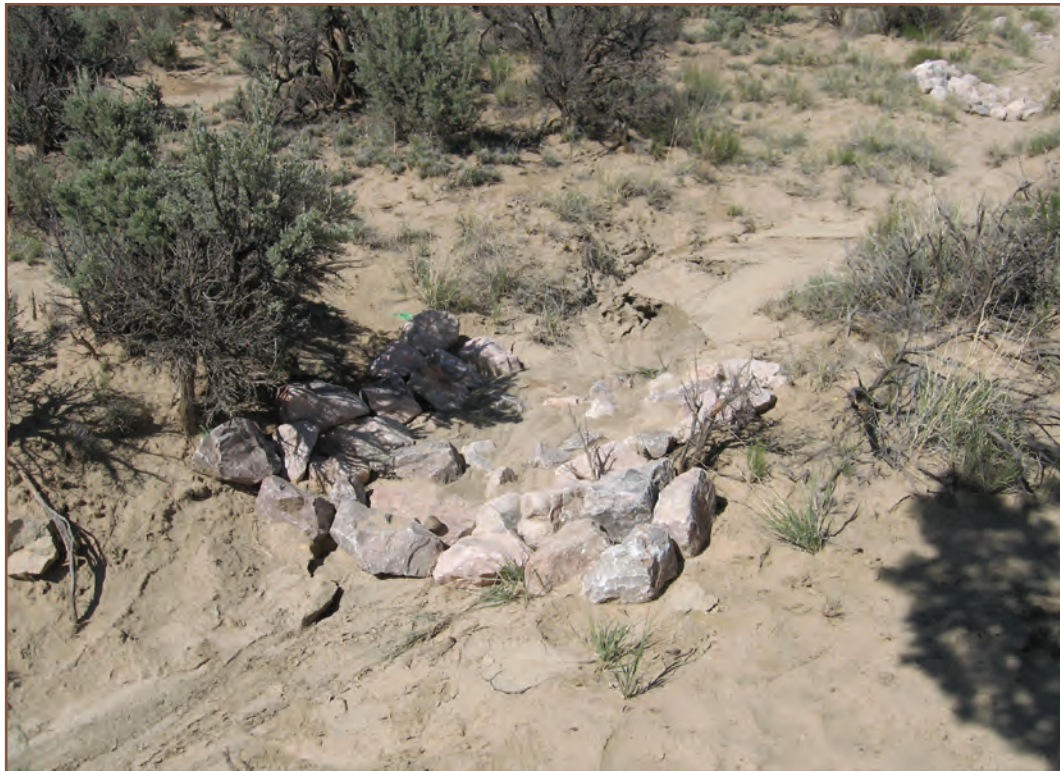
Figure 9. Sediment movement in Papers Wash treated channel following June 9, 2009, 2-year-recurrence-interval precipitation. *A*, Buried base of crest-stage gage. *B*, Sediment captured by one-rock dam and channel infilling above structure.

9, 2009, about 4 in. of sediment were deposited in the vicinity of the CSG at Papers Wash, burying the base. Sediment was both captured by the one-rock dams and deposited in the channel upstream from the structures (fig. 9A, B), indicating loss of surface-flow energy and increased potential for infiltration to the subsurface in the area of sediment deposition. By the end of the study period, one-rock dams at the Papers Wash treated site were wholly or nearly buried in the channel area, and the channel itself was largely infilled (fig. 10). At the Penistaja Arroyo treated site, some channel infilling also occurred but was not as pronounced as at the Papers Wash site, and grasses seeded beneath the one-rock dams at construction were well-established (fig. 11). The implication of the lack of recorded flow at both sites, along with sediment deposition and channel infilling, is that sediment movement in the upland portions of the drainage is by overland runoff or bedload transport and is not dependent on suspended-sediment channel transport. Channel infilling also indicates the effectiveness of the one-rock dams in reversing incipient gully formation and forming a more stable unchanneled hillslope.

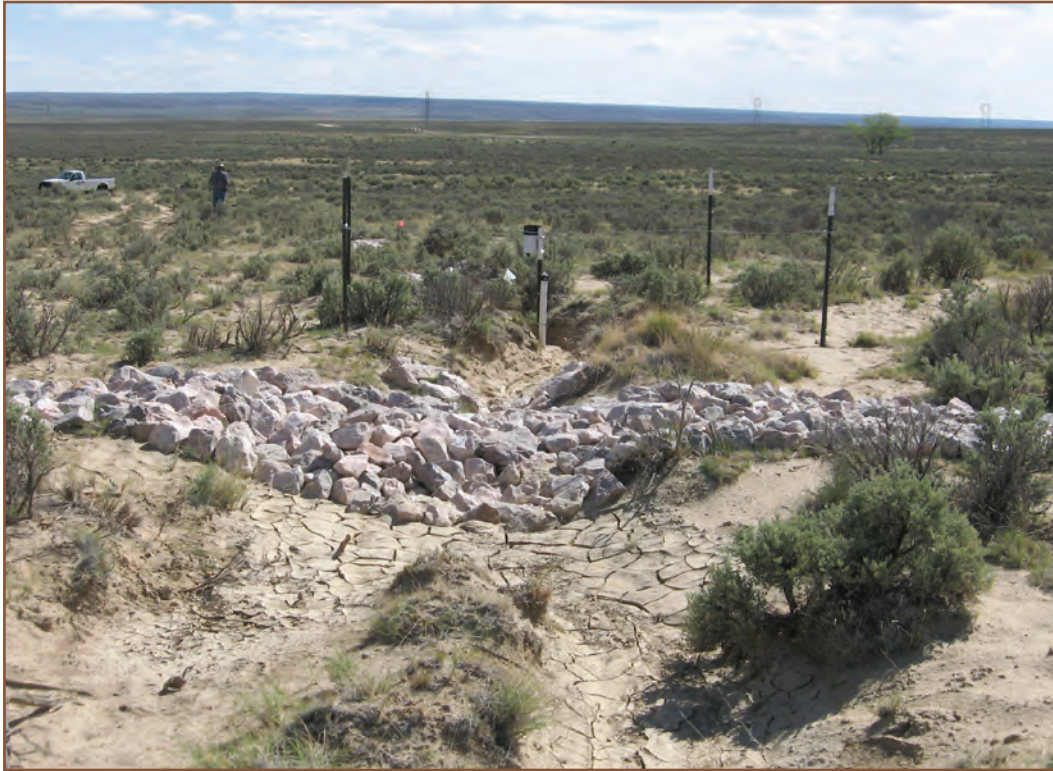
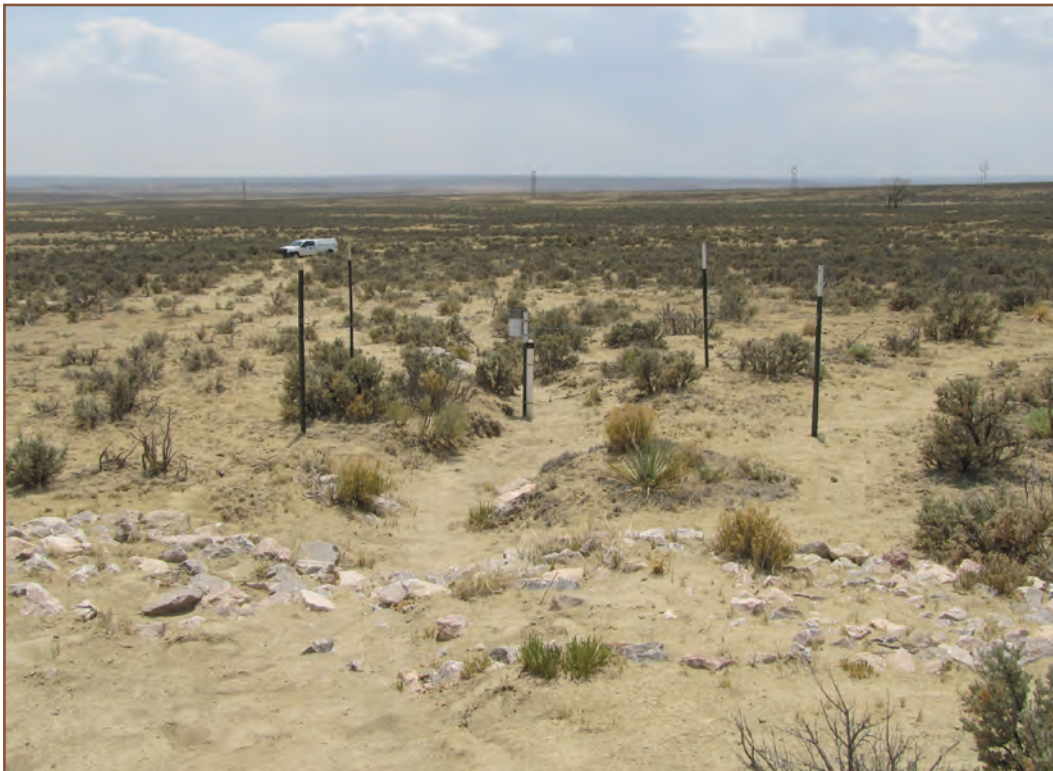
Figure 10. Erosion-control structures on Papers Wash. *A*, July 24, 2009, near the start of the study period. *B*, July 1, 2013, after completion of the study.

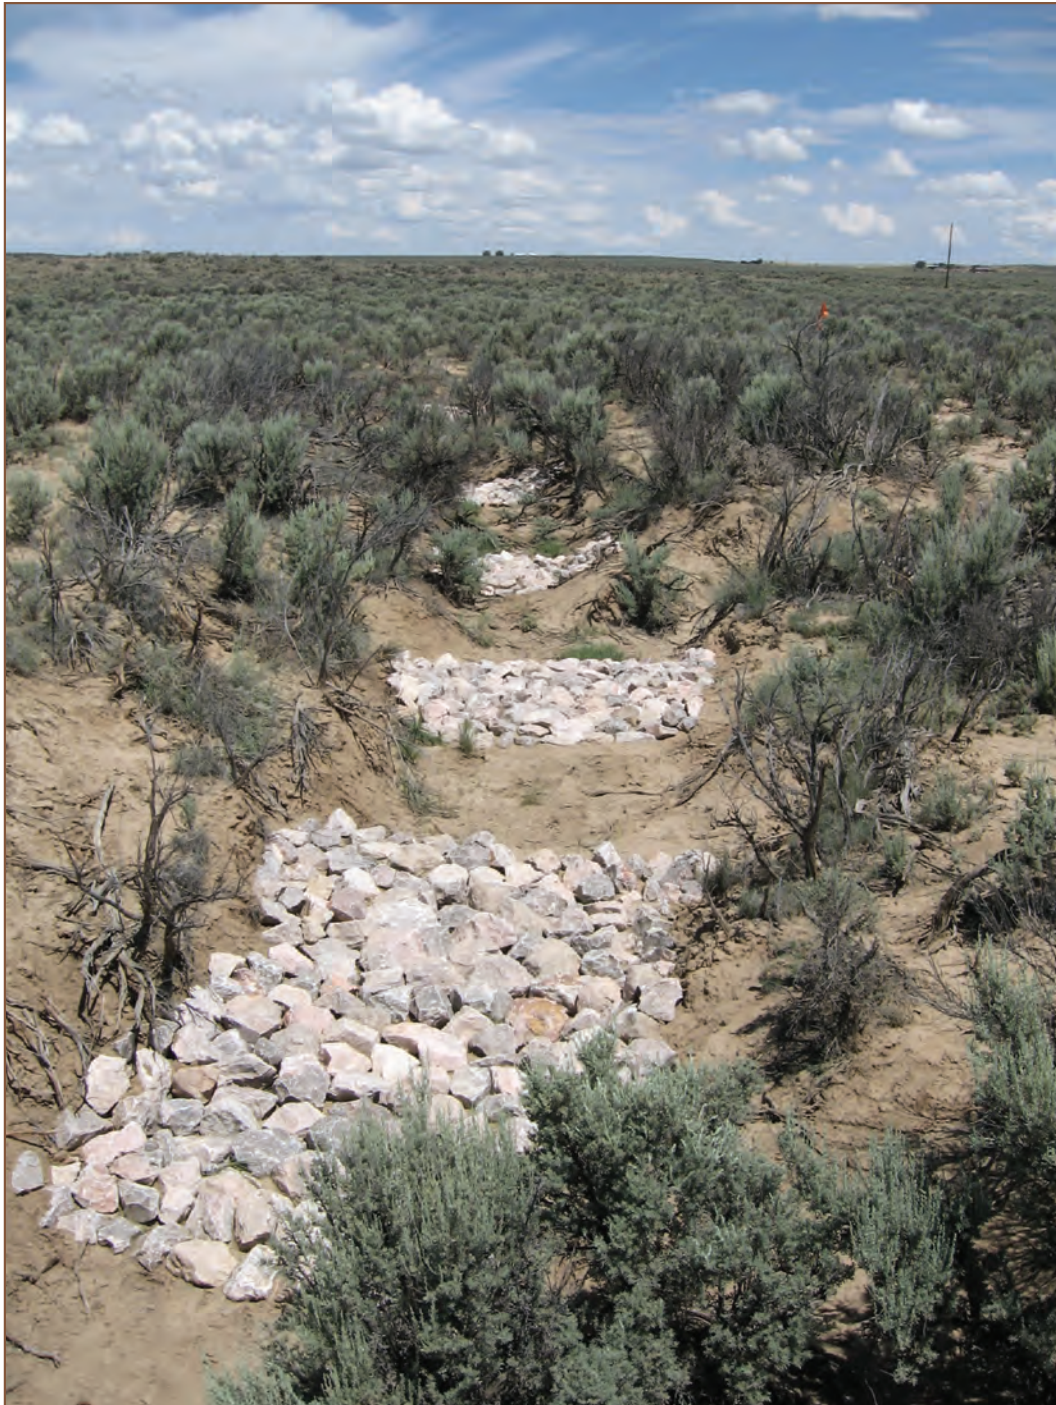
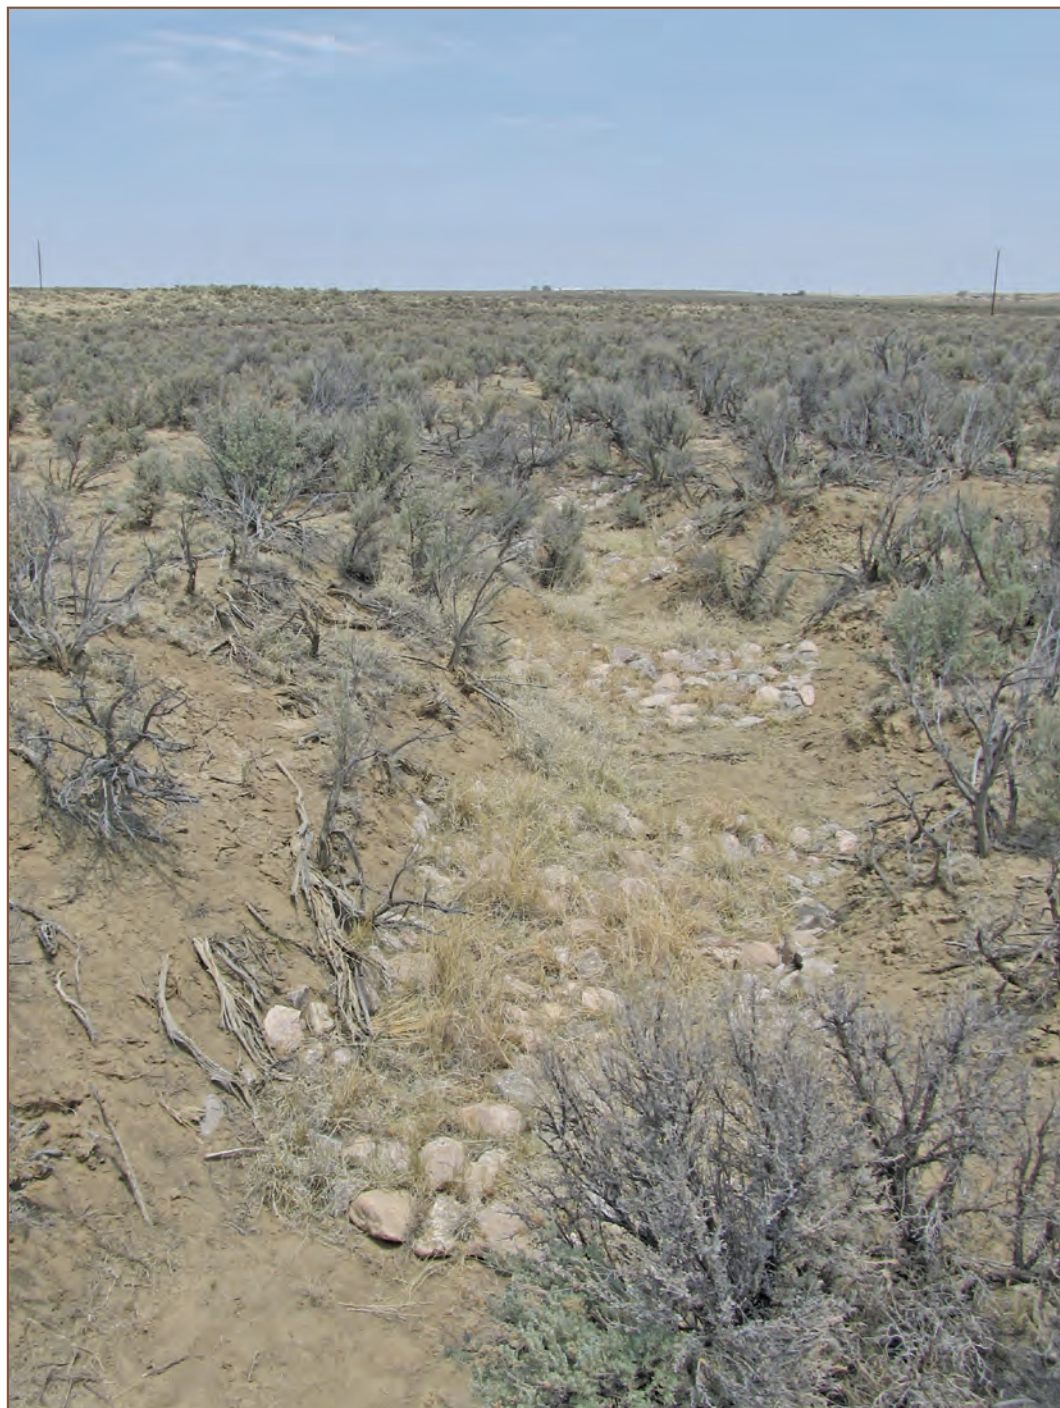
Figure 11. Erosion-control structures in the Penistaja Arroyo drainage. *A*, July 24, 2009, near the start of the study period. *B*, July 2, 2013, after completion of the study.

Figure 11. Erosion-control structures in the Penistaja Arroyo drainage. *A*, July 24, 2009, near the start of the study period. *B*, July 2, 2013, after completion of the study.—Continued

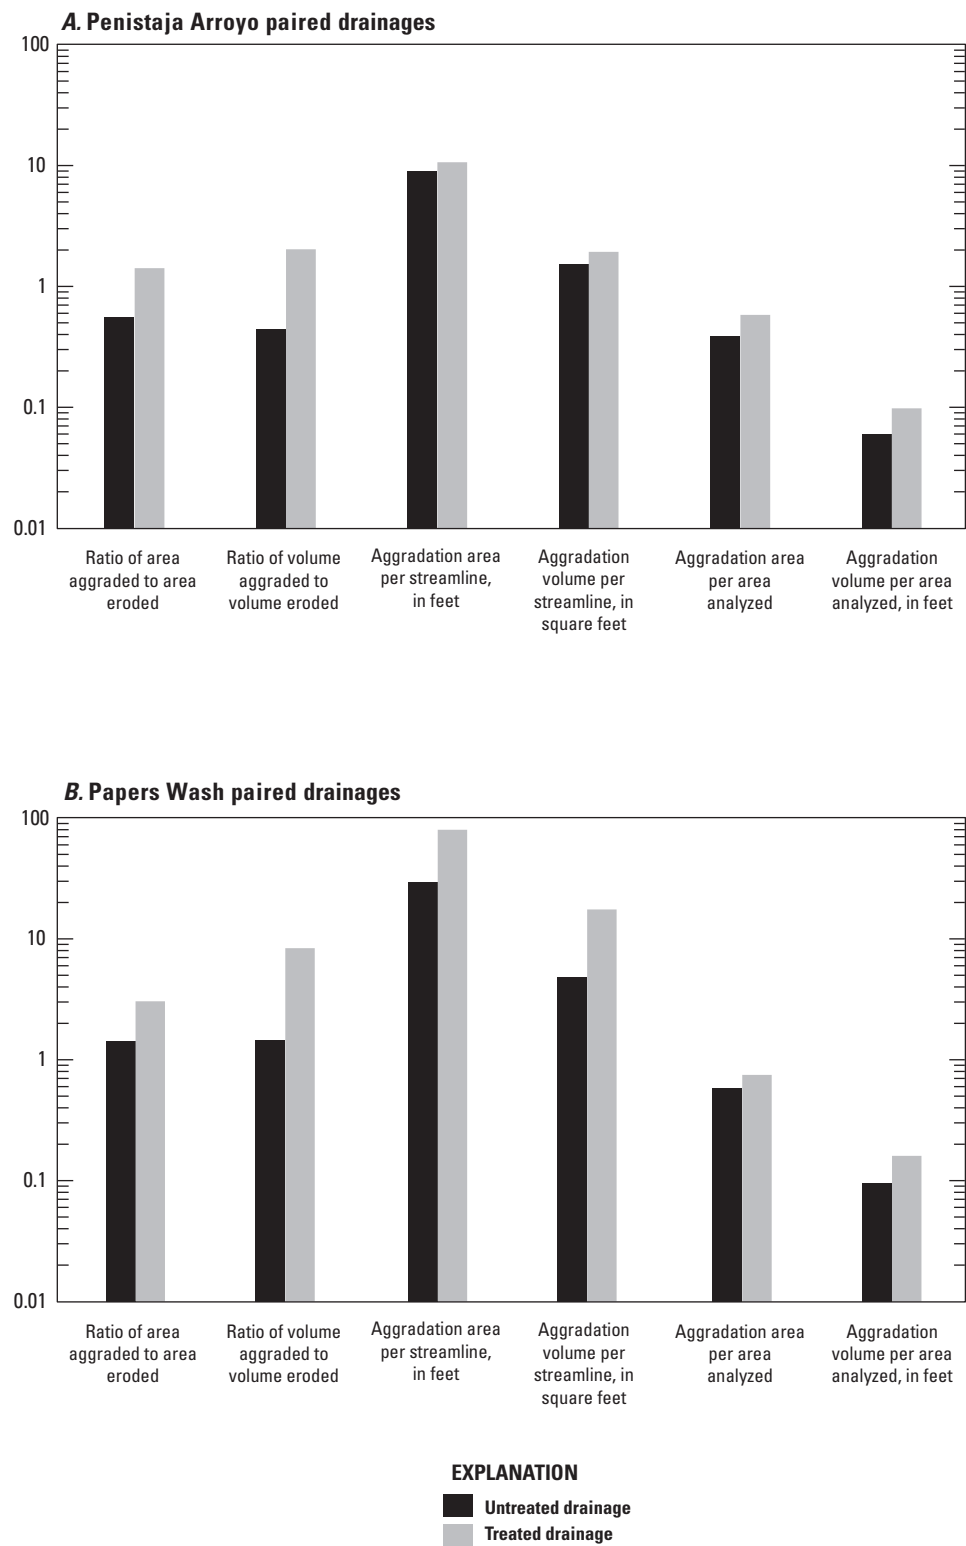
Figure 12. Comparison of aggradation amounts between untreated and treated drainages. A, Penistaja Arroyo paired drainages. B, Papers Wash paired drainages. The y-axis units are variable.

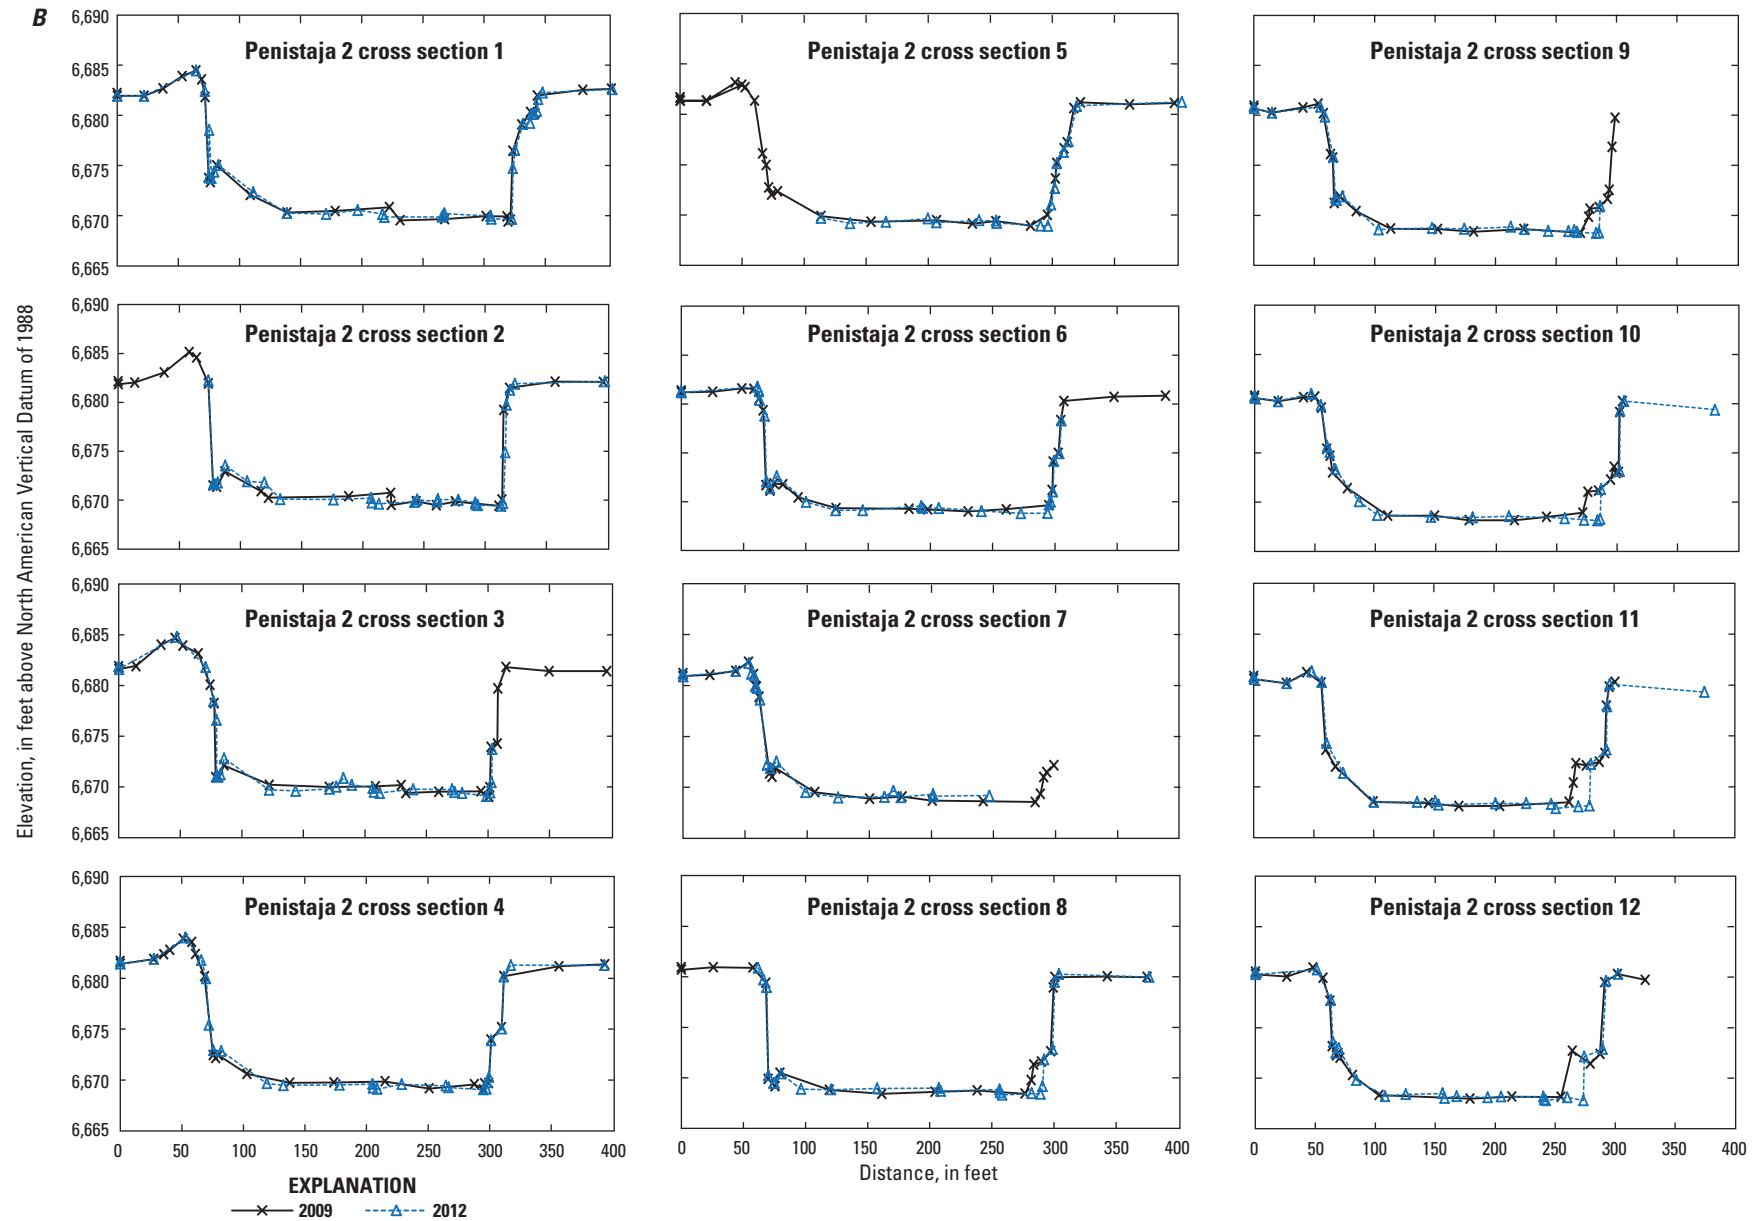
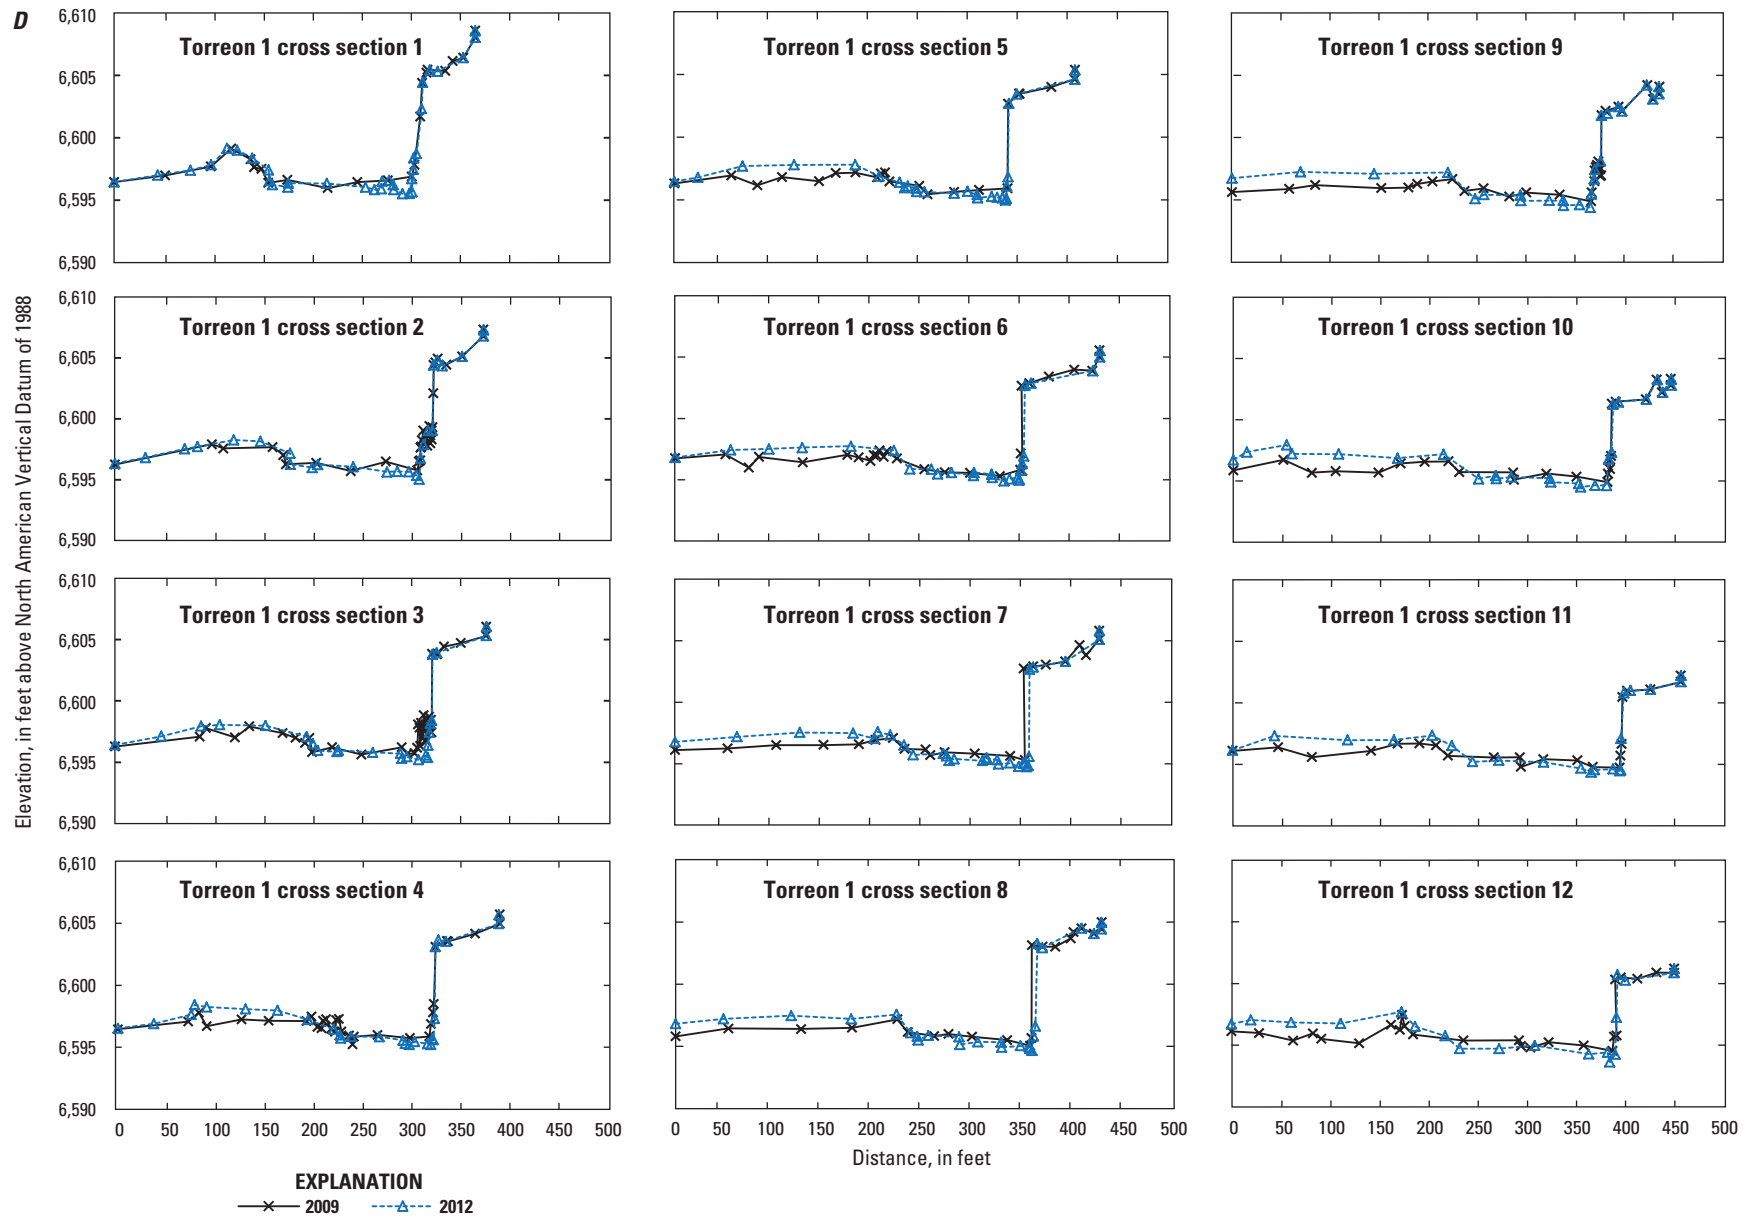
Figure 13. Main-stem channel cross sections in Penistaja Arroyo and Torreon Wash, 2009 and 2011. Locations of stream reaches are shown on figure 6. *A*, Penistaja 1. *B*, Penistaja 2. *C*, Penistaja 3. *D*, Torreon 1. *E*, Torreon 2. *F*, Torreon 3.

The data on which this channel-adjustment analysis is based are available at Matherne and others (2018). The three survey sites on each main-stem channel segment, Penistaja Arroyo [P] and Torreon Wash [T], included cross-section [XS] clusters that showed erosion by both bank failure (P2 XS 7-12; P3 XS 4, 12; and T1 XS 7-8) and partial or complete removal of channel bars (P1 XS 7-10; and T3 XS 6) (figs. 6 and 13). Other cross sections showed deposition, including channel-bank deposition (T2 XS 5; and T3 XS 8) and channel-bar deposition (T1 XS 2-12; T2 XS 1-2, 7-8, 11-12; and T3 XS 7).

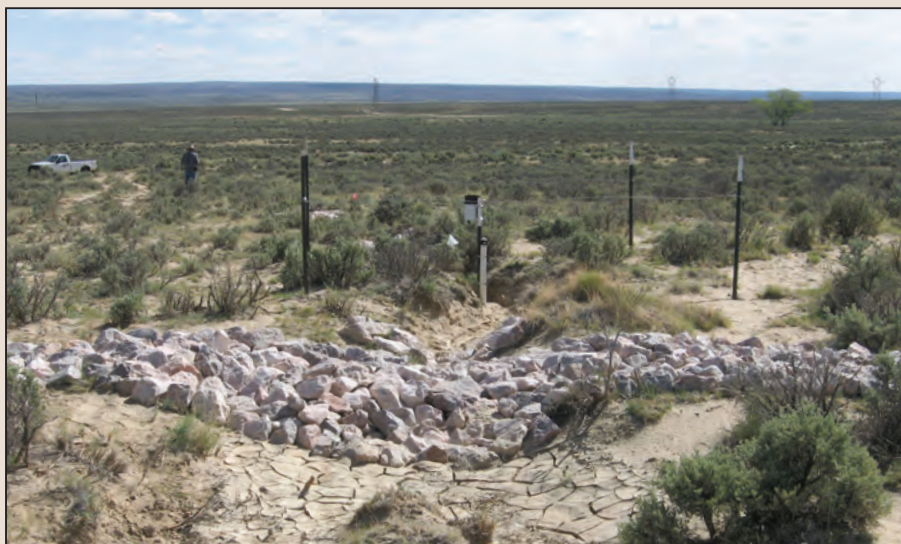
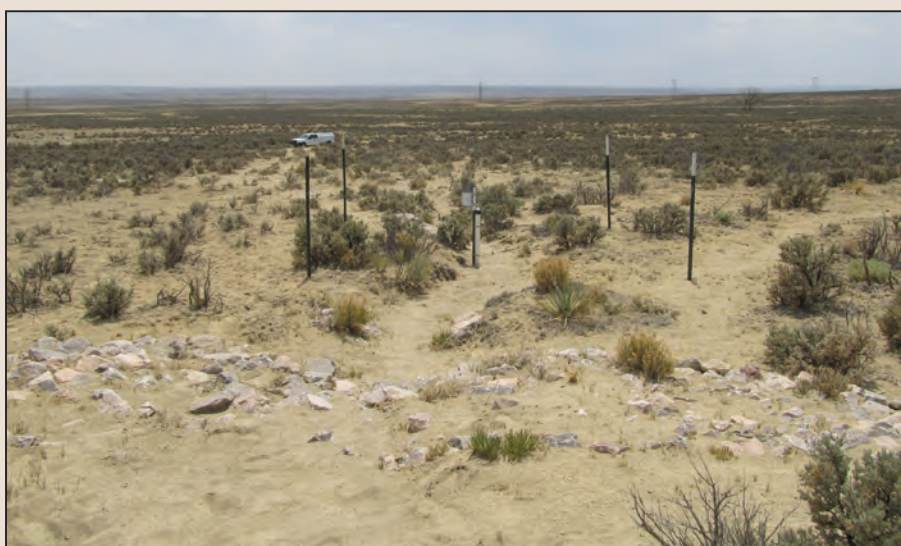
Top. Erosion-control structures on Papers Wash, July 24, 2009, near the start of the study period.

Bottom. Erosion-control structures on Papers Wash, July 1, 2013, after completion of the study.
