FATIGUE FAILURE OF ELECTROFORMED PRINTING PLATES

I. J. Feinberg
Engineering Metallurgy Section
Metallurgy Division

Electrolytic Section
Bureau of Engraving and Printing
Washington, D. C.

Fatigue Failure of Electroformed Printing Plates

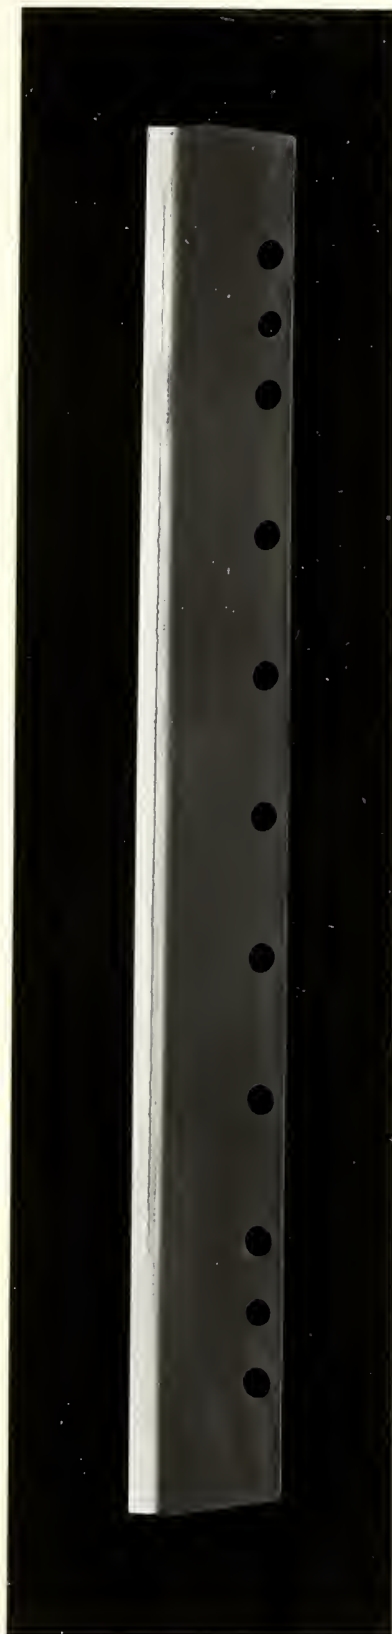
Figure 1. Strip from printing plate No. 40395. The location of the cracks with respect to the plate-bend line is typical of that observed in all of the strips examined.

a. Obverse face. X $1/4$

b. Reverse face. X $1/4$

All of the strips contained cracks that were adjacent to and parallel to the bend line in plate Vee bends - bends necessary for adaptation of the plates to the press cylinder. The cracks observed varied in length from approximately one inch in one plate to three-fourths of the plate width in others. A typical view of the general location of the cracks with respect to the plate bend line is shown in Figure 1. Strip identifications and pertinent plating and service life data are given in Table 1. The Bureau of Engraving and Printing (BE&P) requested NBS to determine whether cracking could be attributed to detrimental material conditions or to mechanical factors. BE&P also requested that the mechanical properties of the materials be established for their records and possible future reference.
