MATERIALS RESEARCH FOR THE CLEAN UTILIZATION OF COAL

QUARTERLY PROGRESS REPORT

July - September 1979

Center for Materials Science
National Bureau of Standards
Washington, D.C. 20234

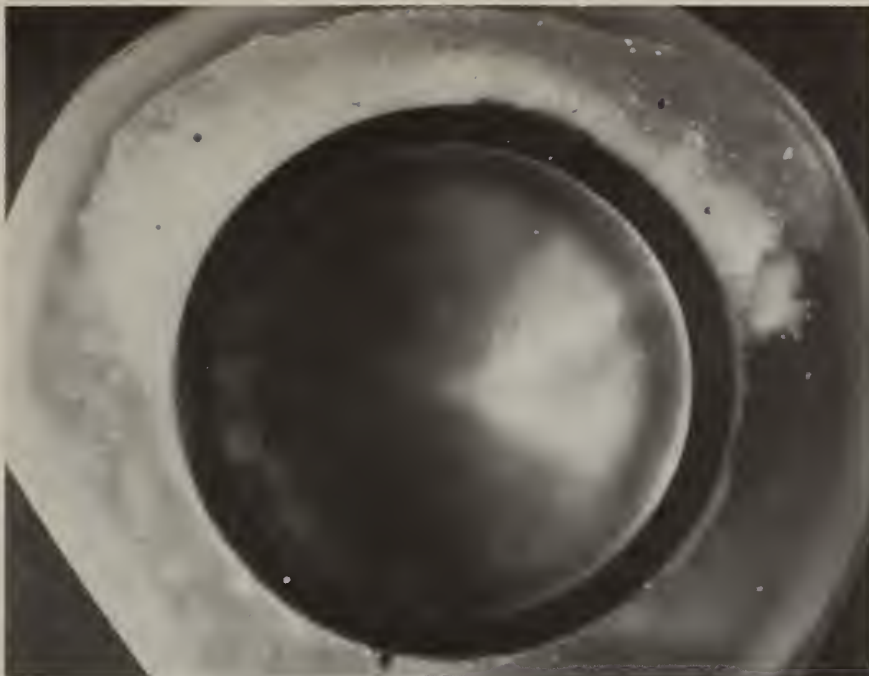
Figure 2. Section of Type 304 stainless steel tubing after exposure to K_2SO_4 seeded oxygen rich hot gas stream. Note formation of thick, 2 mm, deposit on upper surface. Tube temperature $500^{\circ}C$. 6 X.

On each of the three Type 304 stainless steel tubes run under oxygen rich conditions a thick white, somewhat columnar deposit was formed on the upper surface of the specimens, figures 1, 2, and 3, while a thin powdery deposit formed on the remainder of the surface. The columnar deposit was approximately 2 mm thick; the powdery deposit 0.1 mm to 0.2 mm thick. SEM examination and EDX analysis of the metal-deposit interface showed what appears to be corrosion or reaction bands that increase in thickness with temperature and vary in thickness with respect to location; the thickest band being noted in the merge region of the columnar-powdery deposit at 590°C. The reaction band thicknesses range from 3 μm to 20 μm .

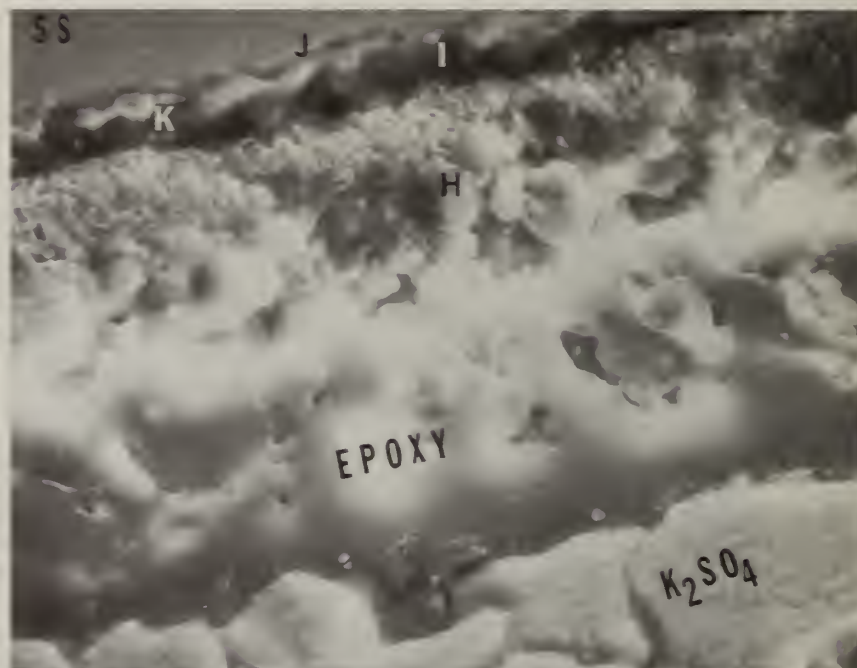
Figure 9. SEM micrograph, 1800 X, of reaction bands formed in the metal interface-columnar deposit powdery merge zone, location X of Figure 3. Lettered regions correspond to EDX spectra of Figures 10 and 11.

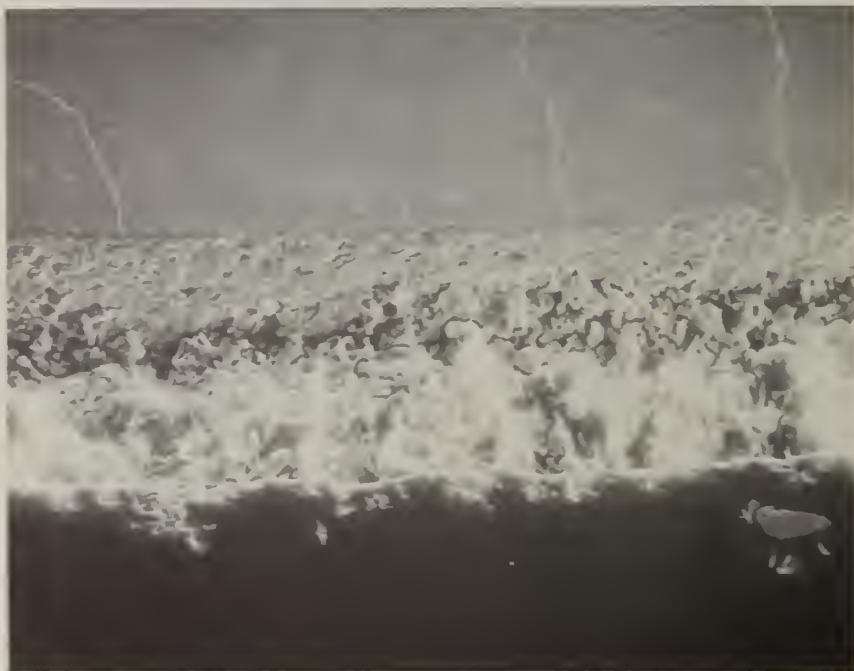
Figure 15. SEM micrograph, 190 X of reaction bands formed in the metal deposit interface of region Y of Figure 14.
