THE APPLICATION OF X-RAY PROJECTION MICROSCOPY TO ROOFING ASPHALT SYSTEMS

August 10, 1962

7589

Organic Building Materials Section
Building Research Division

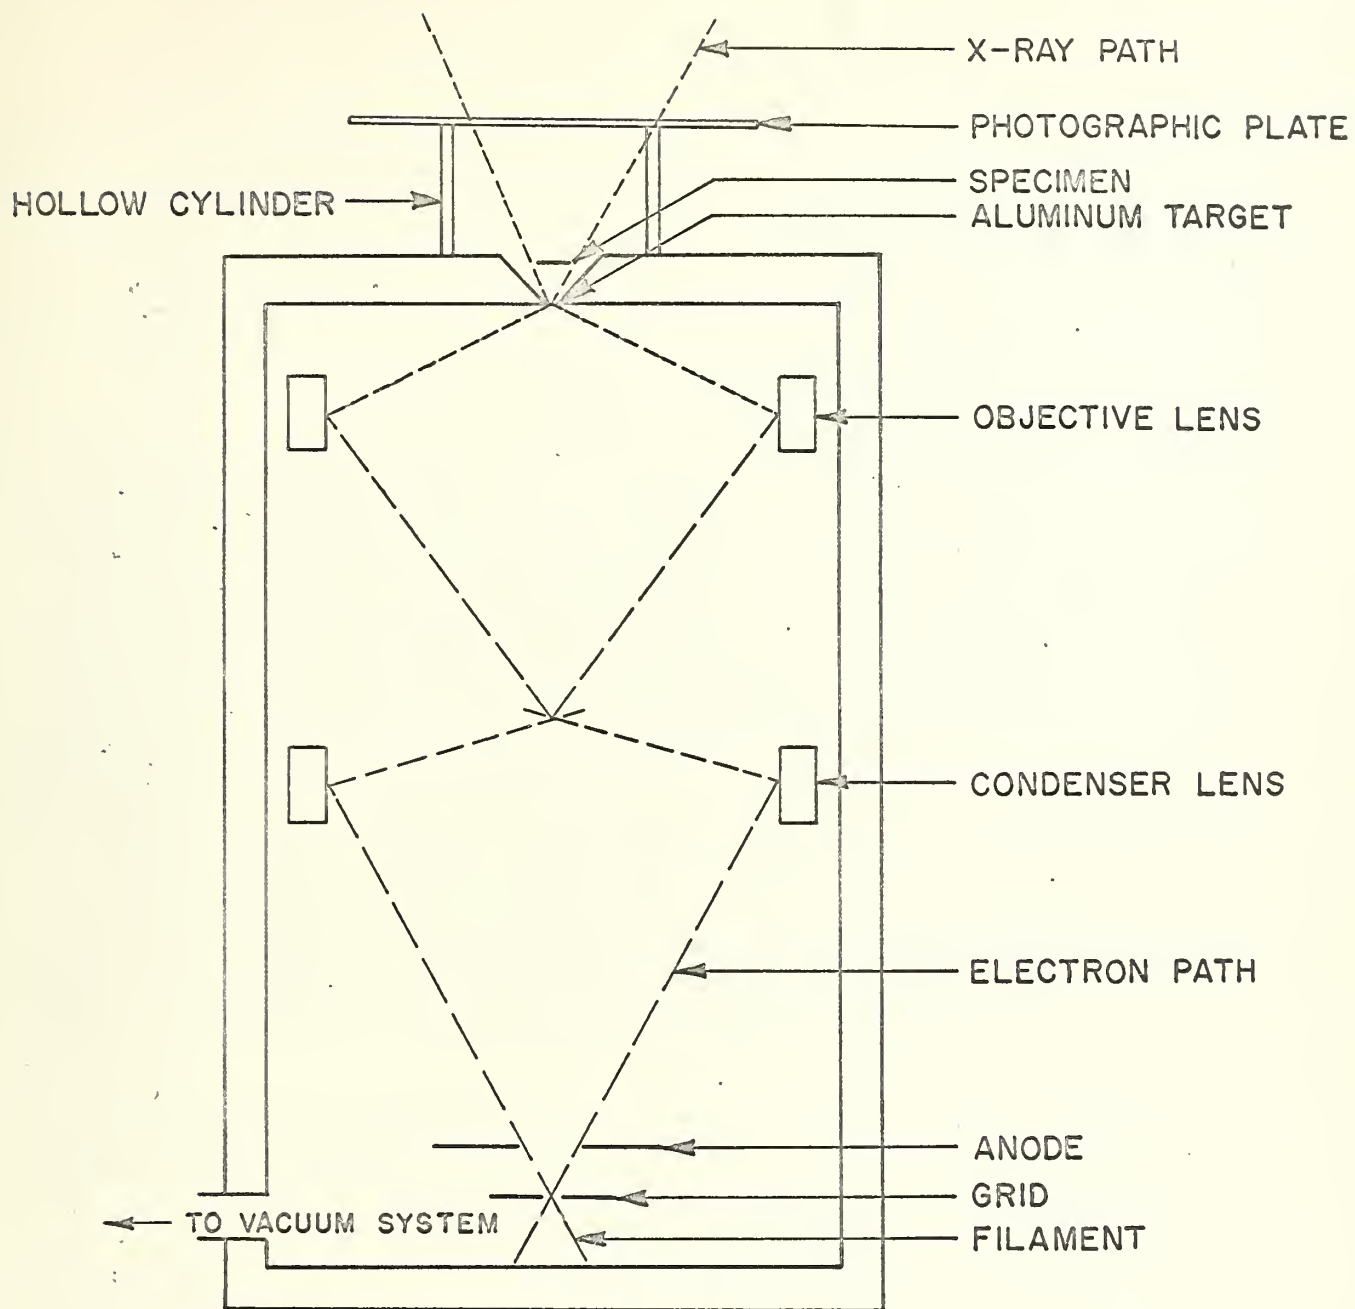
FIGURE 1. SCHEMATIC OF X-RAY PROJECTION MICROSCOPE

The point-projection x-ray microscope, shown schematically in Figure 1, was of the Cosslett and Nixon type [9], manufactured by Micro X-Ray Laboratories, Ltd., of Surrey, London, England. It consisted of a Wehnelt type electron gun with grid bias, electromagnetic condenser and objective lenses and a series of interchangeable targets. The spot size on the targets was about one micron; however, slight scattering of the x-rays resulted in an effective x-ray source slightly larger than this. All x-ray photographs were made with an aluminum target, yielding x-rays of 8.34 Å wavelength.

As seen in Figure 1, the focusing is entirely within the gun, all points in the x-ray path are always in focus when the gun is properly focused. Thus, the magnification is controlled by regulating the relative distances of the specimen and the plate from the x-ray source, the target of the electron gun. All points in the specimen are in focus, but points in different planes within the specimen are magnified to different degrees.

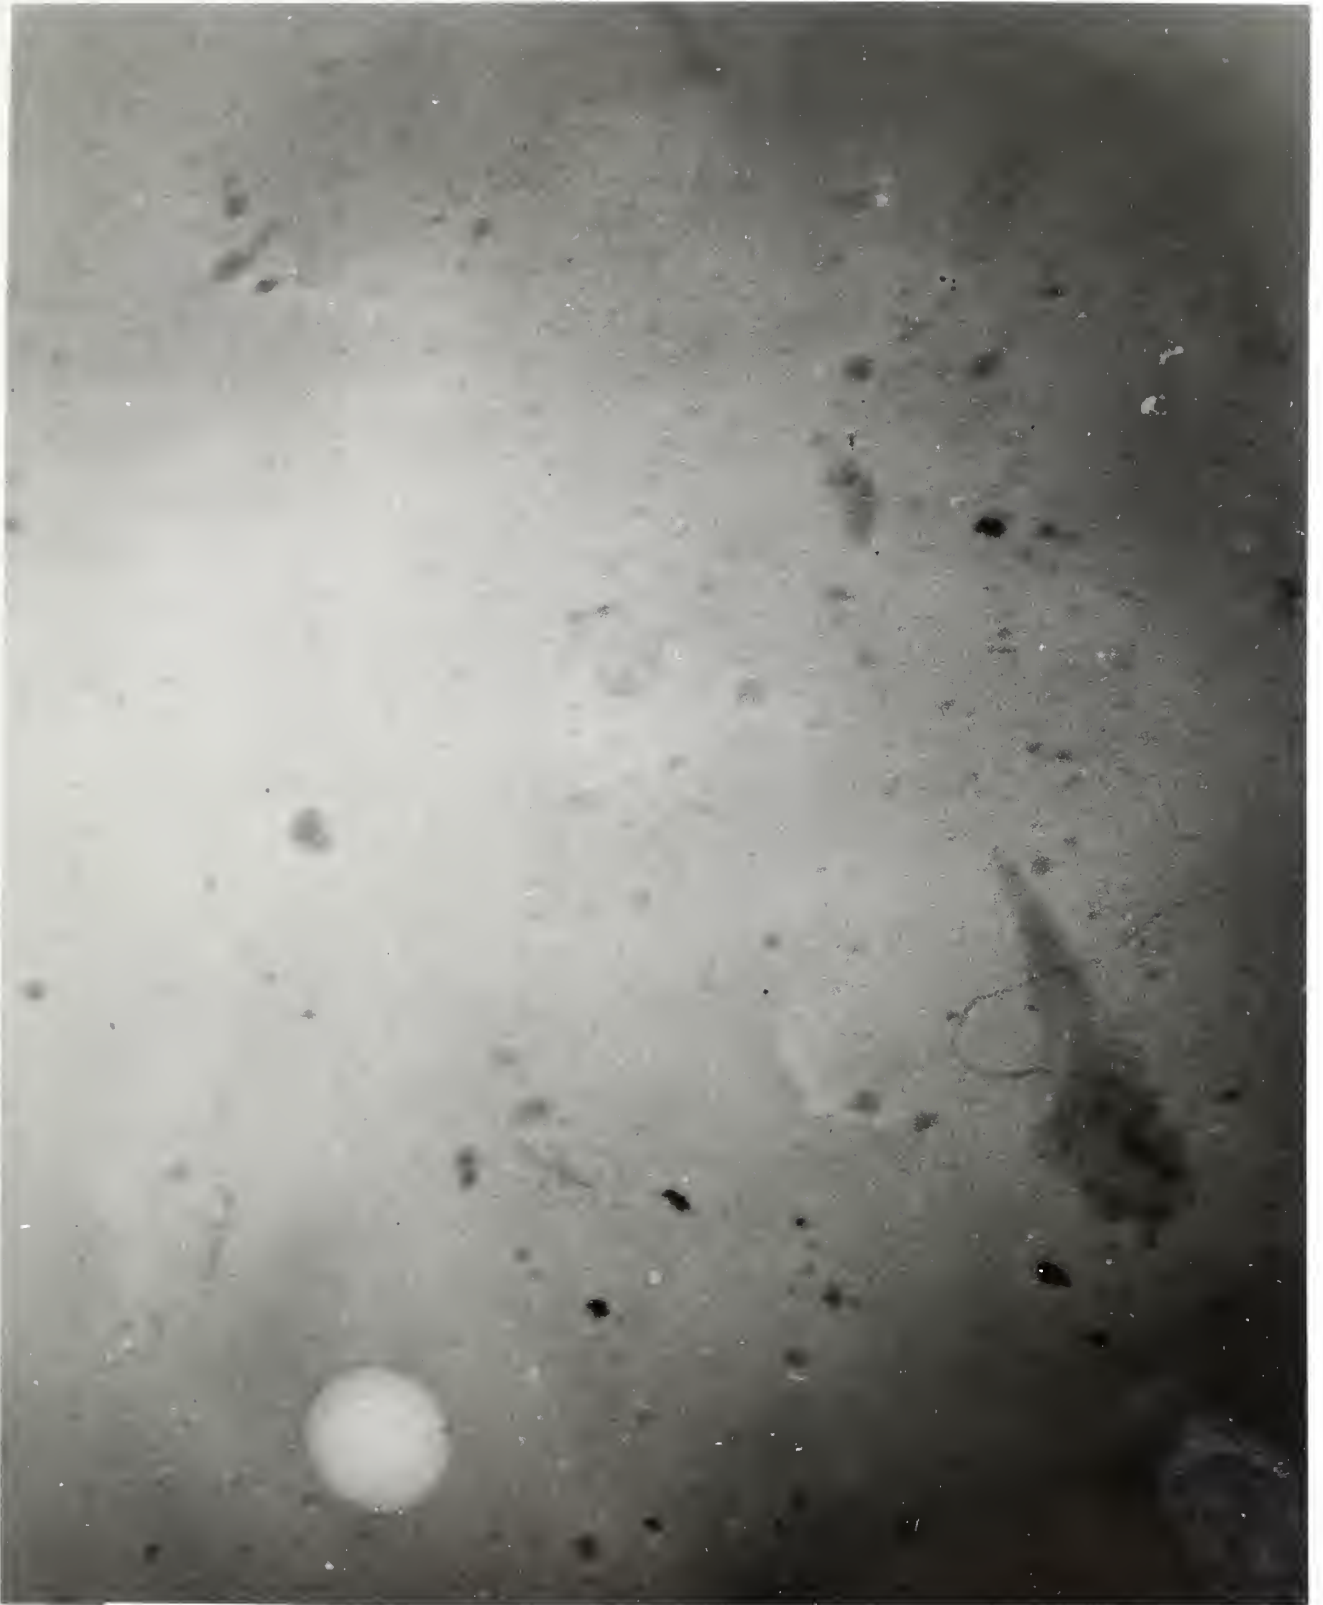
FIGURE 2. A COMMERCIAL COATING-GRADE ASPHALT

Figure 2 - Unexposed Asphalt

This photomicrograph is typical of many taken of commercial samples of coating-grade asphalt. There are indications of materials of different densities dispersed in the asphalt. These range from air bubbles, the white, round area, to various types of debris. Some of this litter may be introduced during specimen preparation, for dust and lint tend to collect on the freshly cut asphalt surfaces, but the bulk of the foreign material is in the asphalt.

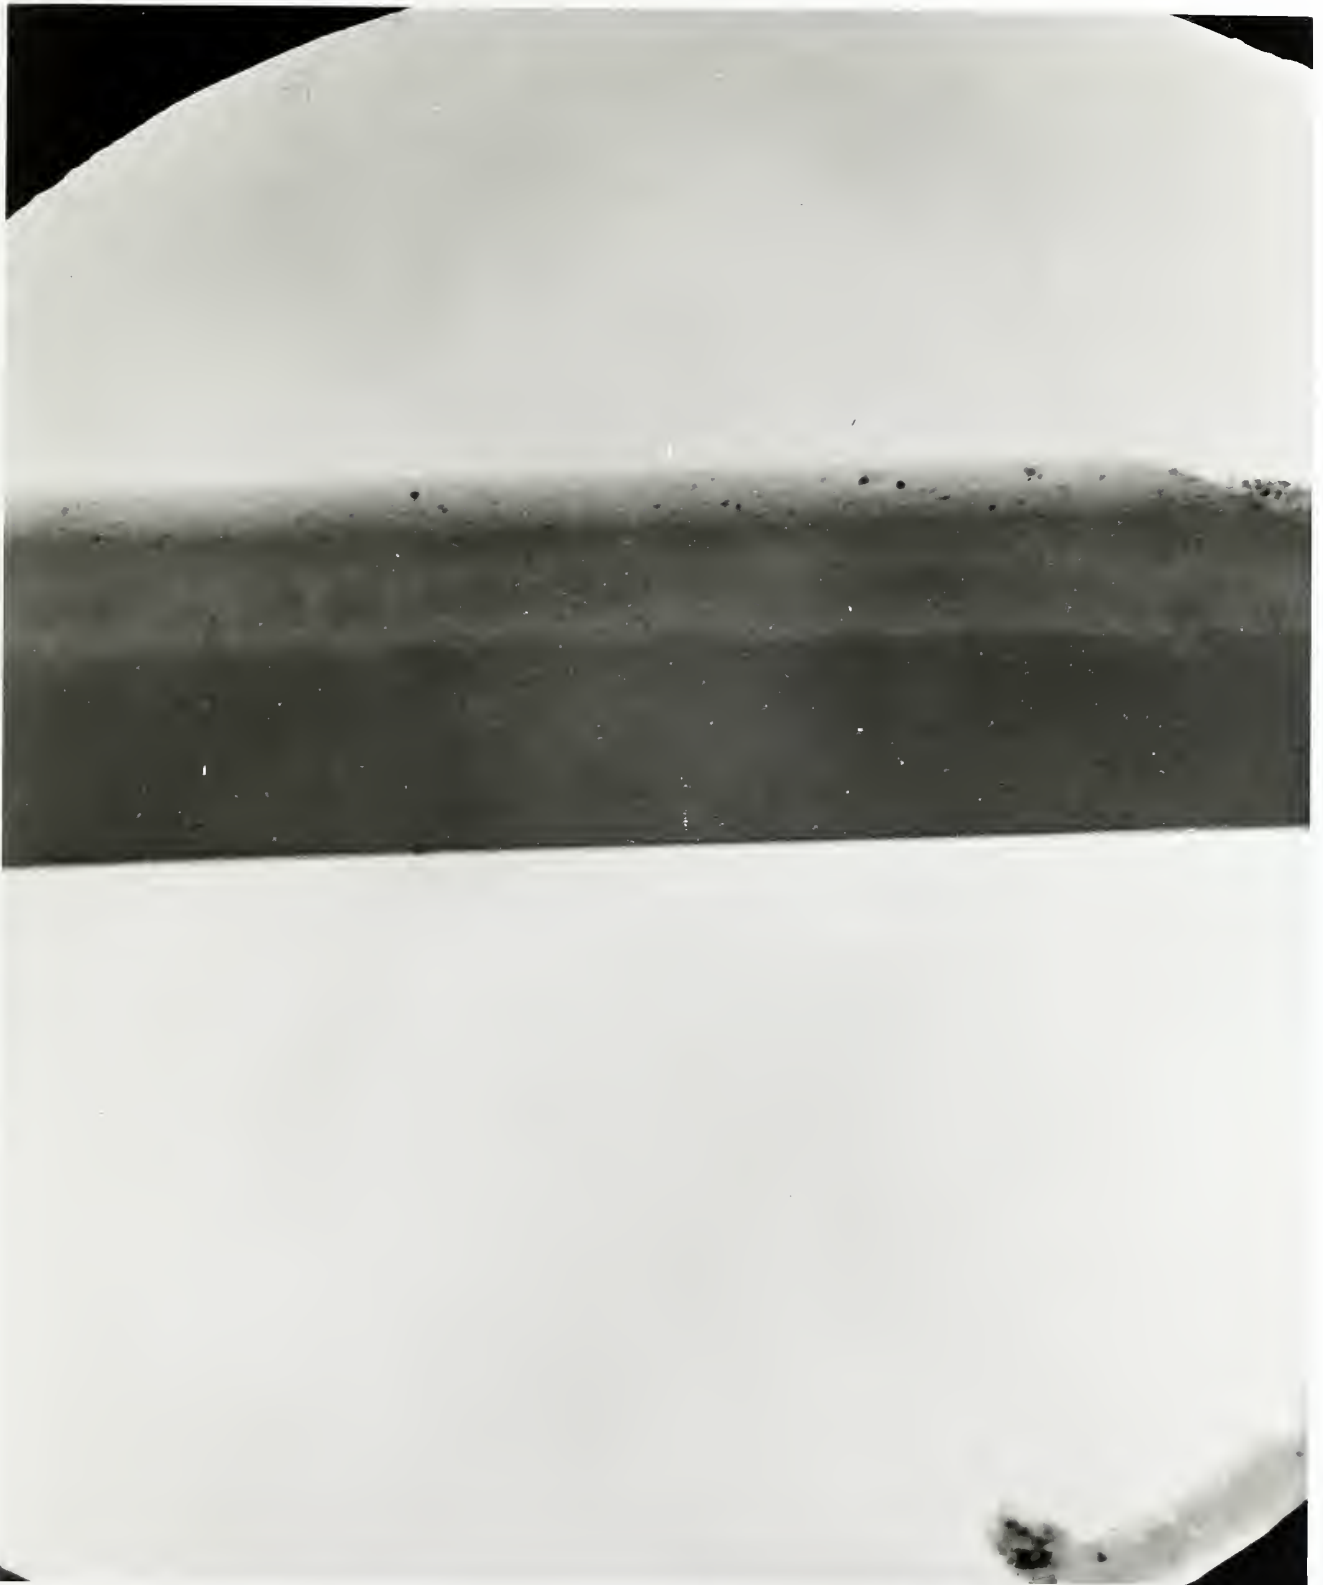
FIGURE 3. AN ASPHALT FILM WEATHERED 88 MONTHS OUT
OF DOORS - 120X

Figure 3 - Cross Section of Asphalt Film Weathered for 88 Months on the Roof of the Industrial Building - Magnification 120X

In all weathered films, a more-or-less stratified appearance has been found. There is a surface layer, which is obviously less dense than the rest of the coating. This layer is the "velvet" film seen on asphalts, which consists of partially oxidized organic material. The more-completely oxidized material has been leached from this layer, leaving a film of low density. Below this surface layer is a denser layer; this second layer possibly consists of an accumulation of non-diffusing materials (primarily asphaltenes) which have partially collapsed on themselves because of a deficiency of oils. The third layer is again less dense, possibly because the oils have diffused out, leaving an incompletely filled, but not collapsed, asphaltene structure. Finally, the bulk of the asphalt remains below.

This particular film is 19.5 mils thick; it had lost 6.5 mils in thickness and 24% of its initial weight.

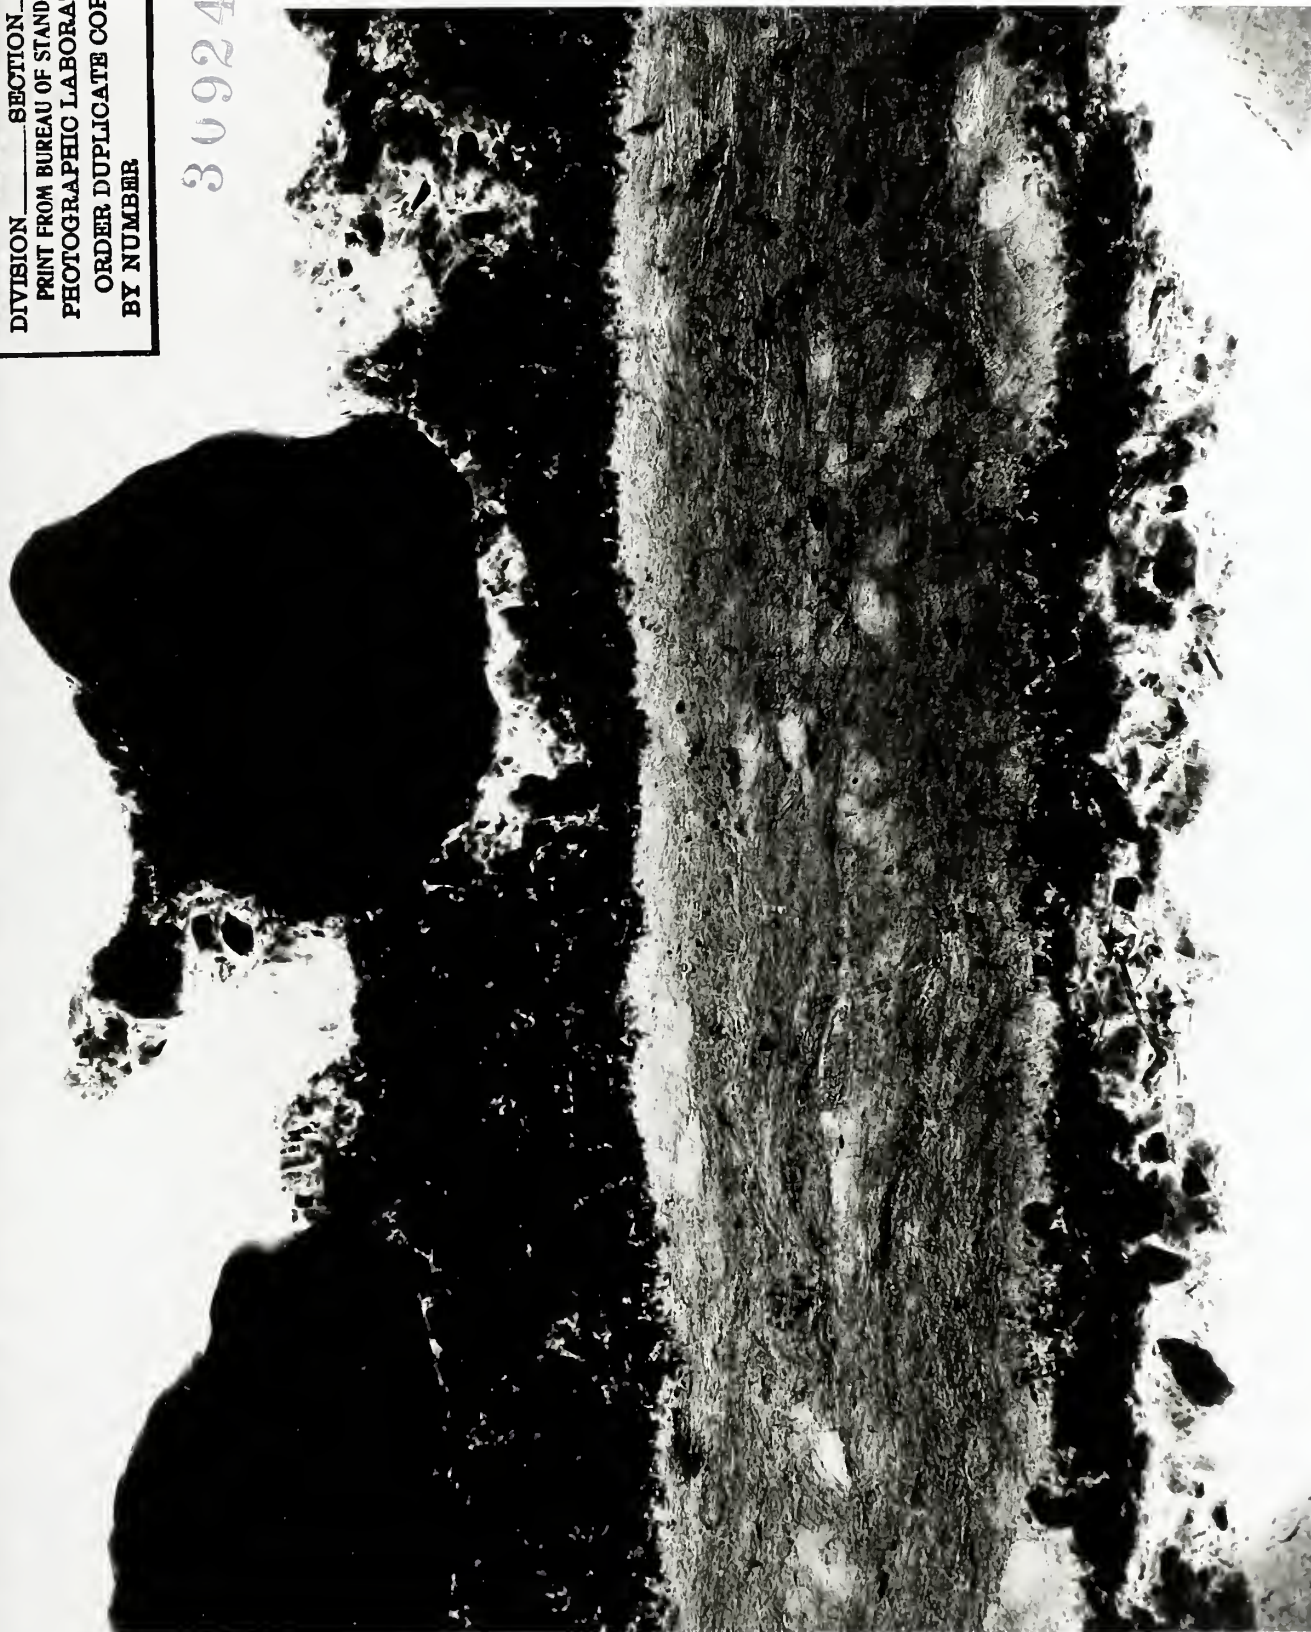
FIGURE 5. A COMMERCIAL, UNEXPOSED UNIFORM-THICKNESS
ASPHALT SHINGLE - 70X

Figure 5 - Random Sample of 215-pound Uniform-Thickness Asphalt Shingle - Magnification 70X

This sample of a commercial asphalt strip shingle may not be typical, but it demonstrates vividly the value of the x-ray microscope for observing latent failures in roofing products. The mechanical embedment of the granules is quite evident. There is no contact (let alone adhesion) of coating and granules in large areas of their interface.

Some coating has been brought on to the exposed surface of the granule in the center of the photograph, possibly by rotation of the granule during embedment. A thin spot in the coating exists just to the right of this granule.

Regions in the saturated felt show significantly lower density than others. If these areas are less dense because of lower saturant, it would appear that the interfaces between coating and felt have become depleted in saturant. The saturant could have fluxed with the coating or could have been driven back into the felt. Small isolated areas in the body of the felt seem to be lacking saturant as well.

The variation in thickness of back-coating and back surfacing is quite apparent.

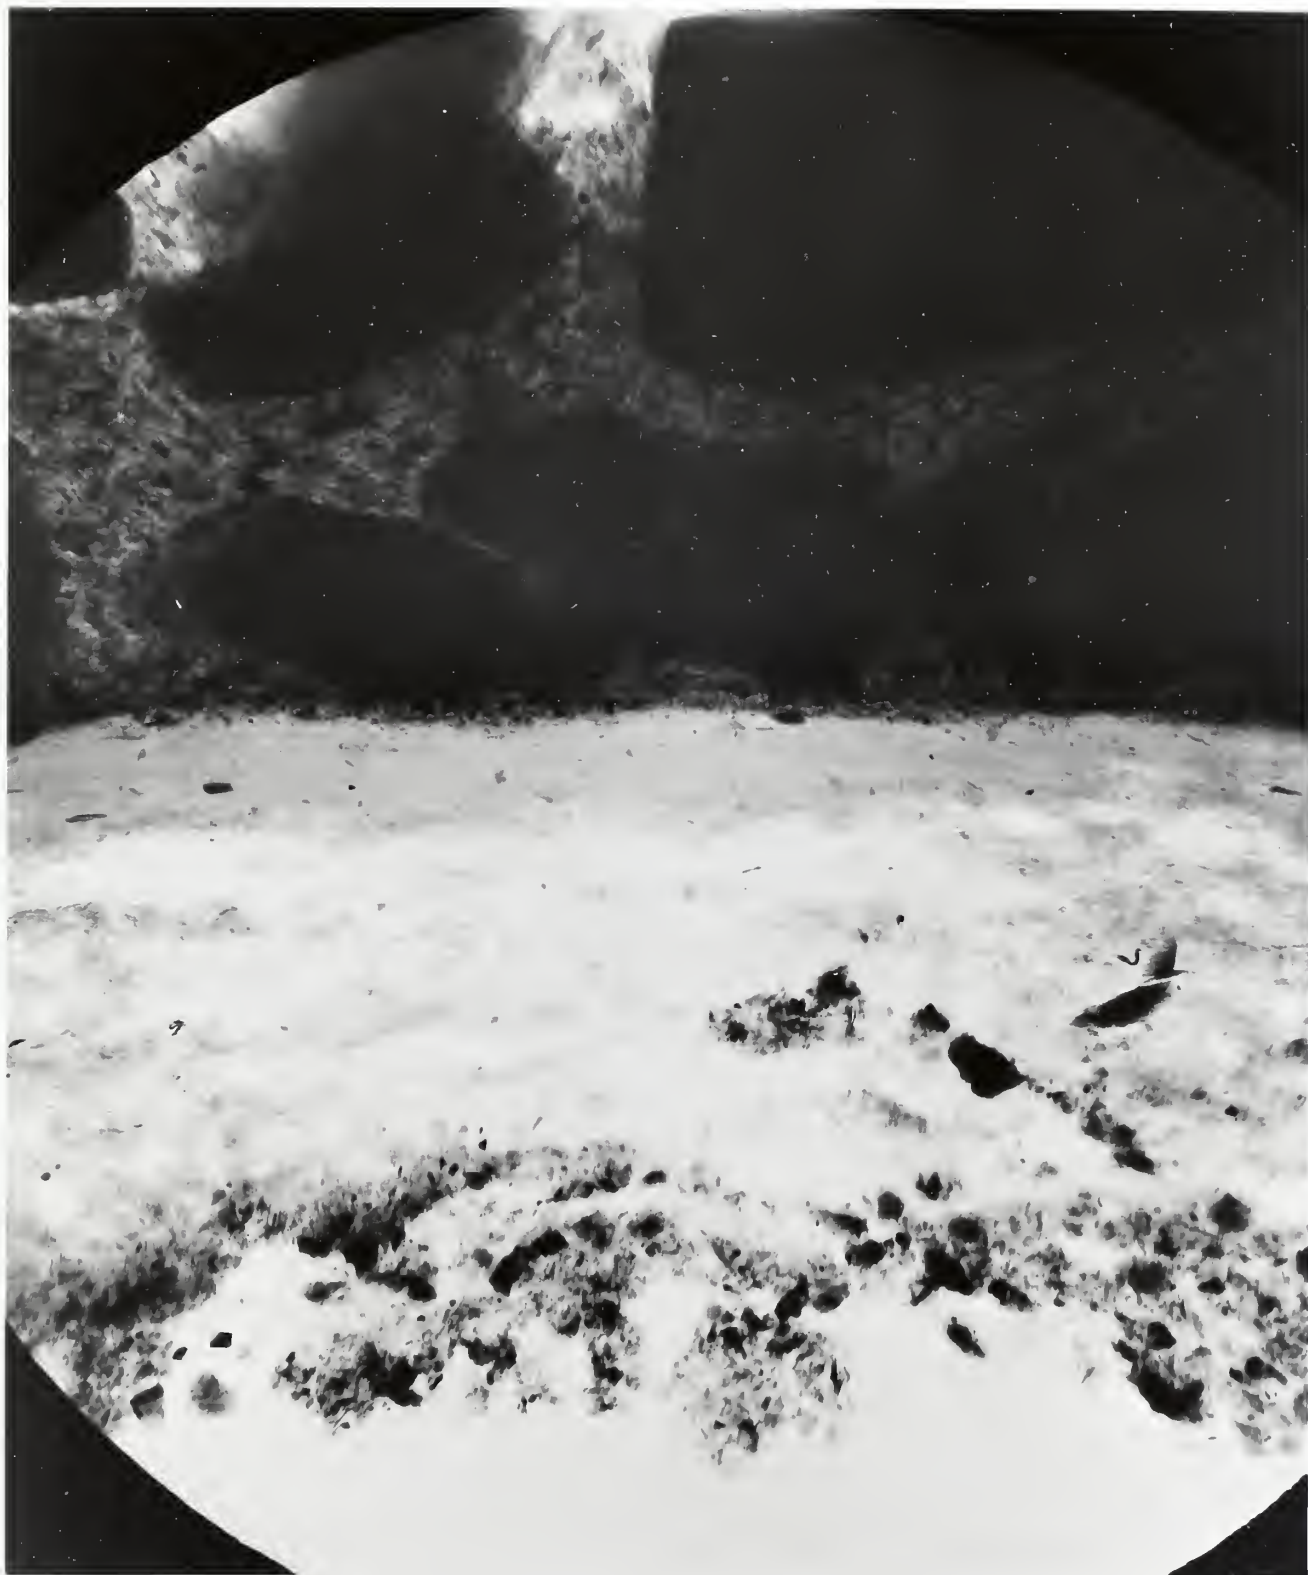
FIGURE 6. A THICK BUTT SHINGLE THAT HAS DEVELOPED SEVERE CLAWING - 70X

Figure 6 - Shingle That Has Clawed - Magnification 70X

This section taken from the center of a tab of a clawed, thick-butt shingle shows the condition existing when extreme clawing has occurred. The double overlay construction is apparent and still in good condition. A thin strata of saturated felt, just below the coating, also seems to be in good condition. (The low-saturation interface area seen in Figure 5 is not apparent here.) However, just below this layer is the bulk of the saturated felt, largely deteriorated. The back surfacing is full of holes and some of it has worked up into the felt. It appears that the original shingle may have had a light back-coating.

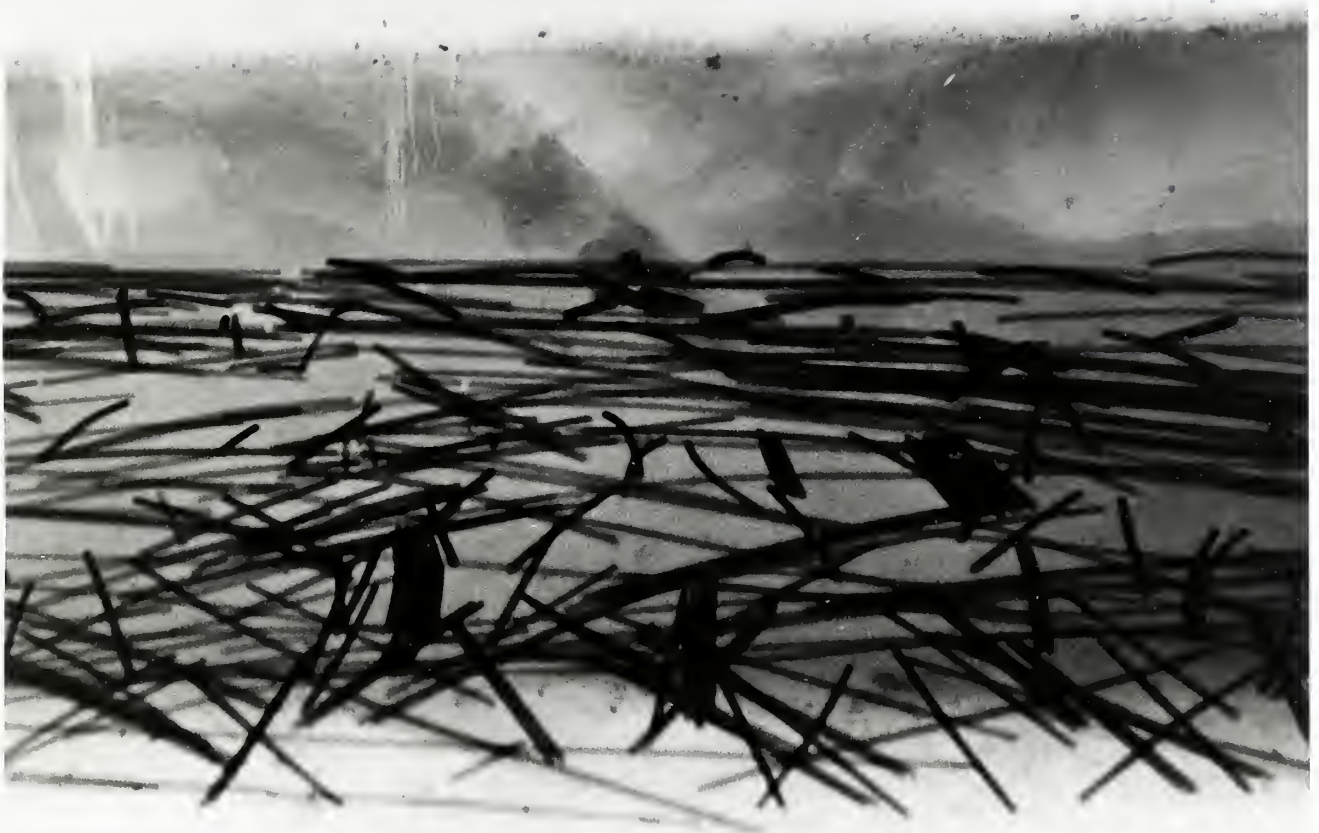
FIGURE 7. AN ASPHALT FILM CONTAINING A PEACE RIVER
GLASS MAT AFTER 600 HOURS IN THE WEATHER-
OMETER - 110X

Figure 7 - Peace River Glass Mat with Kansas Asphalt. Thickness - 42 mils. Exposed 600 hrs to 51-9C cycle. Magnification - 110X

The glass mat occupies the lower two-thirds of the total thickness of this film. The mat is quite open and the individual fibers are surrounded by asphalt. The asphalt surface shows some signs of weathering; it is less dense than the interior and seems to have a fuzzy texture. The mottled appearance of the asphalt is difficult to explain, but is not untypical. Many asphalt specimens, before exposure, appear like this one.

The stratification occurring during weathering is quite apparent in this picture. The glass mat, which is of the same weight as the one in Figure 7, tends to be concentrated in the lowest part of the asphalt film. Some debris is clearly seen in the asphalt.

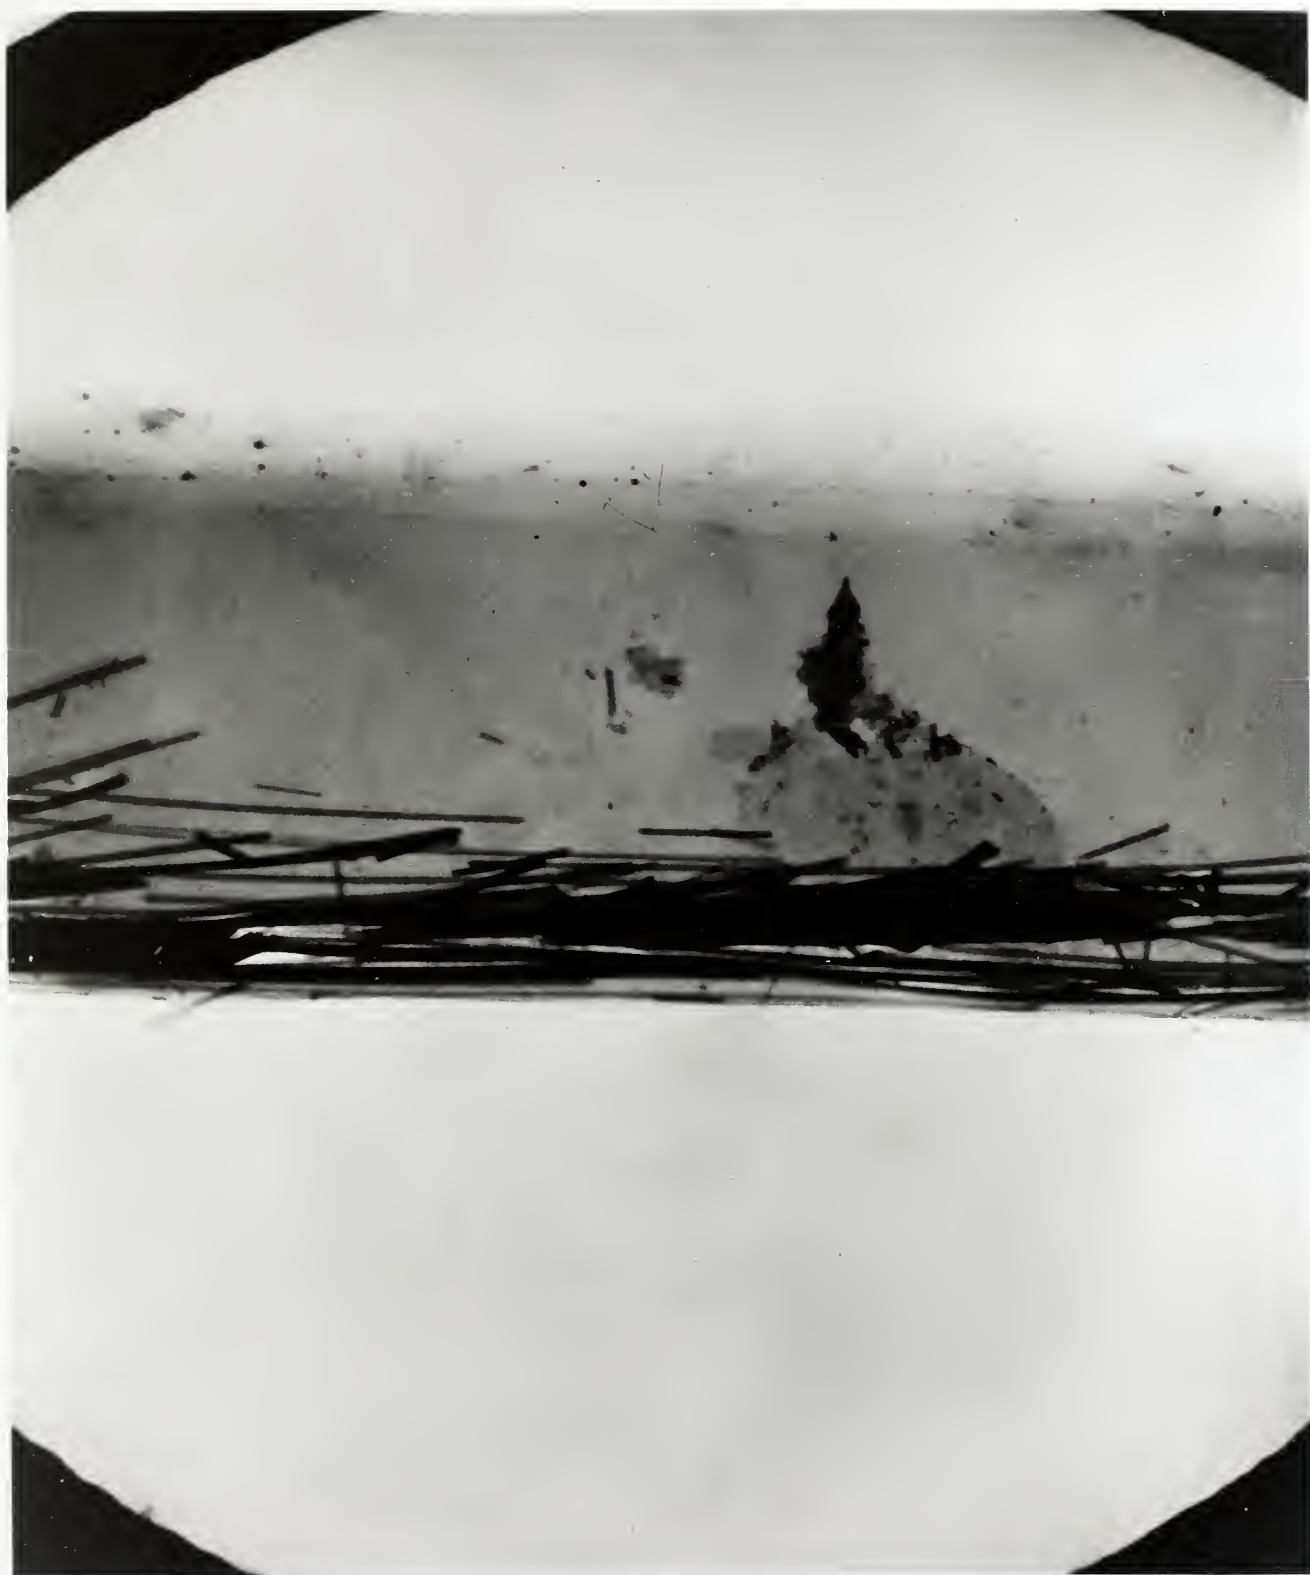
FIGURE 8. AN ASPHALT FILM CONTAINING JOHNS-MANVILLE
GLASS MAT AFTER 600 HOURS IN THE WEATHER-
OMETER - 120X

Figure 8 - Johns-Manville Glass Mat with Kansas Asphalt. Thickness - 30 mils.
Exposed 600 hrs to 51-9C cycle. Magnification 120 X.

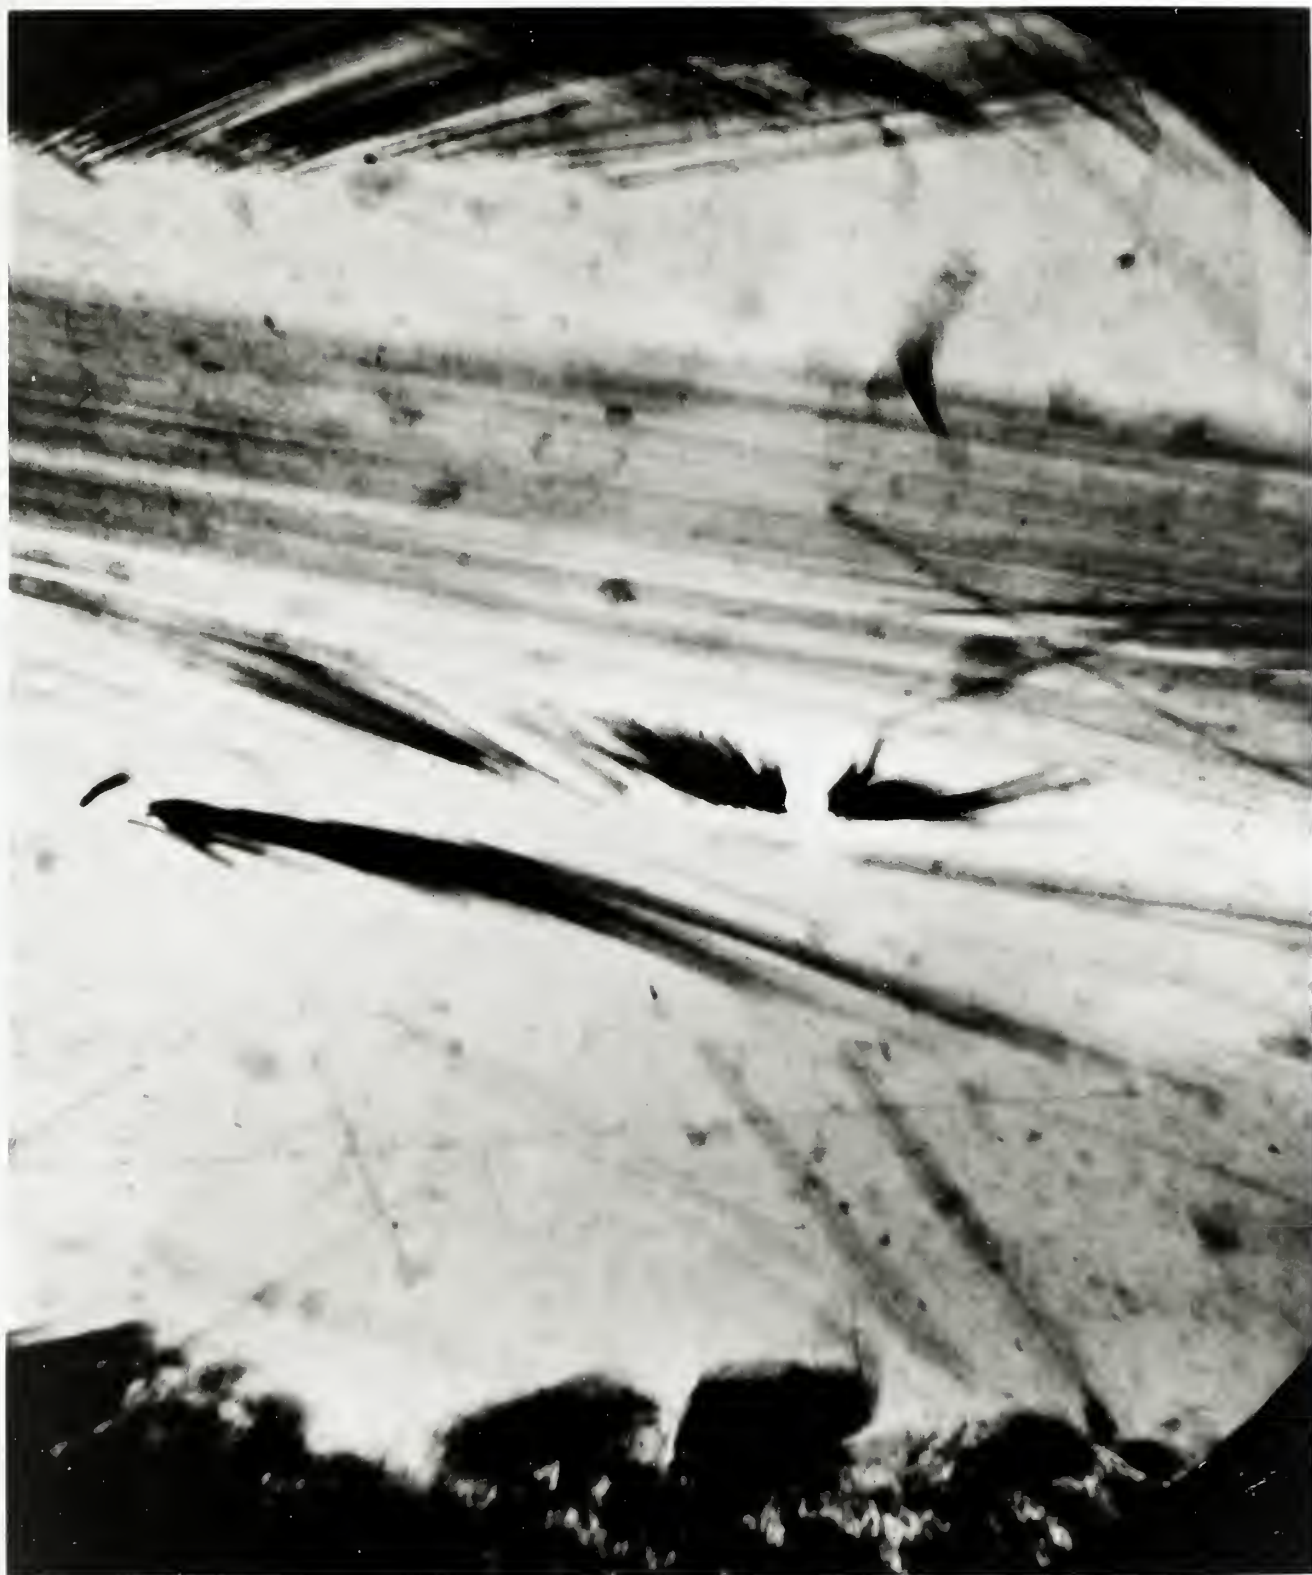
FIGURE 9. GLASS FIBER REINFORCED CLAY EMULSION ON A
COATED BASE SHEET

Figure 9 - Monoform Roofing - Clay Emulsion Reinforced with Chopped Glass Fibers on a Coated Sheet - Magnification Not Determined.

The mineral matter in the coating on the saturated felt is visible at the bottom of the picture. The random and irregular distribution of the glass fibers, as individuals and in clusters, throughout the clay emulsion residue is quite apparent. Clay particles are also quite apparent.
