TWR-18076

Field Joint Protection System Rain Qualification Final Test Report

11 May 1989

MORTON THIOKOL, INC.

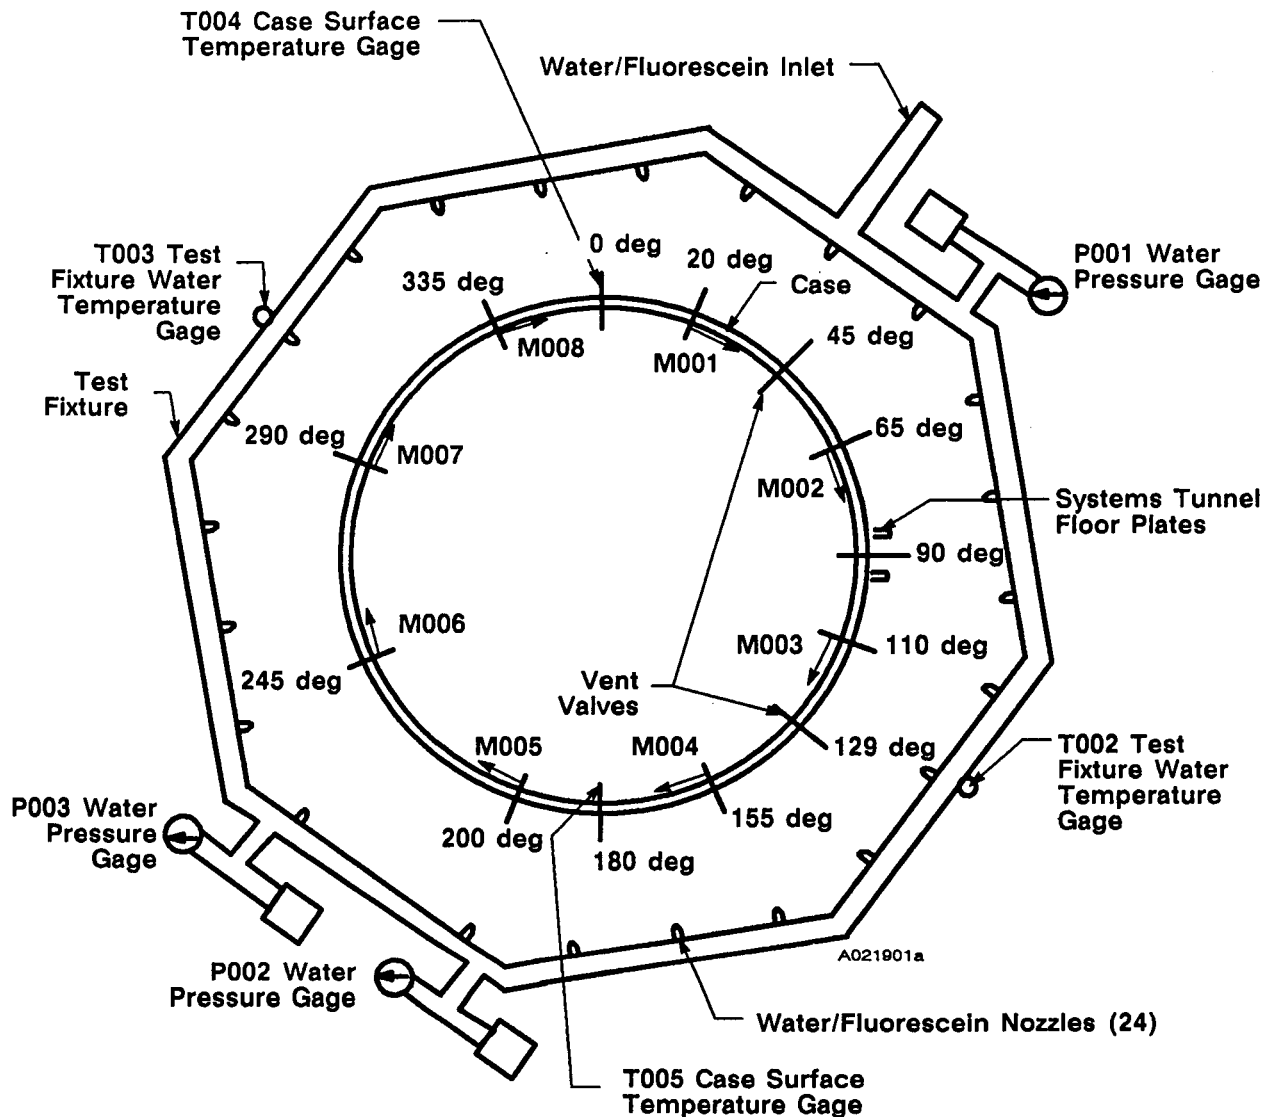
Figure 4. FJPS Rain Test - Top View of Test Configuration

Note: Moisture detection gages (M001 - M008) were installed every 45 deg, beginning at 20 deg. Each gage monitored moisture over the 45 deg it was installed. The gages were installed directly on the case D6AC steel between the joint heater and the clevis, per 7U76498

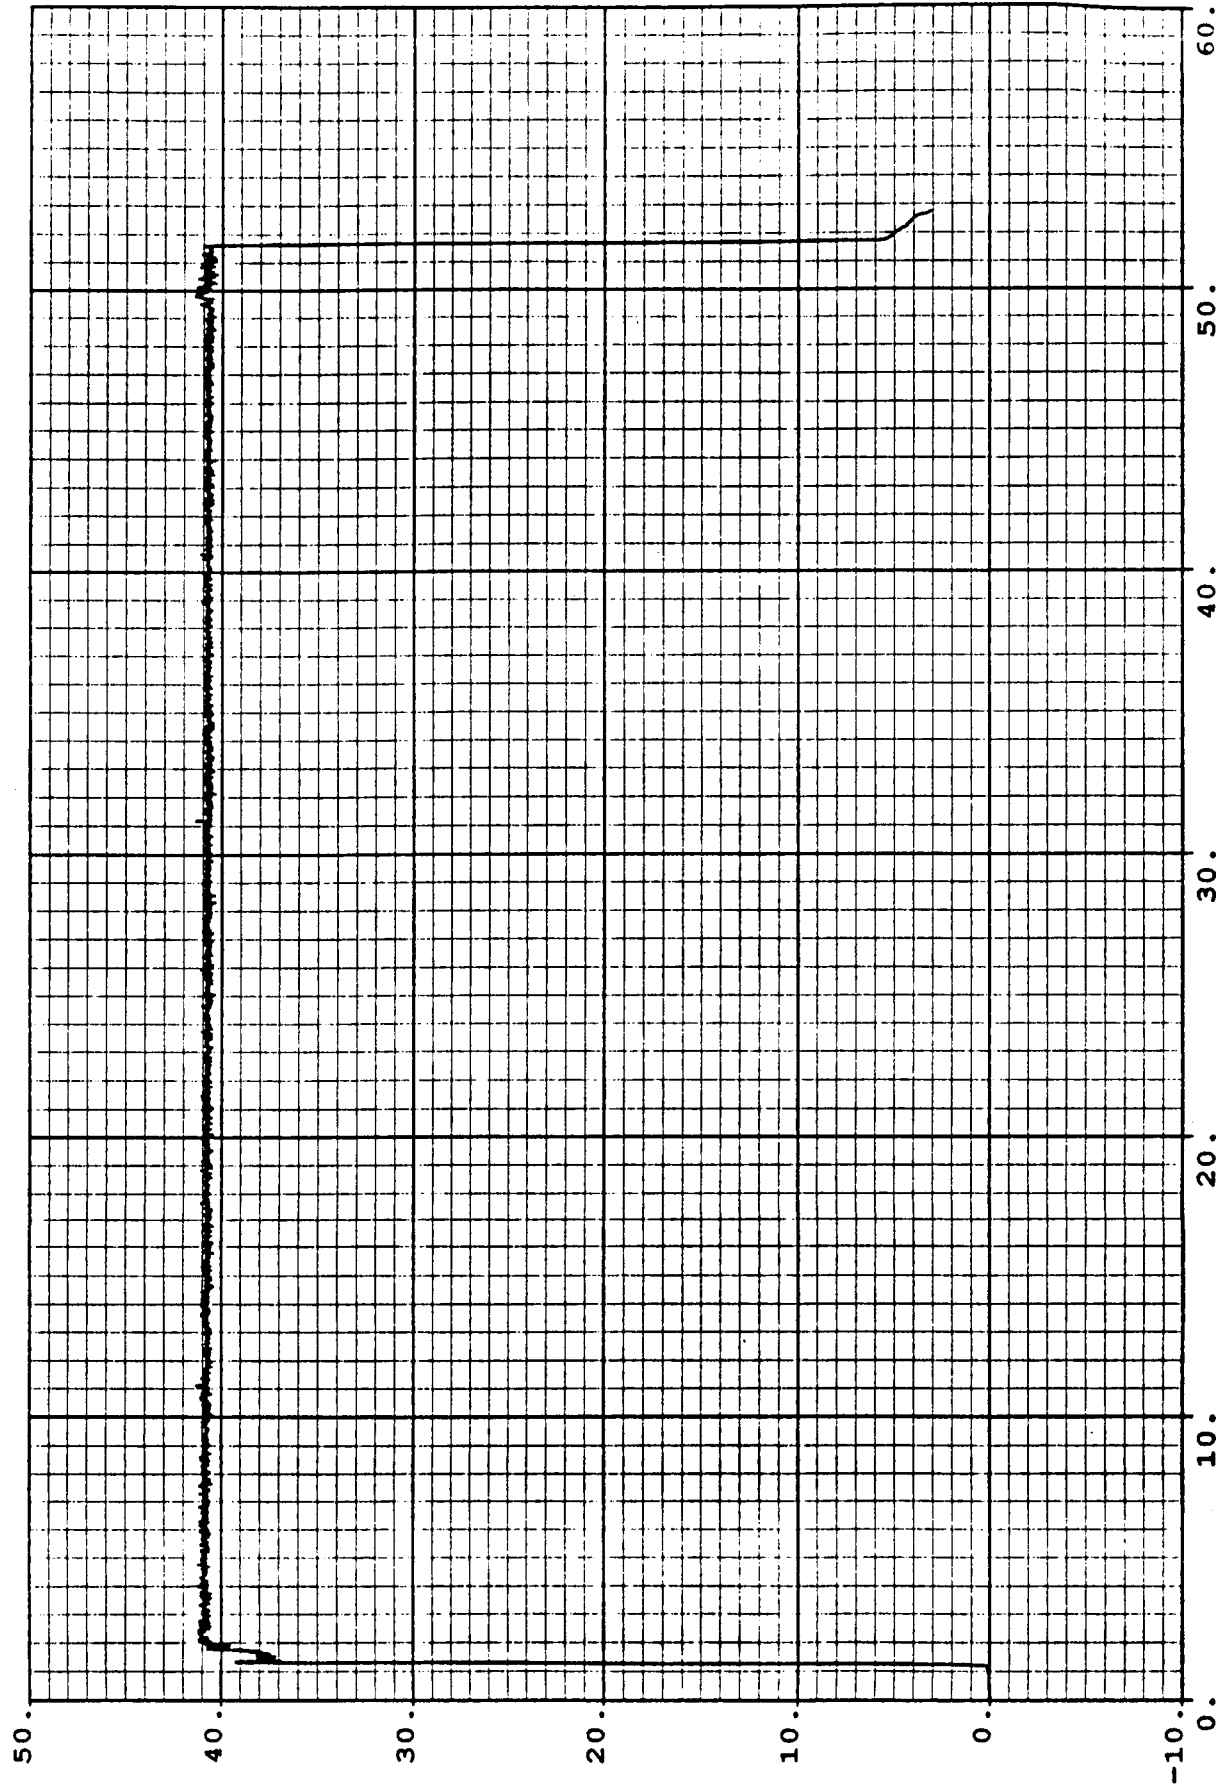
P001 Water Pressure

Three pressure gages (P001, P002, P003, locations shown in Figure 4) were used to monitor test fixture water pressure, and the results are included in the appendix. P001 was damaged at approximately 30 minutes into the test due to water in the gage connector. However, results of the other two gages show that constant water pressure (approximately 41 psi) was maintained throughout the test.
