High-R Walls for Remodeling: Wall Cavity Moisture Monitoring

J. Wiehagen and V. Kochkin
NAHB Research Center

December 2012

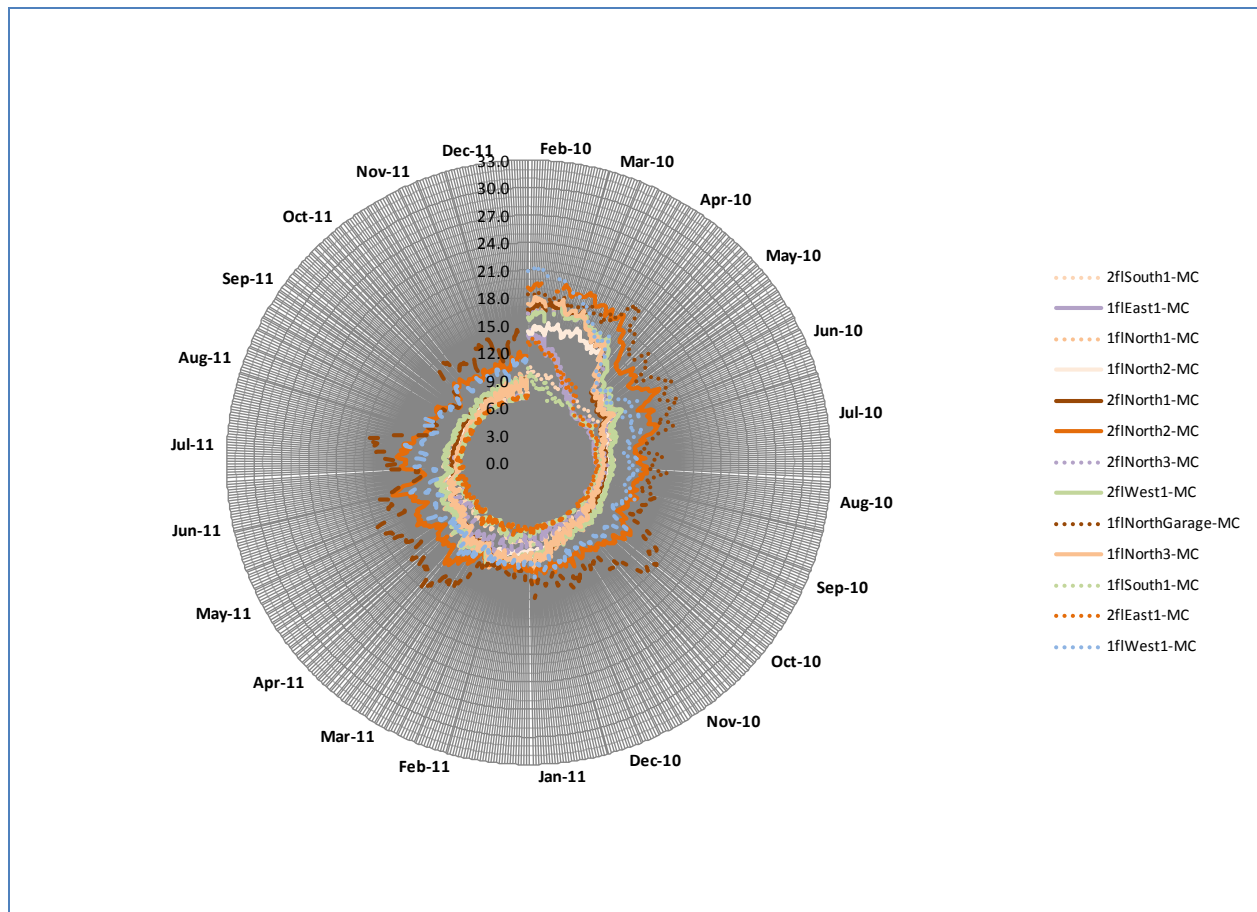
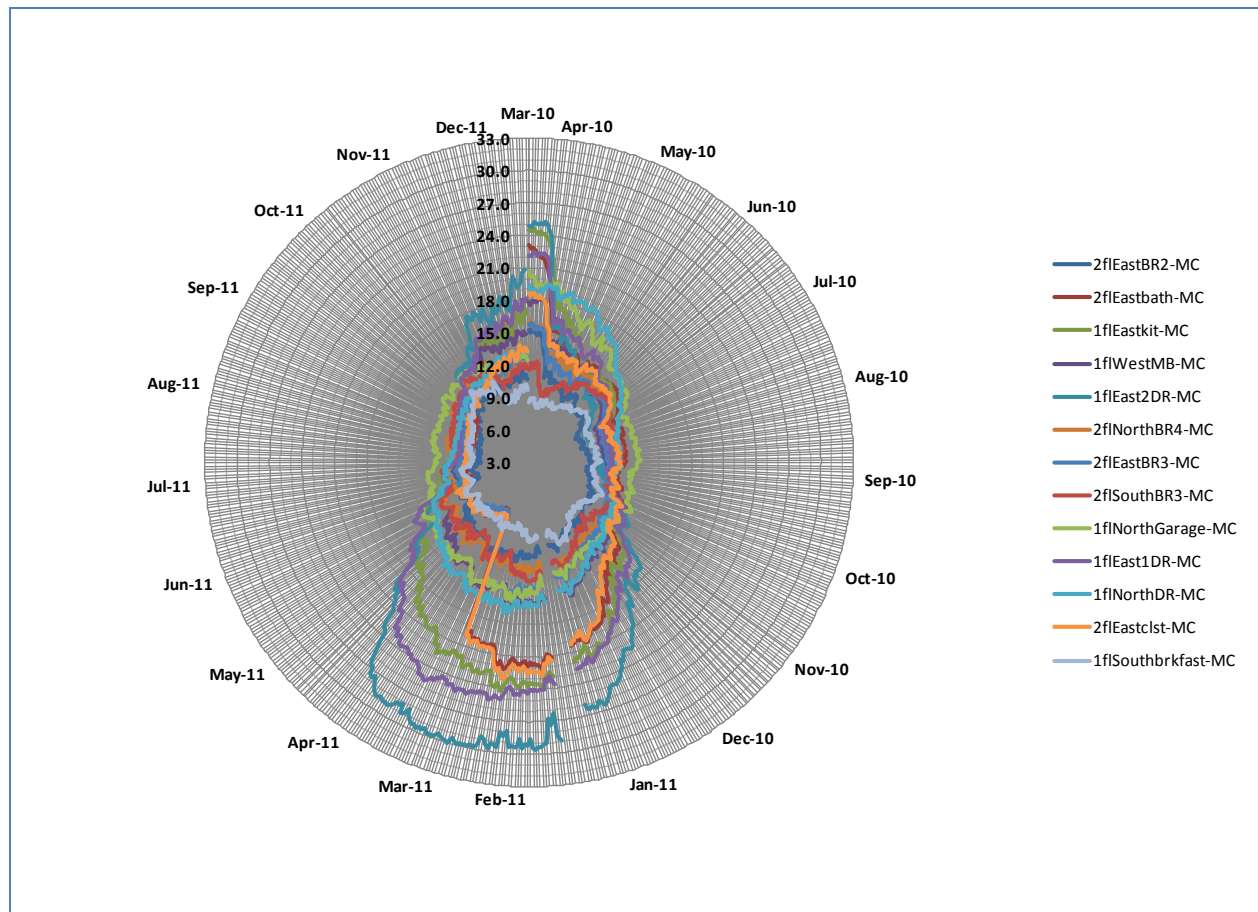
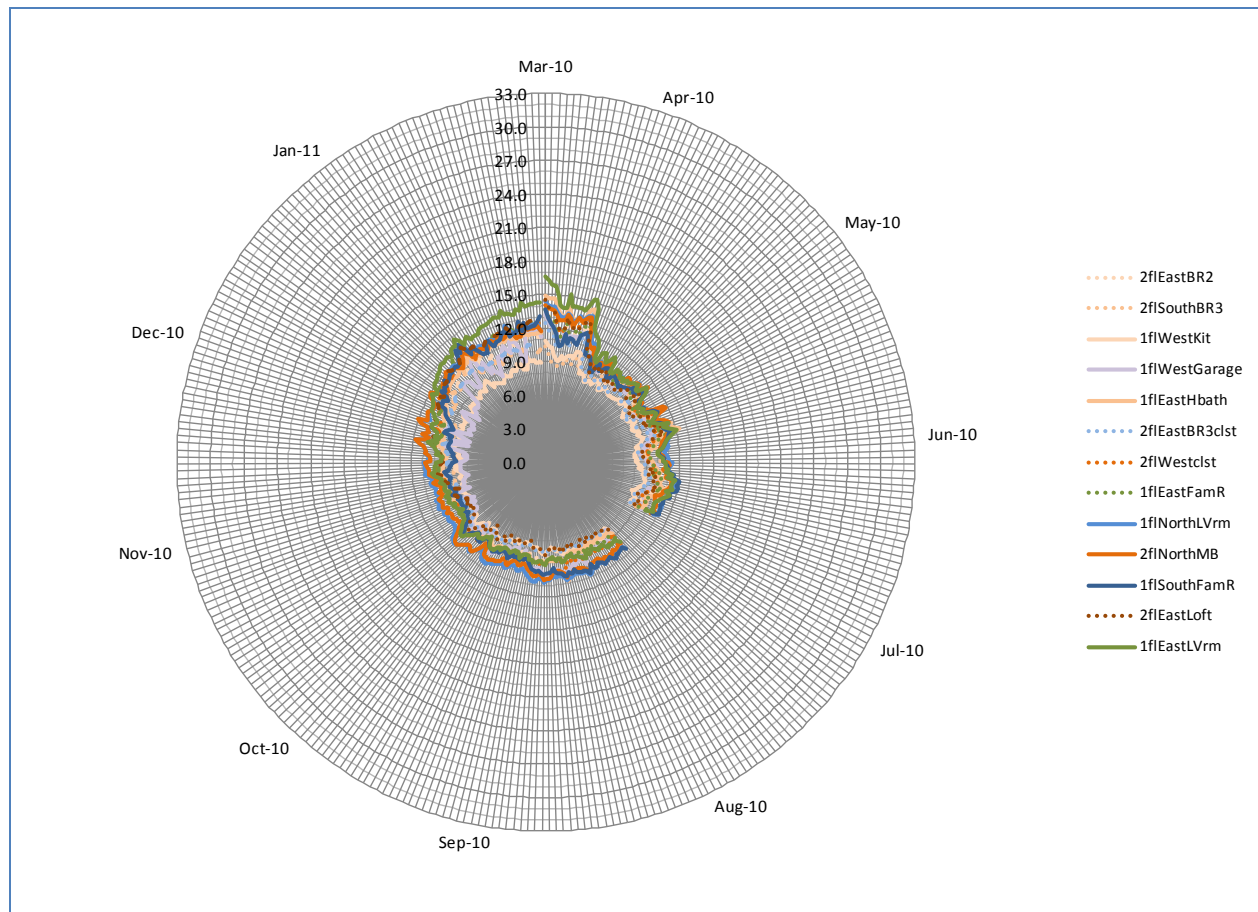
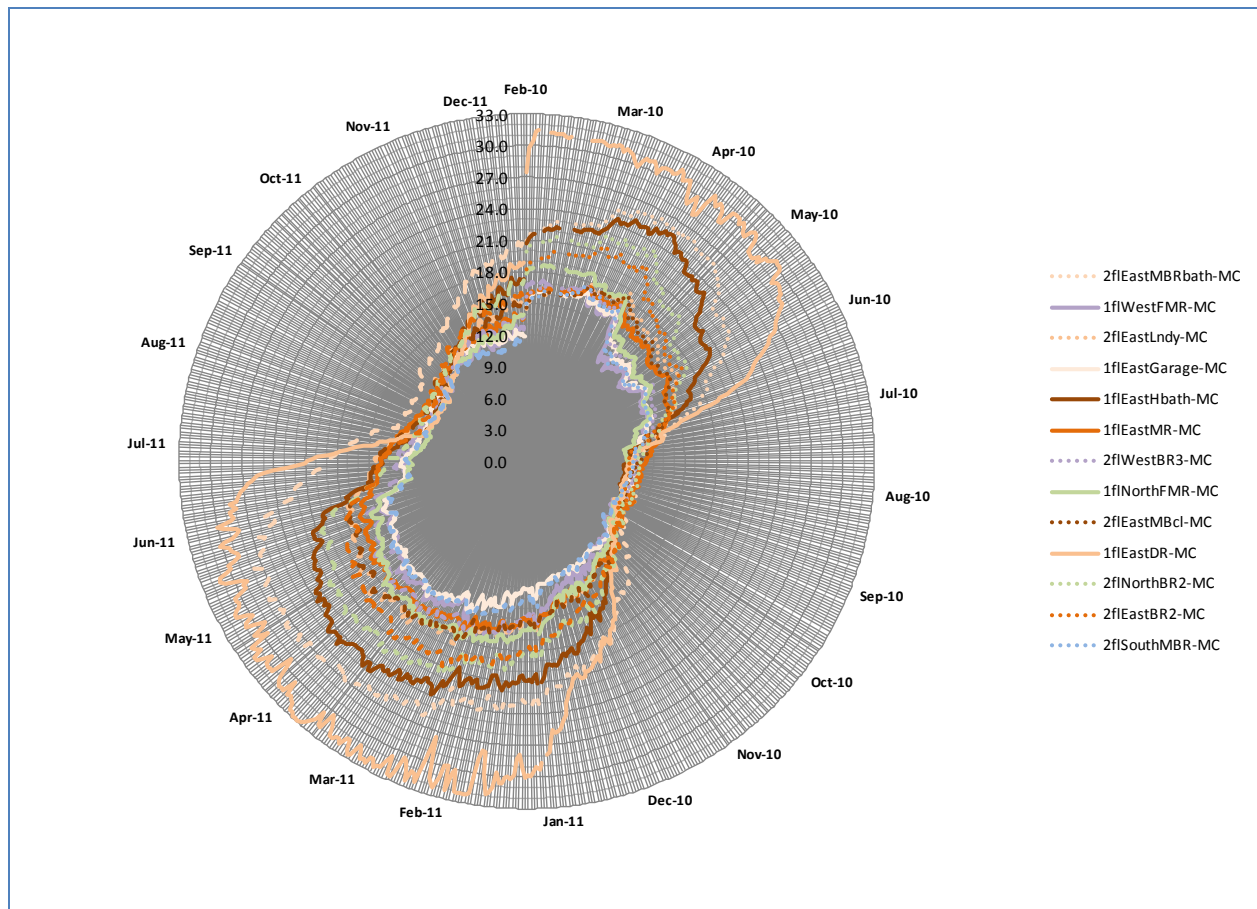
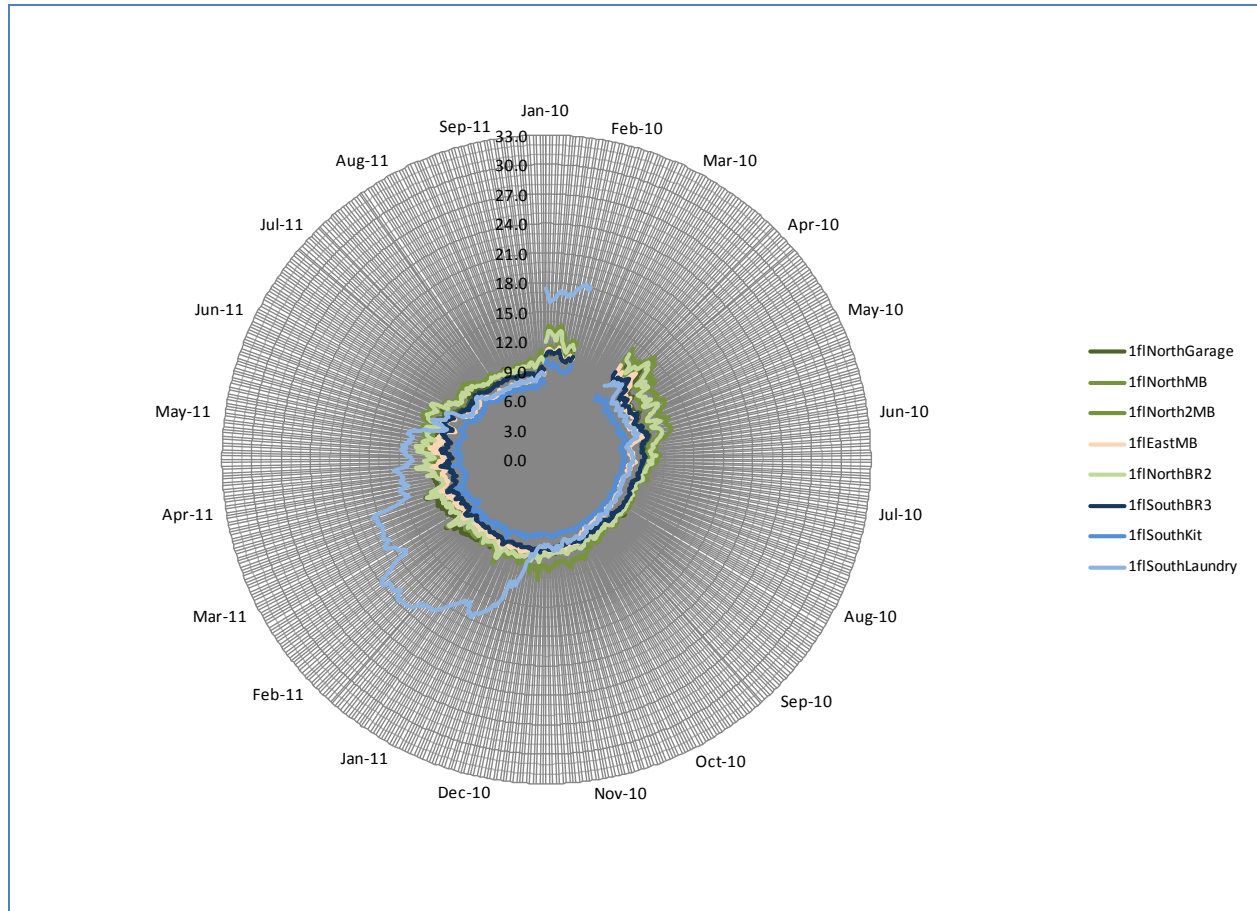
Figure 17 through Figure 21 chart the change in the OSB sheathing MC for each test site based on daily averages. The data come from all wall cavities with available moisture sensor readings, including the unconditioned garage wall cavity. The radial chart begins and ends at the 12 o'clock position regardless of the total range of dates for the plot. In all cases, the starting point is within a few months of construction completion. The same data are included in Section 7.4, but charted using a linear plot line.

As would be expected, the MC of the OSB sheathing increases in the winter months, peaking in late winter. In the colder months, and more generally in occupied homes with lower air infiltration rates, the moisture drive is from the interior to the exterior. The moisture drive would include exfiltration and diffusion. In most cases, the drop-off to lower MC levels occurs in early spring through the summer and into the fall, when the cycle repeats.

As seen in the previous charts, Jobsites 2 and 5 show elevated MC in some wall cavities. The MC measurements indicate levels reaching to slightly greater than 30% in a few wall cavities. This level of MC suggests a fiber saturation point state of the OSB panels.
