NASA/TM-2013-217799

Ultrasonic Nondestructive Evaluation of PRSEUS Pressure Cube Article in Support of Load Test to Failure

Patrick H. Johnston
Langley Research Center, Hampton, Virginia

May 2013

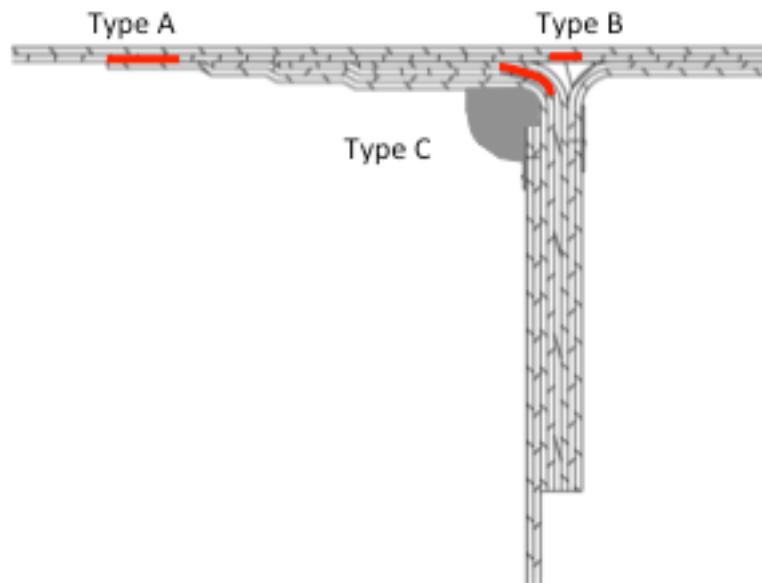
In analyzing the ultrasonic measurements of the cube after the test to failure, there were three distinct types of flaws identified. These three types are schematically depicted in Fig. 4.7. These types are defined as follows:

Figure 4.7. Definition of damage types found in cube following test to failure. Type A is a delamination between the skin laminae and the laminae comprising the flange of a stringer, frame or end cap. Type B is a delamination in the laminae above the noodle of a stringer, frame or end cap. Type C delaminations occur in the curved laminae forming the inner corner of an end cap.

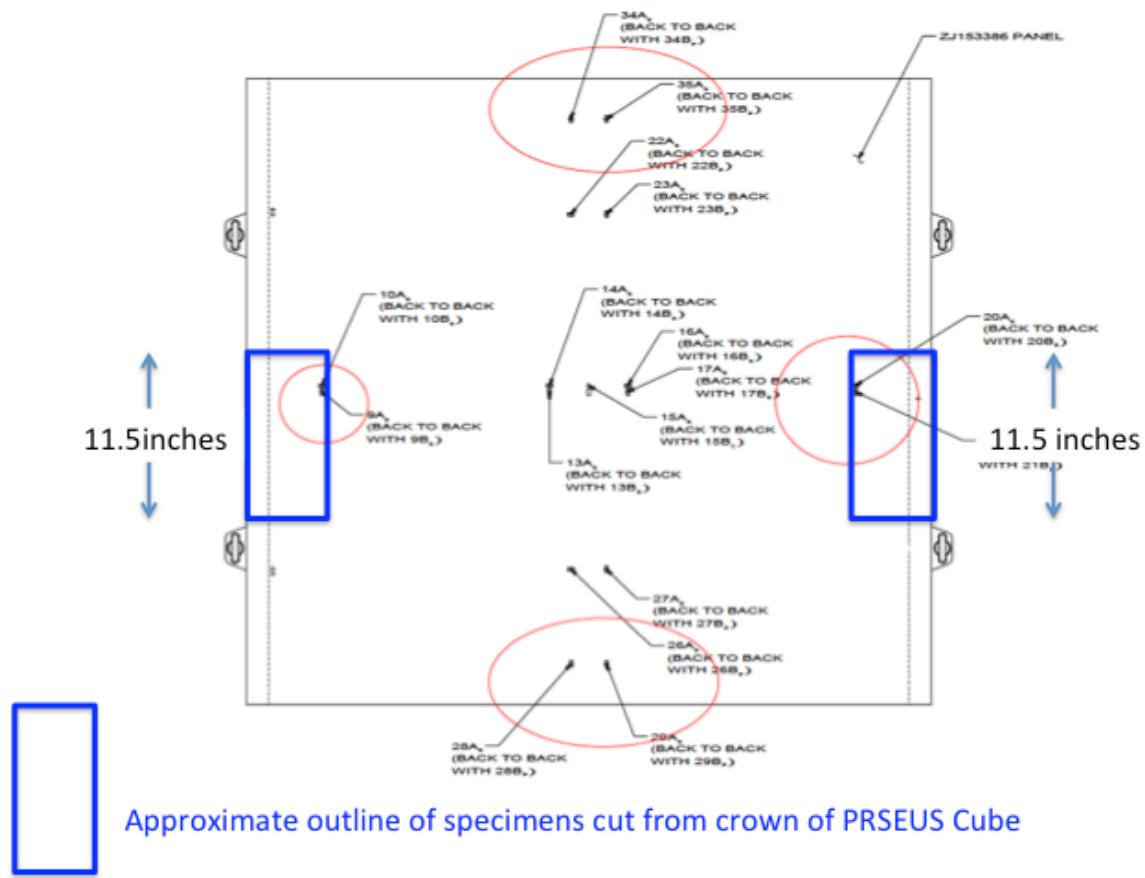
Two sections of the crown end caps were dissected for analysis. Figure 4.15 indicates these areas by blue rectangles. The specimens were labeled Side A and Side B. Because the crown panel had been spray painted after the installation of strain gages and wiring, there was a clearly identifiable pattern on the two specimens where the gages, wiring and tape had been removed. These marks aided in identifying the precise locations of the two specimens on the crown panel. Photographs of specimen Side A and its location on the crown panel are compared in Fig. 4.16.

Figure 4.15. Areas of Crown panel selected for cutout and further inspection

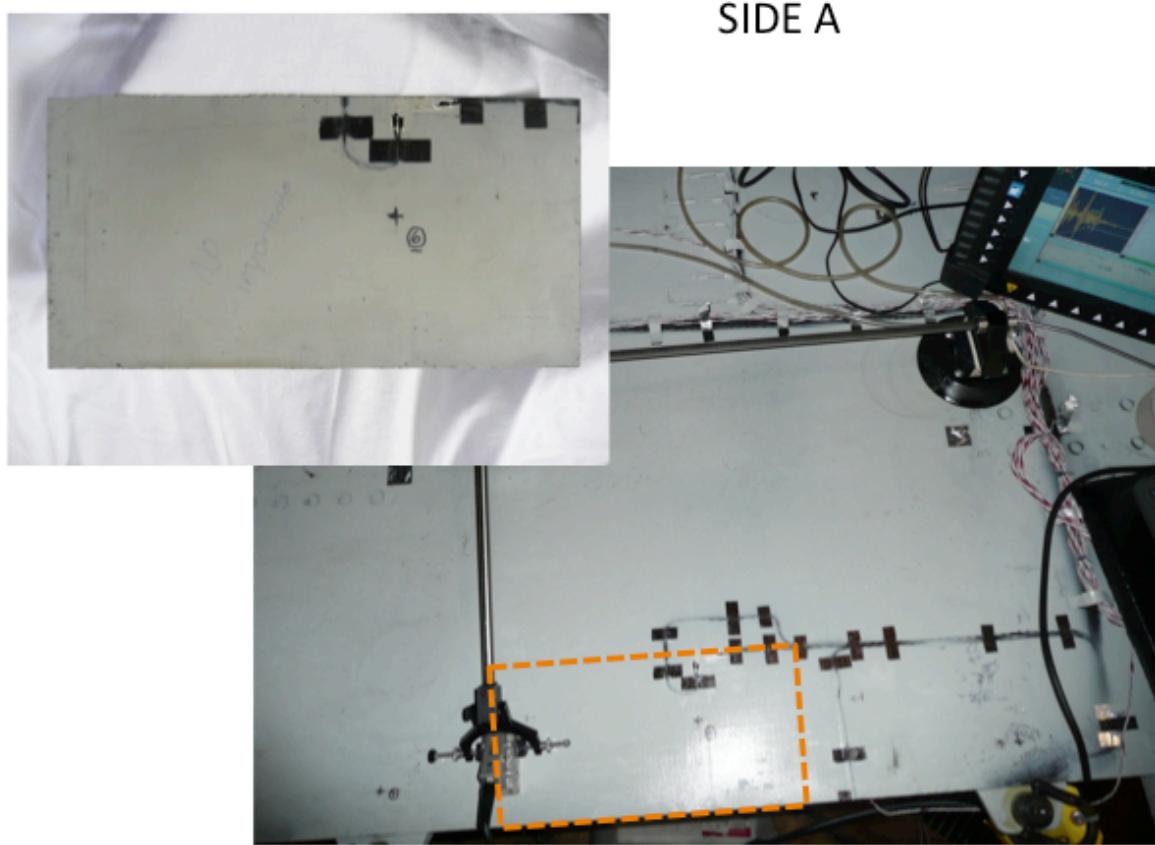
Figure 4.16. Photograph of the external surface of cutout labeled Side A. Below is a photograph of the intact crown under inspection, with the extent of Cut-out Side A identified by an orange dashed rectangle.

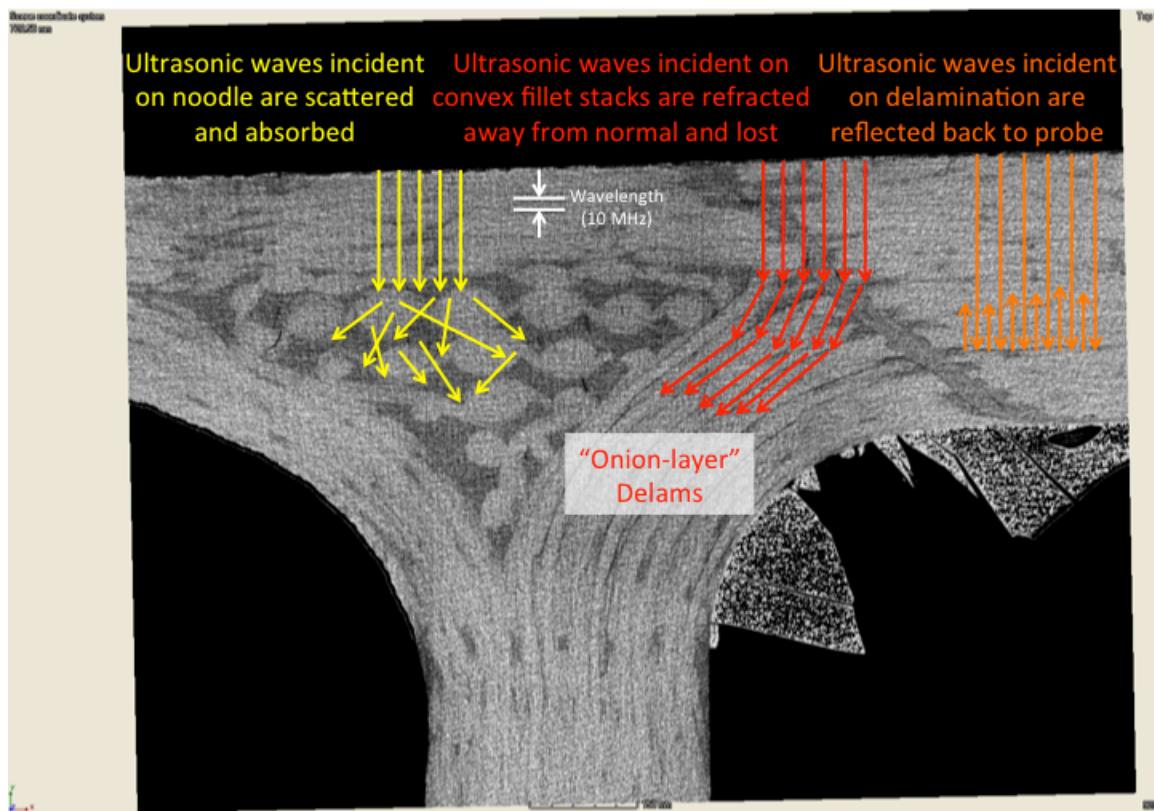
The x-ray CT in Fig. 4.22 is reproduced in Fig. 5.1 to support this discussion. For all of the ultrasonic inspections from the outer surface of the cube, the ultrasonic beam was incident normal to the surface. The ultrasonic waves penetrating the face sheet are represented by the parallel vertical lines in the face sheet area in the figure.

and refractive phenomena which disperse the ultrasonic beam, with the result that little or no ultrasound is sent back in the direction of the transducer, causing an echo-free zone. The yellow arrows in Fig. 5.1 illustrate this behavior.

Further analysis of the structure suggests that another phenomenon, related to the curvature in the fillet laminae, is also acting in this case. The orange arrows in Fig. 5.1 illustrate the normal-incidence ultrasonic waves propagating through the face sheet laminae into the parallel laminae of the end cap flange, beyond the first row of stitches from the end cap. Here, the ultrasonic waves encounter a delamination which has extended beyond the stitch row. This delamination is parallel to the interlaminar interface and perpendicular to the incident wave propagation, so the ultrasound is reflected from the delamination back to the transducer to be detected. These represent the delamination indications labeled Type C.

Figure 5.1. X-ray CT slice with superimposed ultrasonic ray tracings to schematically explain the interpretation of ultrasonic data.
