NASA/TM-2013-217990
NESC-RP-10-00685

Composite Crew Module (CCM) Permeability Characterization

*Michael T. Kirsch/NESC
Langley Research Center, Hampton, Virginia*

May 2013

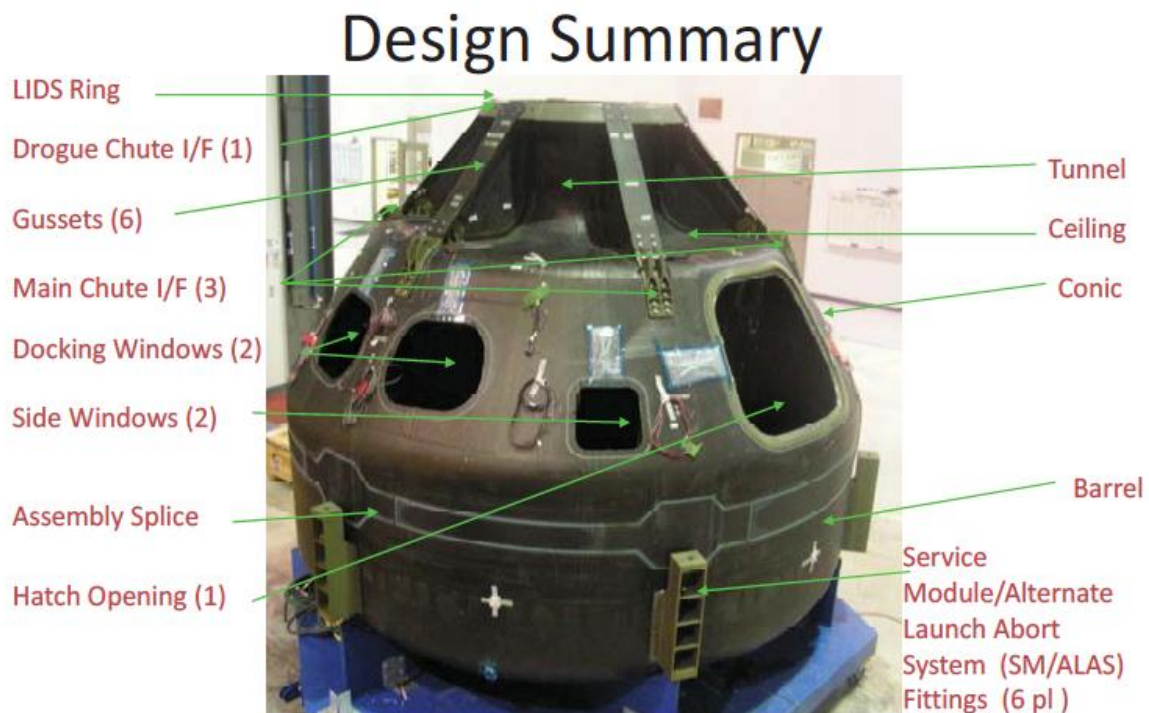
Figure 7.3-1. CCM Design Features

The CCM leak integrity approach was to use predominantly sandwich systems with unvented cores. The approach provided two barriers against through-thickness permeability: the IML skin and the outer mold line (OML) skin. The skins in the acreage areas consisted of four plies of fabric. It was shown that exceedingly low impact damage (less than 2 ft-lb) could cause leakage and would not be detectable visibly or with NDE techniques. Given the extensive subsystem integration both on the inside and the outside of the CCM, there was a possibility of undetected damage coincident on the inside and outside that could provide an undetected leak path. Some areas of solid laminates were also used in the design, specifically the tunnel, the backbone cap, and the pan down regions where metallic fittings such as parachute fittings and SM/ALAS interface fittings were bolted through the shell. Although higher impact energies are required to damage these regions, there is no redundancy to prevent leakage.

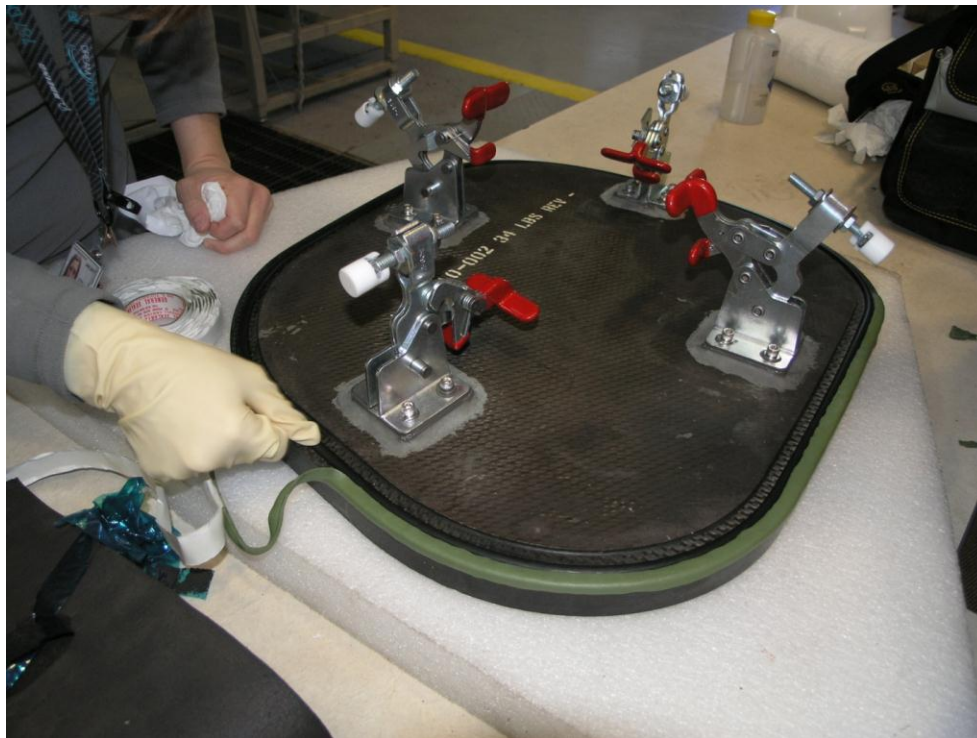
Prior to leak testing, six distinct openings had to be sealed: one docking tunnel cover, one main entry hatch, two docking windows, and two side windows. The single O-ring hatch seals were not expected to be sufficient to meet the leak requirements; additional sealing was provided with vacuum putty. The putty was placed around the inside of the hatch seals just outside the O-rings. Additional putty was placed in gaps around the hatch IML once installed. Figures 7.3-2 through 7.3-5 show the various stages of the hatch installation.

Figure 7.3-2. Vacuum Sealant Tape (i.e., vacuum putty) Installed on a CCM Hatch Cover on the Outside Flange Next to the O-ring

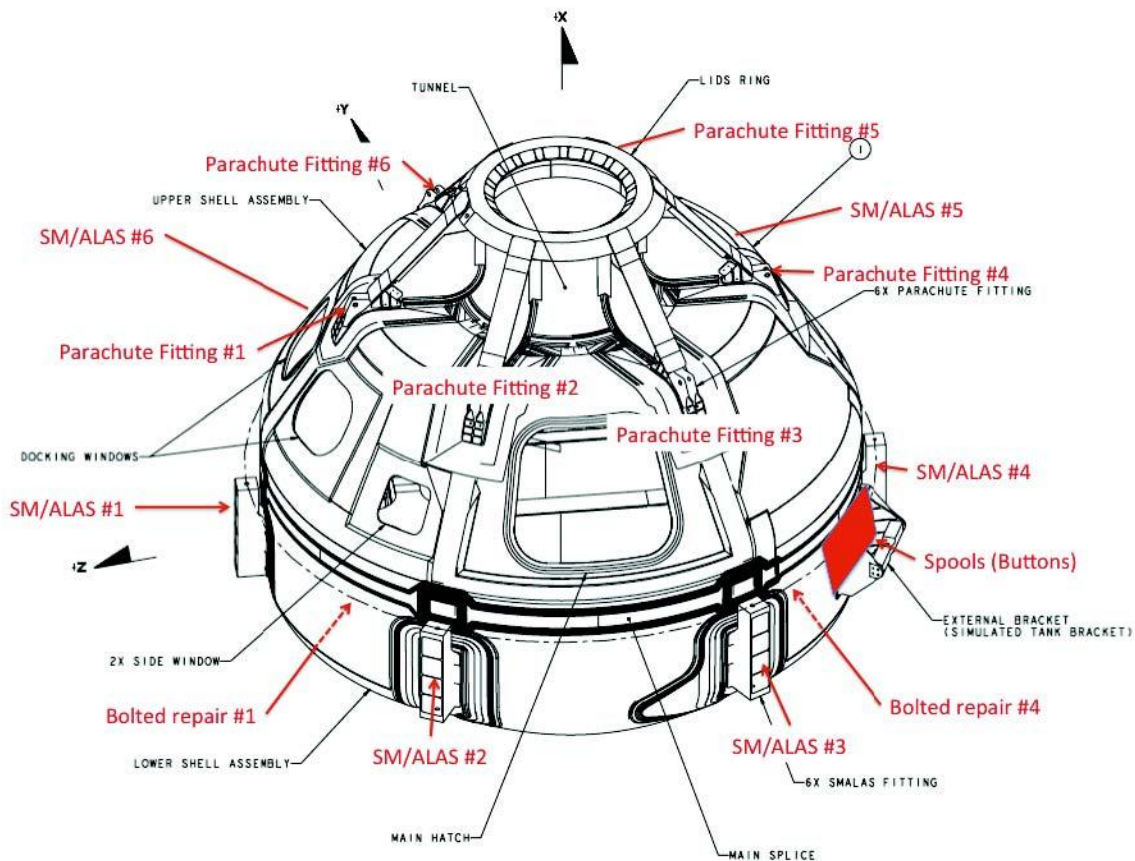
To measure leak rates across a specific CCM feature, a hybrid leak test method was devised that involved placing an active vacuum bag on the feature's external surface and then measuring the helium migration while the CCM was pressurized. This technique was used to measure leak rates on the closed hatch covers and the permanently attached fittings (e.g., six parachute attach points and six SM/ALAS fittings). A schematic of the CCM is shown in Figure 7.3-6; each detail that was measured with an external vacuum bag is labeled in the figure.

Figure 7.3-6. Schematic Illustrating the Features that were Measured Using the Vacuum Bag Technique (indicated in red)

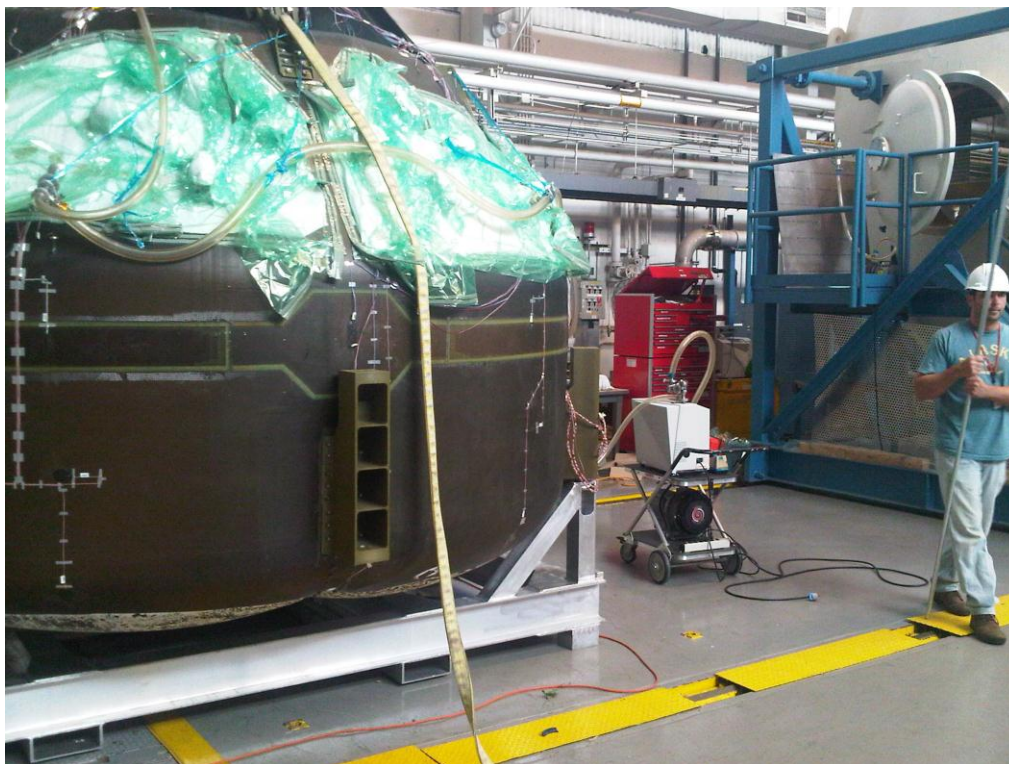
Figure 7.3-9. Installed Hatch Vacuum Bags Attached to a Mass Spectrometer

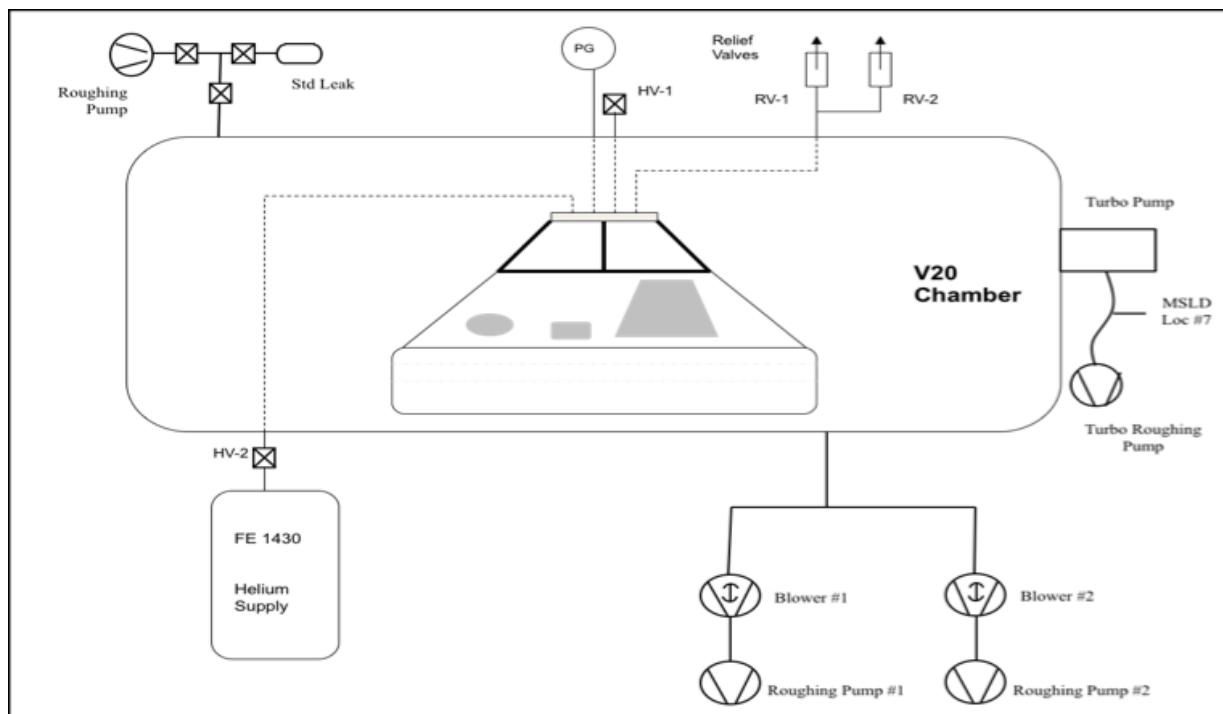
The details of the full-scale leak testing can be found in reference 11, with excerpts contained herein. All the leak rate tests were conducted in the Marshall Space Flight Center (MSFC) V-20 vacuum chamber located in Building 4619. The setup is shown in Figure 7.3-10.

Figure 7.3-10. Schematic for Measuring the Total Leak Rate of the CCM
