NASA/TM-2014-218538 (Corrected Copy)  
NESC-RP-14-00957

# A Comprehensive Analysis of the X-15 Flight 3-65 Accident

*Cornelius J. Dennehy/NESC  
Langley Research Center, Hampton, Virginia*

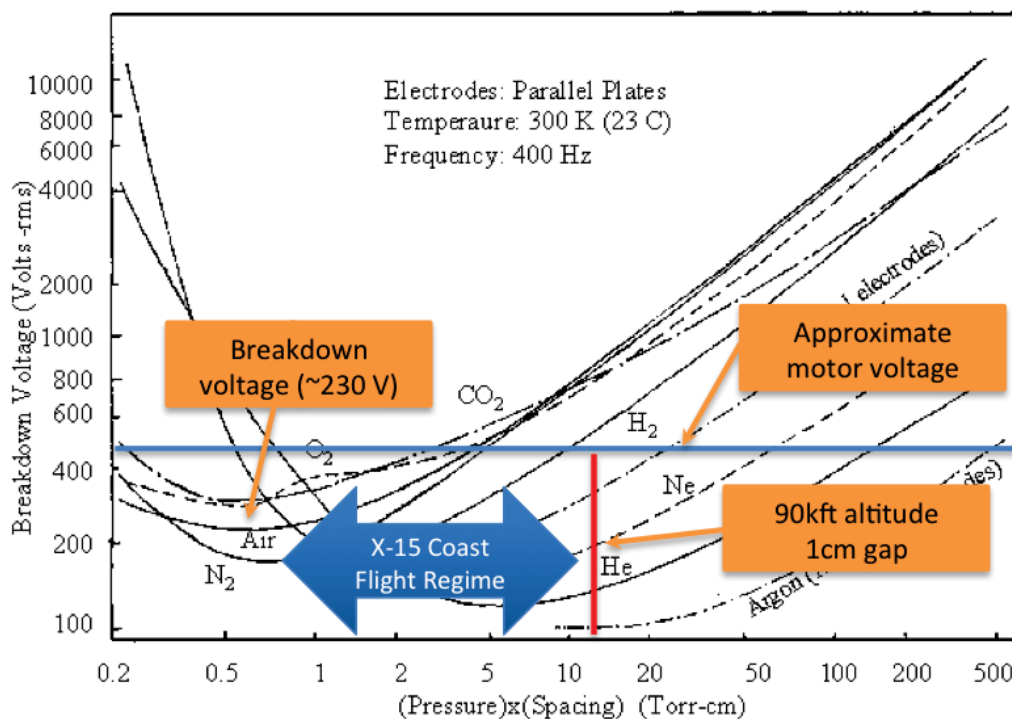
**Figure 8.1-1. Paschen Curve for 400 Hz Potential at 300 degrees Kelvin [ref. 32]**

Dielectric breakdown in low-pressure gases is a known phenomenon in high-voltage systems [refs. 30–32]. Dielectric breakdown phenomena obey the semi-empirical Paschen’s Law, which describes the minimum breakdown potential (in V) associated with a parallel plate electrode configuration as a function of the product of pressure and gap distance ( $pd$ ). The breakdown voltage approaches a minimum at a specific value of the pressure-gap product and increases elsewhere (see Figure 8.1-1, reproduced from data appearing in reference 32).

Even at the critical  $pd$  value, quiescent breakdown in air generally will not occur below 300V. However, deviations from the basic Paschen law result from various factors, including the presence of nonuniform or oscillating electric fields (e.g., conductors with sharp radii and AC potentials, respectively). In the latter case, 400 Hz AC potentials as were used in the X-15 AC power bus reduce the threshold to about 230V. Unknown to the traverse probe experiment developers, the commercial-off-the-shelf (COTS) AC motor selected from existing inventory contained a transformer circuit that multiplied the 115V input by a factor of about 4, yielding a peak potential in the experiment exceeding 630V. Under reduced-pressure conditions, arcing was practically guaranteed across uninsulated gaps of modest spacing. As the design was not thoroughly reviewed for environmental compatibility or tested in simulated altitude conditions prior to installation on the aircraft, the breakdown phenomena was first seen in flight. The investigating board theorized that during the relatively short exposure to the high-altitude environment on the previous two flights, arcing may have occurred, but could have gone undetected as no particularly sensitive electronics were installed on the other X-15 aircraft [ref. 3].

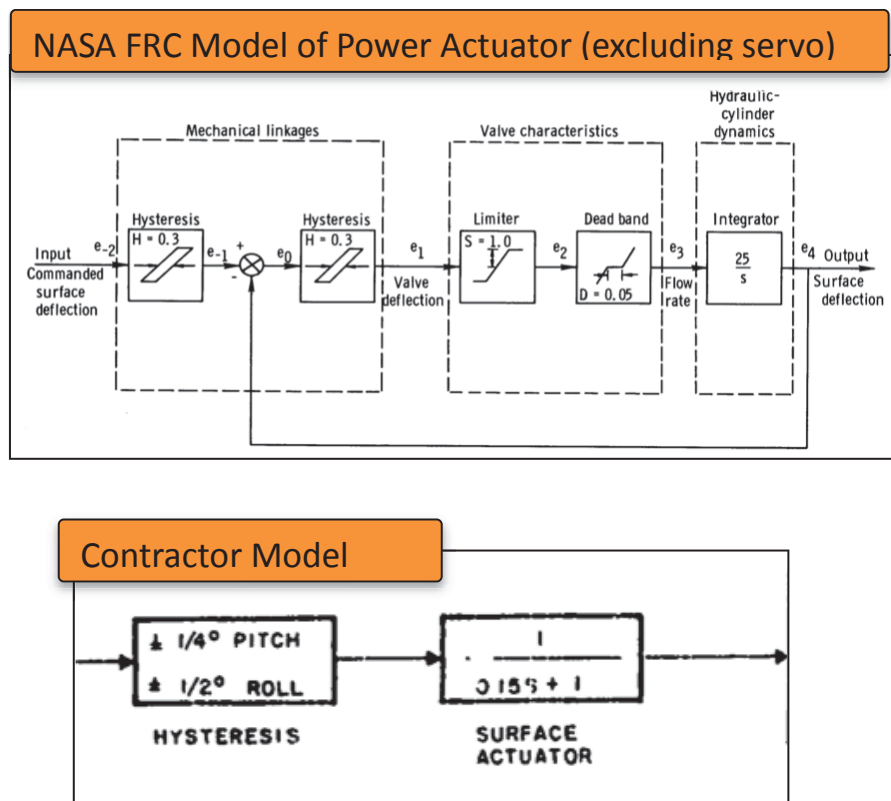
**Figure 8.5-1. Surface Actuator Models Used in Design [refs. 34 and 35]**

However, while NASA FRC had used a nonlinear model of the servo and power actuator with more extensive HWIL simulation to verify the filter design, the contractor apparently did not have access to the same type of model data and used a simple first-order lag model with hysteresis only (Figure 8.5-1). As such, a latent design sensitivity was introduced into the inner loop of the MH-96 SAS that would allow the SAS rate loop to become unstable in the presence of actuator rate saturation.

The transition from the desirable small-amplitude LCO to the large-amplitude destructive LCO was an artifact of the rate-limited power actuator with its semi-integrating servo loop. A known effect of power actuator rate limits is the introduction of an amplitude-dependent equivalent phase lag in the inner loop, which plays an important role in the sensitivity to pilot-induced oscillations (PIO). As can be seen in Figure 8.5-2, the presence of rate limits severely degrades the equivalent nonlinear frequency response of the X-15 actuator. The severe landing PIO encountered on X-15 Flight 1-1-5 was an effect of the same rate-limited actuators, albeit in a different failure mode [ref. 36].

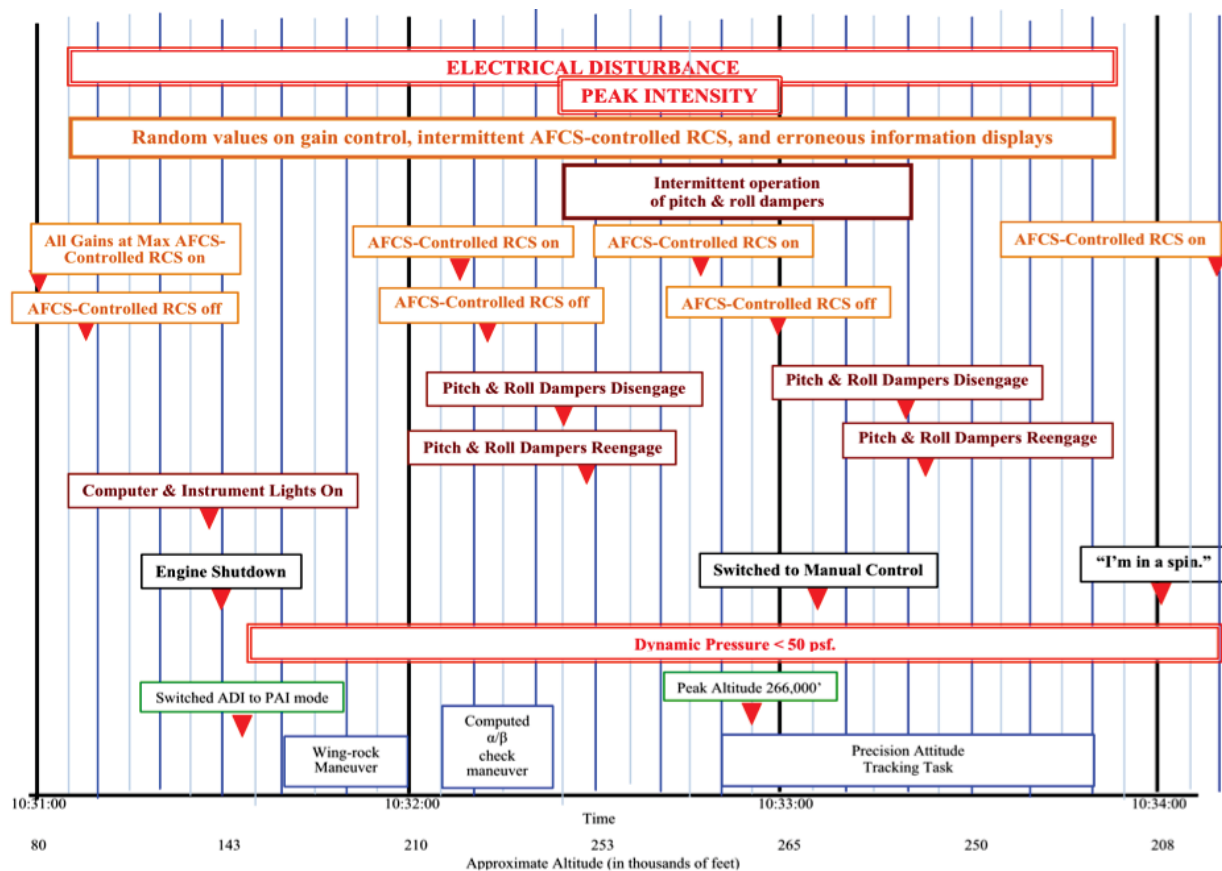
**Figure 9.1-1. 3-65 Event Timeline**

Figure 9.1-1 illustrates the timeline of the major events leading to the loss of the pilot and the aircraft, and diagrams the sequence of key events during the 3 minutes following the initial traverse probe electrical disturbance. Note that the timeline in Figure 9.1-1 ends at about 10:34:17 PST (MET + 249 seconds), or about 37 seconds before breakup. The time history of the MH-96 AFCS gains is shown in Figure 9.1-2.

Beginning at 10:31:07 PST (MET + 59 seconds), the electrical disturbance caused erratic fluctuations in the automated gain control from maximum to minimum as seen in Figure 9.1-2, which caused the pilot's access to the RCS through the right side stick to be intermittent throughout the 2-minute, 46-second duration of the electrical disturbance.

At 10:32:27 PST (MET + 138 seconds), the pilot reported that the pitch and roll dampers had tripped out.

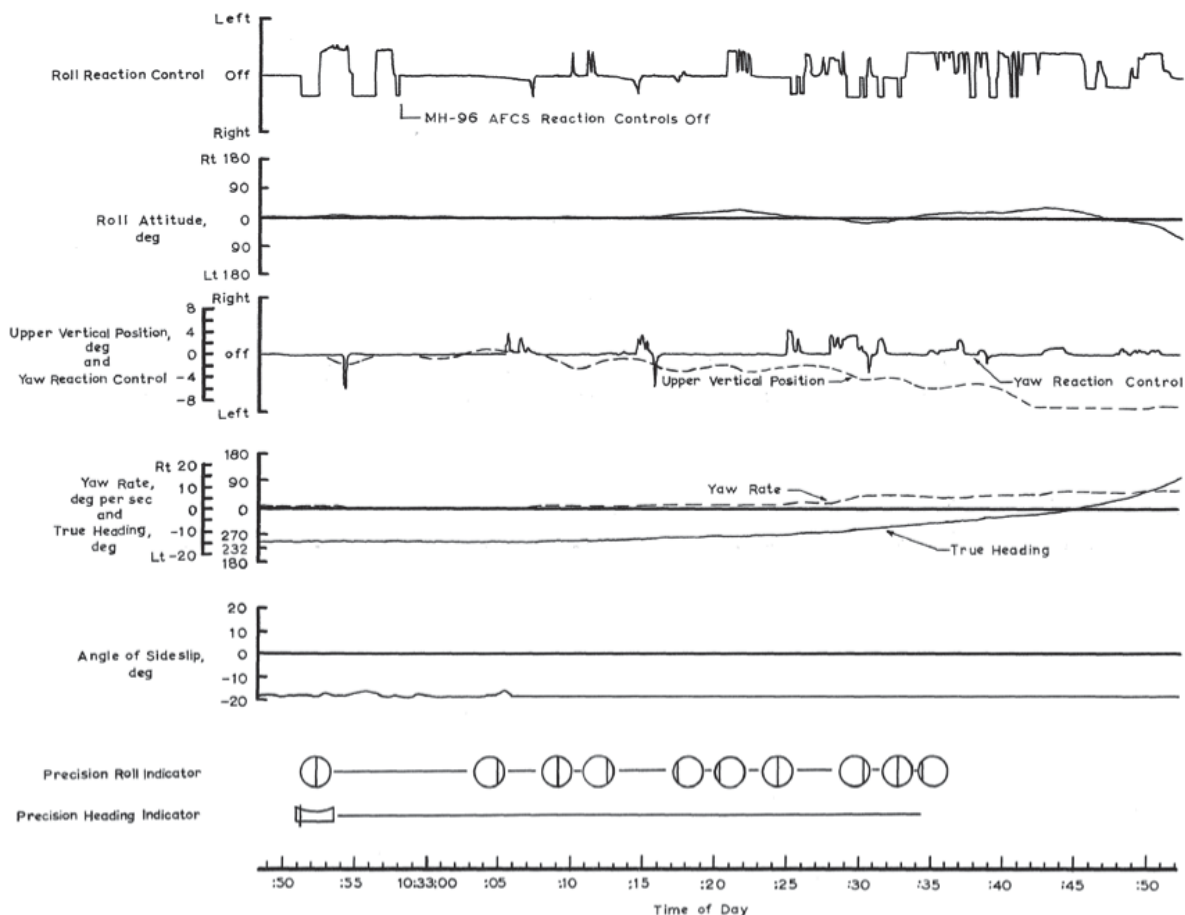
**Figure 9.2-1. Time History of Precision Attitude Tracking Task at Peak Altitude [ref. 3]**

The evidence suggests the pilot forgot he was in the PAI mode when he switched to the left-hand stick RCS control. However, at the moment he switched control, he was performing the precision attitude-tracking task (Figure 9.2-1) and he continued to try to complete that task after he switched hands. It is difficult to believe that the pilot would have forgotten that he was in the PAI mode while he was in the process of performing the very maneuver for which the PAI mode was specifically designed.

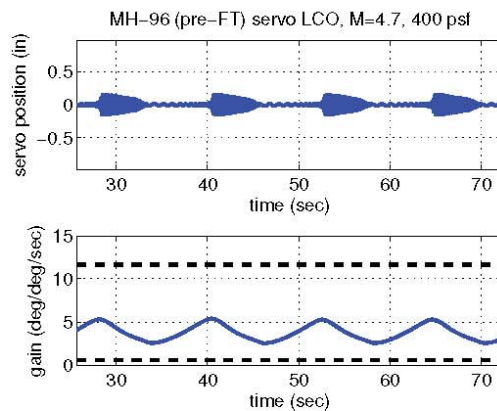
The nominal adaptation test case is designed to evaluate the gain changer behavior. The aircraft dynamics are held in a fixed-parameter configuration at a Mach number of 4.7 and a dynamic pressure of 400 psf. The gain cycling behavior consistent with the literature [17] is shown in Figure A.11. In this case the servo LCO frequency appears at the expected 3.5-4.0 Hz. The cycling behavior appears only in quiescent conditions and is substantially more pronounced with the original filter design. The modified (flight) design, consistent with the data found in [15], exhibits better steady-state convergence and lowers the servo LCO frequency to approximately 2 Hz (Figure A.12). In both cases, the resultant motion at the surface is on the order of 0.5 degree peak. As noted in the original design documentation, the attainable limit cycle frequency and amplitude depends strongly on the hysteresis and deadbanding in the actuator linkages.

Figure A.11: Gain cycling (pre-flight-test configuration)

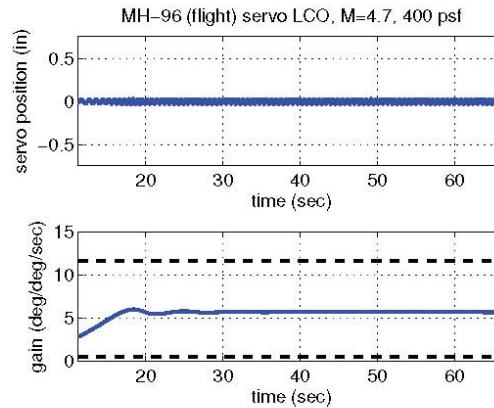
Figure A.12: Gain cycling (flight configuration)

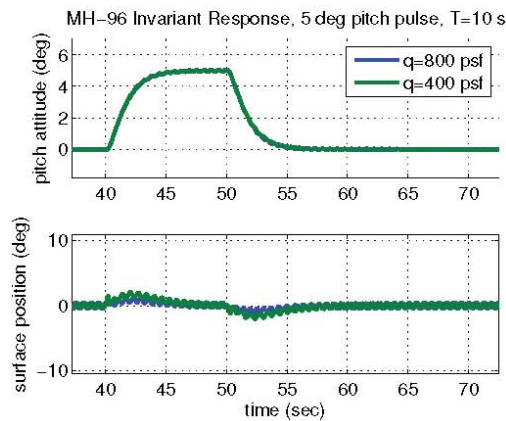
The efficacy of the invariant-response design of the MH-96 can be illustrated using a transient response simulation of a pitch maneuver (Figure A.13). In this case, the attitude loop is closed ( $k_P = 0.7$ ) and a 5 degree pitch attitude command is issued with a period of 10 seconds at a dynamic pressure of 400 psf and 800 psf. The MH-96 provides an aircraft transient response that is invariant with respect to the 2:1 variation in dynamic pressure, and tracks the reference model filter 1st order lag characteristic.

Figure A.13: MH-96 invariant model response

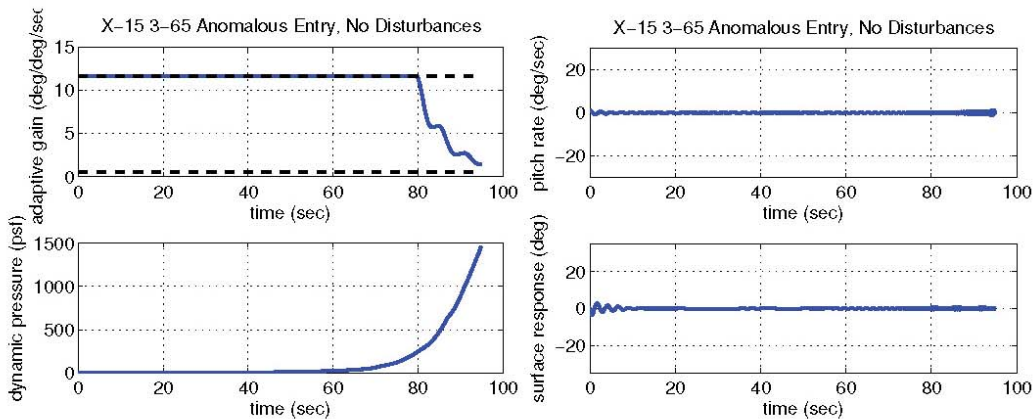
profile, the adaptive law is successful in establishing the desired servoactuator limit cycle and modulating the forward gain to the proper value (Figure A.14). This analysis result contradicts the author's early hypothesis that the adverse LCO was precipitated by a dynamic pressure rate-of-change exceeding the capability of the MH-96 gain changer.

Figure A.14: MH-96 3-65 entry, no disturbances

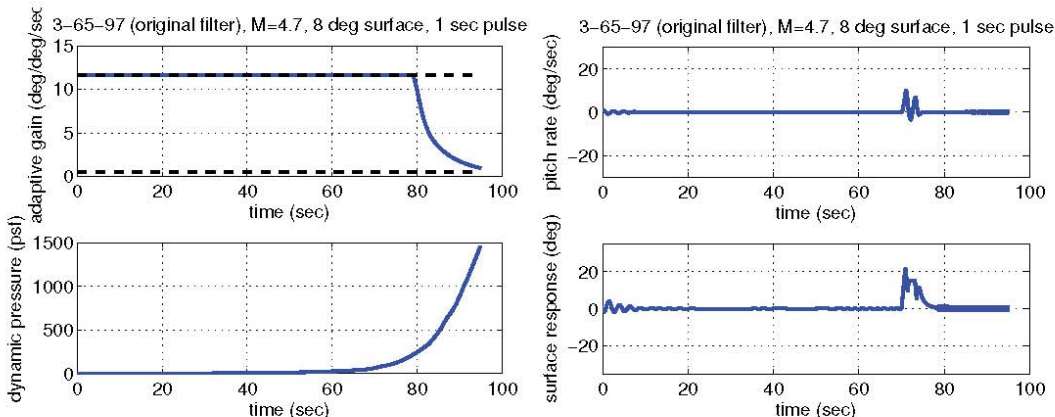
It is illustrative to consider that the introduction of lag due to the implementation of the structural notch filter may be related to the apparent rate-limit divergent limit cycle oscillation. Under the time-varying 3-65 entry conditions, the system is simulated with an identical pilot input but with the original loop filter design (Eq. A.7). Although rate limiting is induced for a short time, the actuator does not couple with the short-period mode and thus no divergent oscillation is induced (Figure A.17).

Figure A.17: 3-65 entry, large pilot input, original filter

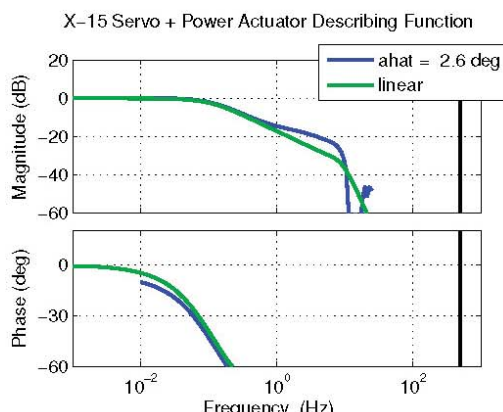
A DF approximation of the servoactuator with these parameters is computed and compared with the nominal linear model of the servoactuator. As can be seen in Figure A.19, the response of the actuator matches well at low frequencies but exhibits slightly more phase lag.

Figure A.19: X-15 servoactuator small-amplitude describing function

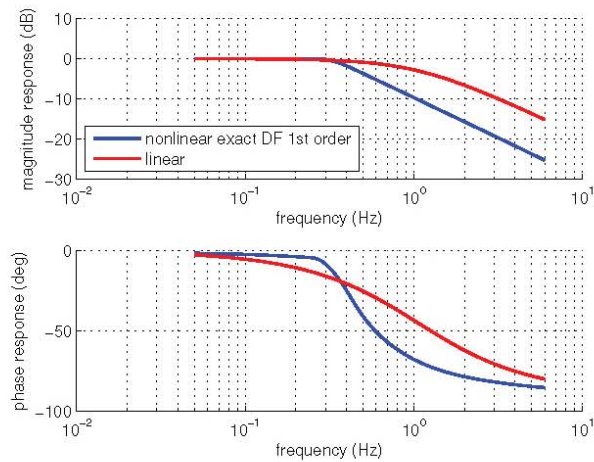
Note that in this analysis, the other actuator nonlinearities in addition to the basic rate limiting contribute to the divergent behavior. However, a describing function analysis of the power actuator alone confirms that the response matches well with the published results in the existing literature [20] (Figure A.20).

Figure A.20: Describing function analysis of X-15 power actuator only, 15 degree input amplitude

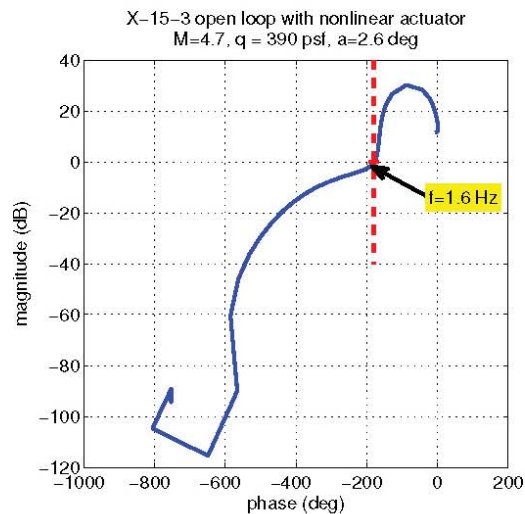
Using the servoactuator DF in-the-loop at the stated forward gain condition, the small-amplitude LCO is accurately predicted by the numerical analysis. Since the forward gain in the DF analysis matches the converged gain, the system intercepts the critical point. The  $-\pi$  phase line is shown for comparison. It should be noted that the short period mode, appearing at approximately 0.4 Hz, has relatively little equivalent phase margin at this condition at stable values of the forward gain.

Figure A.21: X-15 servoactuator small-amplitude LCO prediction

It was noted before in the analysis of the high-frequency desired LCO that the short-period mode had very little phase margin when operating at the critical gain (Figure A.21). In the design of the MH-96, an implicit assumption was that the system phase shaping (via filters in the rate feedback path) provided for a linear phase margin that was approximately invariant with respect to the forward gain. Based on a comparison of the original system response with the flight configuration using the structural notch filter, it appears that the introduction of the notch filter substantially degraded the phasing of the short period mode due to the introduction of additional low-frequency lag (Figure A.23). Even under these conditions, the original design maintains more than 30 degrees of phase margin for the short-period mode.

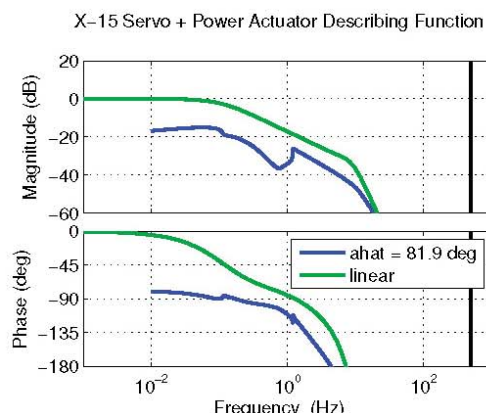
Based upon the time-domain analysis, it was observed that the large-amplitude LCO tended to be precipitated by large inputs causing actuator rate saturation coupled with an excitation of the short-period pitch mode. In order to determine the possible transition amplitude for the adverse LCO, the amplitude-frequency parameter space was searched for a DF such that the short-period mode would approach critical stability when at the 3-65 entry conditions (maximum forward gain, 390 psf). The transition amplitude for this condition consists of a large servo command of approximately 80 degrees peak equivalent, or a command-to-authority factor of about 6:1. Large servo commands exceeding the servocylinder limit of 1 inch (15 degrees equivalent) will cause saturation in the servo, the power actuator, or both. The effects of saturation on the actuator frequency response are shown in Figure A.22. Near the short-period frequency, the effective phase lag is increased by approximately 25 degrees.

Figure A.22: X-15 servoactuator large-amplitude describing function

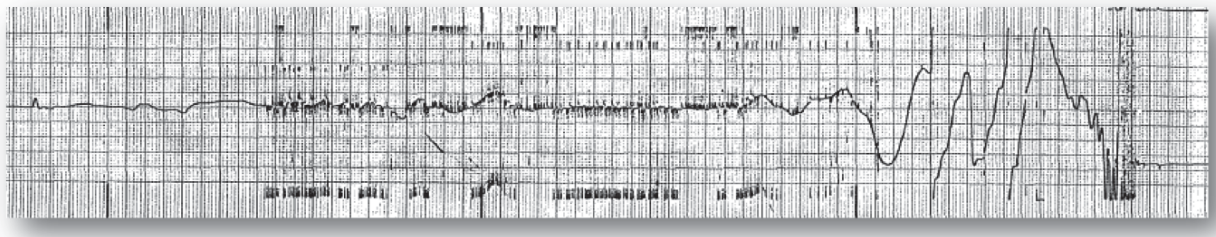
Flight data from X-15 Flight 3-65 appearing in this appendix were reconstructed from a photocopy of the original strip chart recordings (see Figure B-1) appearing in the 1968 AIB report [ref. 3]. As can be expected with data of poor quality, it is subject to some uncertainty and contains a number of filtering artifacts. It is, however, the best available representation of the aircraft states known to the authors.

**Figure B-1. Example of Original Strip Chart Recording**

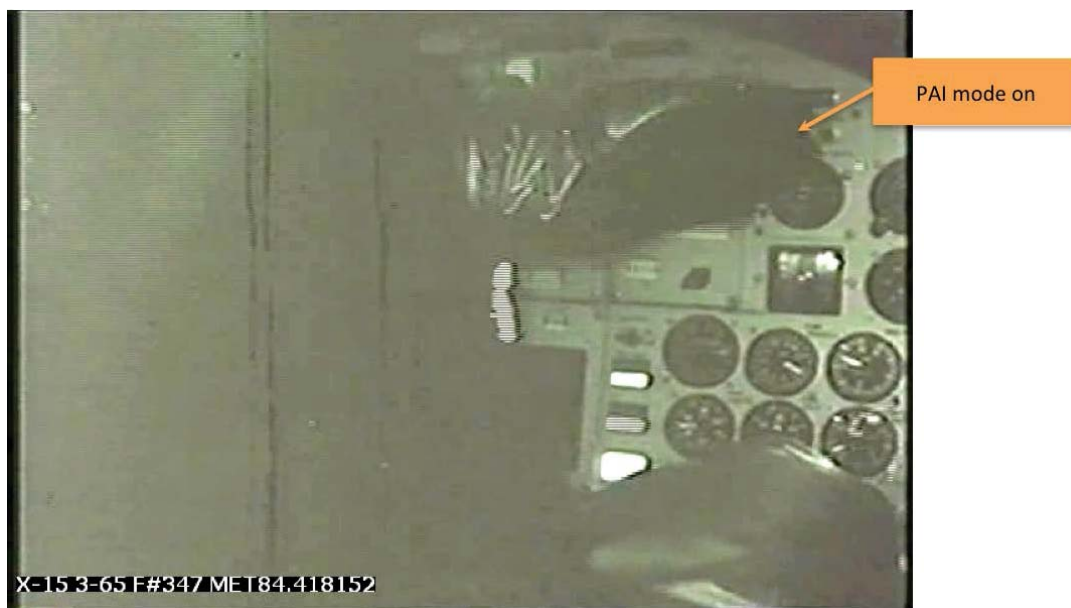
**Figure B-11. Cockpit Film – Pilot Engages PAI (MET = 84 seconds, 10:31:32 PST)**

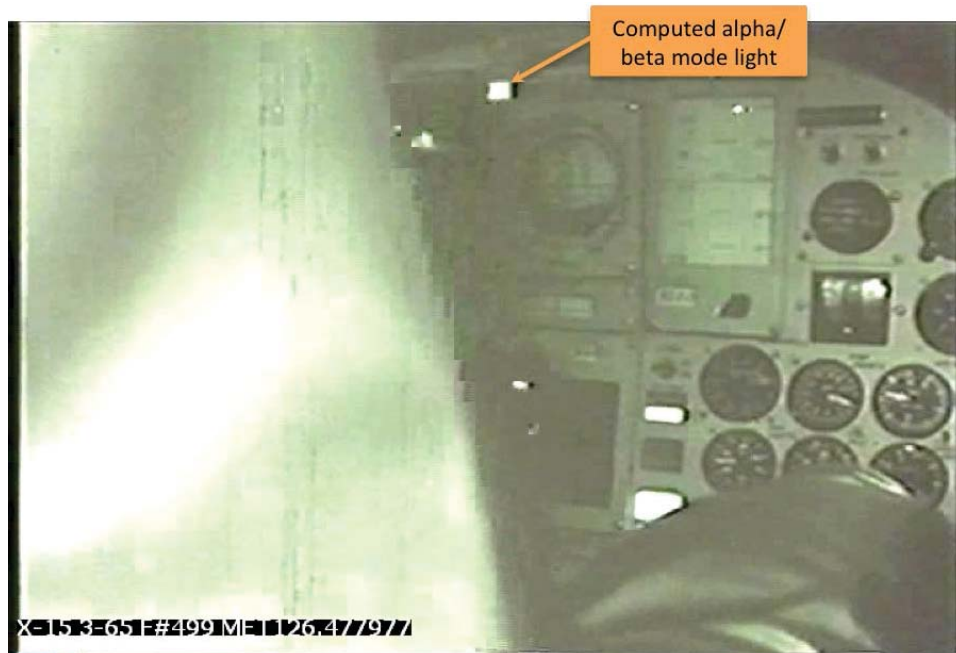
**Figure B-13. Cockpit Film – Pilot Selects Computed IFDS Aerodynamic Angles <50 psf (MET = 126 seconds, 10:32:14 PST)**
