# Public Housing: A Tailored Approach to Energy Retrofits

Jordan Dentz, Francis Conlin, David Podorson,  
and Kunal Alaigh

*Advanced Residential Integrated Energy  
Solutions (ARIES) Collaborative*

June 2014

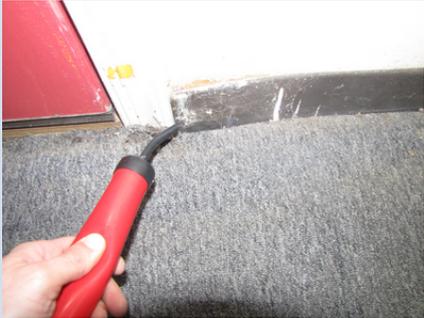
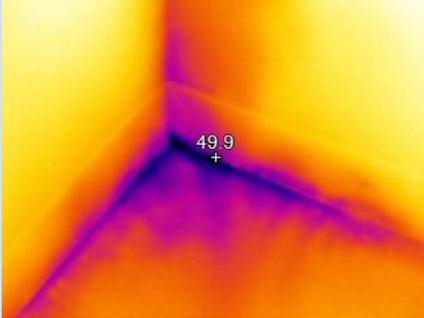
LOCATION	INSTRUCTIONS	MATERIALS	PHOTOS
INTERIOR AIR SEALING	1. Bottom of walls	In rooms without carpet, caulk bottom of wall to floor and/or base molding (may require removal and replacement of vinyl cove). If replacing carpet, caulk between bottom of wall and floor before new carpet is installed. Seal around baseboard heaters with caulk suitable for high temperatures.	Caulk, cove molding and adhesive.

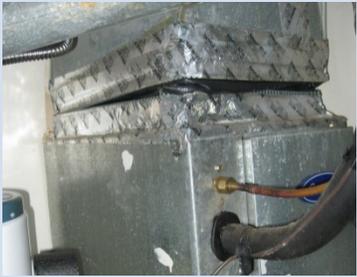
AC	13. Air handler	Ensure that leaks in air handler and return ductwork inside mechanical room are well sealed (including around filter slot).	Mastic and/or foil tape	Well sealed:

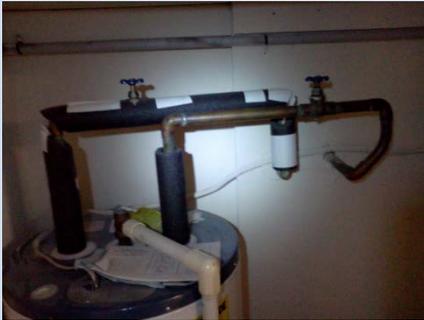
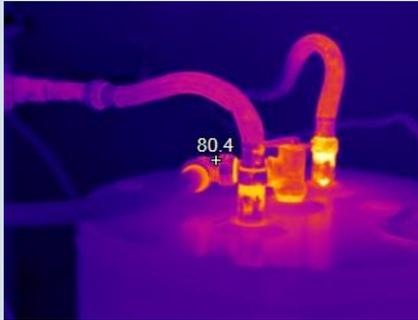
17. Exposed DHW pipes	Add pipe insulation to un-insulated pipes in DHW tank closet	Pipe insulation and compatible tape	<div style="display: flex; justify-content: space-around;">

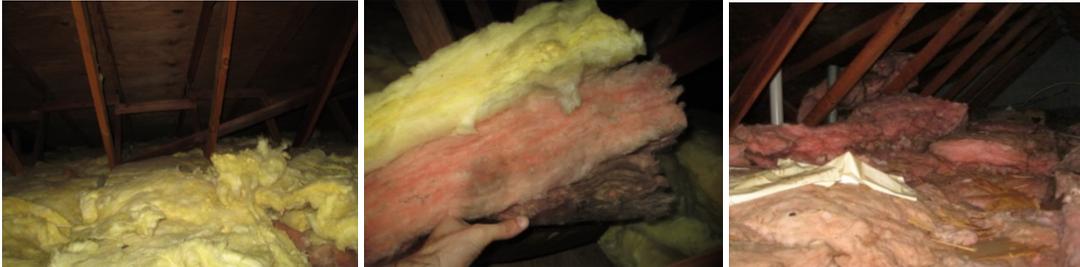
LOCATION	INSTRUCTIONS	MATERIALS	PHOTOS
<b>WATER</b>	19. Shower head	Ensure low-flow showerhead installed - if it takes less than 20 seconds to fill a one gallon container, replace with low-flow showerhead.	Low-flow shower head, thread sealant / compound	
<b>ATTIC</b>	20. Attic insulation depth and distribution	Check that ceiling insulation is dispersed evenly without gaps, is free of water damage, and covers rafters and other framing members fully to the exterior walls. Re-arrange insulation or supplement if necessary.	Flashlight, attic insulation	<p>Poor insulation condition:</p>

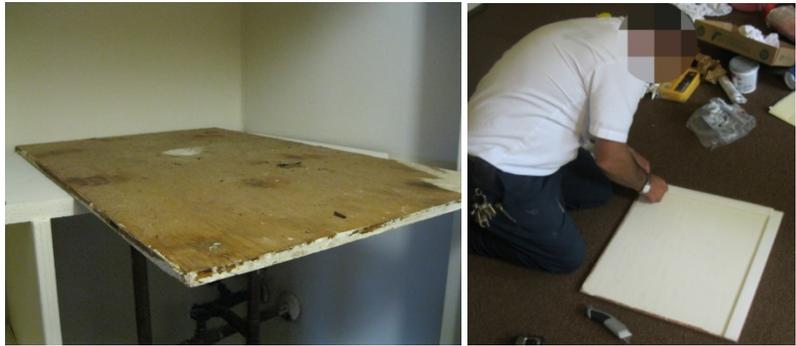
LOCATION	INSTRUCTIONS	MATERIALS	PHOTOS
<b>ATTIC</b>	22. Attic hatch insulation	Glue 2" rigid foam to back of hatch	Rigid foam board and construction adhesive	
	23. Attic hatch air leakage	Add gasket/weather stripping to seal hatch to opening	Gasket or weather stripping
