# The Alaska Earthquake

March 27, 1964

# Effects of the Earthquake Of March 27, 1964 In the Copper River Basin Area, Alaska

GEOLOGICAL SURVEY PROFESSIONAL PAPER 543-E

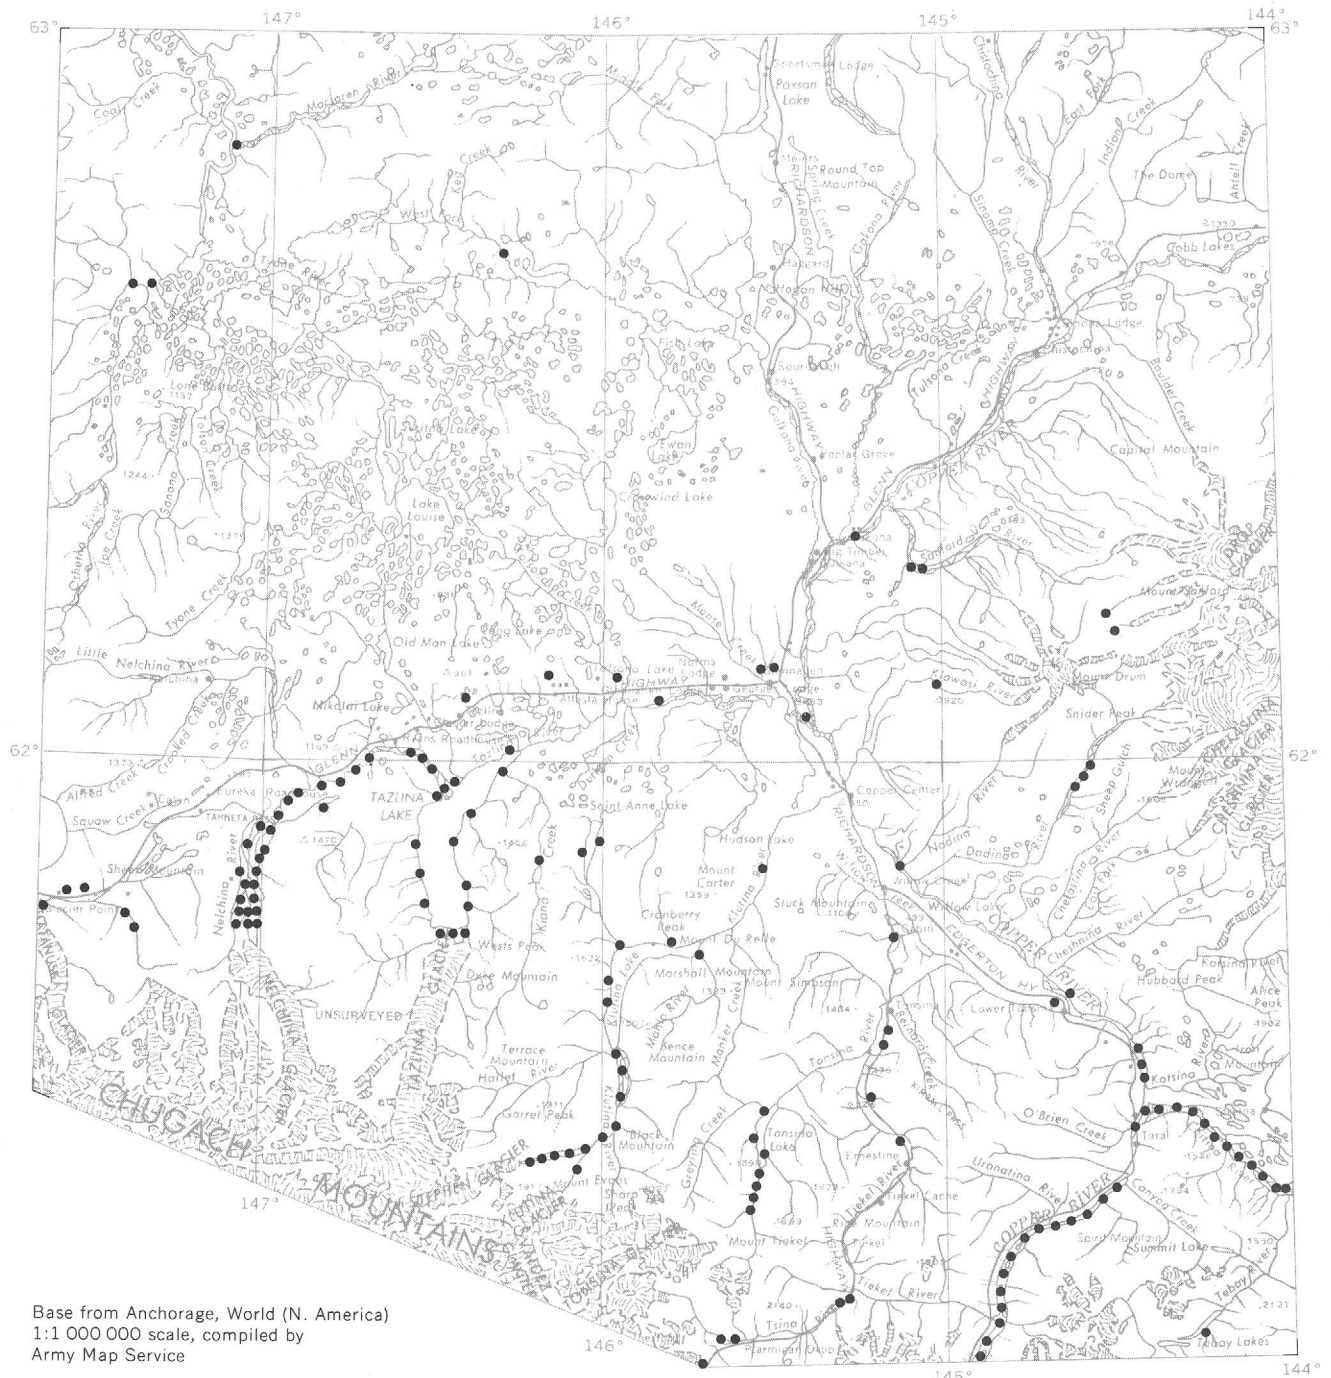
•  
 Area where ground cracks were  
 observed, July 1964

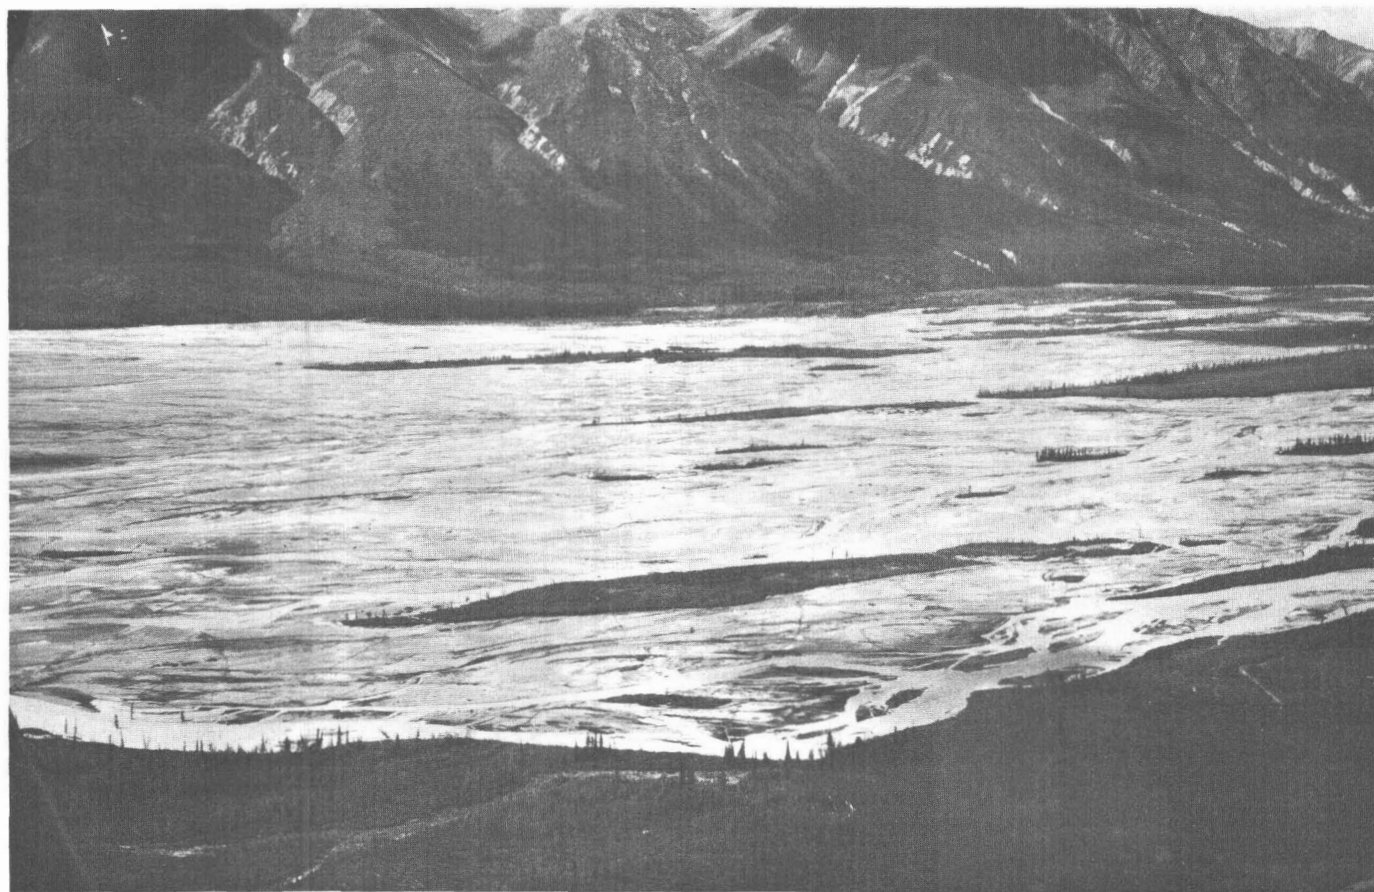
13.—View, to the east, of the large braided flood plain of the Nelchina River 8 miles north of the terminus of the Nelchina Glacier.

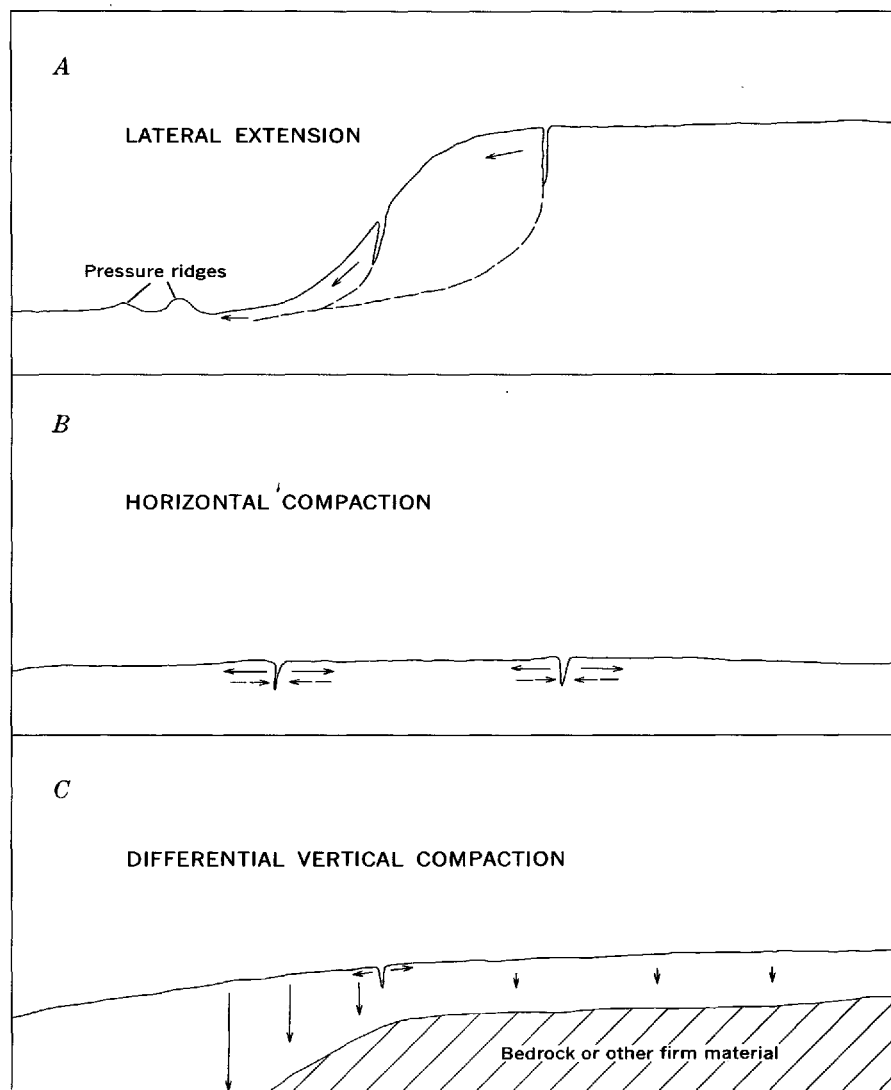
20.—Diagrammatic sections showing mechanism of formation of basic types of ground cracks in unconsolidated deposits in the Copper River Basin area.
