Evaluation of Acoustic Emission NDE of Composite Crew Module Service Module / Alternate Launch Abort System (CCM SM/ALAS) Test Article Failure Tests

NASA/TM-2010-216859

Failure tests of CCM SM/ALAS (Composite Crew Module Service Module / Alternate Launch Abort System) composite panels were conducted during 7/10/2008 and 7/24/2008 at LaRC. This is a report of the analysis of the Acoustic Emission (AE) data collected during those tests.

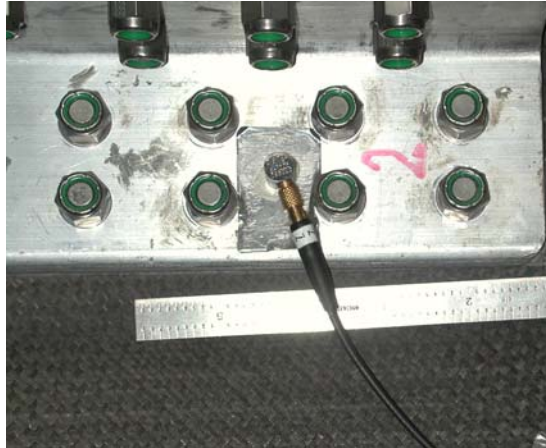
Figure 8 Close-up of sensor 7 location.

Because panel 1 failed in the metallic fittings it was conjectured that most of the AE was due to bracket and bolt noise, while a relatively small amount of damage occurred in the composite. It should be noted that sensor 7 was the only sensor located on the metal brackets as seen in figure 8. Sensor 5 was mounted on the composite stiffener opposite the clevis bracket and sensor 6 was mounted near the bolts, but on the composite skin as seen in figures 9 and 10, respectively. Sensors 5 and 6 would be less sensitive to bolt and bracket noise than sensor 7, but presumably more sensitive than other sensors further away. The metallic bracket failure conjecture is supported by figures 11 and 12, which show the event time of the first sensor arrival and the histogram of the first arrival event count, both plotted per channel (sensor). It is shown that the majority of the events occur near the bracket mounted sensor 7, suggesting that the bracket was failing. Also, a significant burst of that AE occurred in Run 3 at loads between 15 and 30 kips. The percentage of first arrival hits at sensor 8 comes in second after sensor 7 for both runs. Since

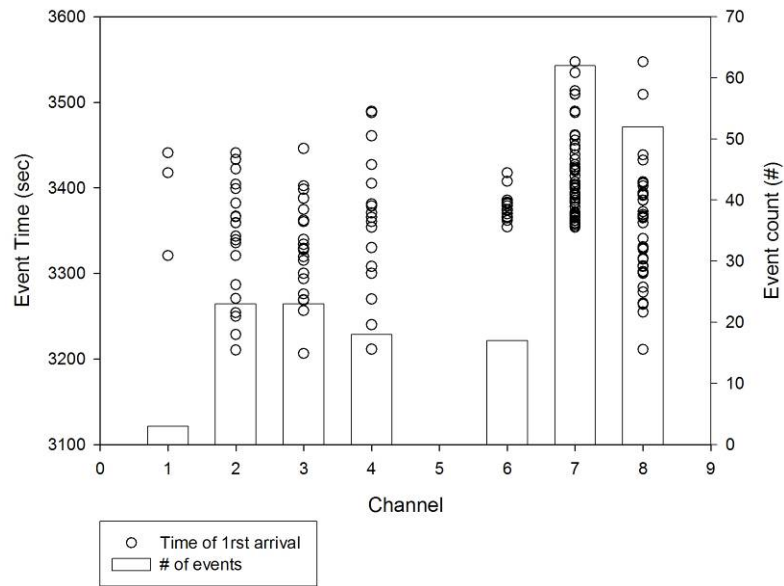
Figure 11 – Identification of sensors that had the most “early” arrivals Panel 1 Run 3

sensor 8 is in the lower corner of the panel, away from the bracket, this could indicate some composite failure occurring in the lower half of the panel.

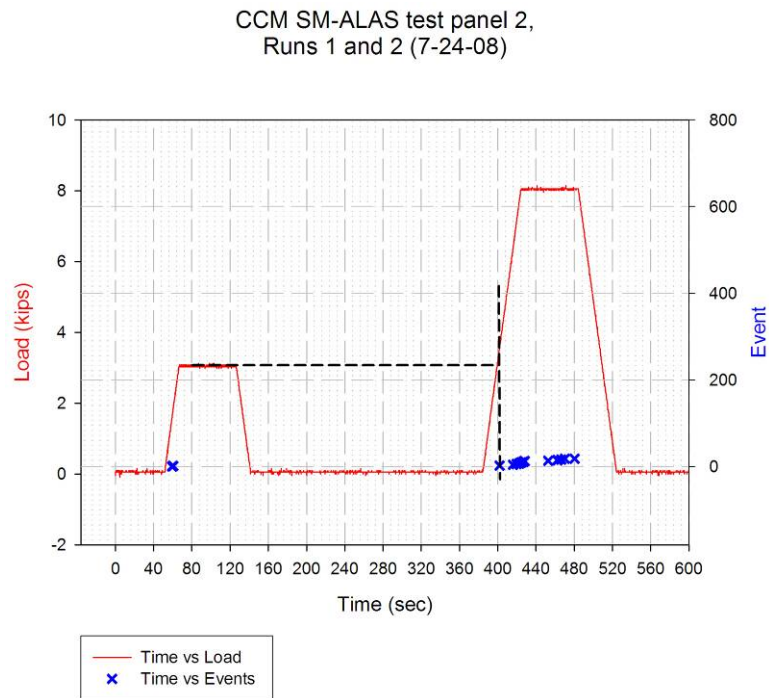
Figure 21 – Kaiser Effect between load cycles (runs) 1 and 2 of panel 2 test

As noted previously the five runs (1-5) produced 2, 17, 477, 98, and 12 AE events respectively. The following figures 23, 24 and 25 show the event time of the first sensor arrival and the histogram of the first arrival event count, both plotted per channel (sensor). As noted above, run 3 was the run likely to develop the most damage and this is supported by this run having at least 5 times more events than the other runs. It is interesting to note that for runs 2 and 4 the region near the corners of the potted core, where sensors 2 and 3 are, dominates the data. However, it may be ill-advised to draw too many conclusions because of the low event count for both of those runs.

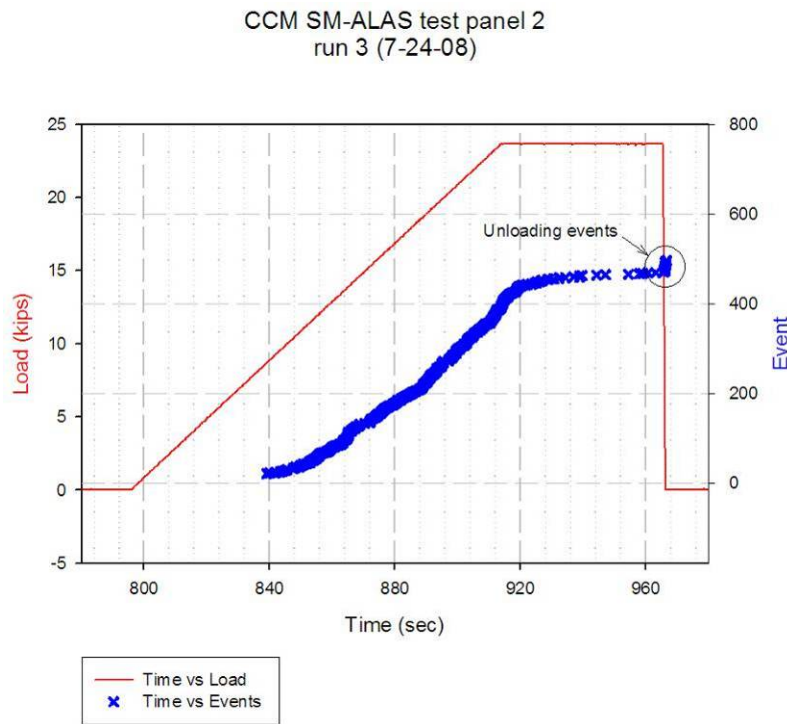
Figure 26 – Events that occurred during unloading for panel 2 run 3.

In the following figures 26 and 27, plots of AE vs. time overlaid on the load profiles of runs 3 and 5 show the unloading events (events that occurred during unloading). These events have the

potential to locate where damage in a composite has occurred during previous loadings because of the increased internal friction in the region of the damage.

Note that the locations definitely cluster in the lower half of the panel. Figure 30 shows a postmortem C-scan of panel 2 and as noted in the cut plan for destructively examining the panel “white areas in the scan are where the threshold was not exceeded, meaning essentially no sound is coupled through the panel.” [3] That means that either delamination in the composite or debonding of skin in the regions of honeycomb core had occurred. Most of the lower half of the panel has that damage. It is very likely that internal friction of the damage contributed to the unloading events. This indicates that the damage was present prior to the unloading of run 3. The large number of events during loading in run 3 could indicate the occurrence of the damage, although as seen in later plots locations of the events do not definitively highlight the damage regions. However, that could be due to the fact that the damage covers almost 75% of the panel.
