NASA/TM-2009-215955

# Experimental Behavior of Fatigued Single Stiffener PRSEUS Specimens

*Dawn C. Jegley*  
*Langley Research Center, Hampton, Virginia*

December 2009

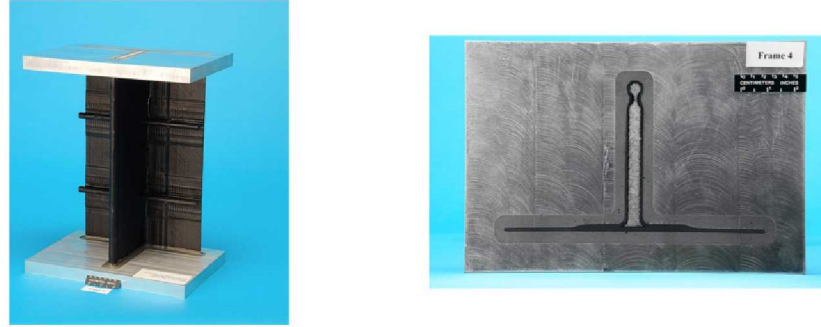
d) Frame specimen F4

Prior to delivery to NASA the OML of specimen F4 was damaged during the machining process. A photograph of this damage is shown in figure 7. The dent is approximately circular with a 1-inch diameter and the maximum depth is approximately 0.1 inches. No damage at this location is visible on the stiffened or Inner Mold Line (IML) side of the specimen.

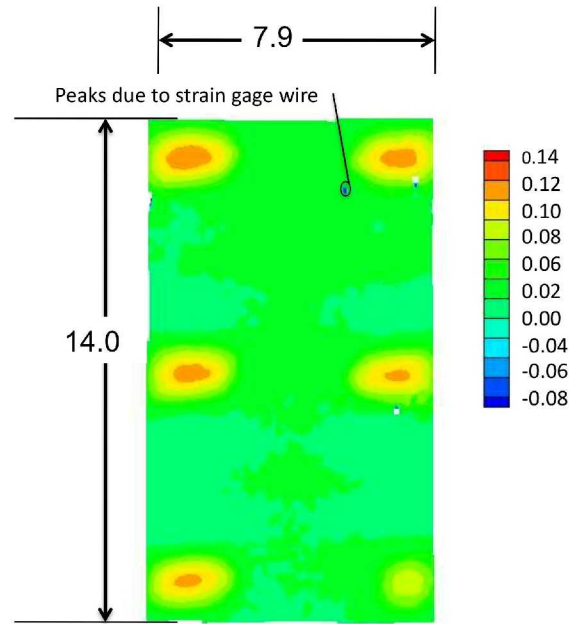
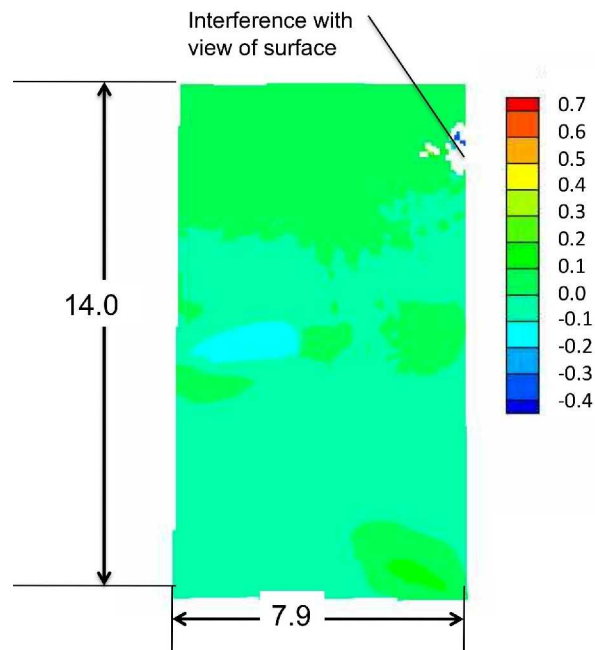
Figure 16. Full-field out-of-plane displacement change from pre-fatigue condition for frame specimens. Dimensions are in inches

Full-field results for out-of-plane deformation at approximately the maximum applied load are shown in figure 15 and 16 for rod and frame specimens, respectively. These results indicate rod specimens buckled prior to failure but frame specimens did not. In the rod specimens the centerline where the rod stiffener was located did not move out-of-plane during loading while the unloaded edges did move out of plane despite the edge restraints. A buckle pattern of approximately three half waves developed in each rod specimen. In each rod specimen one edge moved forward in the positive z direction while the other edge moved in the negative z direction about the same magnitude. In the full-field results, regions where strain gages and wires obscure the specimen surface are removed from the plot. In the undamaged frame specimen the out-of-plane displacements were localized to the corners and midlength location. Bending between the lateral support of the potting and rods is evident. The midlength location is half way between rod stiffeners. The primary deformation seen in the damaged frame specimen is in the region of the damage. The displacements shown are the difference between the surface prior to loading and just before failure.

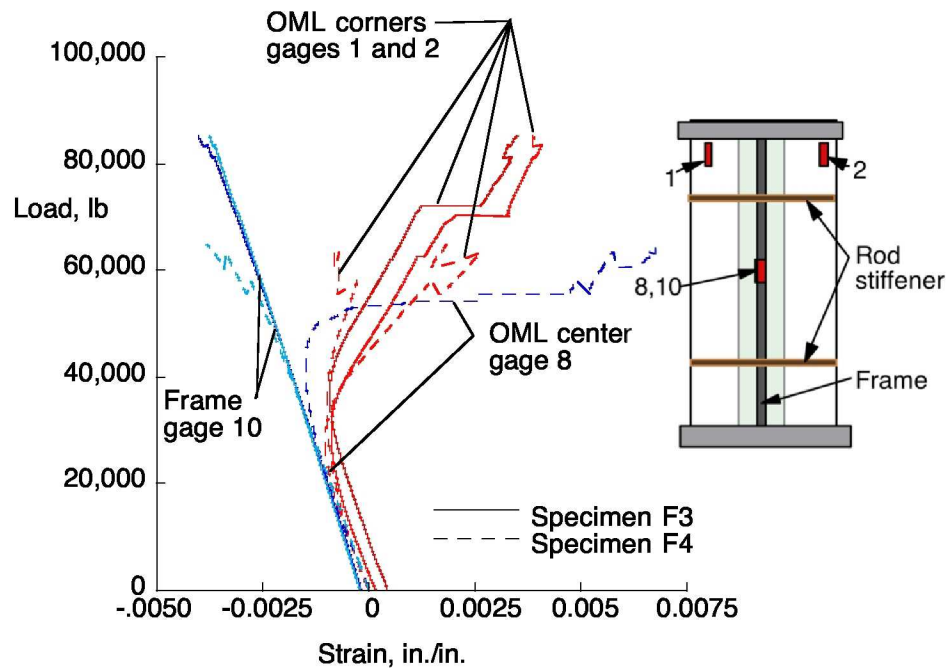
a) Away from damage site

Results for gages away from the pre-test damage site in specimen F4 and the equivalent location on specimen F3 are shown in figure 20a while gages near the pretest damage site in specimen F4 and the comparable locations in specimen F3 are shown in figure 20b. These results indicate that the damage has little impact on strains for loads less than 41,000 lb, which is the maximum load the specimens were subjected to during the fatigue cycling. However for loading greater than this level, the damage had significant influence on strain behavior in the region of damage, causing loss of load-carrying ability at the damaged skin at a load of approximately 50,000 lb rather than the 83,000 lb found in the undamaged specimen.

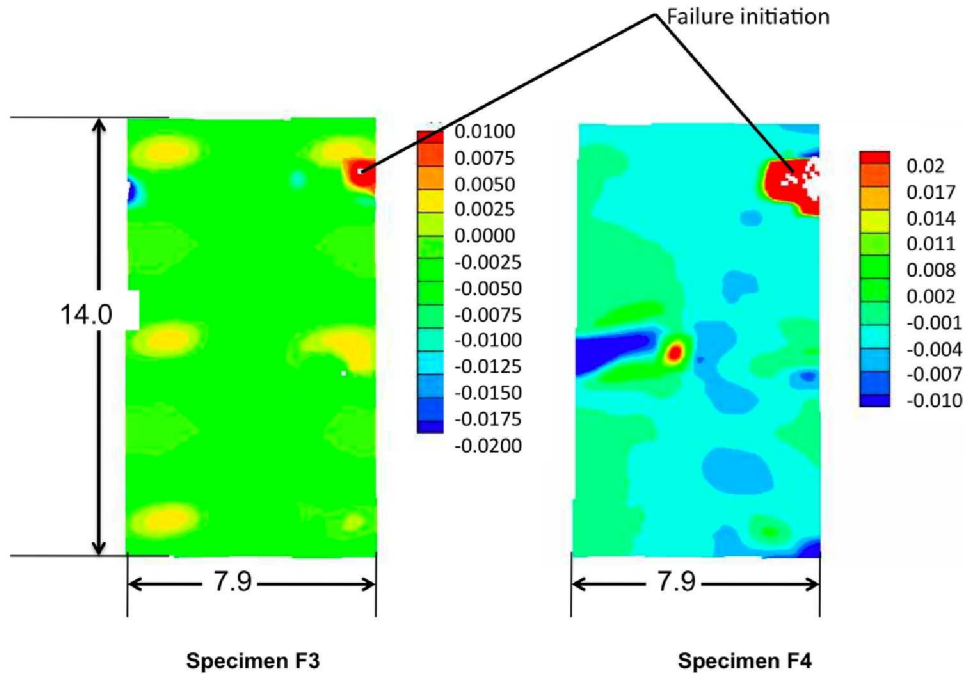
Figure 22. Full field axial strains at failure for frame specimens. Distance shown is in inches. Scale is in in./in.

In frame specimen F3 the peak axial strains in the OML are located near the specimen corner. In frame specimen F4 peaks in axial strain also occur at the damage site. Since the VIC system only monitors the OML, initiation of failure on the IML could not be captured in this manner.

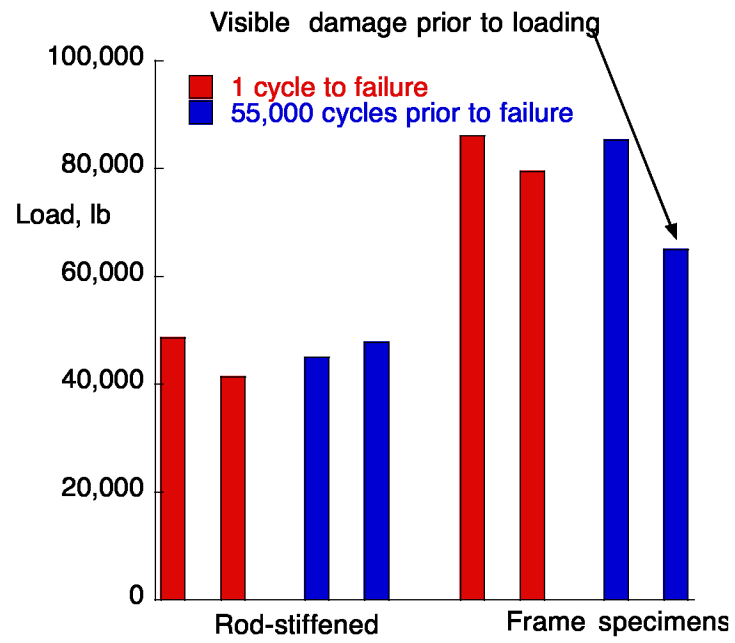
Figure 23. Failure loads.

The failure loads the four fatigued specimens as well as nominally identical specimens previously tested under the Boeing contract are shown in table 3 and figure 23. Photographs of failed fatigued rod specimens are shown in figure 24 and failed frame specimens are shown in figure 25.

Four specimens that were nominally identical to the specimens described herein were loaded in a single test to failure (ref 1). These specimens were cut from the same large panel as the fatigue specimens described herein and tested under the Boeing contract. The failure loads for the NASA-tested and Boeing-tested specimens are shown in table 3 and figure 23 for all eight specimens. Both fatigued rod specimens failed at loads greater than one unfatigued specimen but less than the other unfatigued specimen. Similarly, frame specimen F3 failed at a load greater than one unfatigued specimen but less than the other unfatigued specimen. The fatigued specimens failed in the same manner as the unfatigued specimens. There is no evidence the fatigue cycling had any effect on the failure loads of rod stiffened or frame specimens. Photographs presented in reference 1 show the same failures as seen in specimens R3, R4 and F3. No single-stiffener specimens discussed in reference 1 were damaged prior to loading so no direct comparison to specimen F4 can be made.
