NATIONAL TRANSPORTATION SAFETY BOARD

RAILROAD ACCIDENT REPORT

**COLLISION OF WASHINGTON METROPOLITAN
AREA TRANSIT AUTHORITY TRAIN T-111 WITH
STANDING TRAIN AT SHADY GROVE PASSENGER
STATION, GAITHERSBURG, MARYLAND
JANUARY 6, 1996**

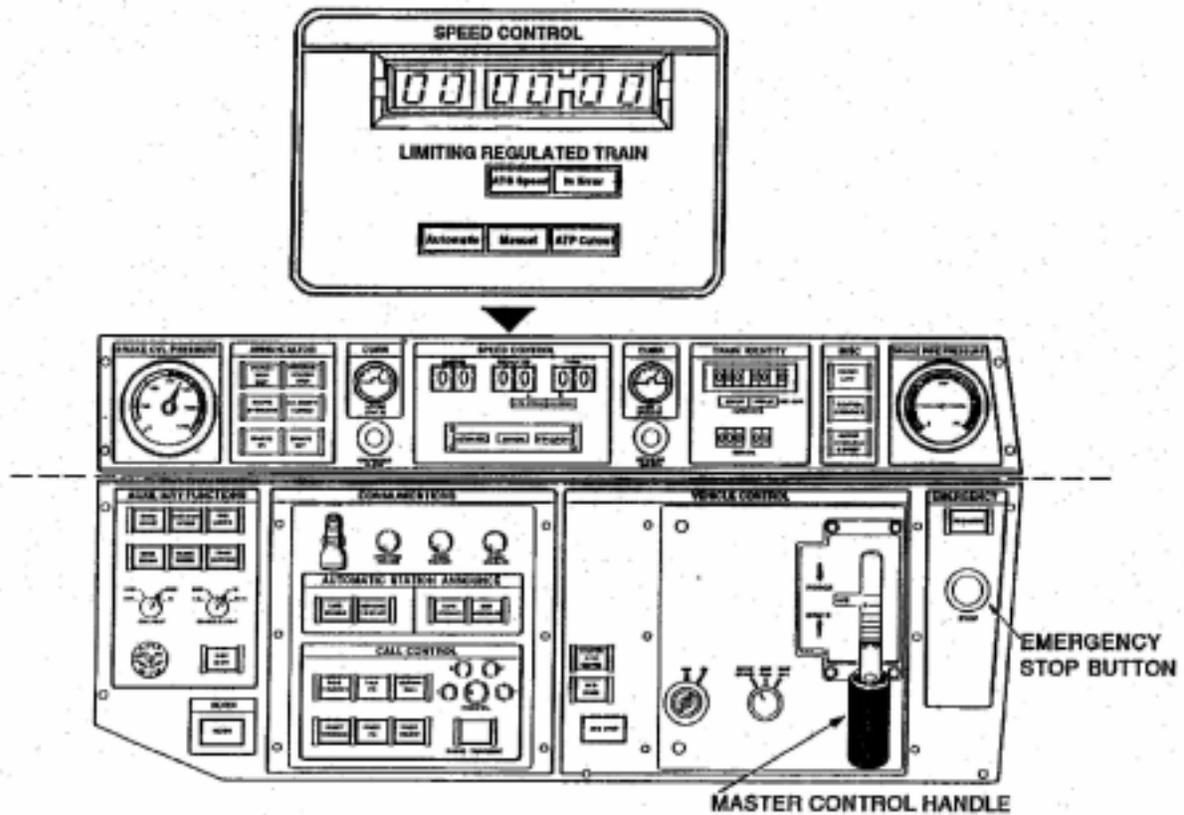
⁷ Operators’ consoles on all Metrorail trains display three speed readouts. (See figure 3.) The first readout is the *automatic train protection*, or ATP speed (labeled and sometimes referred to as the “limiting” speed and representing the maximum speed the ATP system, because

of the physical layout of the track, will allow a train to attain over that route segment under any circumstances). The second readout is the *automatic train supervision*, or ATS speed (labeled and sometimes referred to as the “regulated” speed and representing the maximum speed authorized by the main system computer for the performance level in effect at the time). The third readout, labeled “train” speed, displays the train’s *actual* speed.

Figure 3 – The operator's console on both Breda and Rohr Metrorail cars is a two-part console divided into a sloping indicator panel and a flat control panel section. The speed control blowup illustrates the Breda configuration.

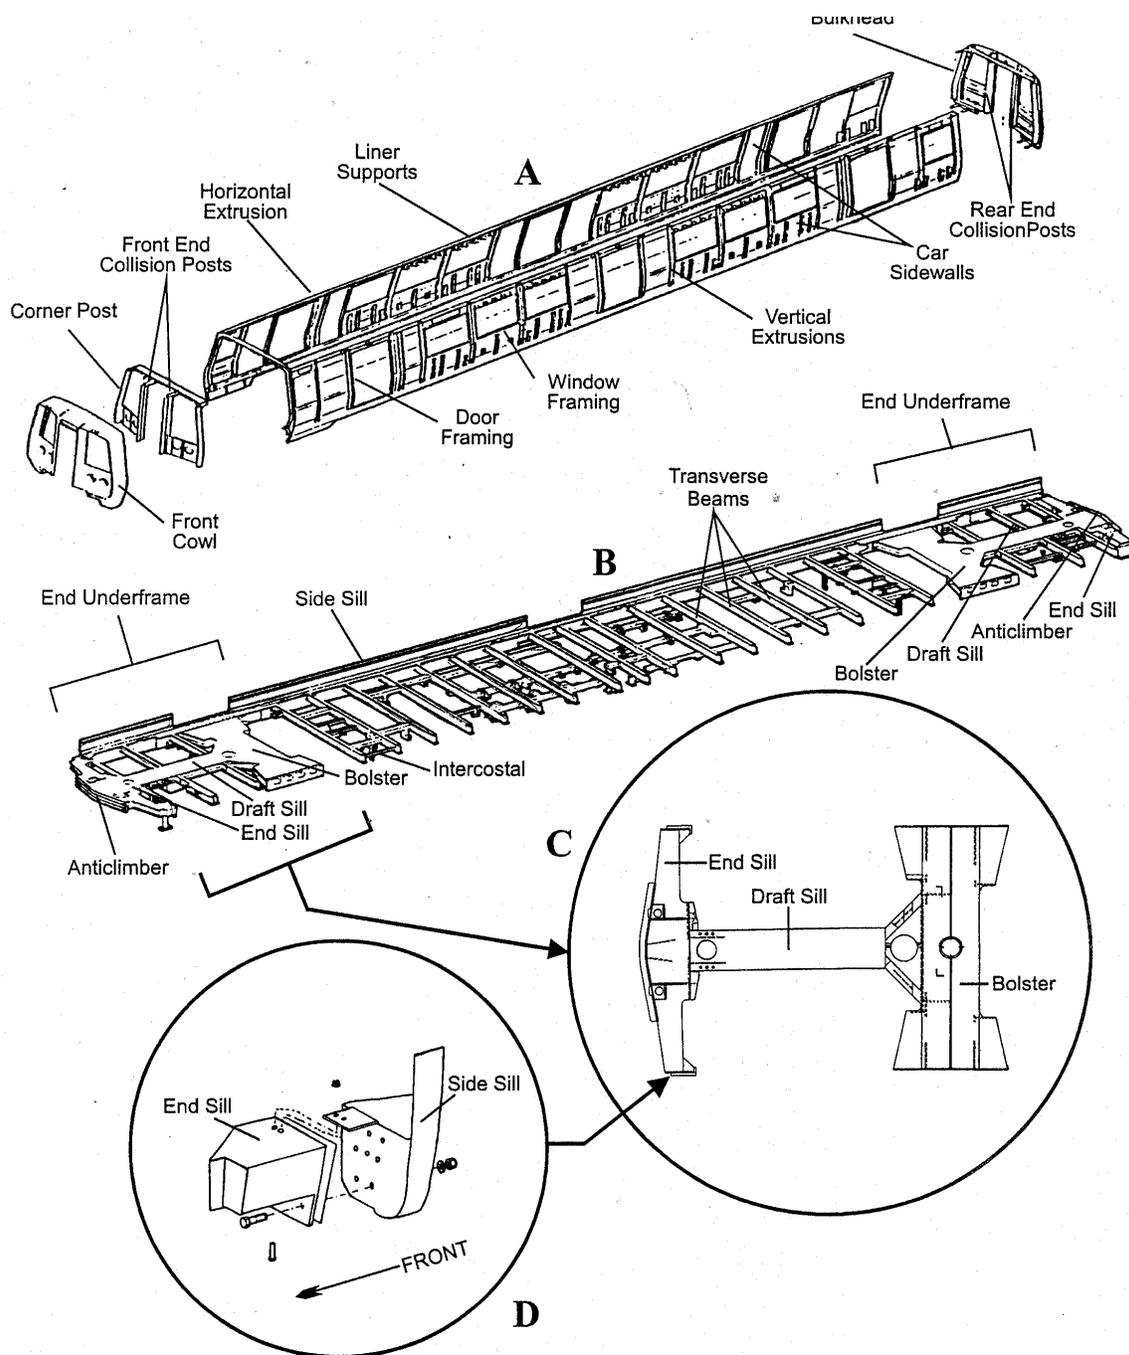
All Metrorail carbodies are constructed primarily of aluminum extrusions that serve both as structural components and as exterior skin for the roof, side walls, and rear-end cowl. The front-end cowl is molded fiberglass. (See figure 8A.) The main underframe consists of transverse aluminum beams attached to the lower side wall extrusions (also aluminum), which run the full length of the car and serve as side sills. The underframe (figure 8B) does not have a center sill that runs the entire length of the car, but does have intercostals (short longitudinal members) between some transverse beams. The end underframe assembly (figure 8C) is fabricated of low-alloy, high-tensile steel and consists of a bolster, draft sill, and angular sill end fitted with a conventional anticlimber. These components are welded together to form a single unit. The end underframe assembly bolster is attached to the side sills by mechanical fasteners referred to as huck bolts.¹² The draft sill of the end underframe assembly is attached to the side sills by four aluminum transverse members (two on each side of the draft sill), which are attached by bolts to the draft sill and welded to the side sill. The end sills of the end underframe assembly are bolted to the ends of the side sills, as shown in figure 8D.

Figure 8 – (A) Typical WMATA Metrorail carbody structure; (B) Underframe of Breda Metrorail car; (C) End underframe assembly; (D) Attachment of side sill to end sill of underframe

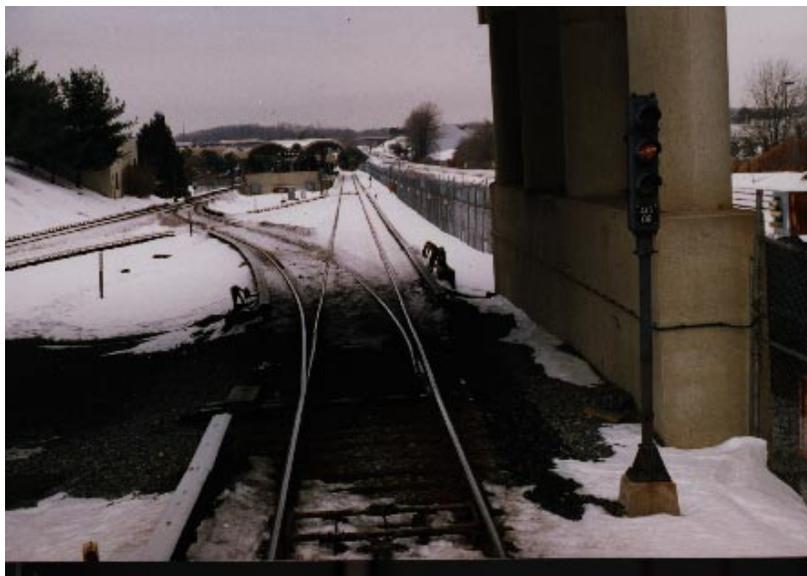
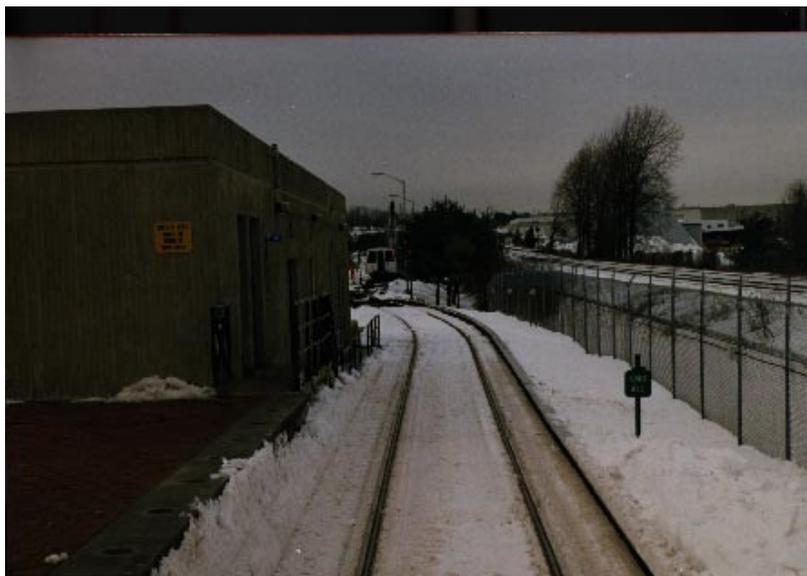
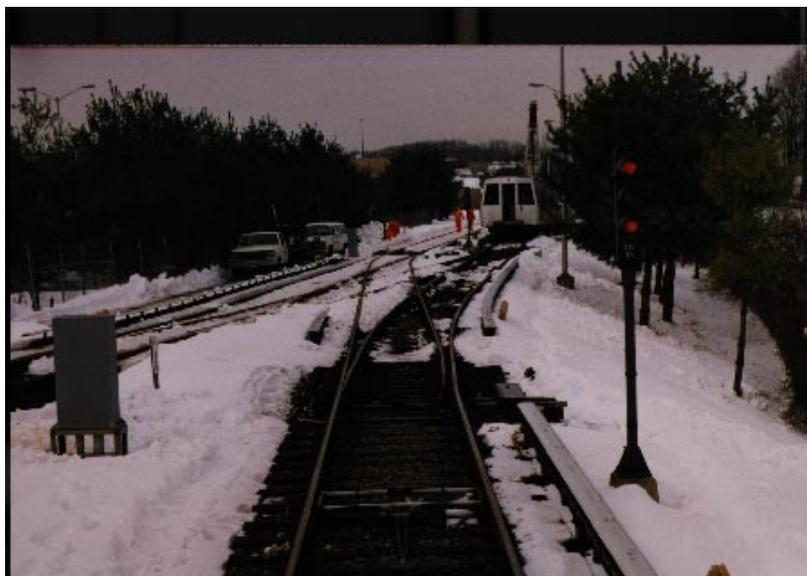
Figure 13

Sight Distance Tests -- For the sight distance tests, a test gap train was placed at the approximate point of impact. A test T-111 train was then operated toward the Shady Grove passenger station on track 2 in a northward direction, and its operator was instructed to stop as soon as the first car of the test gap train came into sight. The test results indicated that the marker lights of the gap train first came into view at 1,134 feet and were fully visible at 664 feet. (See figure 13.)

A – Northbound approach to Shady Grove Passenger Station

B – View from train properly positioned at the station platform. The train visible past the end of the station house is standing at the approximate location of the accident gap train.

C – View as train approaches interlocking north of Shady Grove station.

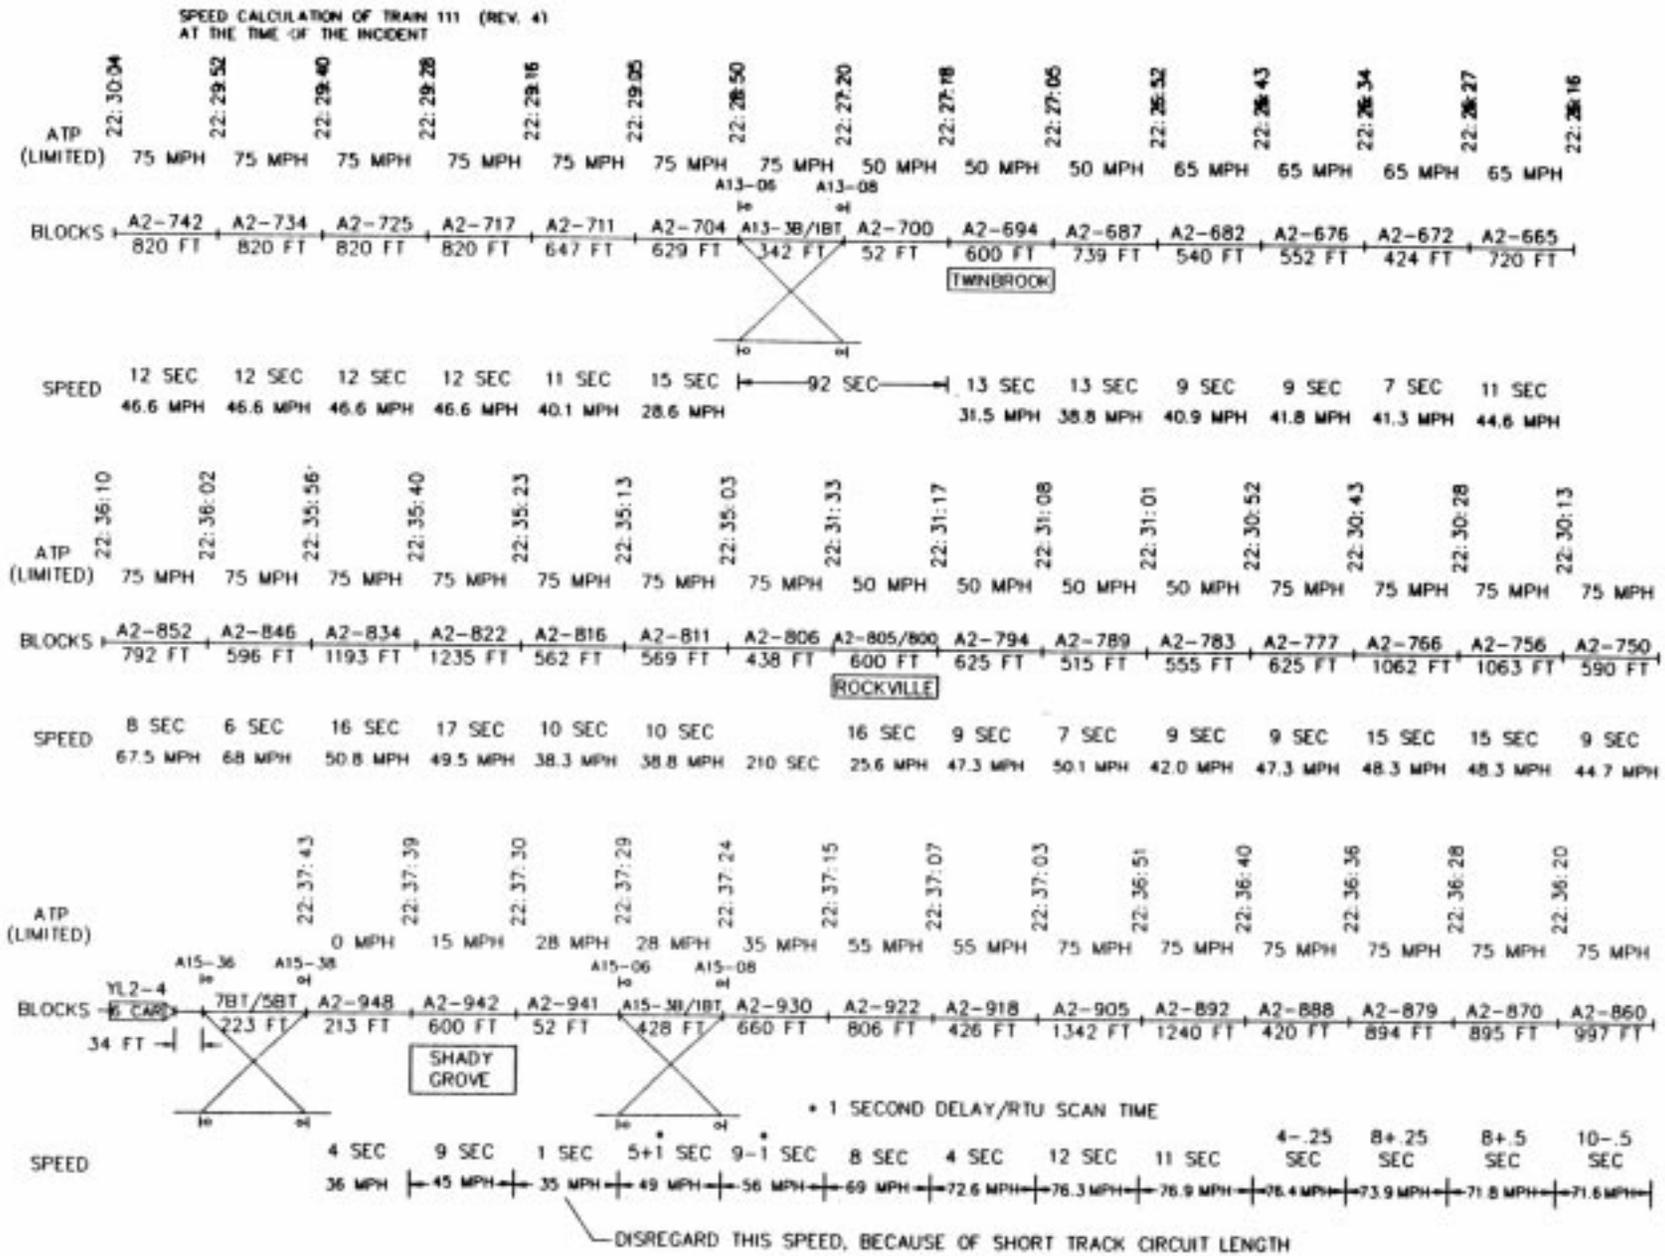
APPENDIX C--WMATA Speed Calculation Chart--Train T-111

⁸The syslog records the time that a train enters and leaves each track circuit. Metrorail officials used the known length of the circuit to calculate the average speed of train T-111 for each of the 18 blocks (ranging in length from 52 feet to 1,342 feet) between the Rockville and Shady Grove passenger stations. (A *block* is a section of track of defined limits, the use of which is governed by interlocking signals and cab signals under control and protection of the automatic train control system.) Because the detection system polls the entire route system about once each second, there may be as much as a 1-second error in recorded block times. This imprecision can affect the accuracy of speed calculations, particularly in very short blocks.
