U.S. Fire Administration/Technical Report Series

Aerial Ladder Collapse Incidents

USFA-TR-081/April 1996

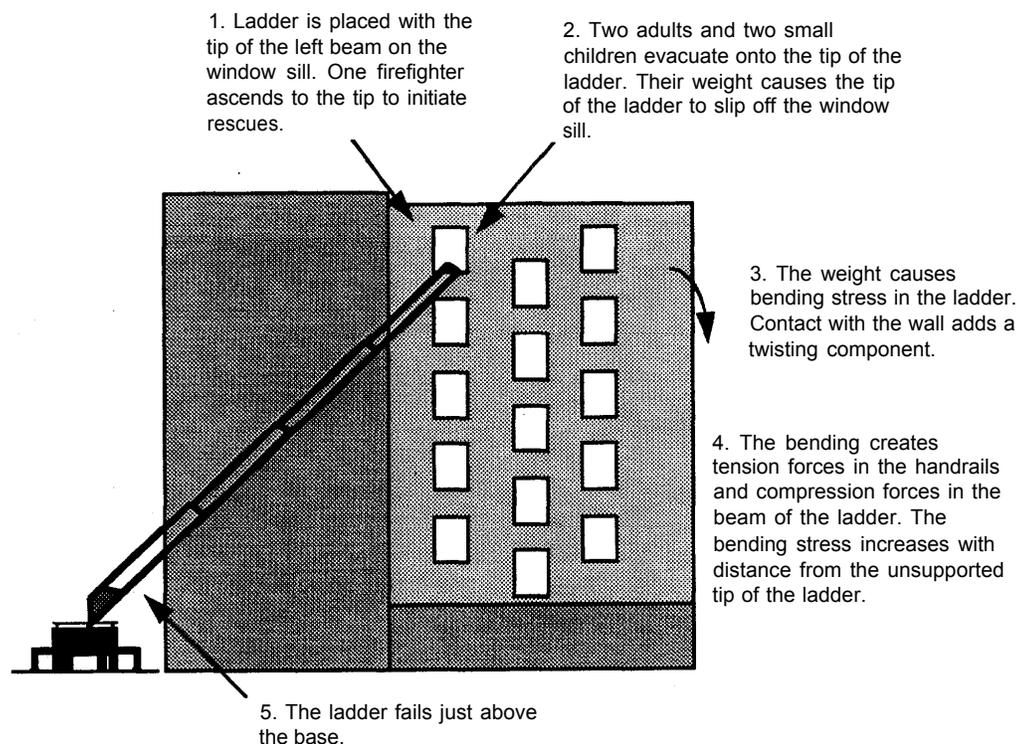
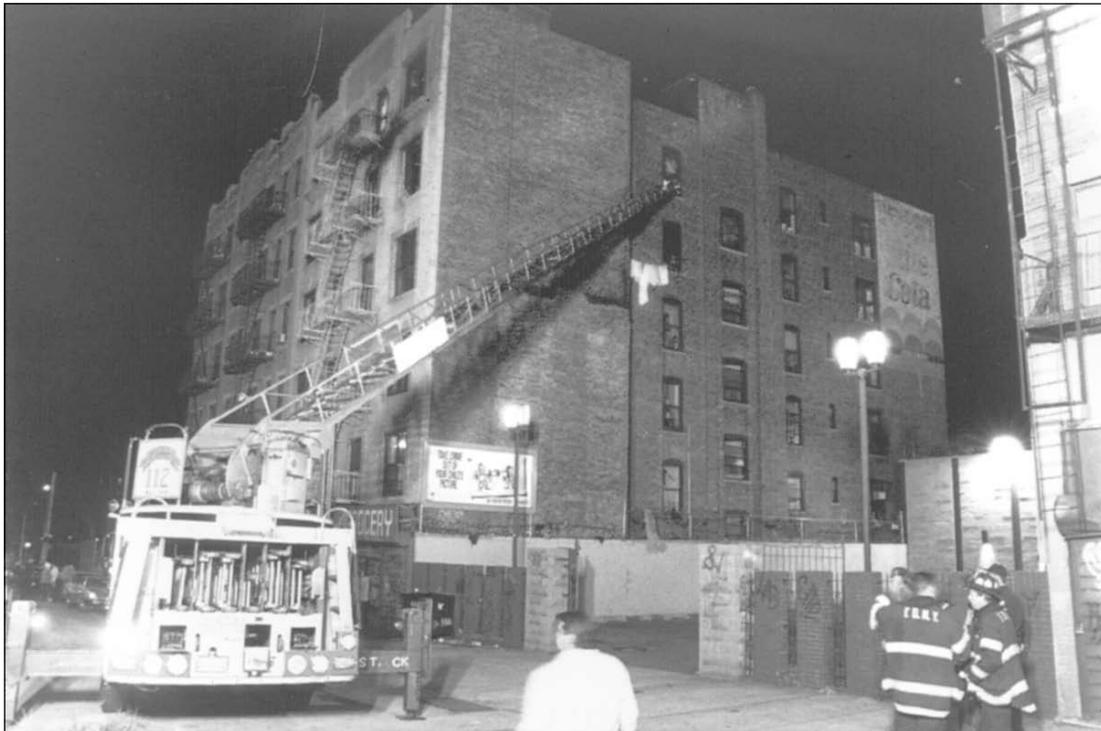
Figure 2. Sequence of Events at New York City Ladder Collapse

In a recreation of the FDNY Ladder104 collapse scene, Ladder 112 is positioned with its ladder extended to the window where the occupants were trapped. The ladder is extended 91 feet at a 31 degree elevation angle.

Prior to the collapse, the tip of the left rail rested on the window sill. The weight of the occupants caused a twisting force to the unsupported right side.

The New York City collapse occurred when the capacity of the lower beam to support the compression forces was exceeded. The ladder was subjected to twisting forces caused by the contact between the building and the tip of the left beam (see Figures 2 and 5). In this situation the twisting increased the compressive load on the bed ladder at the location where the maximum bending stress is applied to the ladder, just above the area where the load is transferred to the vehicle. The inward buckling of the beam caused the right side of the ladder to fail first, which caused the ladder to twist to the right as it fell.

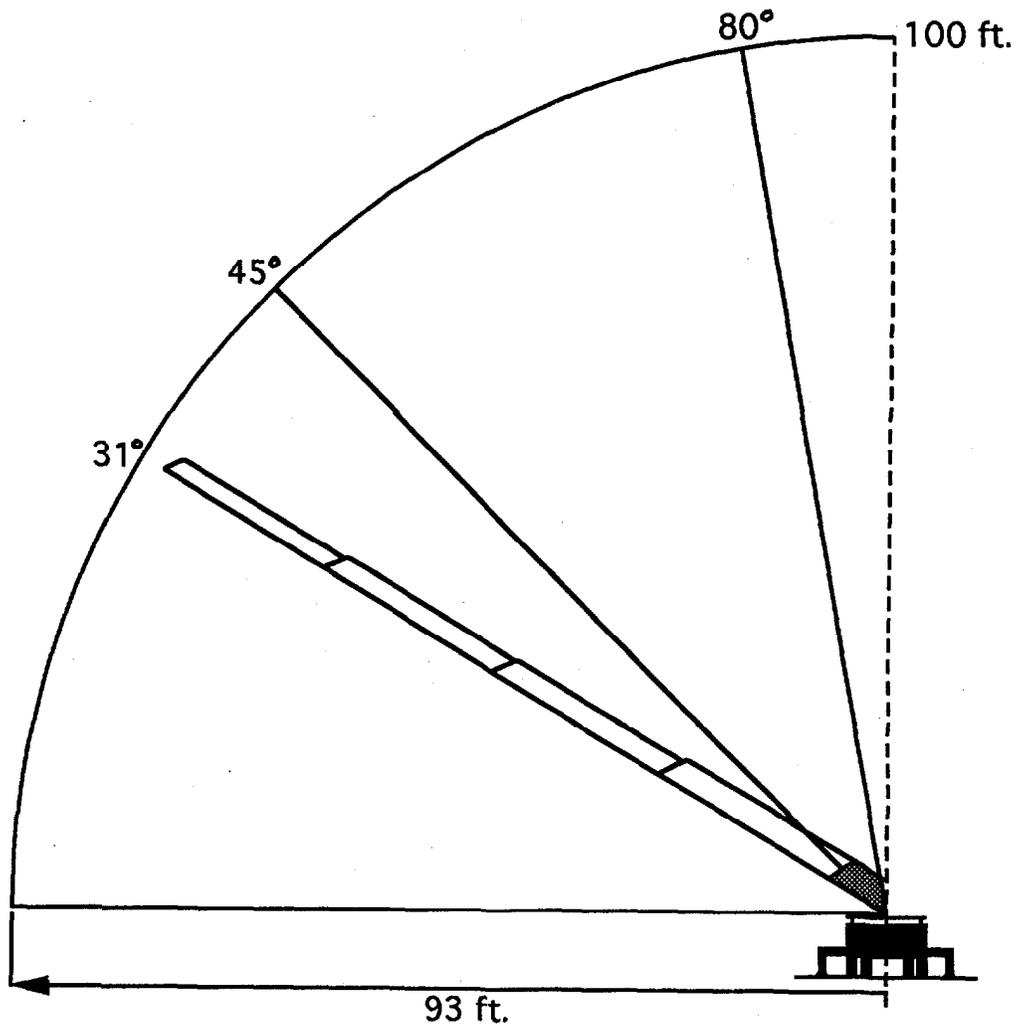
Figure 3. Ladder Position and Angle: New York Ladder Collapse

Load Conditions--To establish the elevation and extension of the ladder at time of failure, a similar vehicle was parked in the same location and the ladder was raised to the same window. To reach the window, the ladder was placed at an elevation angle of 31 degrees and approximately 91 feet, which is three feet short of its maximum extension (see Figure 3). It was rotated approximately 45 degrees to the right of the centerline of the vehicle.

The ladder was constructed of high strength steel with a yield strength of approximately 70,000 lbs. per square inch. The structural analysis indicated that the lower beam, where the primary failure occurred, should buckle when subjected to approximately 50,000 lbs. (pounds of force) of compression. The load calculations estimated that the actual force applied to this member would have been between 48,000 and 54,000 lbs., depending on the allowance for dynamic load when the father dropped onto the ladder. These calculations confirmed that the lower right beam should have been at or very close to the point of failure in the area where the actual failure occurred and that the failure would be caused by compression of the beam. The compression force in the right beam would have been intensified by the tip of the left beam being in contact with the wall; the twisting action would cause more of the load to be transferred to the right side of the ladder.

Based on this analysis it can be concluded that the ladder failed because the load exceeded the capacity of the ladder and not because of a defect in the ladder. The structural analysis also shows that the top chord of the ladder (the handrail) was at or very close to the point of tensile failure when the bottom chord failed in compression. (A copy of this report is provided in the appendix.)

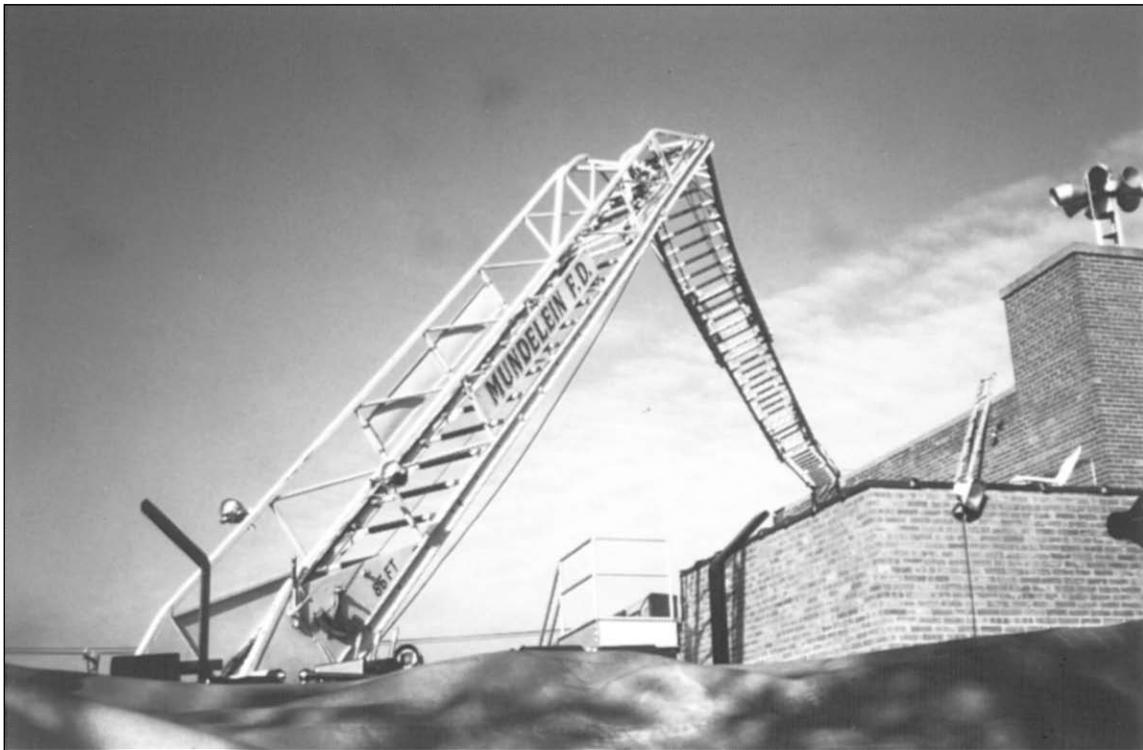
A 1970 Pirsch 100 foot aluminum ladder collapsed during a ladder pipe operation, seriously injuring one firefighter. The ladder was extended 97 feet at an elevation angle of approximately 37 degrees, which was beyond the recommended extension limits for ladder pipe operations. The tractor-trailer vehicle had been parked in a jack-knife position. As a firefighter ascended the ladder, a twisting failure occurred in the bed section, approximately eight feet from the base of the ladder.

State investigators determined that there was no physical problem with the ladder which would have caused the collapse. The cause was attributed to operating the ladder in an unsafe manner.

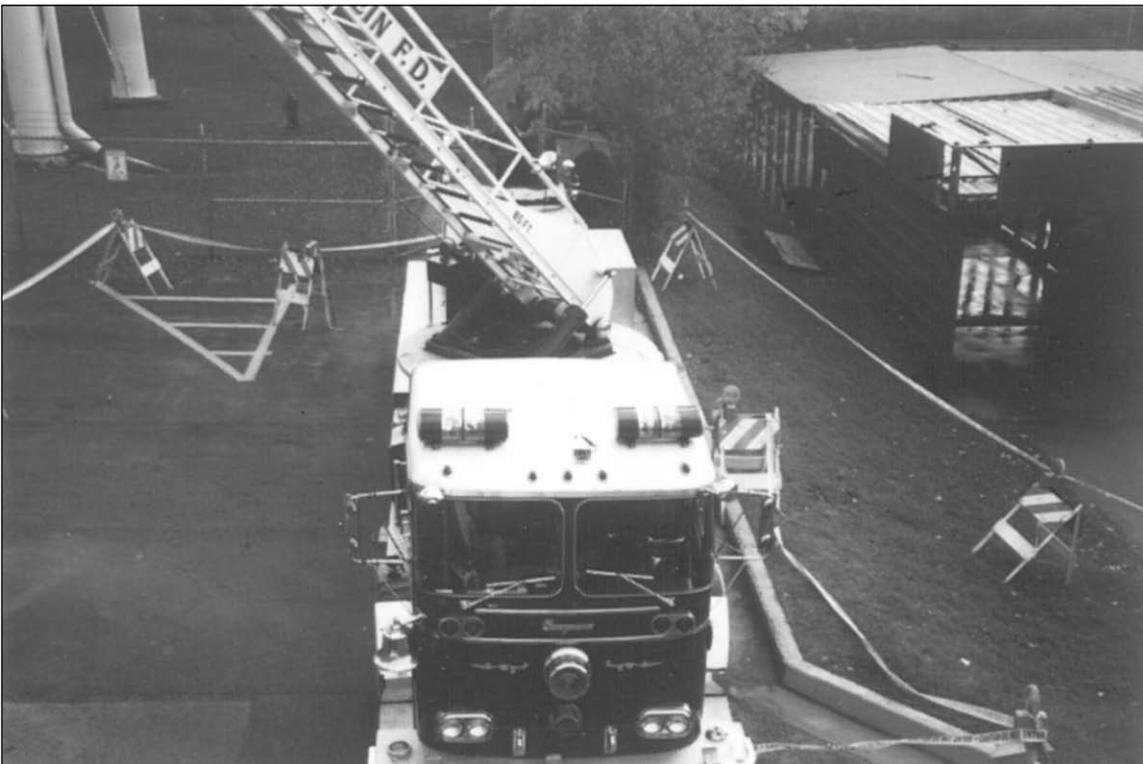
Firefighters in Mundelein, Illinois were practicing a stokes basket evolution when their aerial ladder failed just above the bed section. The firefighters had run a rope through pulleys attached to the tip and the front tow hook (seen below), and were attempting to raise the basket when the collapse occurred.
