U.S. Fire Administration/Technical Report Series

# Highrise Office Building Fire One Meridian Plaza

Philadelphia, Pennsylvania

USFA-TR-049/February 1991

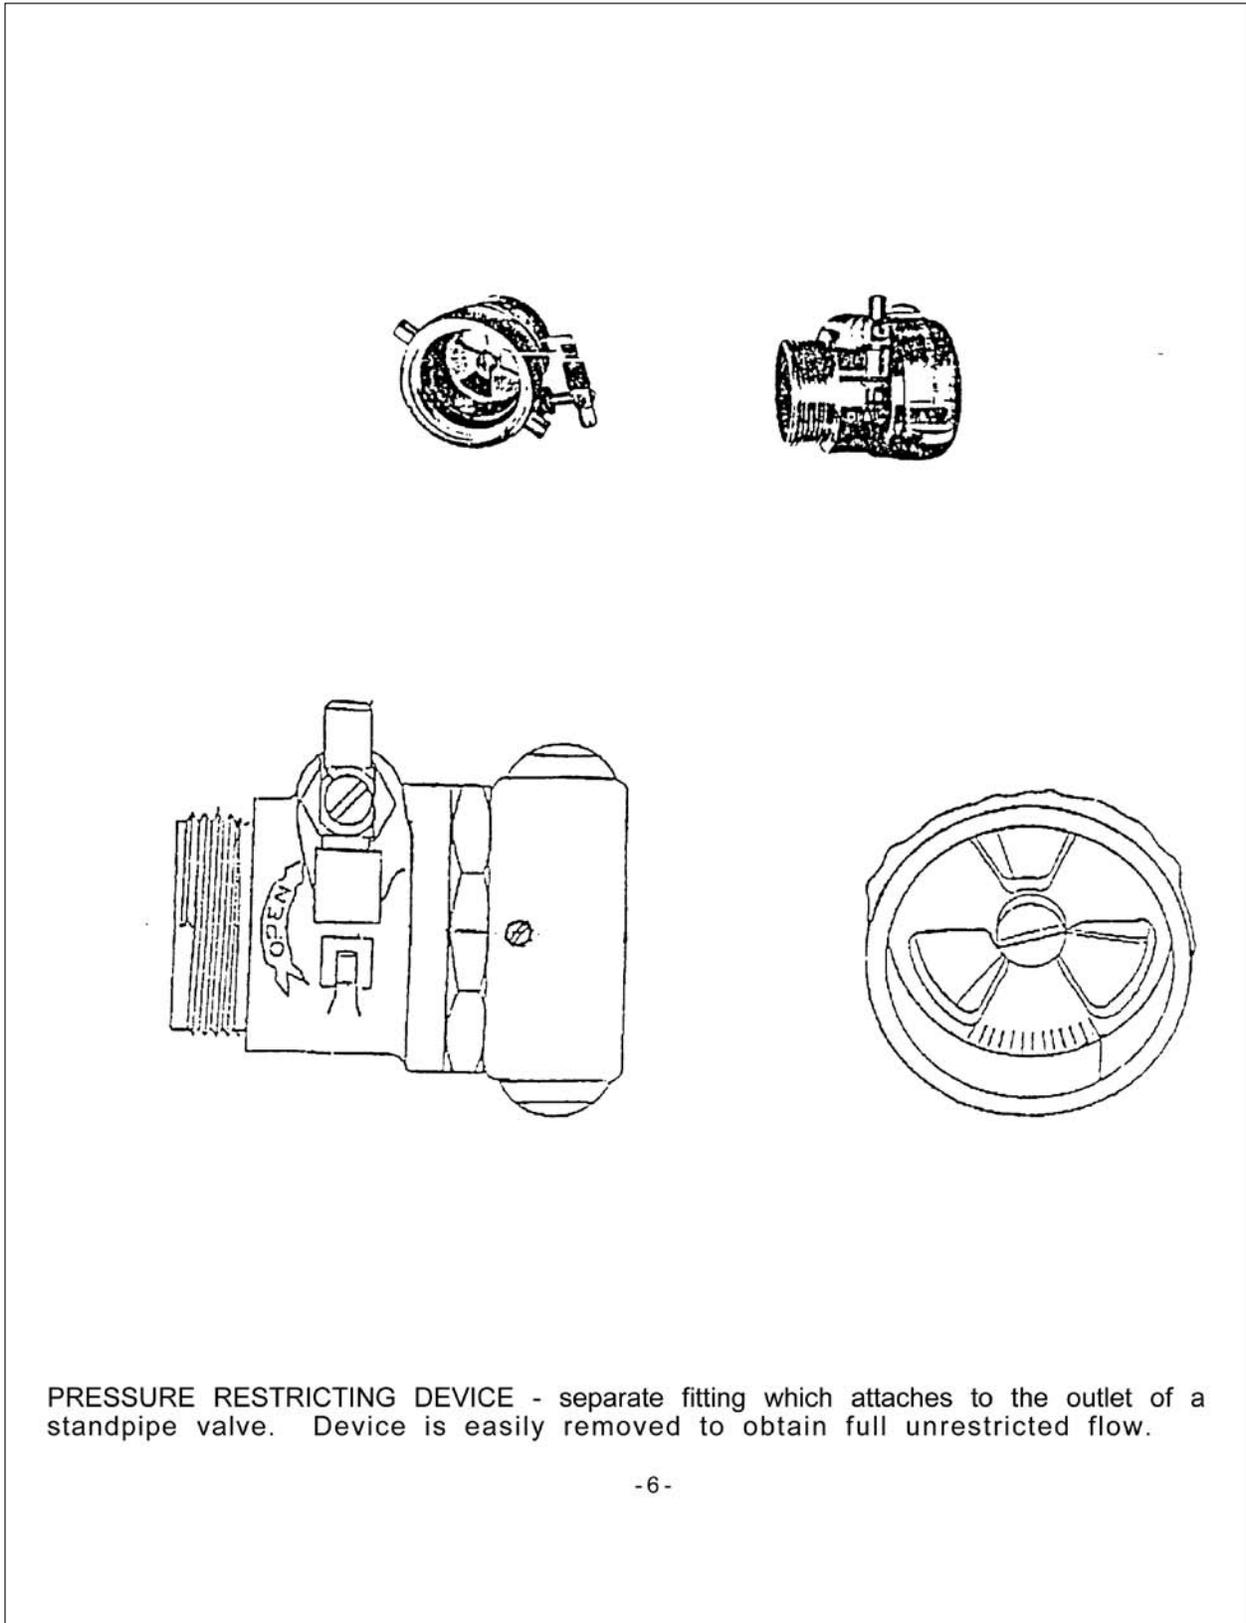
PRESSURE RESTRICTING DEVICE - separate fitting which attaches to the outlet of a standpipe valve. Device is easily removed to obtain full unrestricted flow.

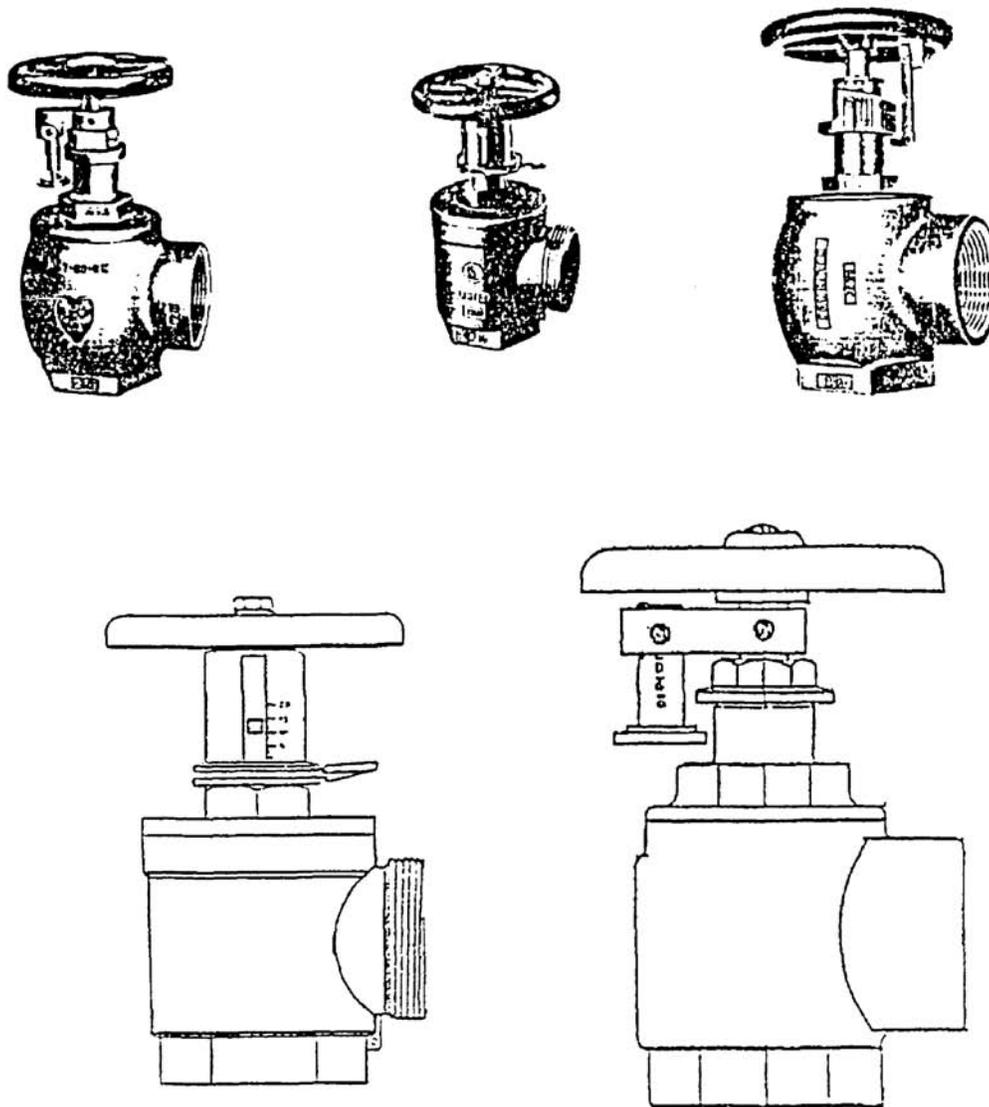
**PRESSURE RESTRICTING VALVES** - Pressure restricting valves are easily recognizable due to the external fittings on the bonnetts and stems (release links and clips, collars, etc.).

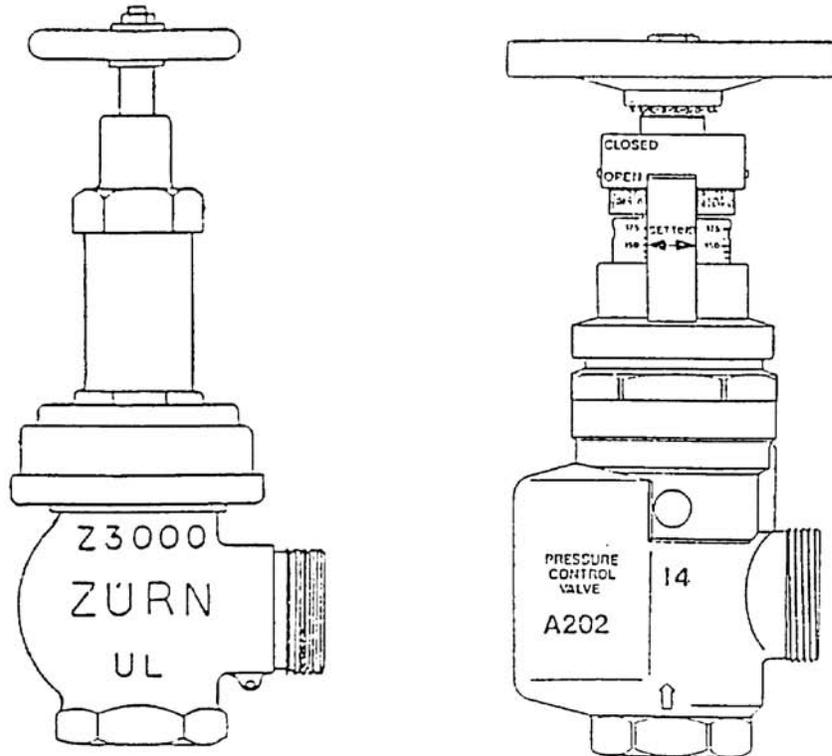
**PRESSURE REGULATING VALVES** - Direct acting pressure reducing (pressure regulating) valves are required to be permanently marked with: the name or trademark of the manufacturer or private labeler, and a distinctive model number, catalog designation, identification mark, or the equivalent. If unsure whether a particular valve is a PRV, contact the Inspections unit with the above information.

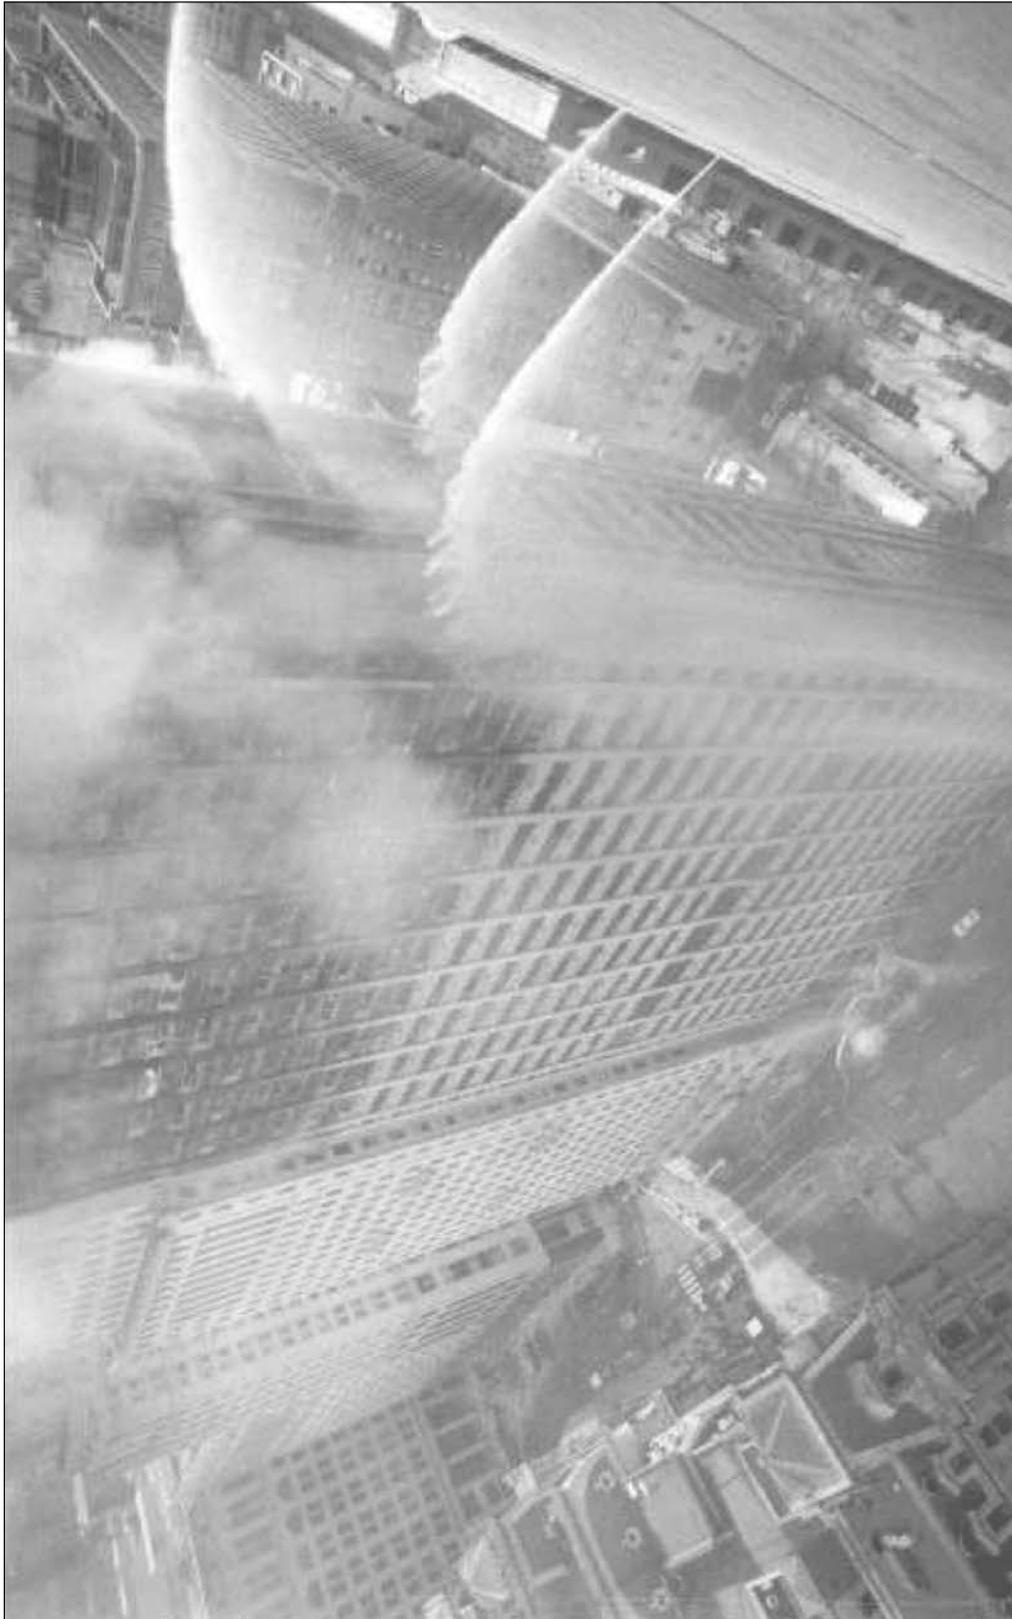
*Philadelphia Inquirer* photo by Michael Maly  
Aerial view of exterior firefighting operations after dawn on February 24, 1991.

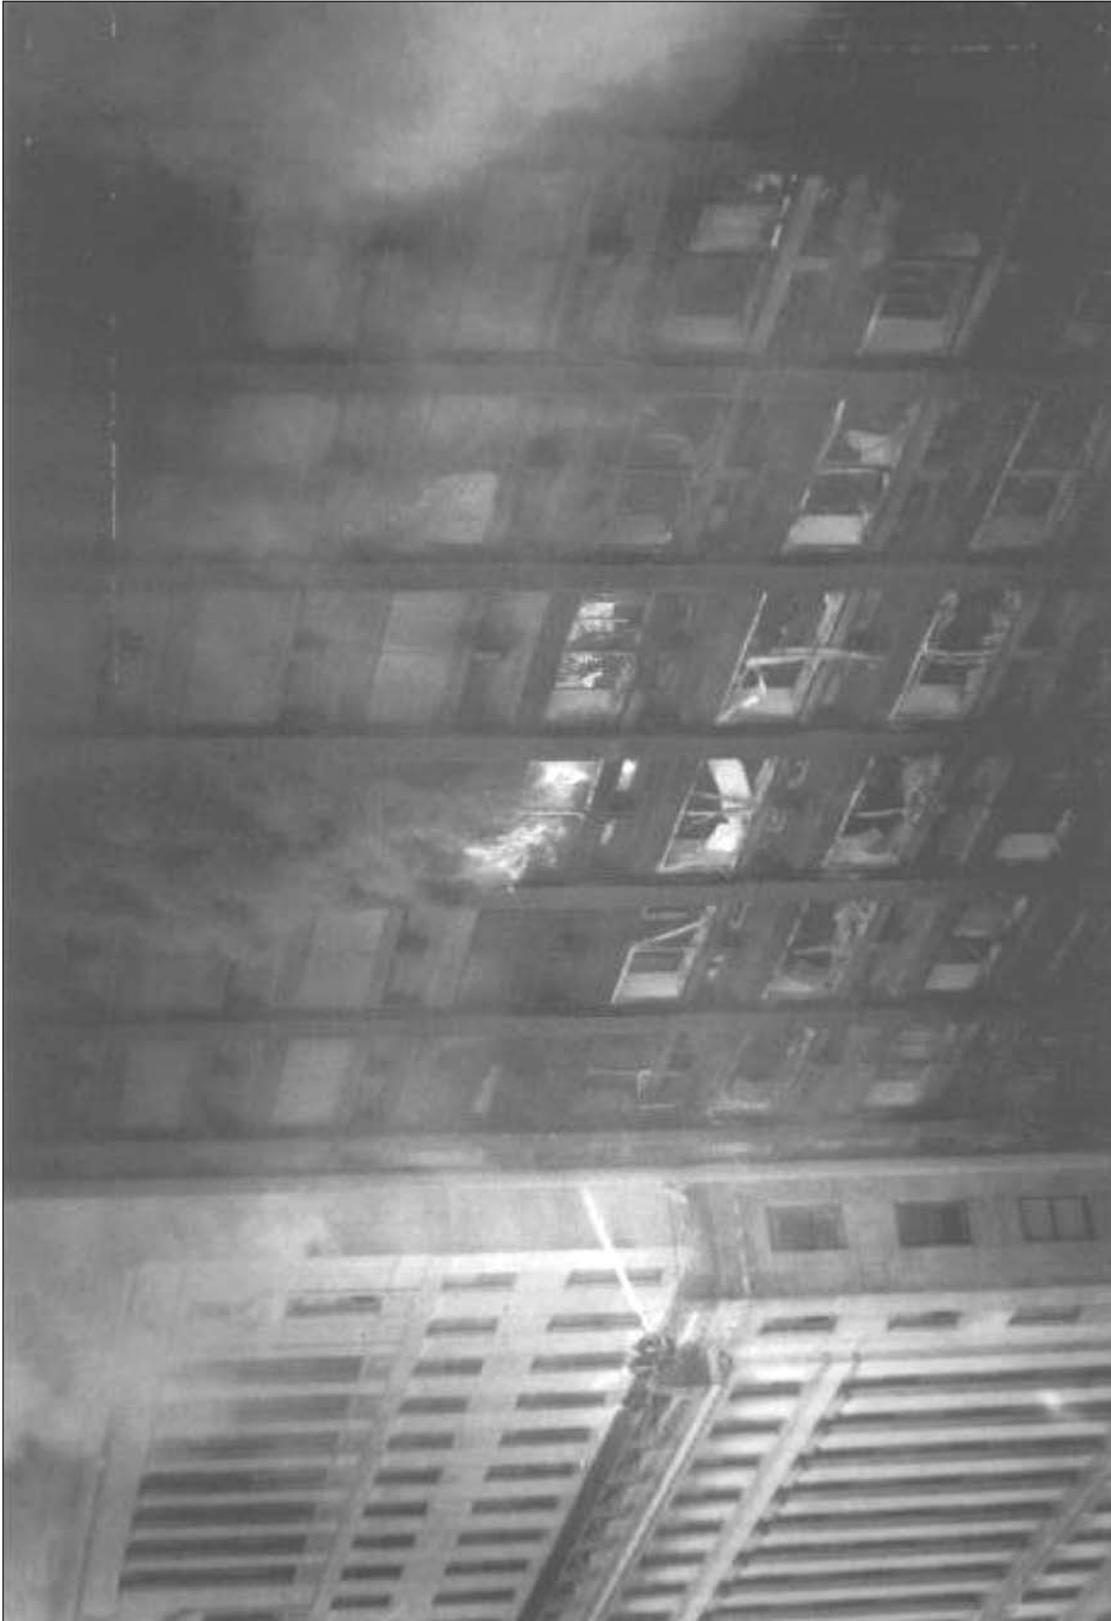
*Philadelphia Inquirer* photo by Michael Mally  
**Exterior firefighting efforts from the Girard Building #1, east of One Meridian Plaza. The two buildings are connected on lower floors.**

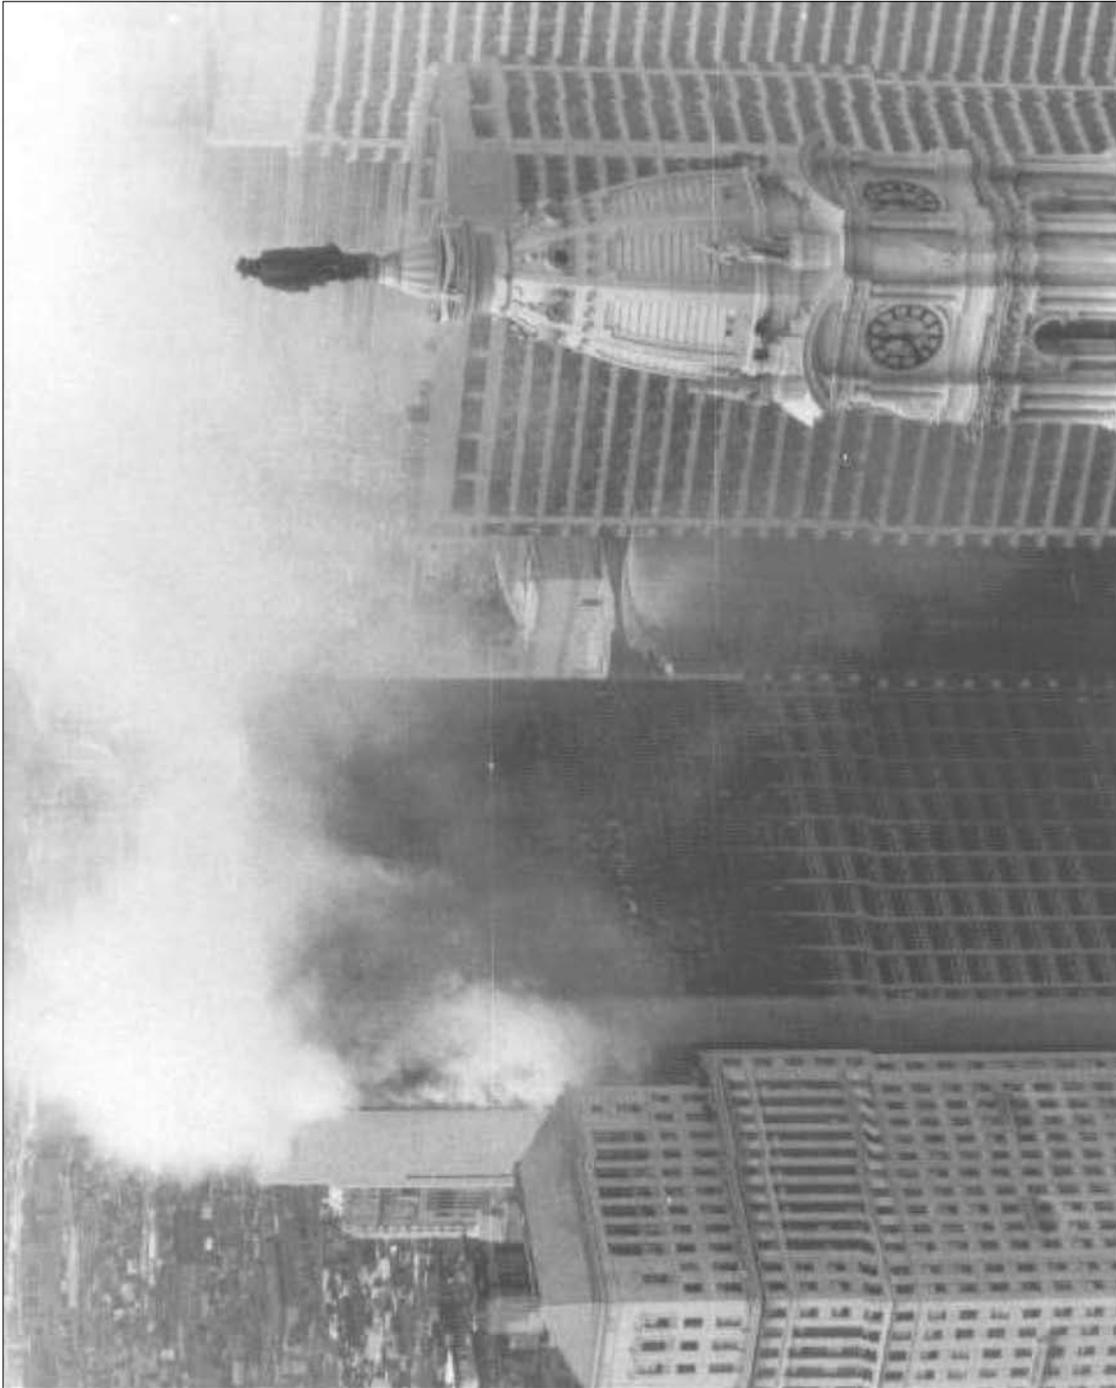
*Philadelphia Inquirer* photo by Rick Bowmer  
**Smoke pours from One Meridian Plaza as William Penn looks on from atop Philadelphia City Hall the morning of February 24, 1991, after interior firefighting efforts have been suspended.**

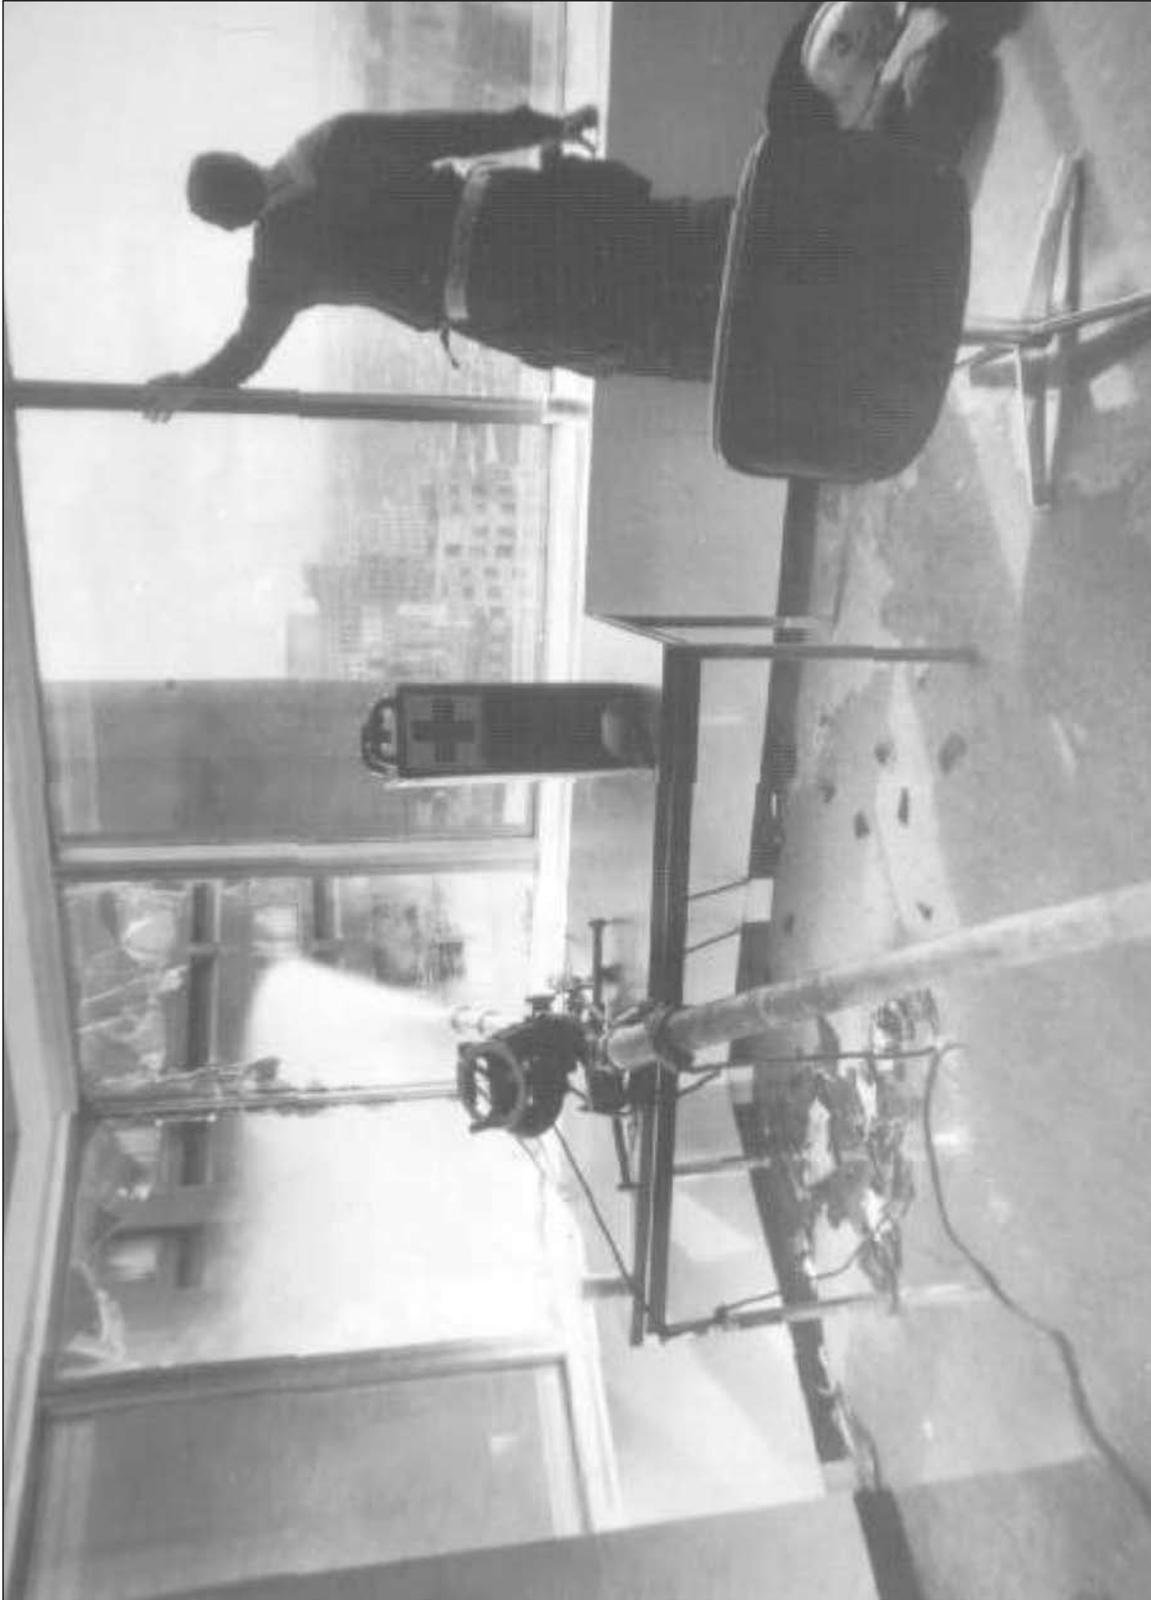
**View of deluge set operating from One Centre Square.**

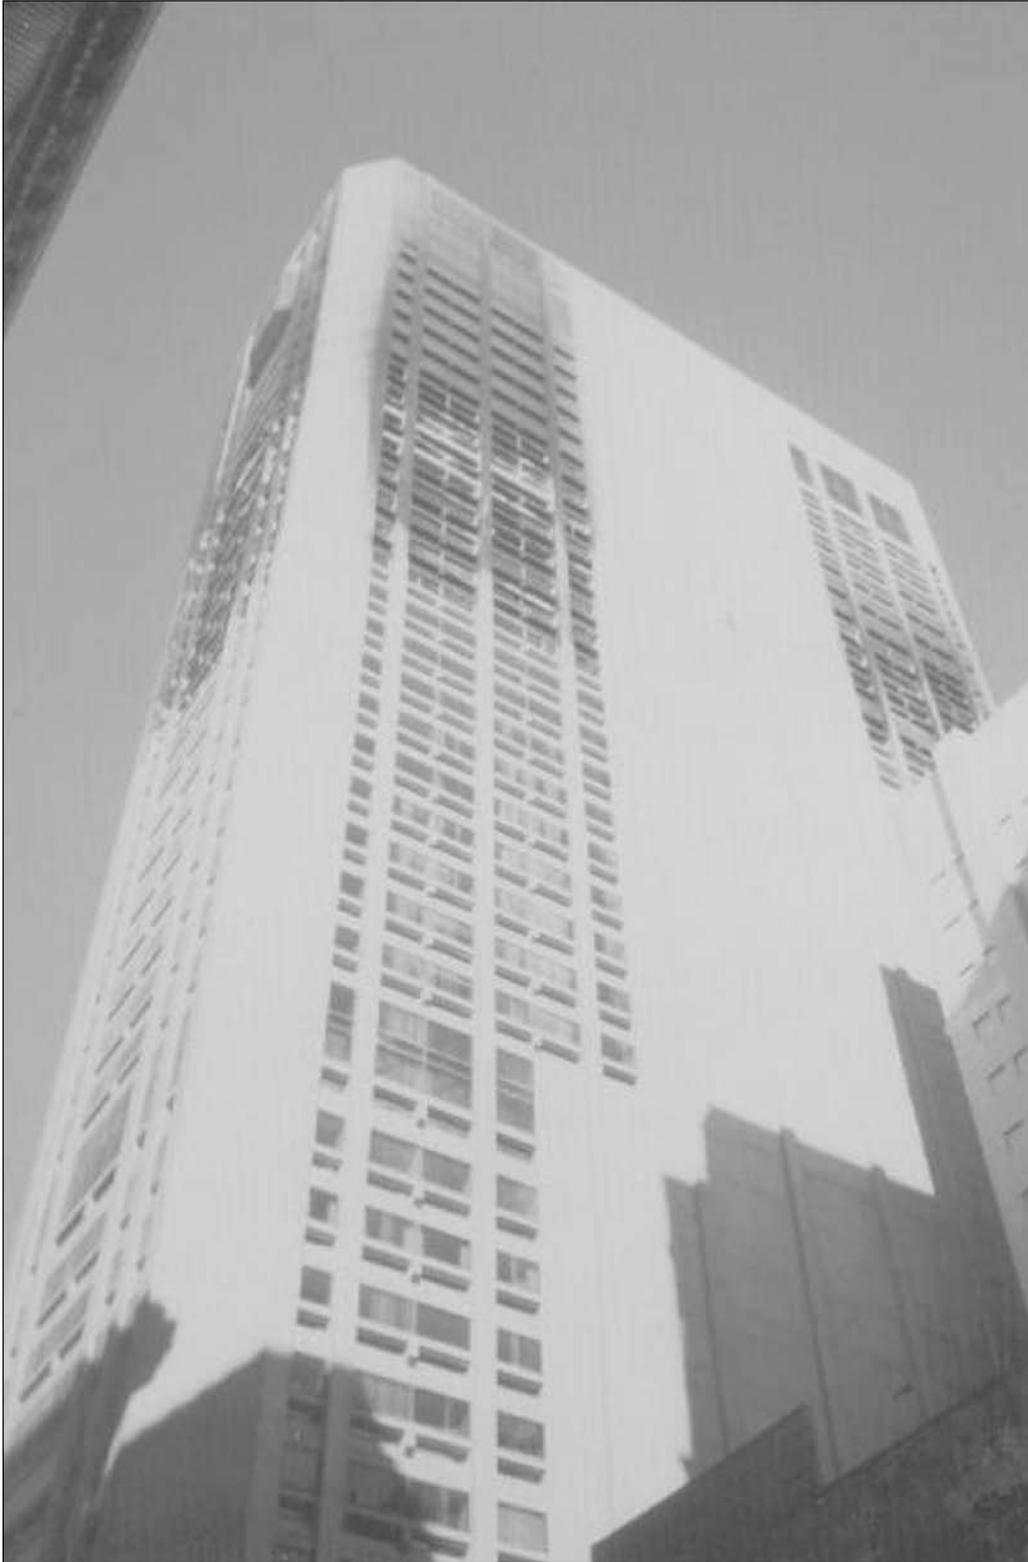
Exterior view of south side of building.

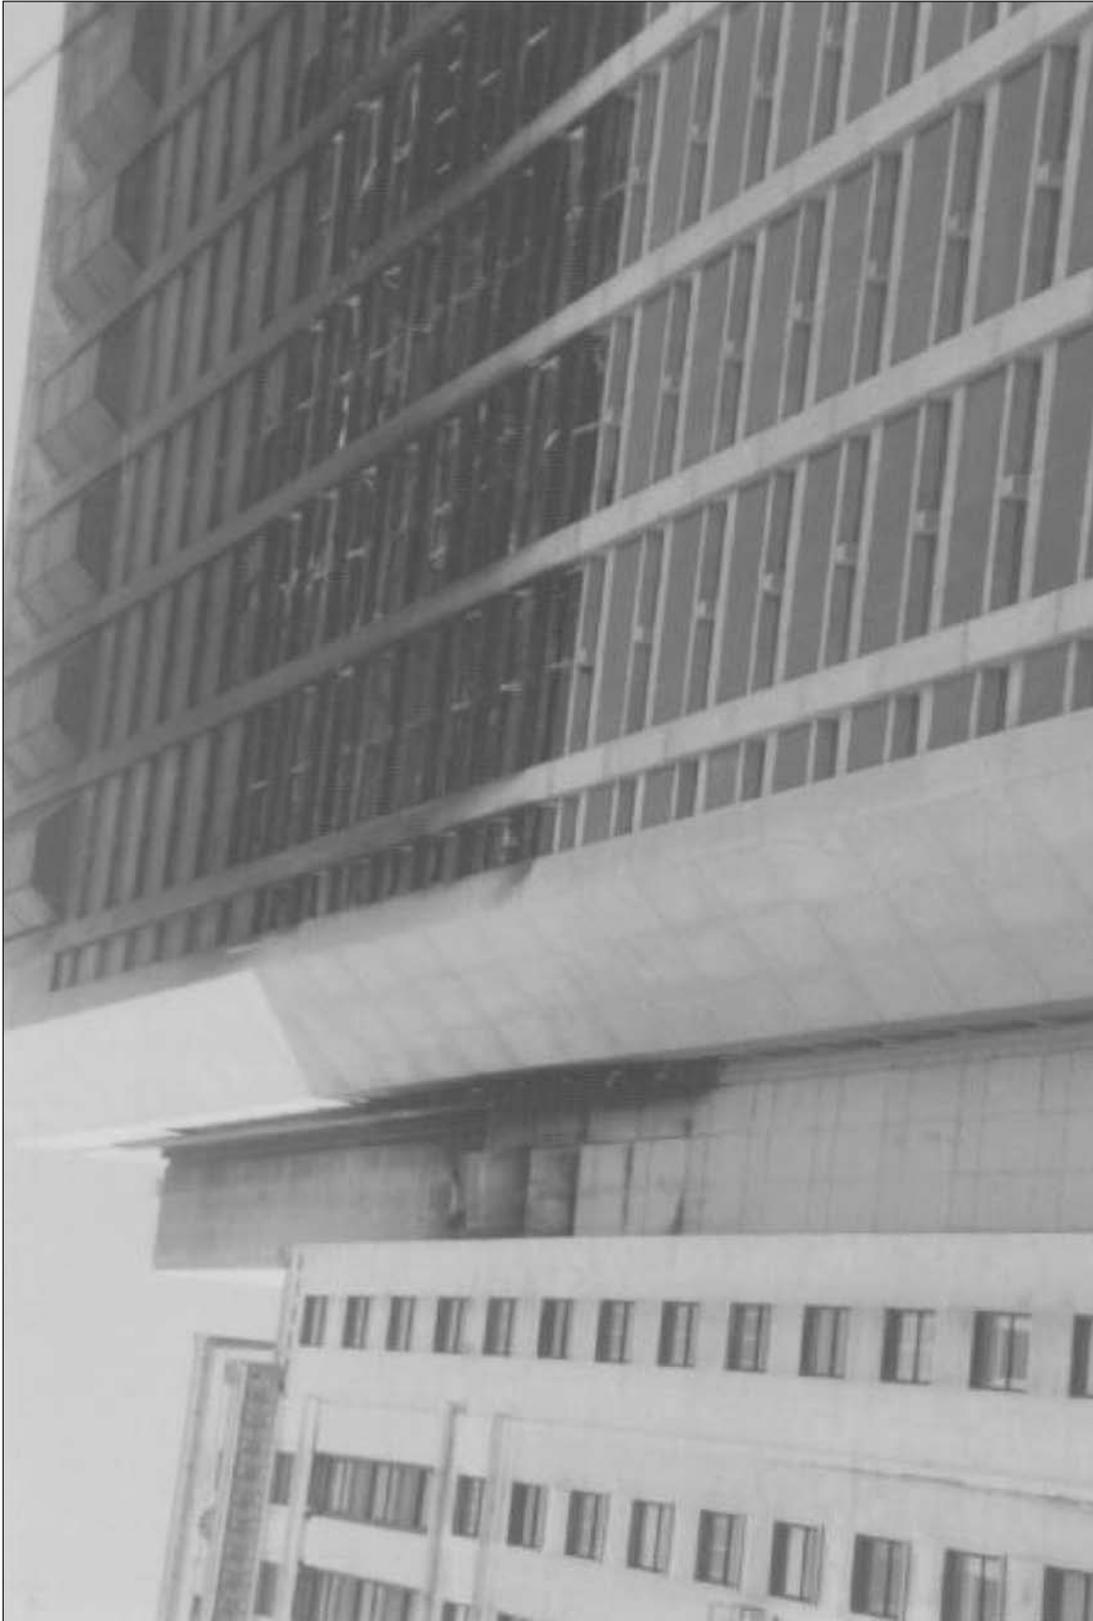
This stairway connected the One Meridian Plaza Building with the adjacent office building.

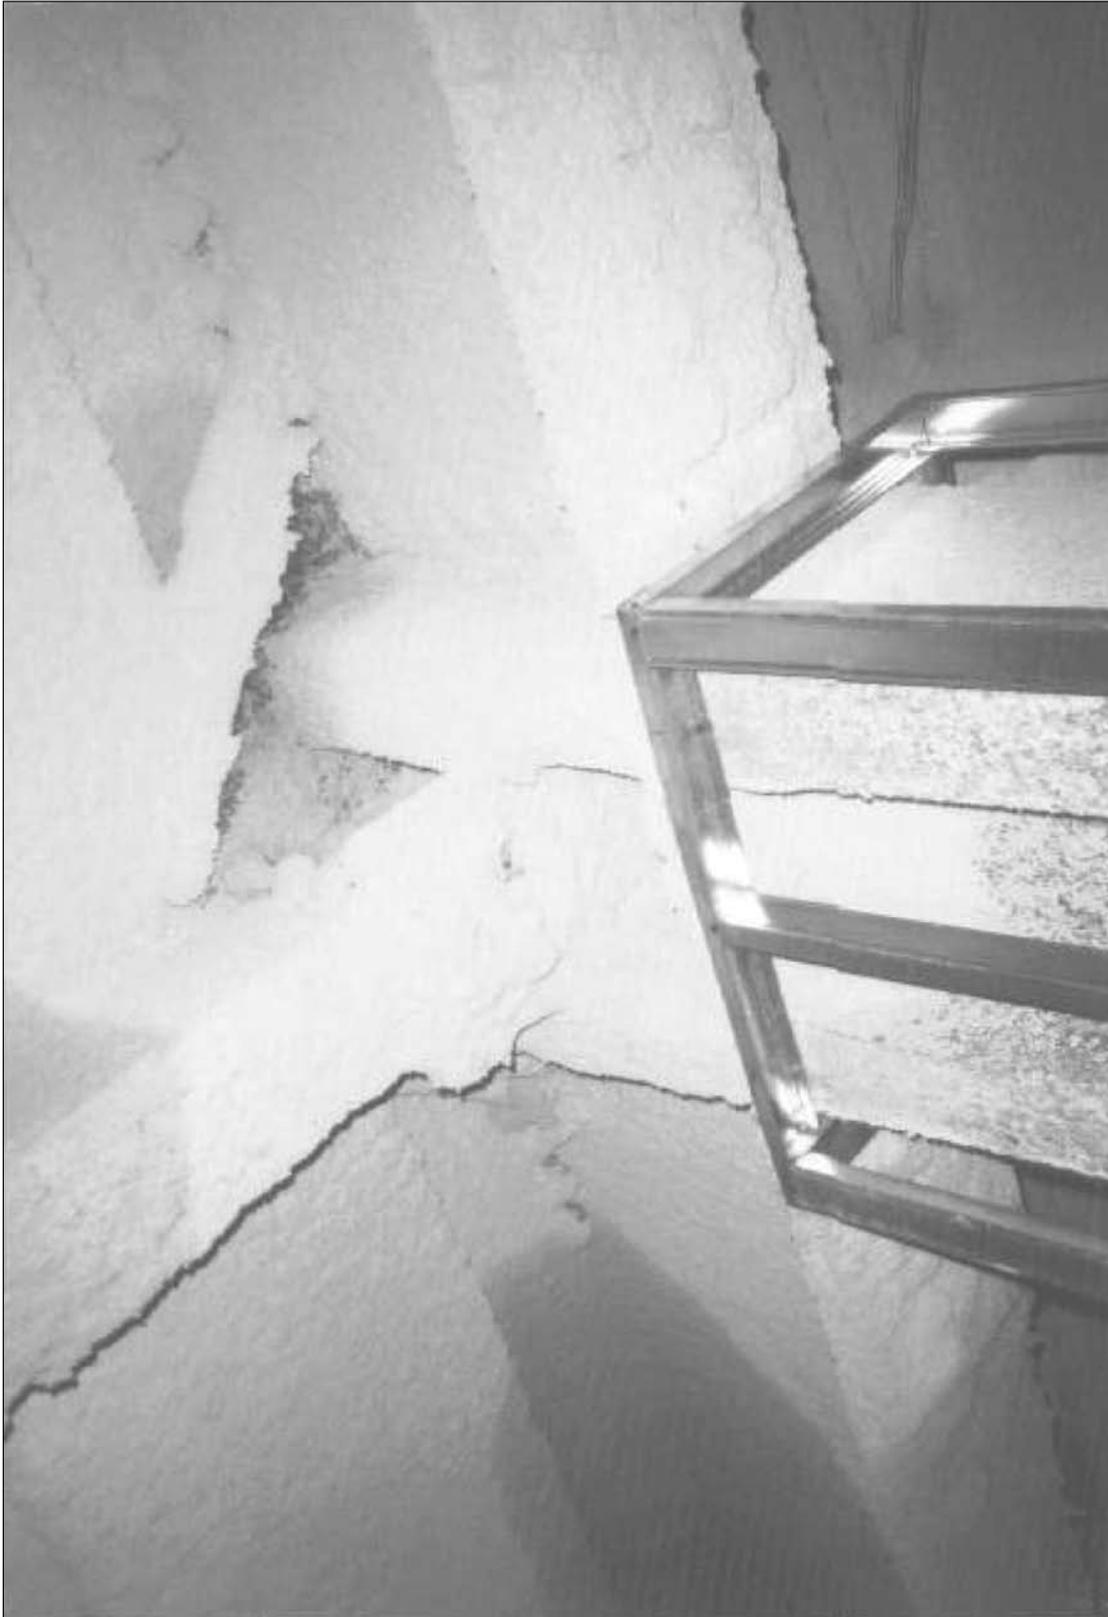
Detail of typical Type 1B construction, 6th floor. Note the spray-applied fireproofing and framing for gypsum wallboard.

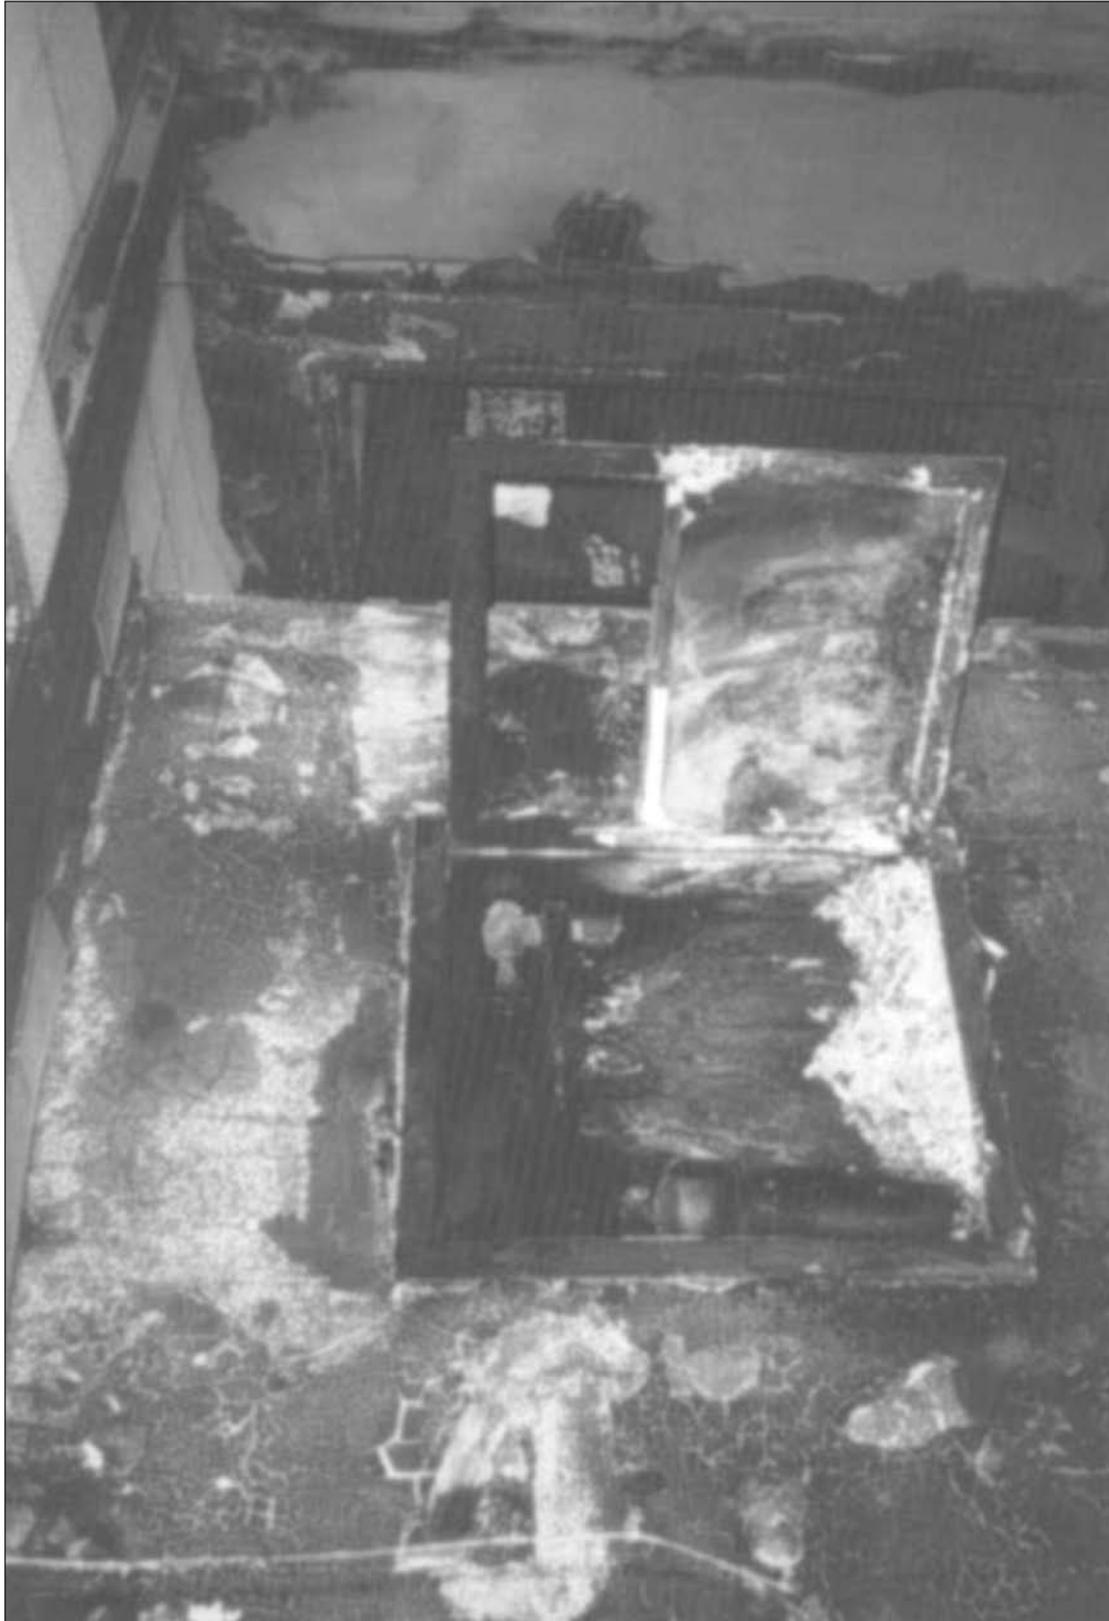
Occupant use standpipe hose cabinet on 26th floor.
