# NBS SPECIAL PUBLICATION 592

## An Investigation of the Miyagi-ken-oki, Japan, Earthquake of June 12, 1978

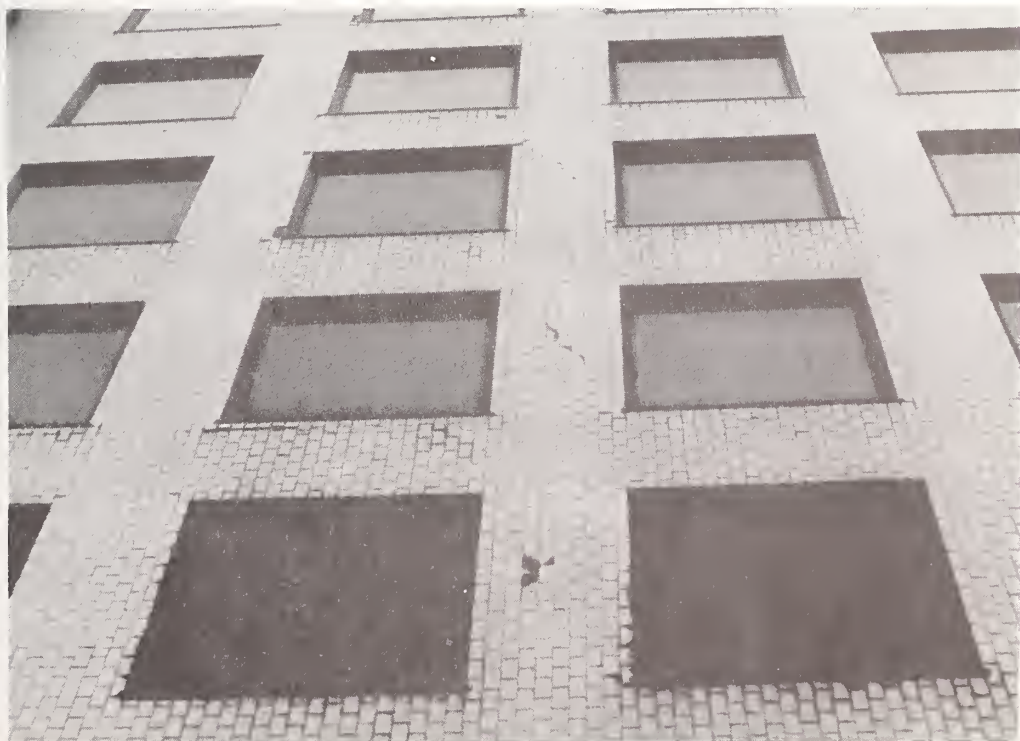
The U.S. team arrived in Sendai June 23rd, 11 days after the earthquake. The first impression upon entering the city was that a significant earthquake had not even occurred. This was due in part to the speed with which the Japanese authorities had responded to the disaster. Evidences of damage that would have otherwise impeded the normal operations of the city had already been cleared away. Upon closer inspection, minor facade damage became obvious (Figures 5.4, 5.5, 5.6, and 5.7. This sort of damage was not widespread by any means and numerous modern buildings did not show any damage to their architectural veneers or glazing. It was reported that many chimneys and stacks had collapsed or were severely damaged (e.g., Figures 5.8 through 5.10).

Figure 5.9 Downtown Sendai. Reinforced concrete chimney failure.

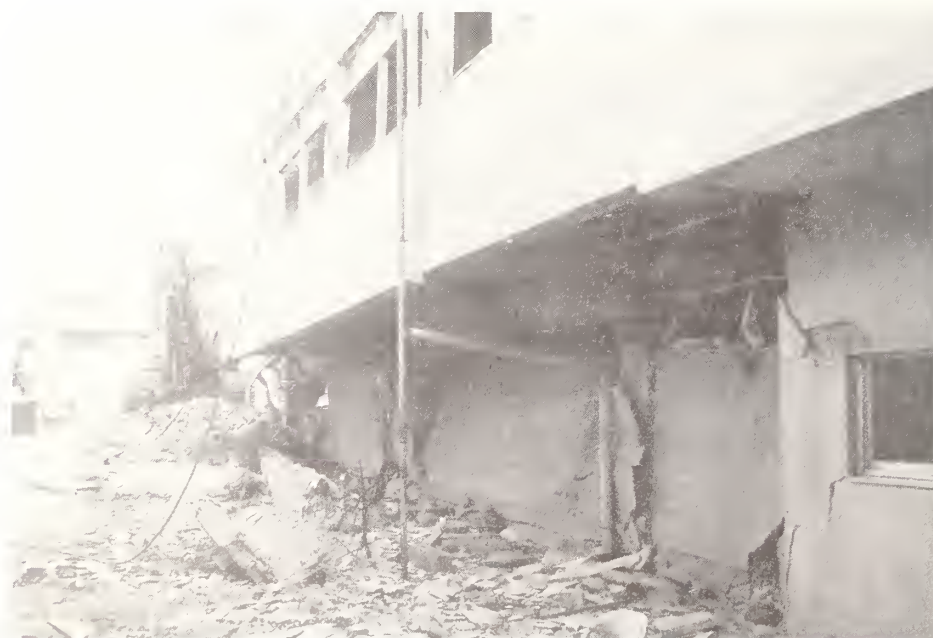
Maruyoshi Building (No. 6, Figure 5.3). This was a three-story reinforced concrete frame building, one span by three, with the long axis of the building running in the E-W direction. There was a 2 m overhang on the north side of the structure (Figure 5.22). The wall shown at the west end was continuous from the second-story on up. The building had a flexible first-story. The building suffered extensive damage to the first-story (Figure 5.23) and, as shown in Figure 5.24 was tilting toward the north. The first story columns on the south side of the building failed in shear due to the strong N-S motion. A detail of the beam-column joint where the second-story floor beam frames into the first-story column is shown in Figure 5.25. Column ties appeared to be spaced at about 300 mm. The shear wall on the west end of the structure appeared to be undamaged. Unfortunately, this caused the structure to behave as an inverted pendulum and caused the first-story columns to accept even more shear. Note the use of the undeformed bars in the beam-column joint (Figure 5.25).

Figure 5.23 Maruyoshi Building, view from the northwest. This three story reinforced concrete frame, one span by three, suffered almost total collapse of the first floor.

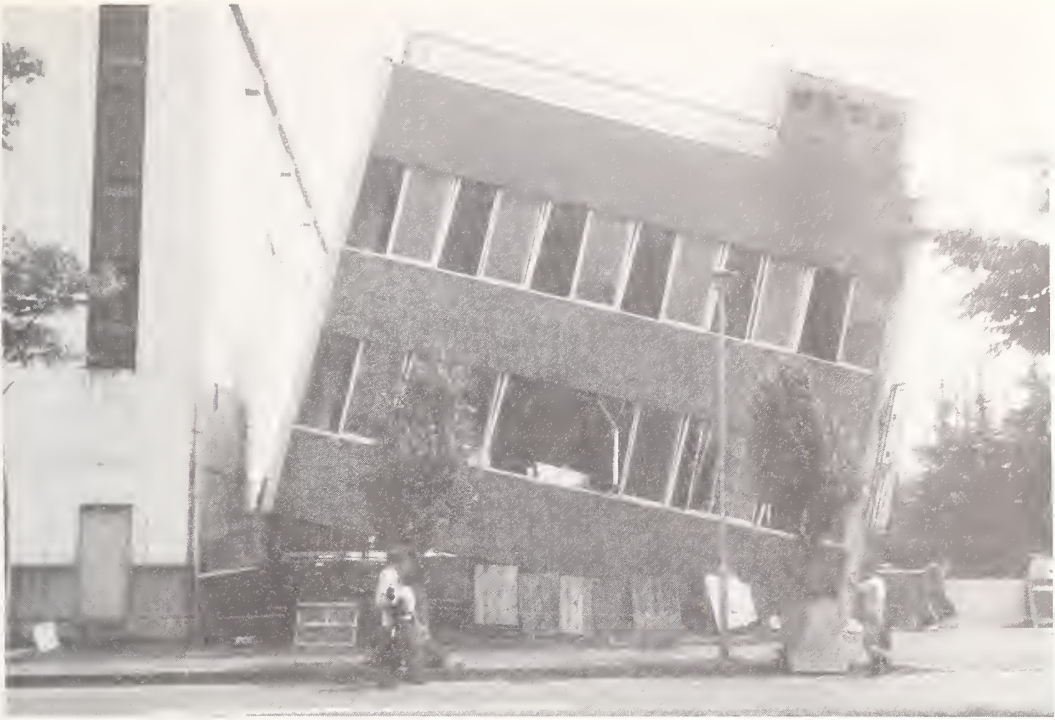
Obisan Building (No. 7, Figure 5.3). This was a three-story reinforced concrete frame building with one span in each direction (Figure 5.26). The portion of the building which overhung the column line by about 2 m contained a heavy stairwell. There were no openings in the overhanging part of the building, which added to the eccentric mass. Coupled with the strong N-S motion, this caused a failure in torsion as the columns at the west end of the building were unable to withstand the forces resulting from the large eccentric mass. Figures 5.27 and 5.28 show the Obisan Building after the earthquake viewed from the north and south, respectively. It may be observed that the upper stories rotated almost as a rigid body when the first floor columns failed. The first-story of the building had been used as a display area, and was completely open. A detail of the SE column is shown in Figure 5.29 and in the plan. As shown in Figure 5.30, the first floor support beams were practically resting on the ground at the west end of the building. The walls above the first-story suffered extensive cracking during the earthquake, but remained intact (Figure 5.31). The reinforcing bars that can be seen are undeformed.

Figure 5.27 Obisan Building, viewed from the North. This three story reinforced concrete frame building had a heavy eccentric stairwell cantilevered over the column line at the right end of the building.

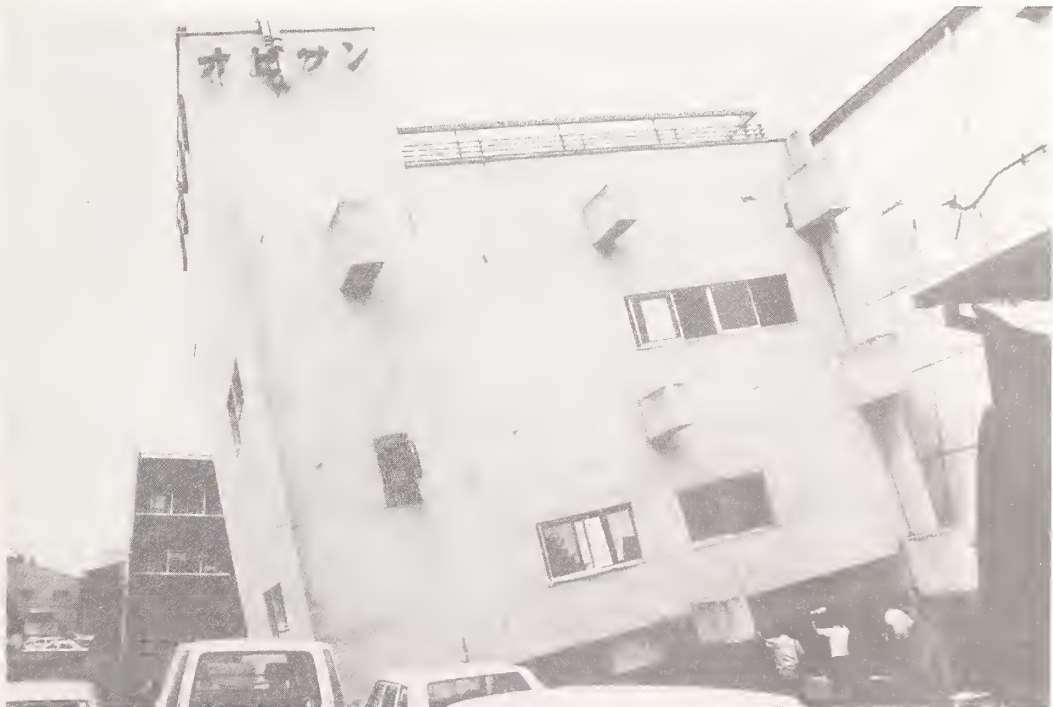
Figure 5.28 Obisan Building, viewed from the south. The upper stories rotated as a rigid body when the first floor column support was lost.

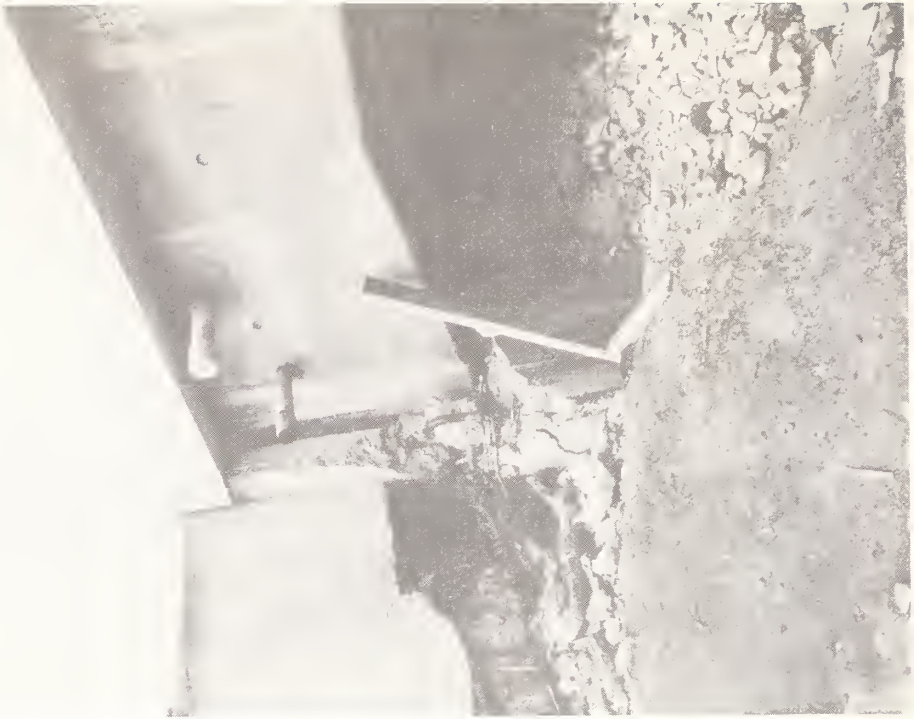
Figure 5.30 Obisan Building, detail of southwest column adjacent to overhang.

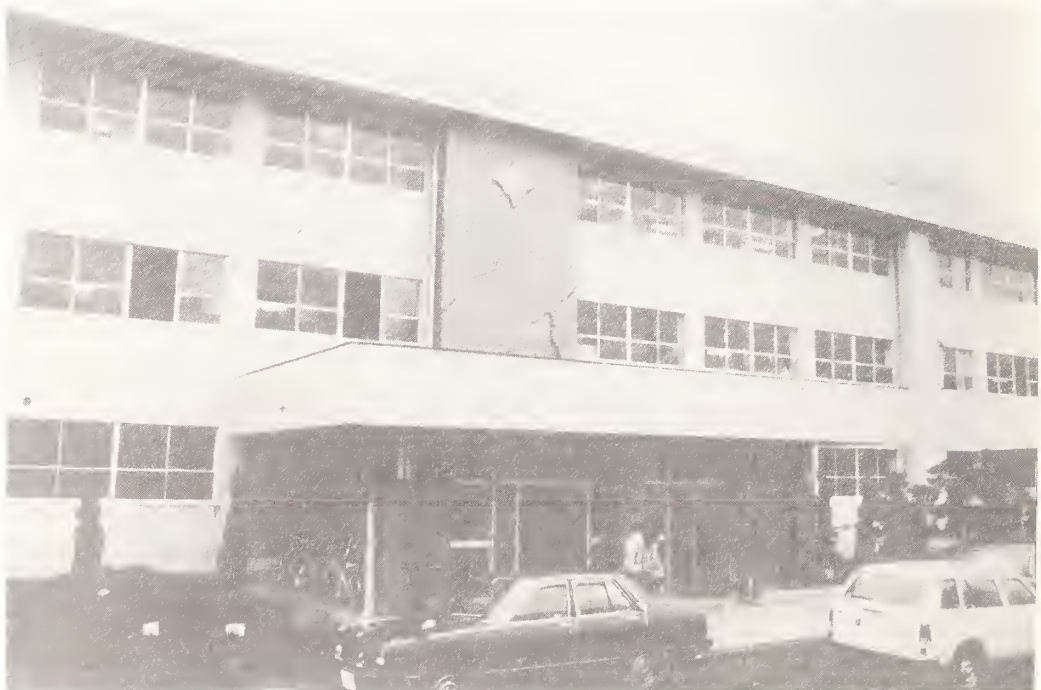
Figure 5.60 Izumi High School. An interior corridor wall in classroom building 1 aligned in the longitudinal direction of the building.

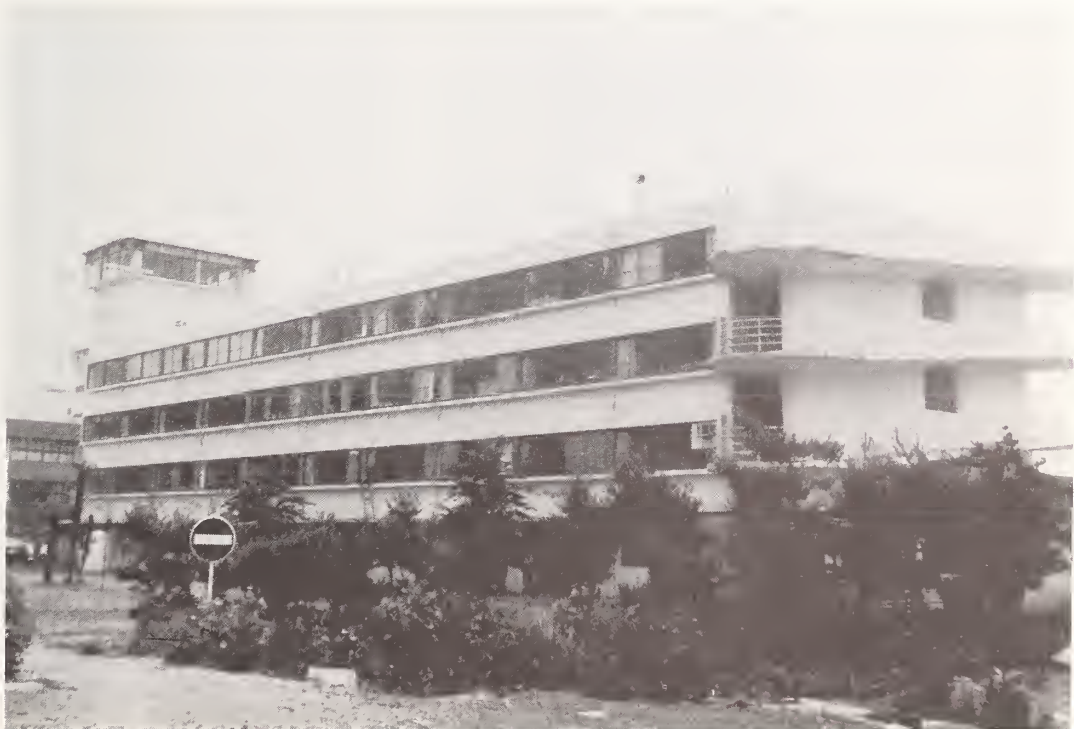
The northeast facade of building 3 is shown in Figure 5.74. This is a four-story reinforced concrete frame building, ten spans by two. While the relatively flexible interior columns were undamaged, all of the exterior columns on the first-story cracked in shear just above the infill panels, as shown in Figure 5.75. Figure 5.76 illustrates this more clearly at one of the first-story columns on the northeast side of building 3. As can be seen, the reinforcement is undeformed. We were informed that core samples taken out of the spandrels showed no apparent damage to the concrete.

Figure 5.75 Tohoku Institute of Technology, Building 3. Damage to the ground floor columns on the south side of the building. Similar damage is present on the opposite side of the building.

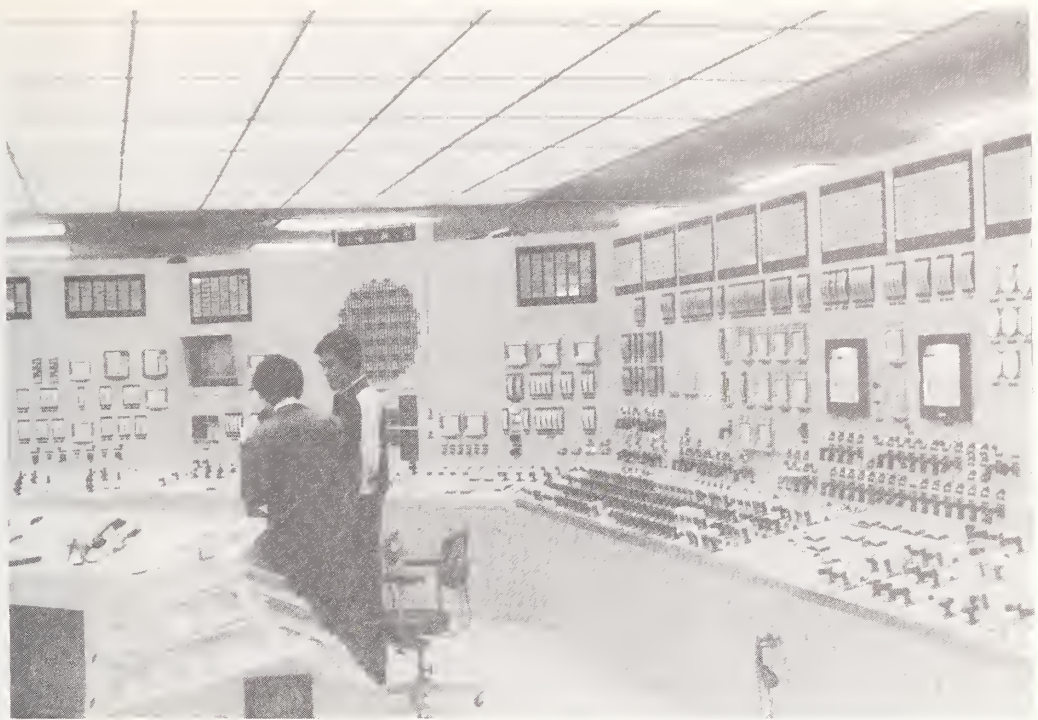
Figure 6.10 Fukushima Nuclear Power Plant. Broken ceramic insulators were the only damage reported for the site. The damaged insulators had been replaced, as illustrated above, within hours after the earthquake and before the reconnaissance visit.

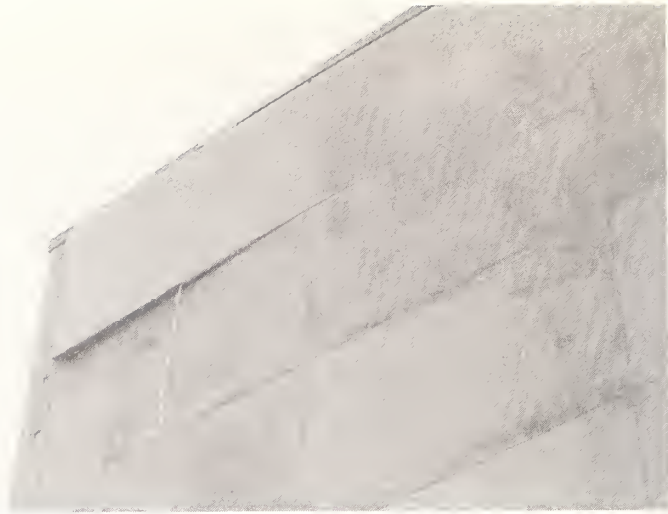
Figure 6.16 New Sendai Power Plant, Tohoku Electric Power Company: a loosened exterior facing panel in the turbine building. This was the only obvious damage to the exterior of the structure. The shear walls of the adjacent administration building showed extensive cracking.

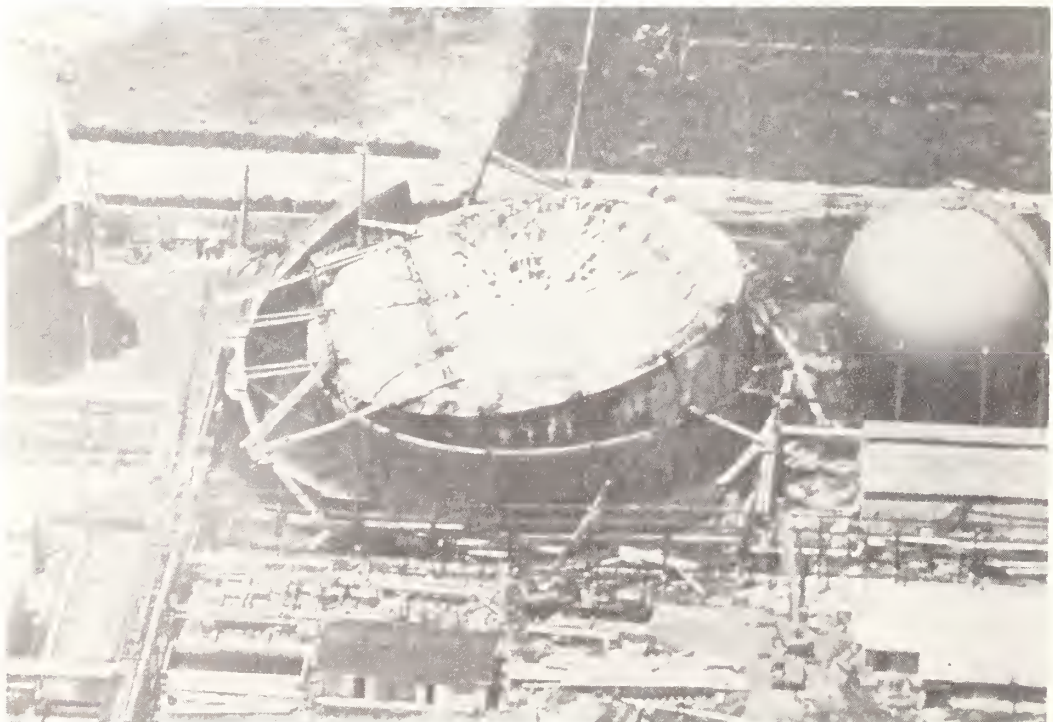
The Sendai City Gas Bureau's Haranomachi Plant, located approximately 3.7 km northwest of the center of Sendai, suffered major damage. The total collapse of a large propane gas holder (Figure 6.30) was partially responsible for the stoppage of gas for the city. It was estimated that gas services for the city would not be restored until the end of June, some three weeks after the earthquake. At the time of the investigation (June 25, 13 days after the earthquake) many restaurants in Sendai were closed because of lack of gas. According to Chapter 2 about 60 percent of the 200,000 households in Sendai are dependent on gas for heating and cooling, and as of June 28, 1978, 22,000 of these households were still without gas. An additional 10,400 households elsewhere in the prefecture were also without gas.

The collapsed holder caught on fire shortly after failure, and all of the stored gas was consumed. The fire burned out, or was extinguished, about 25 minutes later, and did not spread to the nearby high pressure propane tanks. The most serious damage to the gas facility was caused by the collapsing holder. It struck the nearby pipeway for many of the tanks at the plant, causing much damage to the piping systems and other associated equipment. Figure 6.31 shows the collapsed holder and the damaged pipeway just after the earthquake. At the time of the investigation a new pipeway had been erected on the concrete pedestals of the old pipeway, and repairs of the pipelines were proceeding, Figure 6.32. These pipes service the remaining undamaged gas tanks.

Figure 6.30 Haranomachi Plant, Sendai City Gas Bureau: an overall view of a collapsed propane gas holder and some of the surrounding propane storage tanks and affected pipeway and equipment. (Kahoku Newspaper Co. photograph)

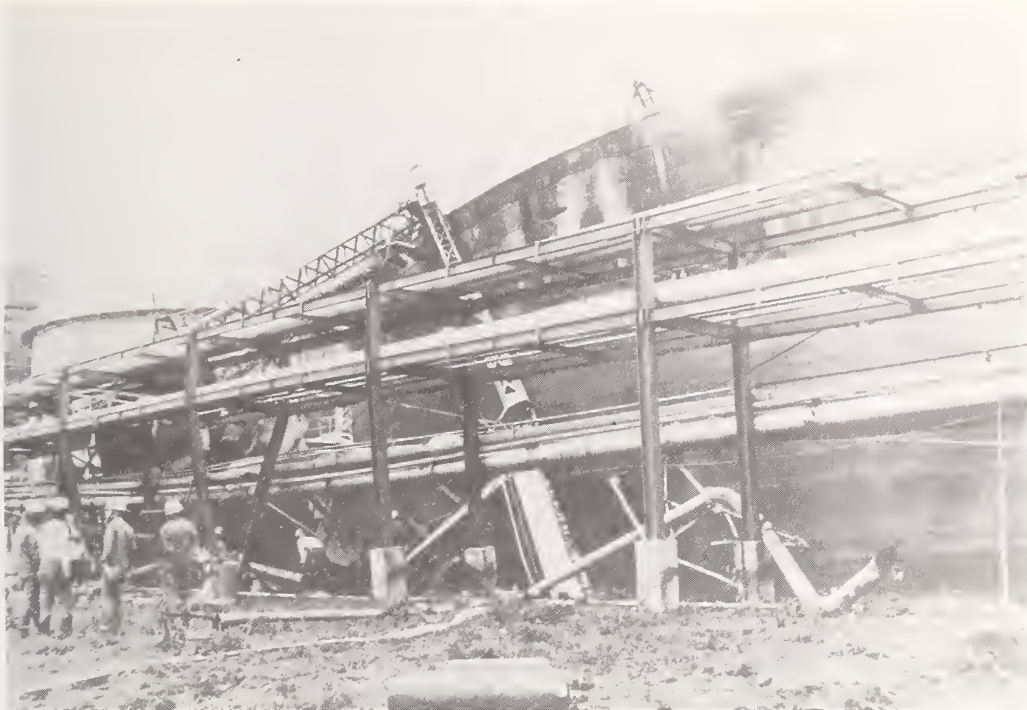
Figure 6.31 Haranomachi Plant, Sendai Gas Bureau; collapsed gas holder and the damaged adjacent pipeway structure just after the earthquake, (Sendai Gas Bureau Photograph)

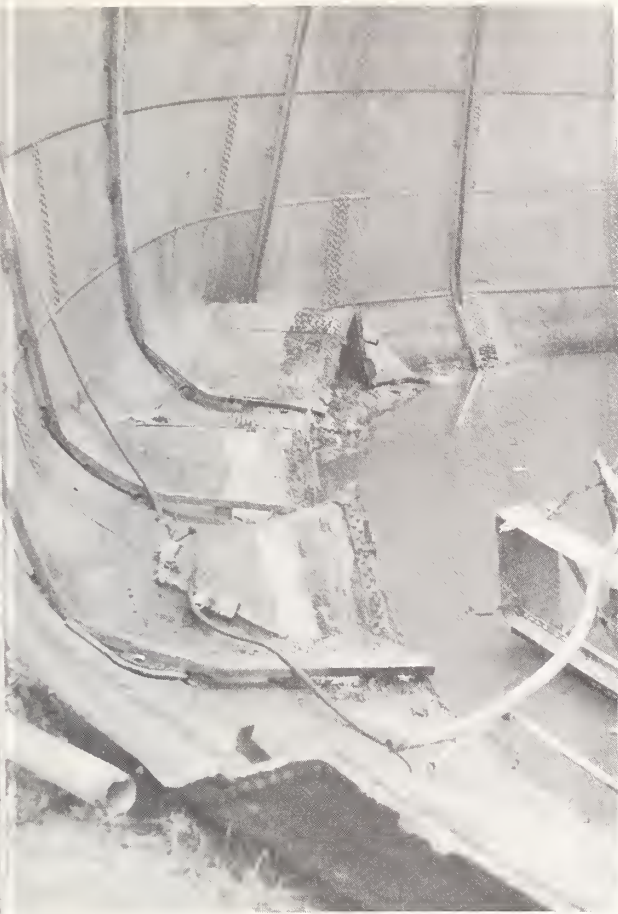
Figure 6.35 Haranomachi Plant, Sendai City Gas Bureau: buckling damage to the lower portion of one segment of the gas holder.

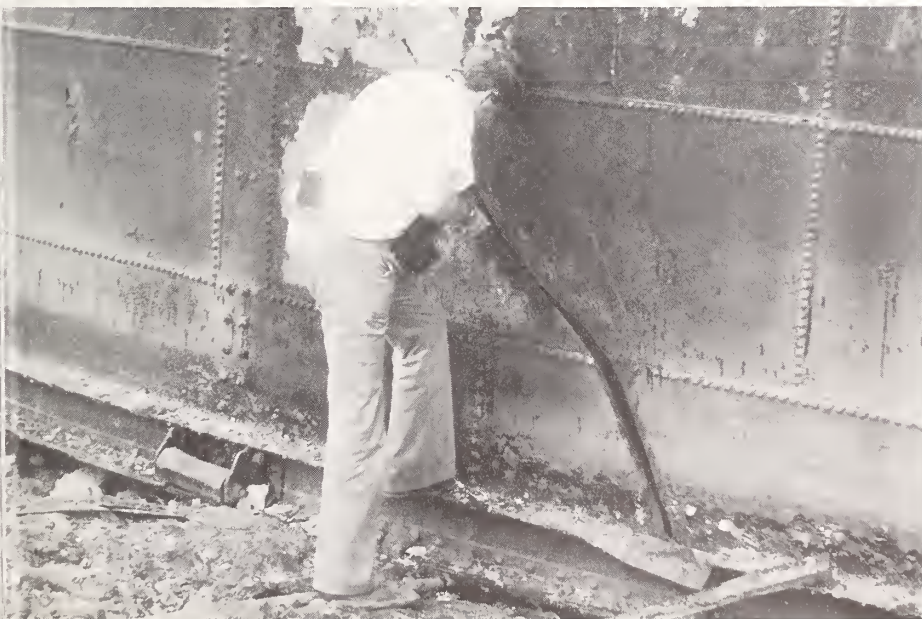
Figure 6.36 Haranomachi Plant, Sendai City Gas Bureau: a fracture of the 3/8-in. plate wall of the collapsed gas holder. The length of the fracture is approximately 1.5 m (5 ft).

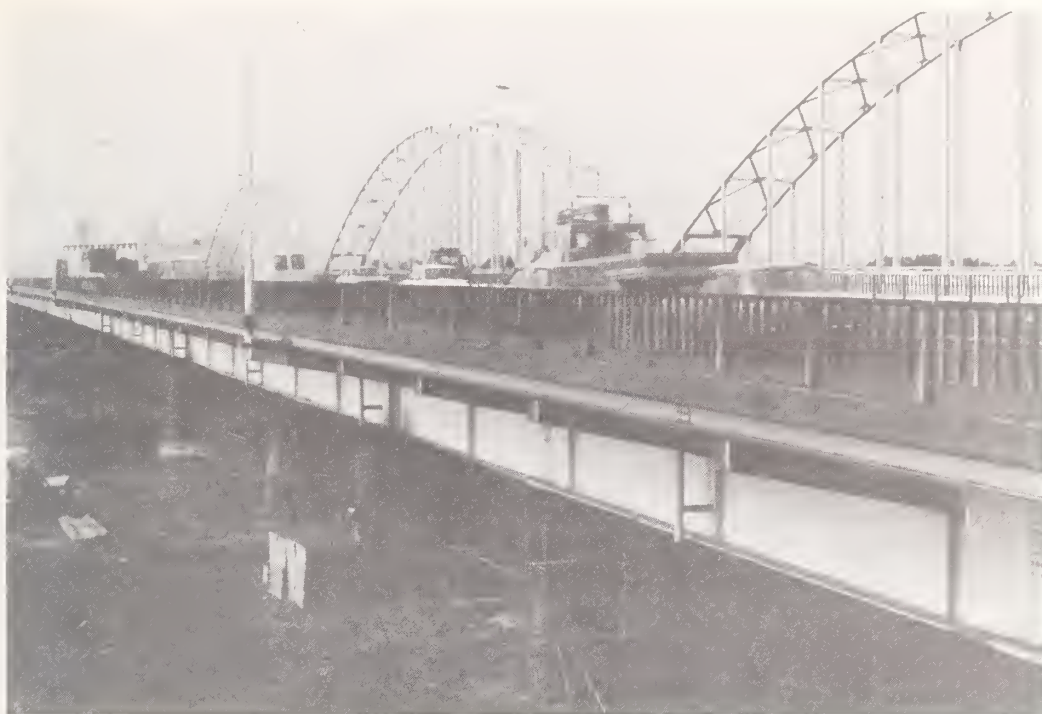
Figure 7.18 Yuriage Bridge. Evidence of 8 cm of longitudinal movement as shown at the handrail expansion joint, Pier 2. However, there was no evidence of damage to the girders or the second pier.

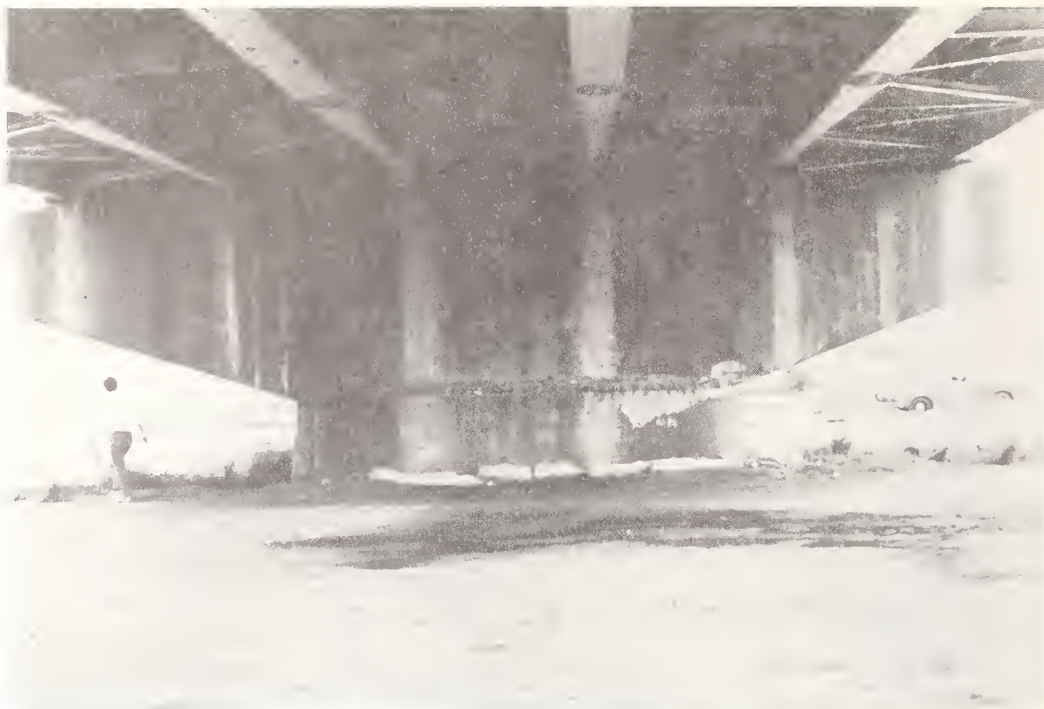
The Sendai Ohashi Bridge over the Hirose River on Japan National Highway, Route 4, constructed in 1965, suffered heavy pier damage (Figures 7.19 - 7.27). The structure is a nine-span, simply supported composite concrete and steel plate girder bridge with 34 m span lengths. The bridge had been retrofitted at points across the joints at the piers with steel restraining plates bolted to the girder webs. The bridge was closed to traffic the night of June 12 while temporary pier supports were constructed at two of the more severely damaged piers.

Figure 7.20 Sendai Ohashi Bridge. Temporary cribbing used to support the steel plate girders.

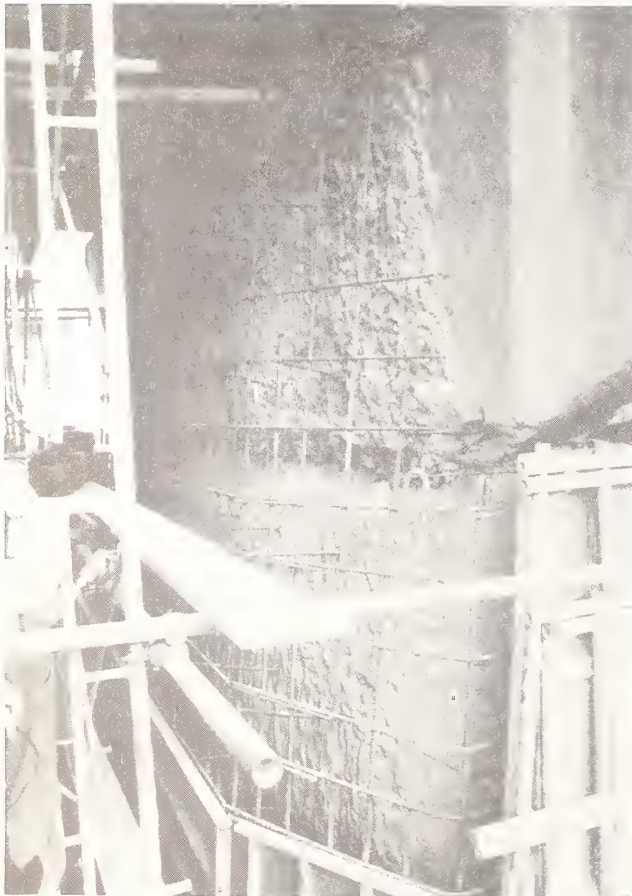
Figure 7.25 Sendai Ohashi Bridge. Typical damage being repaired at the base of the pier. Note the outward buckling of the underformed vertical rebar. The concrete cover had been roughened, the footing strengthened, and additional rebar placed to strengthen the pier.

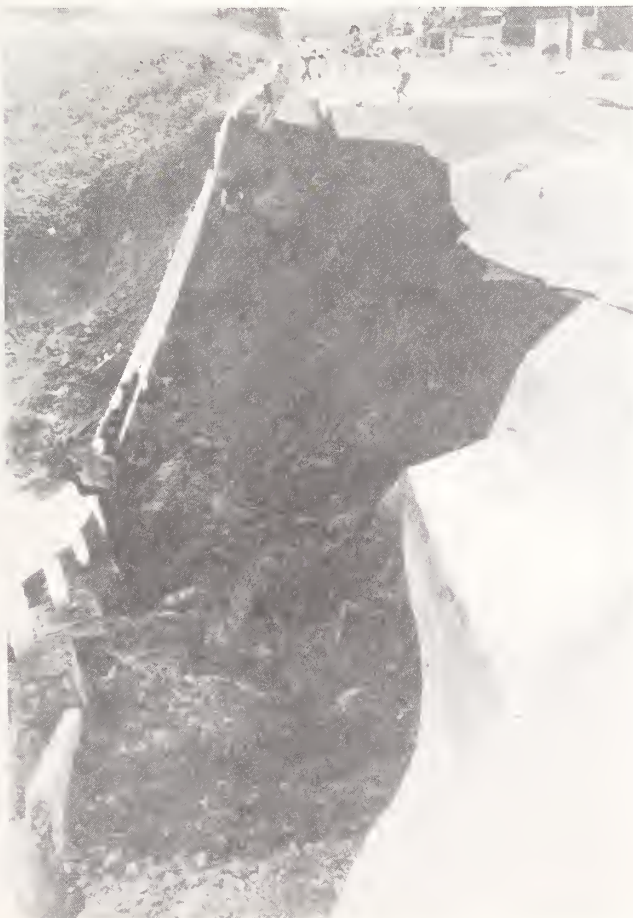
Widespread highway damage (e.g., Figure 7.44) occurred in the region north and east of Sendai. Typical damage included settlement of bridge approaches, cracking of pavements, failure of roadway embankments, and blockage of roads from rockslides. This type of damage has been documented in reports on previous large earthquakes in Alaska, Japan, California, and Guatemala and is virtually impossible to design against.

Figure 7.44 Typical Road Fill Failure.

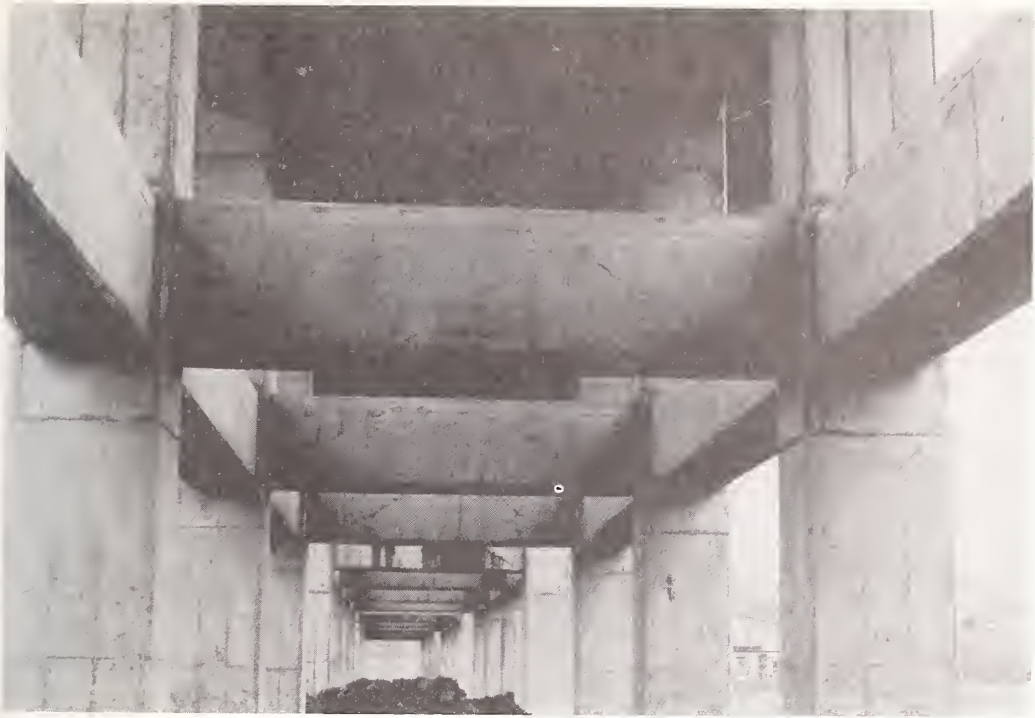
Figure 7.53 Tensile cracking of space frame tie beams near the Rifu Construction Office.

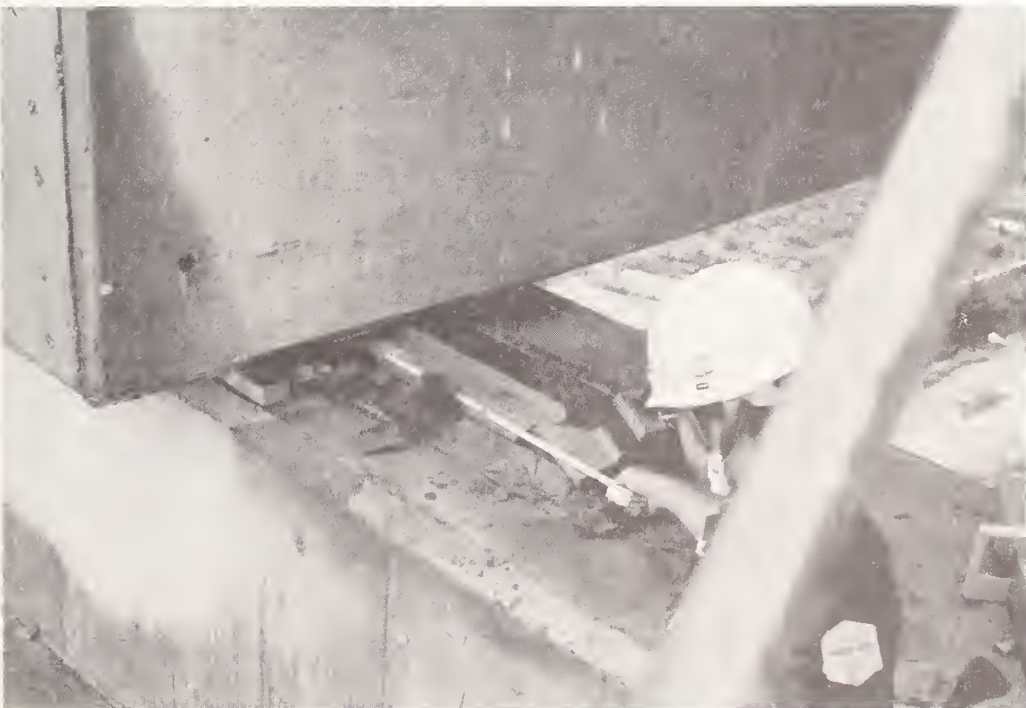
Figure 7.54 Failure of a bearing plate supporting a single cell box girder near the Higashi Sendai Construction Office. Girder displaced laterally 50 cm.

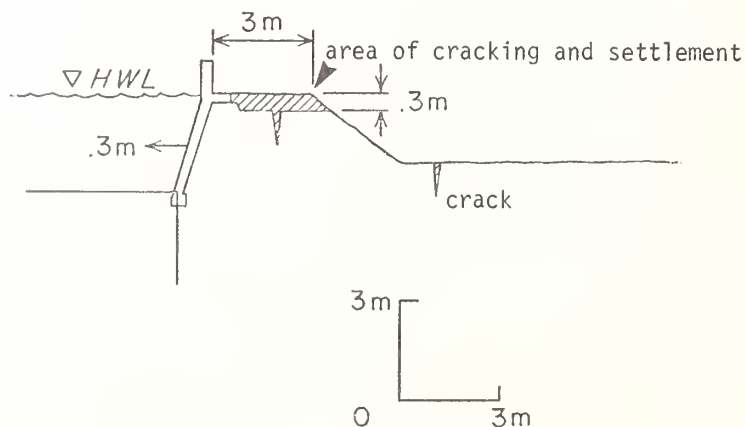
Figure 8.9 Site 2, Natori River--Retaining wall moved laterally and dike crest settled (From Tohoku Regional Construction Bureau, MOC, unpublished data)

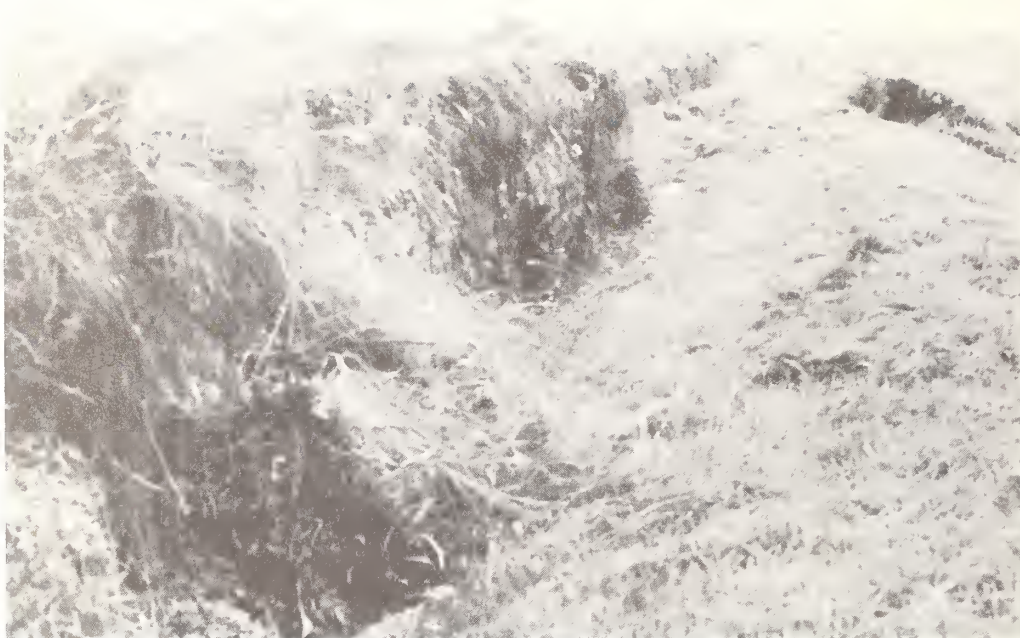
Figure 8.12 Site 3, Yoshida River. Scarps in dike caused by slumping. Note man in background for scale. (Photo courtesy K. Kawashima, PWRI)

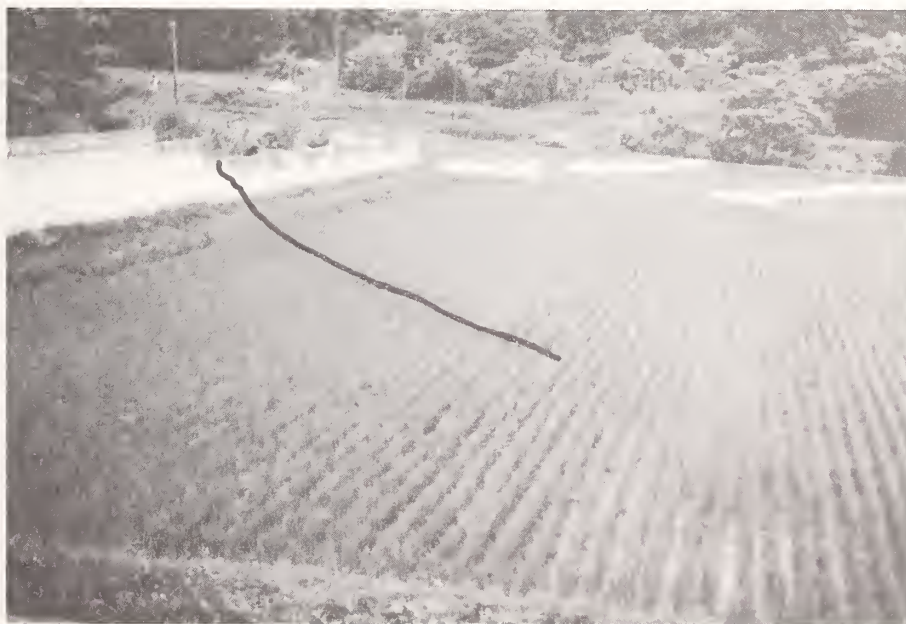
Figure 8.15 Site 4, Eai River - View southwest from crest of dike. Crack (indicated by heavy line) in fence and rice field caused by lateral spreading toward bank of old channel in background.
