# **The Repair and Return to Flight of Solid Rocket Booster Forward Skirt Serial Number 20022**

*T.W. Malone and C.S. Jones  
Marshall Space Flight Center, Marshall Space Flight Center, Alabama*

***June 2008***

## TECHNICAL MEMORANDUM

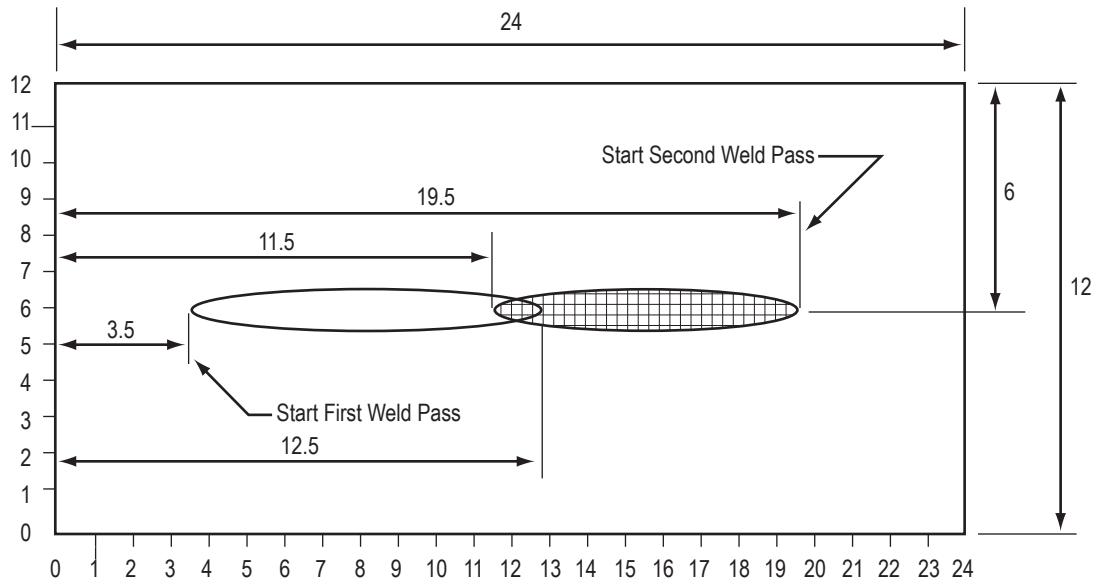
Figure 3. MSFC demonstration panel weld locations/passes.

Tungsten inert gas (TIG) welding was used without filler wire at a current of  $\approx 185$  amps and a weld speed of  $\approx 15$  ipm in accordance with procedures defined in MSFC–SPEC–504C.<sup>1</sup> Two separate weld passes were made in the geometric center of the panel. Each weld pass was  $\approx 0.25$ -in wide. The first pass was  $\approx 9$ -in long. The second was  $\approx 8$ -in long and overlapped the first weld pass by  $\approx 1$  in.

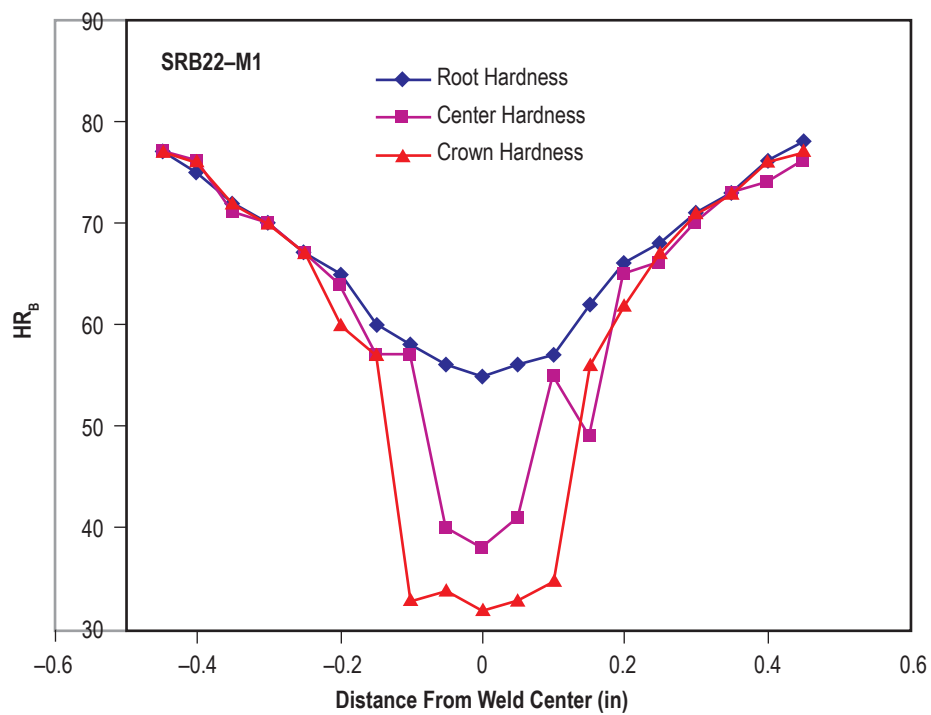
Figure 4. Typical microhardness curve for weld nugget on MSFC demonstration panel.

**2.2.1.1 Metallography** The degree of weld penetration was determined by measuring cross-sections of the weld nugget taken at three locations, with the average measurement indicating a penetration depth of  $\approx 50$  percent. Hardness surveys were taken transverse to the welding direction as shown in figure 4.

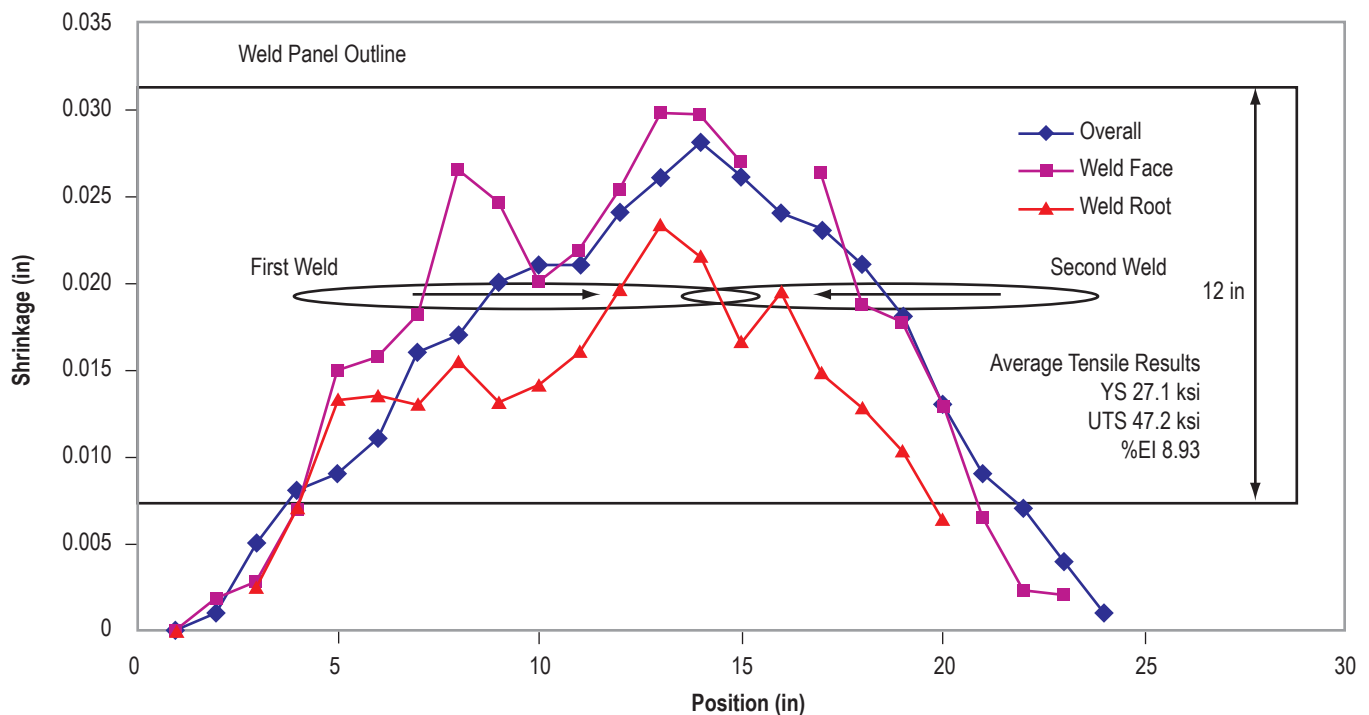
Figure 5. Data curve showing MSFC demonstration panel shrinkage.

- In the transverse direction, maximum shrinkage (0.03 in) was observed at the midpoint of the panel. Minimum shrinkage (averaging 0.0025 in) occurred at the ends of the panel.
- In the longitudinal direction, maximum shrinkage (0.007 in) was observed at the two outer edges of the panel. Minimum shrinkage was zero at the midpoint of the panel (table 1).  
These shrinkage data are also presented graphically as curves in figure 5.

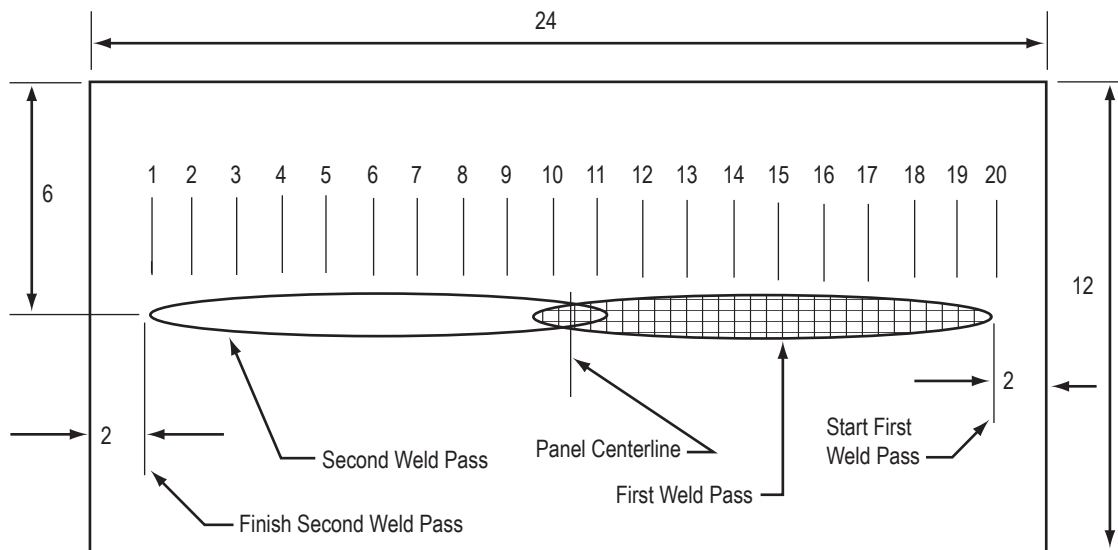
Figure 6. General Products test panel 1, specimen locations 1–20.

- Before and after measurements showed an average shrinkage of 0.028 in at locations 8–12 near the center of the weld side of the panel.
- Welds were evaluated for defects using visual, penetrant, and radiographic inspections. Technical Micronics Control (TMC), Inc. of Huntsville, AL conducted the radiographic inspections in accordance with MIL–STD–453.<sup>4</sup> No indications were observed.
- Average test data included UTS 44.5 ksi, YS (0.2 percent) 27.2 ksi, and %El (2 in) 5.2 percent.
- Weld nugget penetration averaged 46.9 percent, based upon 10 data points.

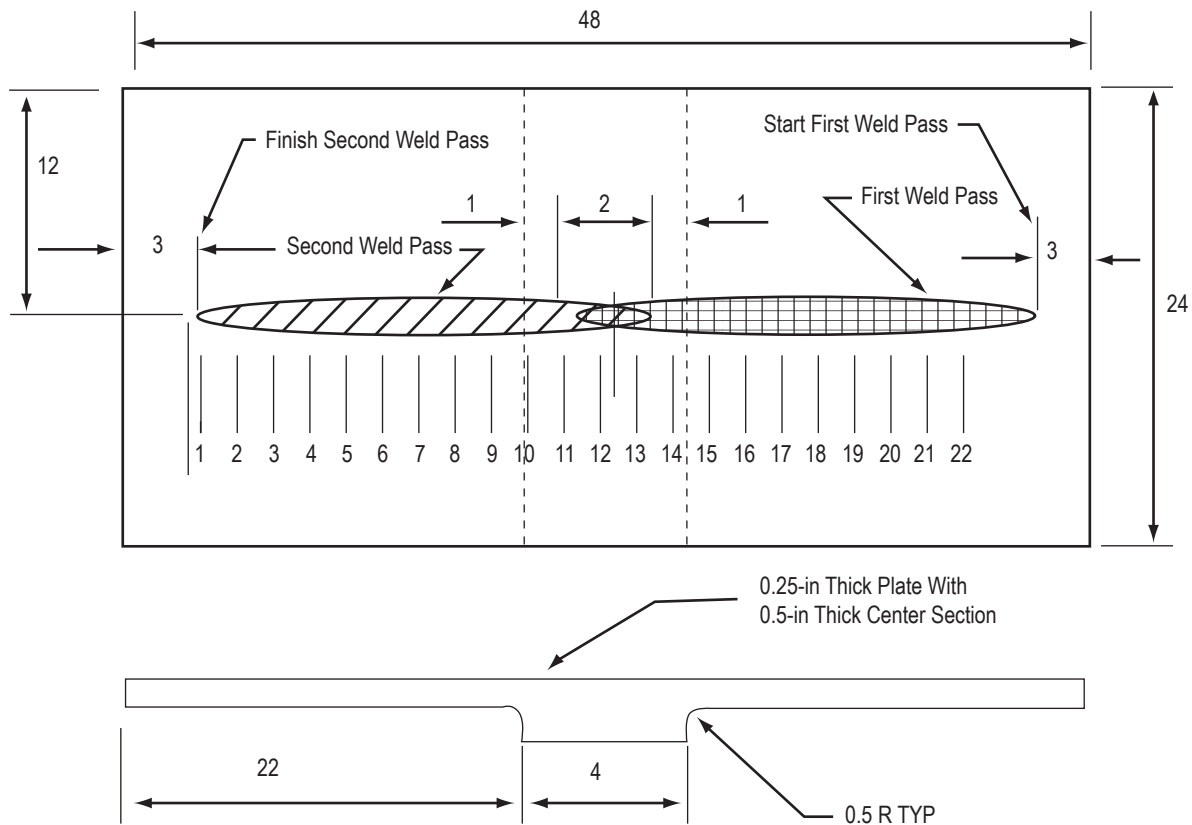
Figure 7. General Products test panel 2, specimen locations 1–22.

- Before and after measurements showed an average shrinkage of 0.017 in at locations 10–14 near the center of the weld side of the panel.
- Welds were evaluated for defects using visual, penetrant, and radiographic inspections conducted by TMC in accordance with MIL-STD-453.<sup>4</sup> No indications were observed.
- Average test data included UTS 48.8 ksi, YS (0.2 percent) 30.7 ksi, and %El (2 in) 5 percent.
- Weld nugget penetration averaged 39 percent, based upon 12 data points. The thick center section (0.5 in) had much lower penetration than the rest of the panel, causing a lower average than for test panel 1.

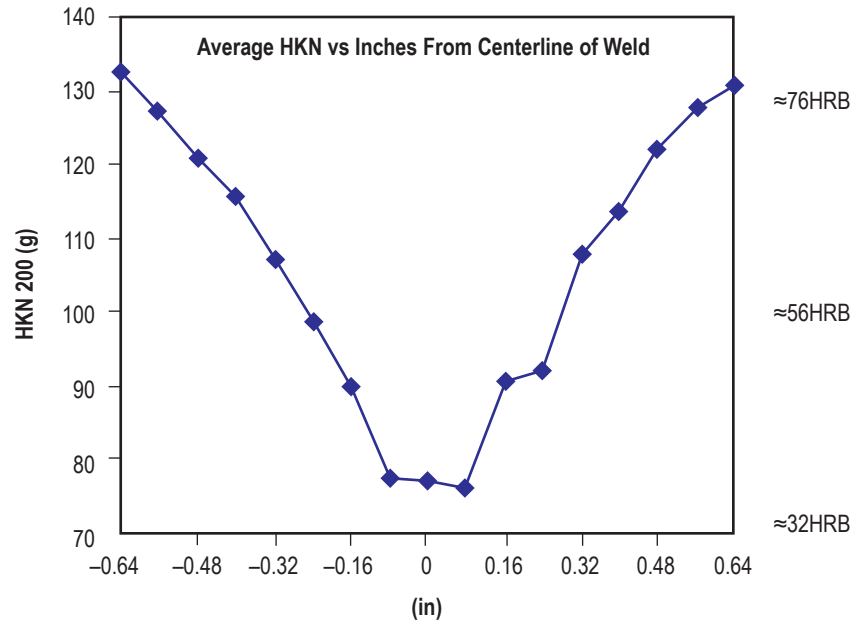
Figure 8. General Products test panel 1 hardness values, from weld centerline into parent material.

A microhardness evaluation was conducted for the weld area on both test panels to define the limit of thermal impact on the parent material, as depicted in figures 8 and 9. These data show a return to the T87 tempered condition (i.e.:  $\approx 76 \text{ HR}_B$ ) at 0.5–0.6 in from either side of the centerline of the weld nugget.

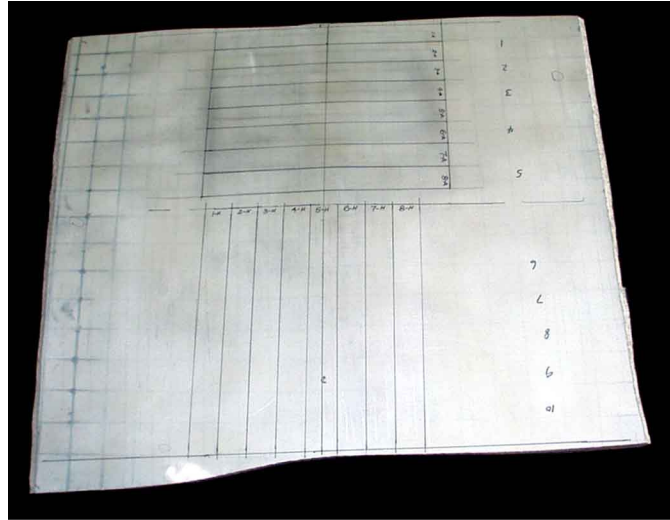
Figure 14. Specimen locations on S/N 007 debuckled test section.

S/N 007 was debuckled and restored to within 0.5 cm (0.2 in) of the original surface by General Products, using the same tooling and expertise as for S/N 20022. Actual postdebuckling measurements indicated a flatness of 0.25–0.38 cm (0.1–0.15 in). The panel was photographed again after debuckling, as shown in figures 12 and 13. No indications were reported during another round of nondestructive evaluation. Tensile specimens were then fabricated from the repaired section, figure 14, per ASTM E 8, “Standard Test Method for Tension Testing of Metallic Materials.”<sup>6</sup>
