Bathymetric and Velocimetric Surveys at Highway Bridges Crossing the Missouri River between Kansas City and St. Louis, Missouri, May 22–31, 2017

Scientific Investigations Report 2020–5018

By Richard J. Huizinga

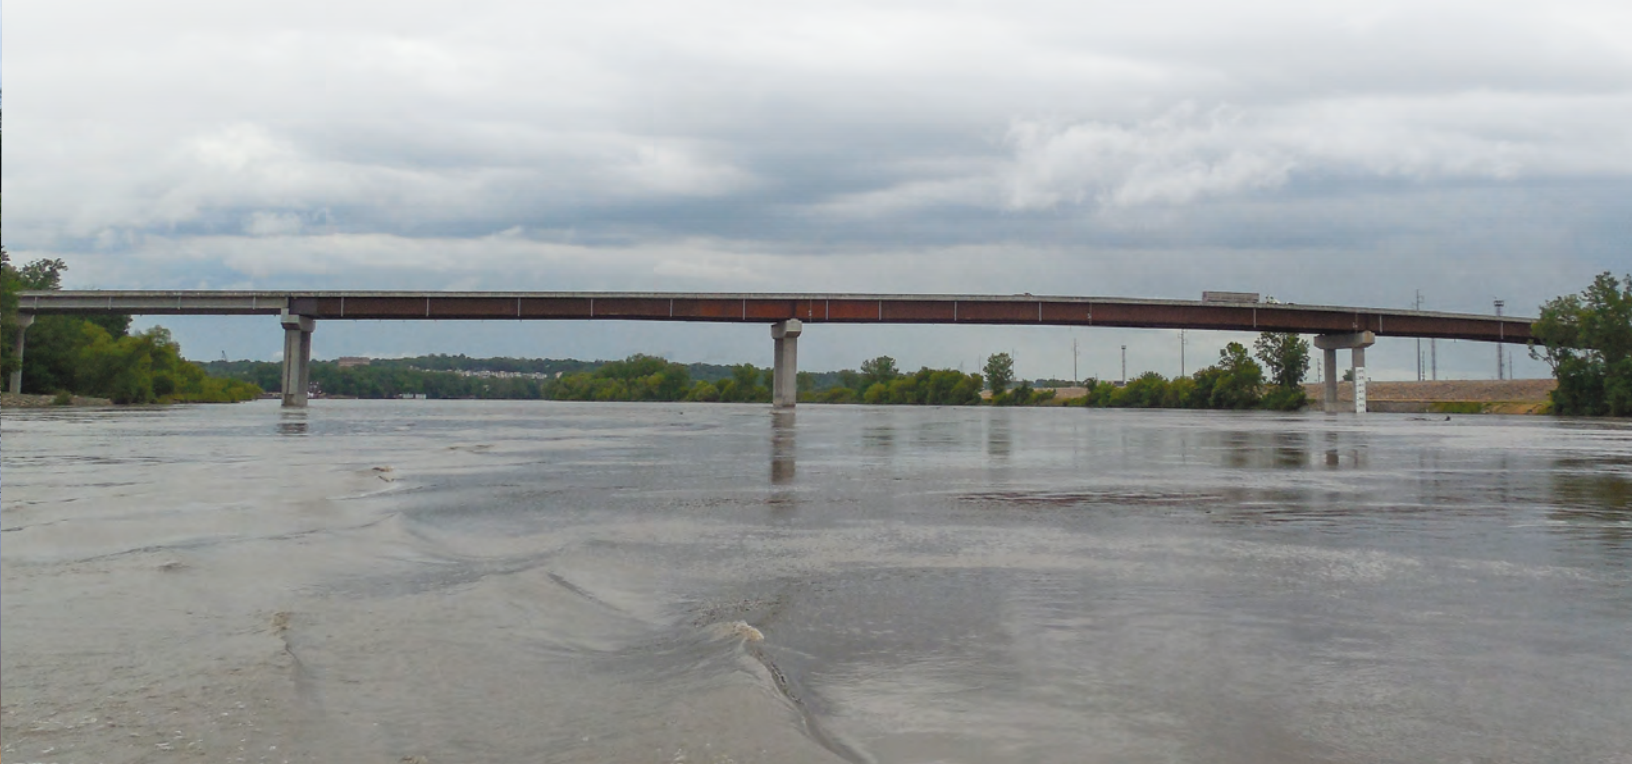
Structure A8340 on U.S. Highway 69

A local scour hole near bent 4 had an approximate minimum channel-bed elevation of about 695 ft (table 6), about 10 ft above the approximate minimum channel-bed elevation of 685 ft (table 5), and about 5 ft below the average channel bed immediately upstream from the bent (the value of the “depth of scour hole from upstream channel bed” in table 6; fig. 6). A local scour hole near bent 5 had a minimum elevation of 710 ft, about 7 ft below the average channel bed immediately upstream from the pier (fig. 6; table 6). Bent 3 is surrounded by the rock revetment on the right (south) bank, but a very small depression of about 3 ft was present in the revetment near the upstream face of the upstream column (fig. 6; table 6). Information from bridge plans indicates that all the main channel bents of structure A8340 are shafts drilled 23 to 28 ft into bedrock and have about 57 ft of bed material between the bottom of the scour hole and bedrock at bent 4 (fig. 8; table 6); bent 5 and bent 3 have about 73 ft and 86 ft of bed material between the bottom of the scour hole and bedrock, respectively (fig. 8; table 6).

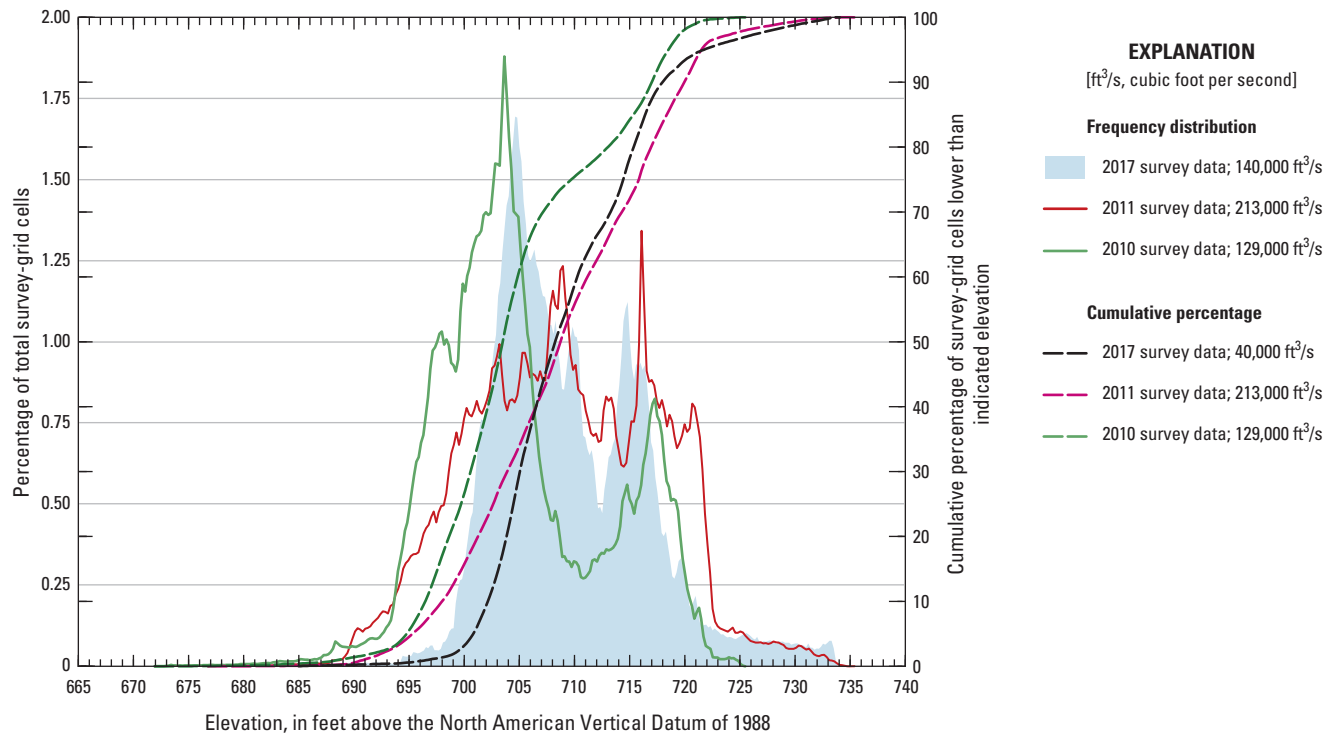
Figure 7. Frequency distribution of bed elevations for bathymetric survey-grid cells on the Missouri River near structure A8340 on U.S. Highway 69 in Kansas City, Missouri, on May 22, 2017, compared to previous surveys.

indicated along the stone revetment on the right (south) bank, again, may be the result of minor positional variations between the surveys. The average difference between the bathymetric surfaces was 2.90 ft (table 7), indicating substantial overall channel aggradation between the 2010 and 2017 surveys for the area common to both surveys. The net volume of cut in the reach from 2010 to 2017 was about 28,700 yd³, and the net volume of fill was about 142,300 yd³, resulting in a net gain of about 113,600 yd³ of sediment.

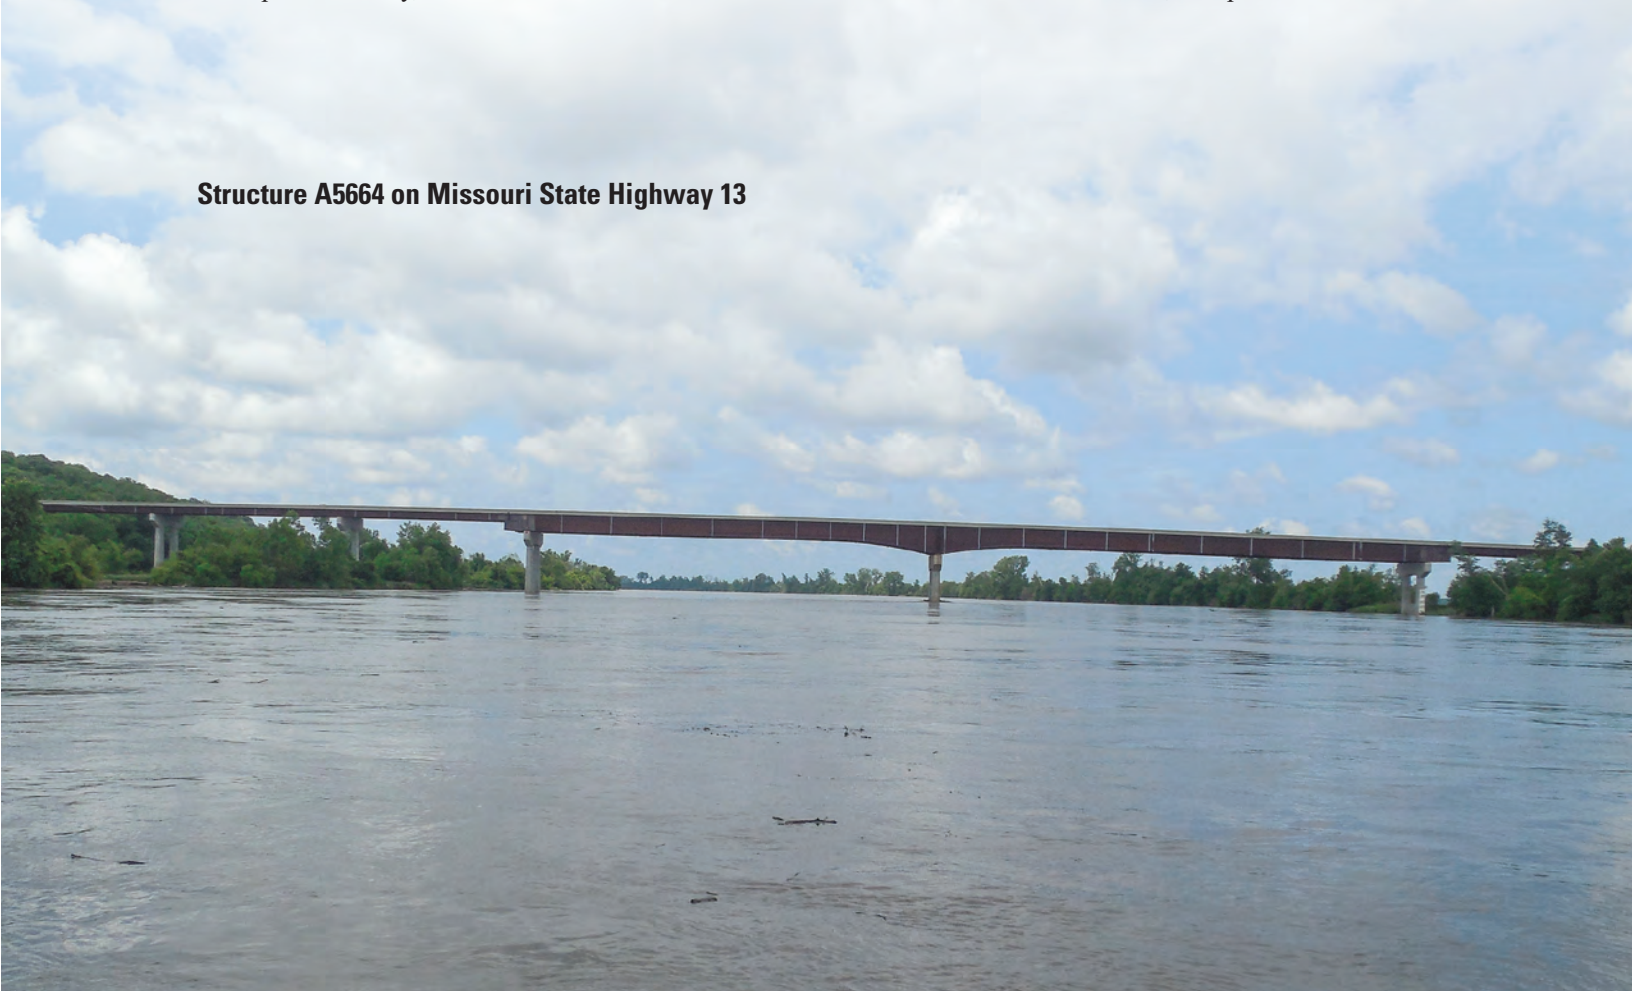
Structure A5664 on Missouri State Highway 13

The survey area was about 1,640 ft long and about 1,000 ft wide, extending from bank to bank in the main channel (fig. 12). The upstream end of the survey area was about 670 ft upstream from the centerline of structure A5664, and piers 21 and 22 were in the water and away from the banks (fig. 12). The approximate channel-bed elevations ranged from about 654 to 674 ft for most of the surveyed area (5th to 95th percentile range of the bathymetric data; table 5; fig. 13), except near the spur dikes on the right (south) bank (fig. 12; table 5). The channel bed between the left (north) bank and the spur dikes was filled with medium to large dune features, and small dunes and ripples were present in the area between the spur dikes on the right (south) side of the channel (fig. 12). Localized scour holes were present downstream from the spur dikes on the right (south) side (fig. 12).

The minor scour hole near main channel pier 21 was difficult to discern from nearby dunes and ripples (fig. 12); however, the top of the footing was evident on the left (north) side of the pier. Similarly, a minor scour hole was evident

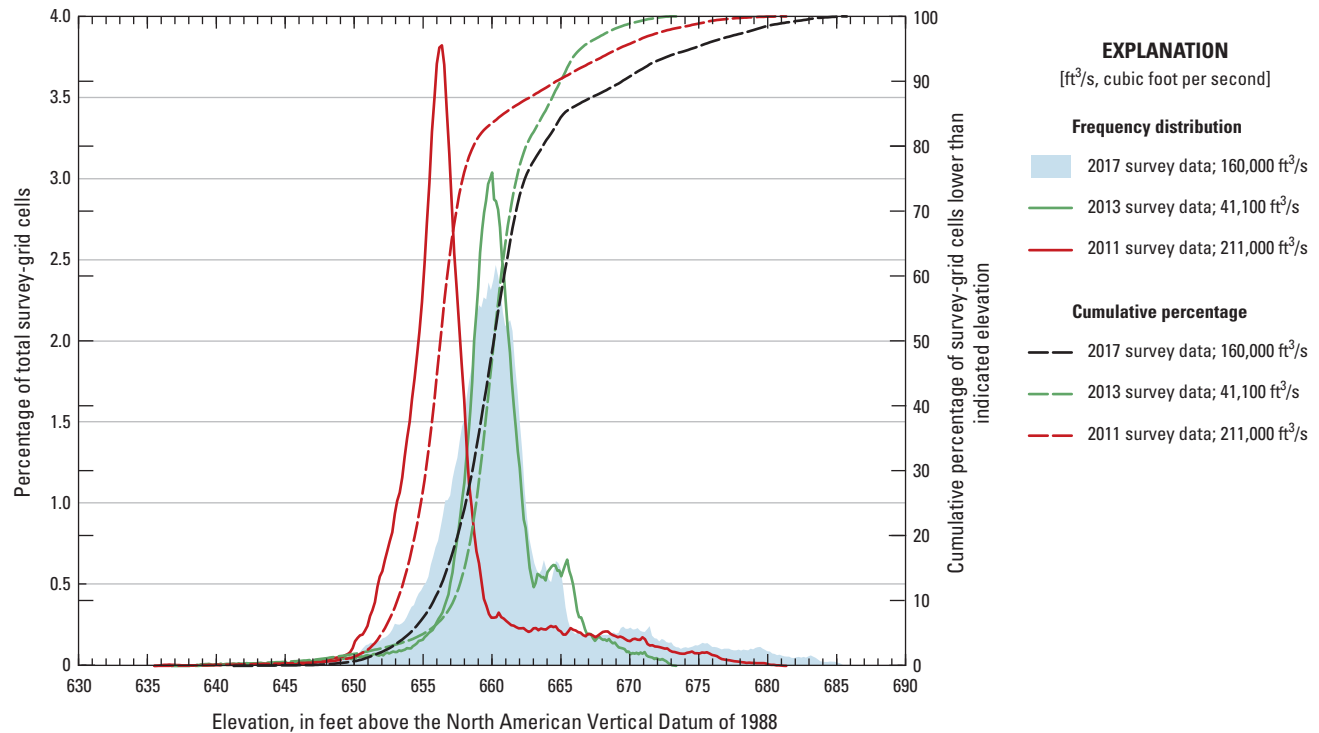
Figure 13. Frequency distribution of bed elevations for bathymetric survey-grid cells on the Missouri River near structure A5664 on Missouri State Highway 13 at Lexington, Missouri, on May 23, 2017, compared to previous surveys.

The difference between the survey on May 23, 2017, and the previous nonflood survey on April 24, 2013 (fig. 15), indicates a generally uniform distribution of scour and deposition throughout the reach between 2013 and 2017, resulting in an average difference of -0.89 ft between the bathymetric surfaces (table 7). The net volume of cut in the reach from 2013 to 2017 was about 82,500 yd³, and the net volume of fill was about 41,200 yd³, resulting in a net loss of about 41,300 yd³ of sediment. The frequency distribution of channel-bed elevations in 2017 was similar to 2013, with a higher percentage of survey-grid cells at elevations between 658 and 668 ft compared to 2017. However, the peak of the data was lower and wider than in 2013, resulting in a slightly different cumulative percentage curve shape at higher percentages than 2013. Data also were captured higher along the banks in 2017 than in 2013, as indicated by the frequency distribution and cumulative percentage curves (fig. 13).

spur dikes on the right (south) side of the channel (fig. 16). The average difference between the bathymetric surfaces was 3.33 ft (table 7), indicating substantial overall channel aggradation between the 2011 and 2017 surveys for the area common to both surveys. The net volume of cut in the reach from 2011 to 2017 was about 21,200 yd³, and the net volume of fill was about 220,300 yd³, resulting in a net gain of about 199,100 yd³ of sediment. The frequency distribution of channel-bed elevations in 2017 was similar to 2011, with a higher percentage of survey-grid cells at elevations between 658 and 668 ft. Data were captured higher along the banks in 2017 than in 2011, as indicated by the frequency distribution and cumulative percentage curves (fig. 13).

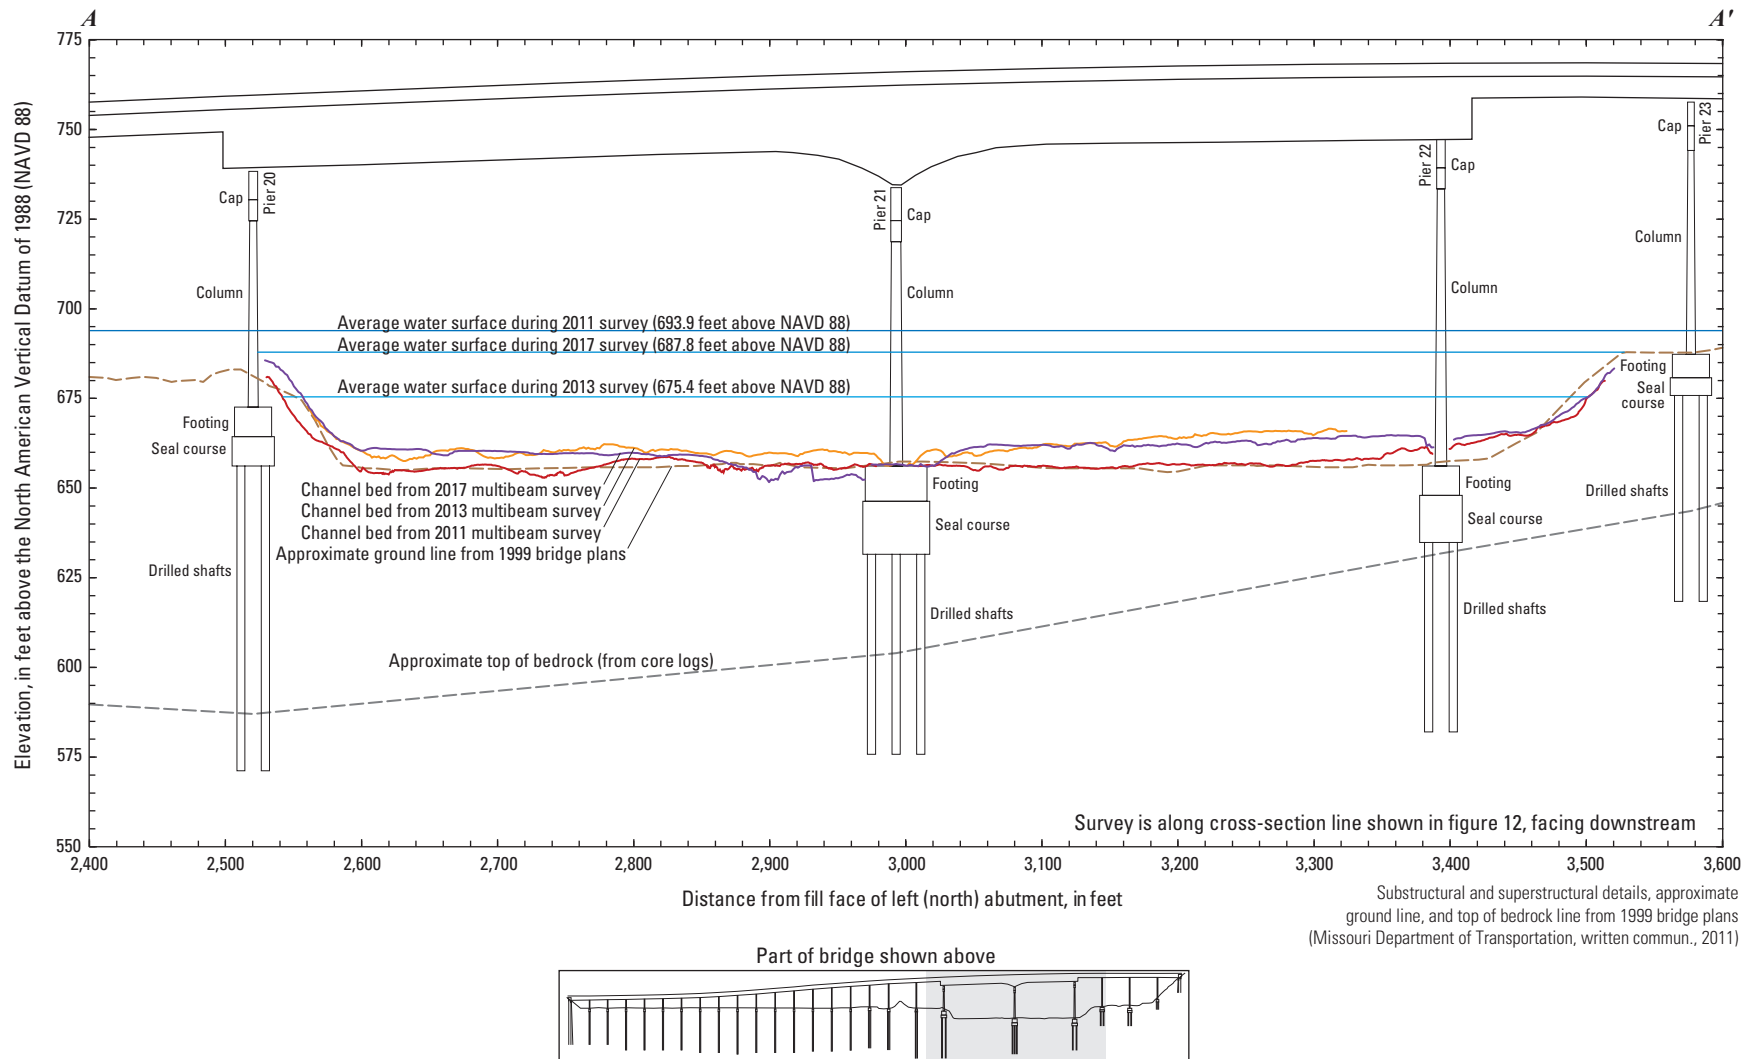
Figure 14. Key features, substructural and superstructural details, and surveyed channel bed of structure A5664 on Missouri State Highway 13 crossing the Missouri River at Lexington, Missouri.

near pier 22 near the right (south) bank (fig. 12). Information from bridge plans indicates that piers 21 and 22 are founded on shafts drilled 28 to 50 ft into bedrock, having about 47 ft of bed material between the channel bottom and bedrock at pier 21 and about 28 ft of material at pier 22 (fig. 14; table 6). The surveyed bed generally was similar to the previous multibeam survey on April 24, 2013, except on the left side of pier 21 (fig. 14).

(fig. 14), which may indicate material was added along this bank after the 2011 flood. This increase was noted in the previous survey at this site (Huizinga, 2014), but the lower flow conditions during the 2013 survey resulted in a more limited vertical extent of the bathymetry data and precluded inferences as to the cause of the observed change.

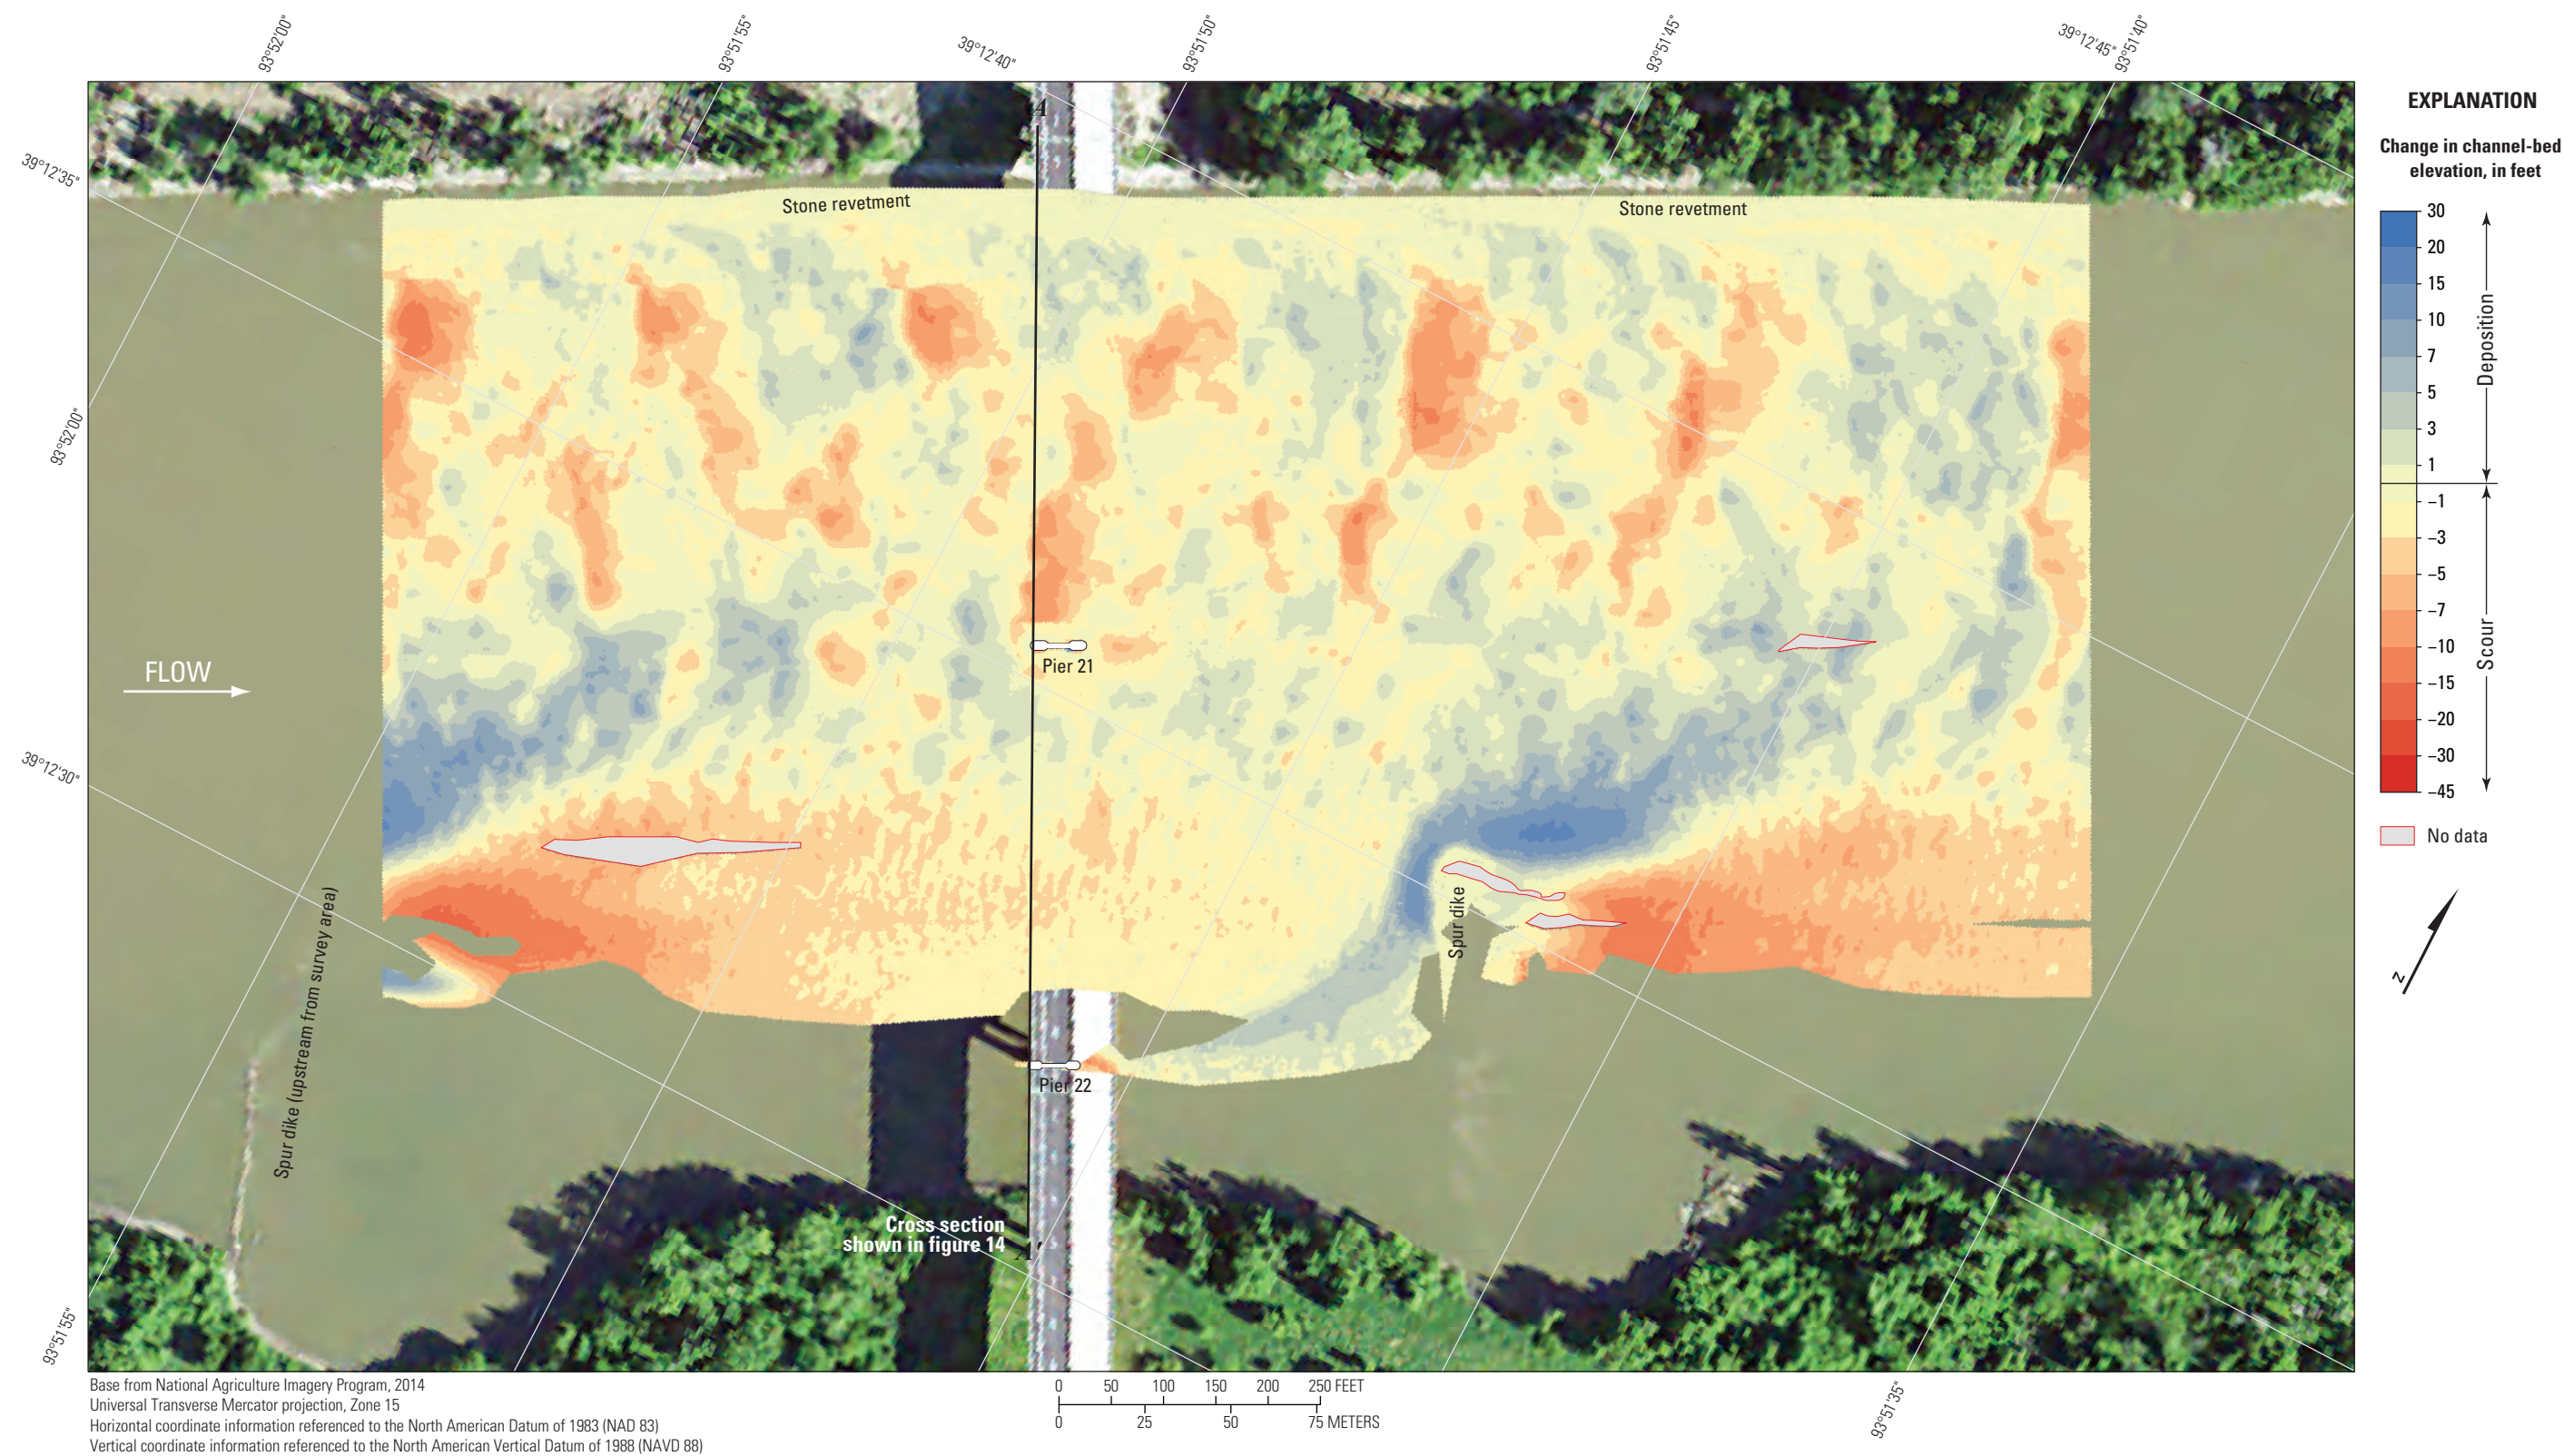
Figure 15. Difference between surfaces created from bathymetric surveys of the Missouri River channel near structure A5664 on Missouri State Highway 13 at Lexington, Missouri, on May 23, 2017, and April 24, 2013.

Although the stone revetment on the left (north) bank indicated no signs of substantial change between the 2013 and 2017 surveys (fig. 15), substantial deposition of as much as 10 ft was evident along the left (north) bank between 2011 and 2017 (fig. 16). The cross sections also indicate this change

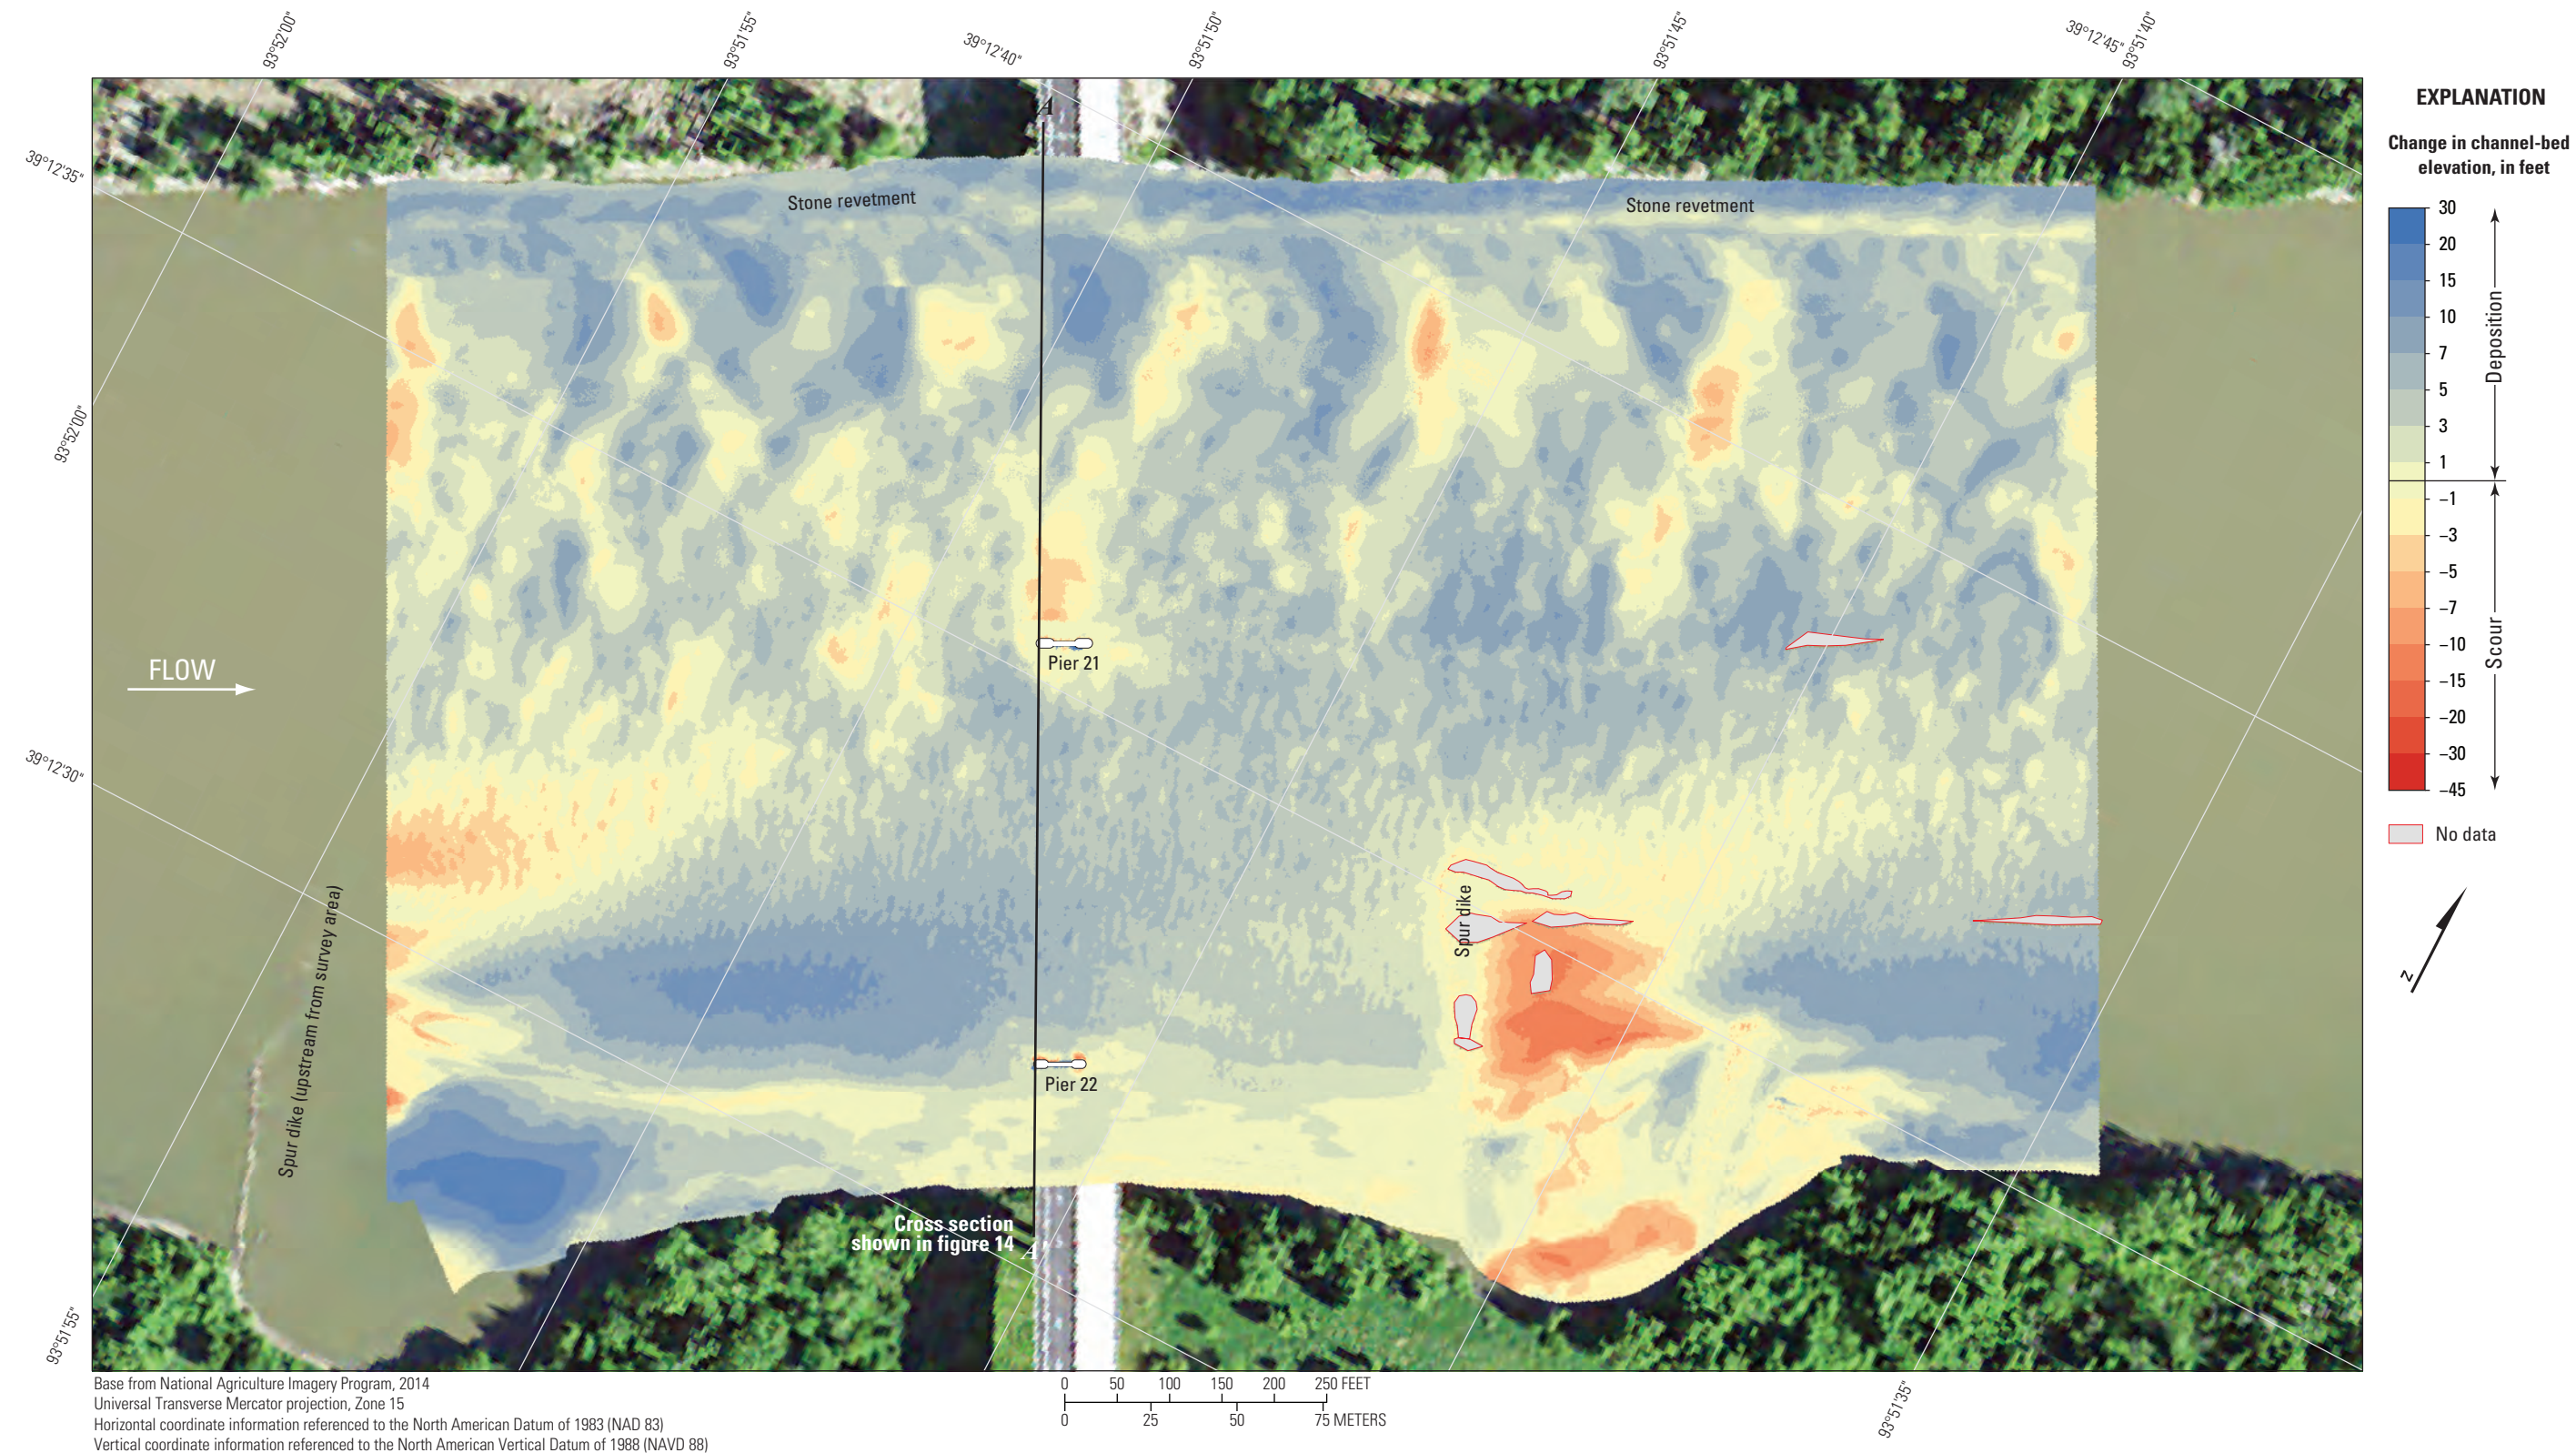
Figure 16. Difference between surfaces created from bathymetric surveys of the Missouri River channel near structure A5664 on Missouri State Highway 13 at Lexington, Missouri, on May 23, 2017, and July 20, 2011.

The difference between the survey on May 23, 2017, and the previous flood survey on July 20, 2011, indicates substantial deposition of more than 15 ft throughout most of the reach between 2011 and 2017, except downstream from the

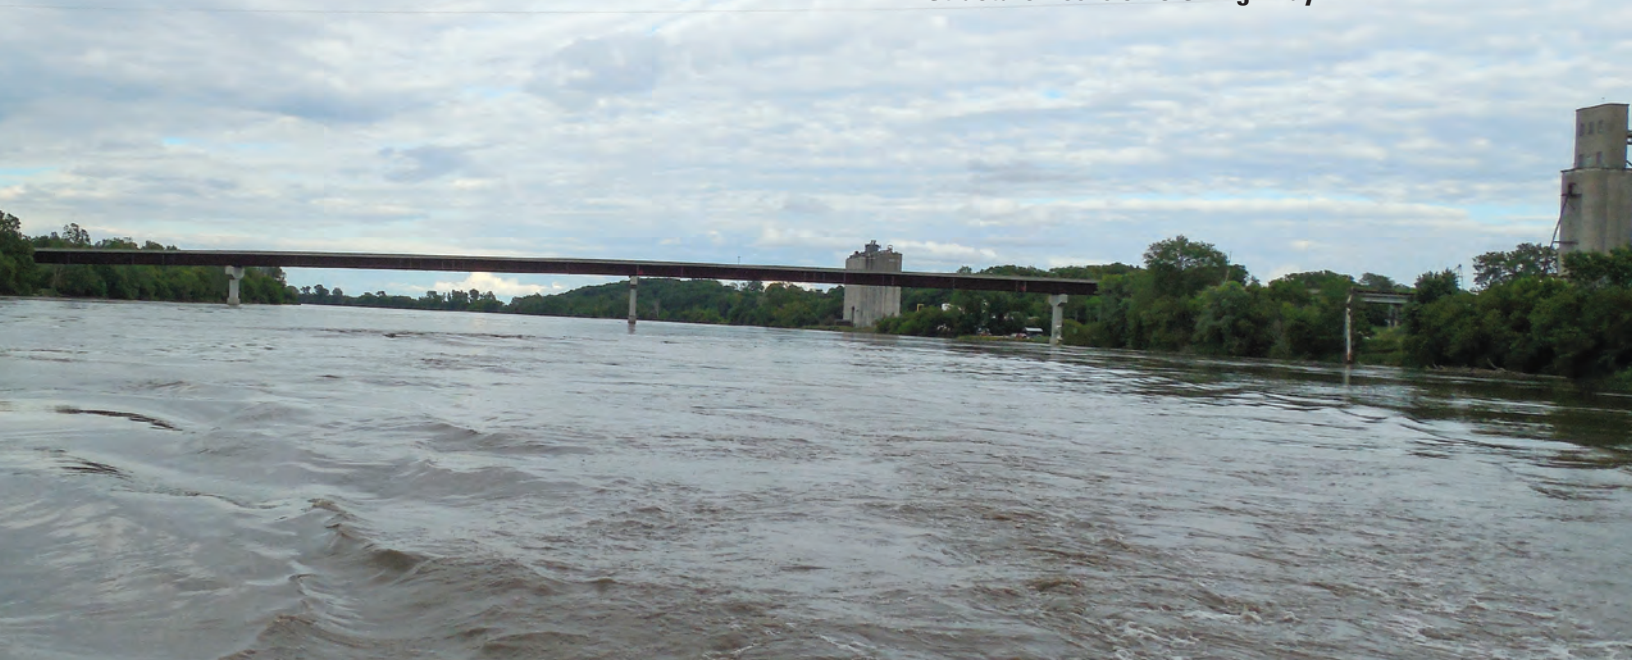
Structure A5910 on U.S. Highway 24

The survey area was about 1,640 ft long and about 1,090 ft wide, extending from bank to bank in the main channel (fig. 18). The upstream end of the survey area was about 650 ft upstream from the centerline of structure A5910, and piers 10 and 11 were in the water and away from the banks (fig. 18). The approximate channel-bed elevations ranged from about 632 to 655 ft for most of the surveyed area (5th to 95th percentile range of the bathymetric data; table 5; fig. 19), except downstream from the spur dikes on the left (north) bank and in the channel thalweg along the toe of the right (south) bank (fig. 18). The thalweg was about 15 to 19 ft deeper than the channel bed in the middle of the channel (fig. 18). A line of medium to large dune features was observed in the middle of the channel through the survey reach, and numerous smaller dunes and ripples were present throughout the channel reach (fig. 18). A localized deep scour hole downstream from the upstream spur dike on the left bank had a minimum channel-bed elevation of about 619 ft (fig. 18). As in previous surveys (Huizinga, 2012, 2014), a rock outcrop was evident on the right (south) bank and the upstream end of the reach, and the stone revetment and a longitudinal spur dike also were present on the right bank throughout the reach (fig. 18).

The minor scour holes near piers 10 and 11 were difficult to discern from nearby dunes and ripples (figs. 18, 20). Information from bridge plans indicates that piers 10 and 11 are founded on shafts drilled 30 to 42 ft into bedrock, having about 34 ft of bed material between the bottom of the scour hole and bedrock at pier 11 (fig. 20; table 6). The surveyed bed generally was similar to a previous multibeam survey on July 21, 2011, but with 5 to 10 ft of deposition between piers 10 and 11 (fig. 20).

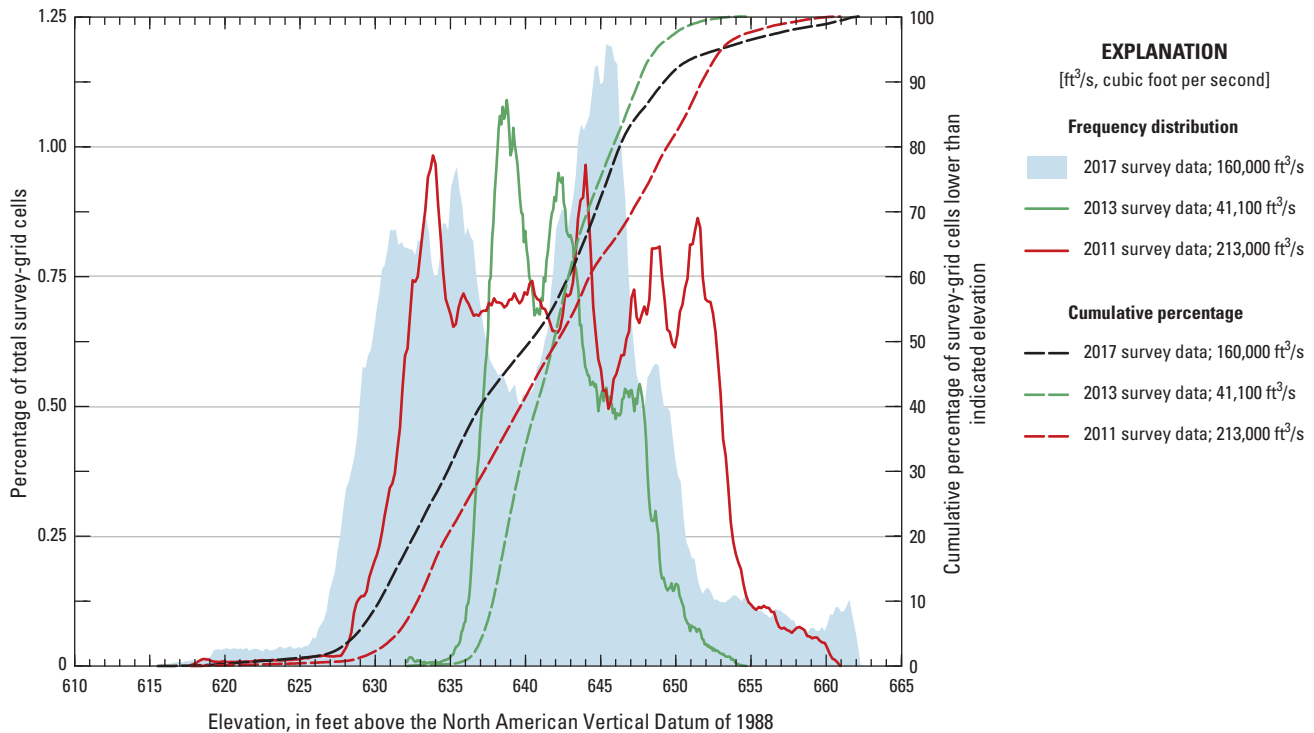
Figure 19. Frequency distribution of bed elevations for bathymetric survey-grid cells on the Missouri River near structure A5910 on U.S. Highway 24 at Waverly, Missouri, on May 23, 2017, compared to previous surveys.

The difference between the survey on May 23, 2017, and the previous flood survey on July 21, 2011 (fig. 22), indicates a relative balance of deposition and scour throughout the reach between 2011 and 2017, resulting in an average difference of +0.64 ft between the bathymetric surfaces (table 7). The net volume of cut in the reach from 2011 to 2017 was about 77,800 yd³, and the net volume of fill was about 118,000 yd³, resulting in a net gain of about 40,200 yd³ of sediment. There was substantial deposition of more than 15 ft in the troughs of the large dunes observed in the middle of the channel in the 2011 survey, but a substantial scour hole was present downstream from the downstream spur dike in the 2017 survey that was not present in the 2011 survey (fig. 22; Huizinga, 2012). The cross-section data from the 2017 survey demonstrate the pattern of deposition in the middle of the channel between piers 10 and 11 compared to the 2011 survey (figs. 20, 22). The frequency distribution of bed elevations was similar in 2017 and 2011; however, more survey-grid cells were present

at lower elevations than in 2011, as evident in the cumulative percentage curves (fig. 19). Minor deposition or scour of the stone revetment on the right (south) bank likely is the result of minor positional variations between the surveys (figs. 20, 22).
