Bathymetric and Velocimetric Surveys at Highway Bridges Crossing the Missouri River between Kansas City and St. Louis, Missouri, May 22–31, 2017

Scientific Investigations Report 2020–5018

By Richard J. Huizinga

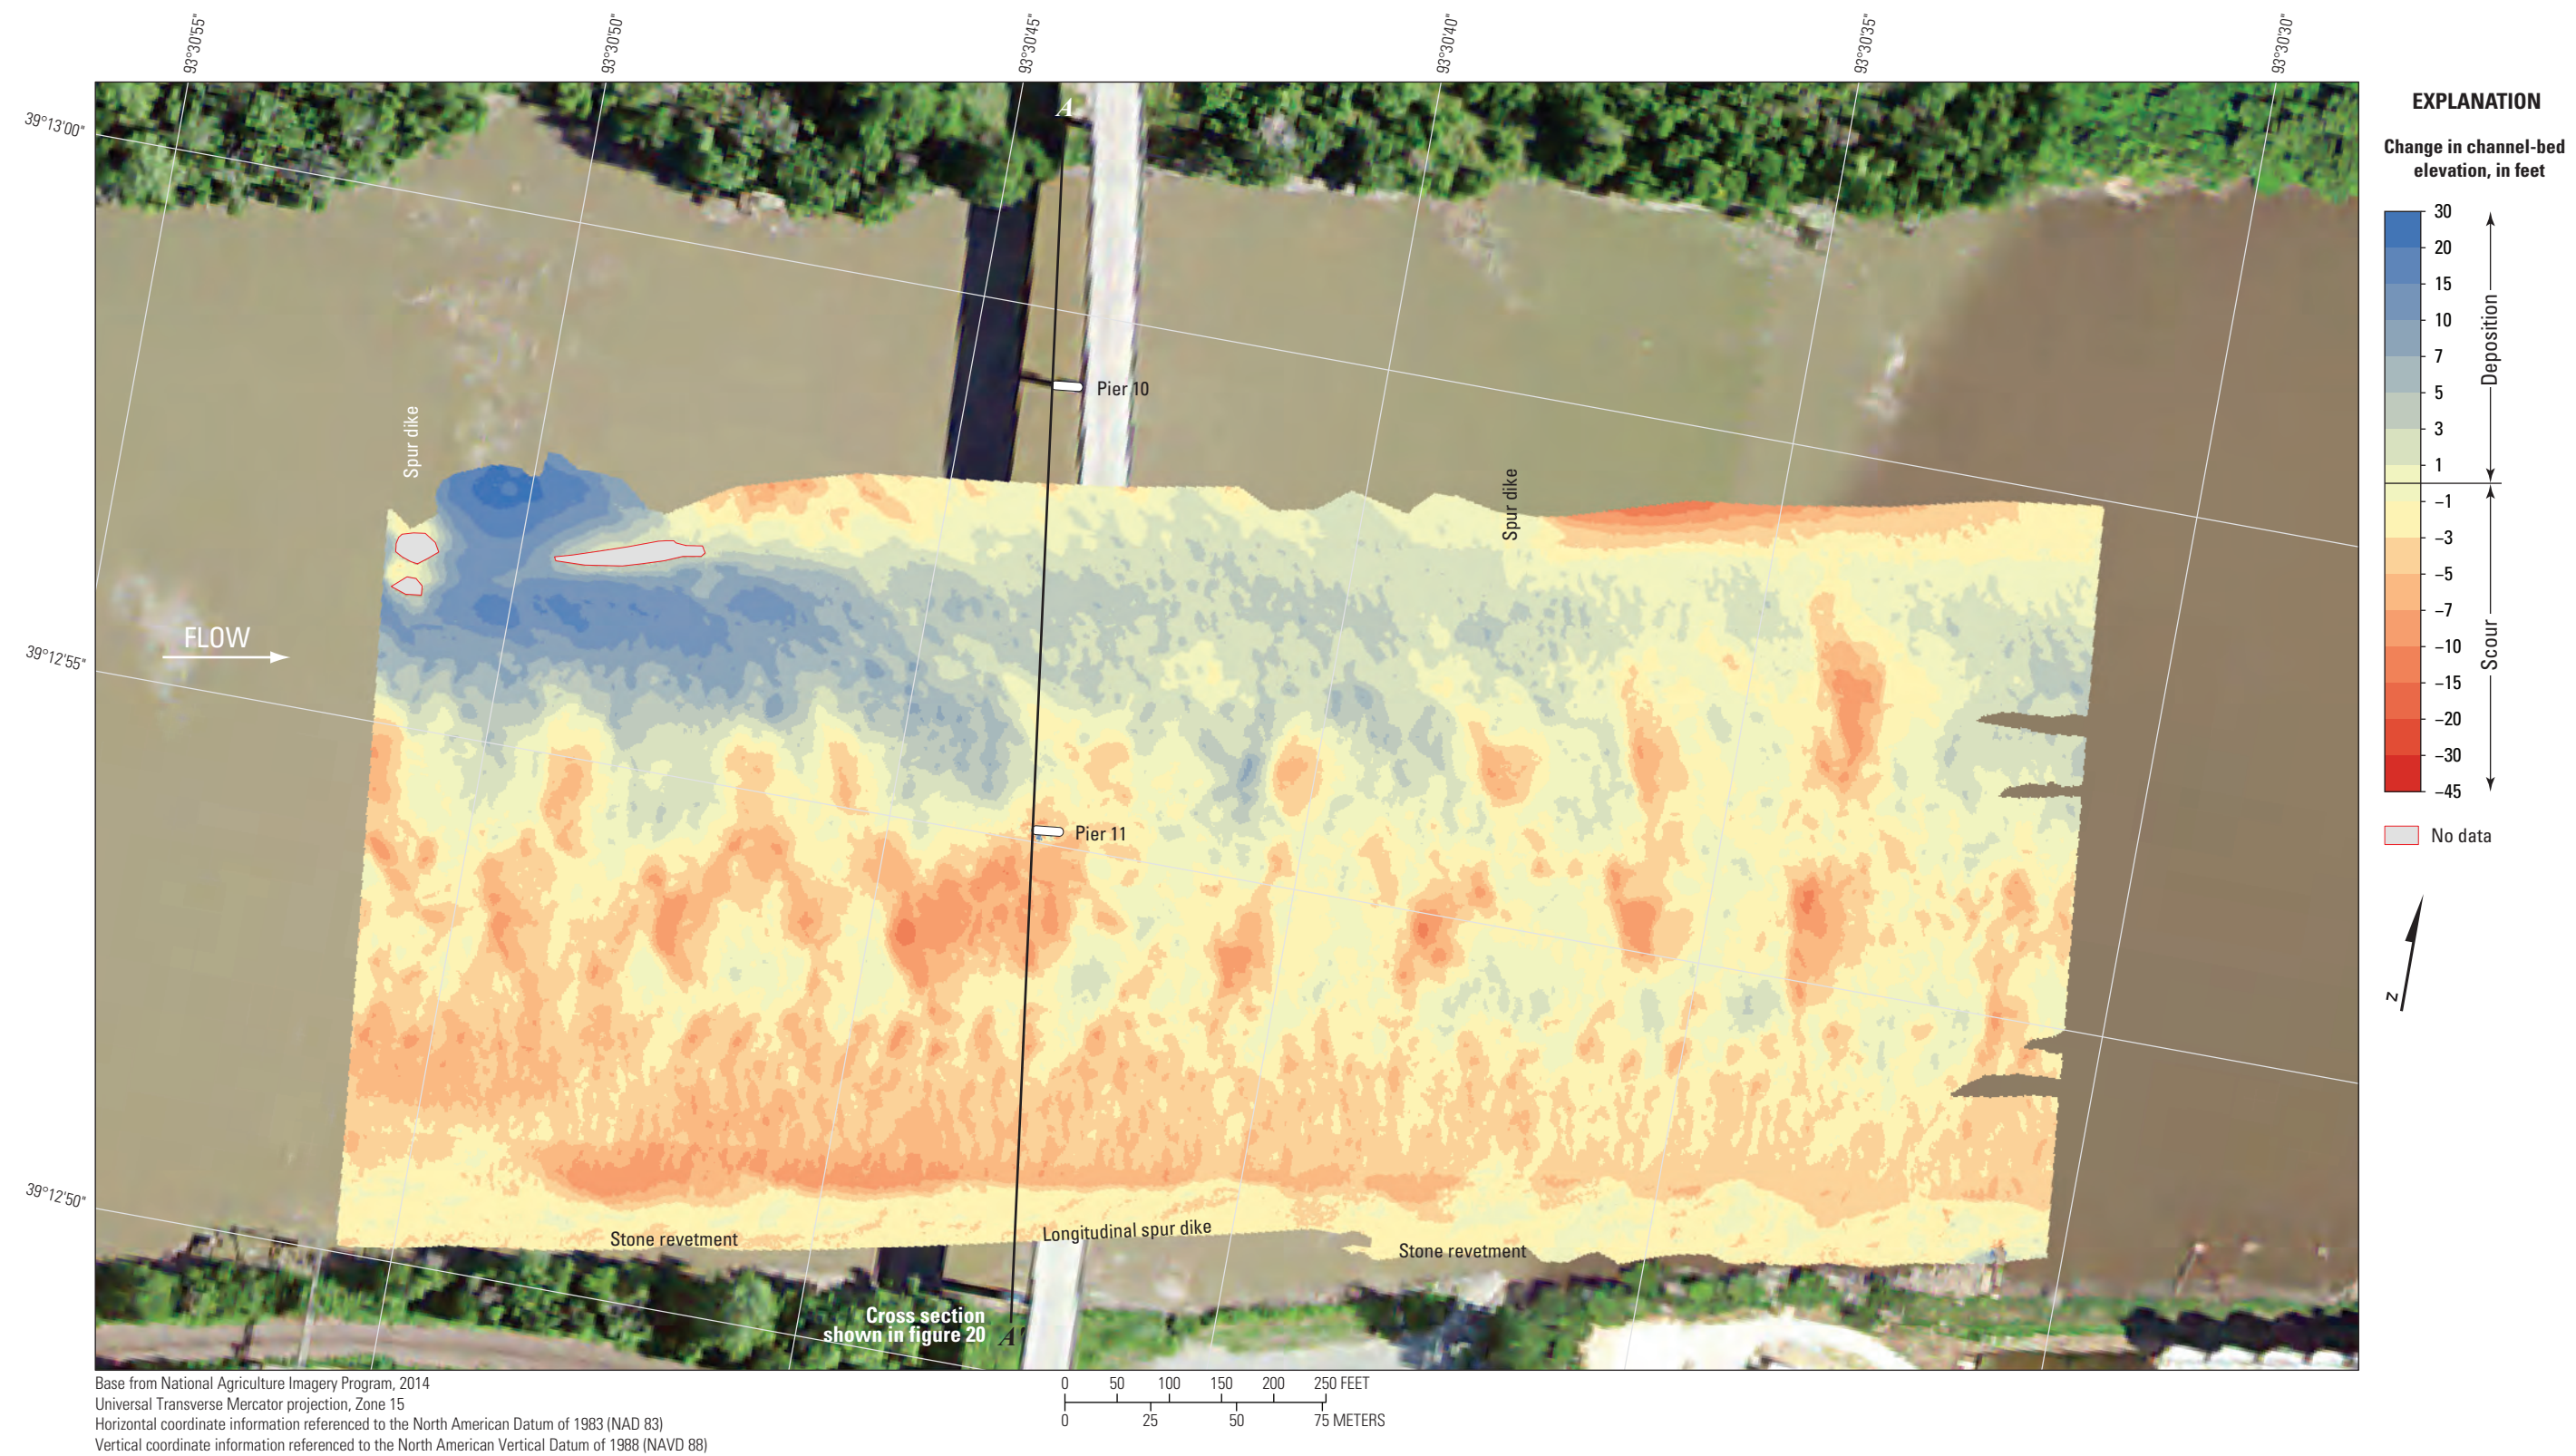
Figure 21. Difference between surfaces created from bathymetric surveys of the Missouri River channel near structure A5910 on U.S. Highway 24 at Waverly, Missouri, on May 23, 2017, and April 25, 2013.

The difference between the survey on May 23, 2017, and the previous nonflood survey on April 25, 2013 (fig. 21), indicates a relative balance of deposition and scour throughout the reach between 2013 and 2017, resulting in an average difference of -0.96 ft between the bathymetric surfaces (table 7). The net volume of cut in the reach from 2013 to 2017 was about 91,400 yd³, and the net volume of fill was about 49,400 yd³, resulting in a net loss of about 42,000 yd³ of sediment. There was substantial deposition of more than 15 ft in the scour hole downstream from the upstream spur dike in the 2013 survey (Huizinga, 2014) and moderate deposition in the middle of the channel throughout the reach (fig. 21). However, moderate localized scour was observed in the channel thalweg along the toe of the right (south) bank and along the right side of the channel throughout the reach (fig. 21). The cross sections from the two surveys indicate the changes between the surveys (figs. 20, 21). The frequency distribution of bed elevations was substantially wider in 2017 than in 2013, and more survey-grid cells were at a lower elevation in 2017 than 2013 (fig. 19). The minor localized scour observed on the stone revetment on the right (south) bank likely is a function of positional variations between the surveys.

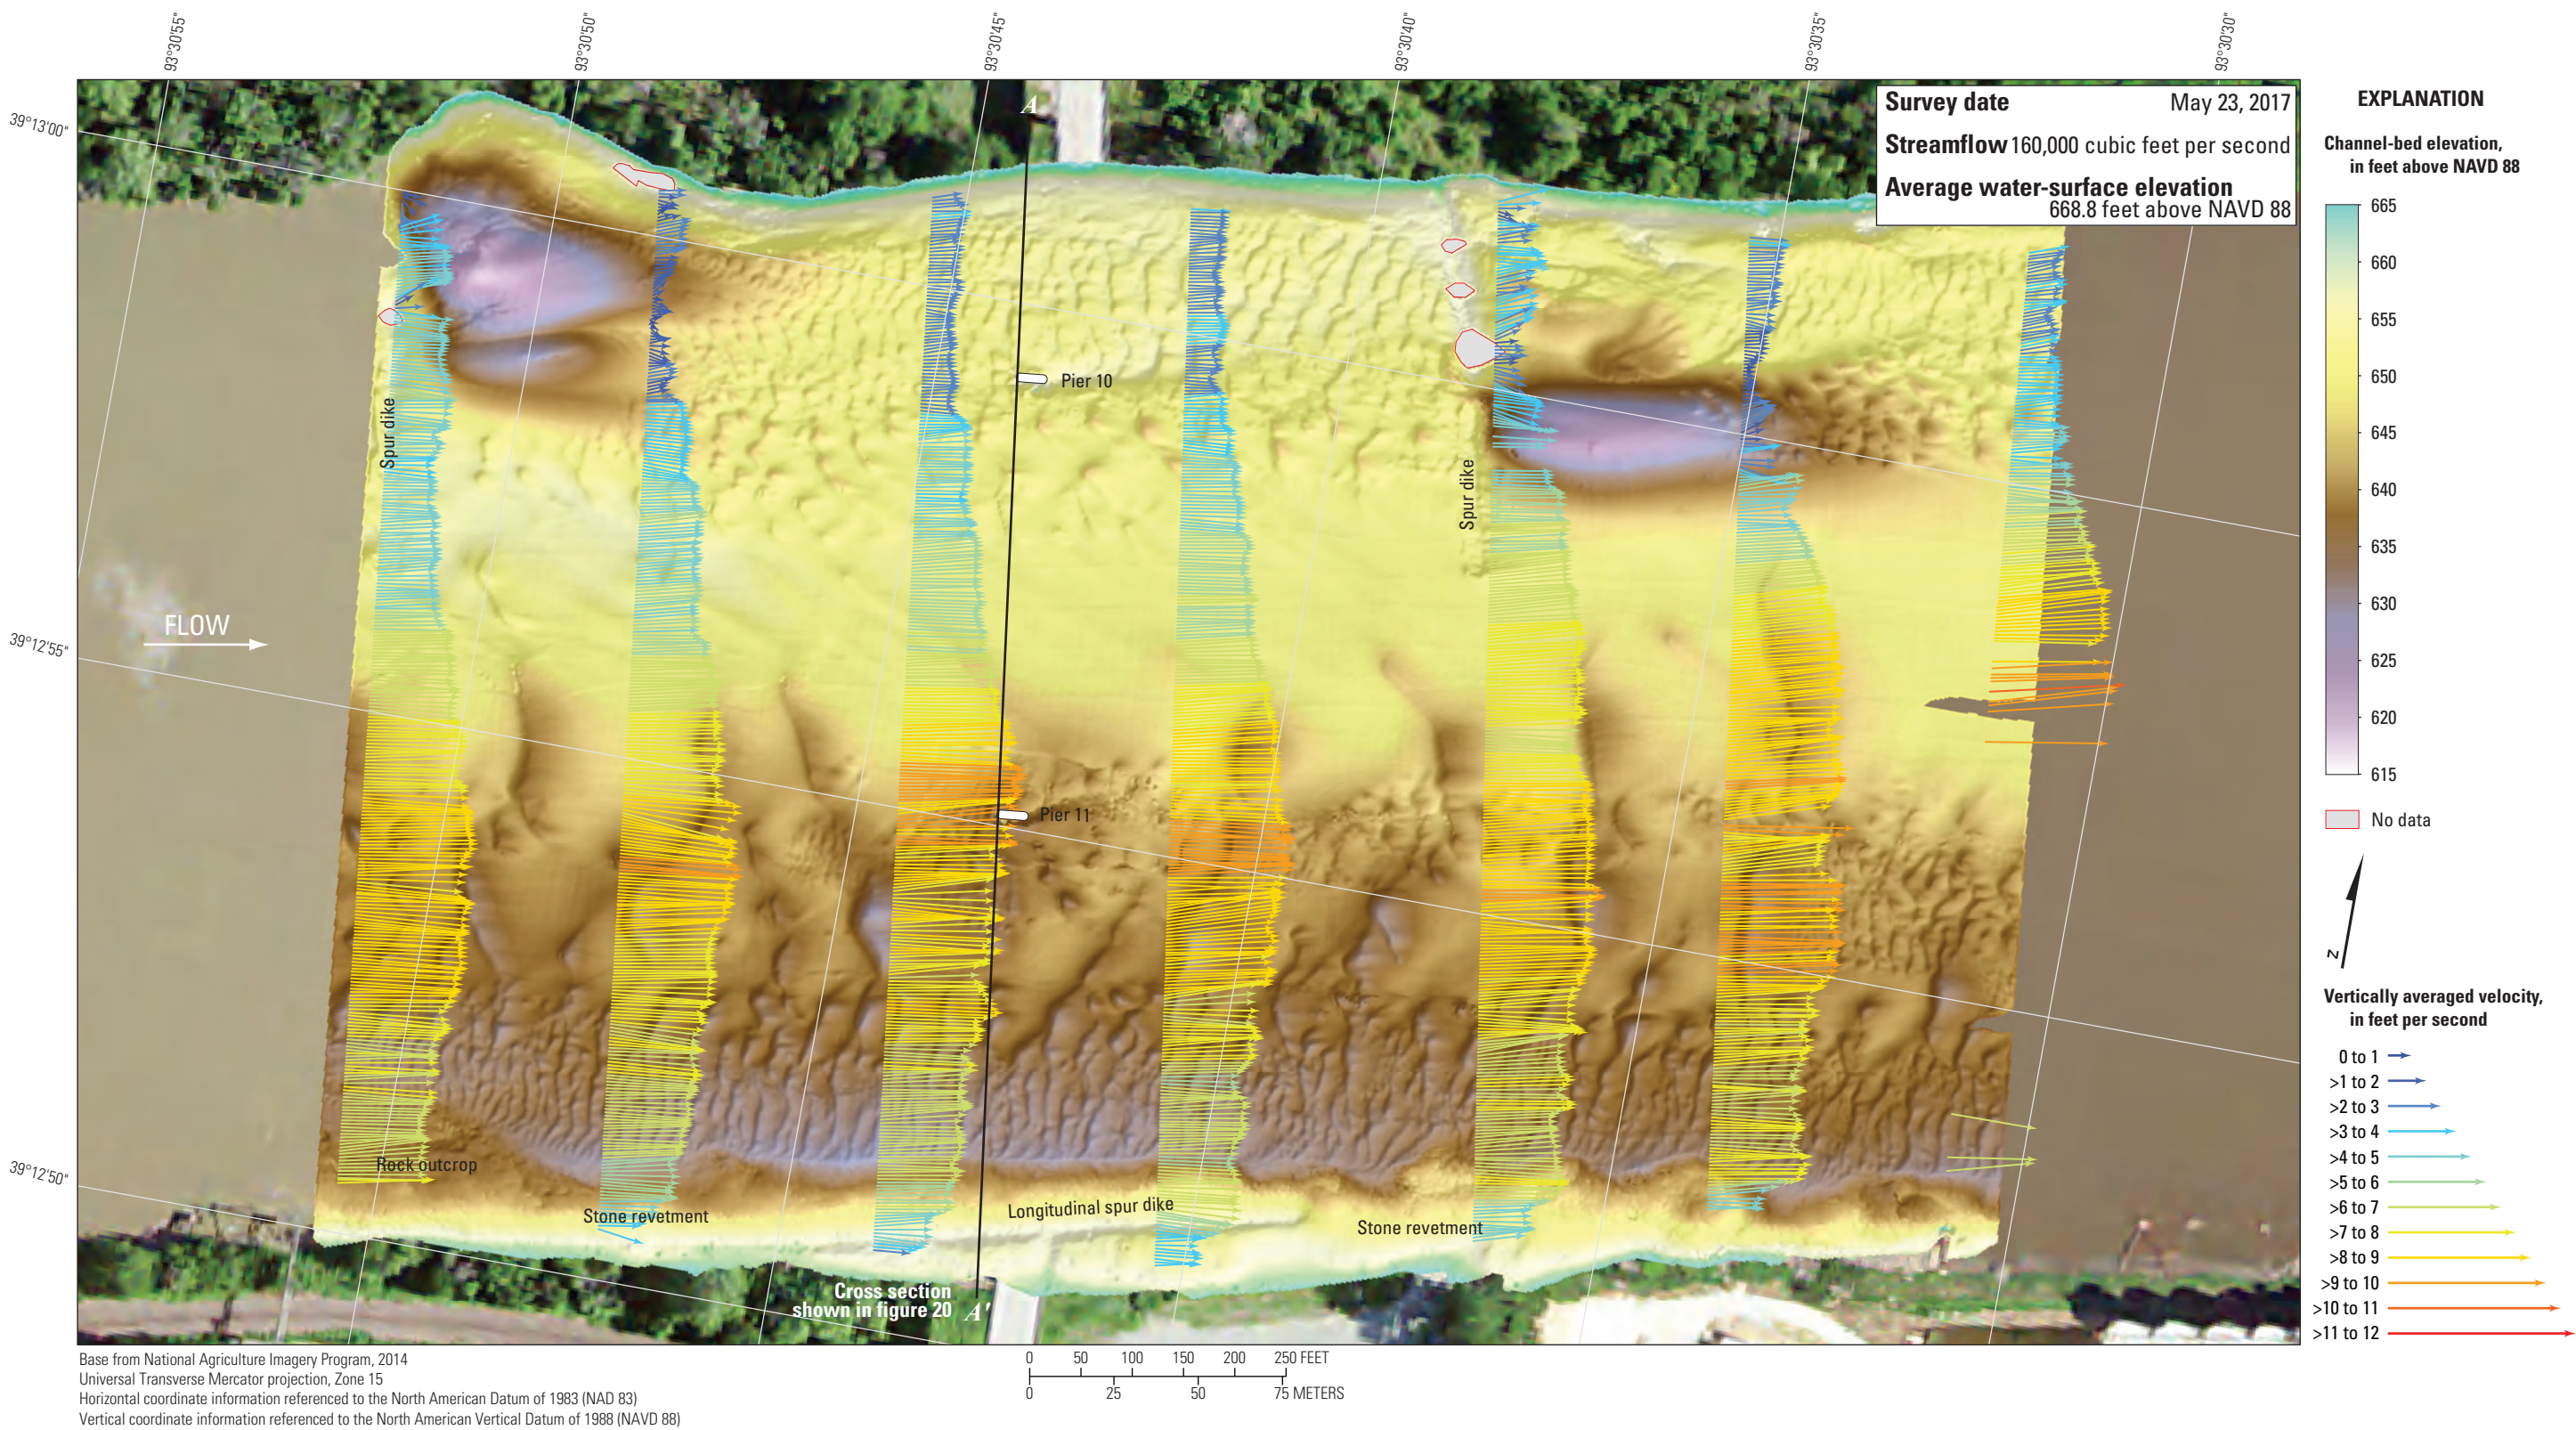
The vertically averaged velocity vectors indicate mostly uniform flow throughout the reach (fig. 23). A maximum velocity of about 9 ft/s was present in the downstream middle of the channel, and a minimum velocity of about 1 ft/s was present with flow reversal downstream from the various spur dikes in the reach (fig. 23). Minimal to moderate turbulence was observed at several transects (fig. 23), likely as a result of localized flow disturbances caused by the spur dikes and bedforms as at other sites in this study. The bridge piers were aligned with flow, with only moderate effects on the velocity and no evident turbulence downstream from either pier (fig. 23). Data for the downstream-most velocity transect were incomplete, although there was no indication of any problems during the survey.

Figure 23. Bathymetry and vertically averaged velocities of the Missouri River channel near structure A5910 on U.S. Highway 24 at Waverly, Missouri.

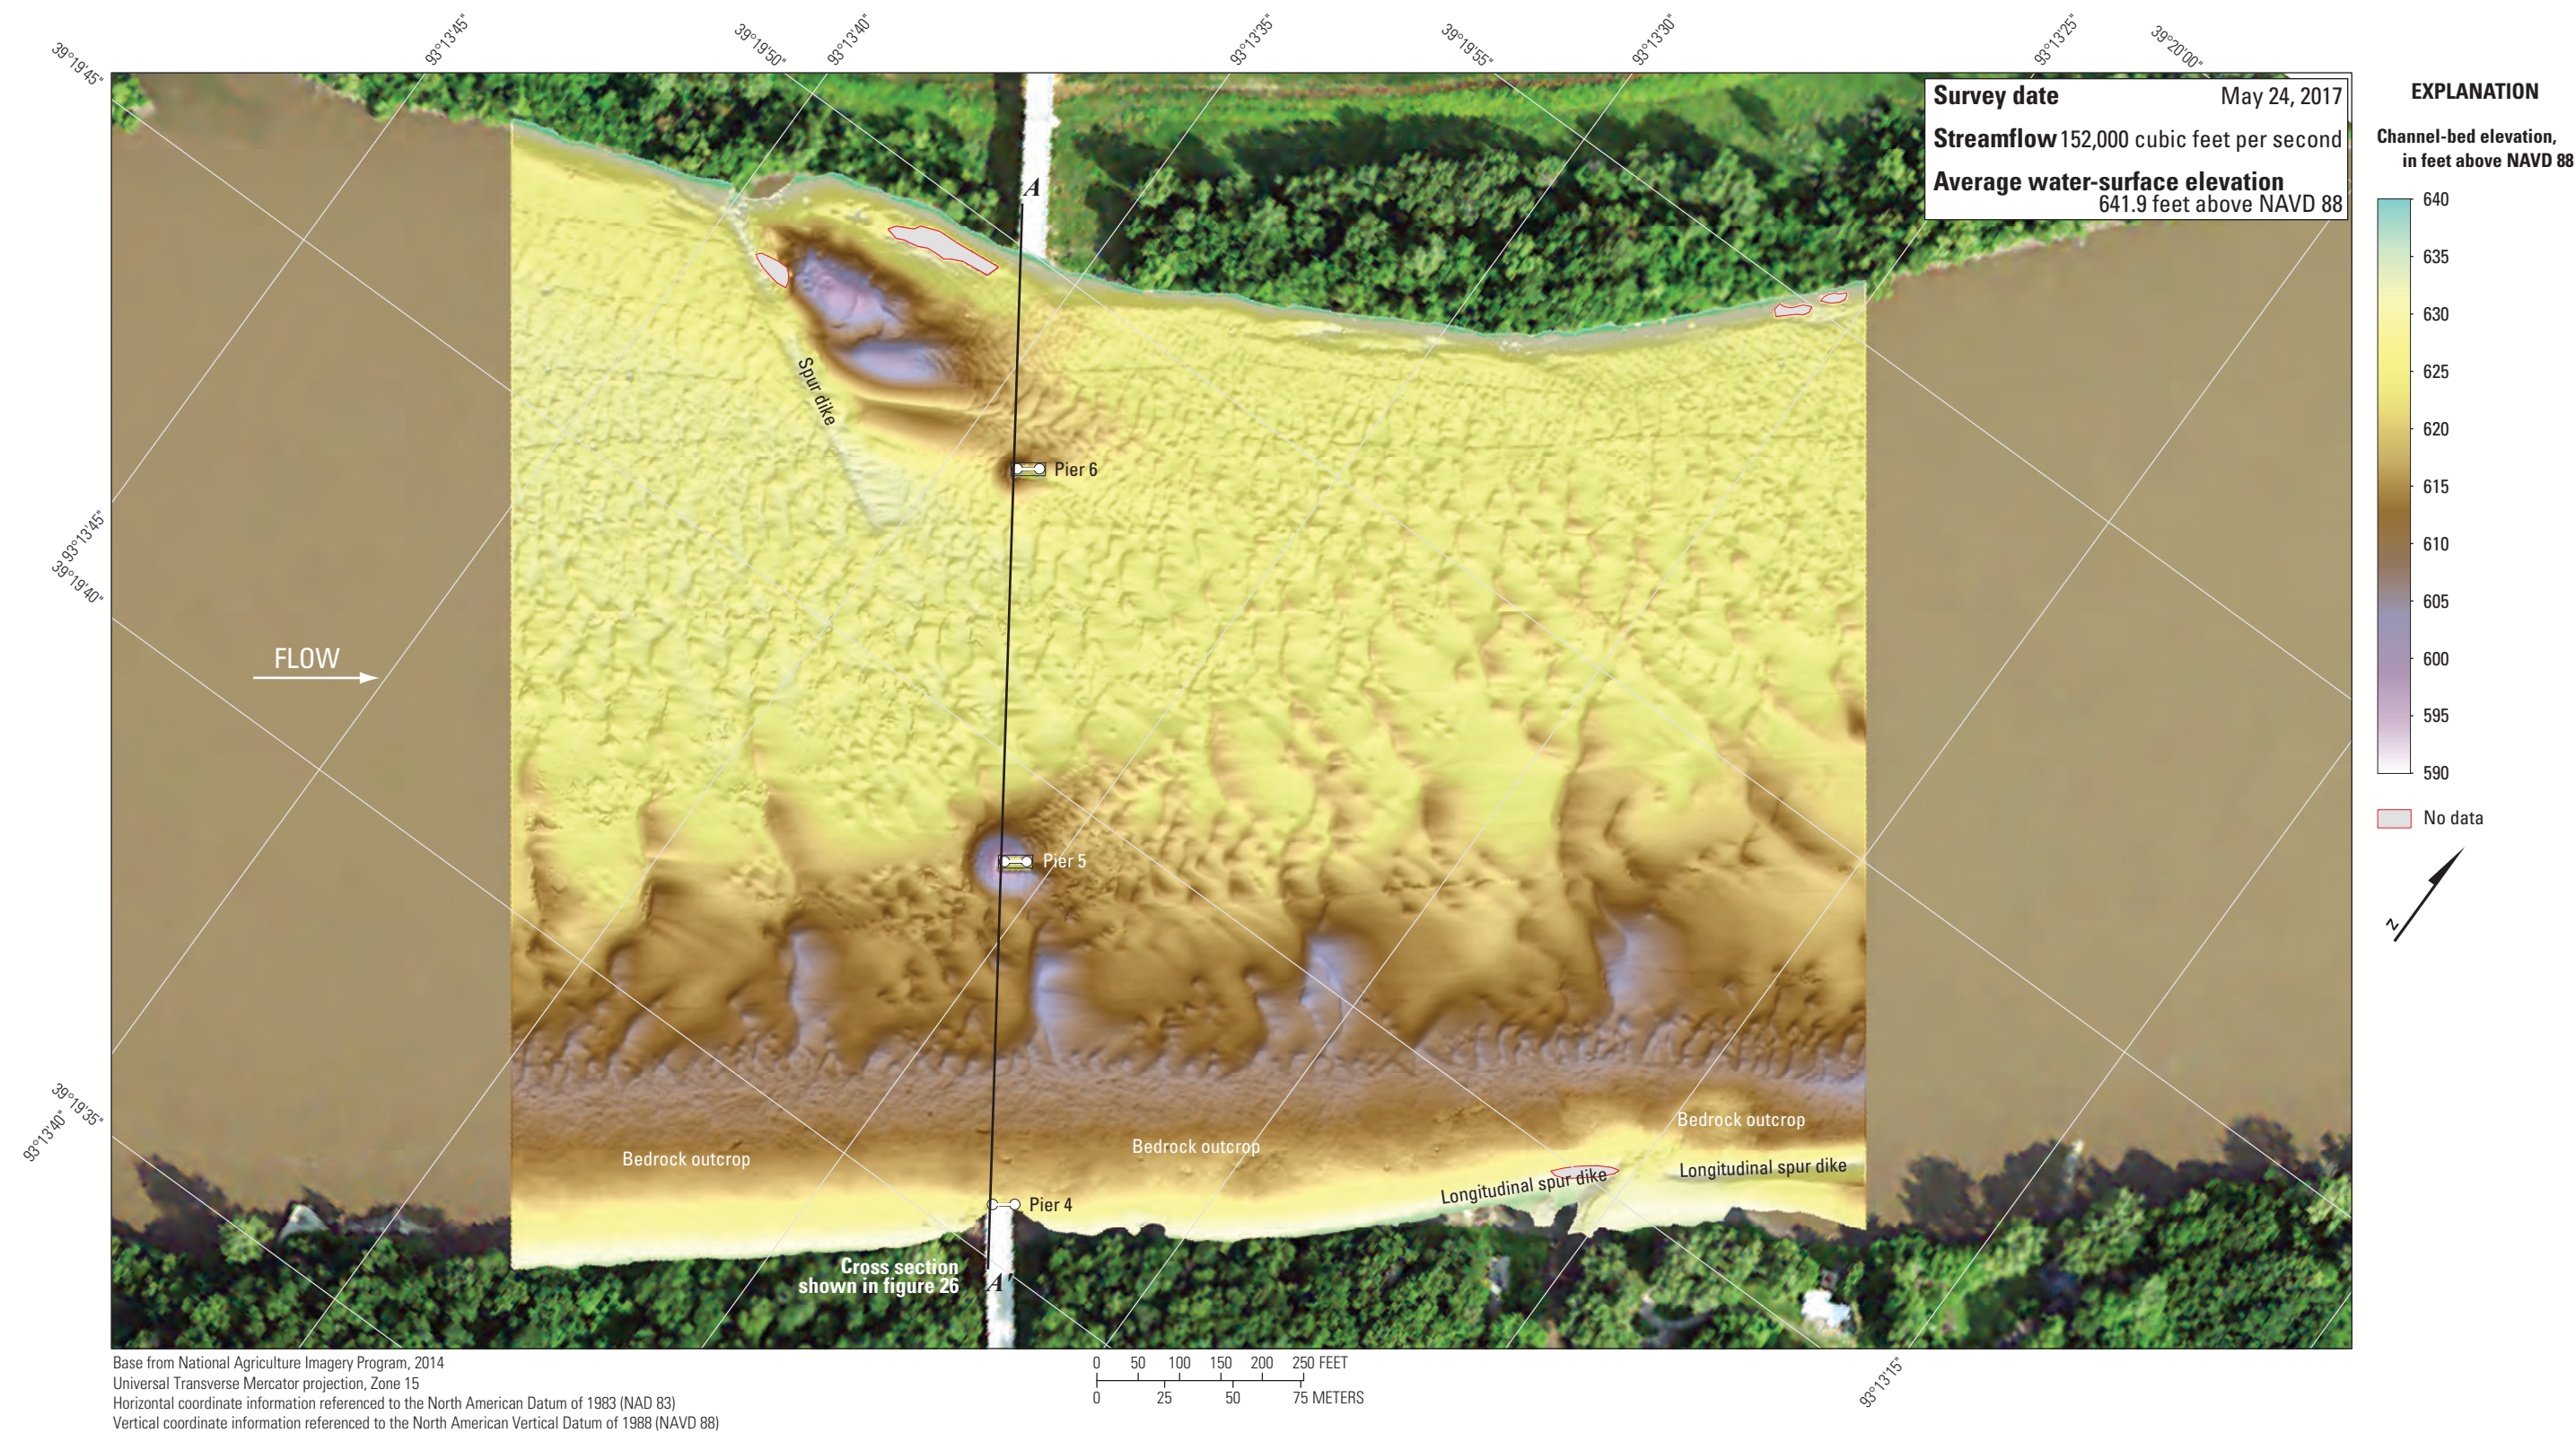
The survey area was about 1,640 ft long and varied from about 1,380 ft wide at the upstream end to about 1,050 ft wide near the downstream end, extending from bank to bank in the main channel (fig. 24). The upstream end of the survey area was about 625 ft upstream from the centerline of structure K0999; piers 5 and 6 were in the water and away from the banks, and pier 4 was surrounded by rock revetment on the right (south) bank (fig. 24). The approximate channel-bed elevations ranged from about 608 to 628 ft for most of the surveyed area (5th to 95th percentile range of the bathymetric data; table 5; fig. 25), except near pier 5, in the scour hole downstream from the spur dike on the left (north) bank, and in the troughs of the large dune features in the thalweg along the toe of the rock outcrop along the right (south) side of the channel (fig. 24). The approximate minimum channel-bed elevation of 594 ft was at the bottom of the scour hole at pier 5 (fig. 24; tables 5, 6). In addition to the large dune features observed in the channel thalweg, numerous small dunes and ripples were detected throughout most of the rest of the channel (fig. 24).

As indicated above, a substantial scour hole was observed near pier 5 (figs. 24, 26; table 6). Information from bridge plans indicates that piers 5 and 6 are caissons founded on bedrock, with about 36 ft of bed material between the bottom of the scour hole and bedrock at pier 6 but only about 6 ft of bed material between the bottom of the scour hole and bedrock at pier 5 (fig. 26; table 6). Pier 4 is founded on a footing on bedrock according to bridge plans (fig. 26; table 6), and no scour hole was observed near the pier (fig. 24). The surveyed bed along the cross section generally was similar to the multibeam survey in 2011 (fig. 26). The approximate top-of-bedrock line from bridge plans confirms that the fluvial material near the right bank has washed away, exposing the bedrock along the thalweg, as in previous surveys (fig. 26). In modern construction, bridge substructural elements usually are pinned or socketed to bedrock (Brown and others, 2010; American Association of State Highway Transportation Officials, 2012), but full exposure of usually buried substructural elements warrants special consideration and observation.

Figure 24. Bathymetric survey of the Missouri River channel near structure K0999 on Missouri State Highway 41 at Miami, Missouri.

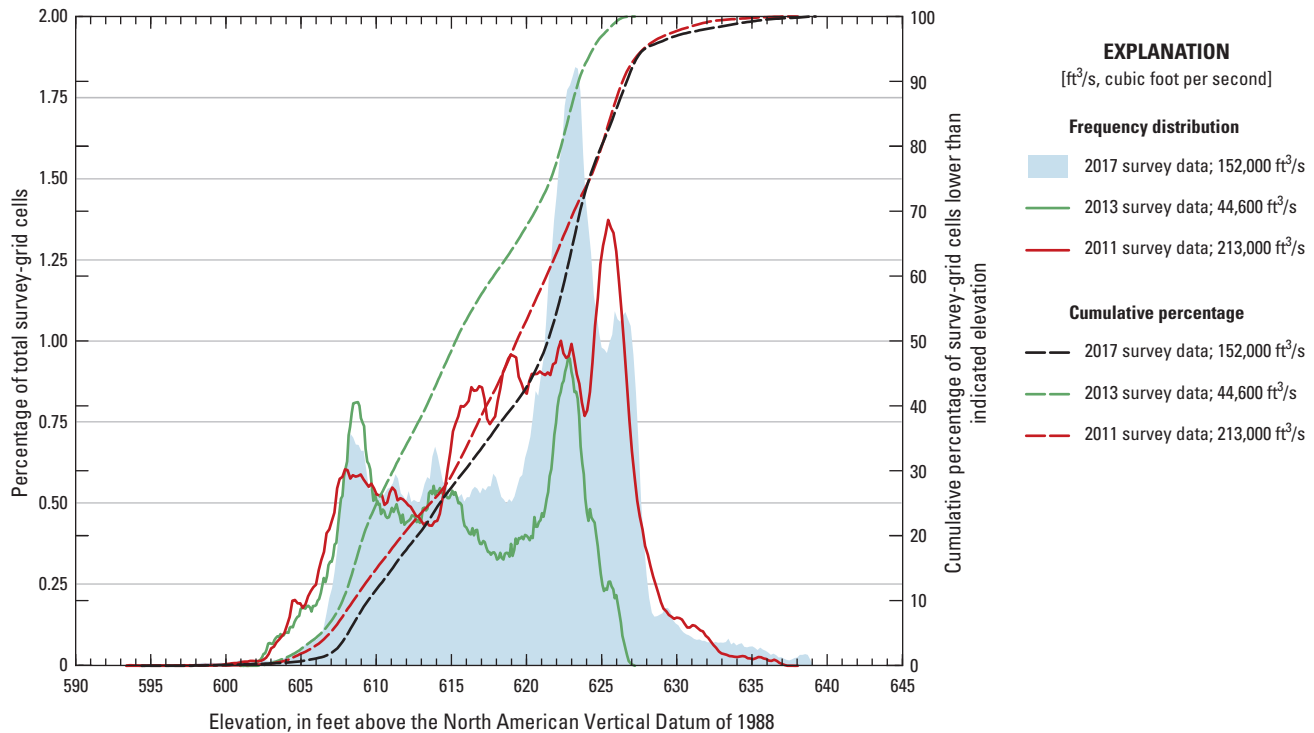
Figure 25. Frequency distribution of bed elevations for bathymetric survey-grid cells on the Missouri River near structure K0999 on Missouri State Highway 41 at Miami, Missouri, on May 24, 2017, compared to previous surveys.

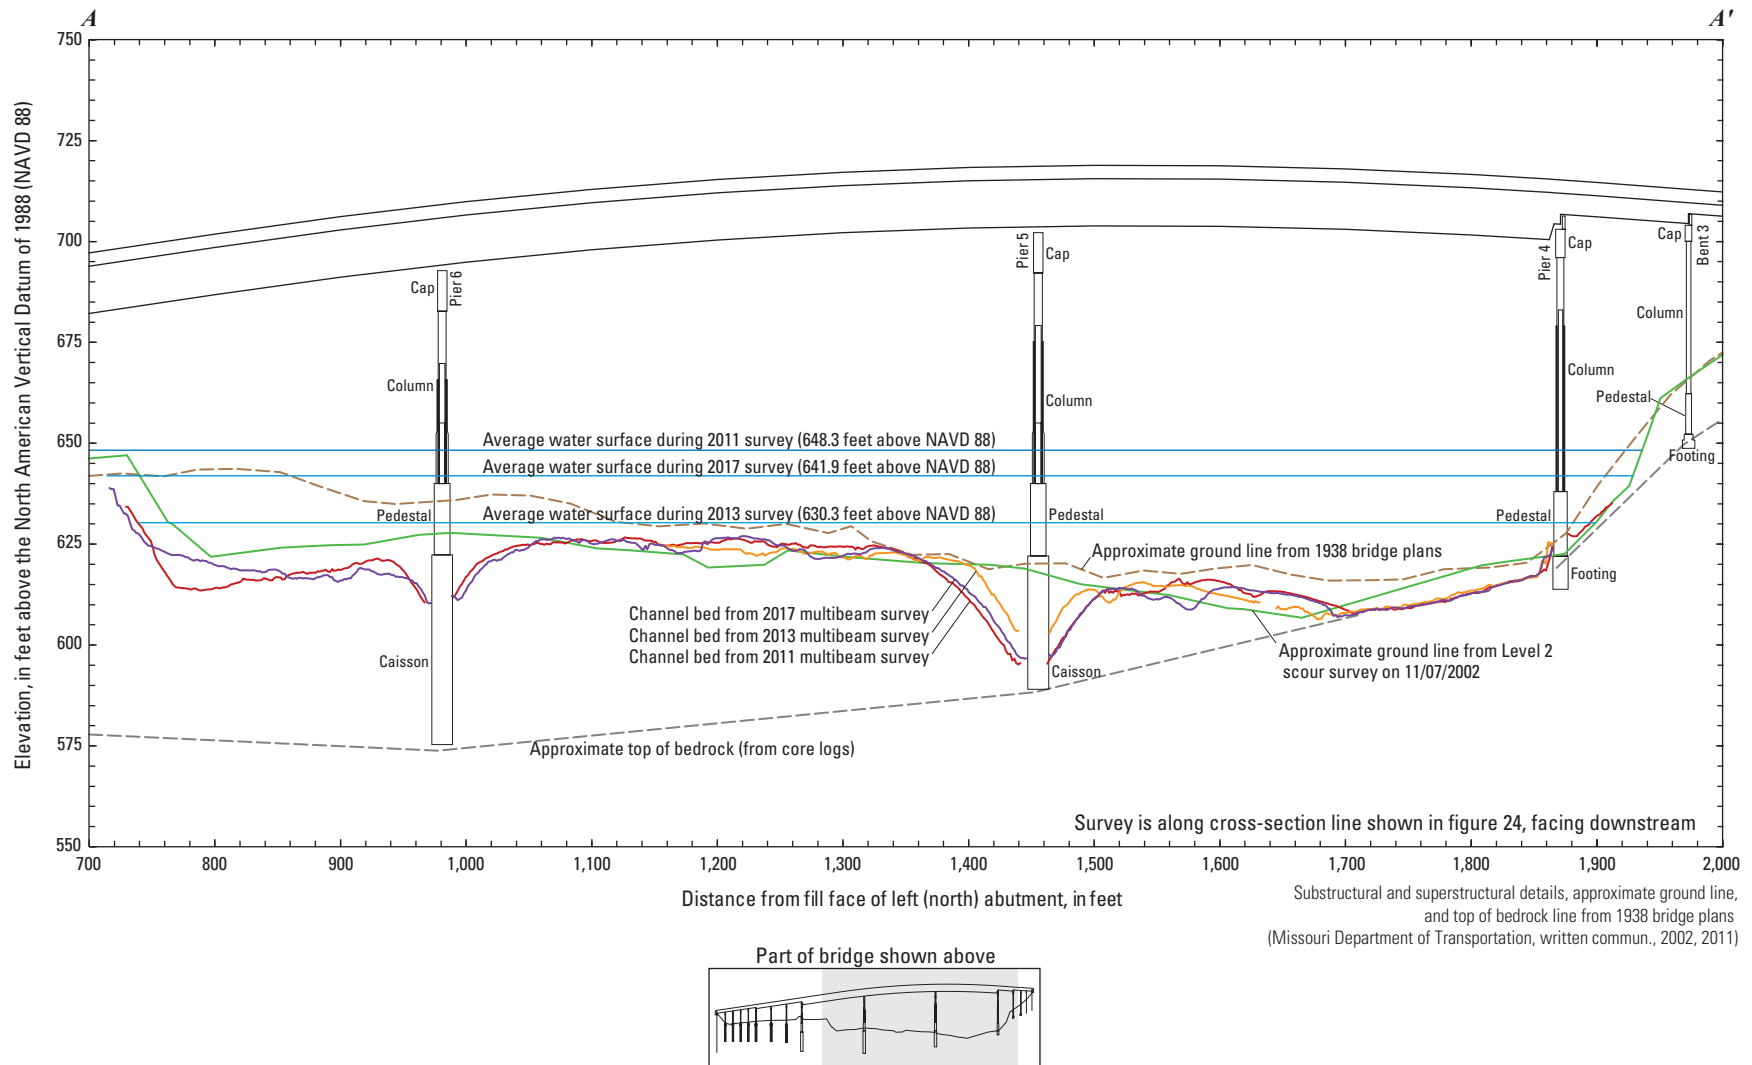
deposition was present throughout the rest of the reach, with moderate deposition in the thalweg downstream from the bridge (fig. 27). The cross sections from these two surveys generally were similar to one another except near pier 5 (figs. 26, 27). The general shape of the frequency distribution of bed elevations was similar in all three of the surveys to date at this site (fig. 25), but the 2017 survey has a substantially higher percentage of survey-grid cells from 620 to 627 ft. The rock outcrop on the right (south) bank indicated no signs of substantial change except for minor localized scour, likely of previously deposited sediment (fig. 27). As with all difference maps in this report, substantial deposition or scour apparent at the faces of the piers results from minor horizontal positional variances between the surveys (see the “Uncertainty Estimation” section).

Figure 26. Key features, substructural and superstructural details, and surveyed channel bed of structure K0999 on Missouri State Highway 41 crossing the Missouri River at Miami, Missouri.

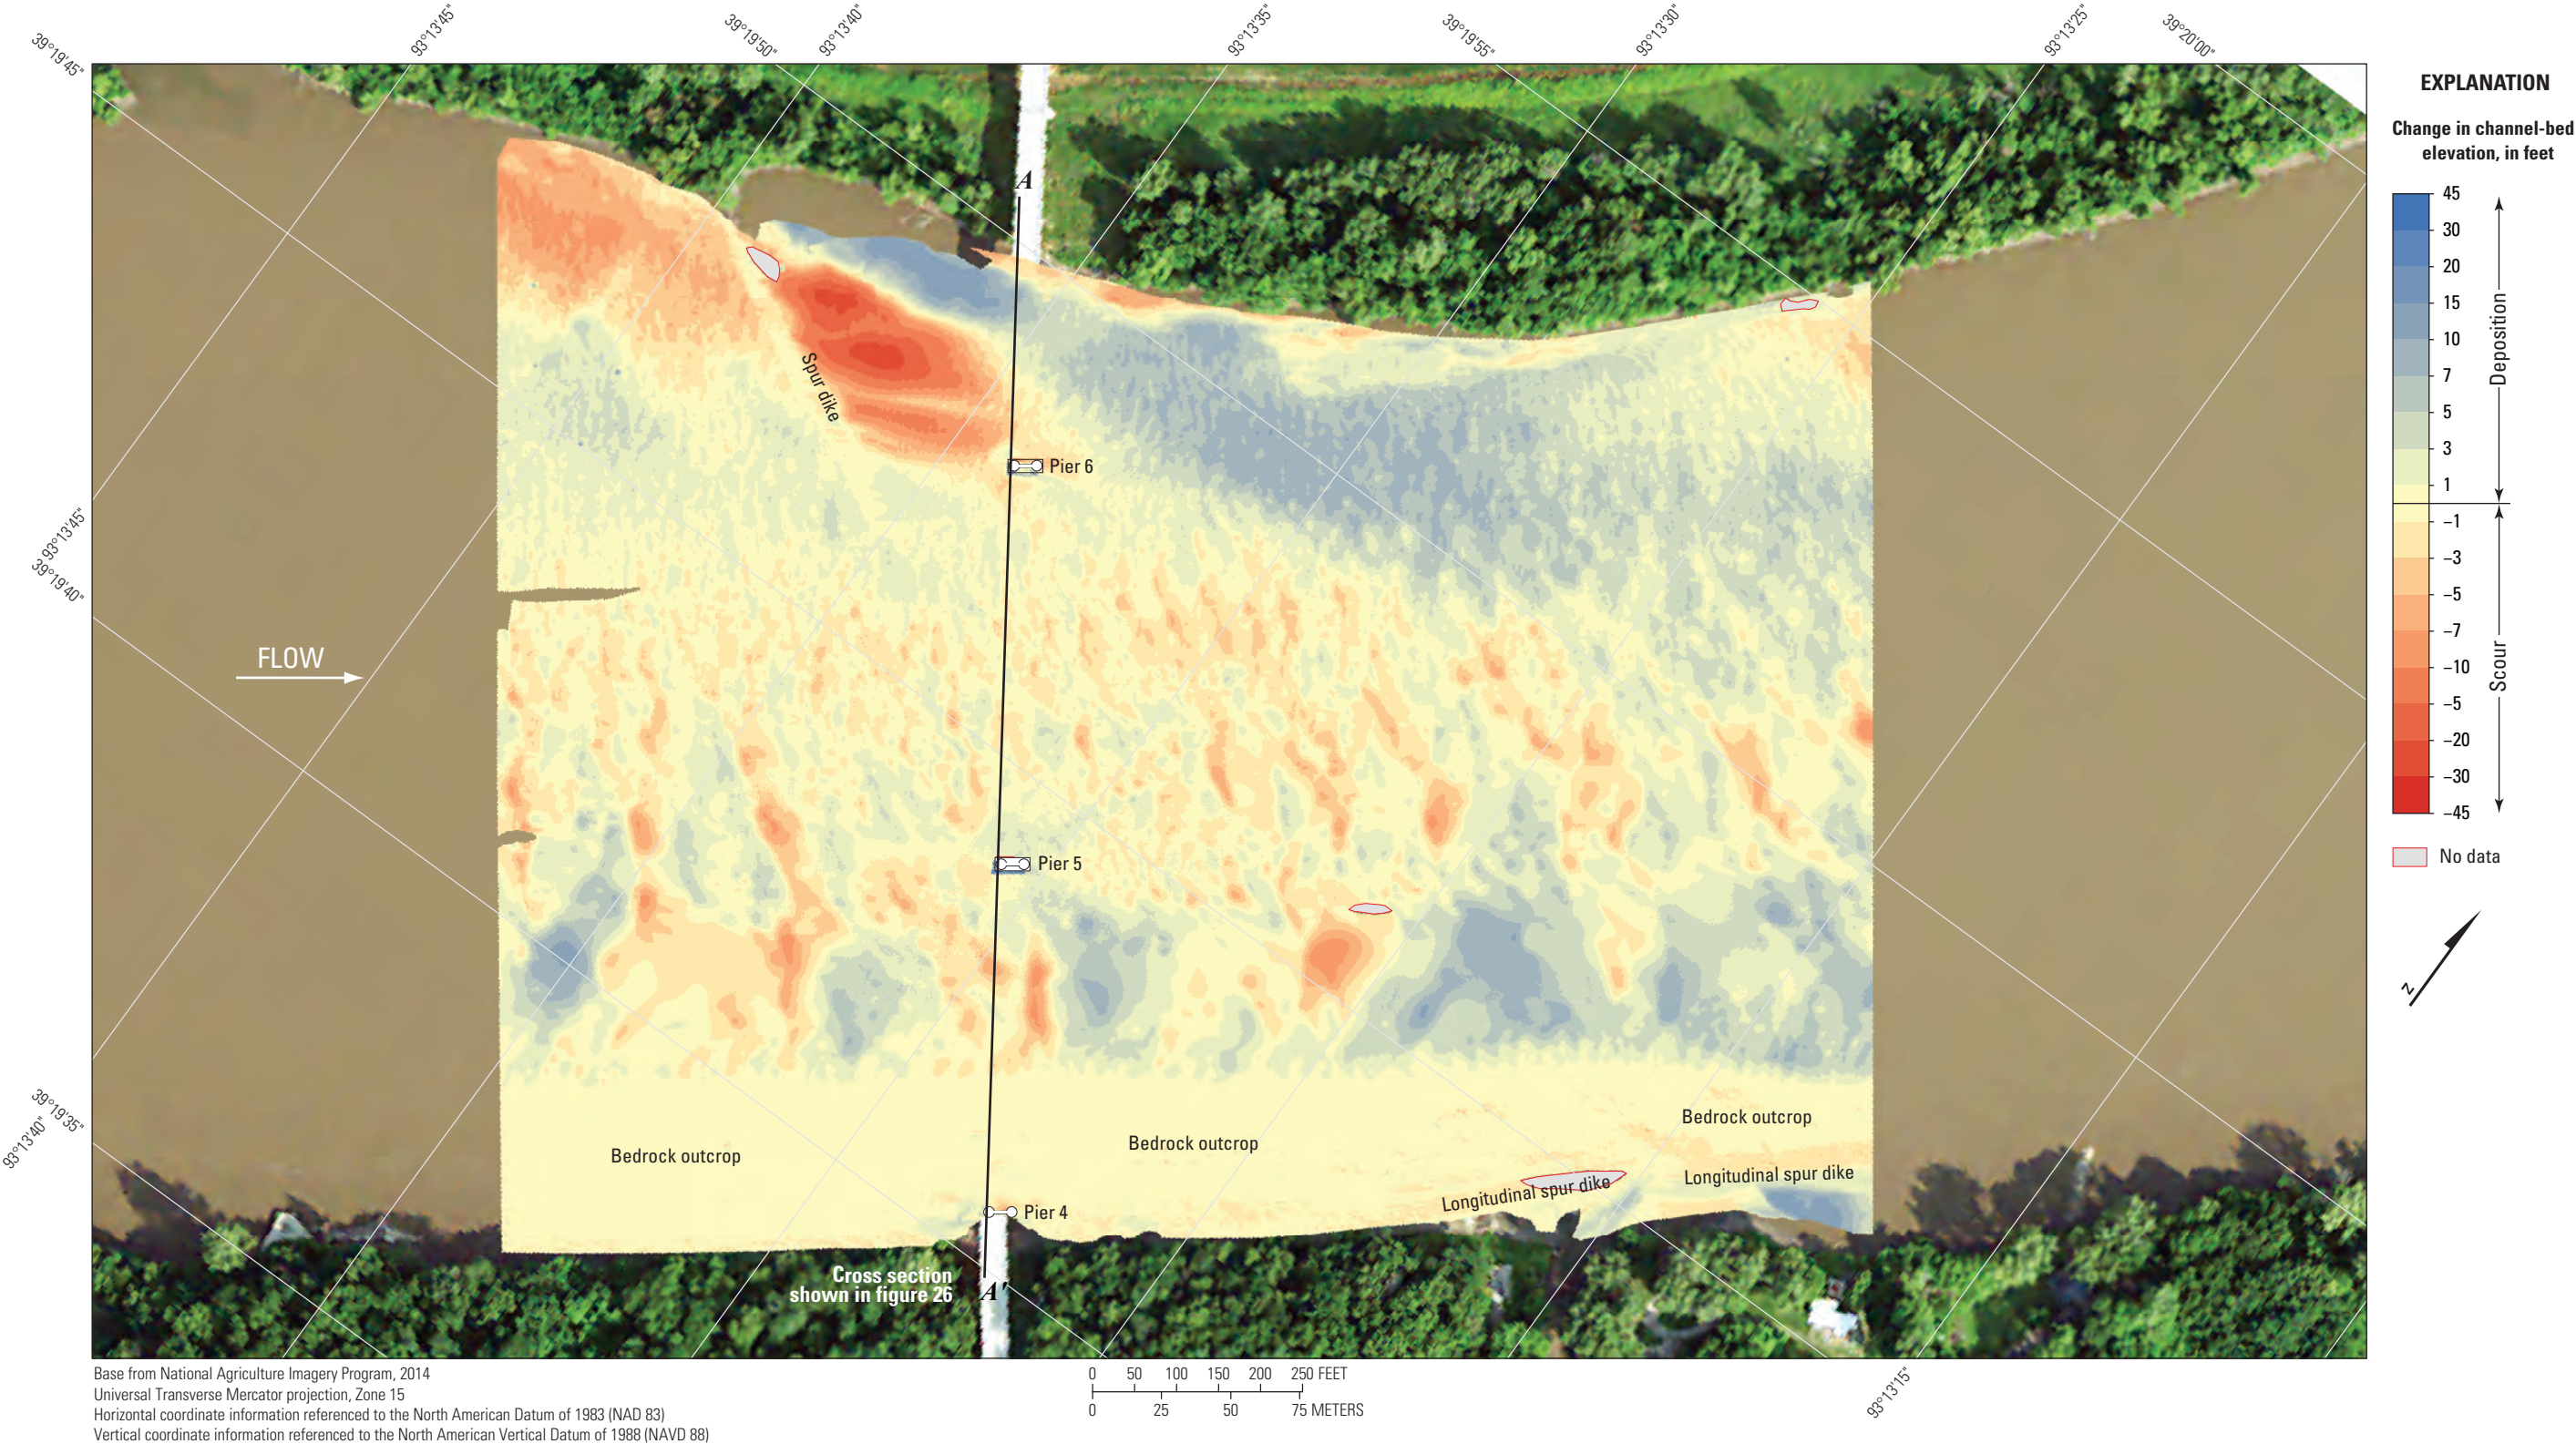
The difference between the survey on May 24, 2017, and the previous survey on July 21, 2011 (fig. 28), also indicates minor deposition between 2011 and 2017, as indicated by an average difference of +0.68 ft between the bathymetric surfaces (table 7). The net volume of cut in the reach from 2011 to 2017 was about 58,400 yd³, and the net volume of fill was about 105,700 yd³, resulting in a net gain of about 47,300 yd³ of sediment between 2011 and 2017. Near the spur dike on the upstream left (north) bank, there was an area of moderate

scour upstream and an area of substantial scour of more than 20 ft immediately downstream, with a commensurate area of deposition continuing downstream along the left (north) bank (fig. 28). Areas of alternating scour and deposition were present along the channel thalweg (fig. 28). The cross sections from these two surveys also were similar to one another except in the channel thalweg and near the toe of the left (north) bank (fig. 26). The rock outcrop on the right (south) bank indicated no signs of substantial change except for minor localized scour, likely of previously deposited sediment, and some deposition behind the downstream longitudinal spur dikes (fig. 28). As with all difference maps in this report, substantial deposition or scour apparent at the faces of the piers results from minor horizontal positional variances between the surveys (see the “Uncertainty Estimation” section).

Figure 28. Difference between surfaces created from bathymetric surveys of the Missouri River channel near structure K0999 on Missouri State Highway 41 at Miami, Missouri, on May 24, 2017, and July 21, 2011.
