Bathymetric and Velocimetric Surveys at Highway Bridges Crossing the Missouri River between Kansas City and St. Louis, Missouri, May 22–31, 2017

Scientific Investigations Report 2020–5018

By Richard J. Huizinga

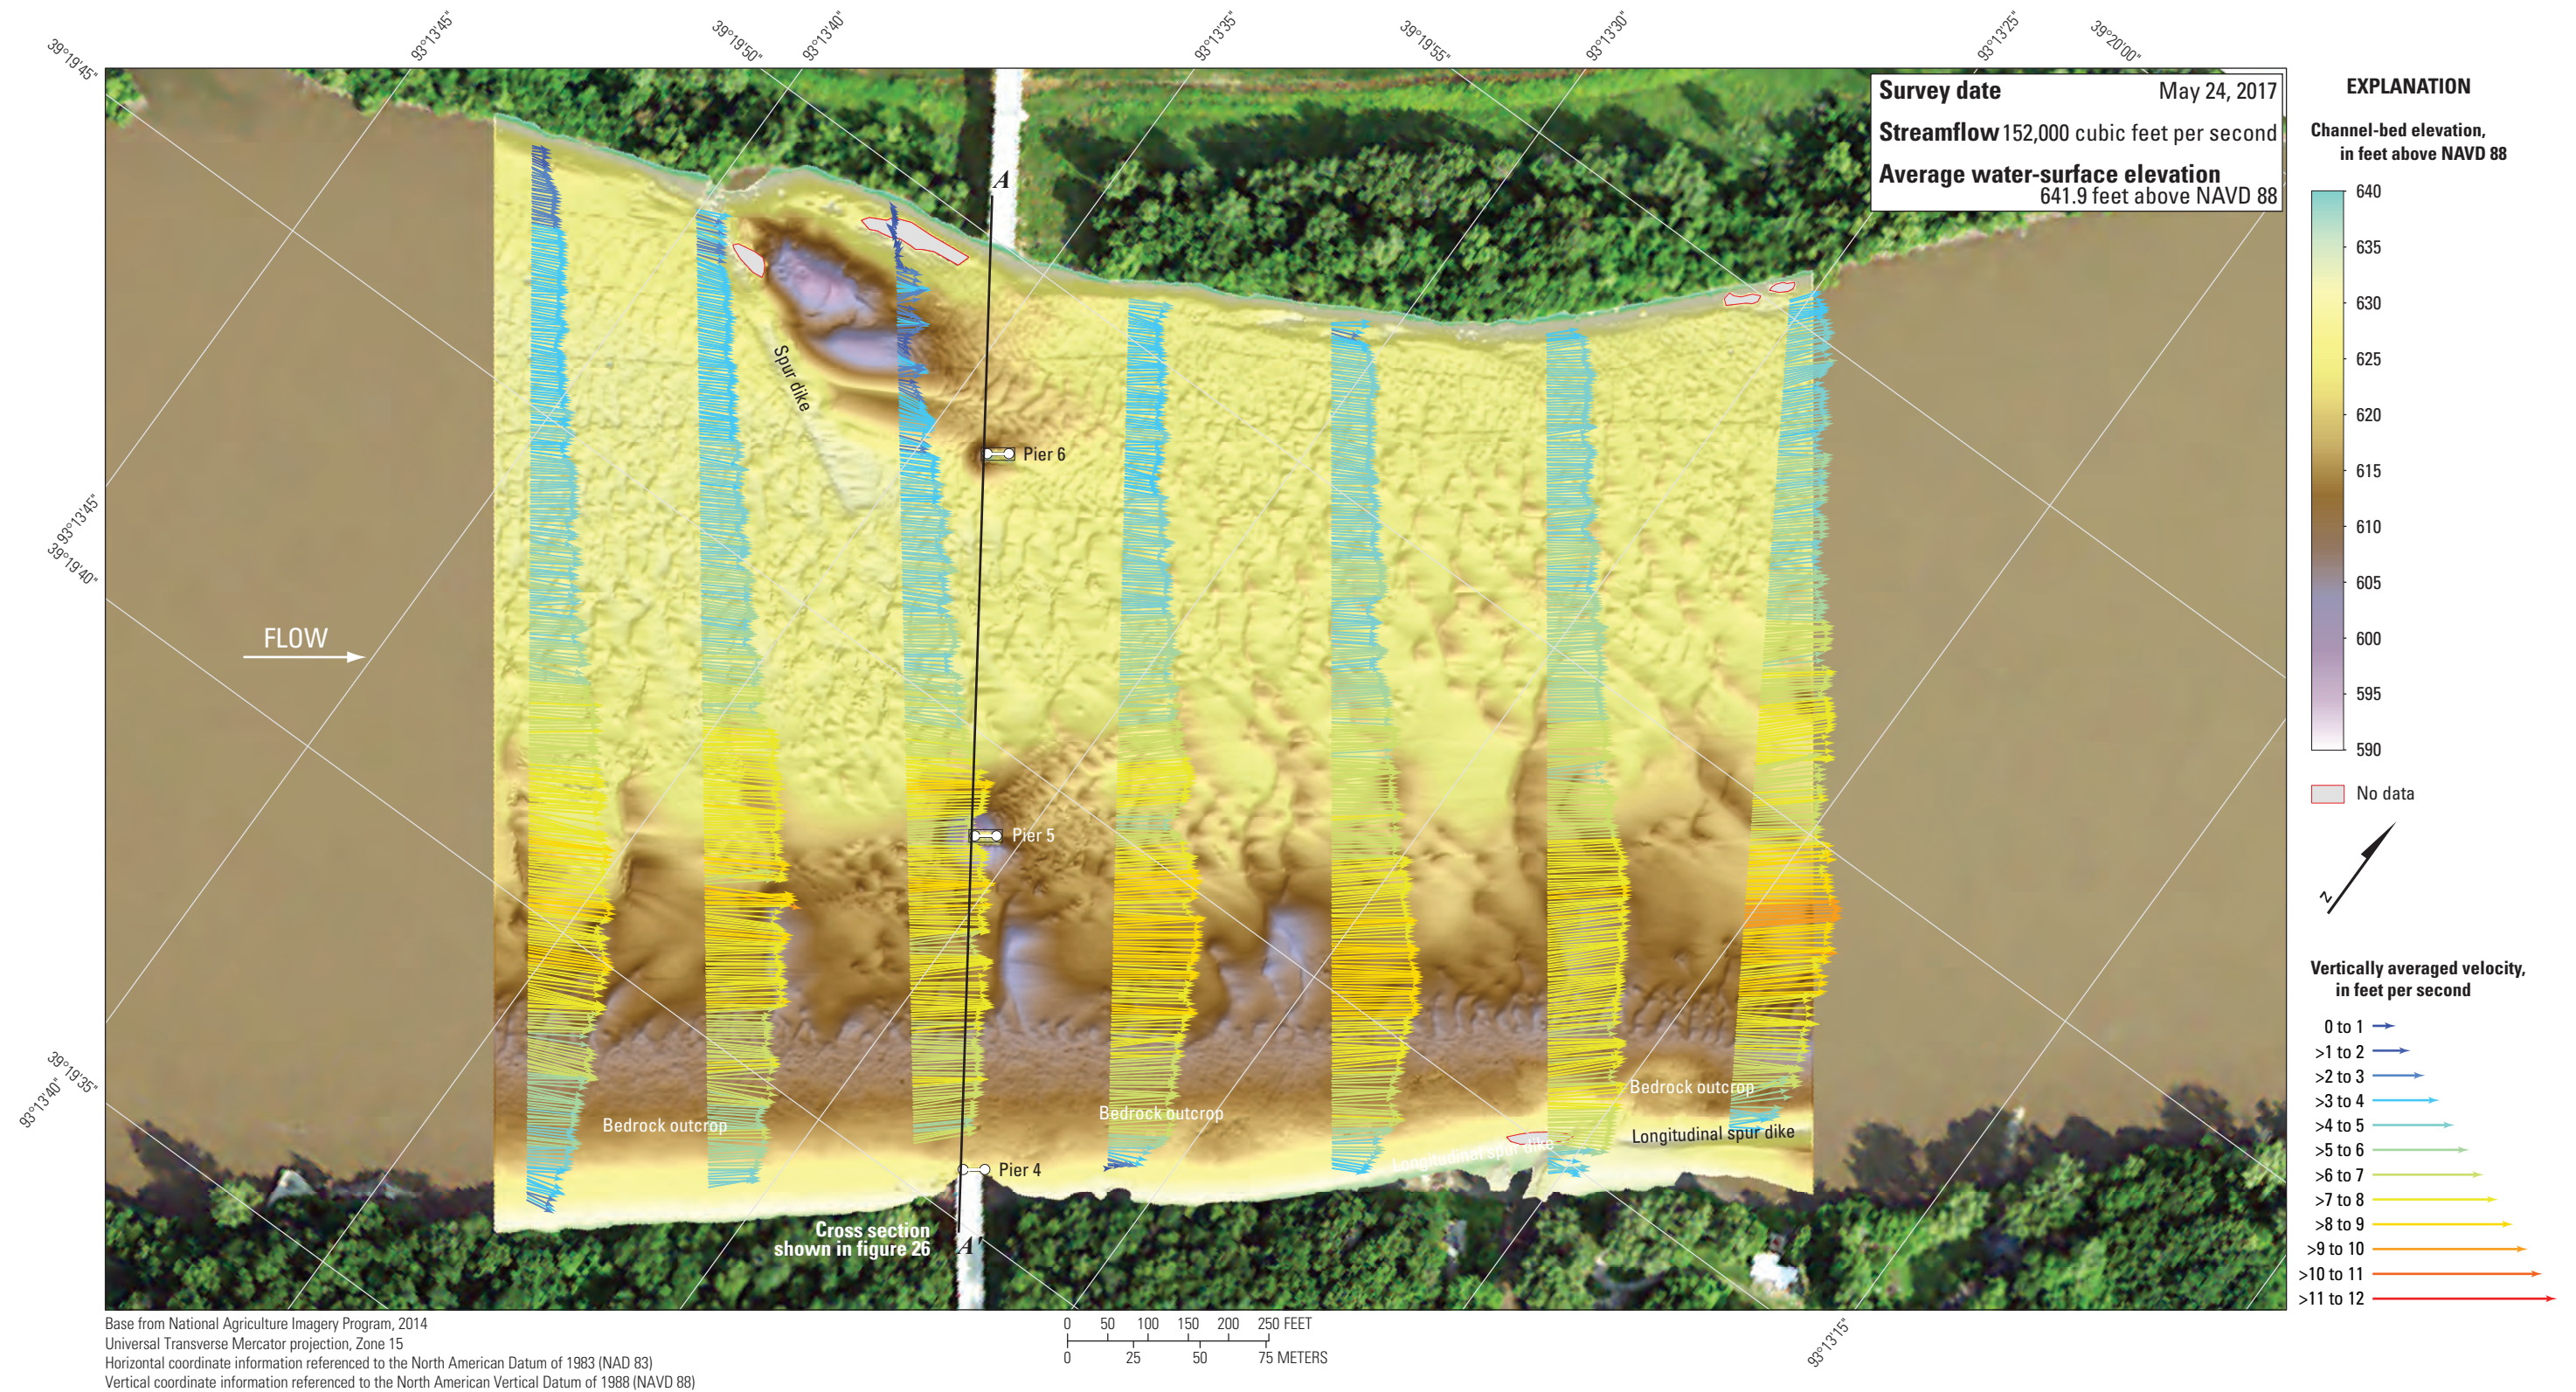
The vertically averaged velocity vectors indicate mostly uniform flow throughout most of the reach, ranging from about 2 to 9 ft/s (fig. 29). Exceptions to uniform conditions include substantial variation in velocities on the left (north) bank downstream from the spur dike, and moderate turbulence observed in the downstream transects near the longitudinal spur dikes (fig. 29). All the piers were aligned with flow, as indicated by little to no turbulence observed downstream that can be directly attributed to the piers (fig. 29).

Figure 29. Bathymetry and vertically averaged velocities of the Missouri River channel near structure K0999 on Missouri State Highway 41 at Miami, Missouri.

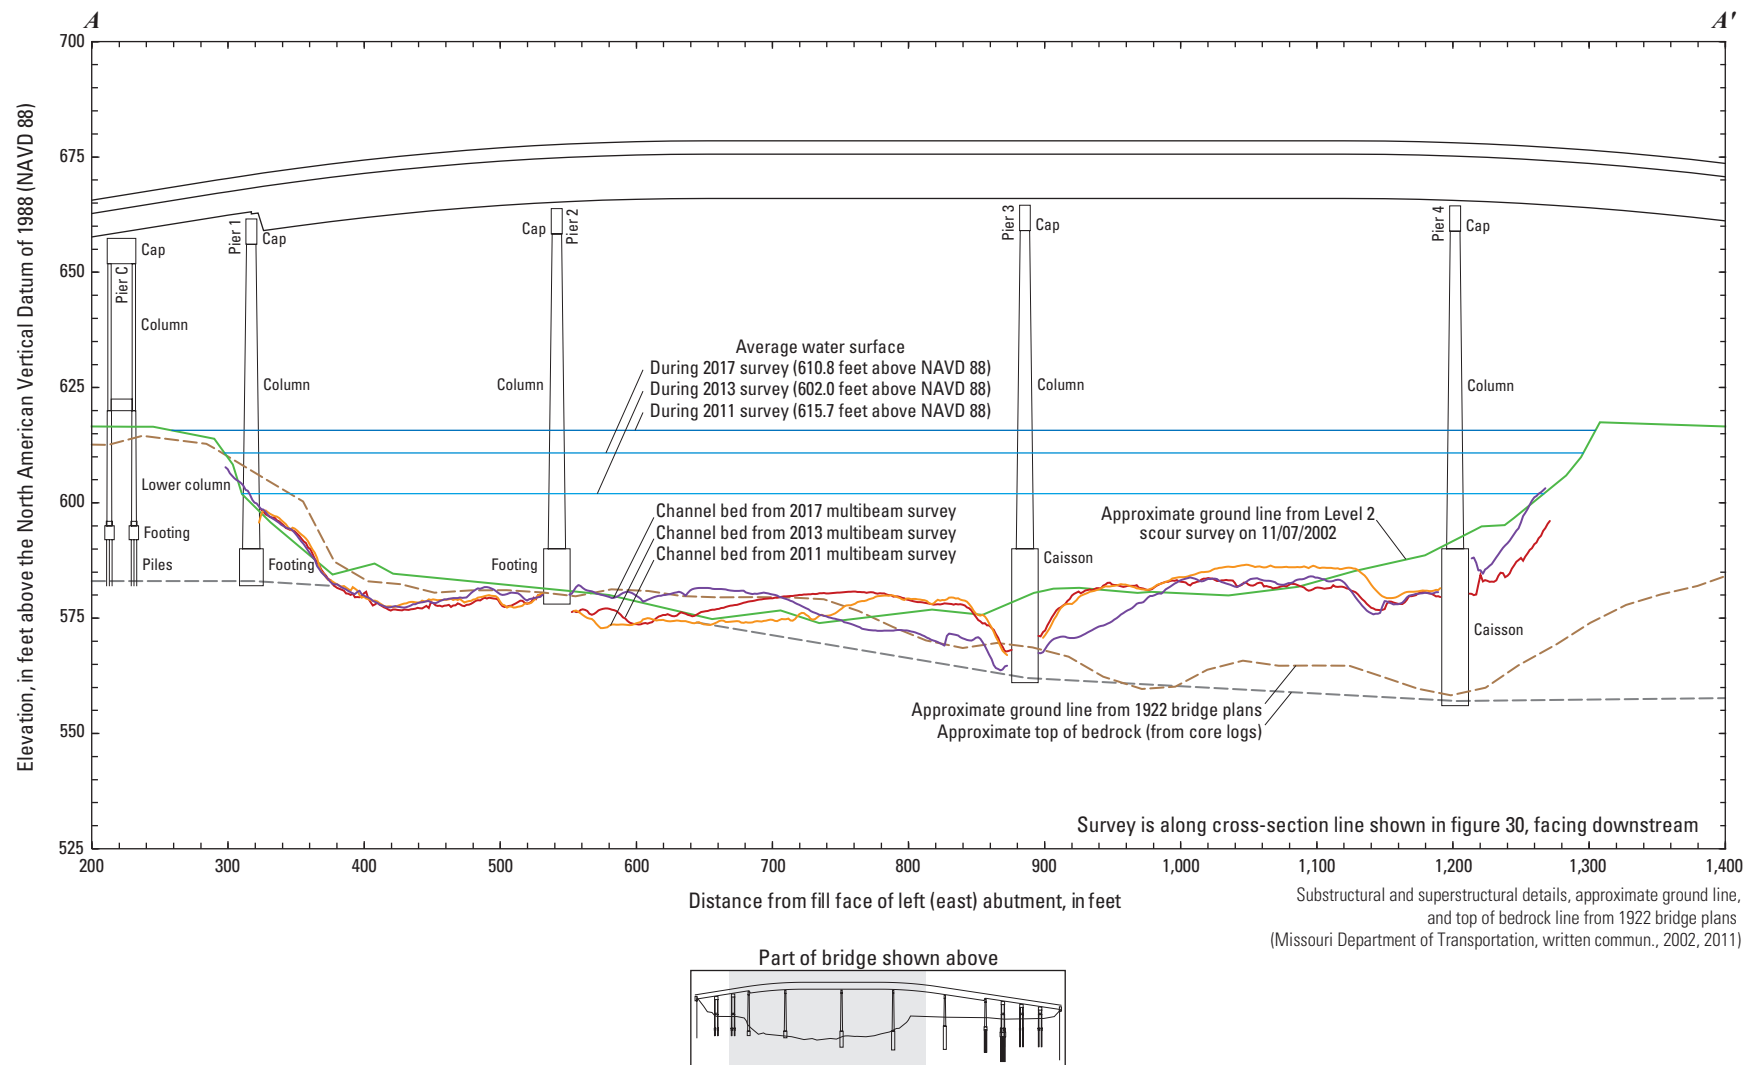
A small scour hole was observed near pier 2 (fig. 30), which is founded on a footing on bedrock according to bridge plans (fig. 32; table 6). The ground line from the bathymetric survey indicated that the right side of the footing seemed to be undermined in previous surveys but was partially buried in bed sediments in the 2017 survey (fig. 32). The details of the footing of pier 2 in the bridge plans for structure G0069 are not sufficient to tell if it was entrenched in the bedrock in any way, particularly if the top of the bedrock was not level, as indicated by previous surveys (Huizinga, 2014; fig. 32). In modern construction, bridge substructural elements usually are pinned or socketed to bedrock (Brown and others, 2010; American Association of State Highway Transportation Officials, 2012), but full exposure of usually buried substructural elements warrants special consideration and observation, particularly at an older bridge such as structure G0069 (built in 1922).

A substantial scour hole was observed near main channel pier 3, and a smaller scour hole was observed near pier 4. Near pier 3 (fig. 30), the scour hole had a minimum channel-bed elevation of about 560 ft (table 6), which is about 20 ft below the average channel bed immediately upstream from the pier (figs. 30, 32; table 6). The scour hole was substantially larger in 2017 than in the previous surveys. Near pier 4, the scour hole had a minimum channel-bed elevation of about 572 ft (figs. 30, 32; table 6). Information from bridge plans indicates that piers 3 and 4 are caissons founded on bedrock; the bedrock is exposed at pier 3, and there is about 15 ft of bed material between the bottom of the scour hole and bedrock at pier 4 (fig. 32; table 6). The scour observed near all the highway bridge piers was substantially affected by the upstream railroad bridge piers (fig. 30). The surveyed bed was similar to the previous multibeam surveys between the left bank and pier 2, alternated from 5 to 10 ft above to 5 to 15 ft below the

previous multibeam surveys between piers 2 and 3, and was similar to the 2011 survey between piers 3 and 4 except near pier 3 (fig. 32). The approximate top of bedrock confirmed in the previous multibeam surveys seems to have a thin layer of fluvial material near the left bank in the 2017 survey (fig. 32), with further evidence from small dunes and ripples in that area (fig. 30). The base of an old railroad bridge pier was clearly evident in the scour hole near pier 3 (fig. 30). A differential bed at the upstream face of the scour hole near pier 3 may indicate the presence of a sunken barge but also may result from bed-material movement between the parts of the survey obtained with the untilted and tilted sonar head at this site (fig. 30).

Figure 32. Key features, substructural and superstructural details, and surveyed channel bed of structure G0069 on Missouri State Highway 240 crossing the Missouri River at Glasgow, Missouri.

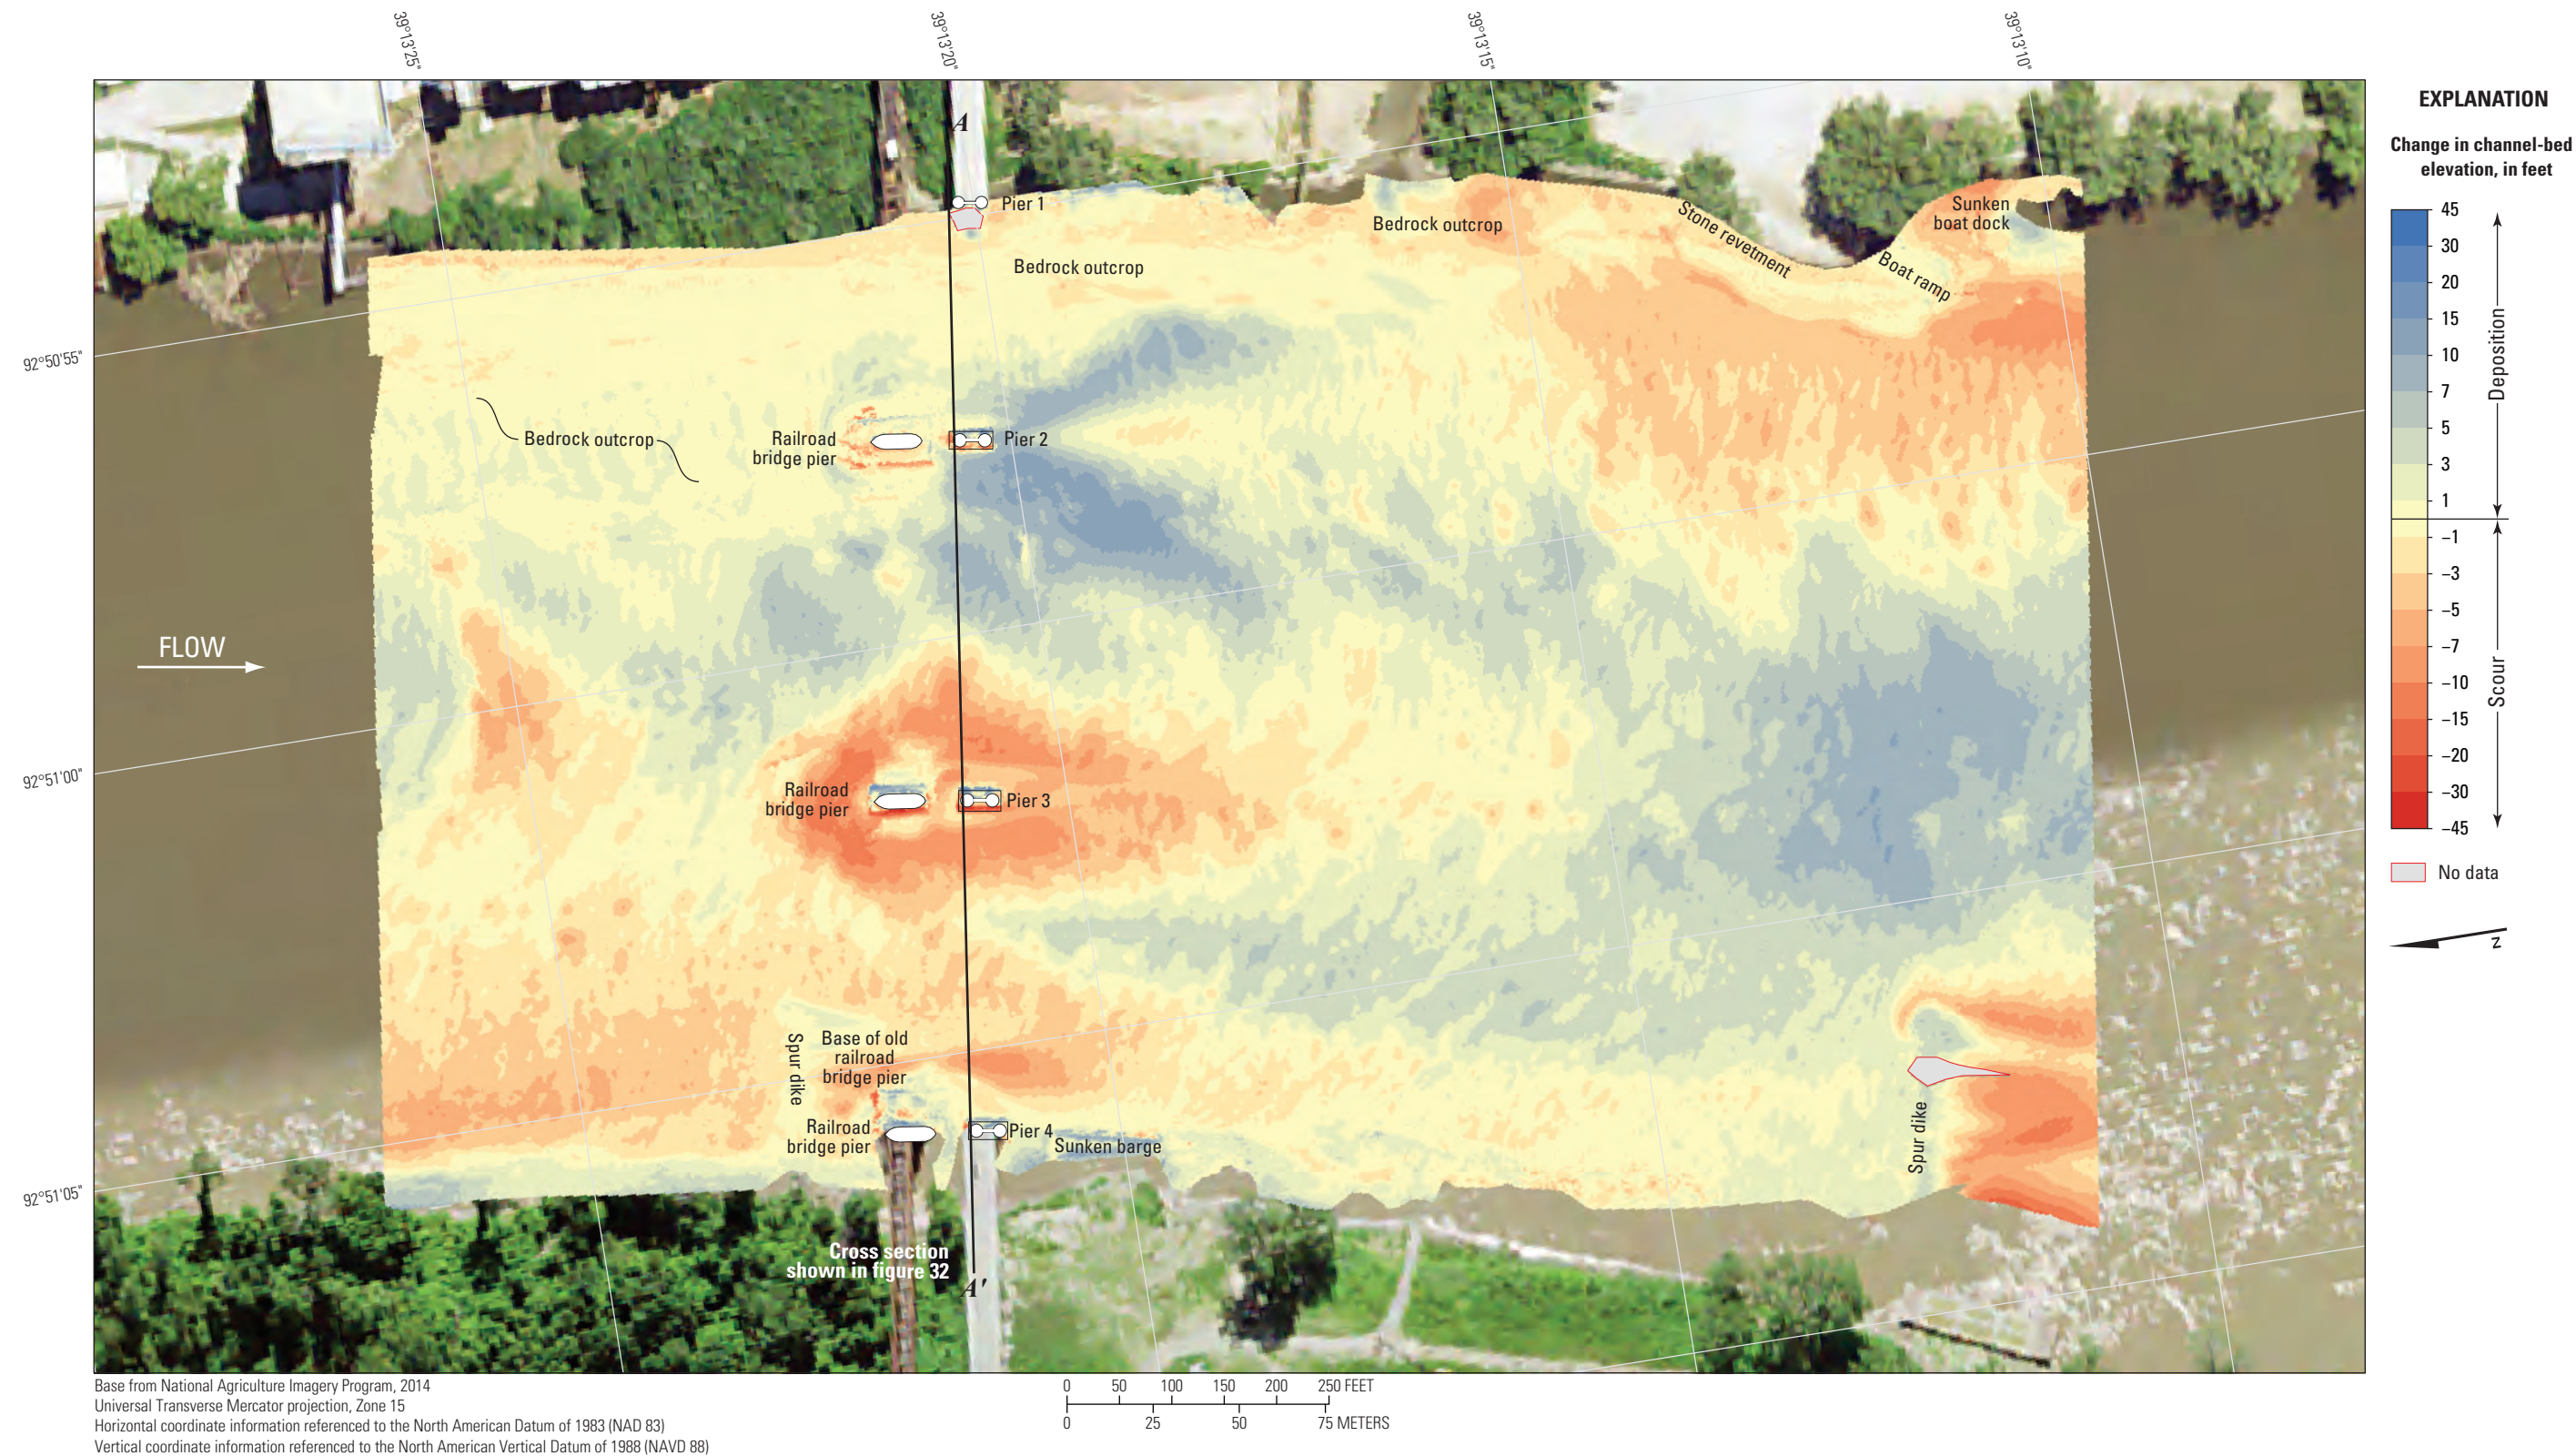
The difference between the survey on May 24, 2017, and the previous nonflood survey on April 26, 2013 (fig. 33), indicates minor deposition (an average difference of +0.43 ft between the bathymetric surfaces) throughout the reach between 2013 and 2017 (table 7). The net volume of cut in the reach from 2013 to 2017 was about 65,500 yd³, and the net volume of fill was about 89,500 yd³, resulting in a net gain of about 24,000 yd³ of sediment. Scour was observed in the upstream right and downstream left sides of the channel, and near pier 3 and downstream from the downstream spur dike (fig. 33). Deposition was observed on the bedrock outcrop on the upstream left side of the channel, around pier 2, and in the downstream middle of the channel (fig. 33). The frequency distribution of bed elevations was of a similar shape but at a

Figure 33. Difference between surfaces created from bathymetric surveys of the Missouri River channel near structure G0069 on Missouri State Highway 240 at Glasgow, Missouri, on May 24, 2017, and April 26, 2013.

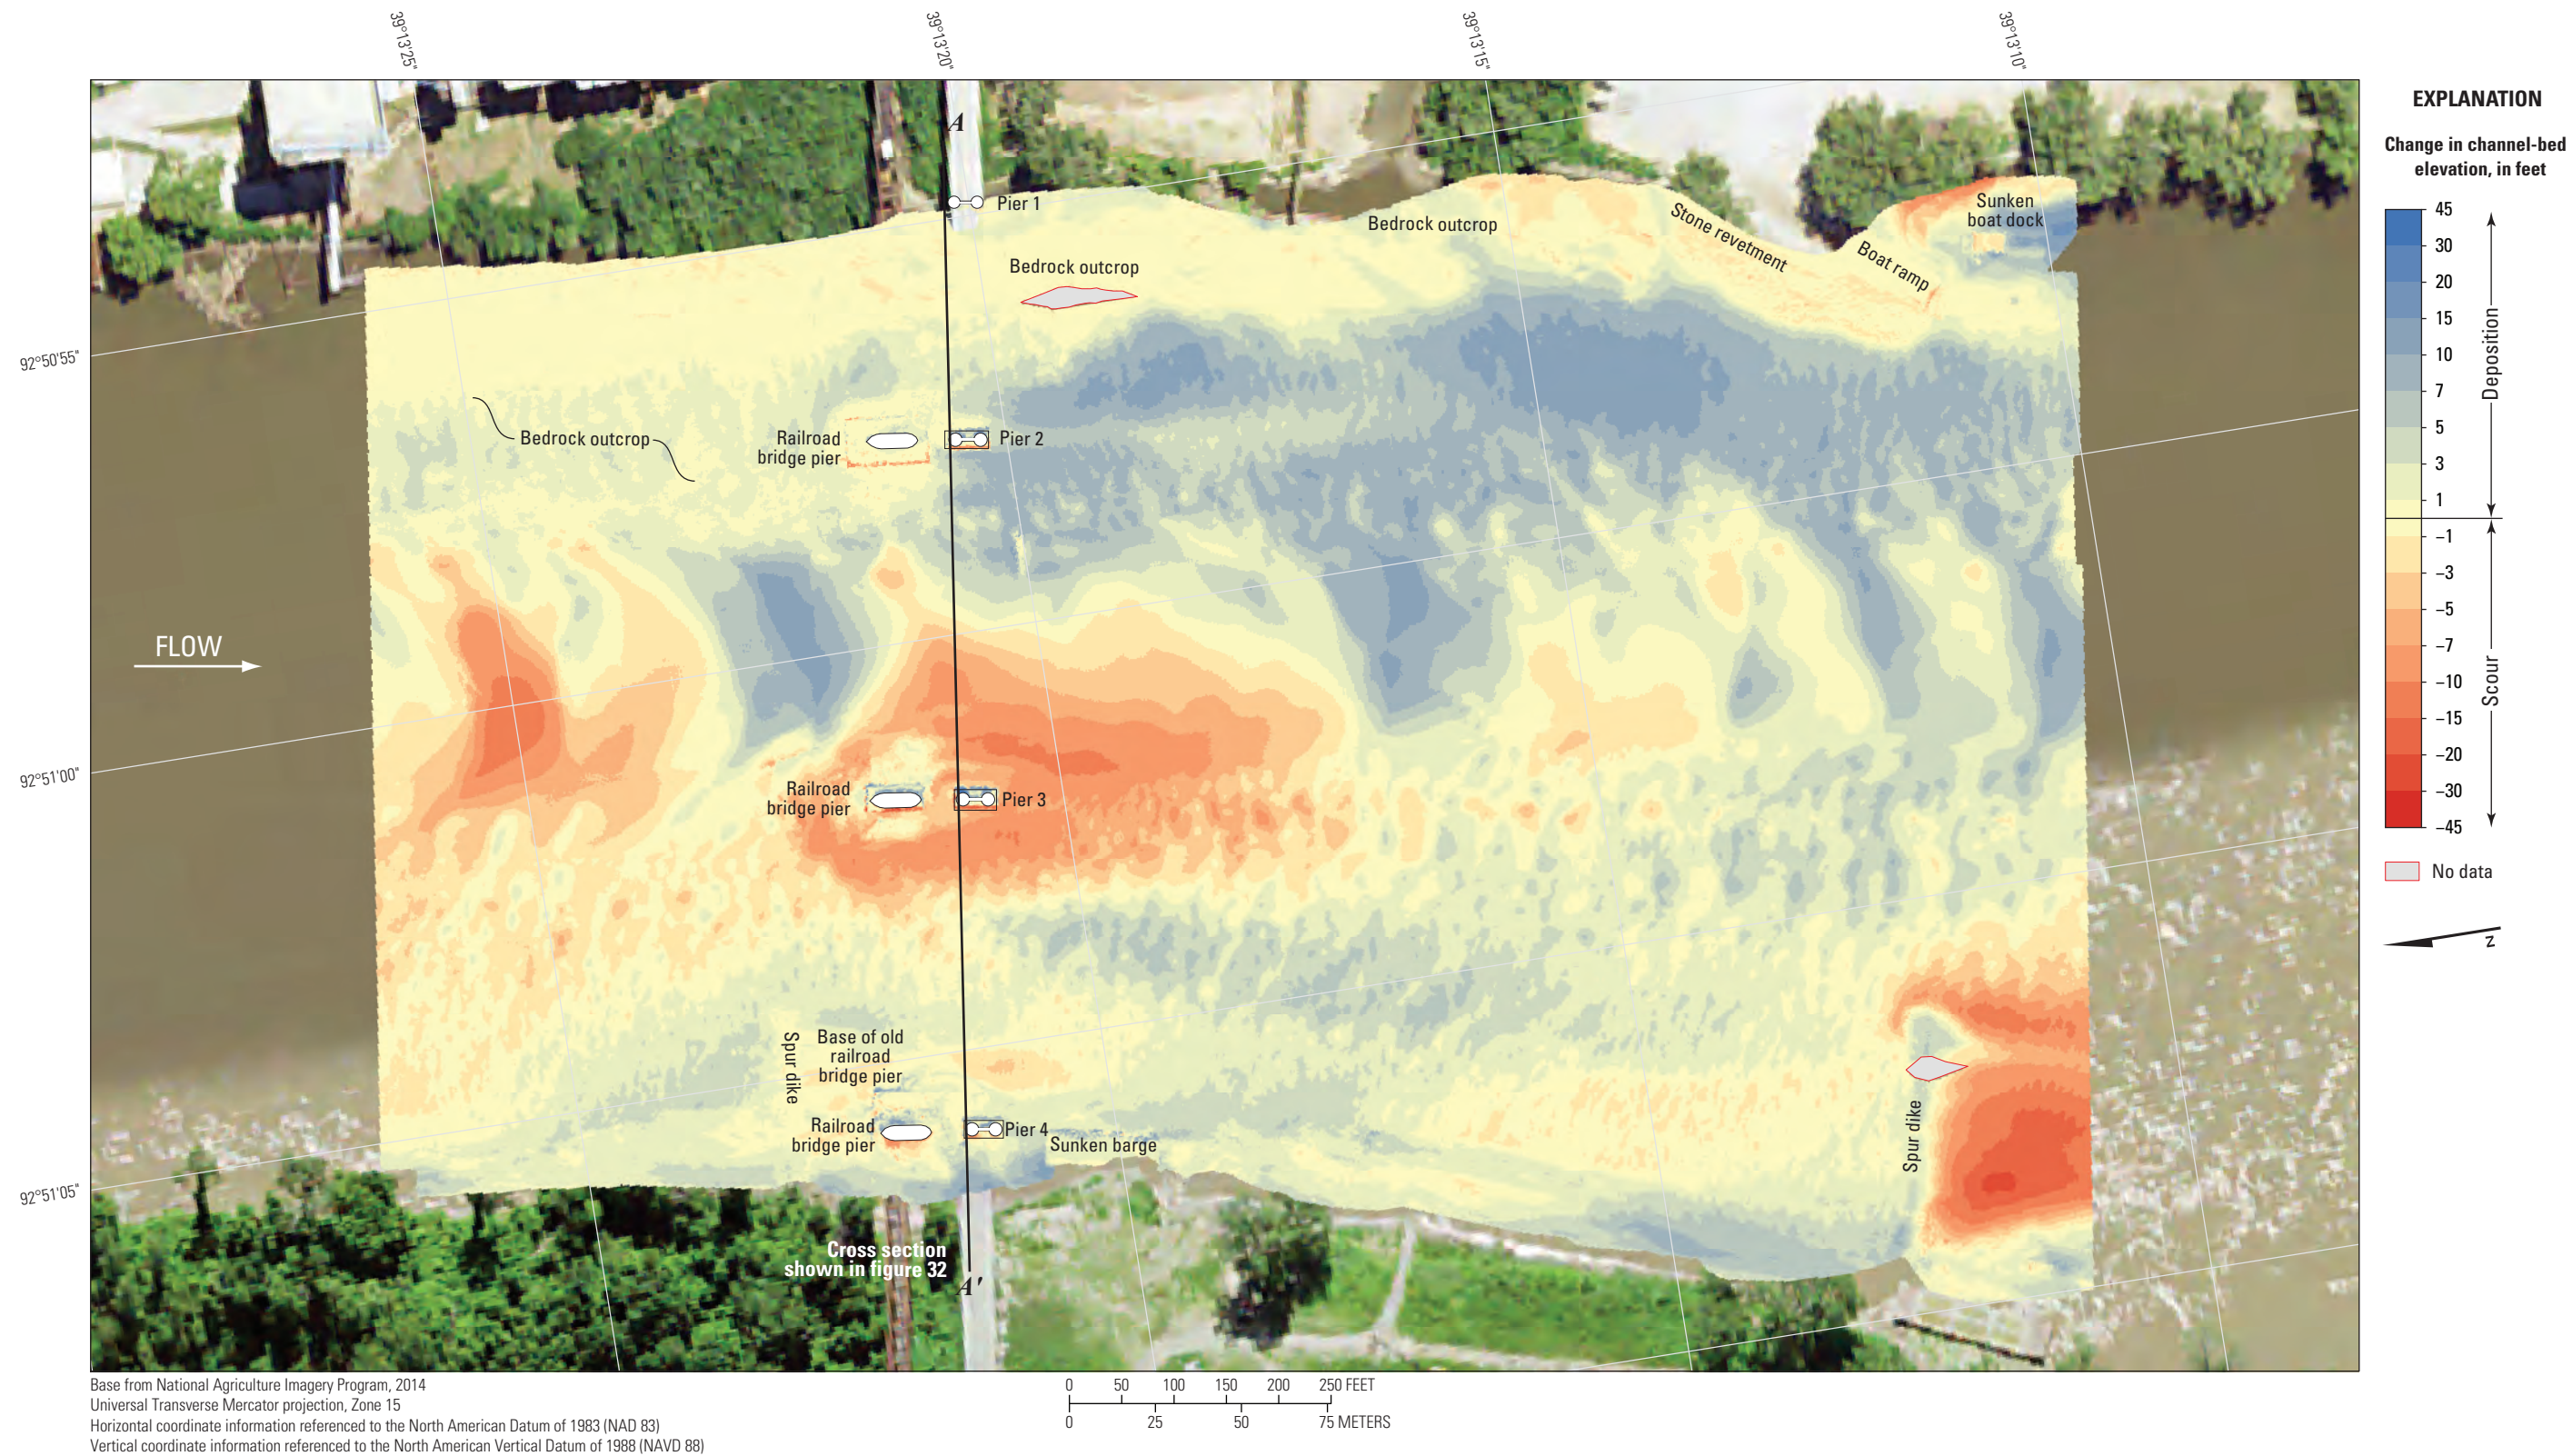
The difference between the survey on May 24, 2017, and the previous flood survey on July 22, 2011 (fig. 34), indicates moderate deposition (an average difference of +1.41 ft between the bathymetric surfaces) throughout the reach between 2011 and 2017 (table 7). The net volume of cut in the reach from 2011 to 2017 was about 55,200 yd³, and the net volume of fill was about 136,600 yd³, resulting in a net gain of about 81,400 yd³ of sediment. There was an area of moderate to substantial scour of more than 15 ft in the upstream middle of the channel, near pier 3, and downstream from the spur dike on the downstream right (west) bank (fig. 34). However, there was substantial deposition of more than 15 ft on the left (east) side of the channel throughout the reach and moderate deposition on the right side of the channel downstream from the bridge. The frequency distribution of bed elevations in 2017 had higher peak percentages and a narrower shape than in 2011, but the cumulative percentage curves for 2017 and 2011 are remarkably similar (fig. 31).

Figure 34. Difference between surfaces created from bathymetric surveys of the Missouri River channel near structure G0069 on Missouri State Highway 240 at Glasgow, Missouri, on May 24, 2017, and July 22, 2011.

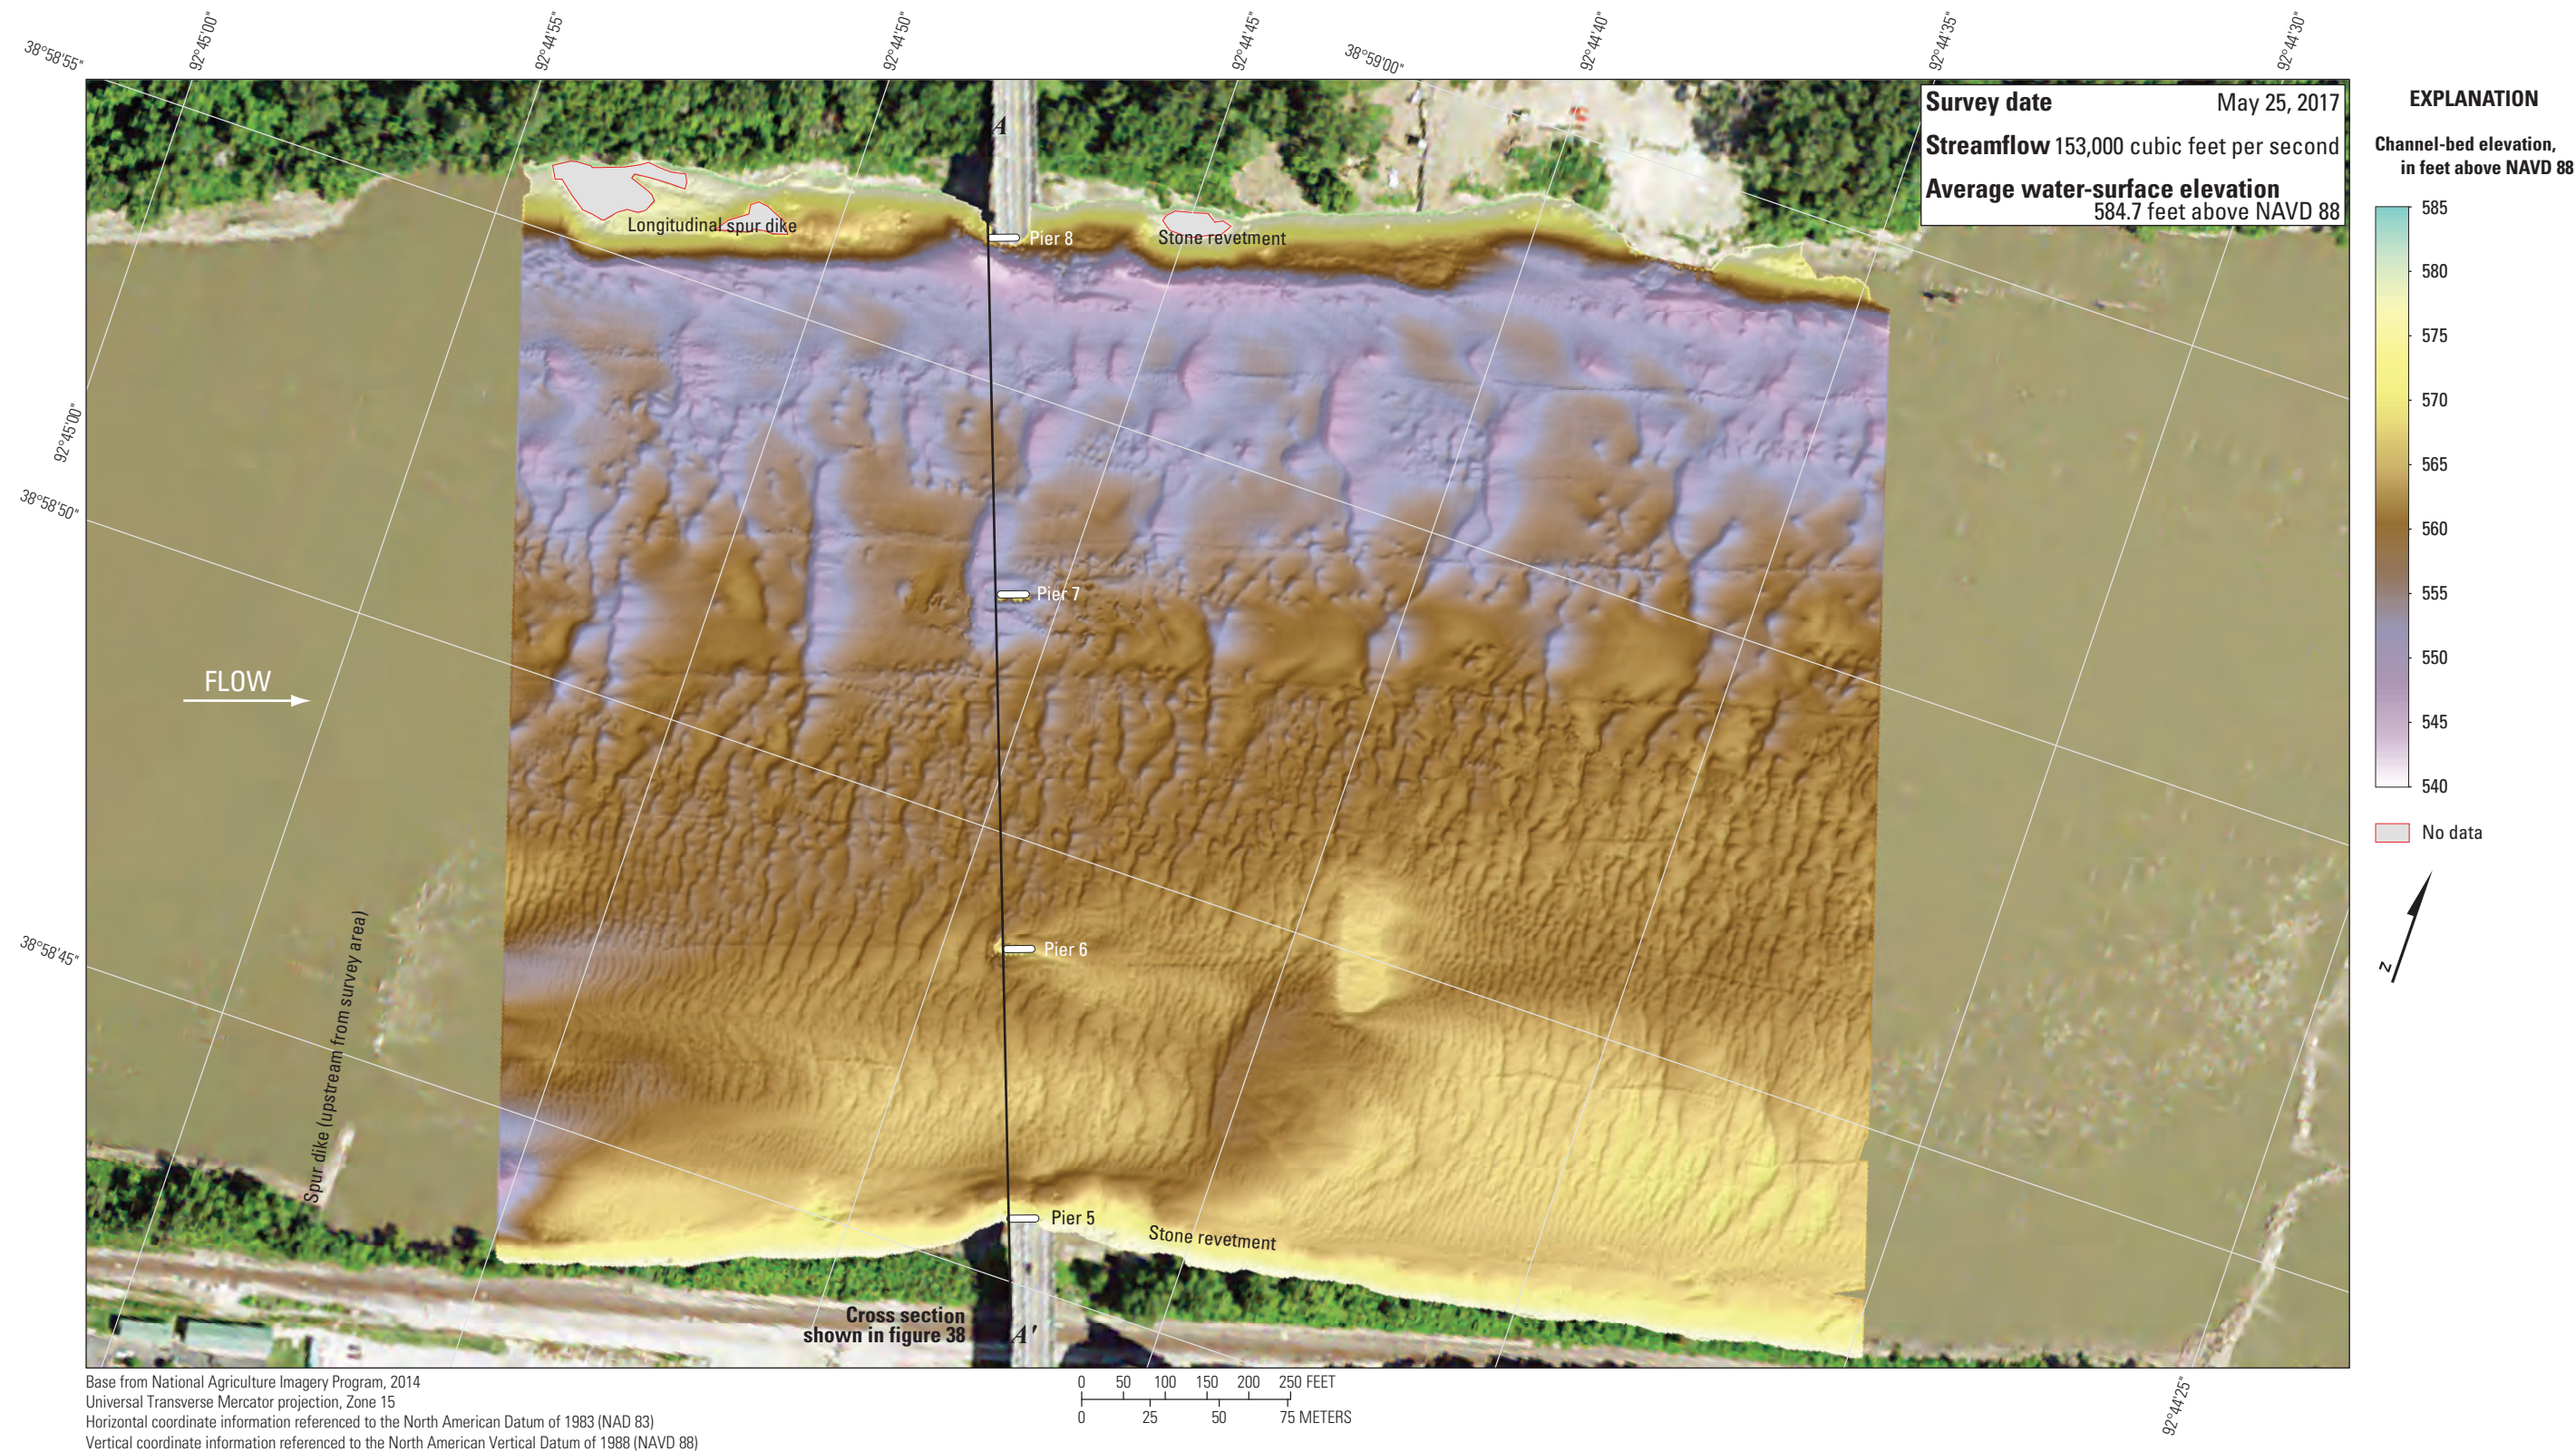
The survey area was about 1,640 ft long and about 1,300 ft wide, extending from bank to bank in the main channel (fig. 36). The upstream end of the survey area was about 620 ft upstream from the centerline of structure A4574 (fig. 36), and piers 5 through 8 were in the water, although piers 5 and 8 were on the extreme edges of the surveyed area (fig. 36). The approximate channel-bed elevations ranged from about 554 to 569 ft for most of the surveyed area (5th to 95th percentile range of the bathymetric data; table 5; fig. 37), reaching a minimum elevation of 547 ft in the channel thalweg along the toe of the left (north) bank (table 5, fig. 36). The well-defined thalweg was present along the left (north) bank throughout the surveyed area and was about 8 to 12 ft deeper than the channel bed in the middle of the channel. Medium dune features with superimposed small dunes and ripples were present in the left (north) side of the channel, and numerous other small dunes and ripples were detected throughout the channel (fig. 36).

Minor scour holes were observed near central main channel piers 6 and 7. Near main channel pier 7 (fig. 36), the scour hole had a minimum channel-bed elevation of about 553 ft

Main channel piers 5 and 8 were along the edges of the surveyed area. Pier 8 is immediately downstream from a longitudinal spur dike and seems to be embedded in the stone revetment along the left bank (fig. 36). A scour hole near the upstream toe of the revetment near the pier reached a minimum channel-bed elevation of about 547 ft (table 6), the minimum of the survey, which is about 20 ft above the elevation of the bottom of the pier seal course of 527.00 ft (fig. 38; table 6). The minimum elevation surveyed near pier 5 was about 560 ft (figs. 36, 38), which is equal to the elevation of bedrock near the pier; pier 5 is founded on a footing on bedrock according to bridge plans (fig. 38; table 6). In modern construction, bridge substructural elements usually are pinned or socketed to bedrock (Brown and others, 2010; American Association of State Highway Transportation Officials, 2012),

Figure 36. Bathymetric survey of the Missouri River channel near structure A4574 on Missouri State Highway 5 at Boonville, Missouri.

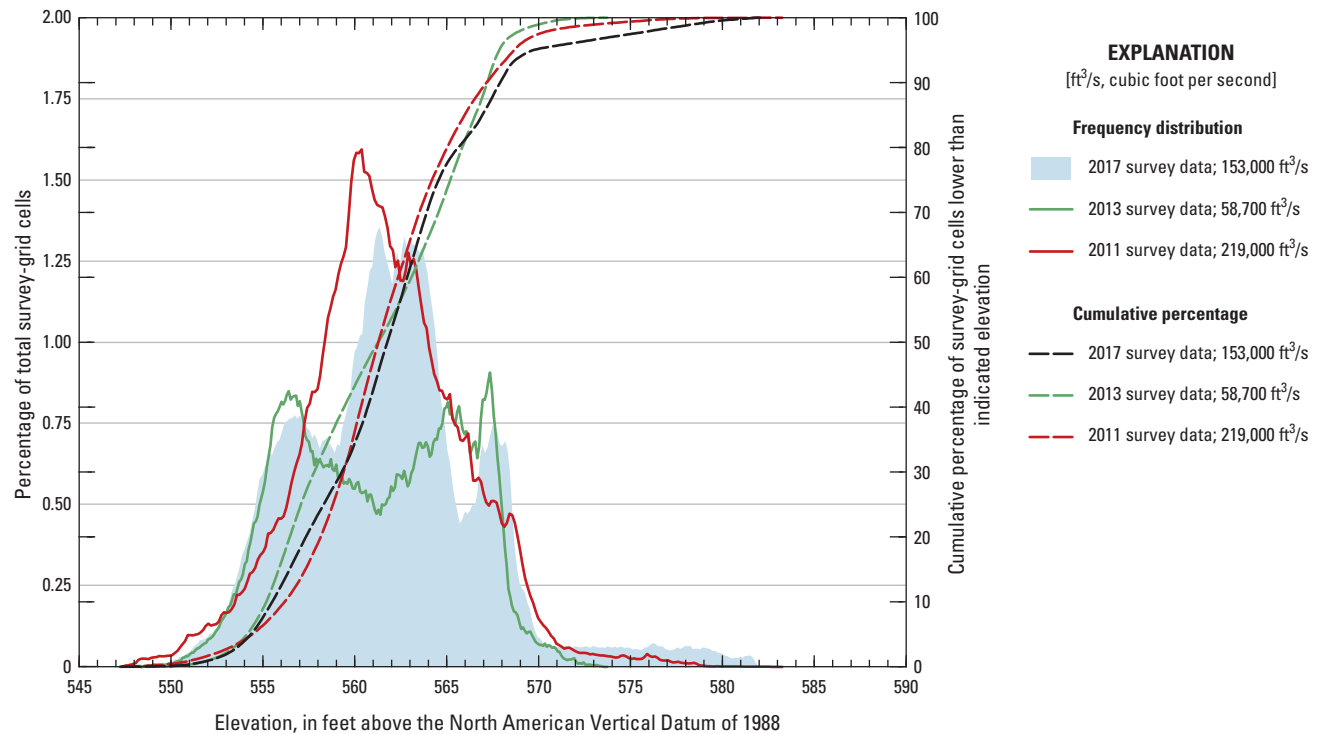
Figure 37. Frequency distribution of bed elevations for bathymetric survey-grid cells on the Missouri River near structure A4574 on Missouri State Highway 5 at Boonville, Missouri, on May 25, 2017, compared to previous surveys.

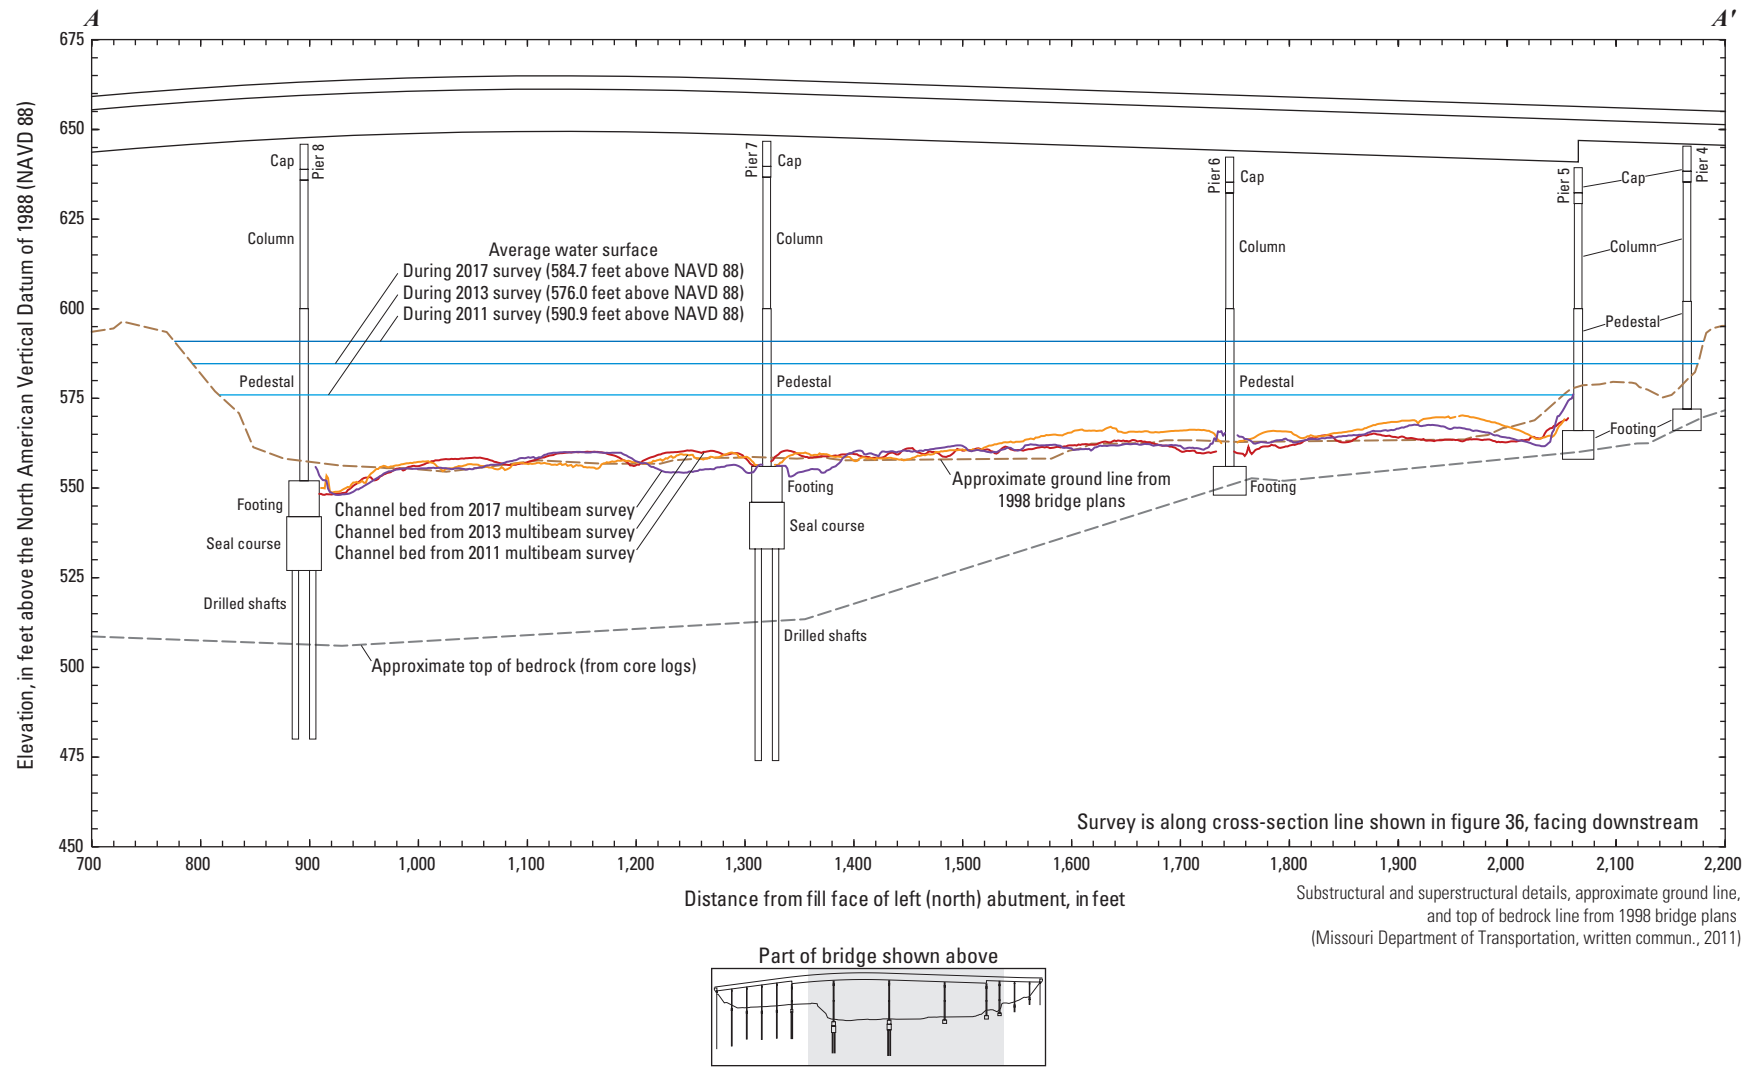
(table 6), about 20 ft above the elevation of the bottom of the pier seal course of 533.00 ft (fig. 38; table 6). The minor scour hole near pier 6 (fig. 36) had a minimum channel-bed elevation of about 560 ft (table 6). Both scour holes were difficult to discern from nearby dunes and ripples, but the upstream edges of the footing of pier 7 were visible during the survey (figs. 36, 38). Information from bridge plans indicates that pier 7 is founded on shafts drilled 39 ft into bedrock, having about 39 ft of bed material between the bottom of the scour hole and bedrock (fig. 38; table 6). Pier 6 is founded on a footing on bedrock, having about 9 ft of bed material between the bottom of the scour hole and bedrock (fig. 38; table 6). The surveyed bed was similar to the two previous multibeam surveys in 2011 and 2013, with the 2017 bed oscillating between the bed in the previous surveys except near pier 7 where the bed was 5 to 7 ft lower in 2017 than in either previous survey (fig. 38).

Figure 38. Key features, substructural and superstructural details, and surveyed channel bed of structure A4574 on Missouri State Highway 5 crossing the Missouri River at Boonville, Missouri.
