Bathymetric and Velocimetric Surveys at Highway Bridges Crossing the Missouri River between Kansas City and St. Louis, Missouri, May 22–31, 2017

Scientific Investigations Report 2020–5018

By Richard J. Huizinga

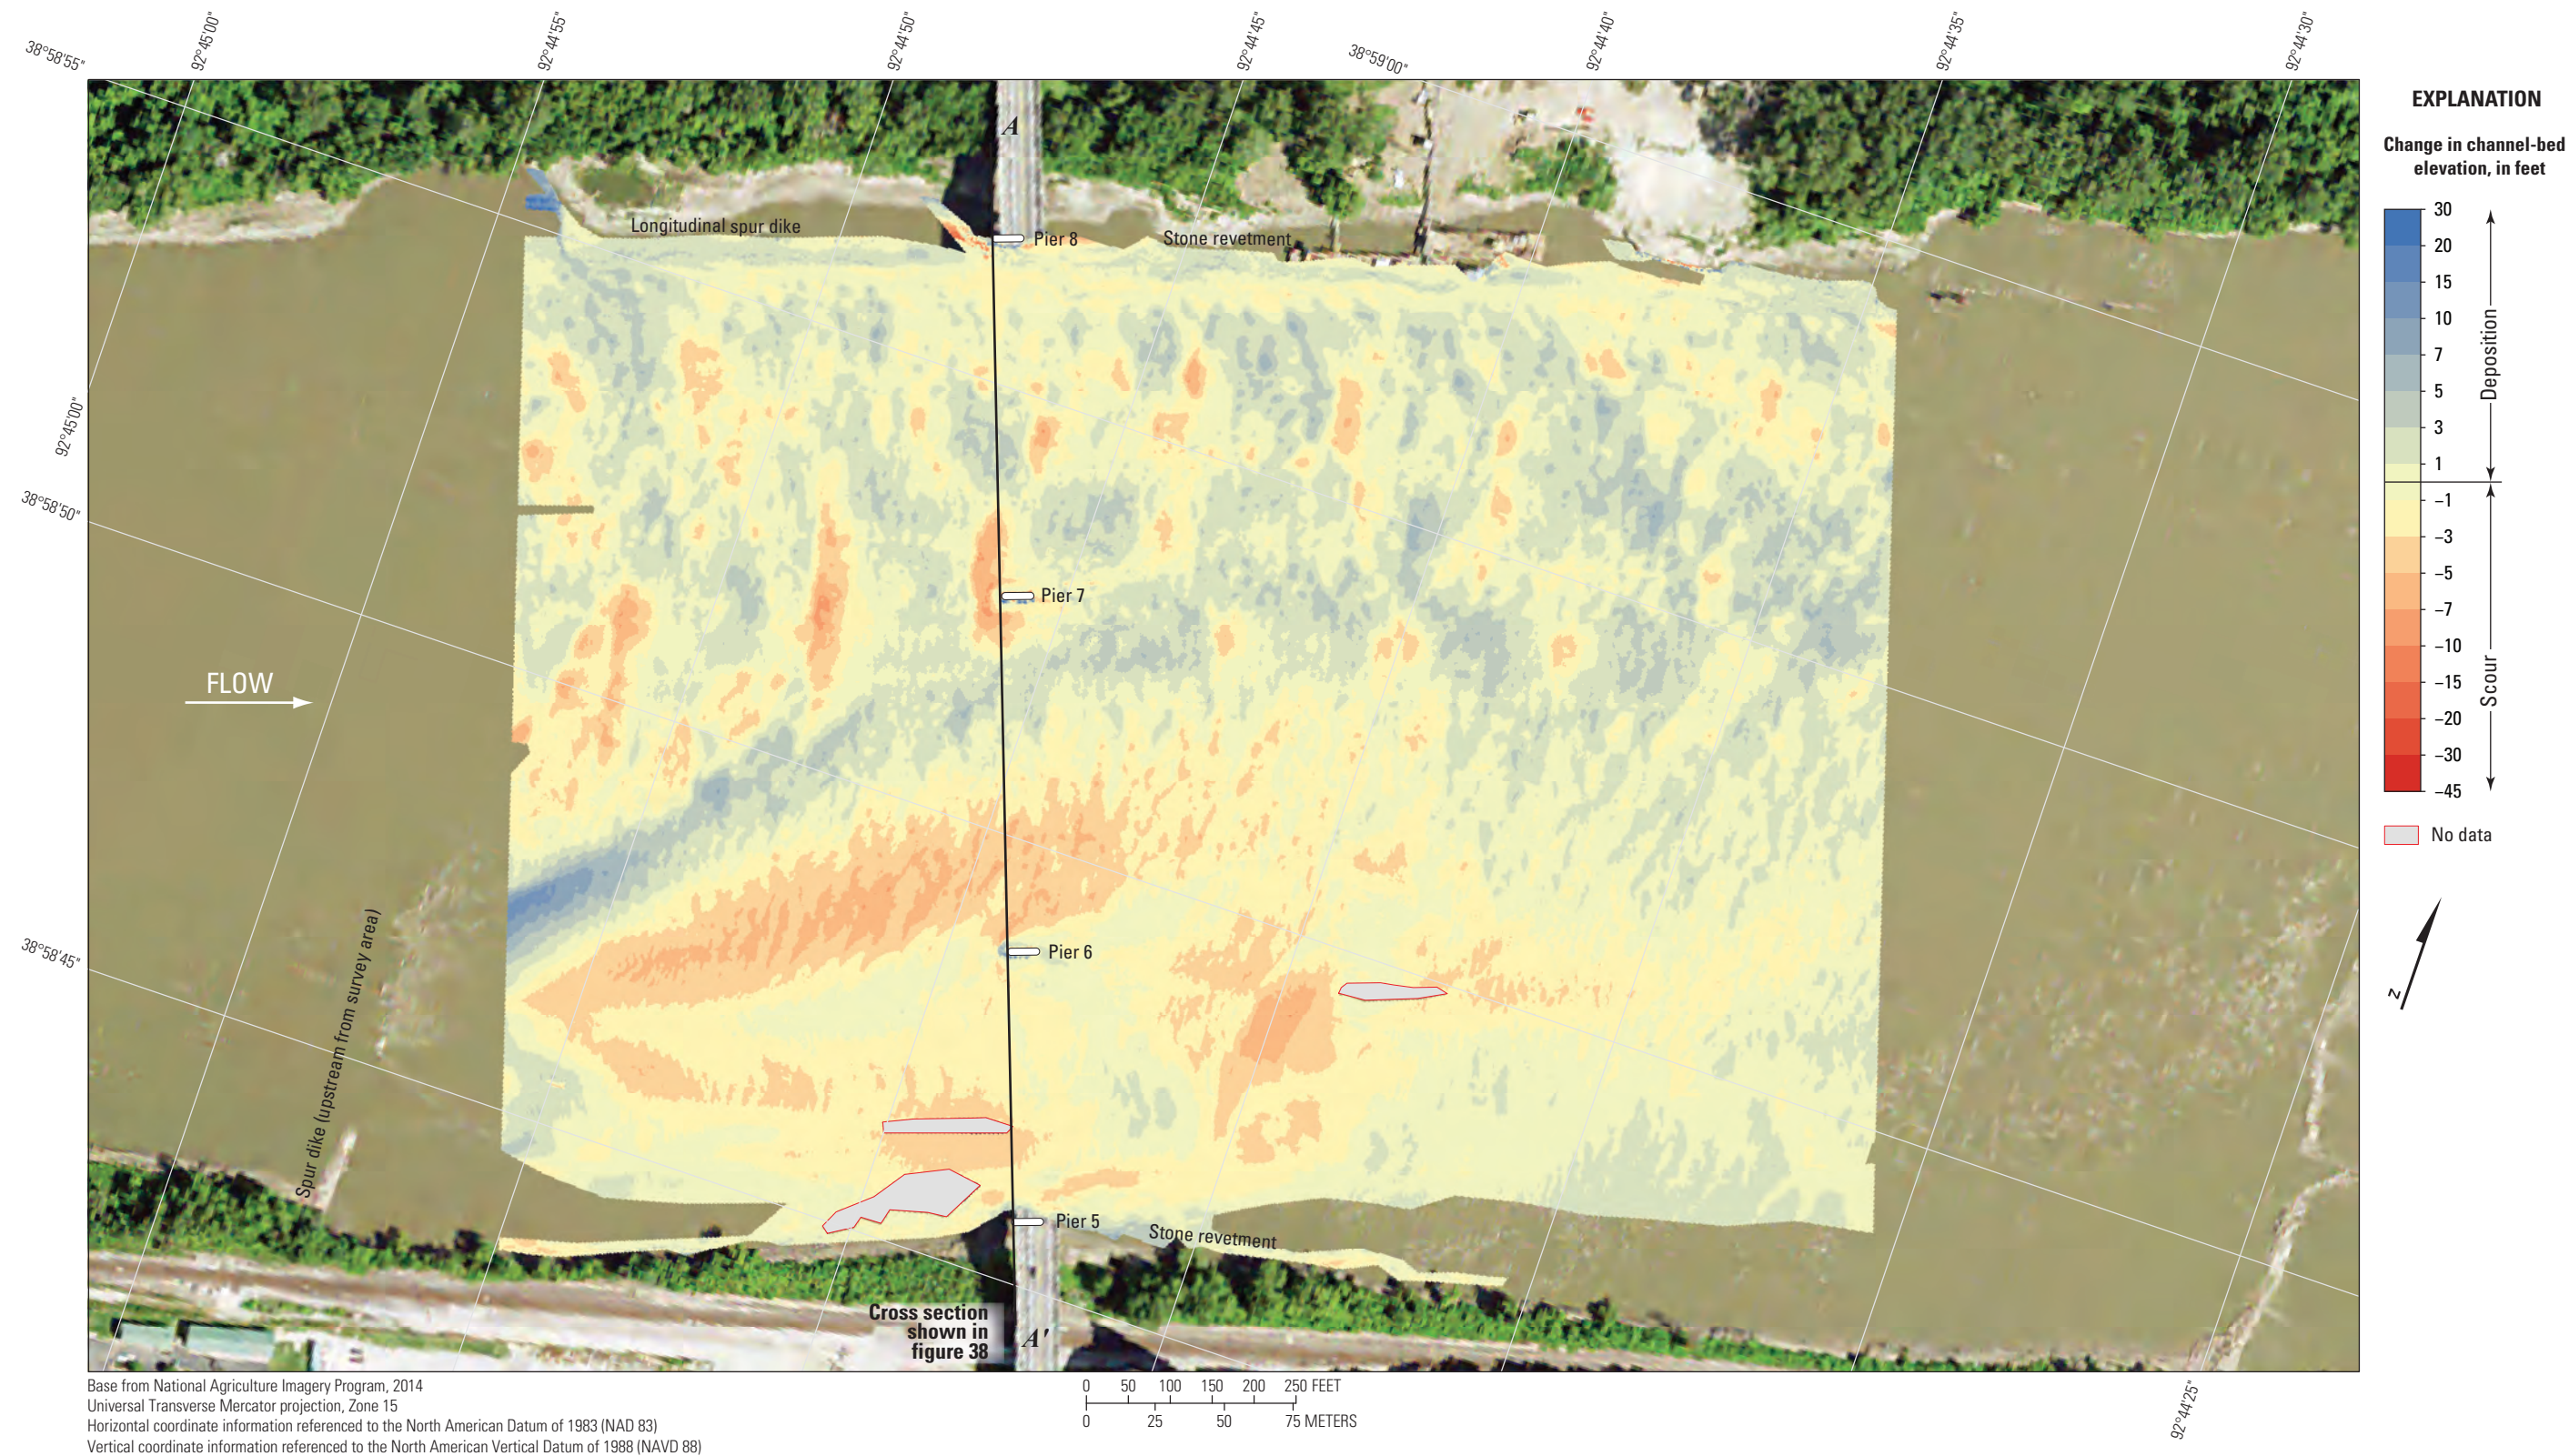
The difference between the survey on May 25, 2017, and the previous nonflood survey on April 29, 2013 (fig. 39), indicates an approximate balance between scour and deposition throughout the reach between 2013 and 2017 (table 7). The net volume of cut in the reach from 2013 to 2017 was about 67,100 yd³, and the net volume of fill was about 54,800 yd³, resulting in a net loss of only about 12,300 yd³ of sediment. Minor to moderate scour of as much as 10 ft is balanced with deposition in the area downstream from the spur dike on the right (south) bank just upstream from the surveyed reach (fig. 39). Scour balanced with deposition is present throughout the left (north) side of the channel as well (fig. 39). The average difference between the April 2013 and May 2017 bathymetric surfaces (−0.18 ft; table 7) indicates essentially zero net change overall, as evident in the difference map (fig. 39). The frequency distributions and cumulative percentage curves were remarkably similar between the various surveys at this site (fig. 37).

Figure 39. Difference between surfaces created from bathymetric surveys of the Missouri River channel near structure A4574 on Missouri State Highway 5 at Boonville, Missouri, on May 25, 2017, and April 29, 2013.

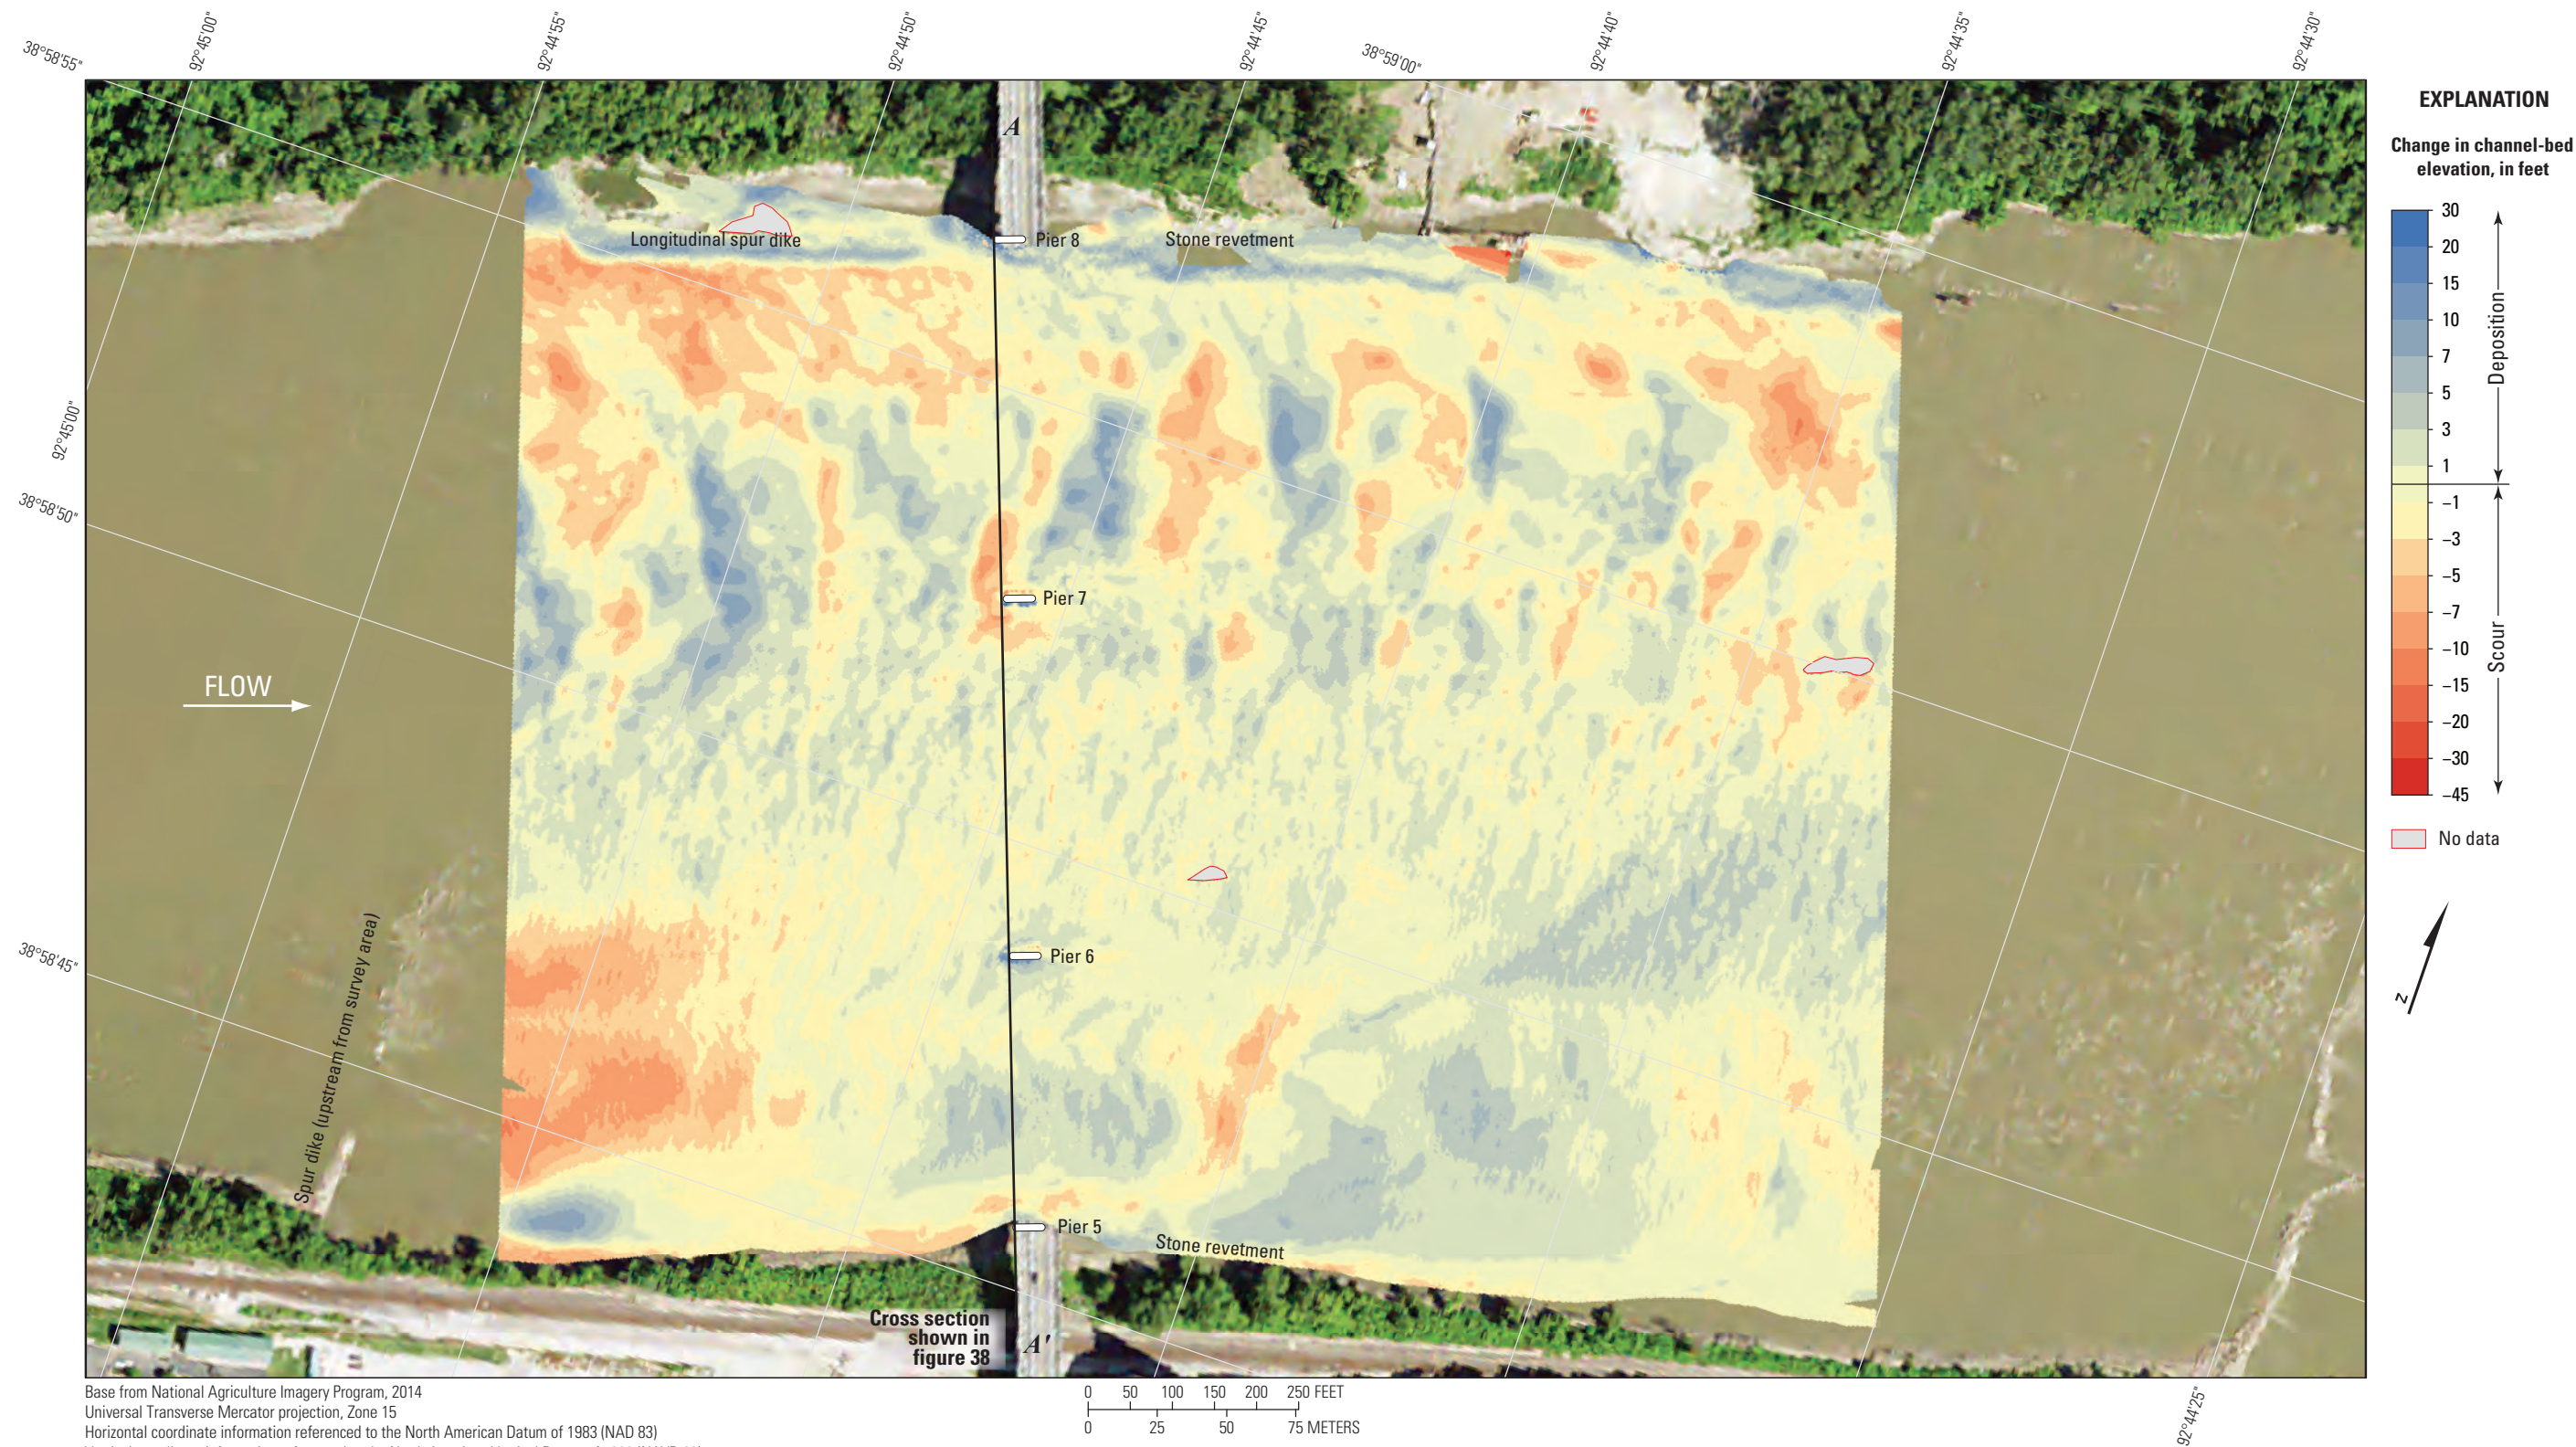
The difference between the survey on May 25, 2017, and the previous flood survey on July 25, 2011 (fig. 40), also indicates an approximate balance between scour and deposition

throughout the reach between 2011 and 2017 (table 7). The net volume of cut in the reach from 2011 to 2017 was about 79,200 yd³, and the net volume of fill was about 76,500 yd³, resulting in a net loss of only about 2,700 yd³ of sediment. Moderate to major scour of as much as 20 ft along the upstream thalweg and in the area downstream from the spur dike on the upstream right (south) bank is balanced with deposition of as much as 15 ft farther downstream (fig. 40). Large dune features present in the thalweg in the 2011 survey were replaced with medium dunes, resulting in an alternating scour/deposition pattern in the thalweg (fig. 40); however, the average difference between the July 2011 and May 2017 bathymetric surfaces was −0.04 ft (table 7), which indicates essentially zero net change overall.

Figure 40. Difference between surfaces created from bathymetric surveys of the Missouri River channel near structure A4574 on Missouri State Highway 5 at Boonville, Missouri, on May 25, 2017, and July 25, 2011.

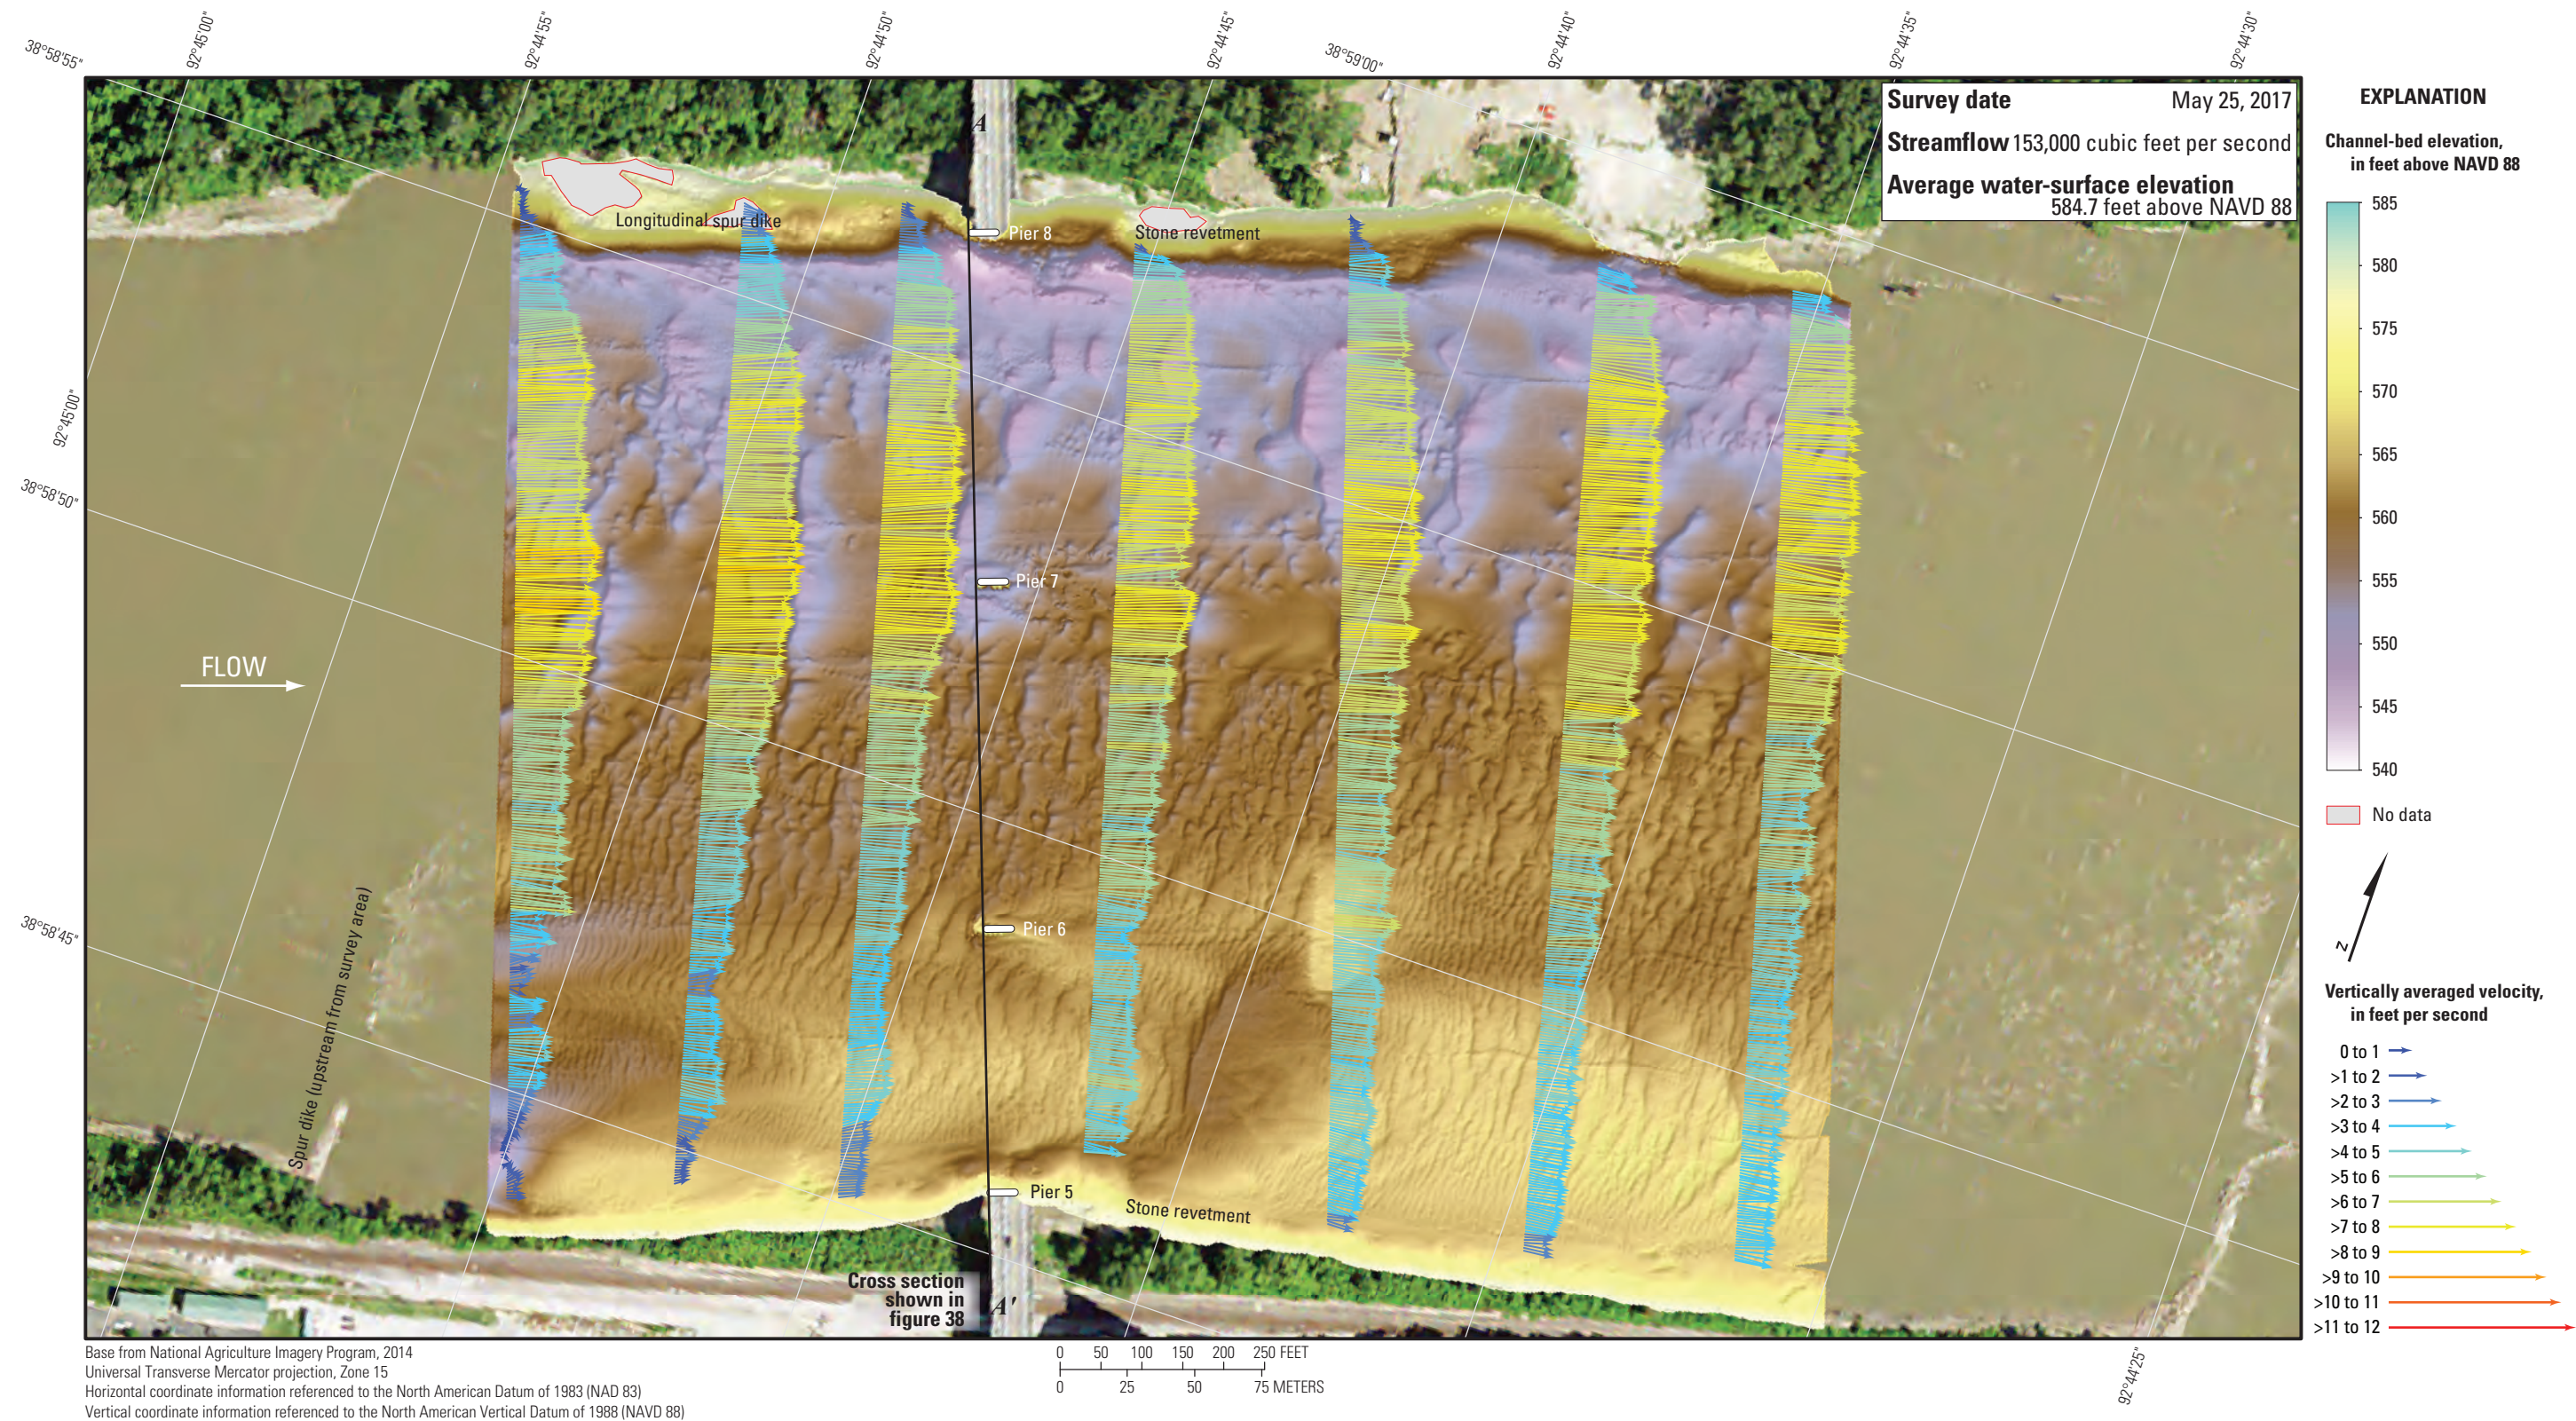
The vertically averaged velocity vectors indicate mostly uniform flow throughout the reach, ranging from about 2 to 8 ft/s (fig. 41). Exceptions to uniform flow include moderate turbulence and flow reversal downstream from the upstream right spur dike and the longitudinal dikes on the left bank (fig. 41). All the piers were aligned with flow, as indicated by little to no turbulence observed downstream that can be directly attributed to the piers (fig. 41).

Figure 41. Bathymetry and vertically averaged velocities of the Missouri River channel near structure A4574 on Missouri State Highway 5 at Boonville, Missouri.

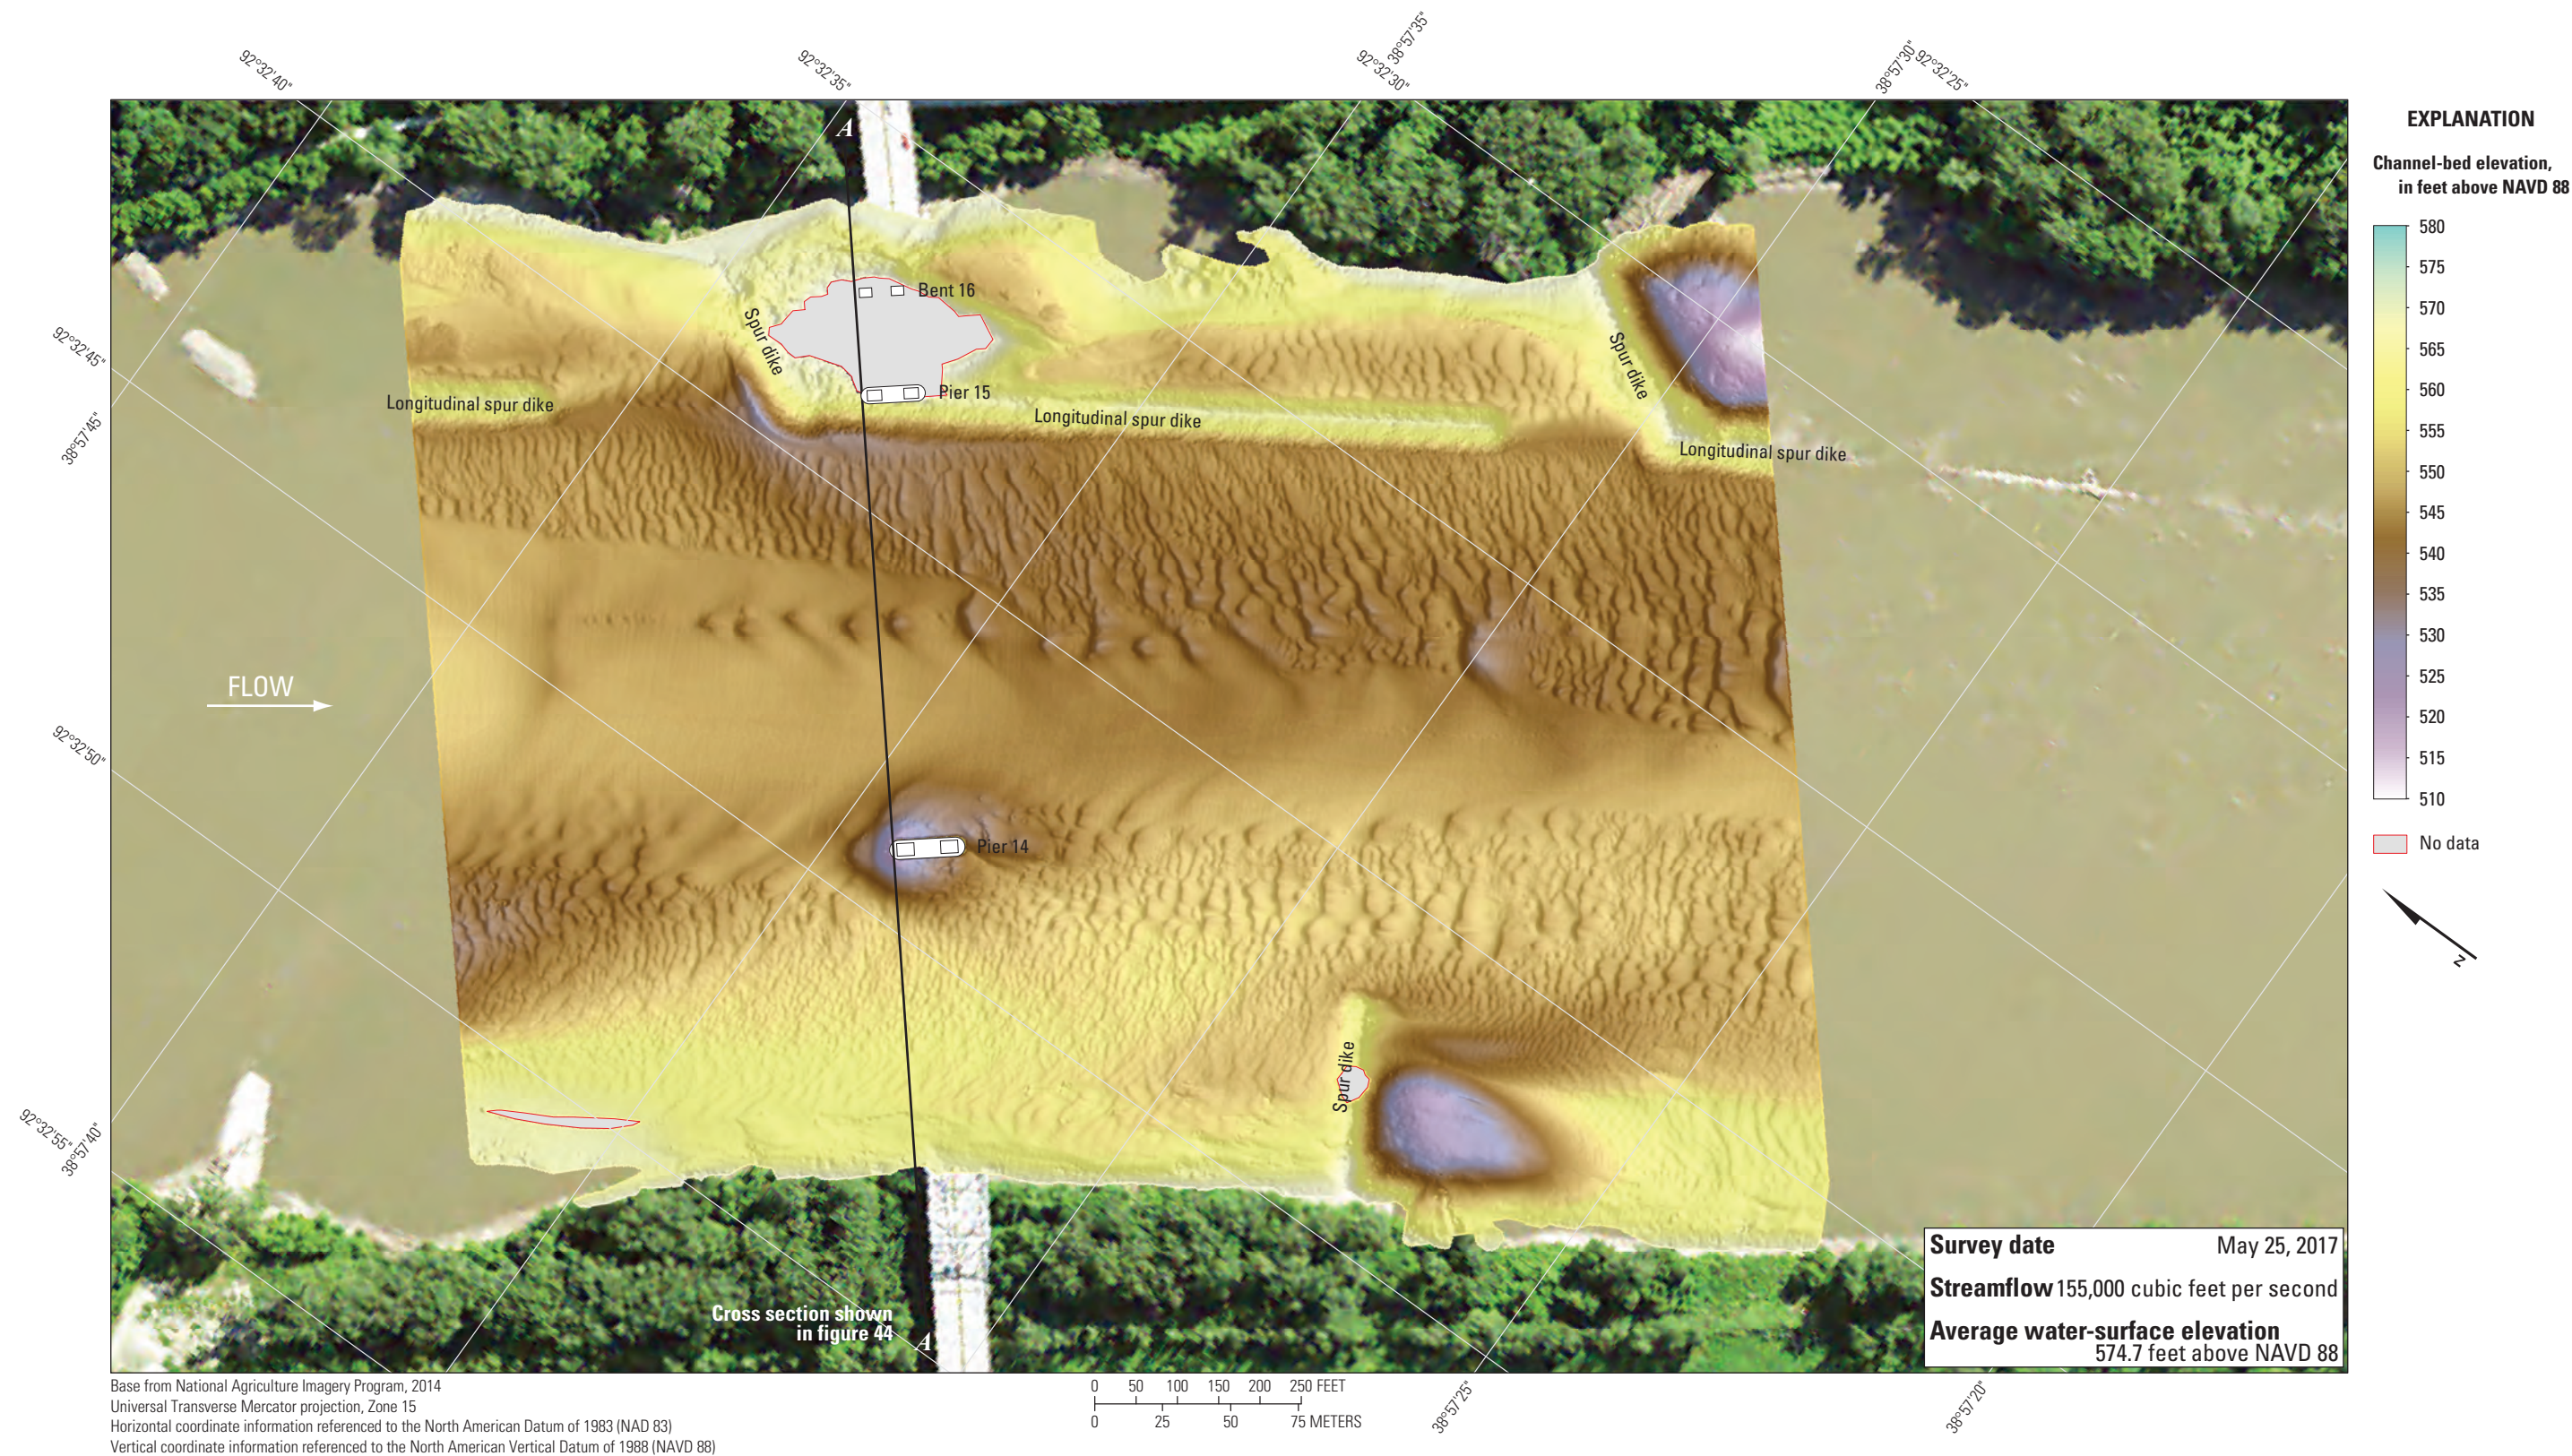
Figure 42. Bathymetric survey of the Missouri River channel near structure L0962 on Interstate 70 near Rocheport, Missouri.

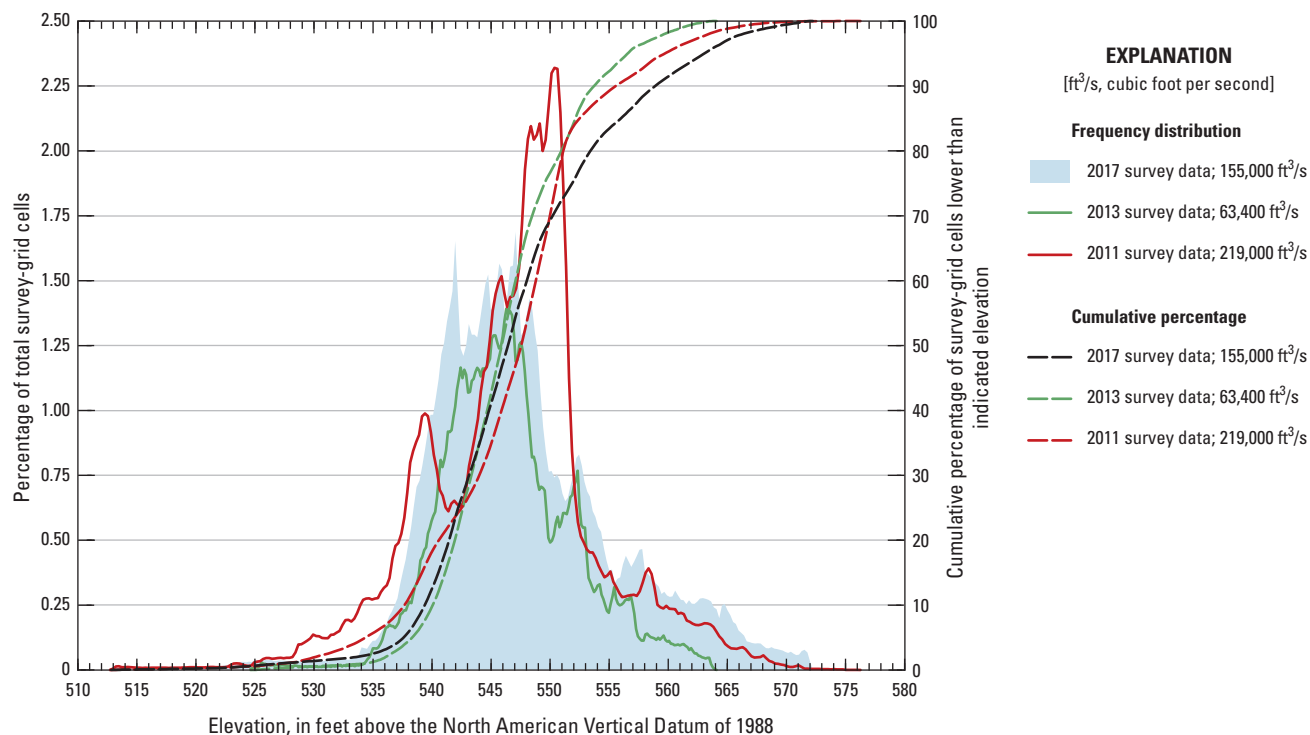
Figure 43. Frequency distribution of bed elevations for bathymetric survey-grid cells on the Missouri River near structure L0962 on Interstate 70 near Rocheport, Missouri, on May 25, 2017, compared to previous surveys.

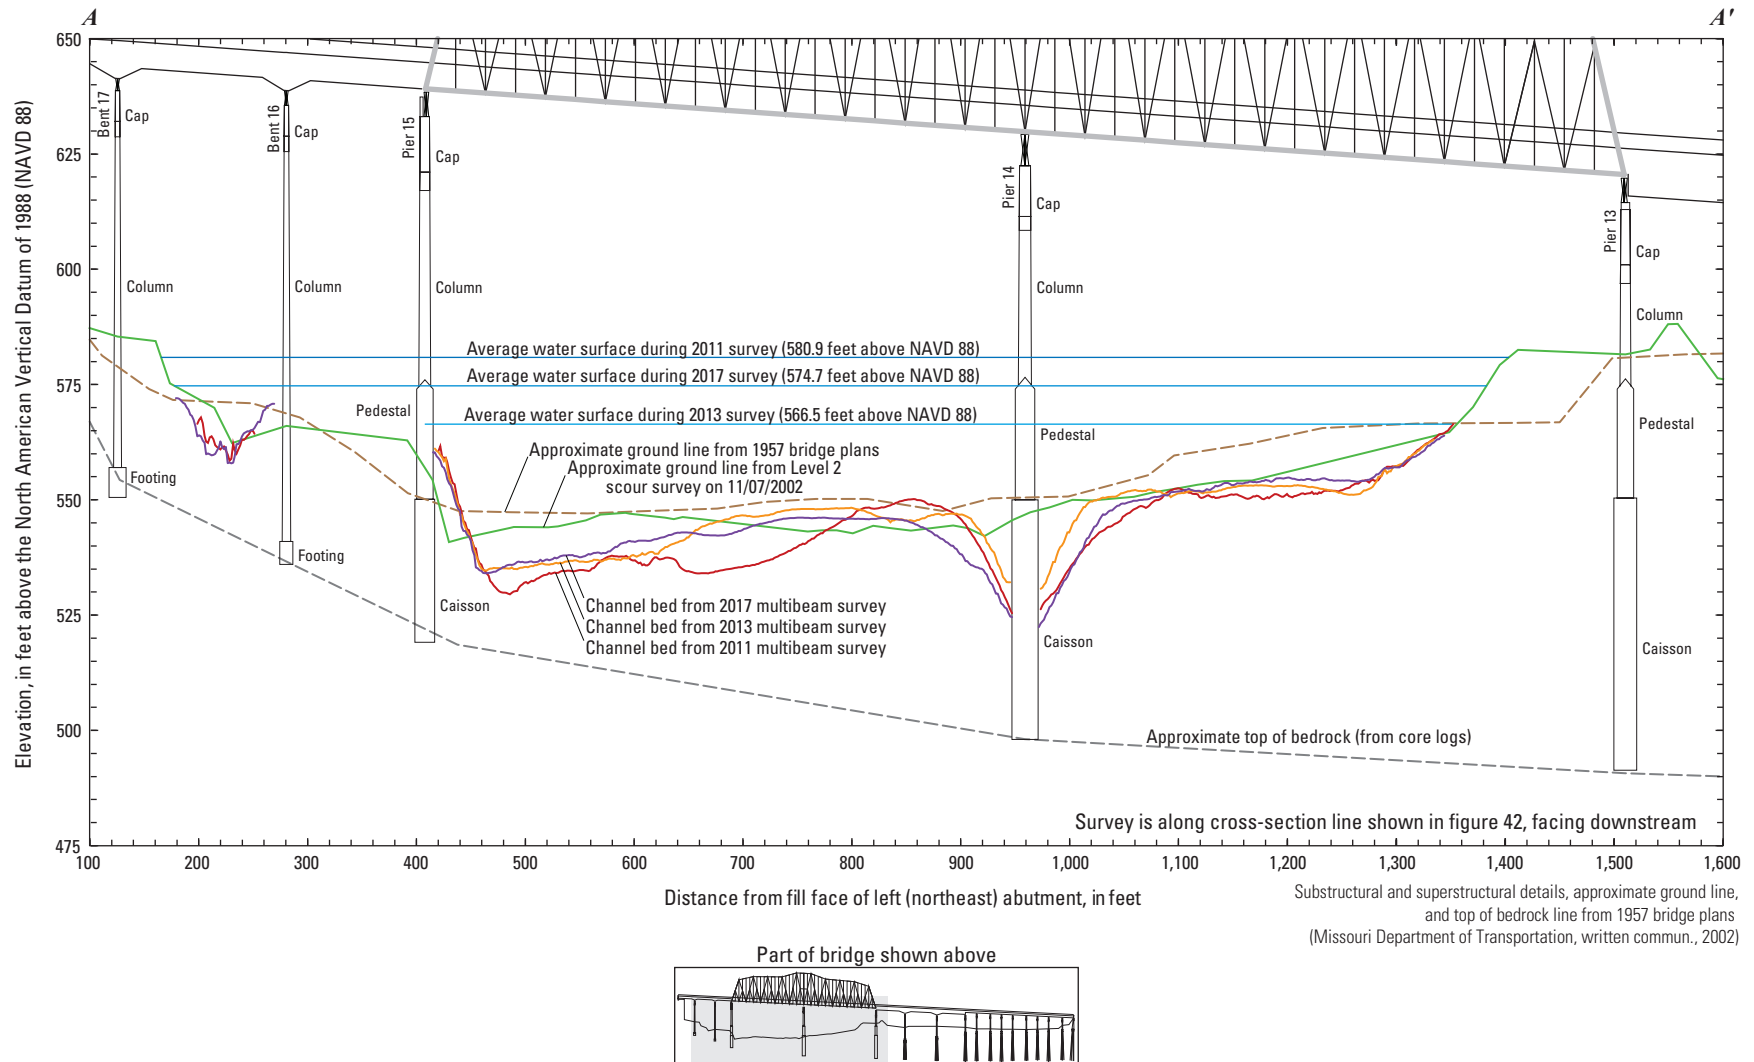
elevation upstream from the bridge (fig. 44; table 6). Information from bridge plans indicates that pier 14 is founded on a caisson on bedrock, having about 24 ft of bed material between the bottom of the scour hole and bedrock (fig. 44; table 6). Pier 15 is embedded in the longitudinal spur dike, and the minimum channel elevation at the toe of the dike near the pier was about 534 ft (figs. 42, 44; table 6). Pier 15 also is founded on a caisson on bedrock, having about 15 ft of material between the minimum channel elevation and bedrock (fig. 44; table 6); however, the rock of the spur dike will limit or prevent a local scour hole near pier 15. Bent 16 was completely surrounded by an island, resulting from a persistent debris raft between pier 15 and bent 16 downstream from the lateral part of the spur dike near those piers/bents (fig. 42). The surveyed bed generally was higher than the previous multibeam survey in 2011, with 15 to 20 ft of deposition in the middle, between piers 14 and 15, and about 5 to 10 ft of deposition between pier 14 and the right bank (fig. 44).

cross section from the 2017 survey is generally similar to the 2013 survey, except near pier 14 where the 2017 survey section is below the 2011 survey (fig. 44). The frequency distribution of bed elevations in 2017 was similar to but wider than in 2013, with a higher percentage of survey-grid cells at higher elevations than in 2013 because of the higher water-surface elevation (fig. 44). Minor scour indicated along the longitudinal spur dikes on the left (northeast) bank may be the result of minor positional variations between the surveys (figs. 44, 45). As with all difference maps presented in this report, substantial deposition or scour apparent at the faces of the piers results from minor horizontal positional variances between the surveys (see the “Uncertainty Estimation” section).

(fig. 46). The cross section from the 2017 survey is generally similar to the 2011 survey between pier 14 and the right (southwest) bank, but the cross sections alternate as to which is at a higher elevation between piers 14 and 15 (fig. 44). The frequency distribution of bed elevations in 2011 was different from both 2013 and 2017, with a substantially higher percentage of survey-grid cells at elevations between 545 and 555 ft (fig. 44). Minor scour was again indicated along the longitudinal spur dikes on the left (northeast) bank (figs. 44, 46) but may be the result of minor positional variations between the surveys. As with all difference maps presented in this report, substantial deposition or scour apparent at the faces of the piers results from minor horizontal positional variances between the surveys (see the “Uncertainty Estimation” section).

Figure 44. Key features, substructural and superstructural details, and surveyed channel bed of structure L0962 on Interstate 70 crossing the Missouri River near Rocheport, Missouri.
