Bathymetric and Velocimetric Surveys at Highway Bridges Crossing the Missouri River between Kansas City and St. Louis, Missouri, May 22–31, 2017

Scientific Investigations Report 2020–5018

By Richard J. Huizinga

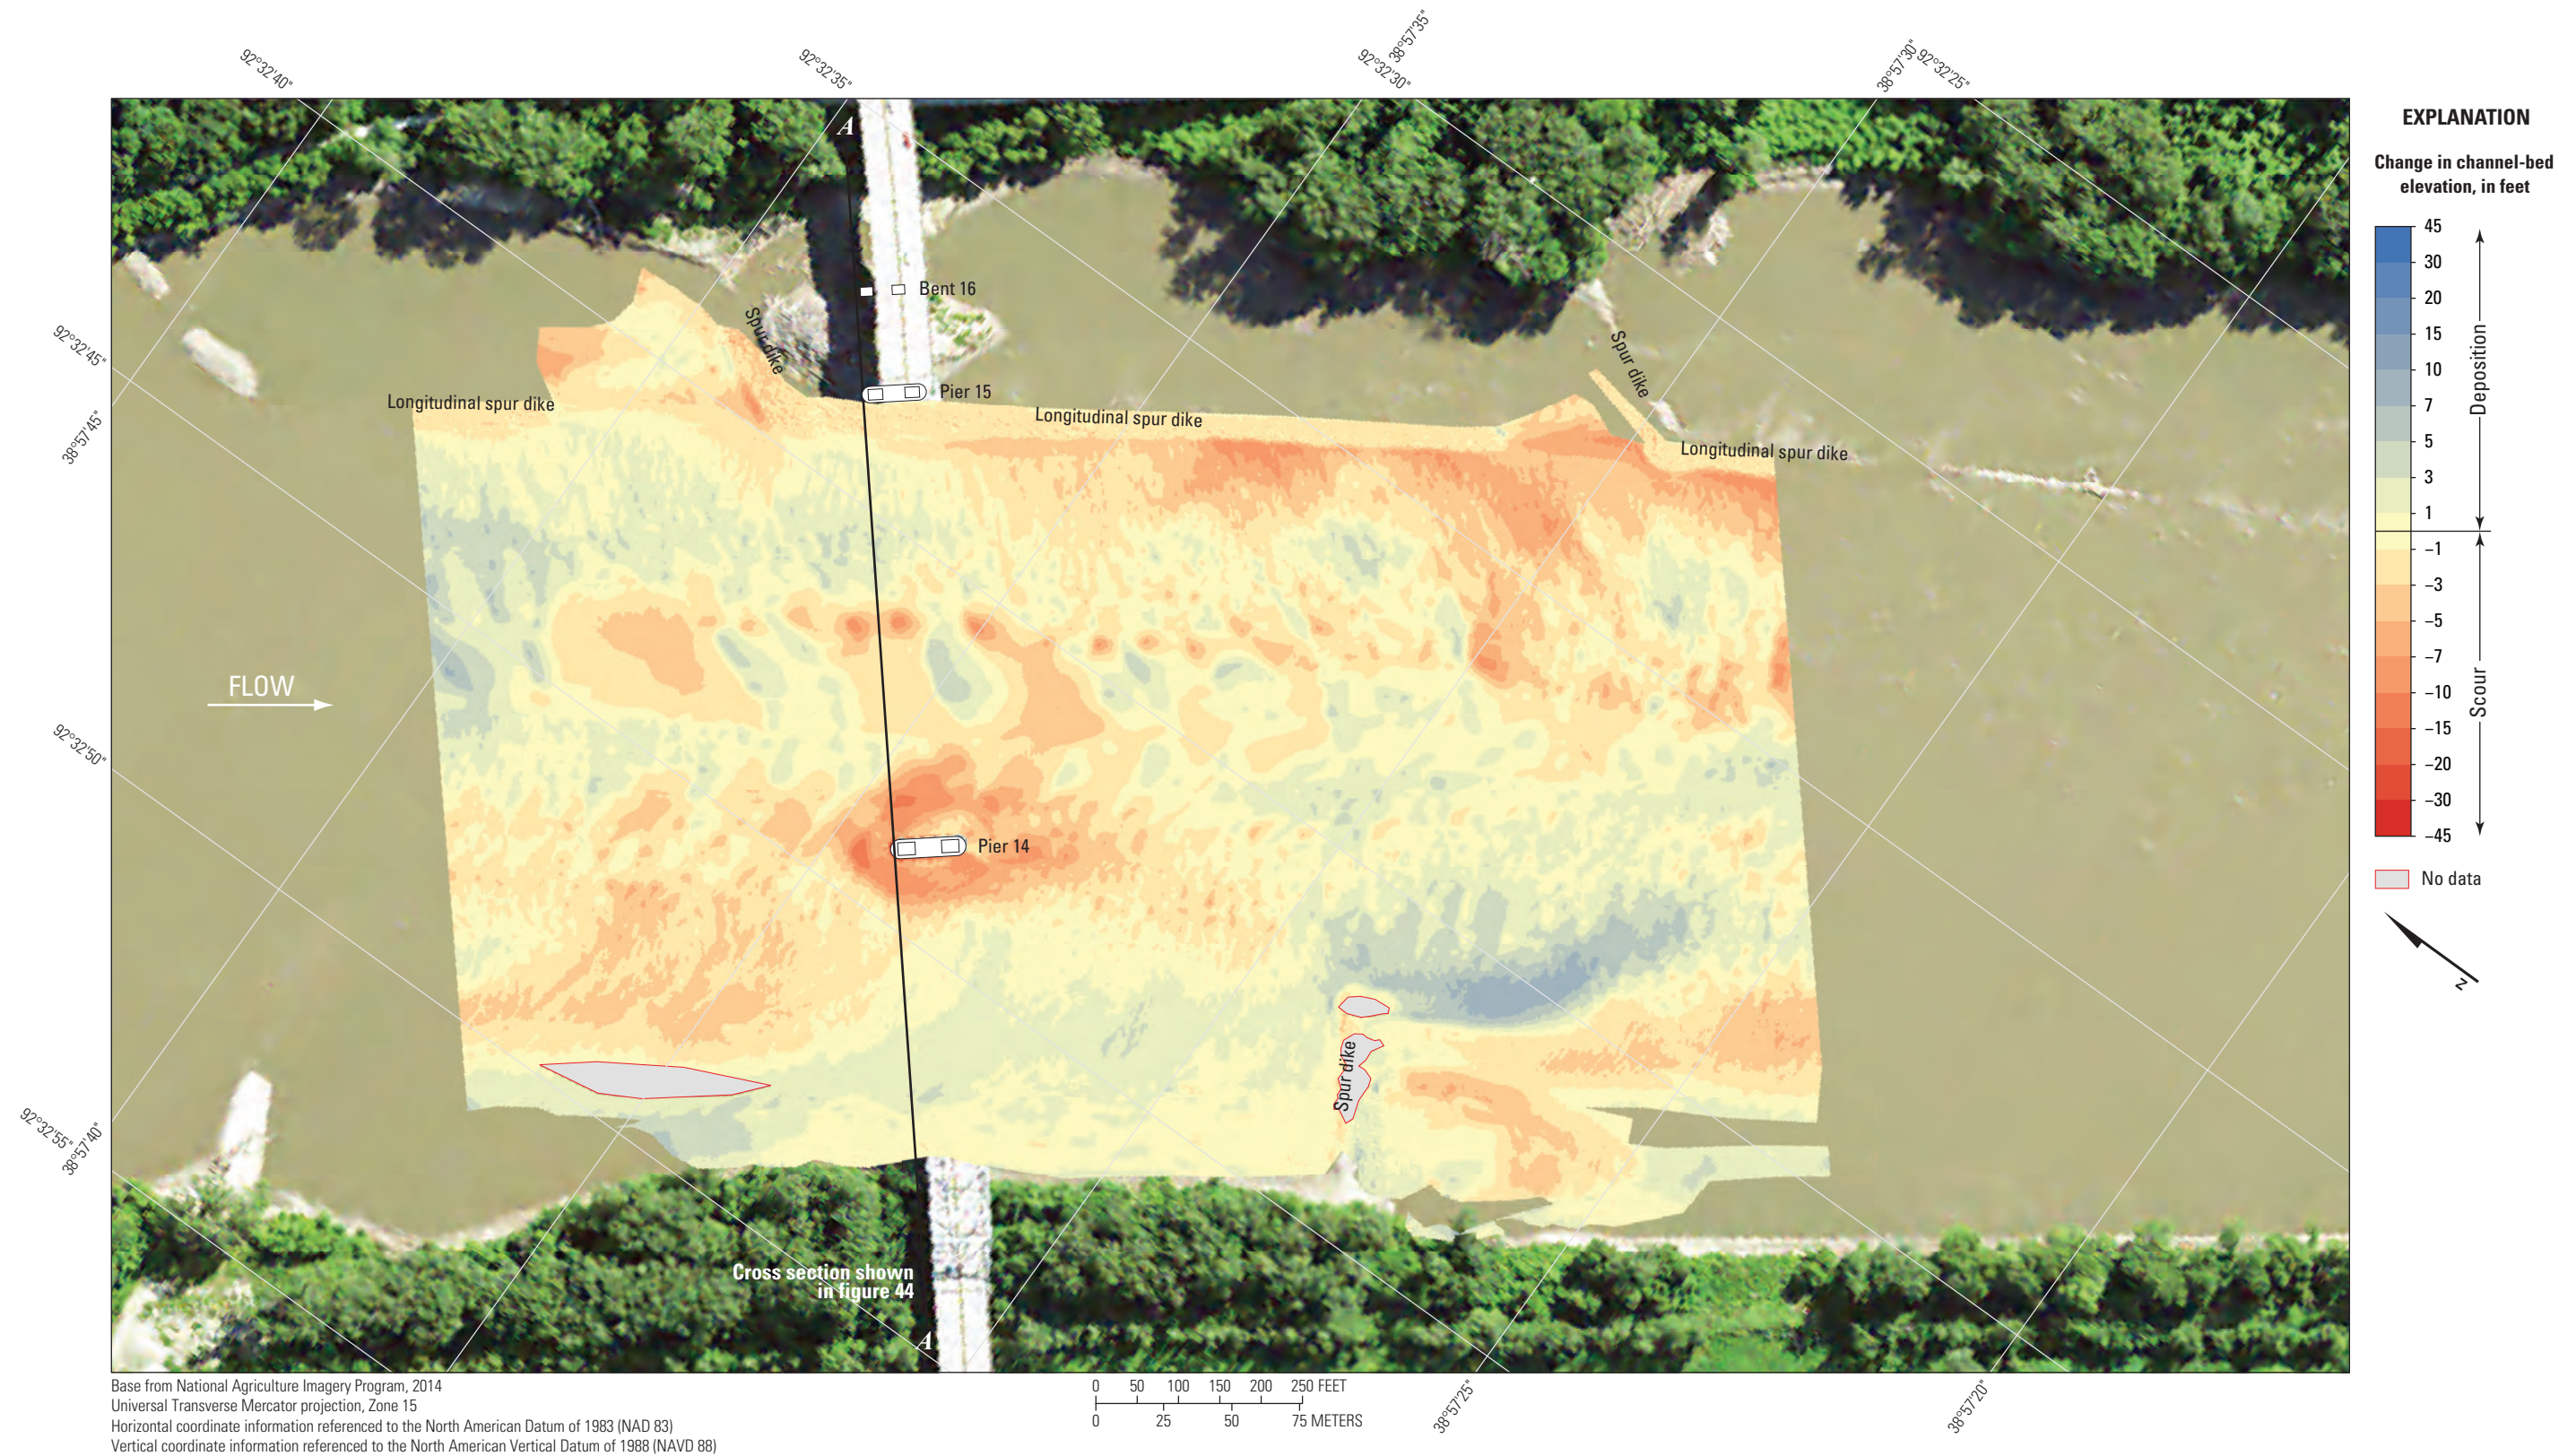
The difference between the survey on May 25, 2017, and the previous nonflood survey on April 29, 2013 (fig. 45), indicates an approximate balance of scour and deposition throughout the reach between 2013 and 2017; however, the average difference of -0.56 ft between the bathymetric surfaces indicates minor scour between the surveys (table 7). The net volume of cut in the reach from 2013 to 2017 was about 72,500 yd³, and the net volume of fill was about 40,700 yd³, resulting in a net loss of about 31,800 yd³ of sediment between 2013 and 2017. There was minor to moderate deposition of as much as 10 ft in the upstream left part of the channel and downstream from the spur dike on the right (southwest) part of the channel downstream from the bridge (fig. 45); however, moderate to substantial scour of as much as 15 ft was observed near pier 14 and along the toe of the longitudinal spur dikes along the left (northeast) side of the channel (fig. 45). The

Figure 45. Difference between surfaces created from bathymetric surveys of the Missouri River channel near structure L0962 on Interstate 70 near Rocheport, Missouri, on May 25, 2017, and April 29, 2013.

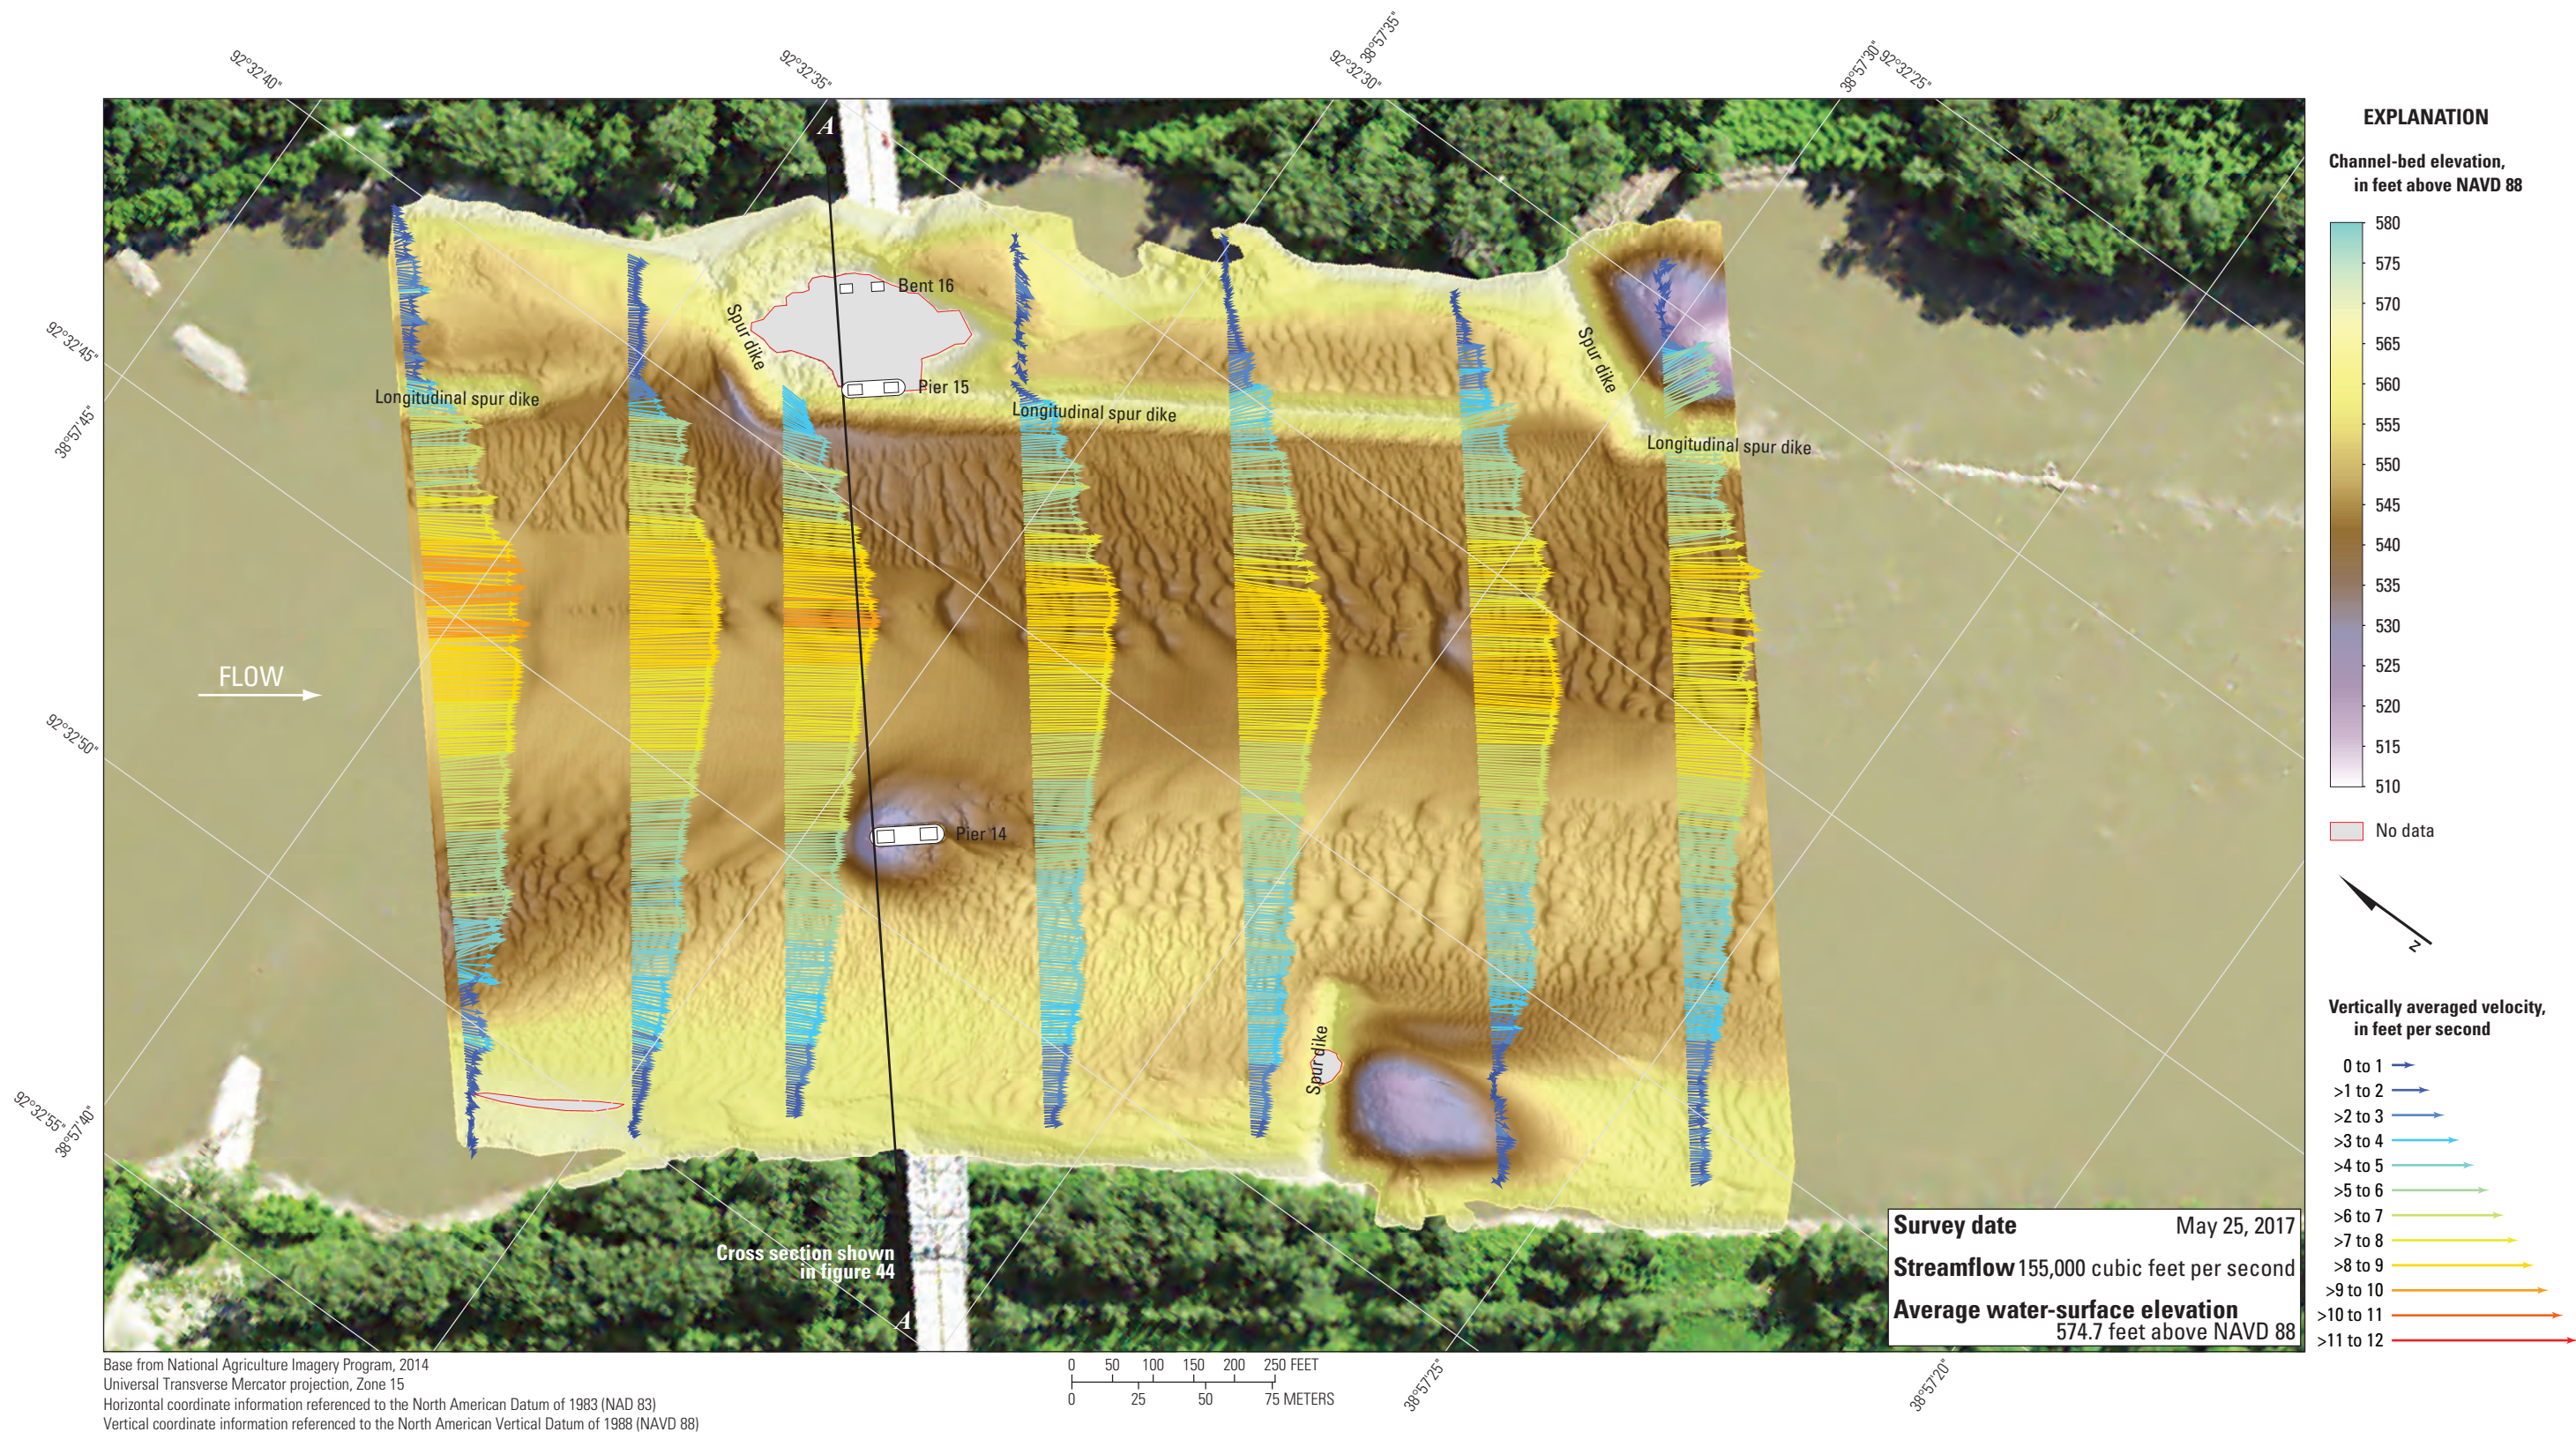
The vertically averaged velocity vectors indicate mostly uniform flow throughout the reach, ranging from about 1 to 10 ft/s (fig. 47), with locally lower velocities and flow reversal along the banks, particularly downstream from the various spur dikes in the reach (fig. 47). Pier 14 was mostly aligned with flow, causing minimal turbulence downstream (fig. 47); however, flow approached pier 14 from the left side, causing an asymmetric scour hole that is longer and slightly deeper on the left side, similar to observations from previous surveys (fig. 47).

Figure 47. Bathymetry and vertically averaged velocities of the Missouri River channel near structure L0962 on Interstate 70 near Rocheport, Missouri.

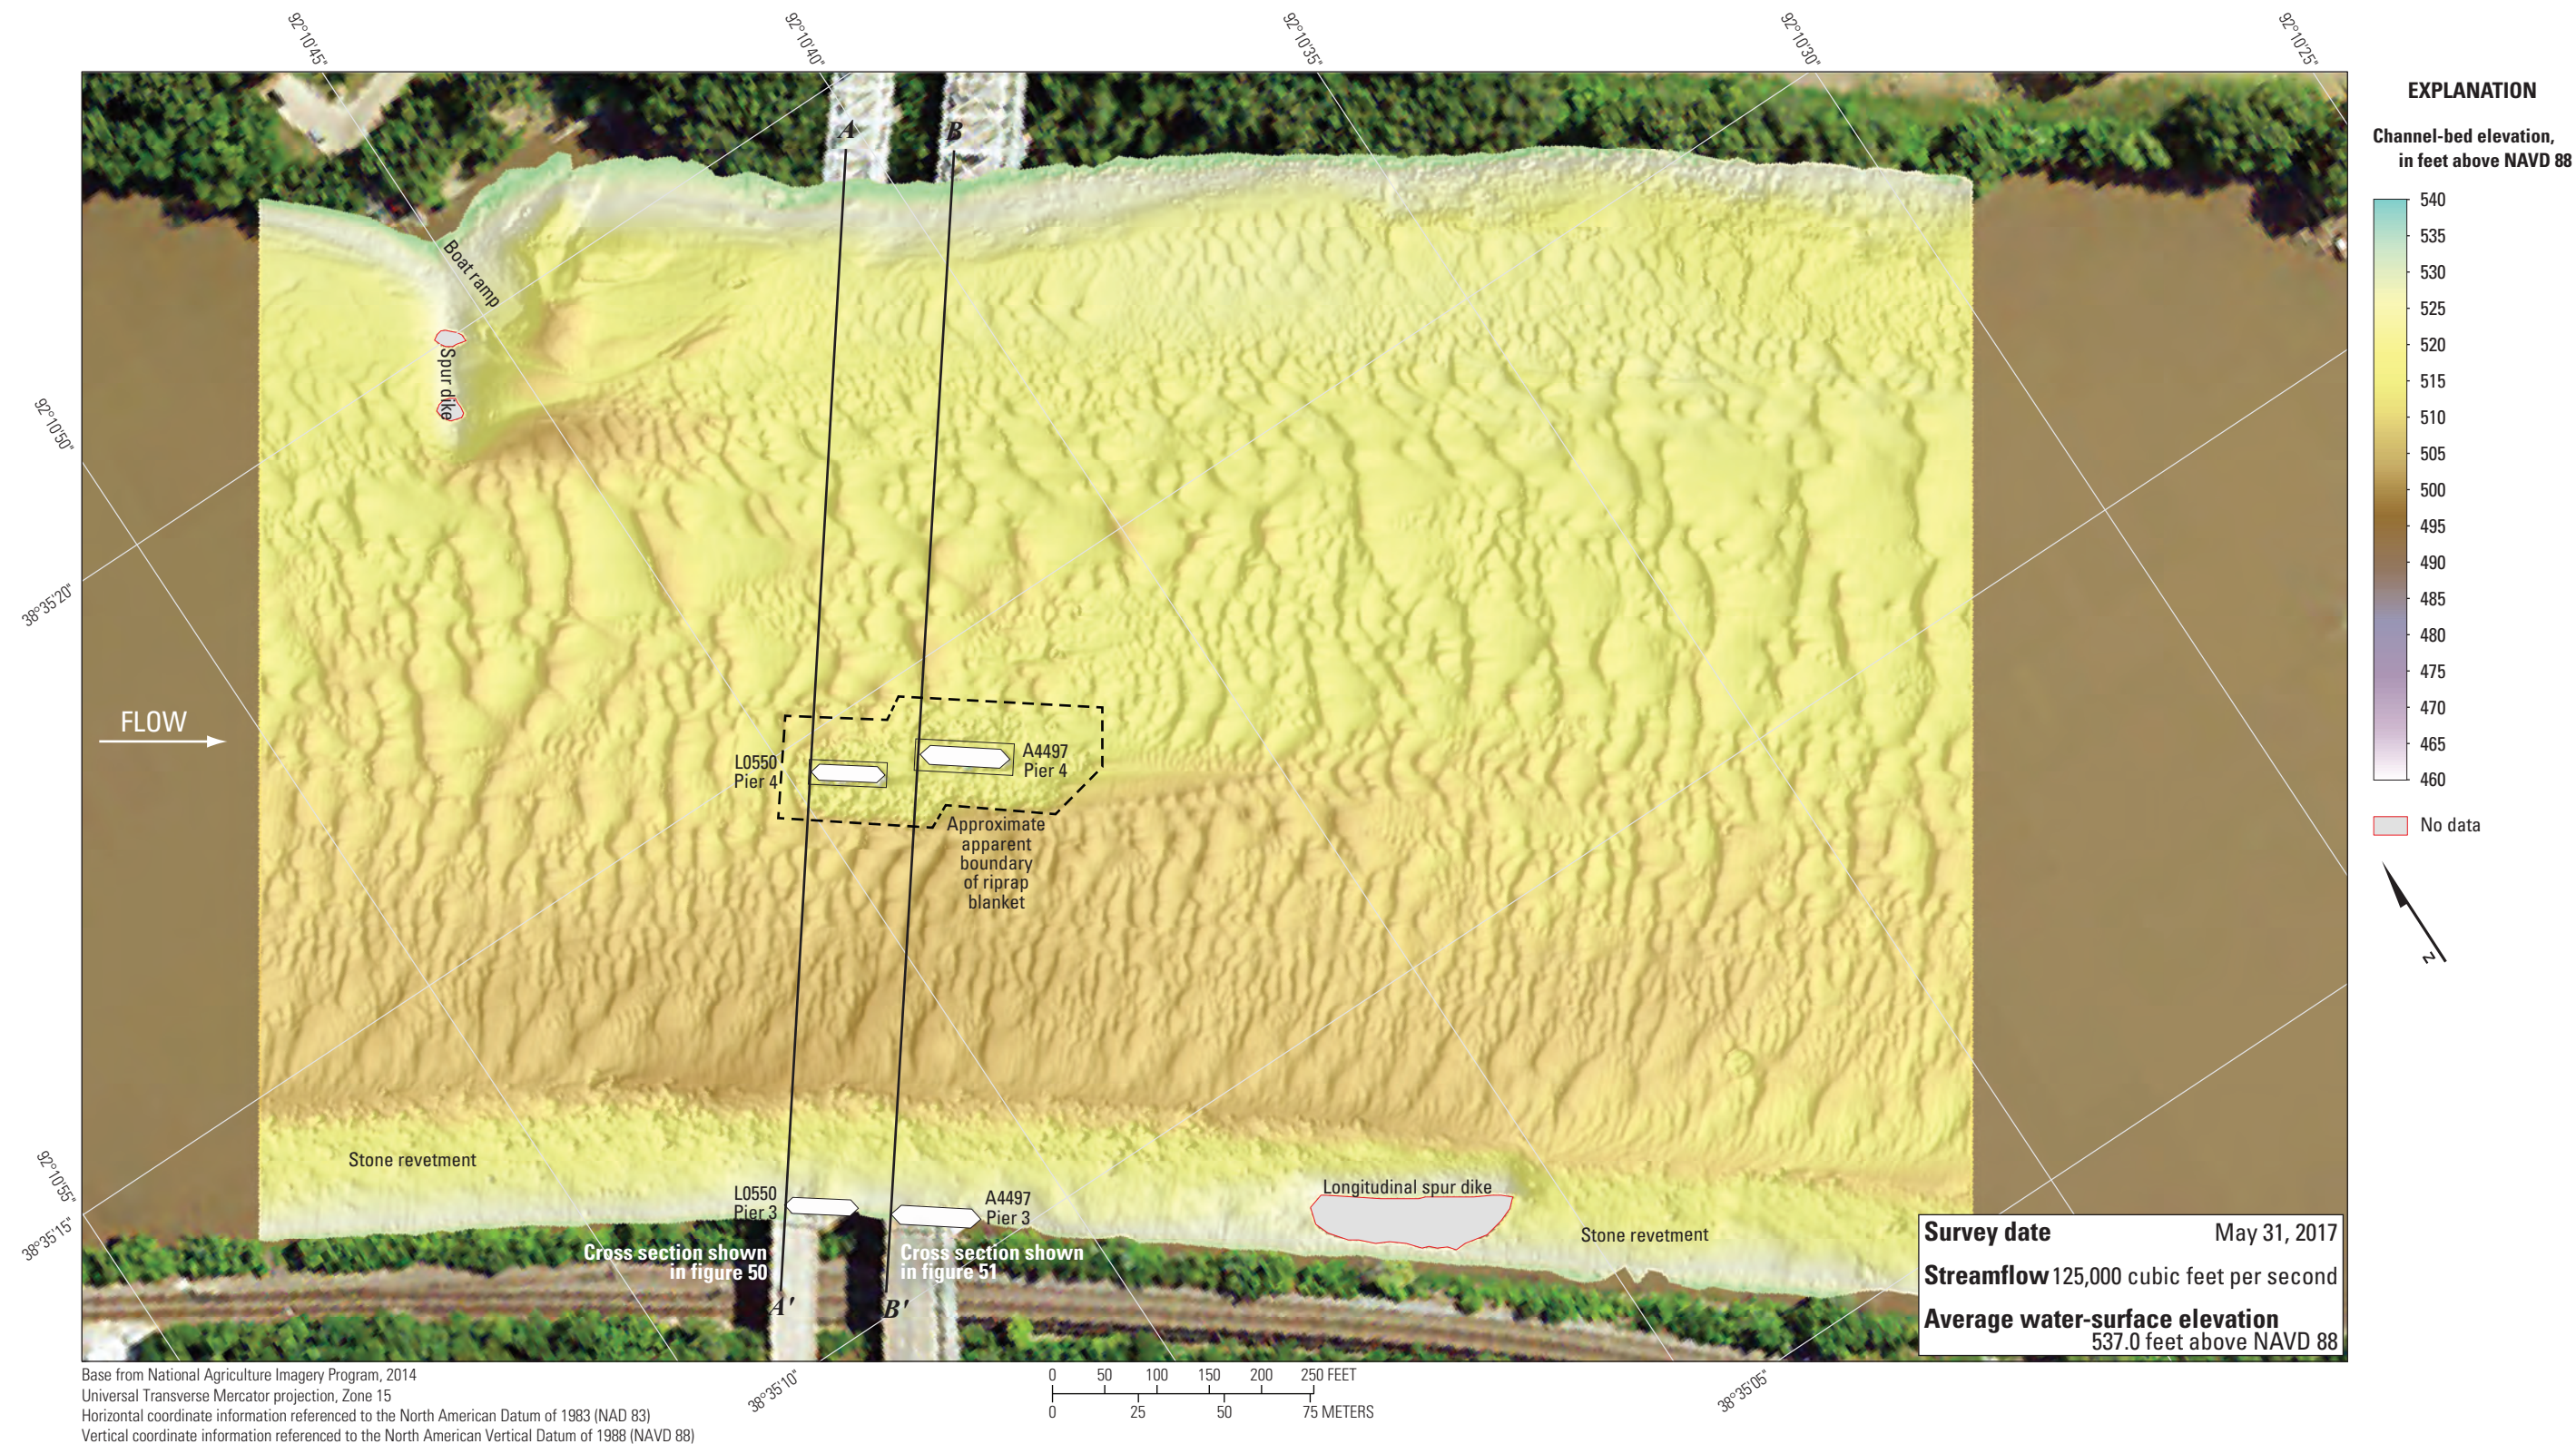
Figure 48. Bathymetric survey of the Missouri River channel near structures L0550 and A4497 on U.S. Highway 54 at Jefferson City, Missouri.

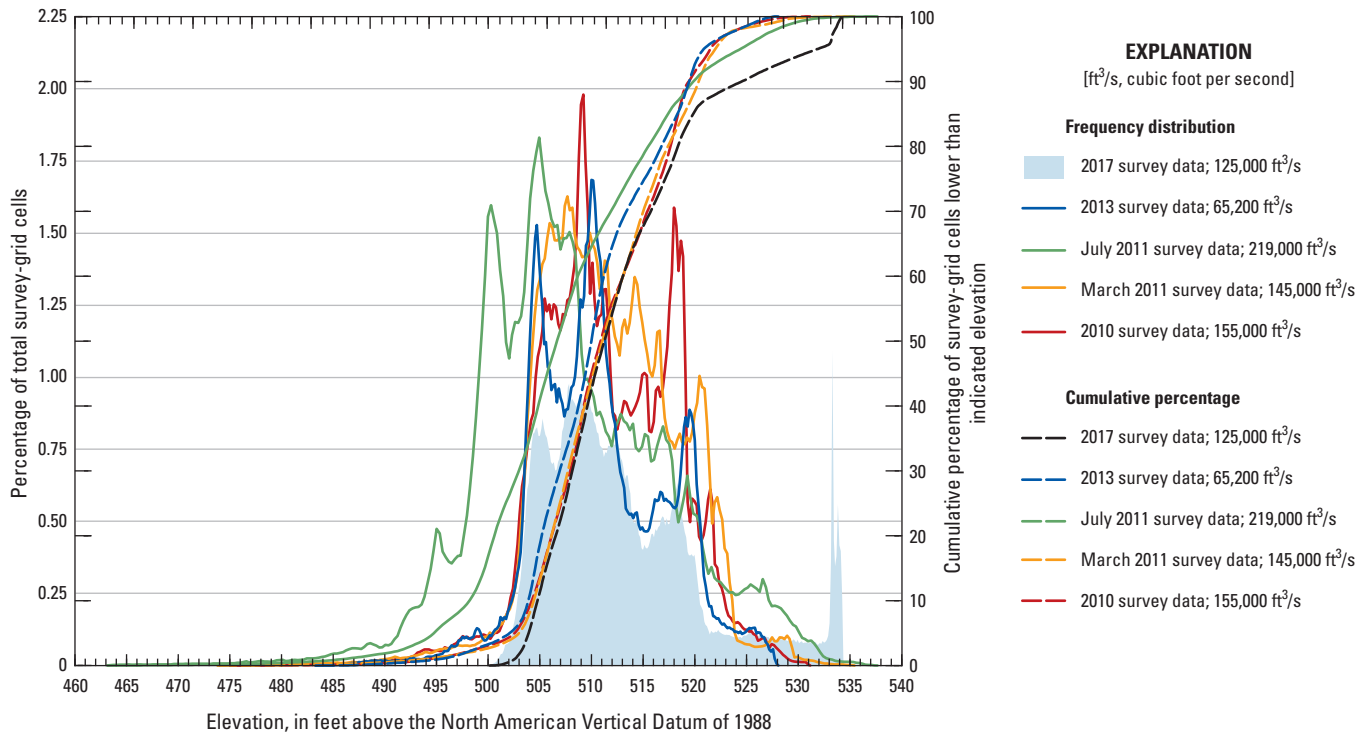
Figure 49. Frequency distribution of bed elevations for bathymetric survey-grid cells on the Missouri River near structures L0550 and A4497 on U.S. Highway 54 at Jefferson City, Missouri, on May 31, 2017, compared to previous surveys.

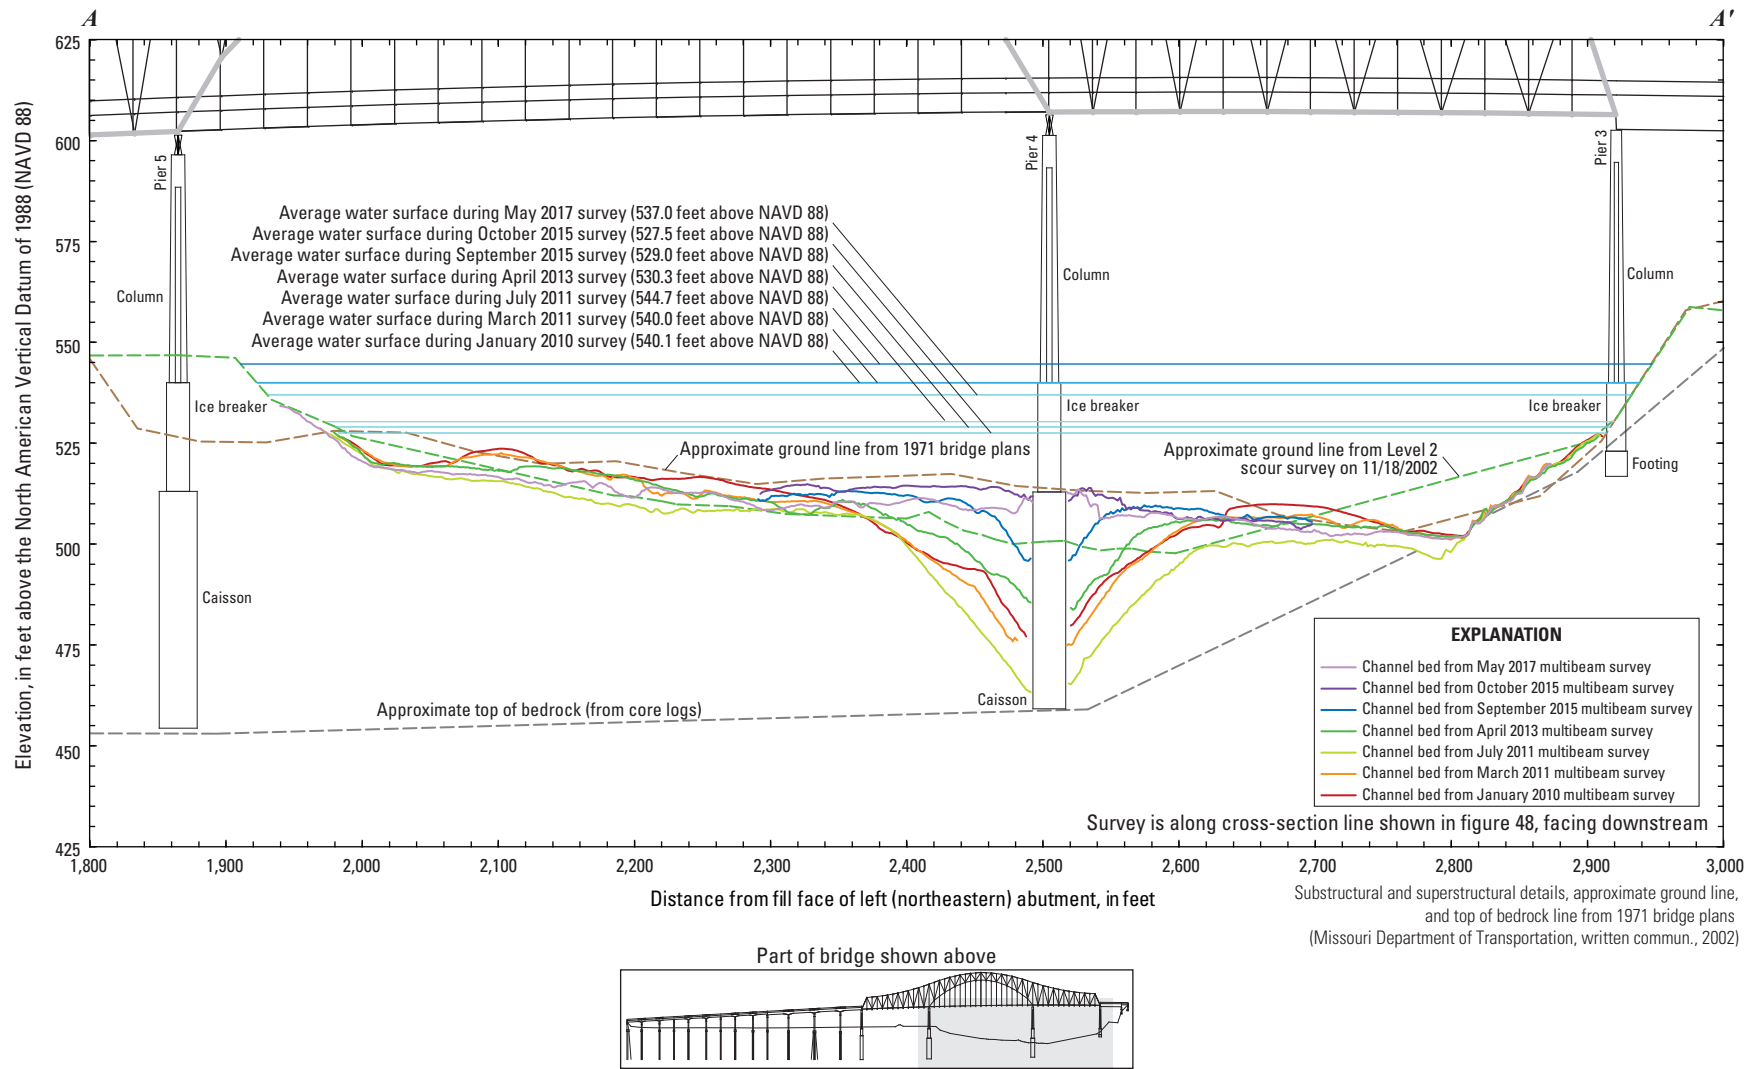
Figure 50. Key features, substructural and superstructural details, and surveyed channel bed of structure L0550 on U.S. Highway 54 crossing the Missouri River at Jefferson City, Missouri.

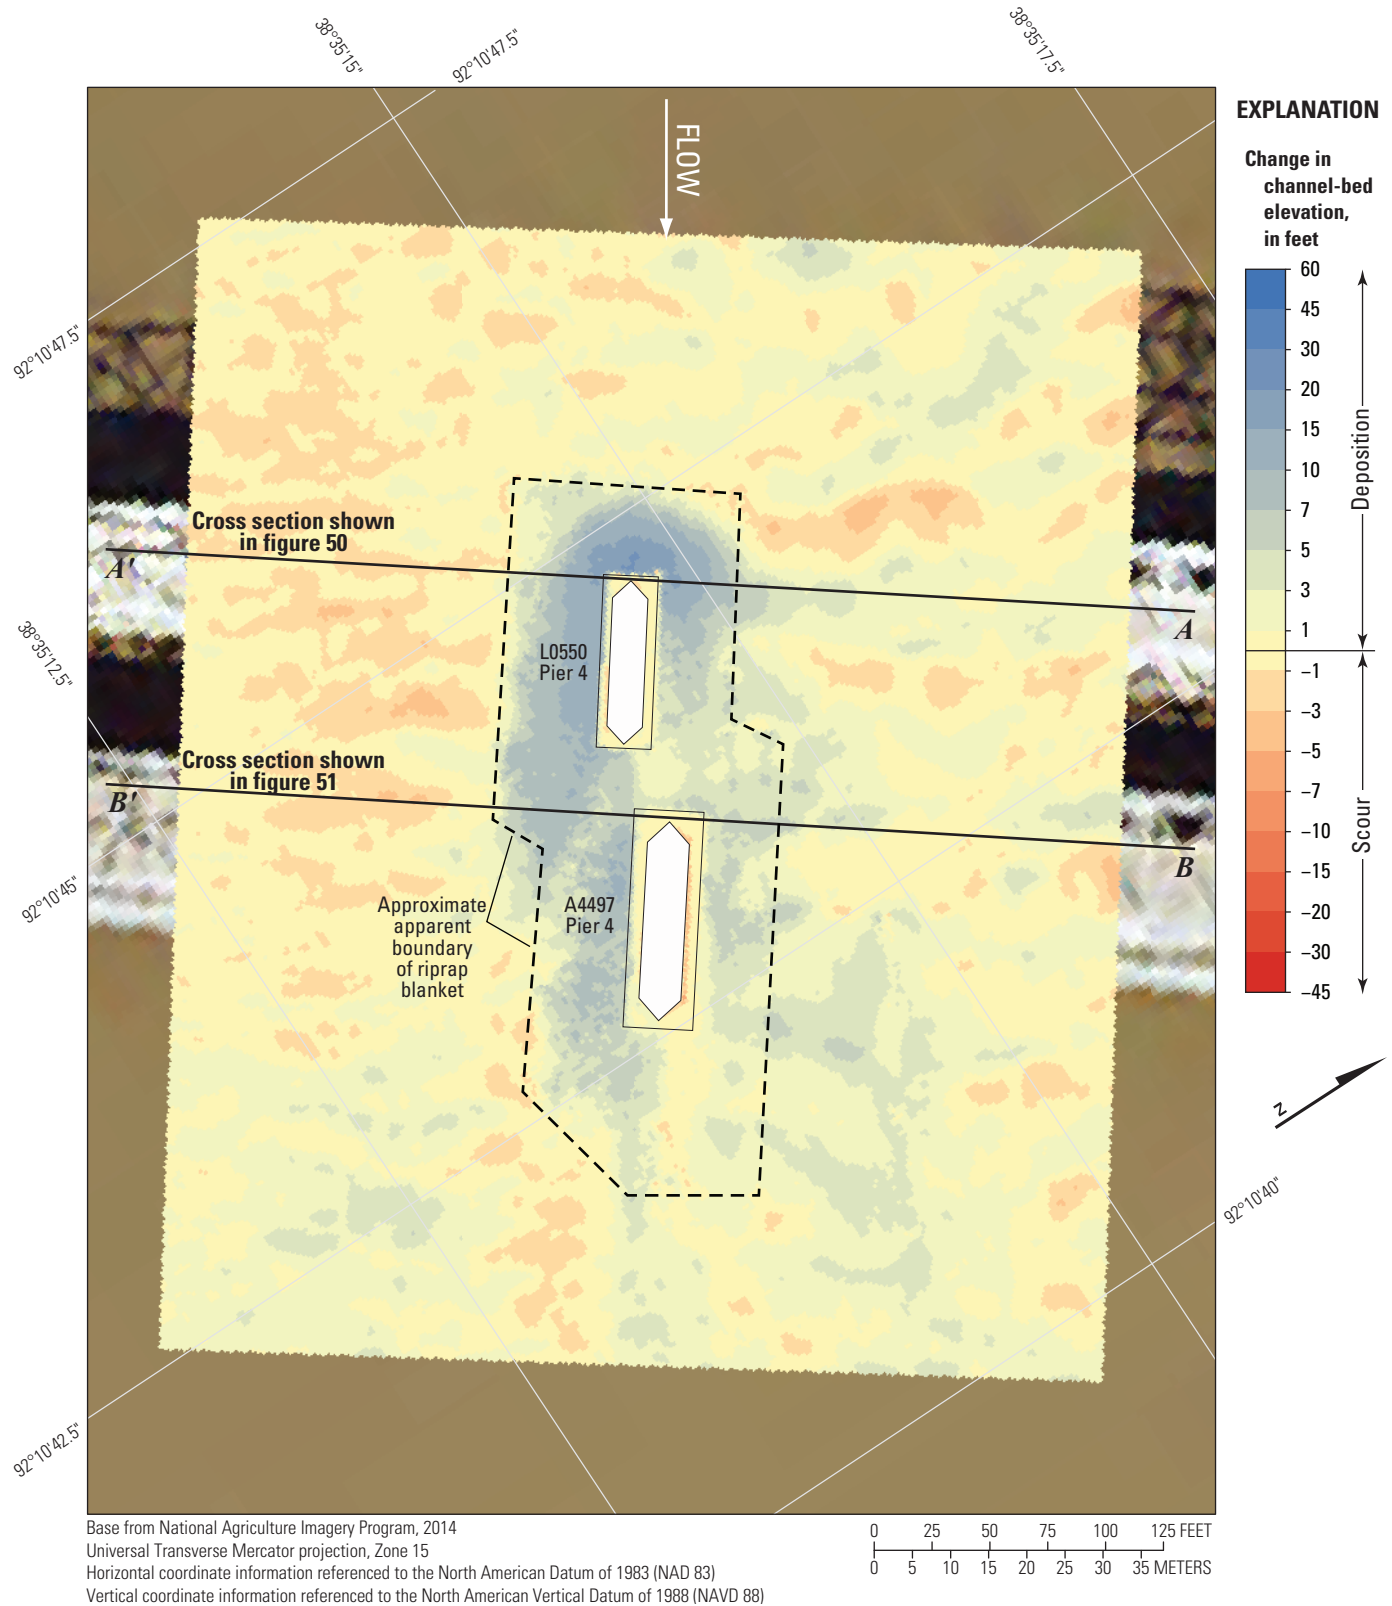
The difference between the survey on May 31, 2017, and the partial surveys on September 22 and October 29, 2015, clearly indicate the changes resulting from the installation of the riprap blanket countermeasures around pier 4 (fig. 54). The scour hole near pier 4 of both structures before the installation experienced deposition of as much as 20 ft (fig. 54A). Minor scour of 7 to 10 ft was observed throughout the partial reach in the areas away from the riprap blanket (fig. 54). Additionally, settling of the riprap blanket seems to have occurred along the upstream edge and along both sides of the blanket, with as much as 10 ft of scour indicated in those areas (fig. 54B), particularly near pier 4 of structure L0550. The cross sections from the 2017 survey compared to the postinstallation survey indicate the pattern of settling of the blanket along the edges (figs. 50, 51). Cut and fill volumes were not computed for the partial reaches of the before- and after-installation surveys.

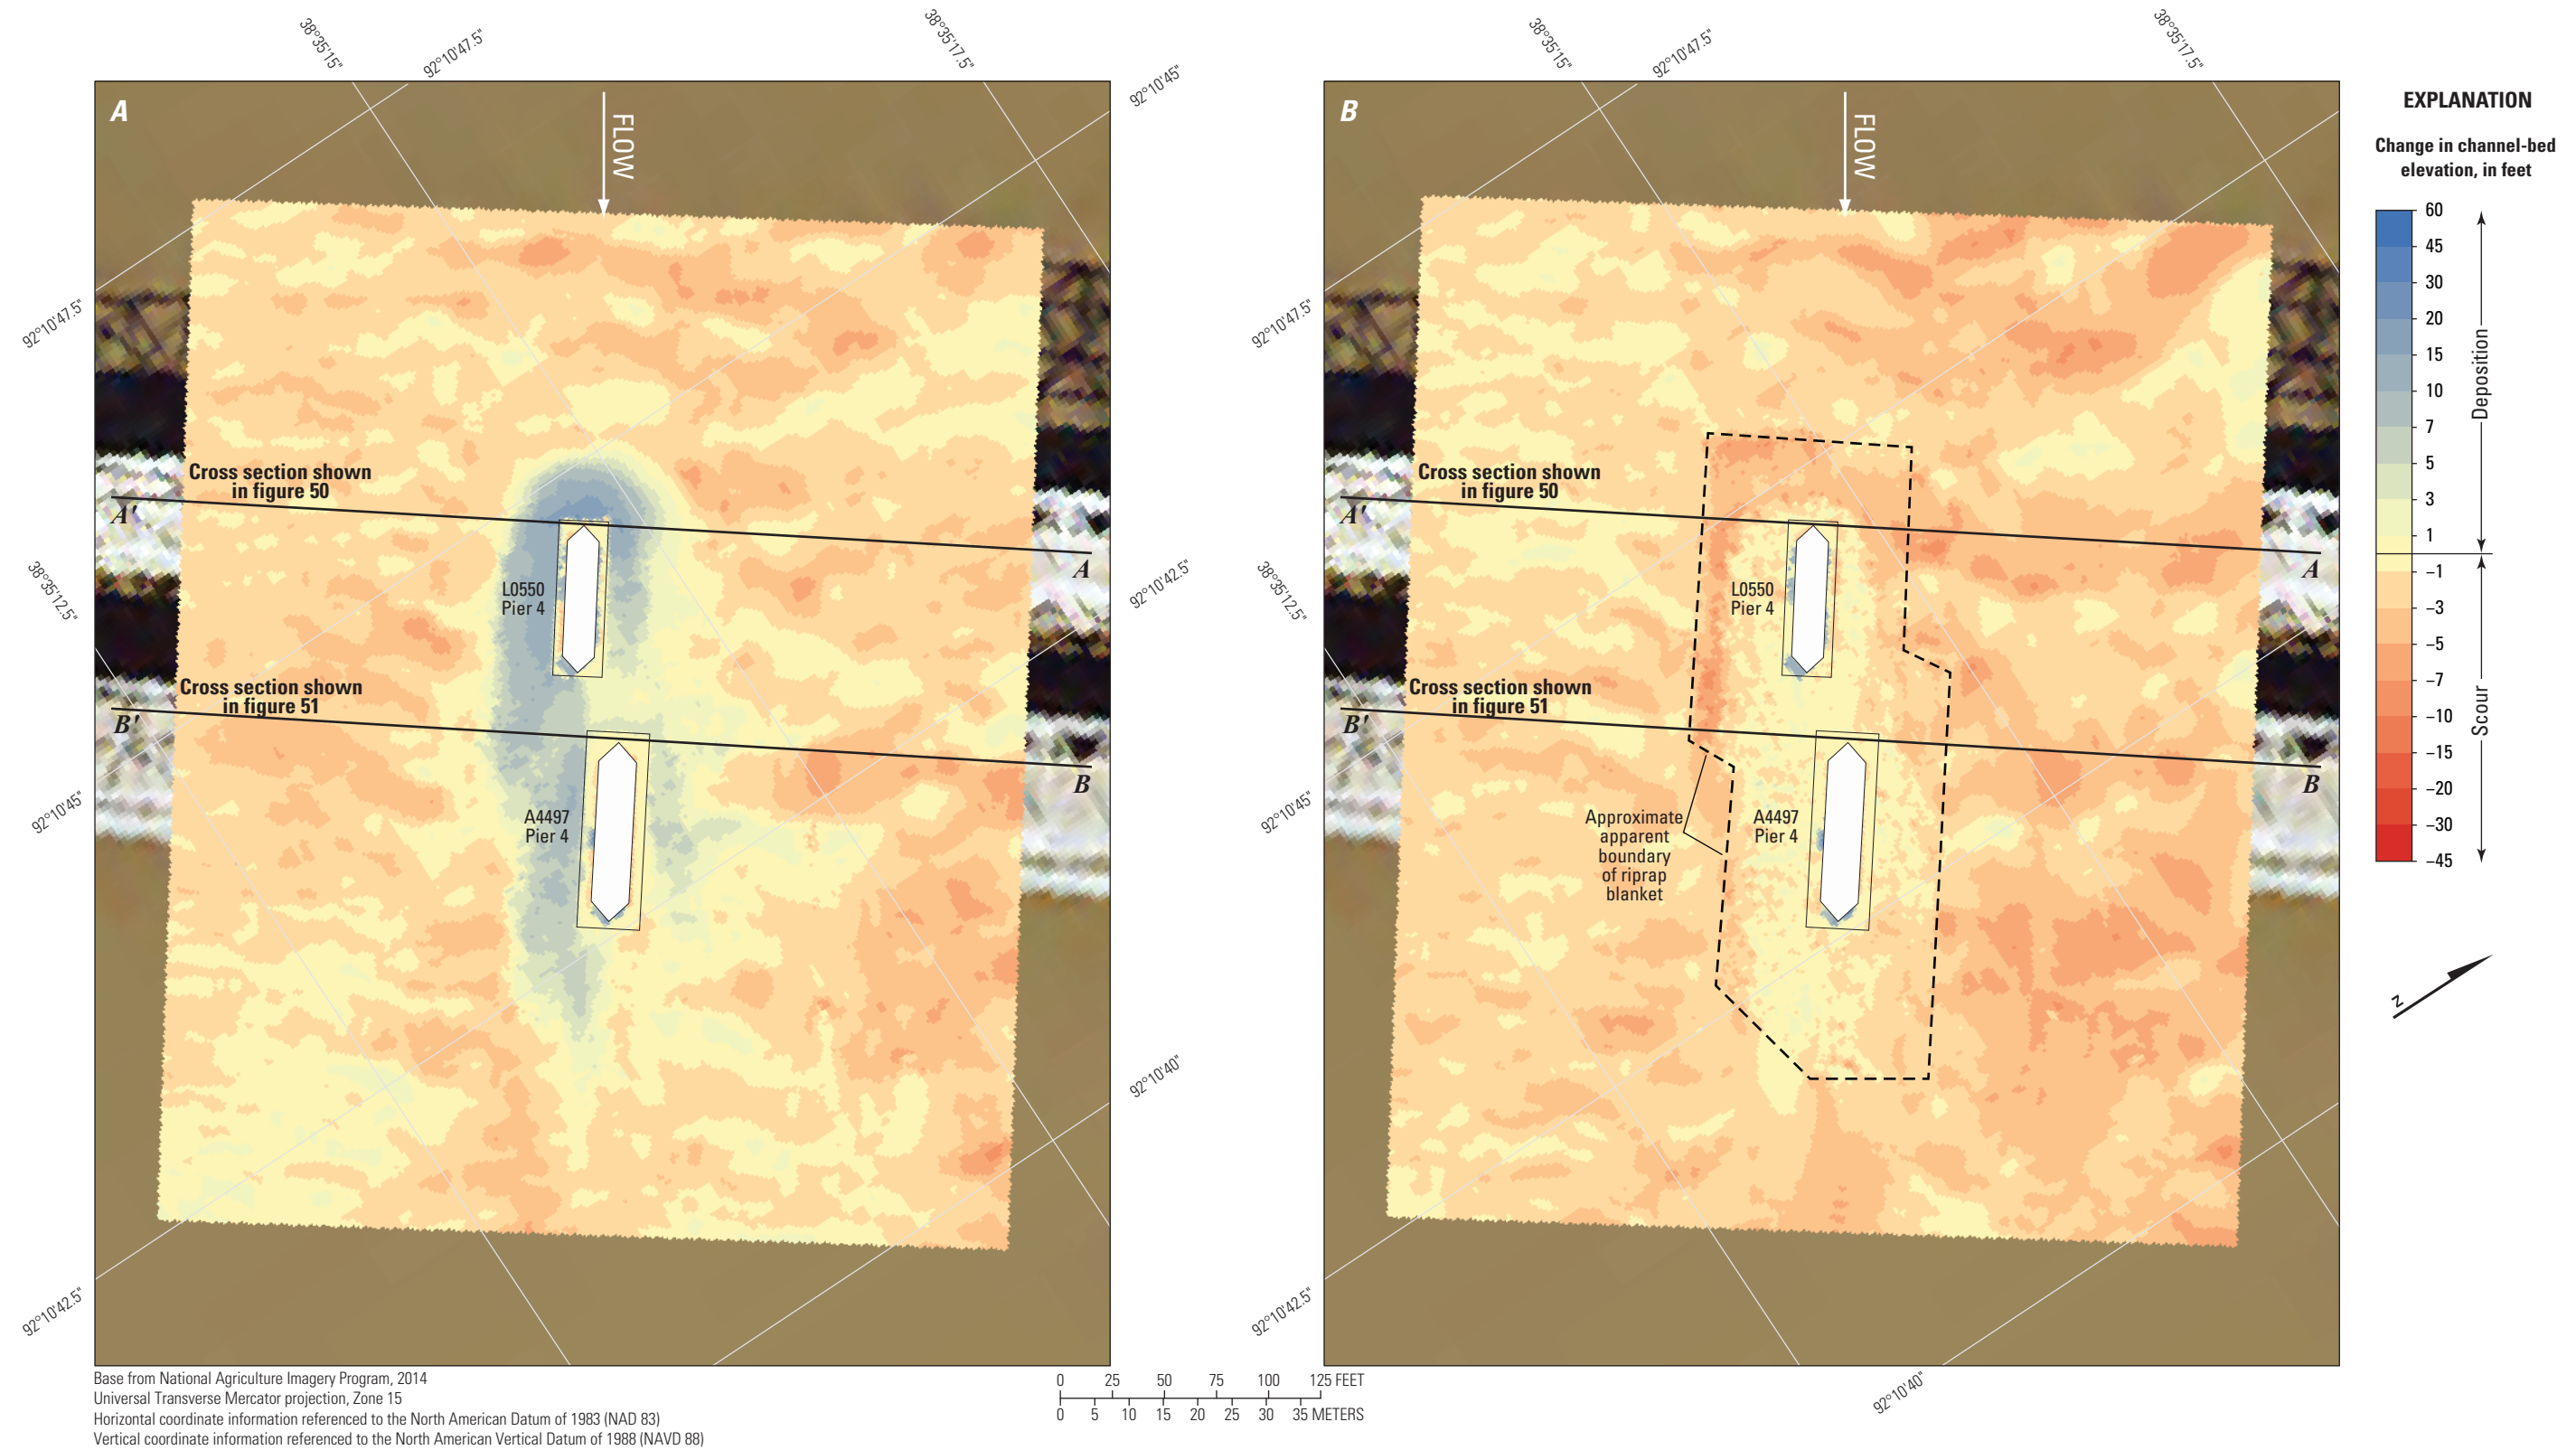
The riprap blanket installed around pier 4 of structures L0550/A4497 (site 20) as a scour countermeasure has effectively mitigated the scour hole typically observed at these piers in previous surveys (figs. 54A, 55–58). The apparent settling around the edges of the blanket since it was installed in 2015 (fig. 54B) warrants monitoring in future surveys for any further settling, but this likely will not adversely affect the scour mitigating effect of the countermeasure.
