Bathymetric and Velocimetric Surveys at Highway Bridges Crossing the Missouri River between Kansas City and St. Louis, Missouri, May 22–31, 2017

Scientific Investigations Report 2020–5018

By Richard J. Huizinga

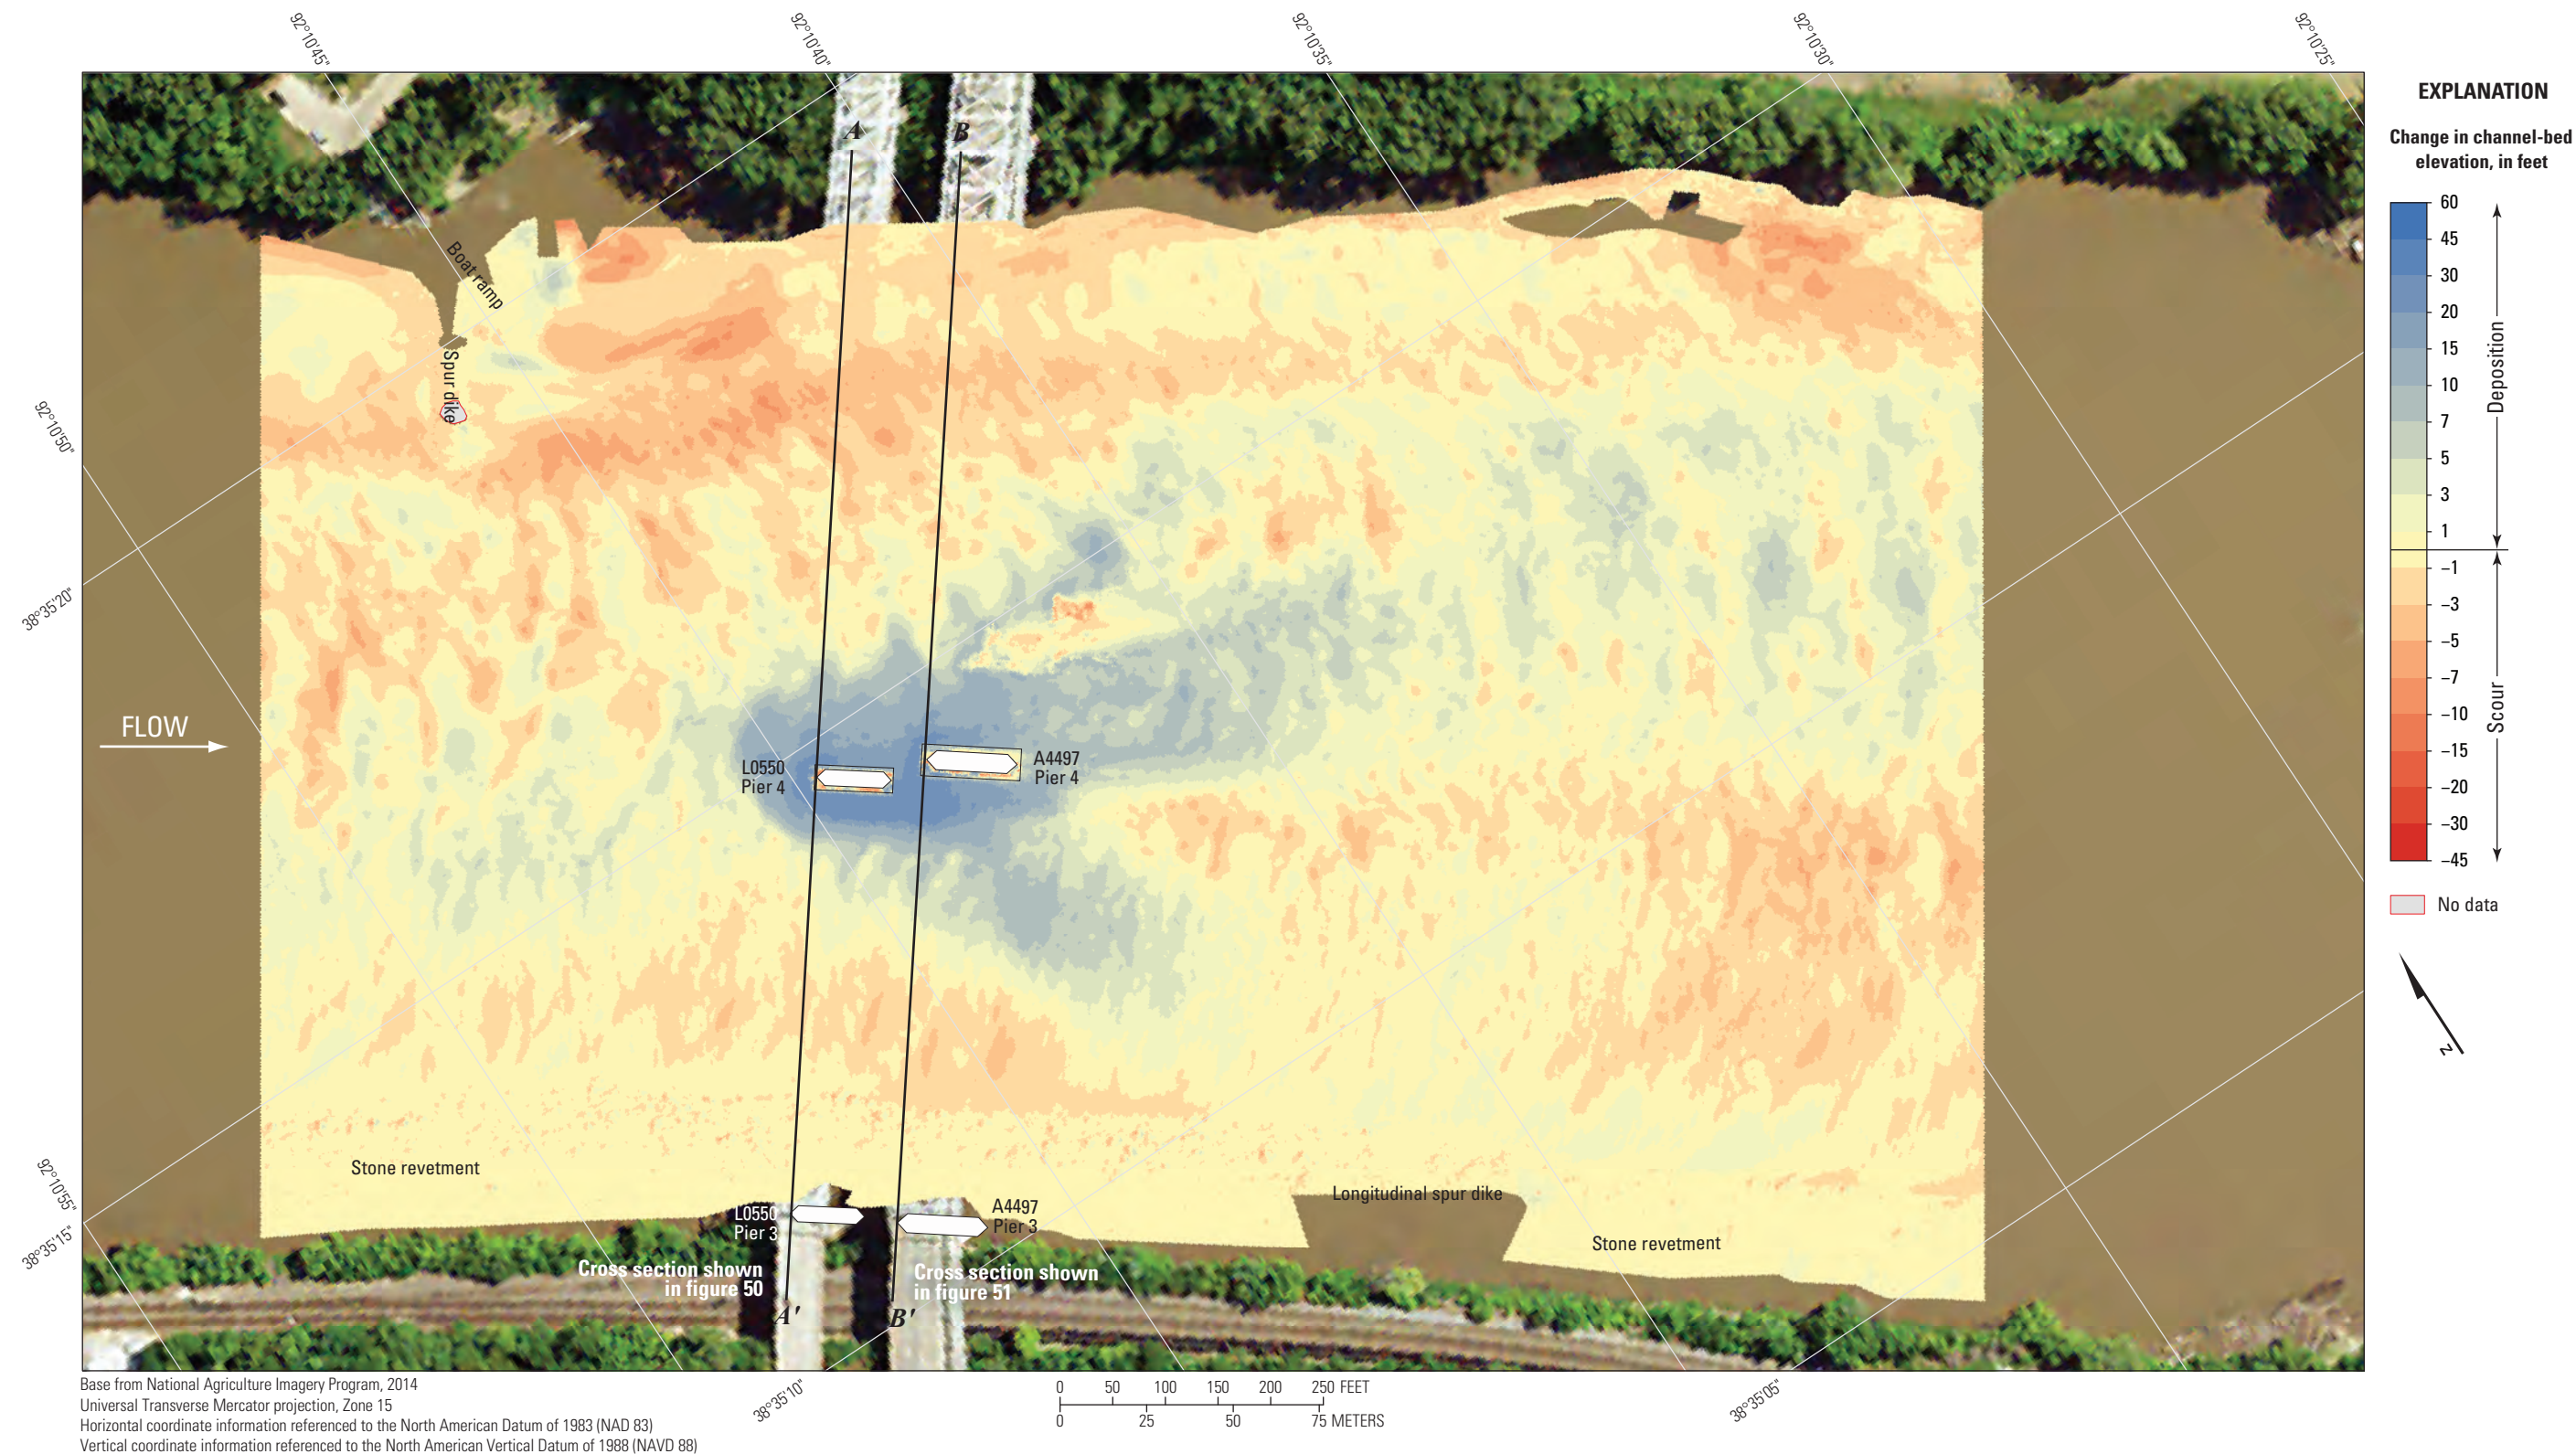
Figure 55. Difference between surfaces created from bathymetric surveys of the Missouri River channel near structures L0550 and A4497 on U.S. Highway 54 at Jefferson City, Missouri, on May 31, 2017, and April 30, 2013.

much as 10 ft in the wake zone on either side and downstream from the piers (fig. 55). Elsewhere throughout the reach, scour of as much as 15 ft was balanced by deposition of as much as 10 ft (fig. 55). The frequency distribution of bed elevations was of a similar shape in 2017 compared to 2013, albeit with a lower peak percentage of survey-grid cells in 2017 than 2013 (fig. 49). The resulting cumulative percentage curve is shifted to the left in 2013 compared to the 2017 curve (fig. 49). The rock outcrops on the right (south) bank seem to have experienced localized scour (fig. 55), but it is uncertain how much of this apparent difference is a function of positional variations between the surveys. As with all difference maps presented in this report, substantial deposition or scour apparent at the faces of the piers likely results from minor horizontal positional variances between the surveys (see the “Uncertainty Estimation” section).

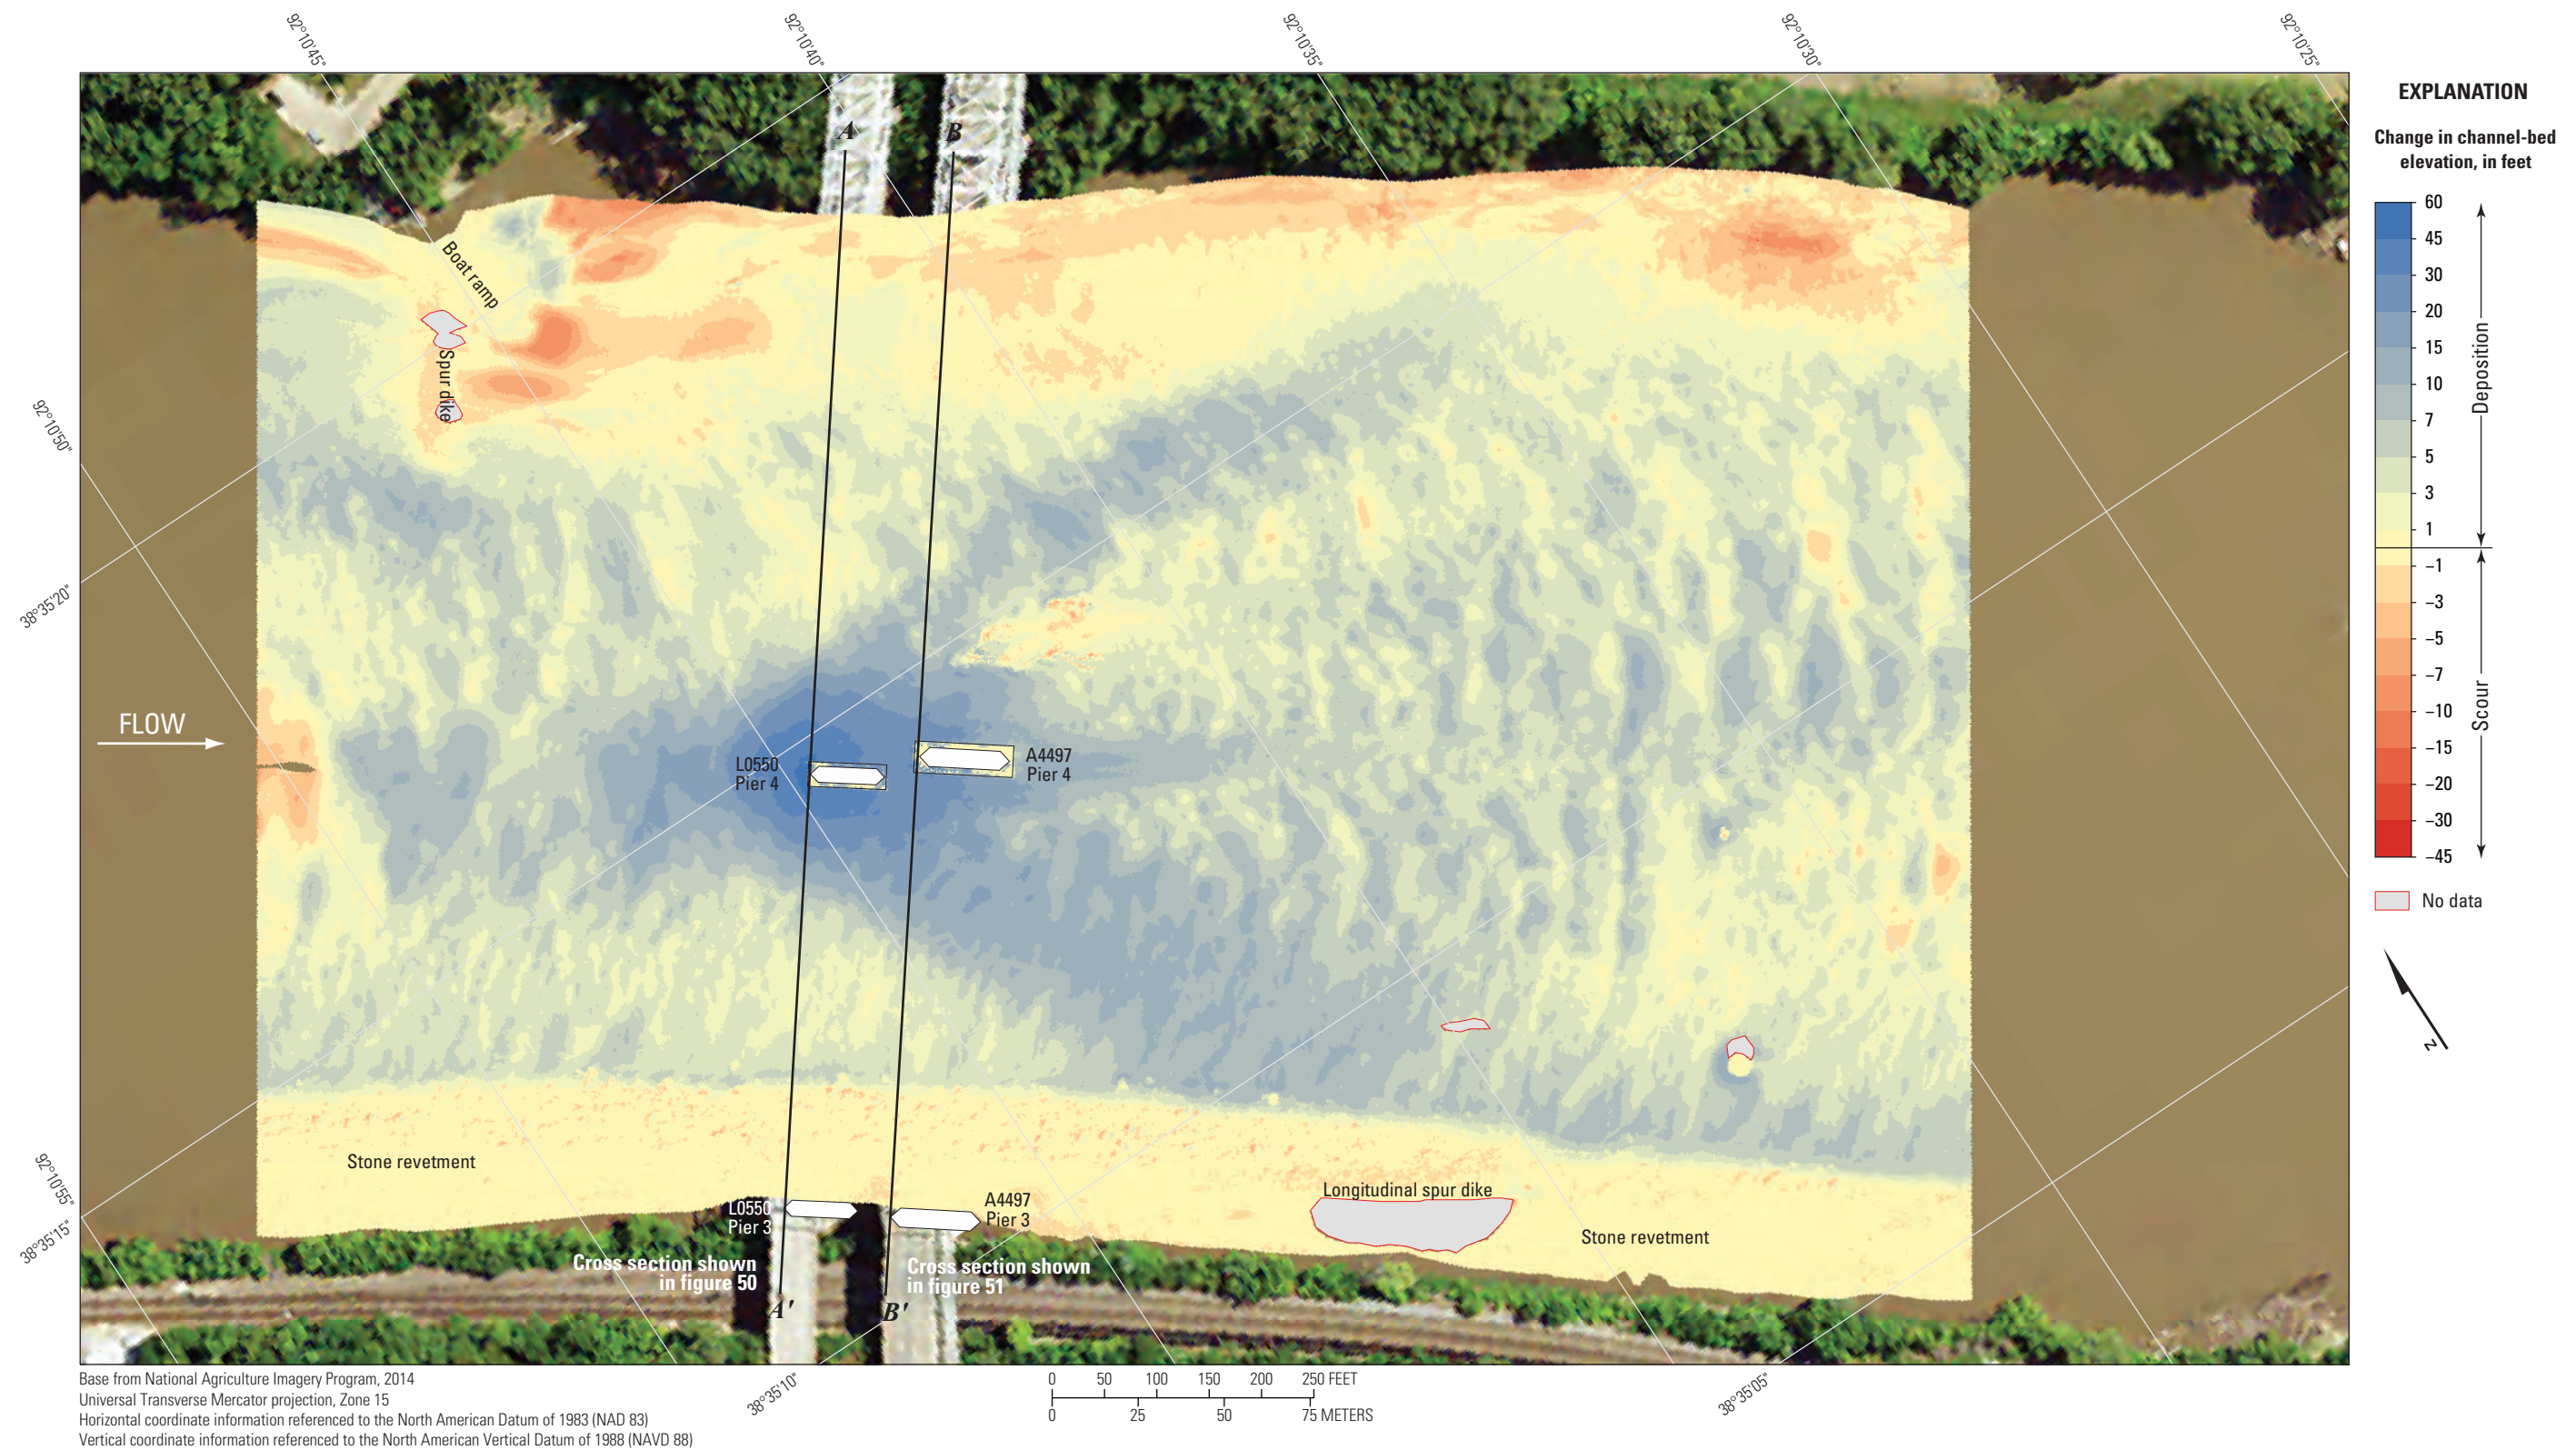
The difference between the survey on May 31, 2017, and the previous flood survey on July 27, 2011 (fig. 56), indicates widespread deposition throughout the reach between July 2011 and 2017, with an average difference of +3.88 ft between the bathymetric surfaces (table 7). The net volume of cut in the reach from July 2011 to 2017 was about 14,300 yd³, and the net volume of fill was about 249,000 yd³, resulting in a net gain of about 234,700 yd³ of sediment. There was substantial deposition of as much as 60 ft in the scour holes upstream from pier 4 of both structures with the installation of the countermeasures, and moderate deposition of as much as

15 ft in the wake zone on either side from the piers (fig. 56). Elsewhere throughout the reach, deposition of as much as 10 ft was balanced by localized scour of as much as 15 ft along the left (north) bank (fig. 56). The frequency distribution of bed elevations was unique in July 2011, with a substantial percentage of survey-grid cells at elevations below 500 ft compared to 2017 (fig. 49). The cumulative percentage curve is substantially shifted to the left in July 2011 compared to the 2017 curve (fig. 49). Again, the rock outcrops on the right (south) bank seem to have experienced localized scour (fig. 56), but it is uncertain how much of this apparent difference is a function of positional variations between the surveys. As with all difference maps presented in this report, substantial deposition or scour apparent at the faces of the piers likely results from minor horizontal positional variances between the surveys (see the “Uncertainty Estimation” section).

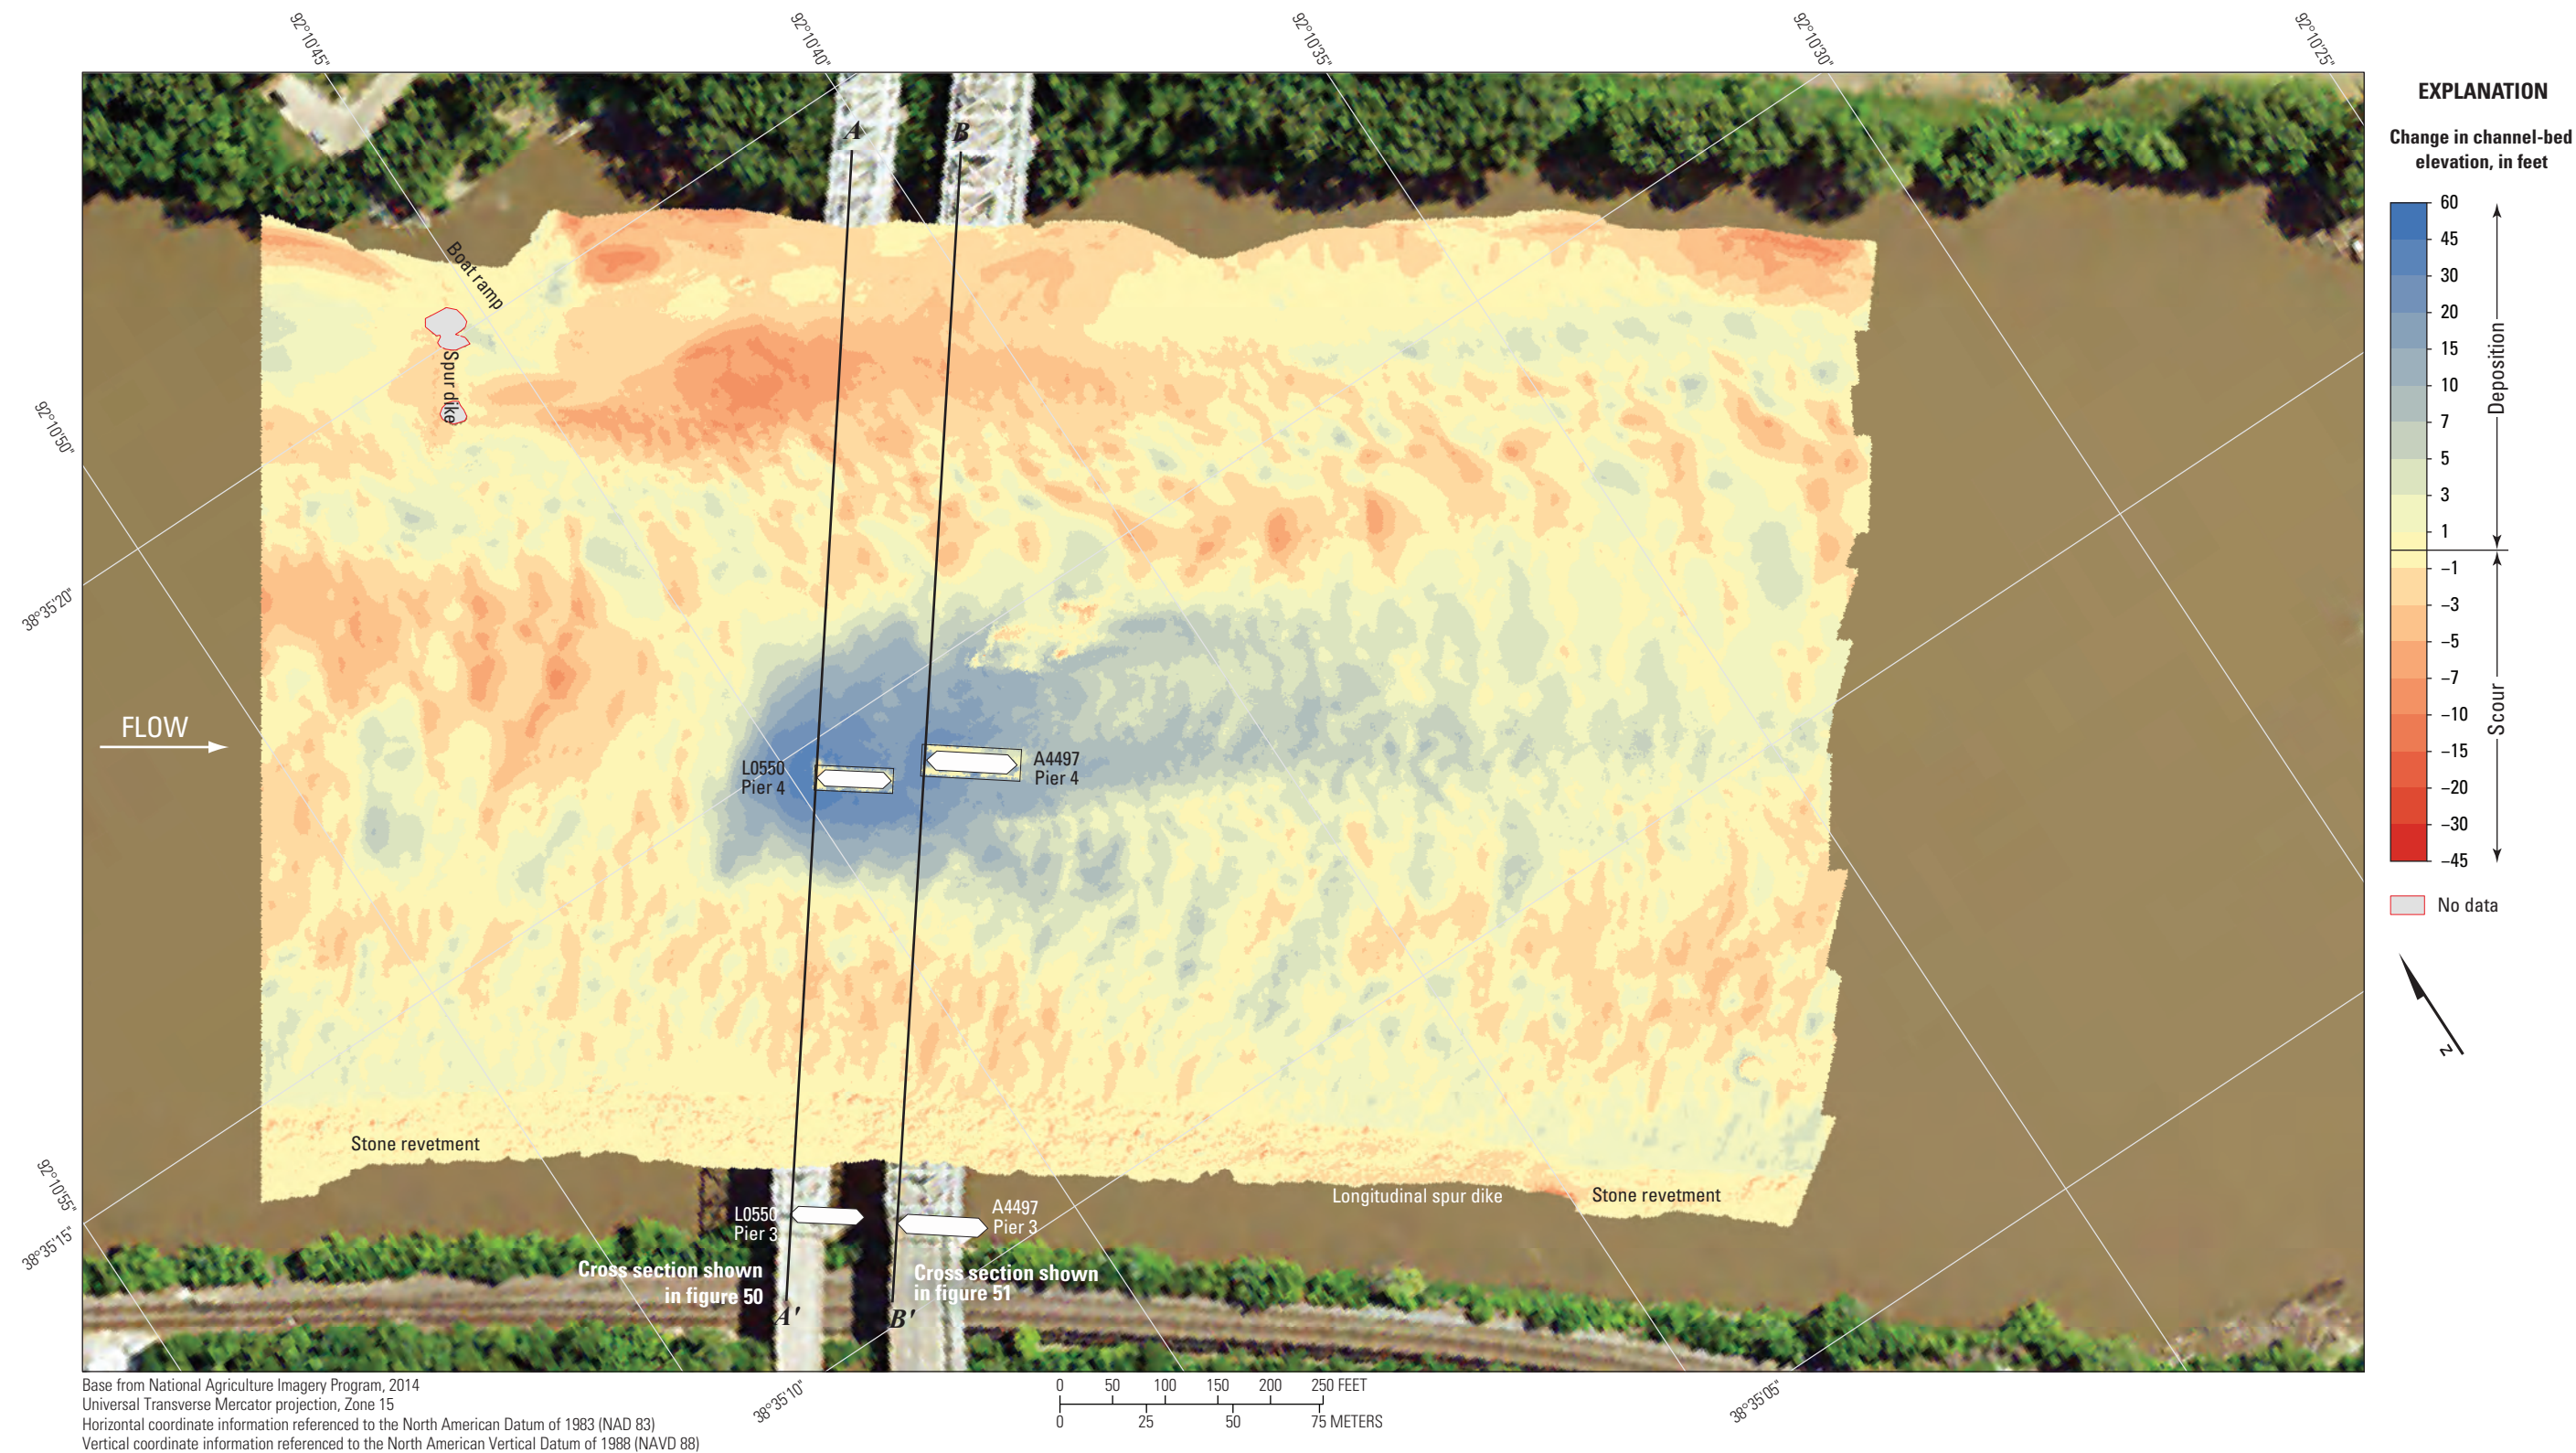
Figure 57. Difference between surfaces created from bathymetric surveys of the Missouri River channel near structures L0550 and A4497 on U.S. Highway 54 at Jefferson City, Missouri, on May 31, 2017, and March 1, 2011.

The difference between the survey on May 31, 2017, and a previous survey on March 1, 2011 (fig. 57), indicates moderate deposition (an average difference of +0.76 ft between the bathymetric surfaces) throughout the reach between March 2011 and 2017 (table 7). The net volume of cut in the reach from March 2011 to 2017 was about 43,000 yd³, and the net volume of fill was about 81,200 yd³, resulting in a net gain of about 38,200 yd³ of sediment. Once again, there was substantial deposition of as much as 45 ft in the scour holes upstream from pier 4 of both structures with the installation of the countermeasures, and moderate deposition of as much as 15 ft in the wake zone on either side and downstream from the piers, balanced with scour of as much as 15 ft elsewhere throughout the reach (fig. 57). The frequency distribution of bed elevations was similar in March 2011 and 2017, albeit with a lower peak percentage of survey-grid cells in 2017 compared to March 2011 and with a larger percentage of survey-grid cells at higher elevations in 2017 (fig. 49). The cumulative percentage curves in March 2011 and 2017 are similar, except where greater than 90 percent because of the higher percentage of survey-grid cells at a higher elevation than in March 2011 (fig. 49). Again, the rock outcrops on the right (south) bank seem to have experienced localized scour (fig. 57), but it is uncertain how much of this apparent difference is a function of positional variations between the surveys. As with all difference maps presented in this report, substantial deposition or scour apparent at the faces of the piers likely results from

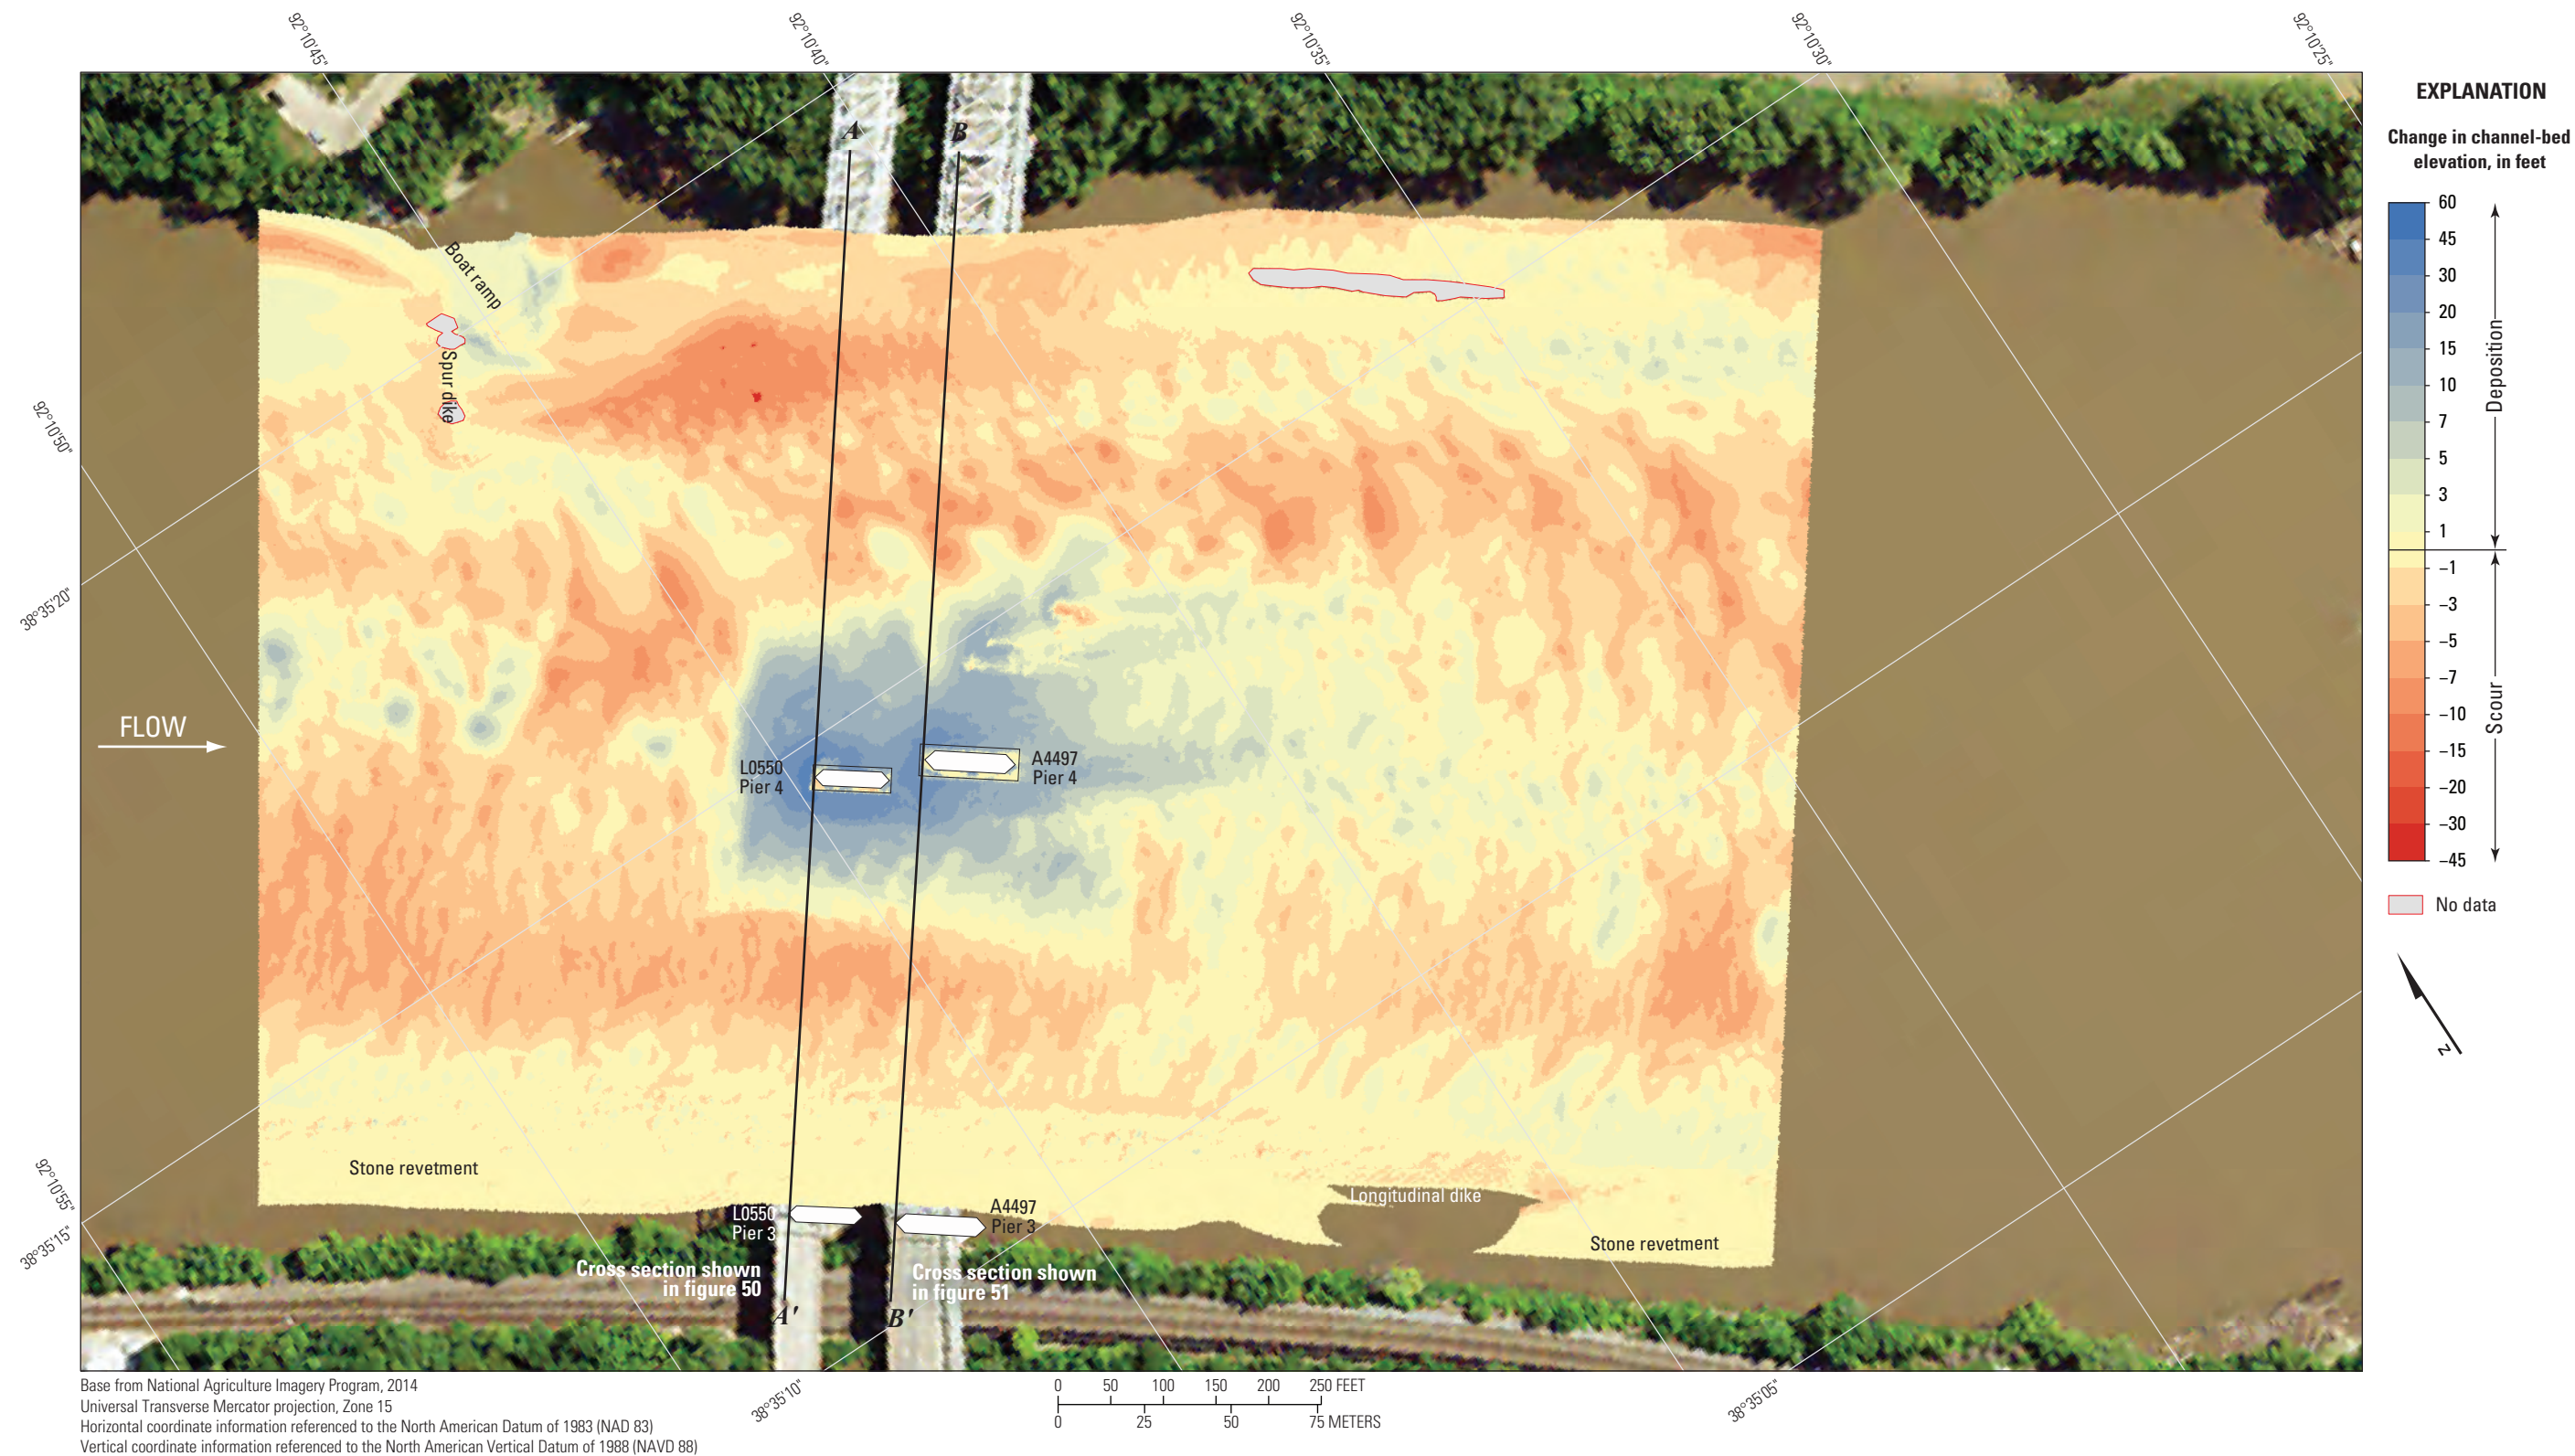
Figure 58. Difference between surfaces created from bathymetric surveys of the Missouri River channel near structures L0550 and A4497 on U.S. Highway 54 at Jefferson City, Missouri, on May 31, 2017, and January 26, 2010.

The difference between the survey on May 31, 2017, and the first survey at this site on January 26, 2010 (fig. 58), indicates moderate scour (an average difference of -0.63 ft between the bathymetric surfaces) throughout the reach between 2010 and 2017 (table 7). The net volume of cut in the reach from 2010 to 2017 was about 83,900 yd³, and the net volume of fill was about 51,700 yd³, resulting in a net loss of about 32,200 yd³ of sediment between 2010 and 2017. Once again, there was substantial deposition of as much as 45 ft in the scour holes upstream from pier 4 of both structures with the installation of the countermeasures, and moderate deposition of as much as 15 ft in the wake zone on either side and downstream from the piers; however, moderate scour of as much as 15 ft was present elsewhere throughout most of the reach (fig. 58). The frequency distribution of bed elevations in 2010 was similar to March 2011 and 2017, albeit with a lower percentage of survey-grid cells in 2017 than either March 2011 or 2010 and with a larger percentage of survey-grid cells at higher elevations in 2017 (fig. 49). The cumulative percentage curves in 2010 and 2017 are similar, except where greater than 90 percent because of the higher percentage of survey-grid cells at a higher elevation, as in March 2011 (fig. 49). Again, the rock outcrops on the right (south) bank seem to have experienced localized scour (fig. 58), but it is uncertain how much of this apparent difference is a function of positional variations between the surveys. Position information for surveys before mid-2010 were not processed through POSPac MMS and, therefore, have more questionable positional accuracy, particularly near the bridges where the GNSS signal might be lost. As with all difference maps presented in this report, substantial deposition or scour apparent at the faces of the piers likely results from minor horizontal positional variances between the surveys (see the “Uncertainty Estimation” section).

Most of the surveys at this site had a positive average difference, likely affected by the placement of the scour countermeasures around pier 4 of both structures. However, the negative average difference between the surfaces from 2010 to 2017 may have been the result of the timing of the first survey in January 2010. Although the streamflow was higher in 2010 than 2017, colder water temperatures during the winter months and generally lower streamflows before the 2010 survey might have allowed sediment to deposit in the reach just before the 2010 survey. On the other hand, the March 2011 survey was after a previous rise in February 2011 and sustained higher flow, which might have removed sediment until the March 2011 survey.

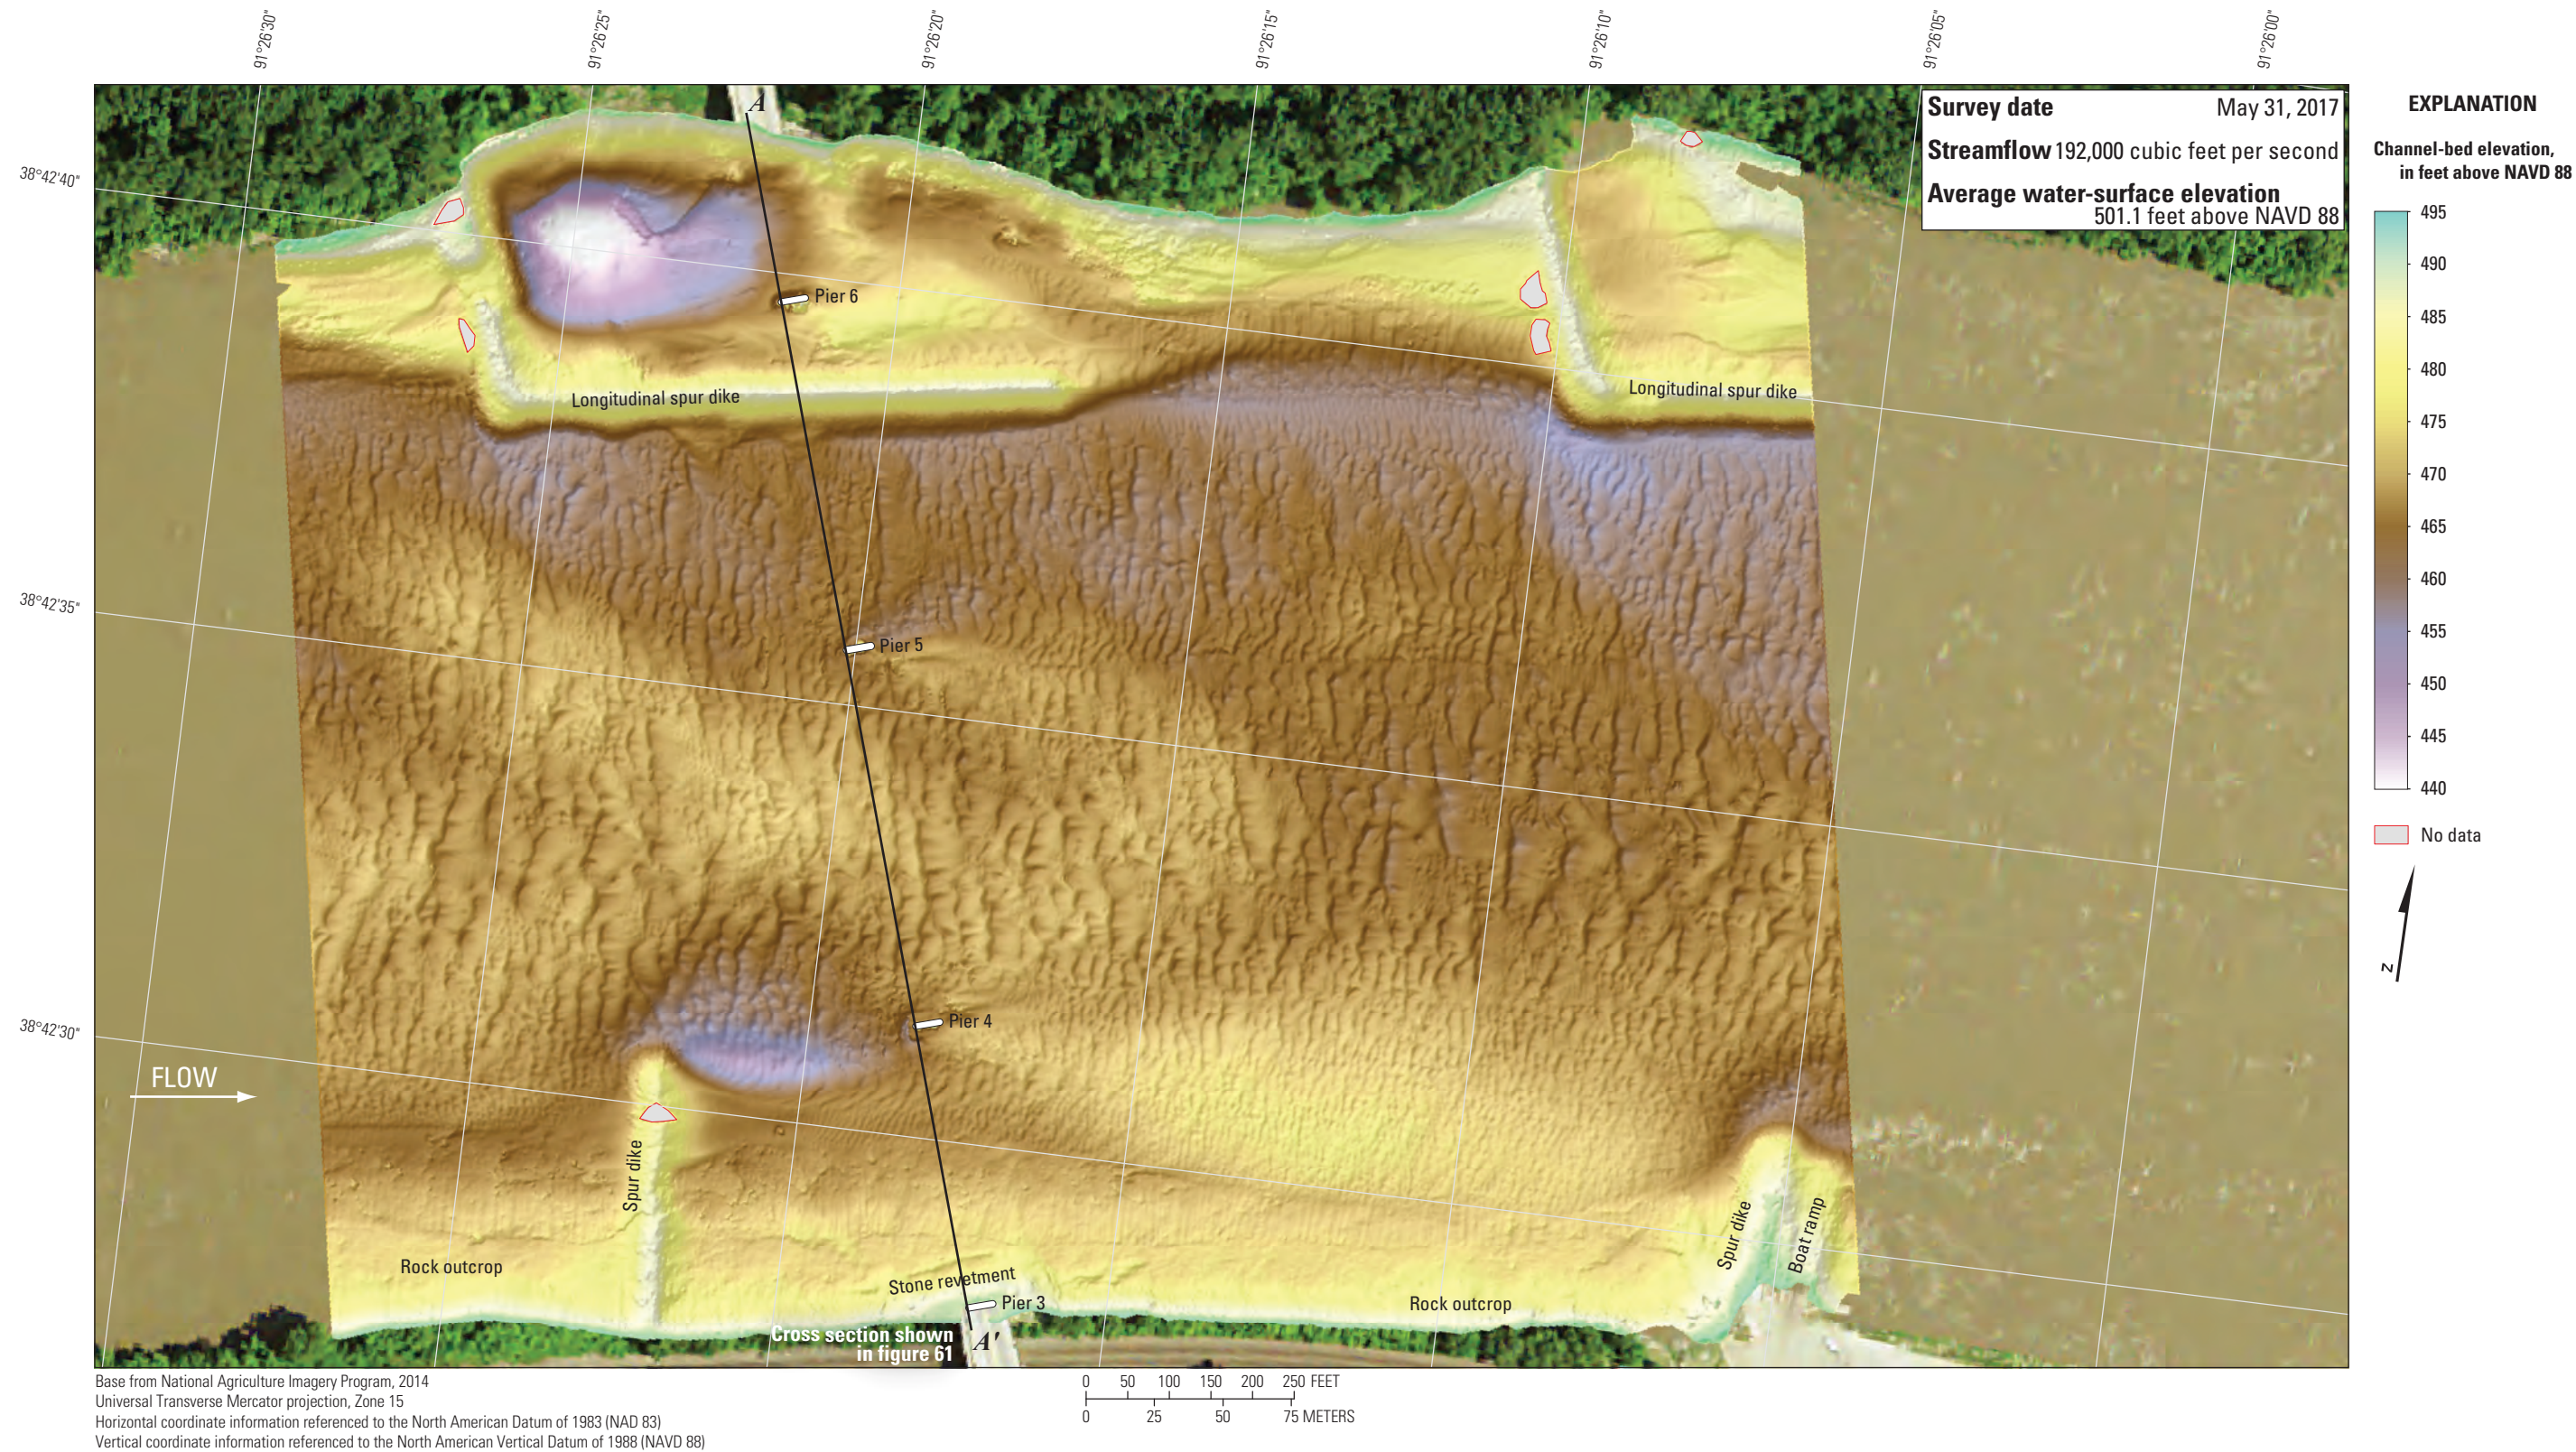
Figure 59. Bathymetric survey of the Missouri River channel near structure A6288 on Missouri State Highway 19 at Hermann, Missouri.

The survey area was about 1,840 ft long and about 1,450 ft wide, generally extending from bank to bank in the main channel (fig. 59). The upstream end of the survey area was about 690 ft upstream from the centerline of structure A6288 at pier 5 (fig. 59), and piers 4 through 6 were in the water; pier 3 was on the edge of water at the right (south) bank. The channel-bed elevations ranged from about 464 to 487 ft for most of the surveyed area (5th to 95th percentile range of the bathymetric data; table 5, fig. 60), except inside the upstream left (north) longitudinal spur dike where a local minimum channel-bed elevation of 444 ft was observed (fig. 59; table 5). A poorly defined thalweg was present along the toe of the left longitudinal spur dikes that deepened as one progressed downstream, and numerous small to medium dunes and ripples were present throughout the channel (fig. 59).

Minor scour holes were observed near both of the piers in the main channel, and near pier 6 behind the longitudinal spur dike on the left (north) side (fig. 59). The minor scour hole near pier 6 had a minimum channel-bed elevation of about 465 ft (table 6), which is about 23 ft above the elevation of the bottom of the pier seal course of 442.00 ft (fig. 61; table 6). The minor scour hole near pier 5 had a minimum channel-bed elevation of about 465 ft (table 6), which is about 21 ft above

Several of the surveyed bridges had piers that were skewed to approach flow, resulting in asymmetric scour holes at those bridges: pier 14 of structure L0962 on Interstate 70 near Rocheport, Mo. (fig. 42), and pier 5 of structure A6288 on Missouri State Highway 19 at Hermann, Mo. (fig. 59). The scour hole typically was deeper and longer on the side of the pier with impinging flow, with some amount of deposition on the leeward side.
