Bathymetric and Velocimetric Surveys at Highway Bridges Crossing the Missouri River between Kansas City and St. Louis, Missouri, May 22–31, 2017

Scientific Investigations Report 2020–5018

By Richard J. Huizinga

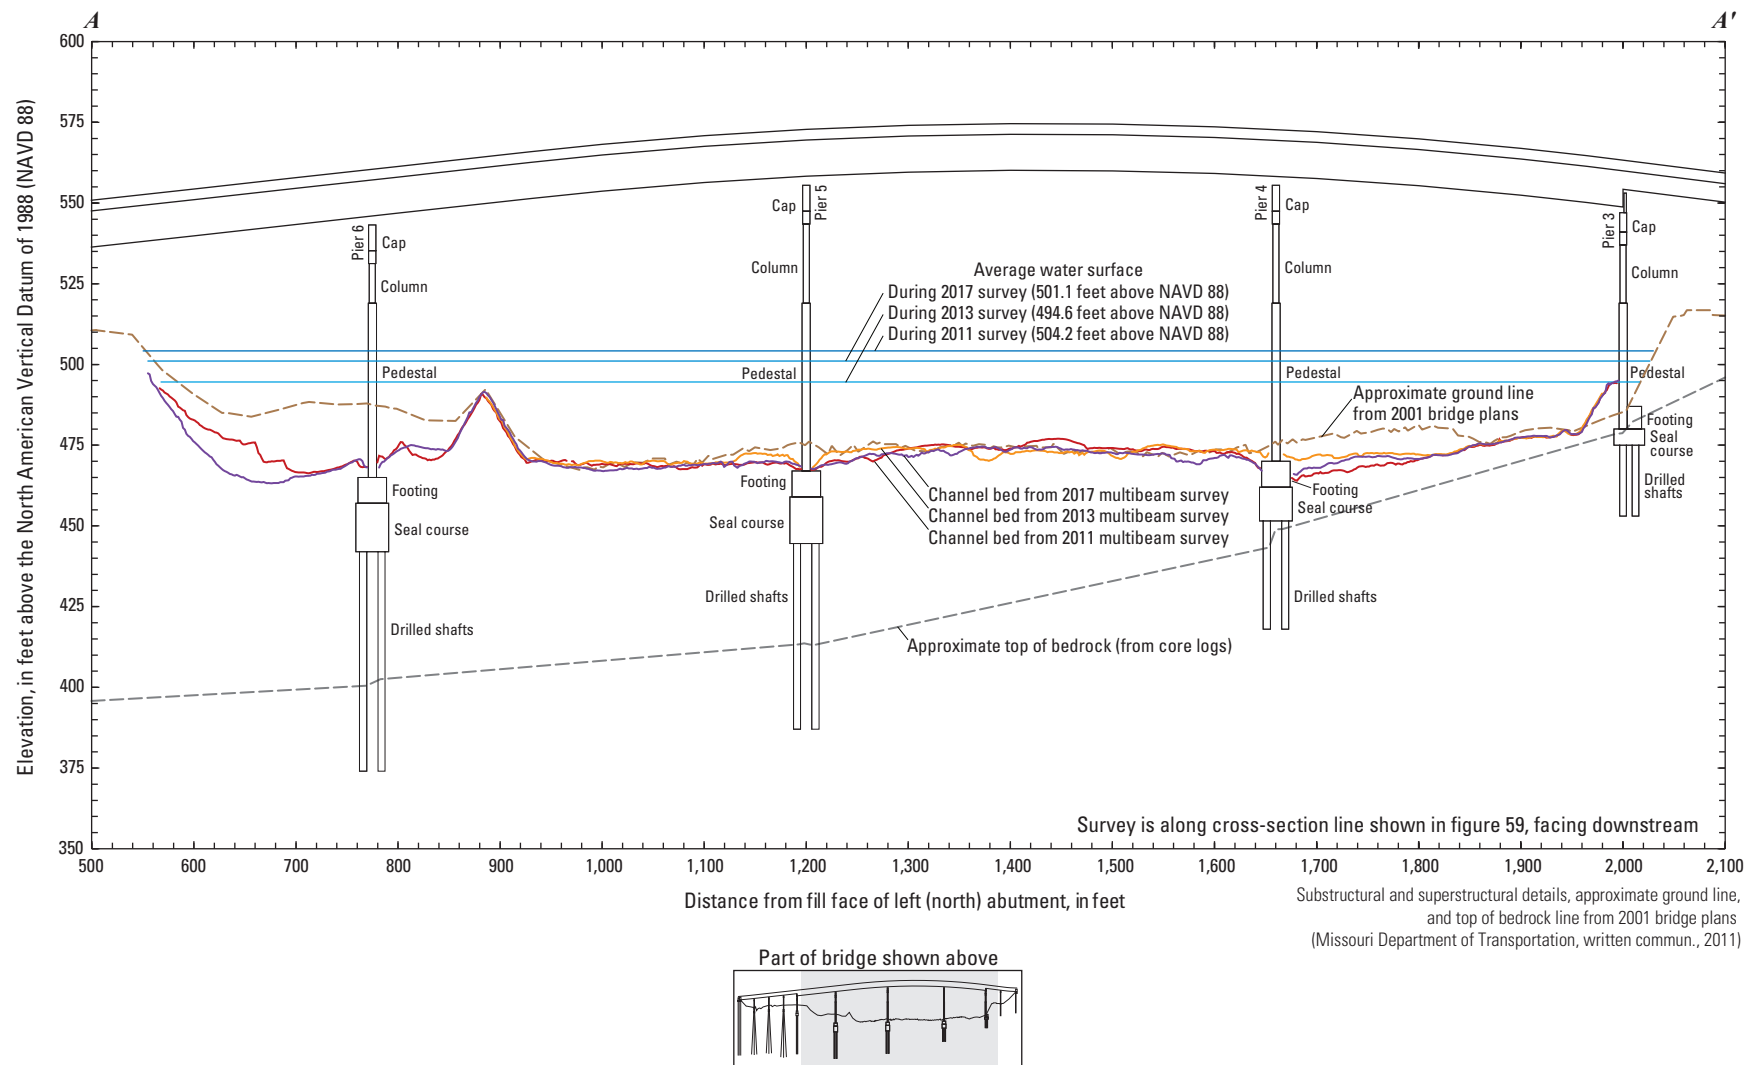
Figure 61. Key features, substructural and superstructural details, and surveyed channel bed of structure A6288 on Missouri State Highway 19 crossing the Missouri River at Hermann, Missouri.

the elevation of the bottom of the pier seal course of 444.50 ft (fig. 61; table 6). The minor scour hole near pier 4 had a minimum channel-bed elevation of about 463 ft (table 6), which is about 12 ft above the elevation of the bottom of the pier seal course of 451.50 ft (fig. 61; table 6). Both scour holes near main channel piers 4 and 5 were difficult to discern from nearby dunes and ripples, but the upstream edges of the footing of pier 4 were visible during the survey (figs. 59, 61). Information from bridge plans indicates that piers 4, 5, and 6 are founded on shafts drilled as much as 27 ft into bedrock, having about 64 ft of bed material between the bottom of the scour hole and bedrock at pier 6, about 51 ft of material at pier 5, and about 20 ft of material at pier 4 (fig. 61; table 6). The surveyed bed in 2017 generally was similar to both previous multibeam surveys in 2011 and 2013, which in turn, were similar to the original ground line in 2001 from bridge plans, except between pier 4 and the right (south) bank and to the left of the spur dike on the left (north) side (fig. 61).

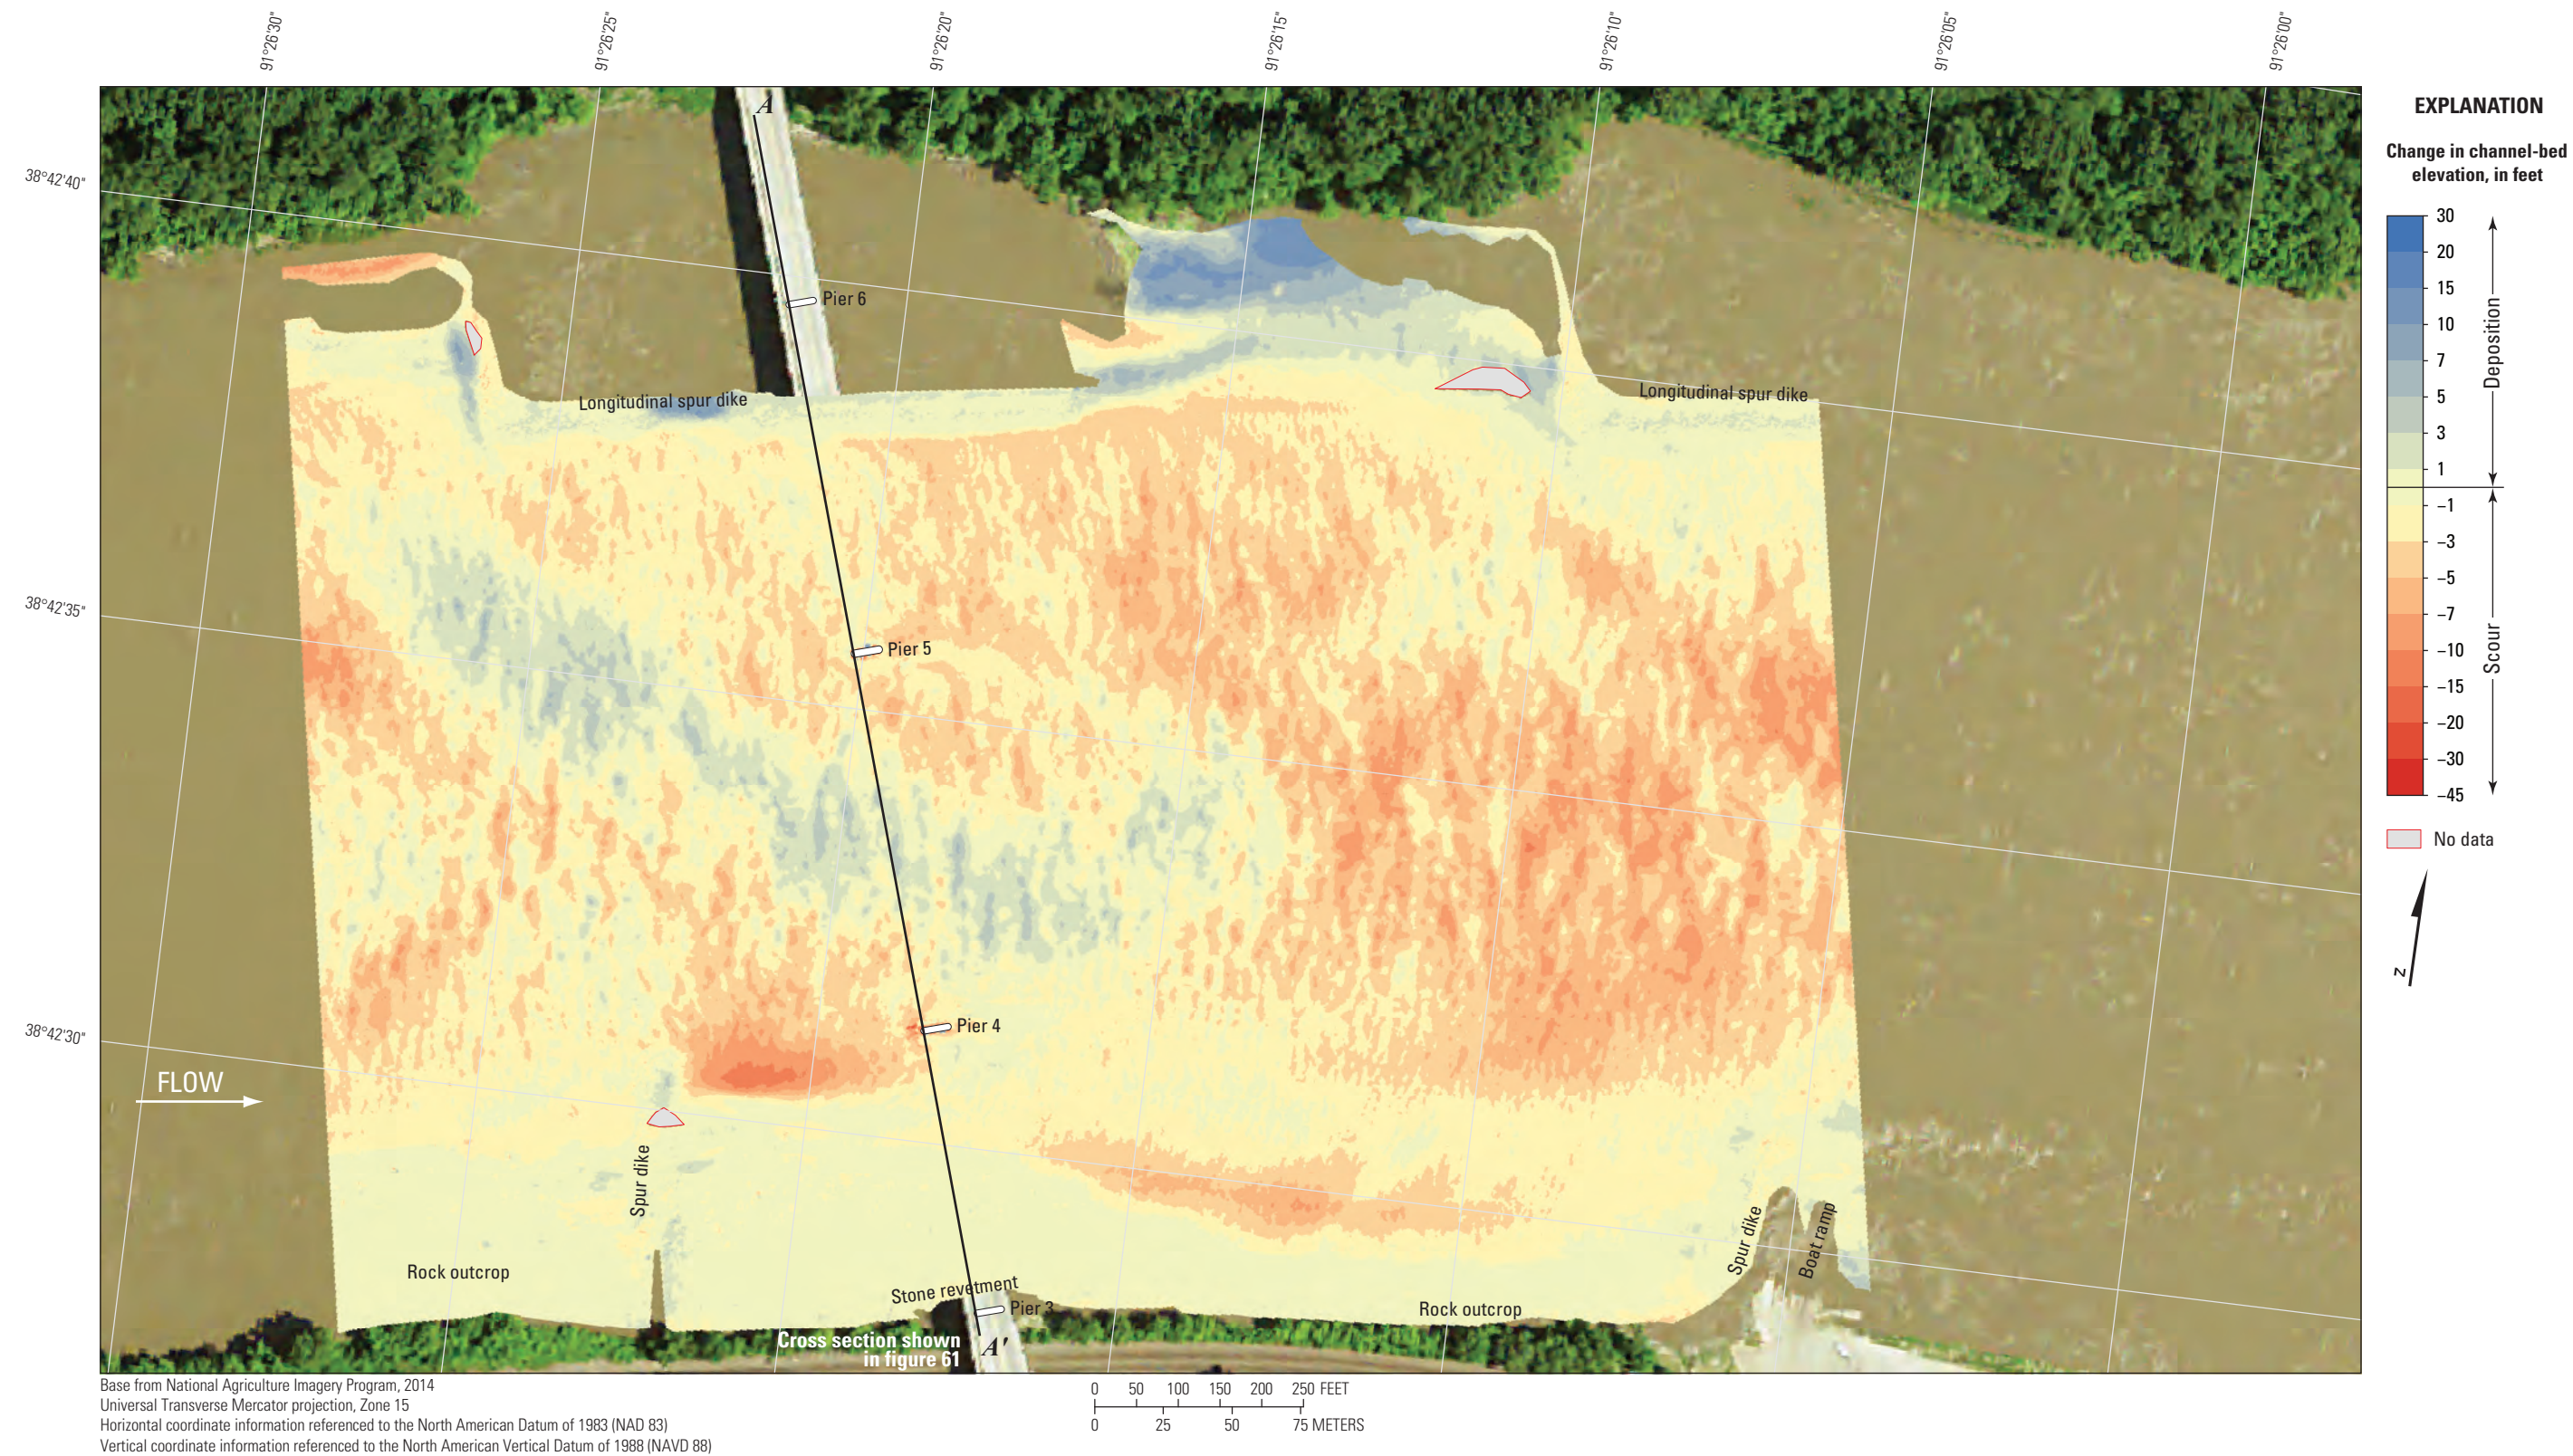
Figure 62. Difference between surfaces created from bathymetric surveys of the Missouri River channel near structure A6288 on Missouri State Highway 19 at Hermann, Missouri, on May 31, 2017, and May 2, 2013.

The difference between the survey on May 31, 2017, and the previous nonflood survey on May 2, 2013 (fig. 62), indicates minor to moderate scour has occurred throughout the reach between 2013 and 2017, with an average difference between the May 2013 and May 2017 bathymetric surfaces of -1.95 ft (table 7). The net volume of cut in the reach from 2013 to 2017 was about 176,900 yd³, and the net volume of fill was about 23,000 yd³, resulting in a net loss of about 153,900 yd³ of sediment between 2013 and 2017. Minor to moderate scour of as much as 10 ft throughout most of the reach is partially balanced with deposition in the area downstream from the spur dike on the left (north) bank and across the upstream center of the reach (fig. 62). The frequency distributions and cumulative percentage curves were remarkably similar in shape between the various surveys at this site (fig. 60), with a slightly higher percentage of survey-grid cells at a slightly lower elevation than in 2011.

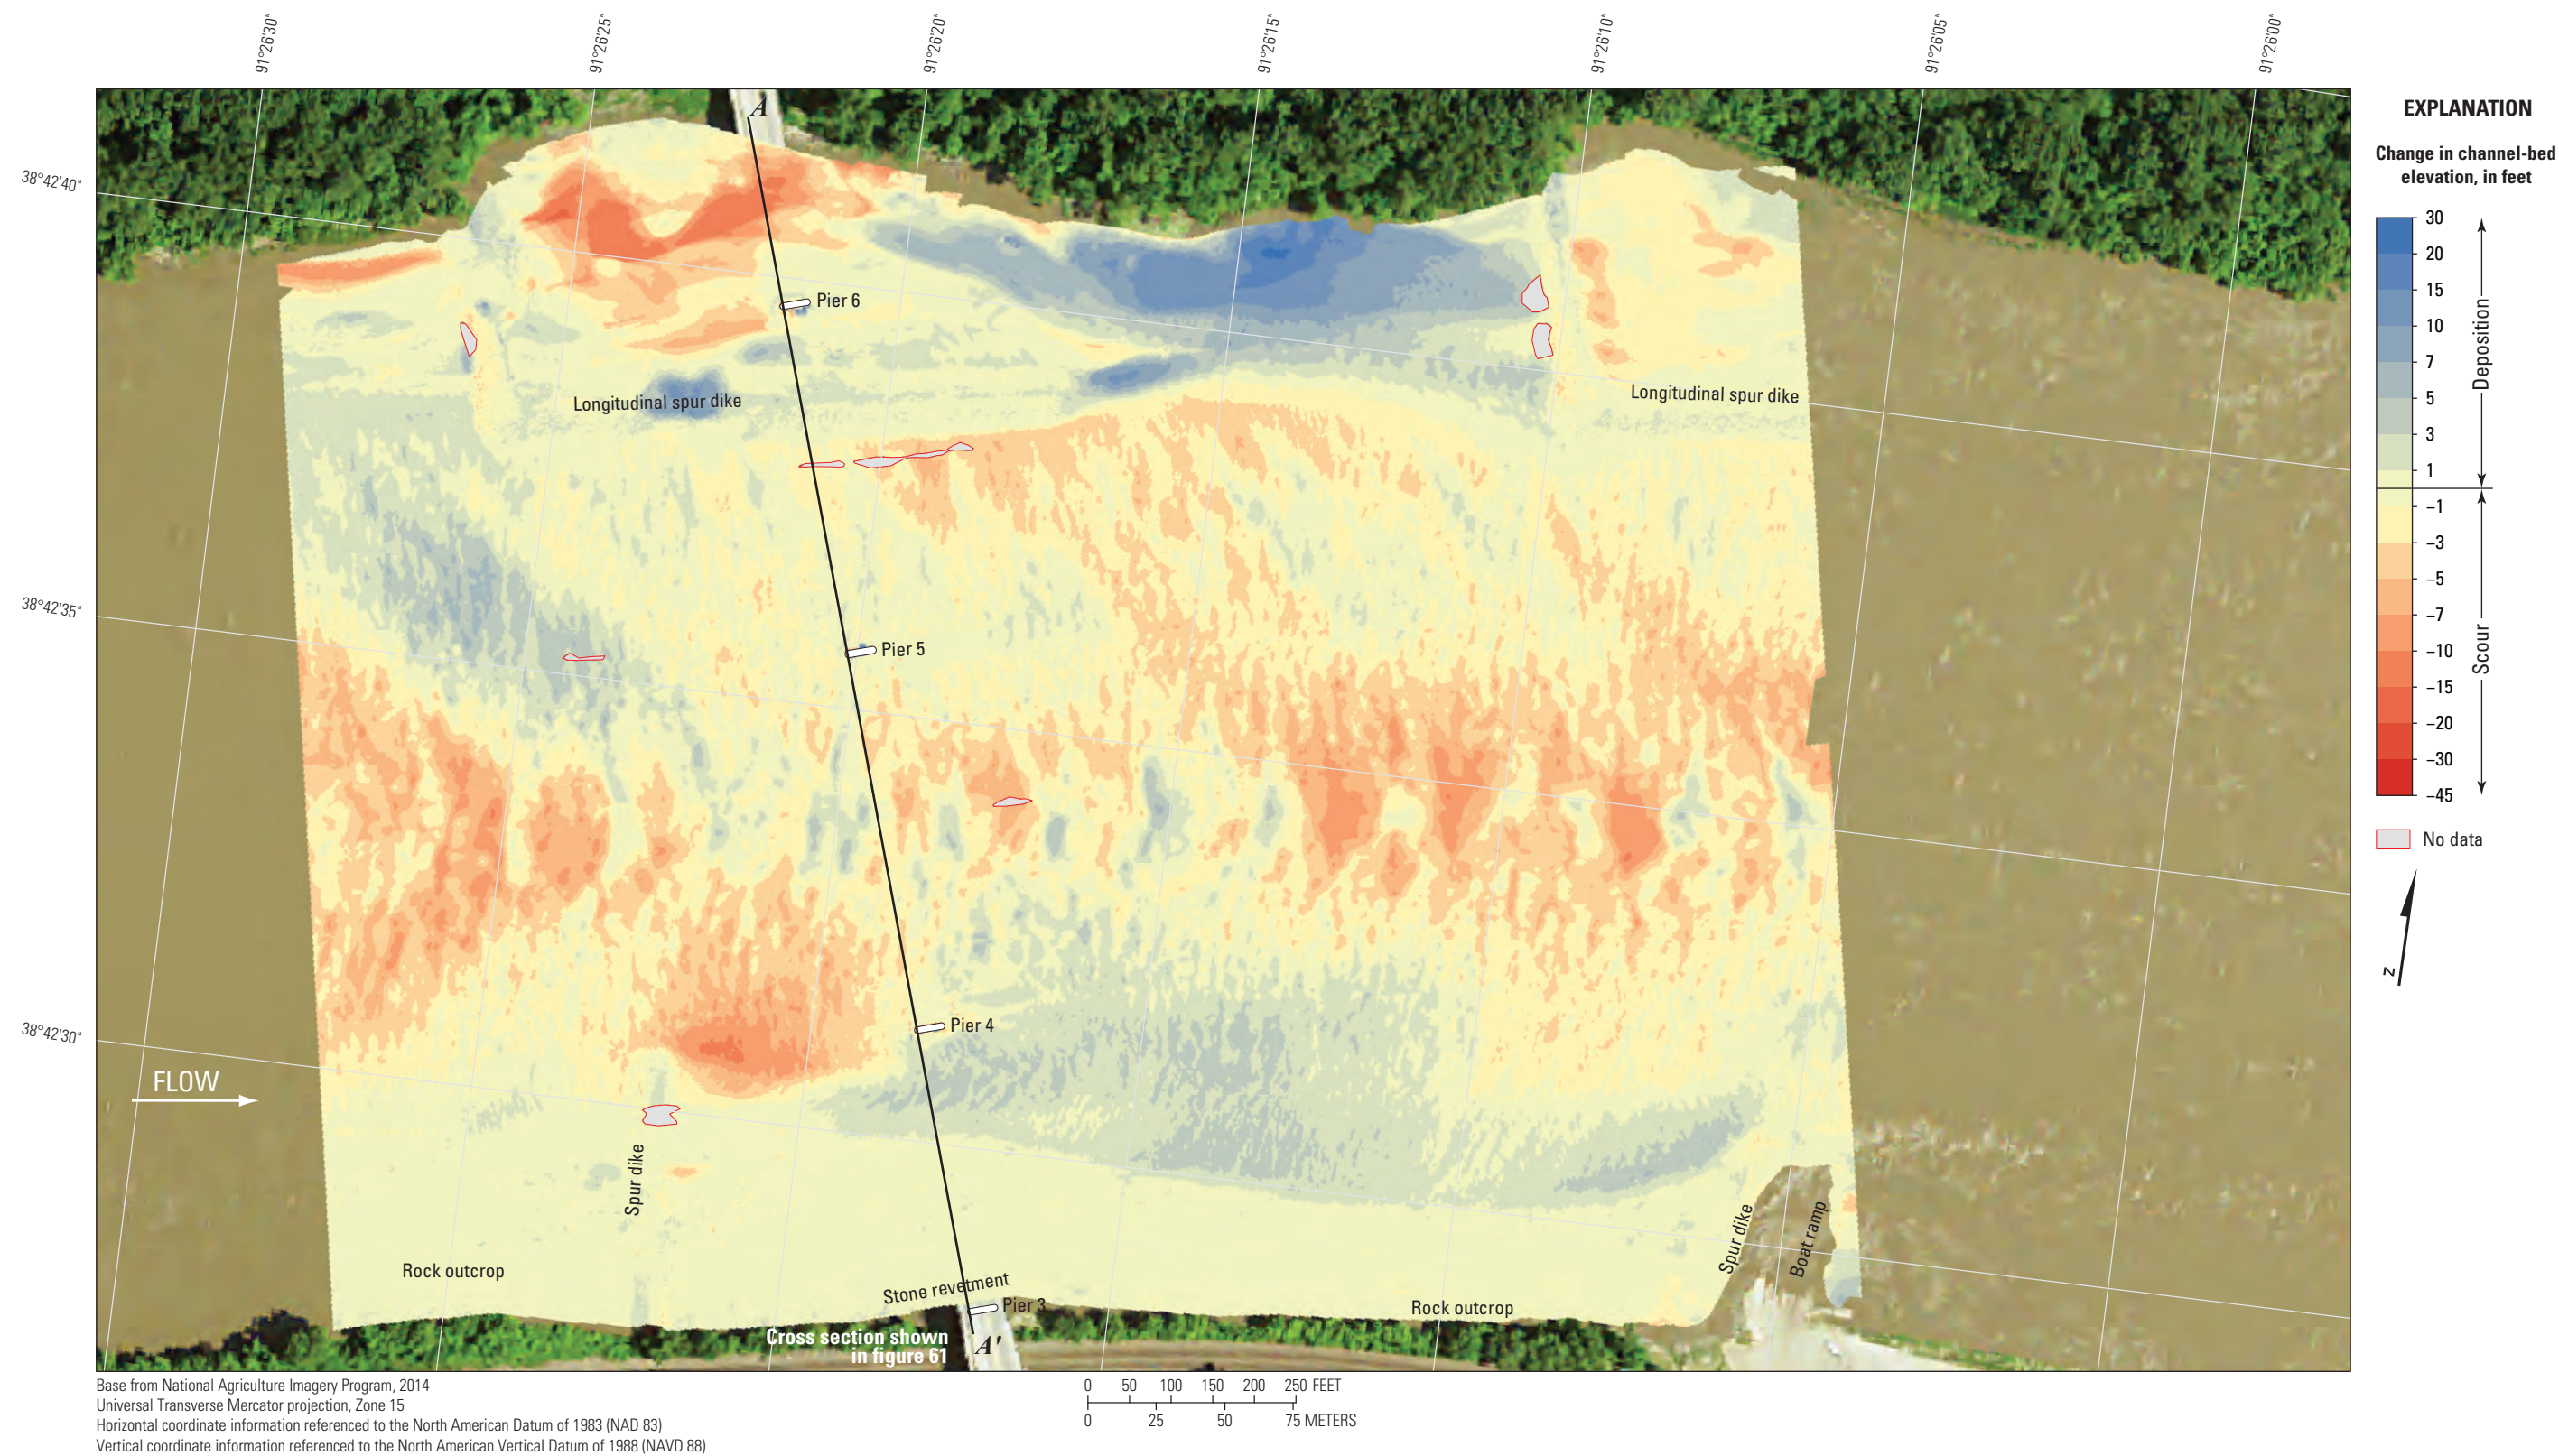
Figure 63. Difference between surfaces created from bathymetric surveys of the Missouri River channel near structure A6288 on Missouri State Highway 19 at Hermann, Missouri, on May 31, 2017, and July 28, 2011.

The difference between the survey on May 31, 2017, and the previous flood survey on July 28, 2011 (fig. 63), indicates an approximate balance between scour and deposition throughout the reach between 2011 and 2017, with a tendency towards minor scour (the average difference between the July 2011 and May 2017 bathymetric surfaces was -0.73 ft; table 7). The net volume of cut in the reach from 2011 to 2017 was about 133,200 yd³, and the net volume of fill was about 66,700 yd³, resulting in a net loss of about 66,500 yd³ of sediment between 2011 and 2017. Moderate scour of as much as 15 ft in the center part of the channel, and moderate to major scour of as much as 20 ft inside the longitudinal spur dike on the left (north) side near the bridge

is balanced with localized deposition of as much as 30 ft in other areas of the channel (fig. 63). Large dune features present in the middle of the channel in the 2011 survey were replaced with medium to small dunes, resulting in an alternating scour/deposition pattern in that area (fig. 63).

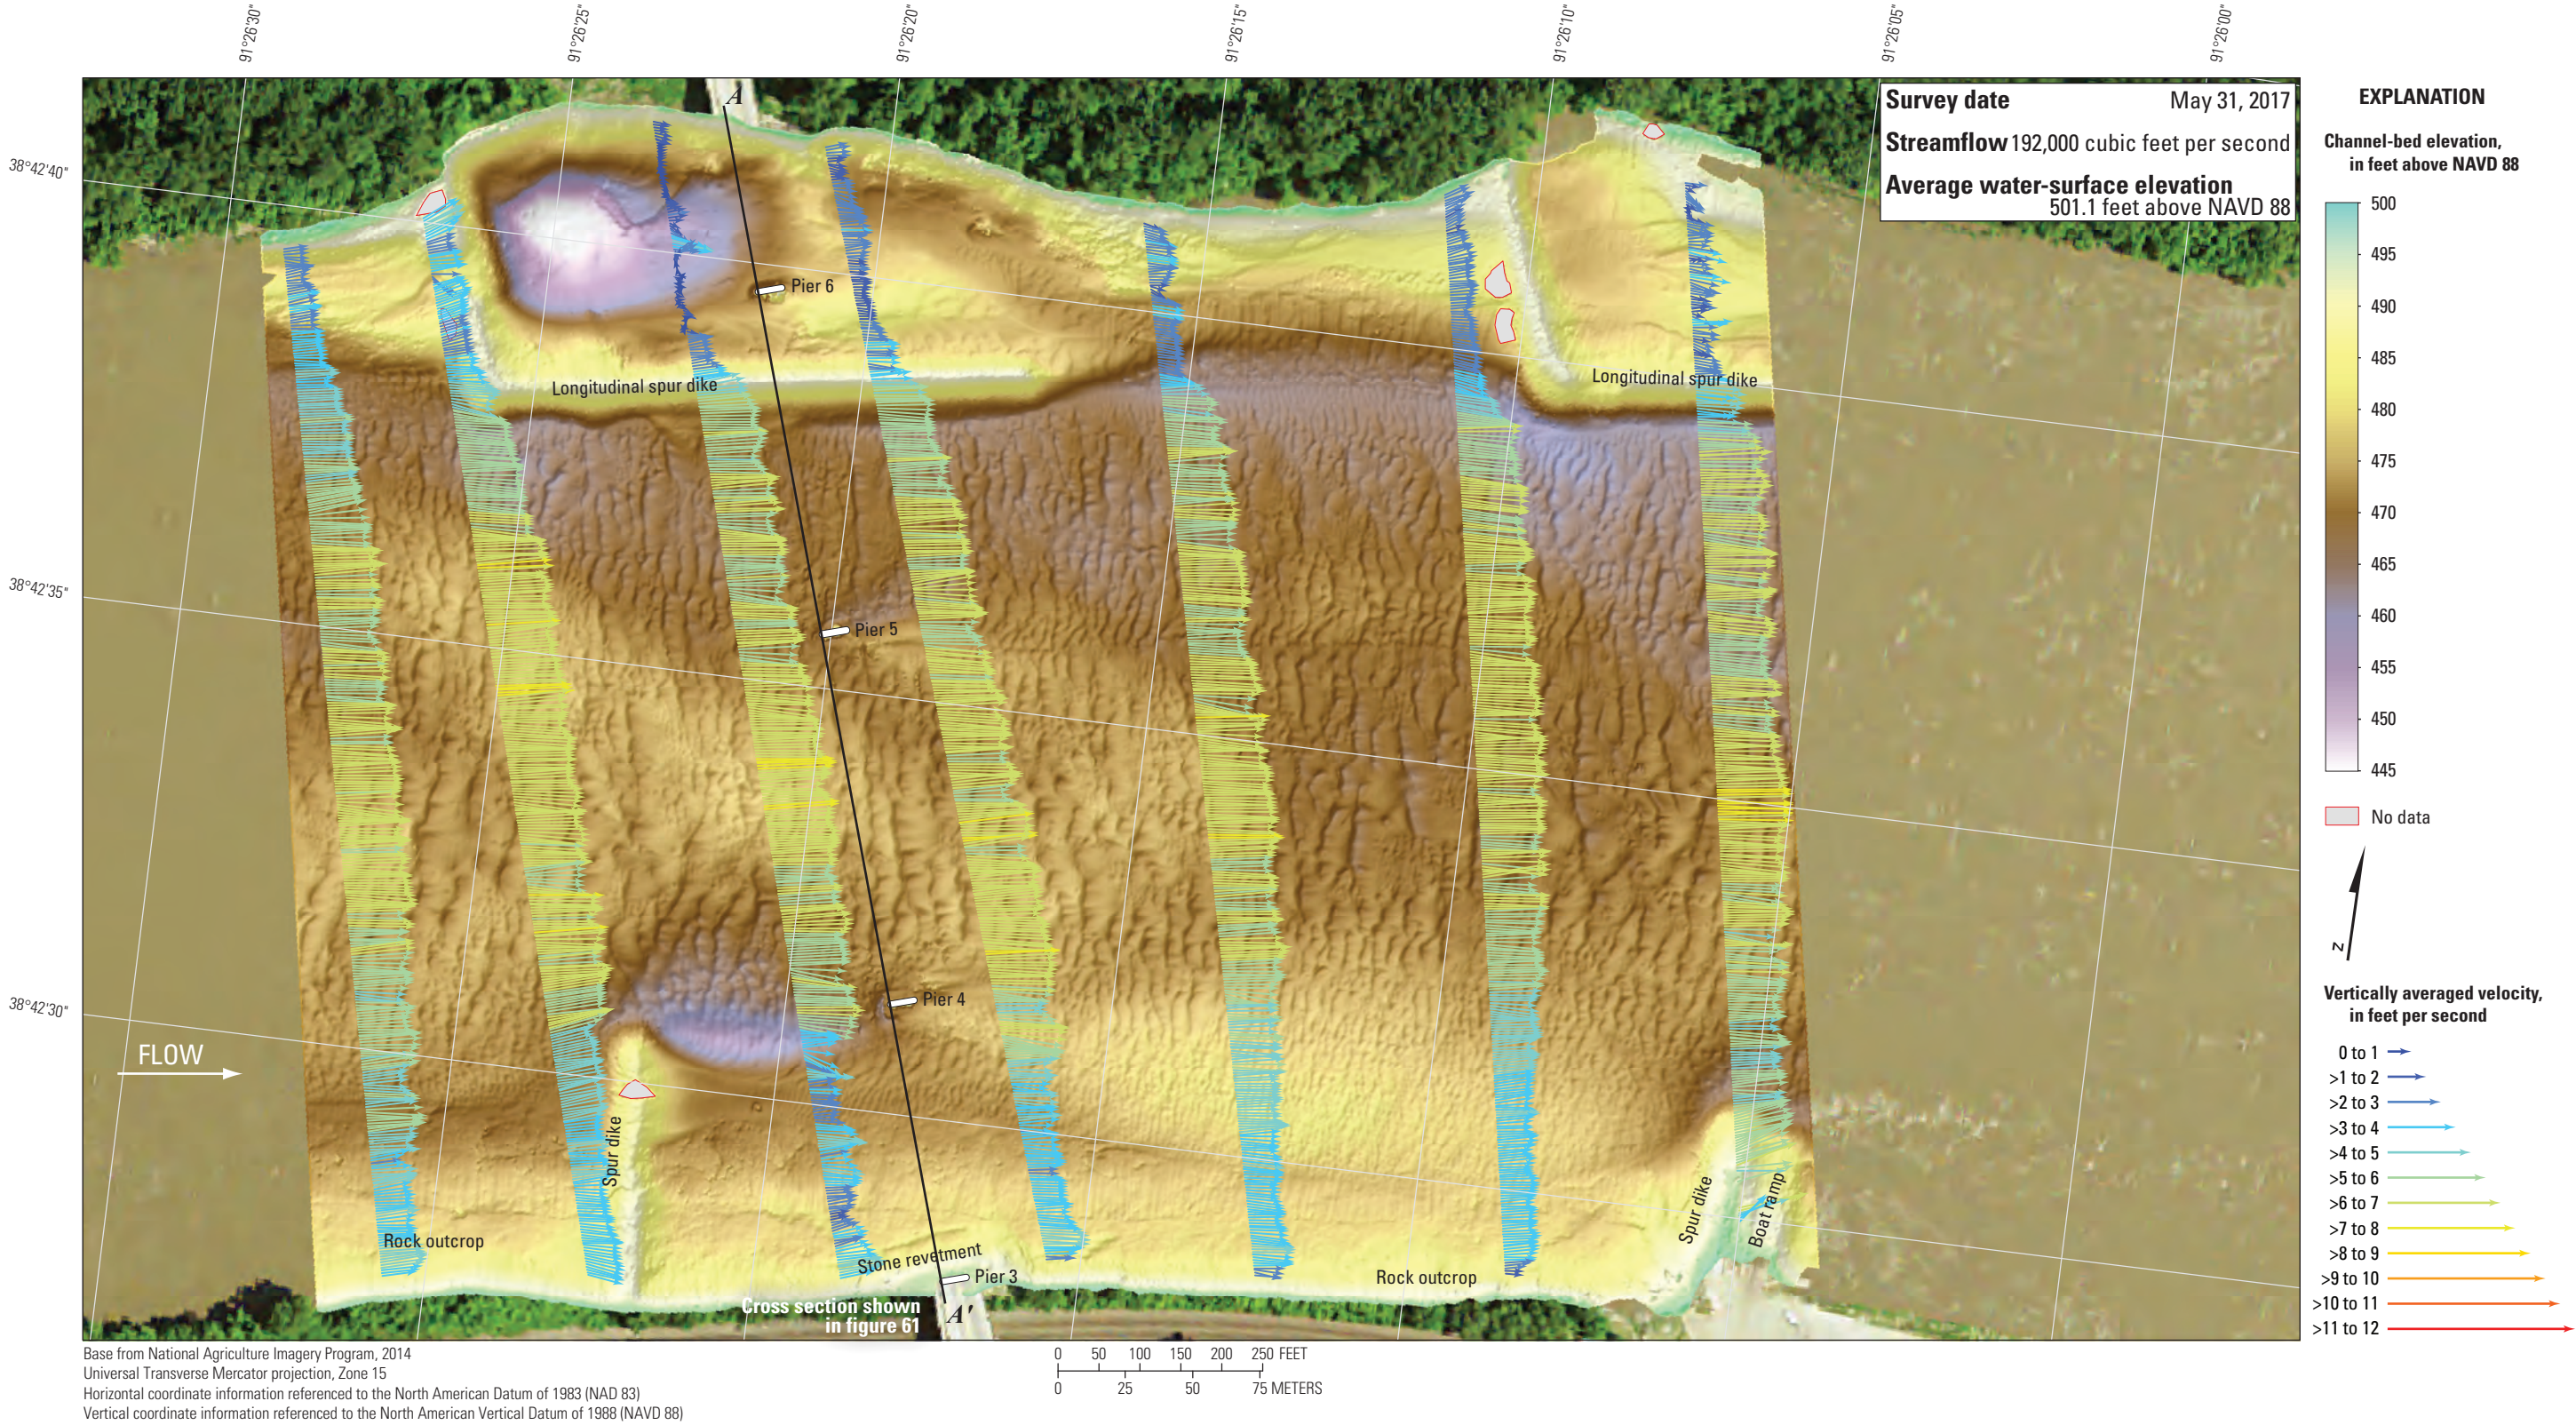
Figure 64. Bathymetry and vertically averaged velocities of the Missouri River channel near structure A6288 on Missouri State Highway 19 at Hermann, Missouri.

The vertically averaged velocity vectors indicate mostly uniform flow throughout the reach, ranging from about 1 to 8 ft/s (fig. 64). Exceptions to uniform flow include moderate turbulence and flow reversal downstream from the upstream right spur dike and the longitudinal dikes on the left bank (fig. 64). The bridge piers were skewed to flow but caused only minor turbulence downstream (fig. 64).

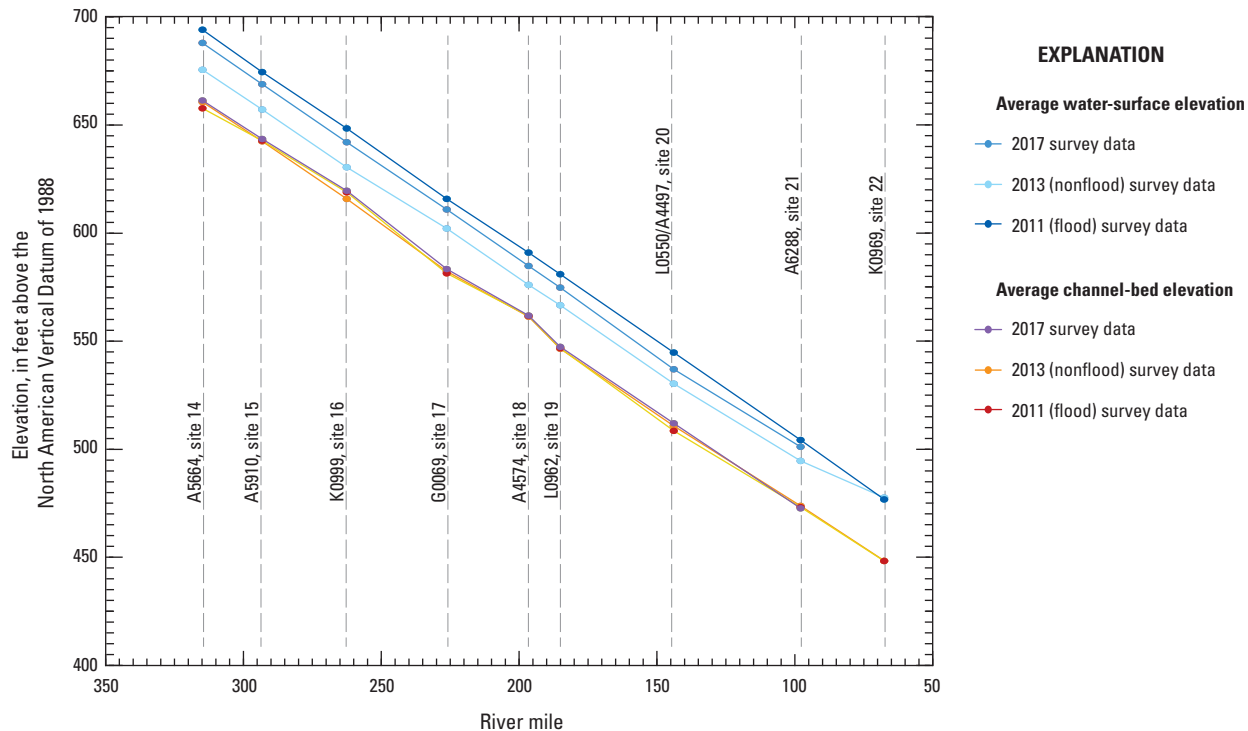
Figure 65. Average channel-bed and water-surface elevations near bridges on the Missouri River between Kansas City and St. Louis, Missouri, from surveys in 2011, 2013, and 2017.

The average channel-bed elevation at structure A4574 (site 18) was remarkably similar in all three surveys (0.5-ft overall variation in all three surveys) and higher than what might be implied by a trendline along the reach between Kansas City and St. Louis (fig. 65). This lack of variability may indicate this site is at or near a local feature that controls sediment deposition and scour. The Missouri River flood plain is somewhat narrower downstream, and the transition in physiographic province from the Central Lowlands to the Ozark Plateau occurs near this area (Missouri Department of Natural Resources, 2002).
