NASA TECHNICAL MEMORANDUM

NASA TM-82424

LOX/GOX RELATED FAILURES DURING
SPACE SHUTTLE MAIN ENGINE DEVELOPMENT

By C. E. Cataldo
Materials & Processes Laboratory

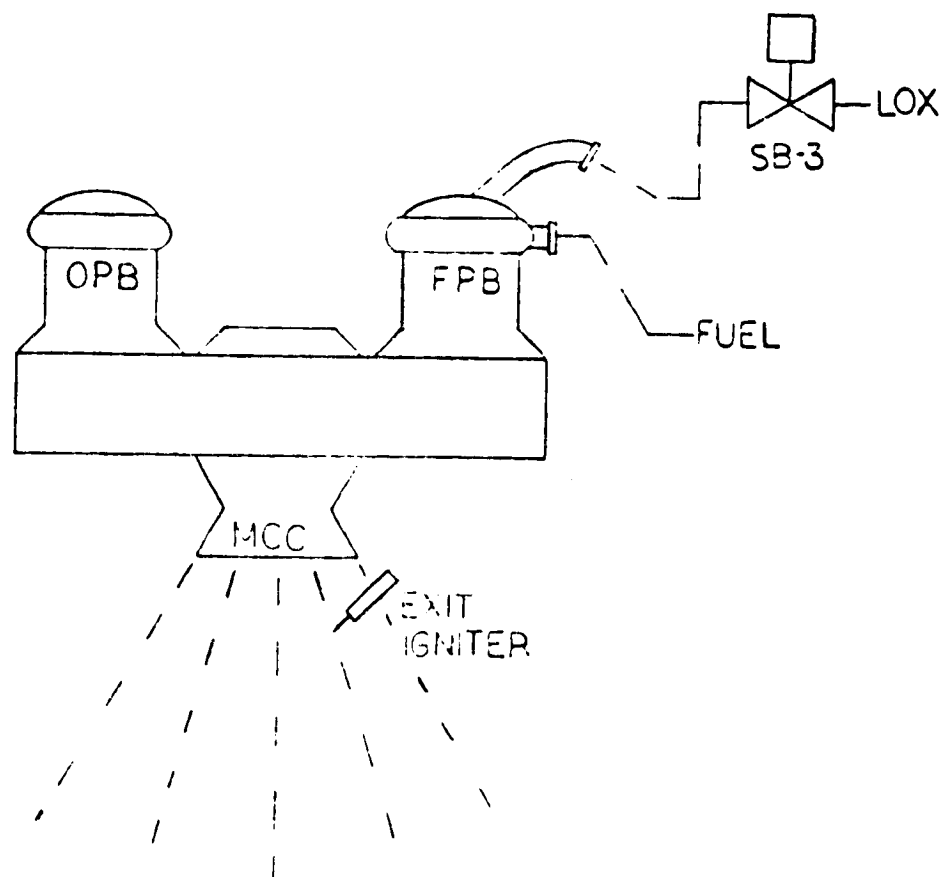
Figure 1. Coca 4B Test 014

On March 7, 1975, an SSME Powerhead test (014) was underway at the Rocketdyne Santa Susana Test Facility in Los Angeles, California, when the test was terminated by an explosion. The test objective was to complete a preburner ignition and main combustion chamber ignition. The failure resulted in moderate to extensive damage to several components of the assembly. Most of the damage resulted from a combustion wave propagating through the system from the ignition of mixed gases at the nozzle exit. Figure 1 is a simplified schematic of the test assembly. However, the propellant feed lines contained numerous ball valves, filters, and flowmeters, as shown in Figure 2, which is an isometric schematic of the oxidizer system. Note the flow of lox from the lox tank to the oxidizer preburner (OPB). LB-7 is a 2 in. 7800 series Annin valve used as a lox bleed valve, and is

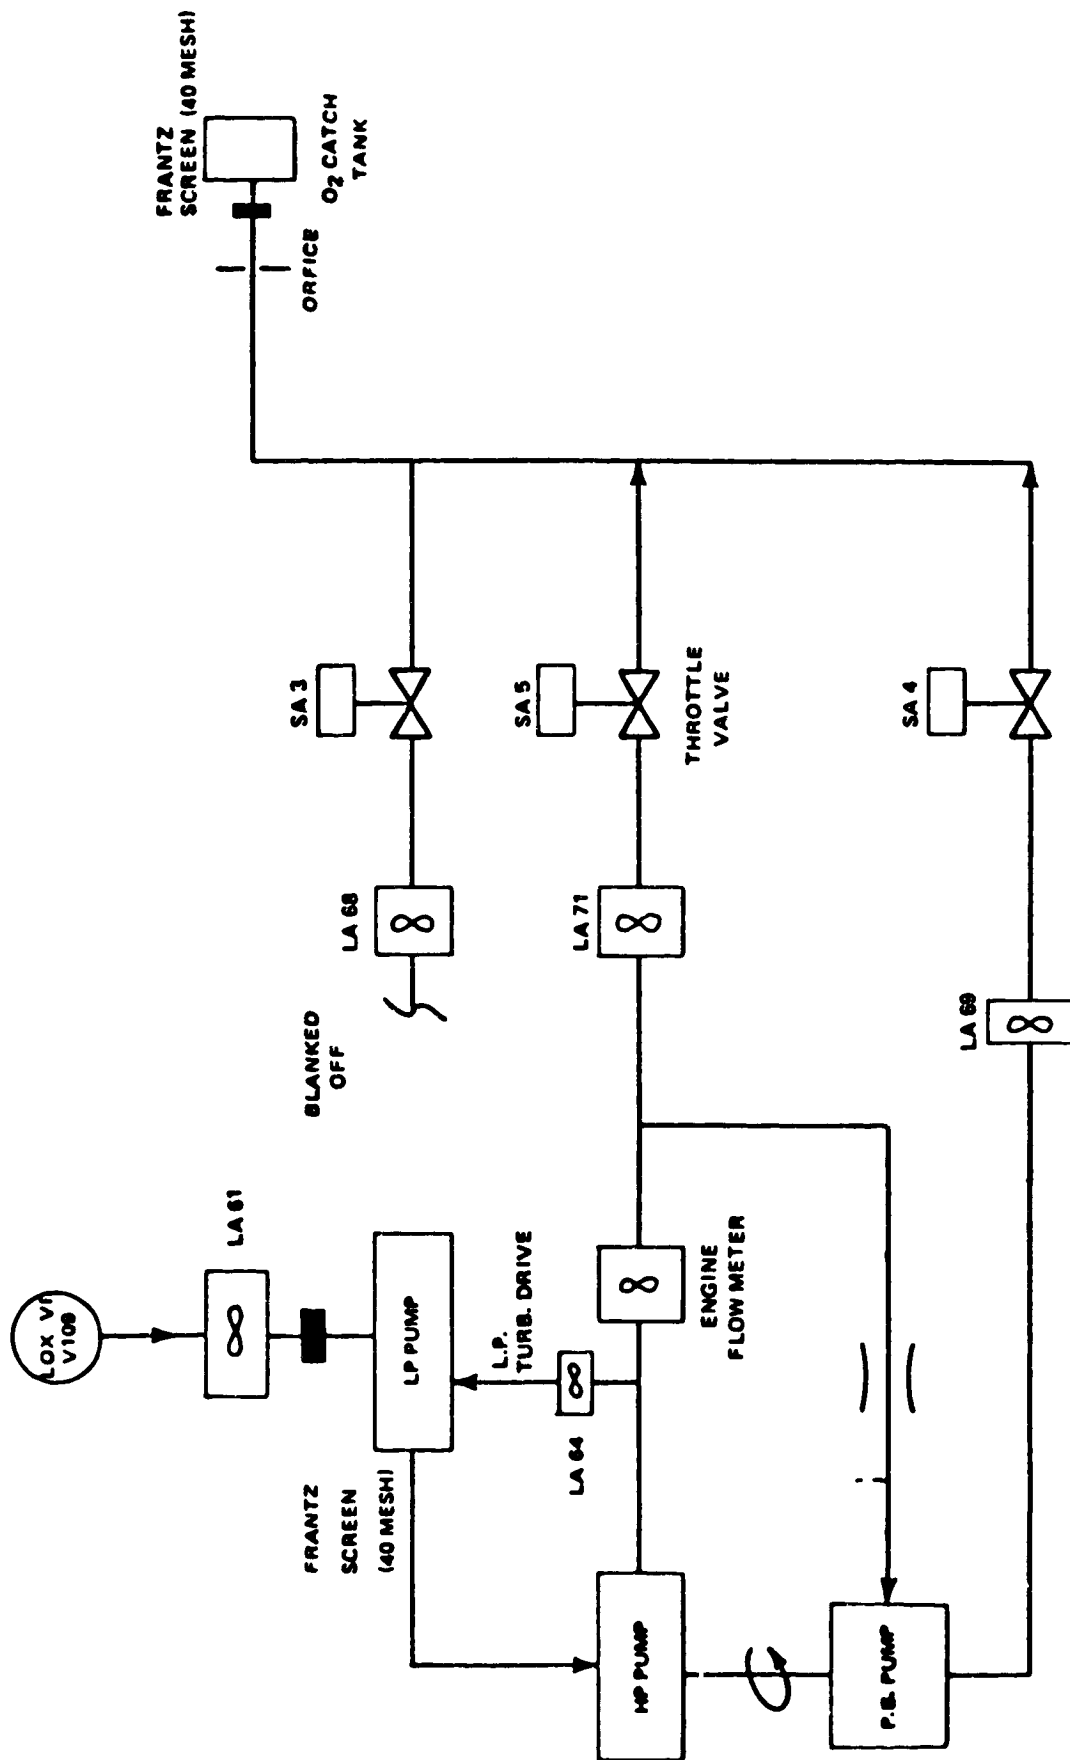
Figure 4. Coca 1A simplified schematic of test hardware.

A simplified schematic of the test hardware is shown in Figure 4. The test set up and annotations as to post test observations are shown in Figure 5. Extensive burning occurred in the SA-5 Annin Throttling valve, as illustrated in Figures 6 and 7. Also, damage was observed in a flowmeter (LA-71). The meter lost two adjacent rotor blades; a retaining ring was dislodged; and two anti-rotation pins were missing (Fig. 8 and 9).

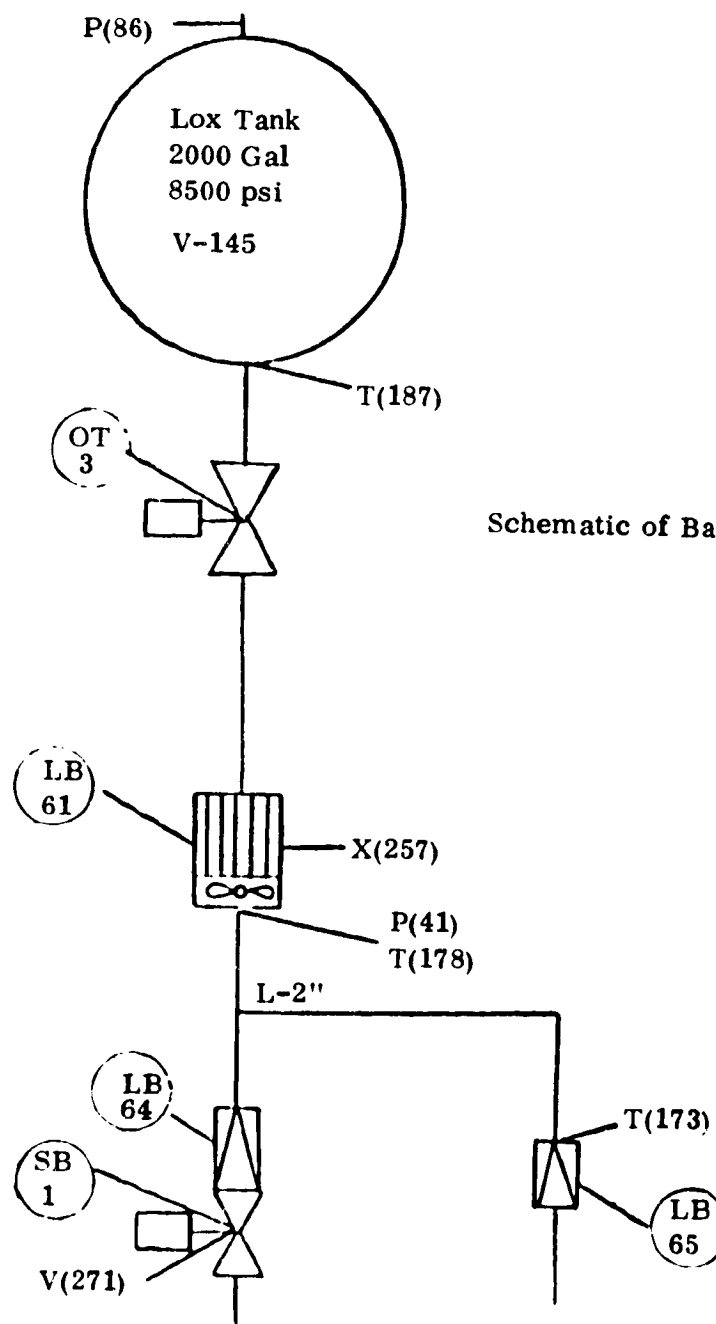
Figure 16. Coca IB test 018 system schematic.

A sketch of the basic facility system is shown in Figure 16. A sketch of the SB-1 valve seat and stem assembly is shown in Figure 17.

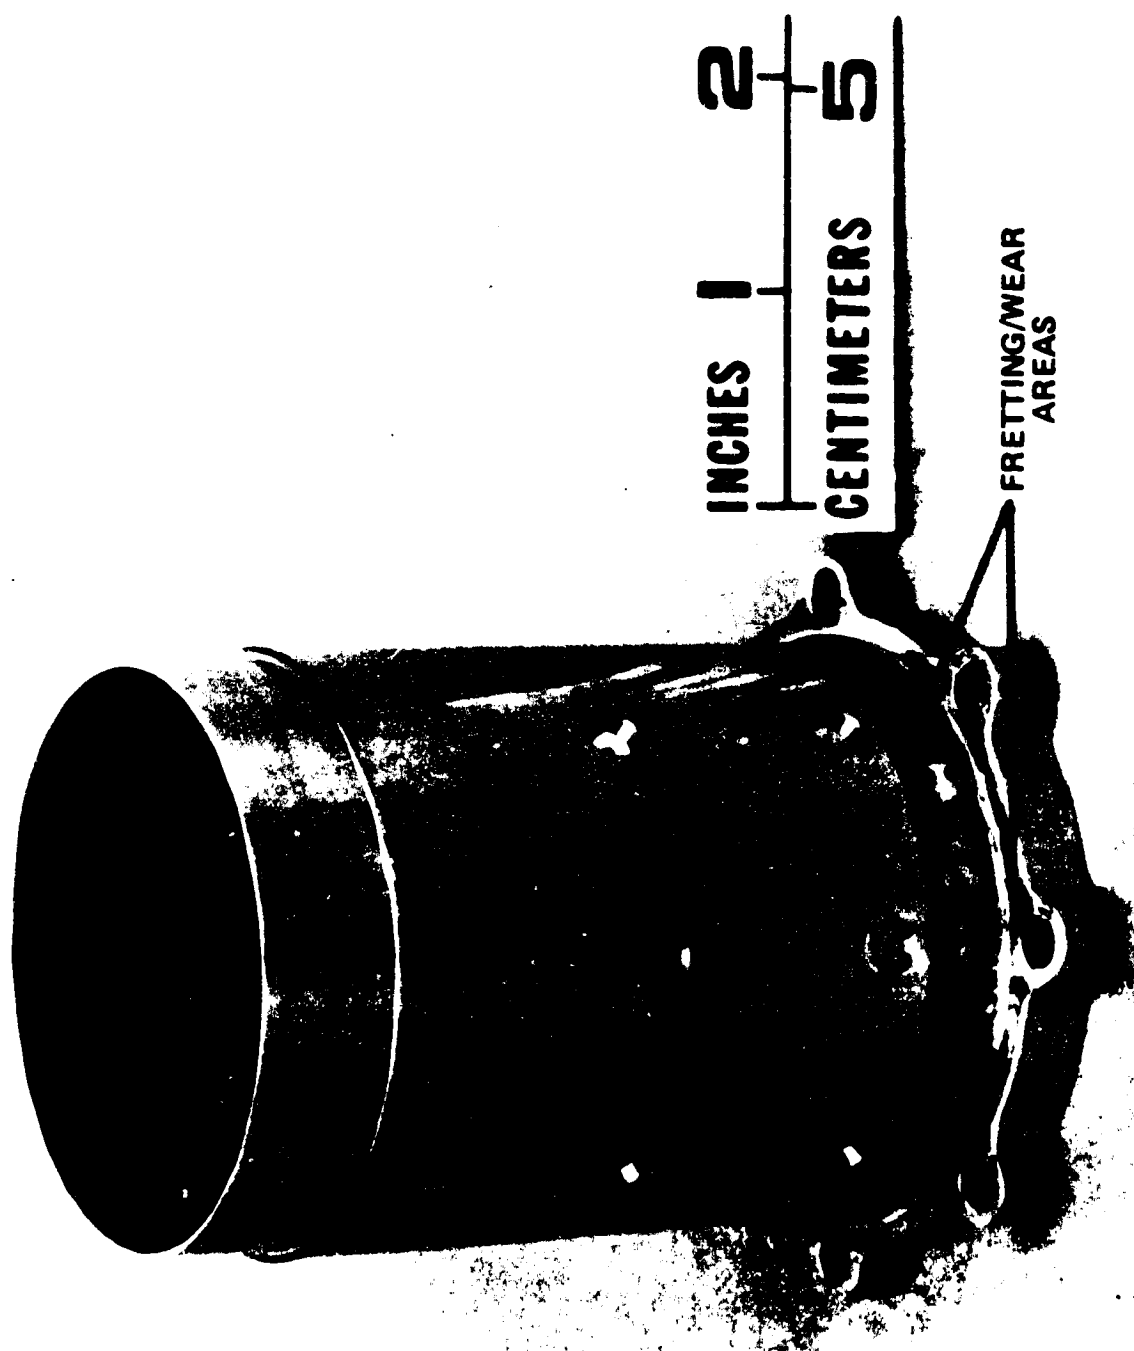
Figure 46 is a photograph of the inlet sleeve removed from the burned MOV. Note the thin shims used at the flange and the eroded flange section originating at a screw hole. This evidence and other observations led the failure investigation team to conclude that:

- 1) The MOV was undergoing severe vibrations due to an acoustic/flow characteristic of the propellant flow through the valve. (This vibration characteristic, predominantly in the 7200 Hz range, was later eliminated by closing the small gap at the inlet flange interface.)
- 2) The A286 steel screw loosened sufficiently to allow fretting of the mating parts, and the generation of localized heat where the screw threads fretted against the thin 302 CRES shims in the flange area (Fig. 46).
- 3) Ignition of the shims occurred and the burning propagated to the 21-6-9 CRES inlet liner and subsequently to the Inconel 718 bellows surrounding the liner.
- 4) The burning began to erode the downstream duct and simultaneously increased the pressure in the duct and injector manifold to a pressure exceeding the strength of the hot Inconel 718 ducting, resulting in rupture of the duct.

Figure 46. Inlet sleeve removed from the burned MOV.

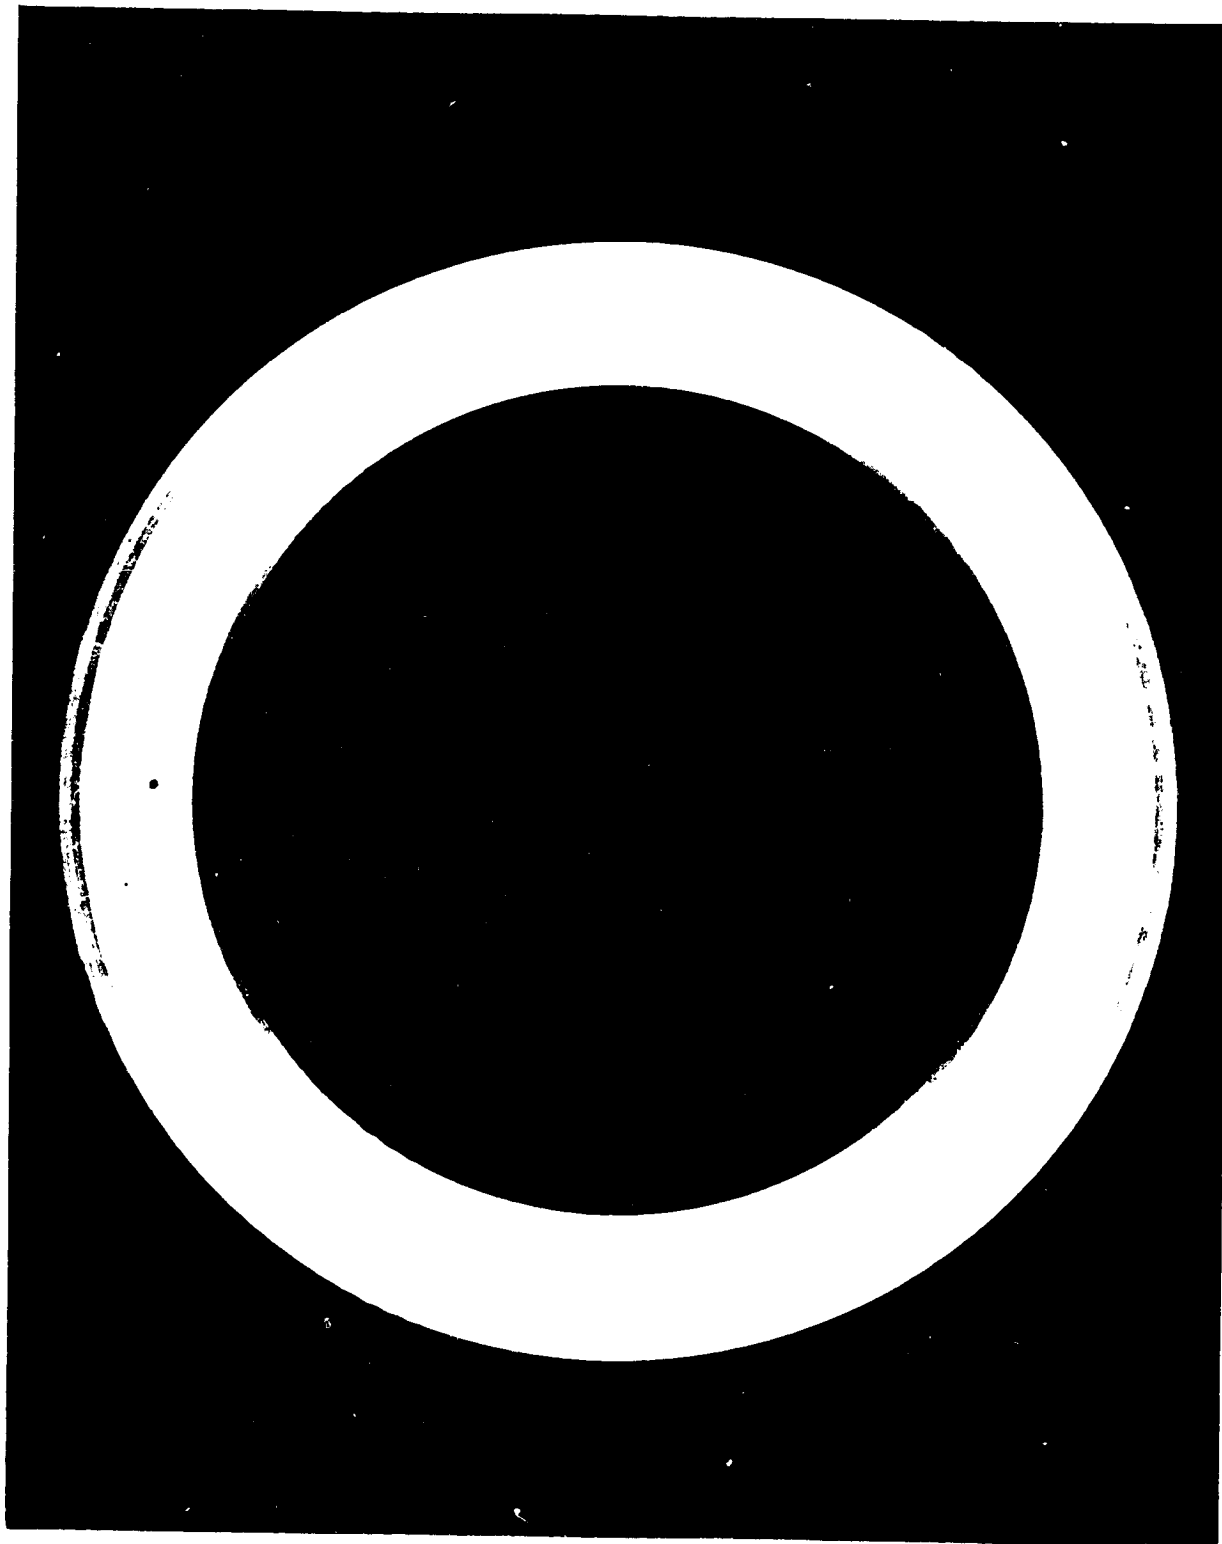
Figure 50. MOV Kel-F ball seal configuration.

Figure 49 is a cross-section of the MOV showing the location of the Kel-F ball seal. Figure 50 shows the original configuration of the seal and Figure 51 is the damaged seal from the 0201 test. Approximately 120 degrees of the seal circumference remained; the other material was washed downstream by the lox flow into the lox dome and injector. The seal appeared to have been heated to the melting point beneath the surface. Many small pieces were recovered from the backside of the injector and all showed evidence of erosion and/or melting.
