Bulletin 685

RELATION OF LANDSLIDES AND GLACIAL
DEPOSITS TO RESERVOIR SITES

SAN JUAN MOUNTAINS, COLORADO

WALLACE W. ATWOOD

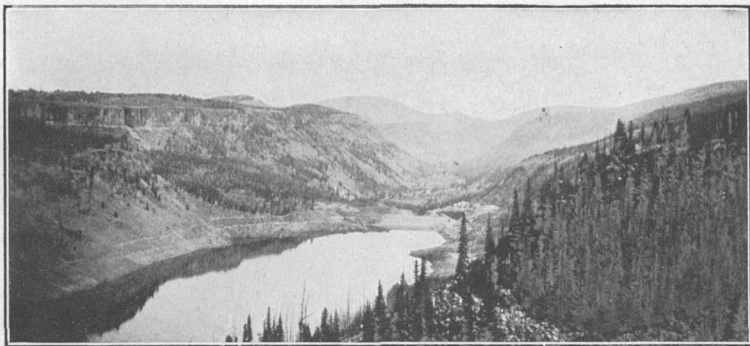
A. FARMERS' UNION RESERVOIR, LOOKING DOWN THE VALLEY OF THE RIO GRANDE FROM A POINT ON THE WEMINUCHE TRAIL.

View showing the location of the dam and the great landslide area to the north.

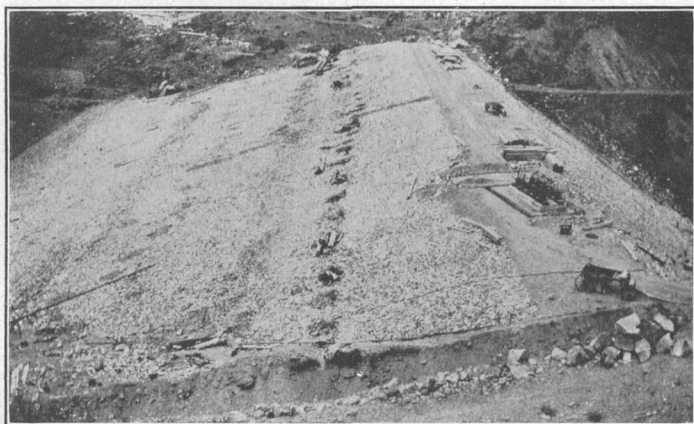
B. DAM OF THE FARMERS' UNION RESERVOIR FROM THE SOUTH.

The spillway appears in the foreground, and the reservoir is to the left. Control gates are near the roadway on the crest of the dam.

The dam is built of earth and rock and contains a concrete core wall. (See Pl. I, B.) It is about 100 feet high and 400 feet wide and appears to be watertight. The tunnel and spillway (fig. 5) are near

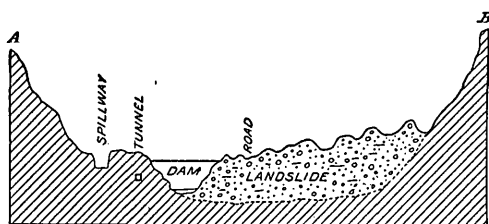
FIGURE 5.—Cross section along the line A-B on figure 4. The diagonal lining simply indicates the extent of the consolidated rock formations, which lie nearly horizontal.

the south side of the valley and are cut through rock, which is in place, though somewhat fractured. The level of the spillway permits waters to accumulate in the reservoir to a height of 85 feet just above the dam, and with that height of water there would be a reservoir 7 miles in length

unless the tunneling had gone perhaps a quarter of a mile, so as to reach the north wall of the canyon. (See fig. 5.)

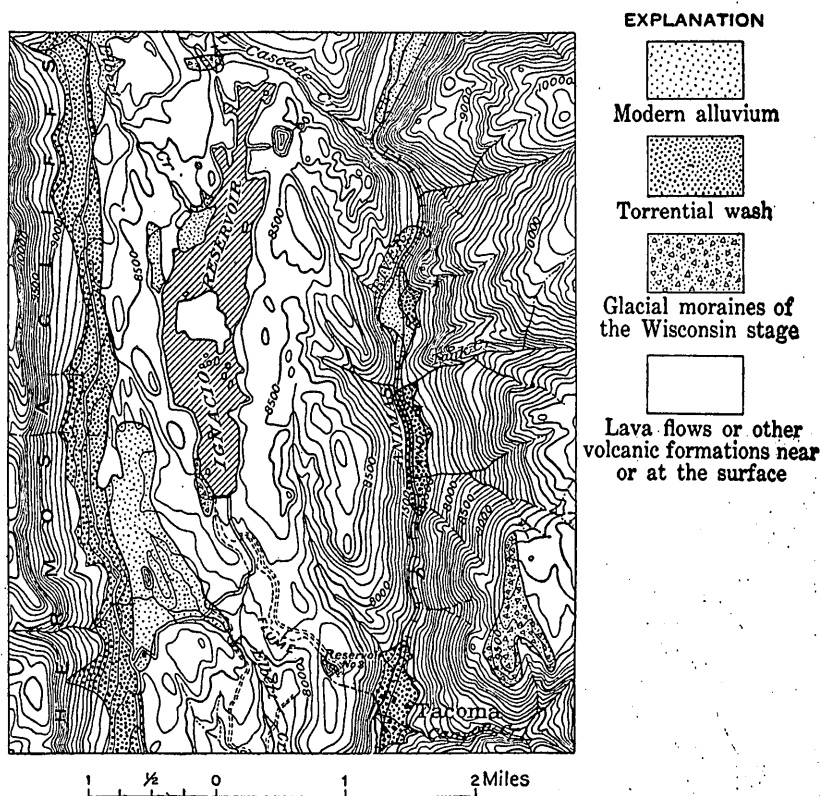
FIGURE 6.—Map of a part of the Engineer Mountain quadrangle, showing the location and topographic relations of the Ignacio reservoir and the distribution of the loose or unconsolidated formations within the area shown. The bench on which the reservoir lies has been severely glaciated, and there is a scattering of glacial drift over most of its surface.

dam is built of log cribbing with rock fill. (See Pl. II, *C.*) It is faced with three thicknesses of planking with tar paper between. Ordinarily this dam will hold from 48 to 50 feet of water. No overflow is allowed, for the waters come into the reservoir through flumes and, when necessary, may easily be diverted. The outlet from the reservoir is through a large pipe in the dam, and thence into a 6-foot concrete tunnel through a morainic hill. The intention may have been to rest this dam upon bedrock throughout its length, but as several serious leakages have occurred beneath the dam it appears that the base of the dam was not at all places below the glacial débris.

The dam was not constructed at so great expense or with so much care as many of the more modern structures, and there is always some leakage. It has been reported that twice in the history of the reservoir large leaks have developed. The timbers are now very badly rotted, and the remaining life of the dam would appear to be relatively short.

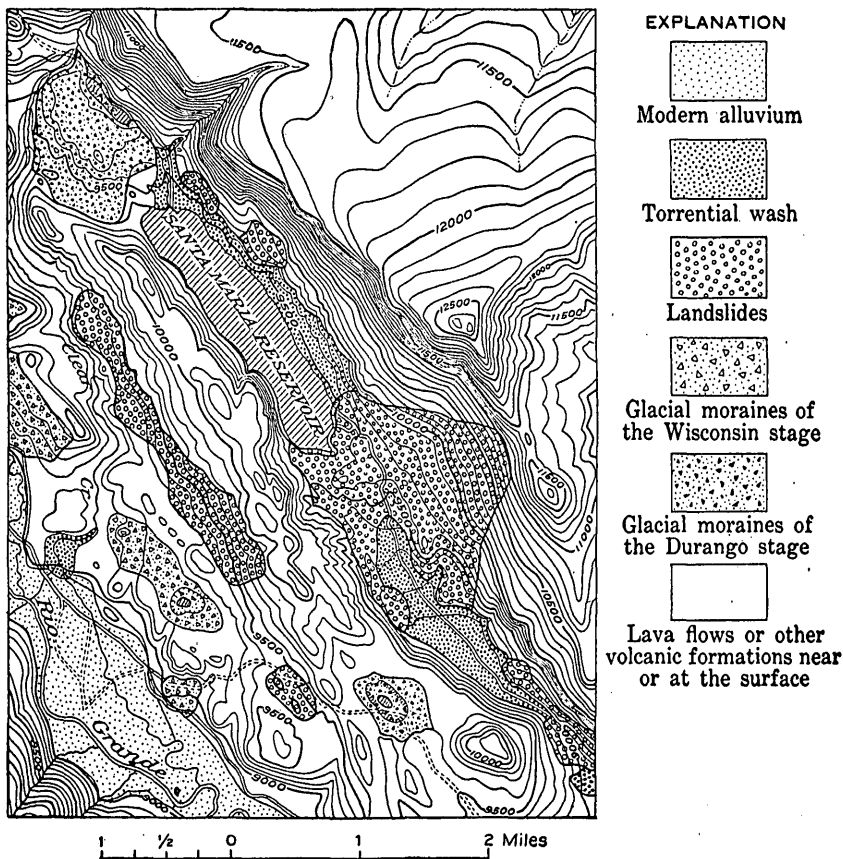
FIGURE 8.—Map of a part of the San Cristobal quadrangle, showing the location and topographic relations of Santa Maria reservoir and the distribution of the loose or unconsolidated formations within the area shown.

The nearly vertical wall of Bristol Head, to the east of the lake, rises over 3,000 feet above the lake level. To the west there is also a steep wall, but this one rises only 800 feet above the average level of the lake. Vast quantities of debris have fallen from the cliff immediately below Bristol Head and partly filled the depression just west of the mountain and south of the lake. (See fig. 8.) There is now a landslide mass at this locality fully 1 mile wide and 500 feet thick, extending for a distance of nearly 2 miles along the axis of the

rim of the lake basin (fig. 9), large quantities of water have seeped through and issued fully a mile and a half to the south, forming a small pond from which, at times, a rushing torrent flows by Antelope Springs and into the Rio Grande. About the south end of the reservoir, however, no signs of leakage appear in the great landslide mass; the surface is apparently entirely unmodified. The water appears at the south margin of this landslide mass not from a single exit, like an underground stream, but probably from general seepage through this huge mass of material. About half a mile below the reservoir there is a small lake or pond in the midst of the landslide masses (fig. 9), and the waters in this small lake have risen and fallen with the waters in the reservoir. It is clear, therefore, that the seepage is quite free as far south as this lake, and the stream already referred to makes it also very apparent that the seepage is free still farther south and, indeed, throughout the mass.

During September, 1915, the waters were being withdrawn from this reservoir. Exploratory work was being carried on at the south margin to determine the nature of the material where the leakage was taking place. This work did not seem to yield significant results,

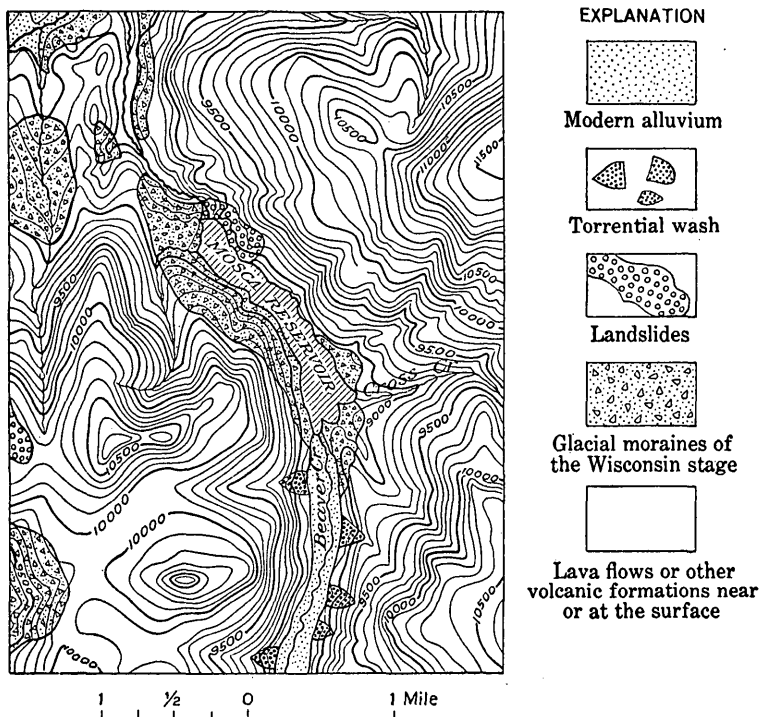
FIGURE 10.—Map of a part of the Creede quadrangle, showing the location and topographic relations of the Mosca reservoir and the distribution of the loose or unconsolidated formations within the area shown.

The essential causes of the failure of the Mosca reservoir to retain water are clearly the presence of the buried channel and the unusually high porosity of the sands and gravels that fill it. This porosity is shown by the fact that at the time of the examination the

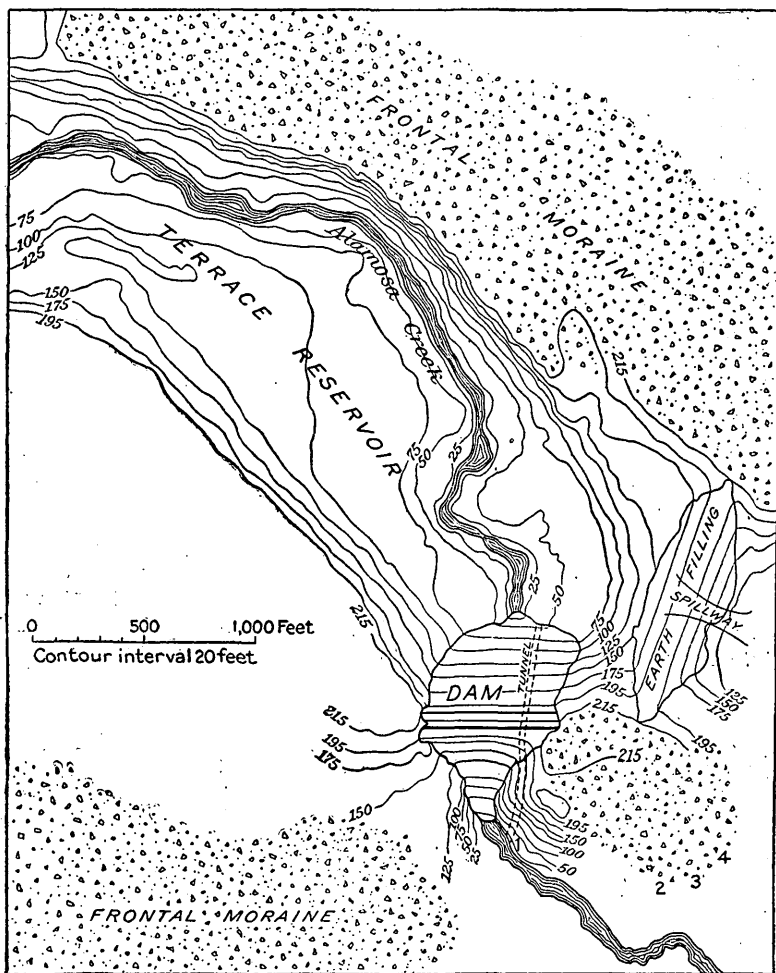
FIGURE 13.—Sketch map of the lower end of the Terrace reservoir, showing the general distribution of the frontal moraine that determined the location of the dam and reservoir site. 1, Lower-opening of tunnel; 2, 3, 4, seepage vents. Contours have been taken from a map in the office of the State engineer of Colorado.

This reservoir draws upon a large drainage area. Alamosa Creek and its tributaries head far back in the high mountain area to the west, and there is usually an abundance of water available. At points 2, 3, and 4 on figure 13 large leakages, which appear as springs on the

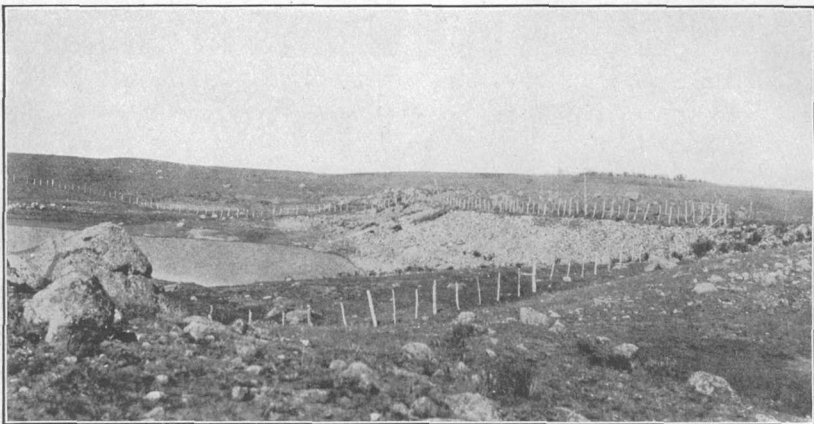
A. LA JARA RESERVOIR DAM.
Morainic material appears in the foreground.

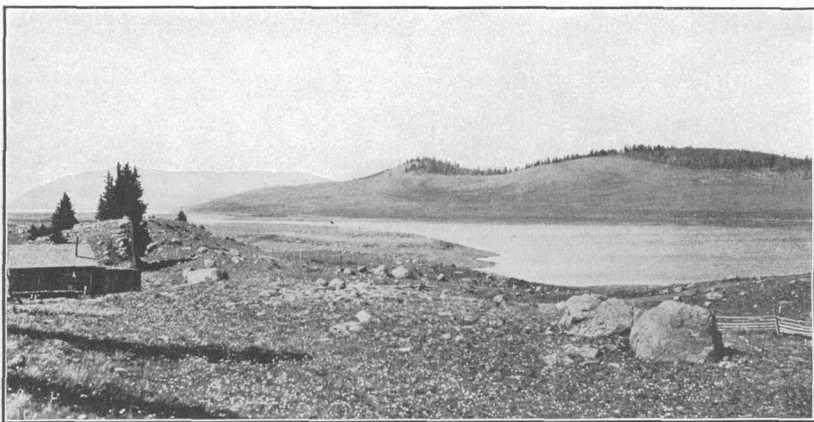
B. LA JARA RESERVOIR.
The moraine shows in the foreground. The distant hills are composed of lava flows.

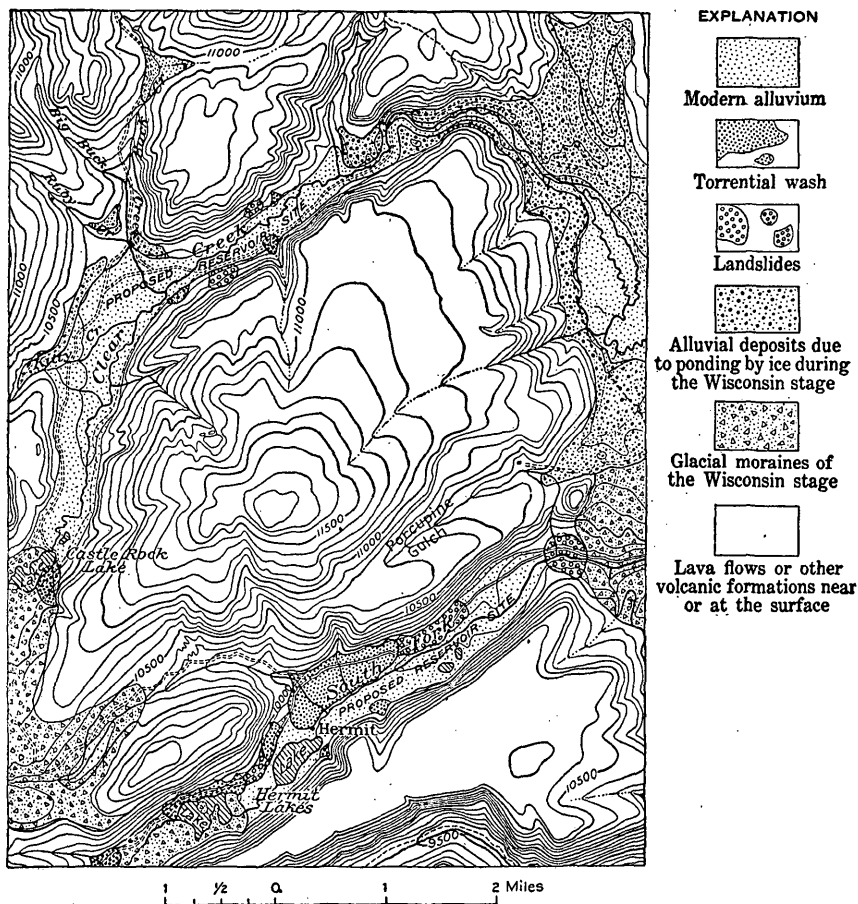
been thought of as a possible site for a dam, above which the waters would collect on the present meadows. This is a very unfortunate selection for a reservoir site, as the deposits at the proposed site are of glacial and landslide origin. It is extremely doubtful whether that material would hold in more than a low head of water. The fate of the Mosca reservoir, in the Creede quadrangle, should be a

FIGURE 17.—Map of a part of the San Cristobal quadrangle, showing the location and topographic relations of the proposed reservoir sites in Clear Creek and South Fork of Clear Creek and the distribution of the loose or unconsolidated formations within the area shown.

sufficient warning against undertaking a project under geologic conditions such as exist near the mouth of the South Fork of Clear Creek. Furthermore, the surplus waters of that fork are exceedingly small, and the project would certainly not justify large investments. Before construction work is begun a detailed geologic study should be made of the land immediately adjoining the proposed site for the dam.
