# **ANP District Headquarters Facilities in Helmand and Kandahar Provinces Have Significant Construction Deficiencies Due to Lack of Oversight and Poor Contractor Performance**

SIGAR Audit-11-3

## ANP District Headquarters Facilities In Helmand and Kandahar Provinces Have Significant Deficiencies Due to Lack of Oversight and Poor Contractor Performance

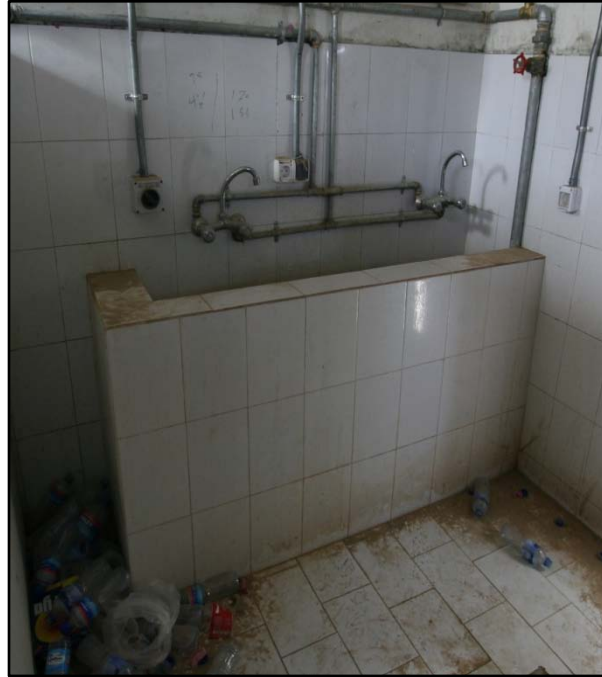
**Photo16: Properly Constructed Trough-Style Sink at Nad Ali Site**

The contract and construction documents specify that sinks throughout the project are to be trough-type sinks constructed of concrete blocks with a tile exterior; however, at 4 of the 6 sites, residential-grade porcelain sinks were substituted. AED estimated that it will require approximately \$30,000 to correct this deficiency. According to USACE officials, Afghan men often stand or sit on the sink to wash their feet, frequently breaking the porcelain pedestal sinks installed in ANP facilities. Photo 15 shows an unauthorized residential-grade porcelain sink and photo 16 shows a properly constructed trough-style sink at Nad Ali.
