# **NATIONAL BUREAU OF STANDARDS REPORT**

5223

## **SUMMARY REPORT - VAPOR BARRIER INVESTIGATION**

Thule and Sondrestrom Air Force Bases, Greenland

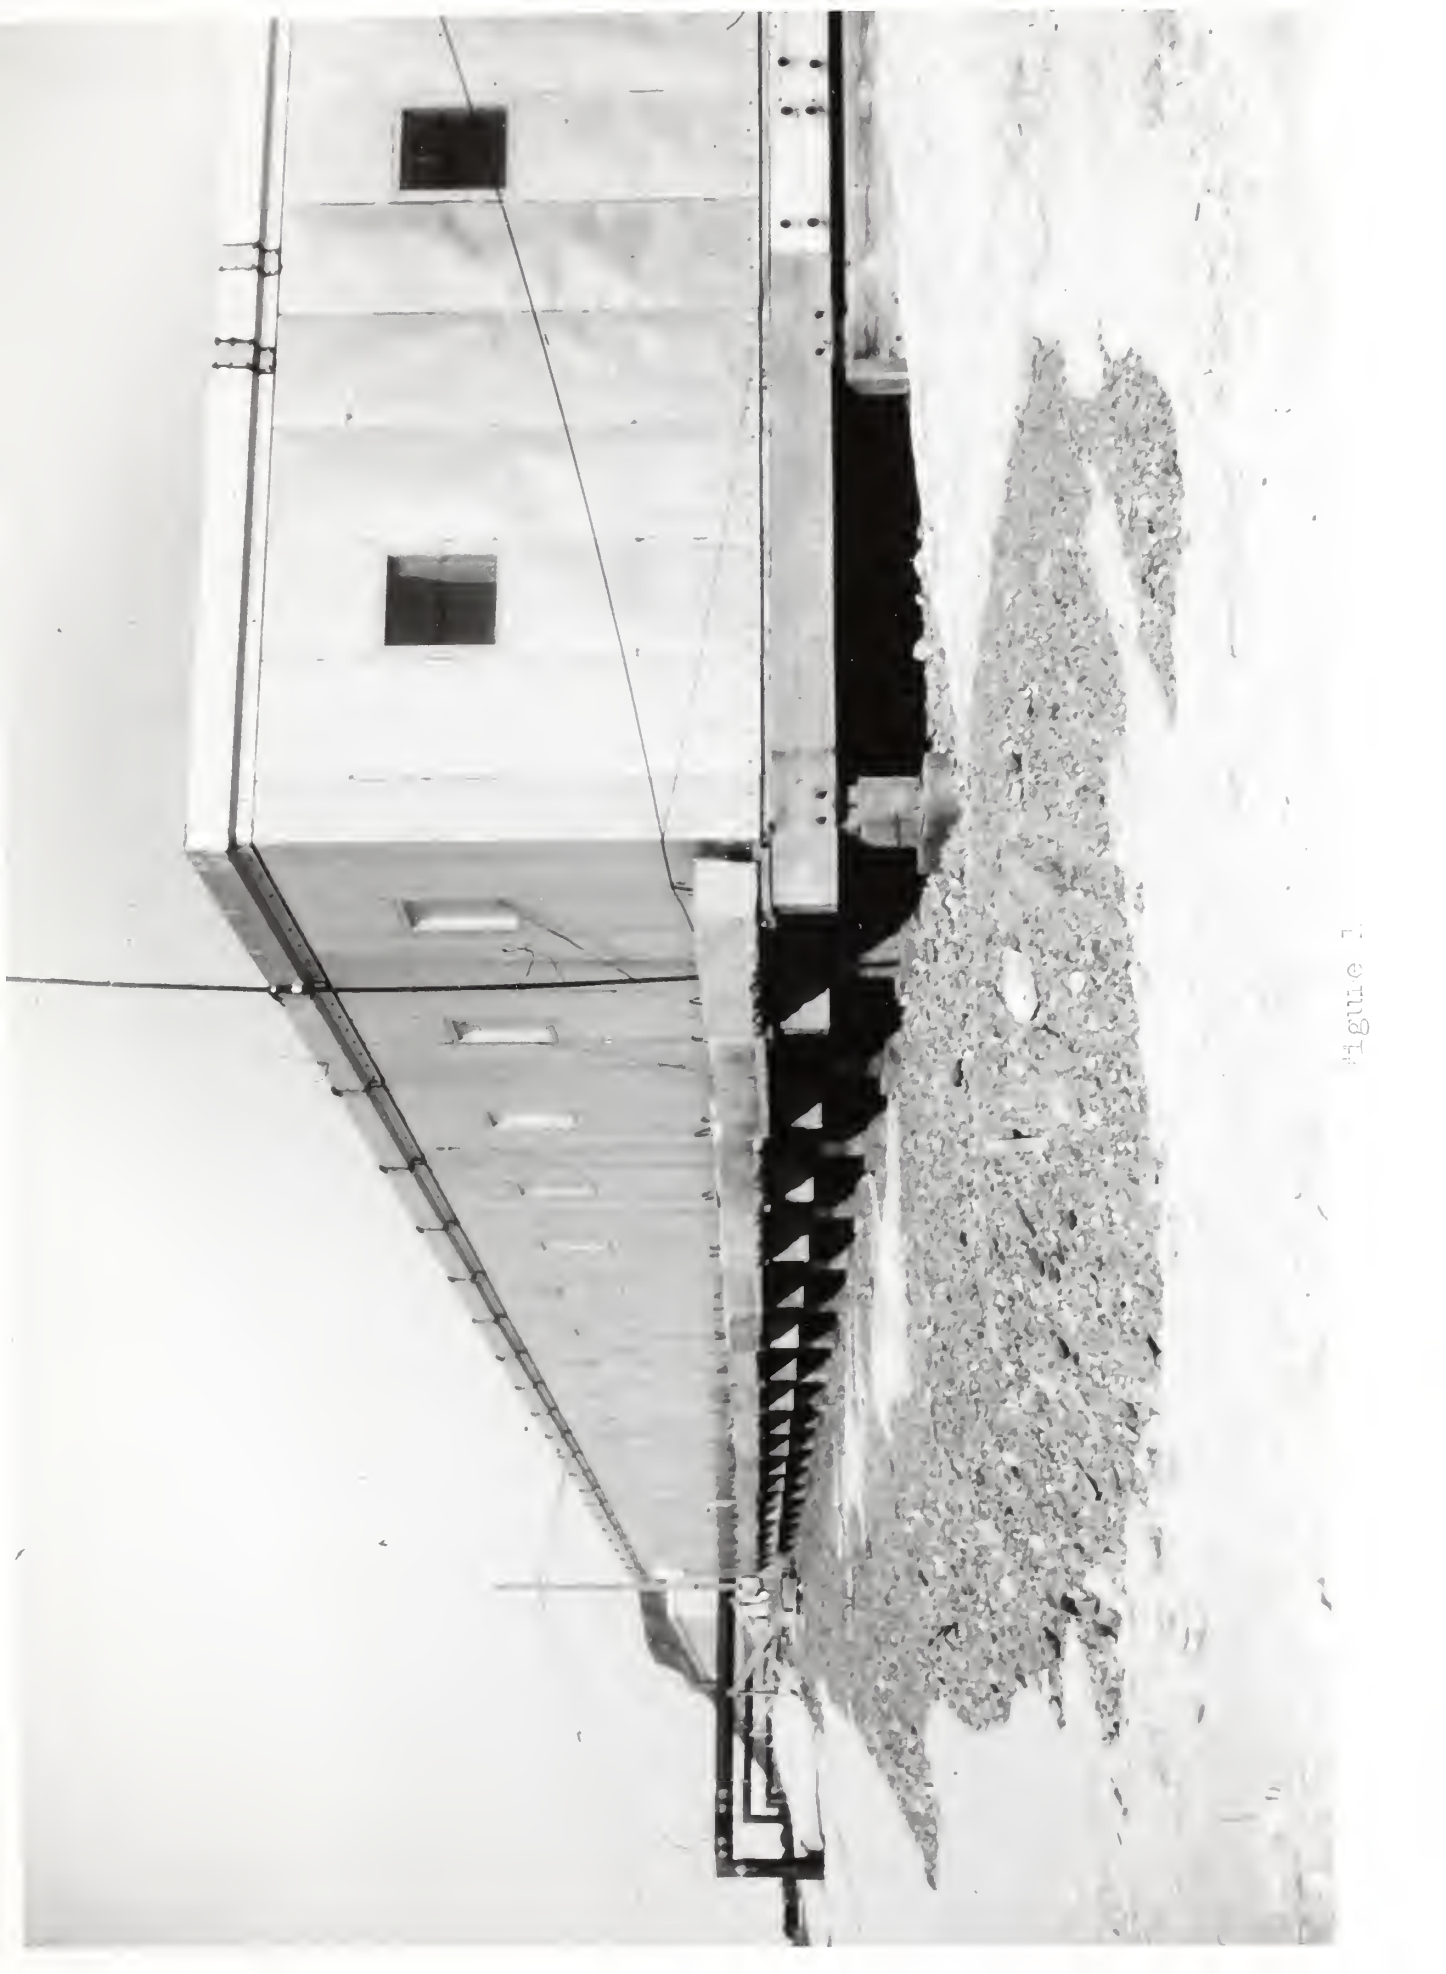
Figure 1

#### 1. No. 1 (See Figure 1).

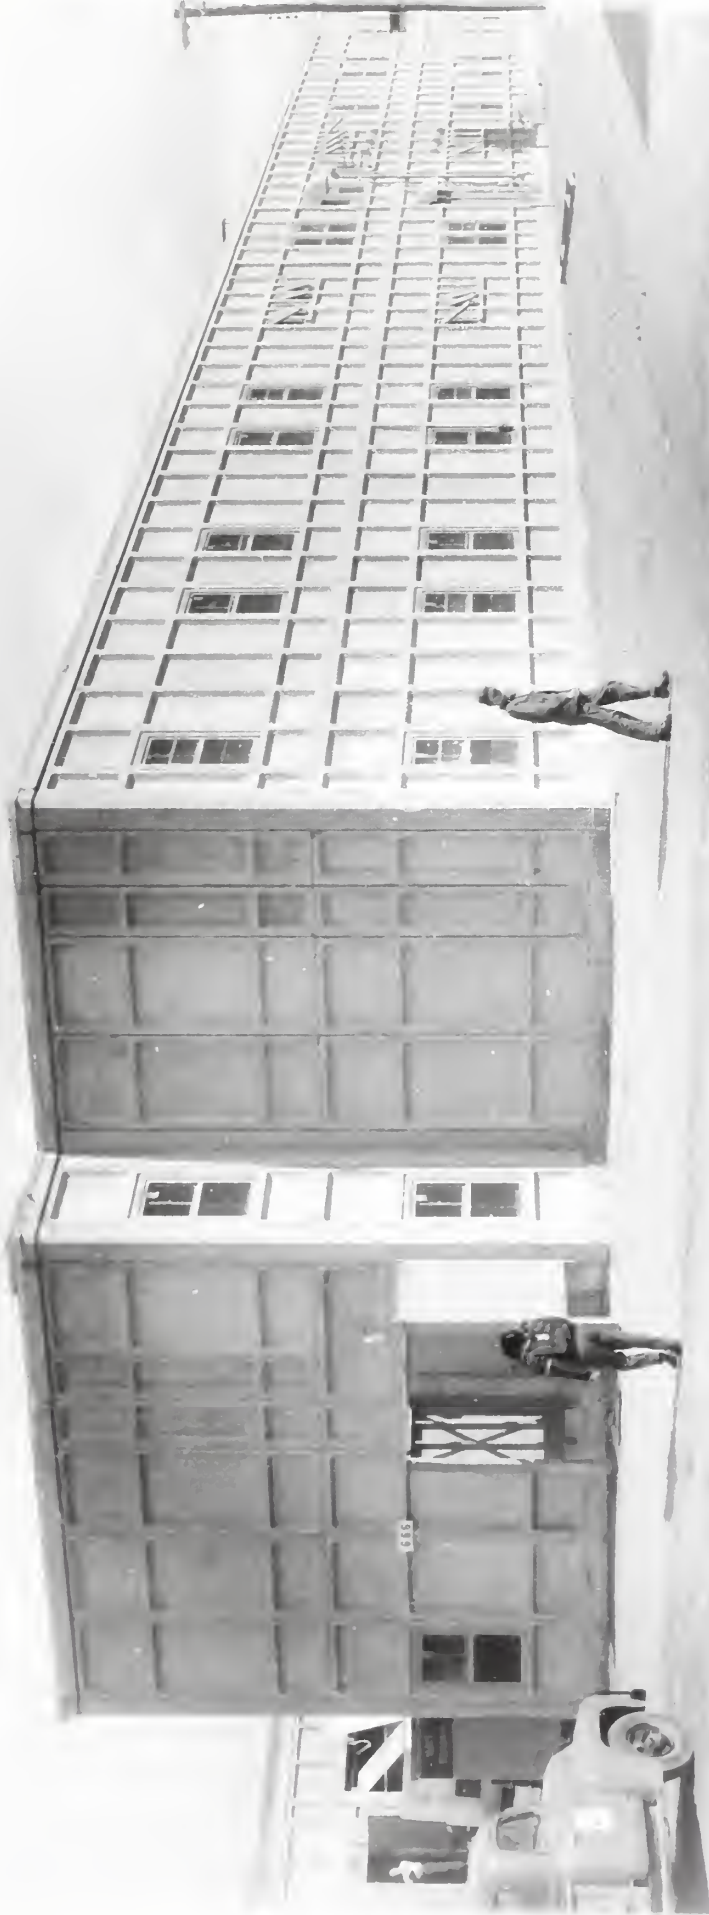
Figure 2

## 2. No. 2 (See Figure 2).

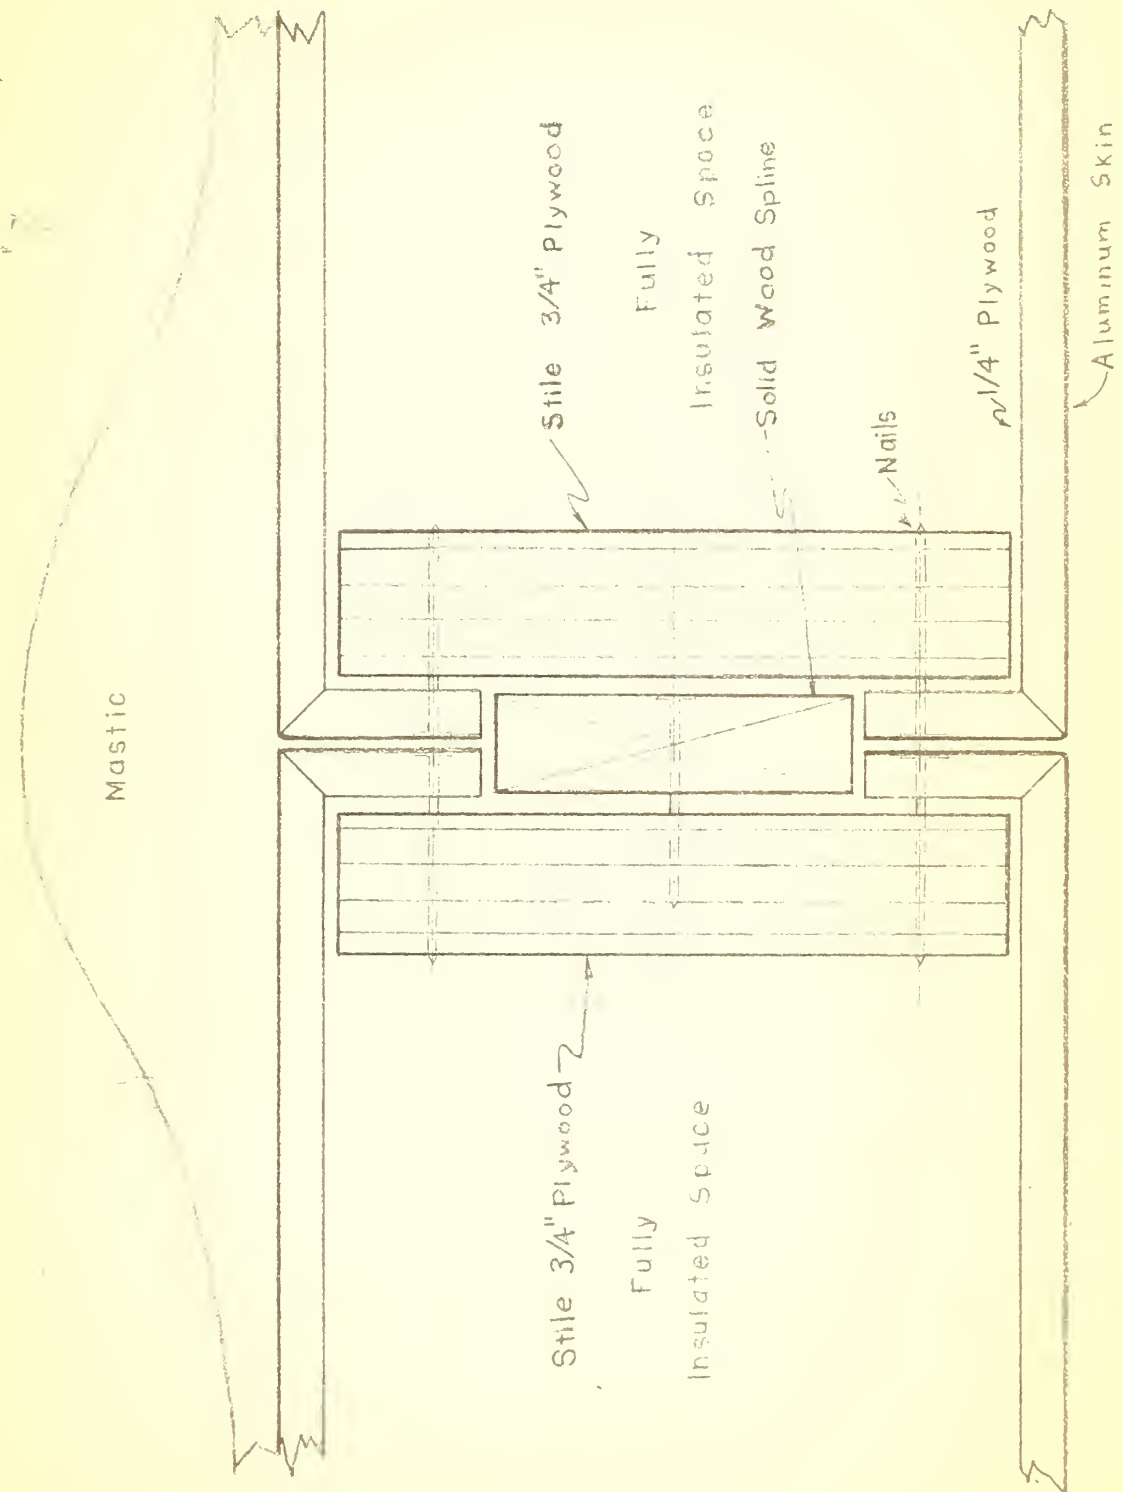
Figure 6

Panel Joint, Building Type No.1, Exploded View

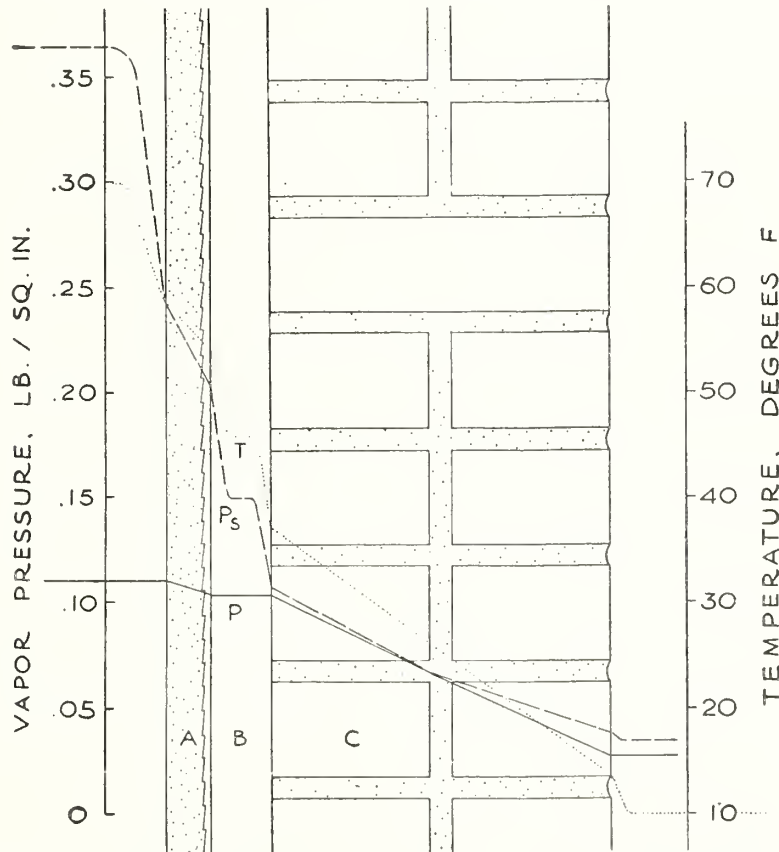
FIGURE 1.—Nature of the temperature, corresponding saturation vapor pressure, and actual vapor pressure distributions in an uninsulated brick wall.

Wall composed of A/plaster on metal lath; B, air space between furring strips; and C, brick, exposed to 70° F and 30-percent relative humidity indoors and 10° F and 80-percent relative humidity outdoors.

1. A brick wall composed of metal lath and plaster, air space between furring strips, common and face brick is exposed to 70° F and 30-percent relative humidity indoors and 10° F and 80-percent relative humidity outdoors. A section of this wall is pictured in figure 1 with curves showing the nature of vapor-pressure and temperature distributions within the wall. To determine whether condensation will occur on the inner surface of the brick, data on vapor resistance and thermal resistance of the various parts of the wall are examined.<sup>2</sup>

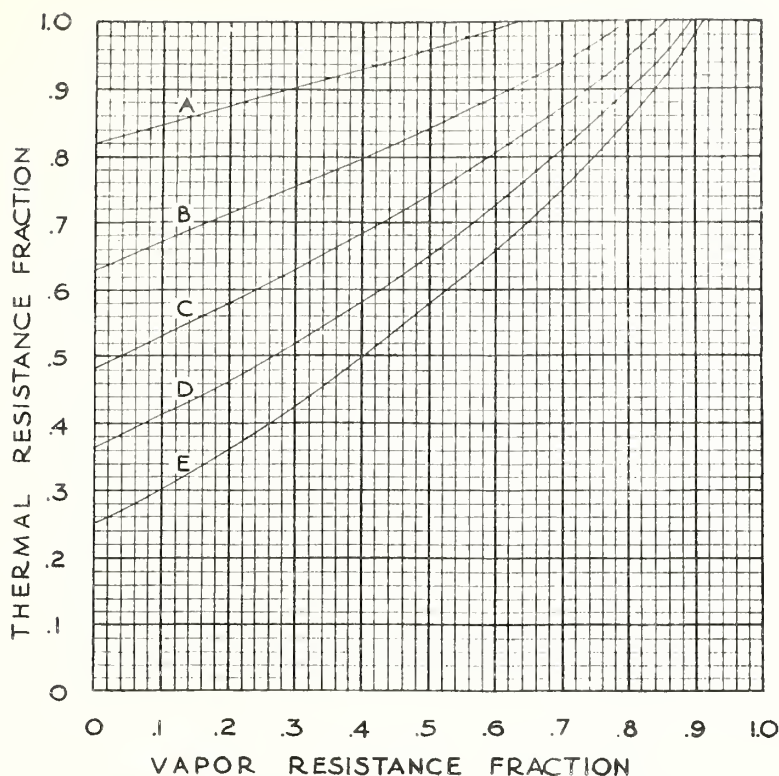
FIGURE 2.—Indoor relative humidity able to cause condensation at a given point in a wall, as determined by the thermal-resistance fraction and the vapor-resistance fraction.

Thus one may consider the case of a wall the thermal-resistance fraction of which is 0.50 and the vapor-resistance fraction 0.13. Figure 2 shows that a relative humidity of about 54 percent or more indoors could lead to condensation when the outdoor temperature is 30° F. Figure 3 indicates about 38 percent for a temperature of 10° F, and figure 4 indicates about 26 percent for an outdoor temperature of -10° F. These results would doubtless be consider-

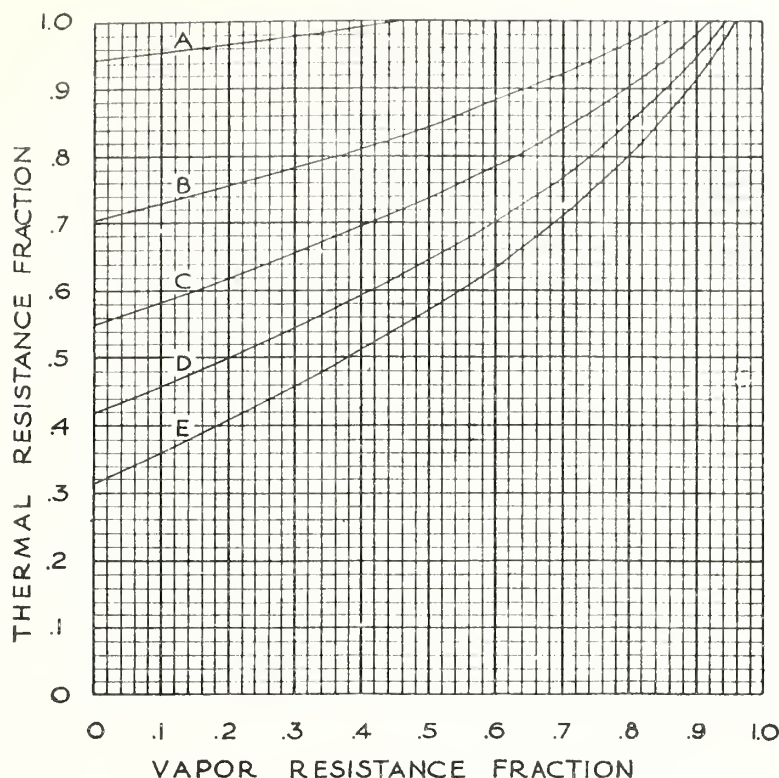
FIGURE 3.—Indoor relative humidity able to cause condensation at a given point in a wall, as determined by the thermal-resistance fraction and the vapor-resistance fraction.

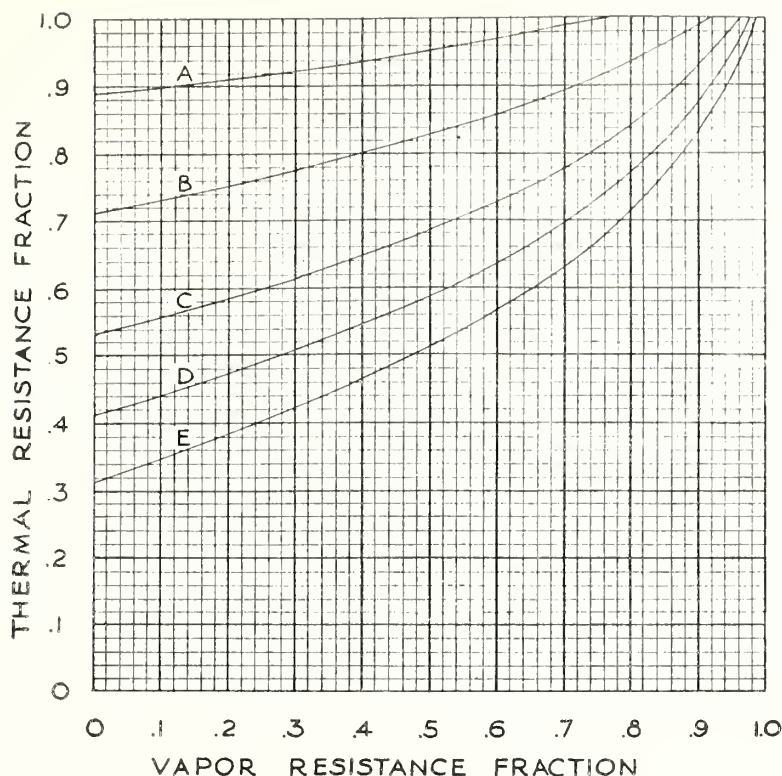
FIGURE 4.—Indoor relative humidity able to cause condensation at a given point in a wall, as determined by the thermal-resistance fraction and the vapor-resistance fraction.

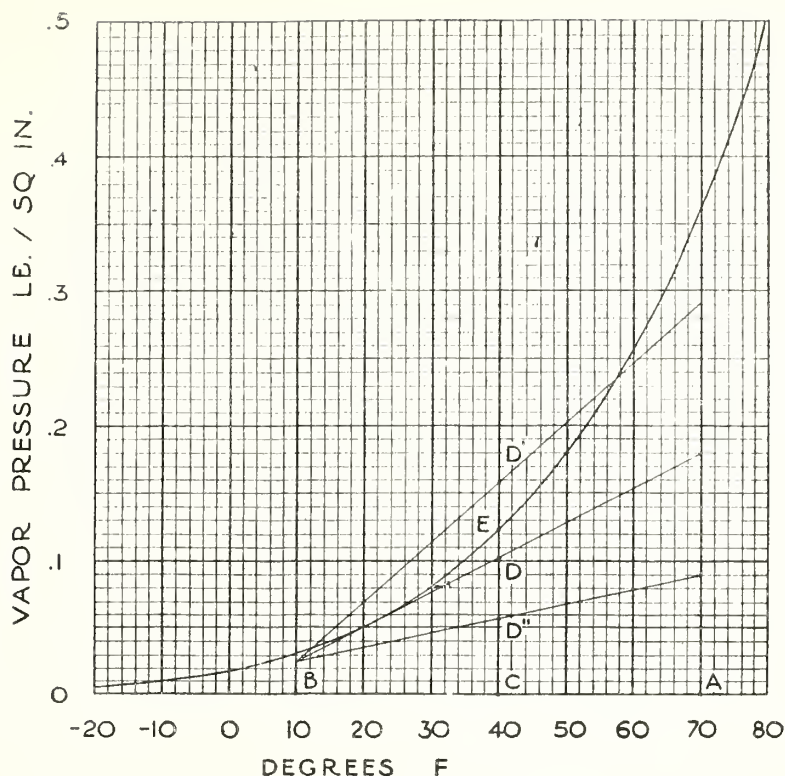
has been established. The vapor-pressure drop is then uniformly distributed across the material in the same manner as is the temperature drop. This may be illustrated by figure 5 in which the temperature is indicated at uniform intervals along a horizontal axis. This may be considered the direction across the layer of material having uniform spacing of insulation of uniform thermal resistance or at least uniform sections of the total thermal resistance of the material. The two surfaces of the material are then located on this scale by their corresponding temperatures. Plotted vertically are the saturation pressures for water vapor corresponding to all temperatures along the horizontal axis. If the actual vapor pressures at the two surfaces are now plotted for their positions as indicated on the temperature scale, for example A and B, the vapor pressure at any point between will be indicated by the distance vertically upward to the straight line between them. As examples, three cases have

FIGURE 5.—Method of predicting vapor pressure conditions in a wall composed of a single slab of permeable material. 80-percent outside humidity (at B);  $D'$ , line for 80-percent humidity inside (at A);  $D$ , line for 50-percent humidity inside (at A);  $D''$ , line for 25-percent humidity inside (at A); straight lines, actual vapor pressures; and curve, saturation vapor pressures.
